# TV RECEPTION SURVEY REPORT

**DATE OF SURVEY:** 21<sup>st</sup> November 2022  
**REF NO:** TBAER024

**THE DEVELOPMENT:**

103 Rochdale Road  
Manchester

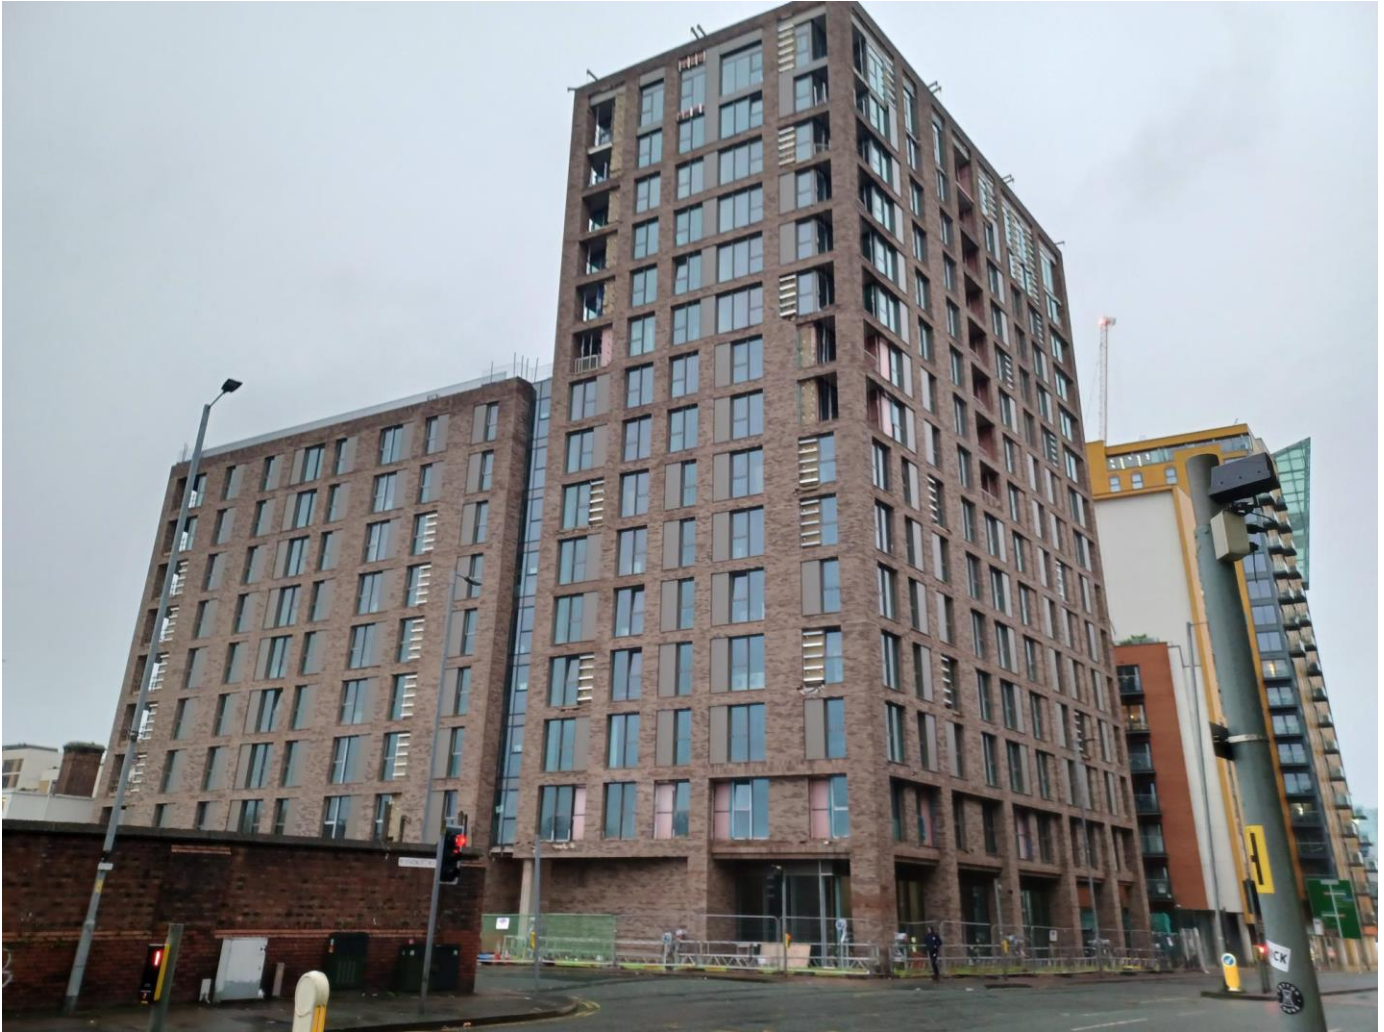
**PHOTO A: The new development**

The development is a new build, of 15 storeys at the location of 103 Rochdale Rd

Building Height: The development is to have varying heights but with a maximum elevation of 15 storeys, including ground floor, (maximum height 49.8m).
