Design & Heritage Statement (P0224\_HS\_REP001)

Clayton Hall, Manchester

Security Installation & Fabric Repairs

Doc No: P0224\_HS\_REP001  
Issue: FOR CONSENT  
Rev: -  
Date: SEPT 2022

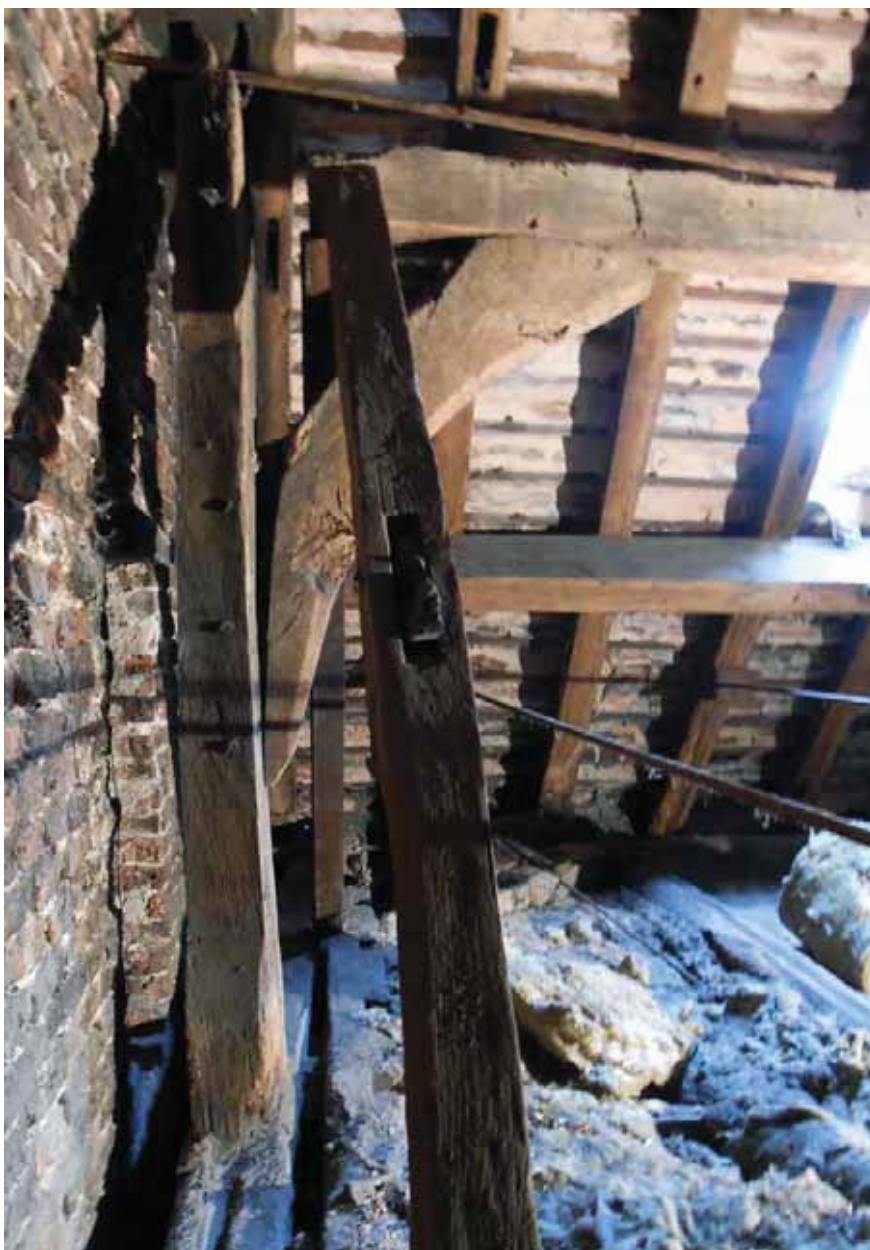
Plate 36. Bay 2, roof space, remains of northernmost crown post truss, viewed from west.

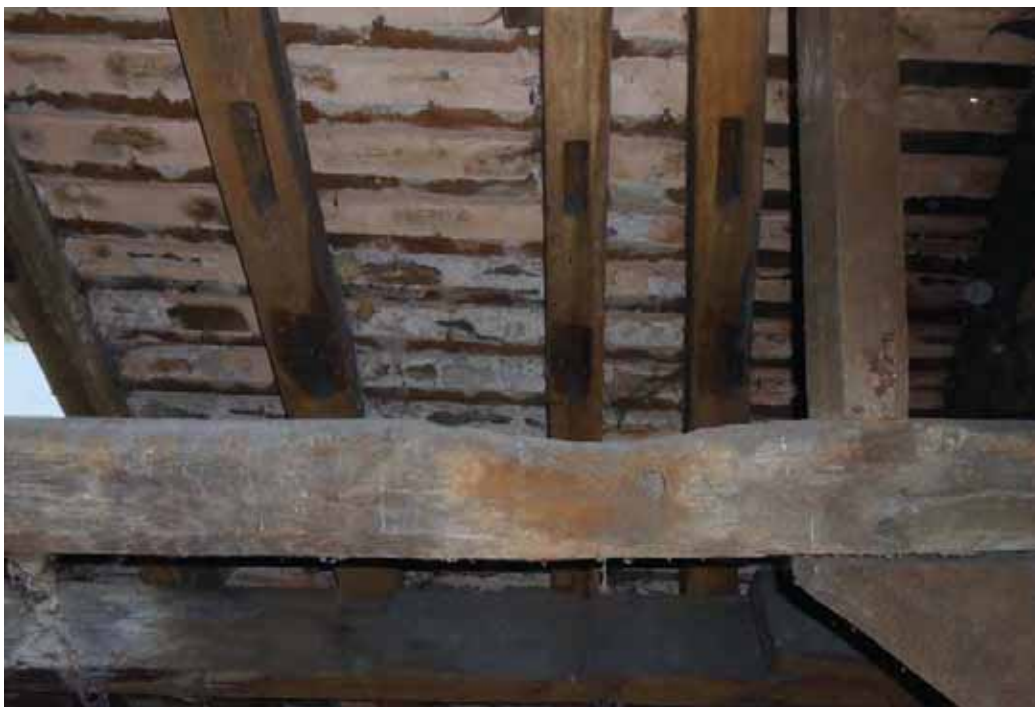
Plate 37. Bay 2, roof space, crown plate and double mortices to rafters, viewed from west.

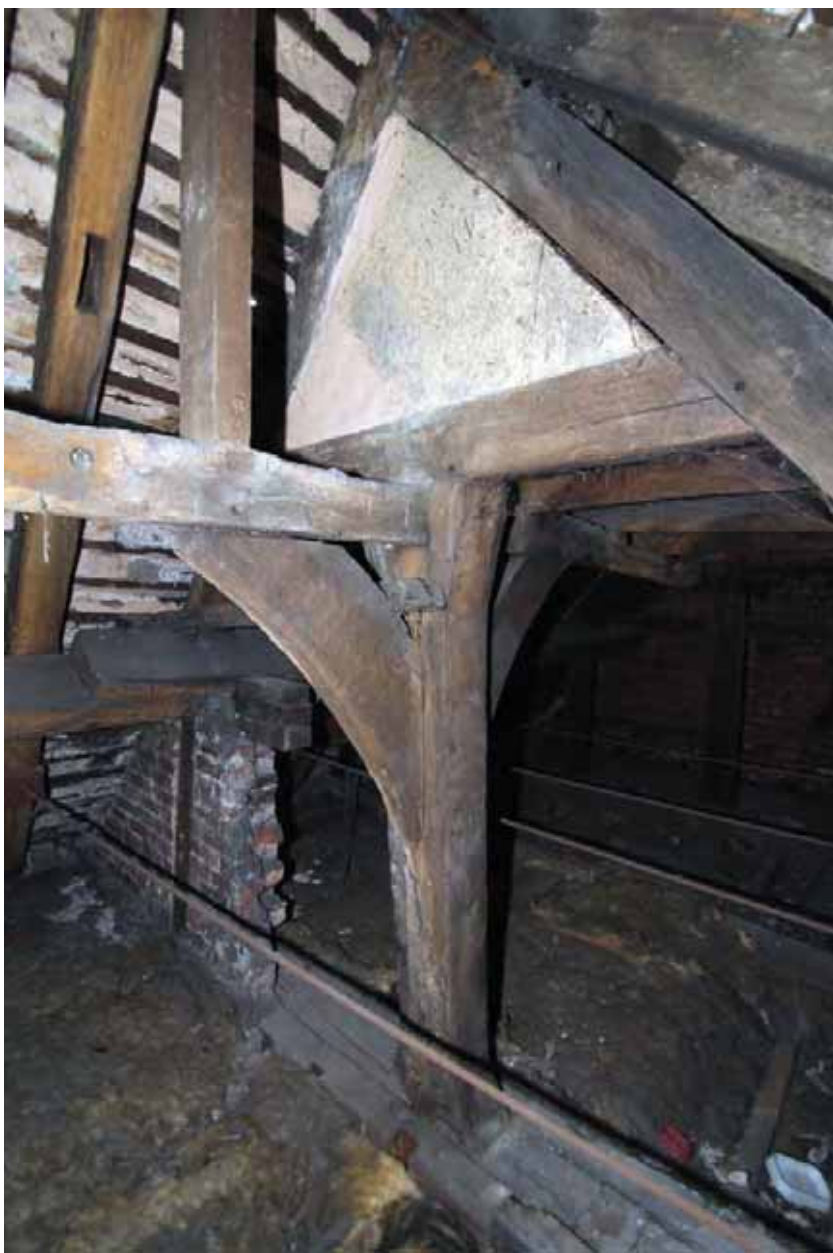
Plate 38. Bay 2, roof space, general view of central crown post truss, viewed from north-west.

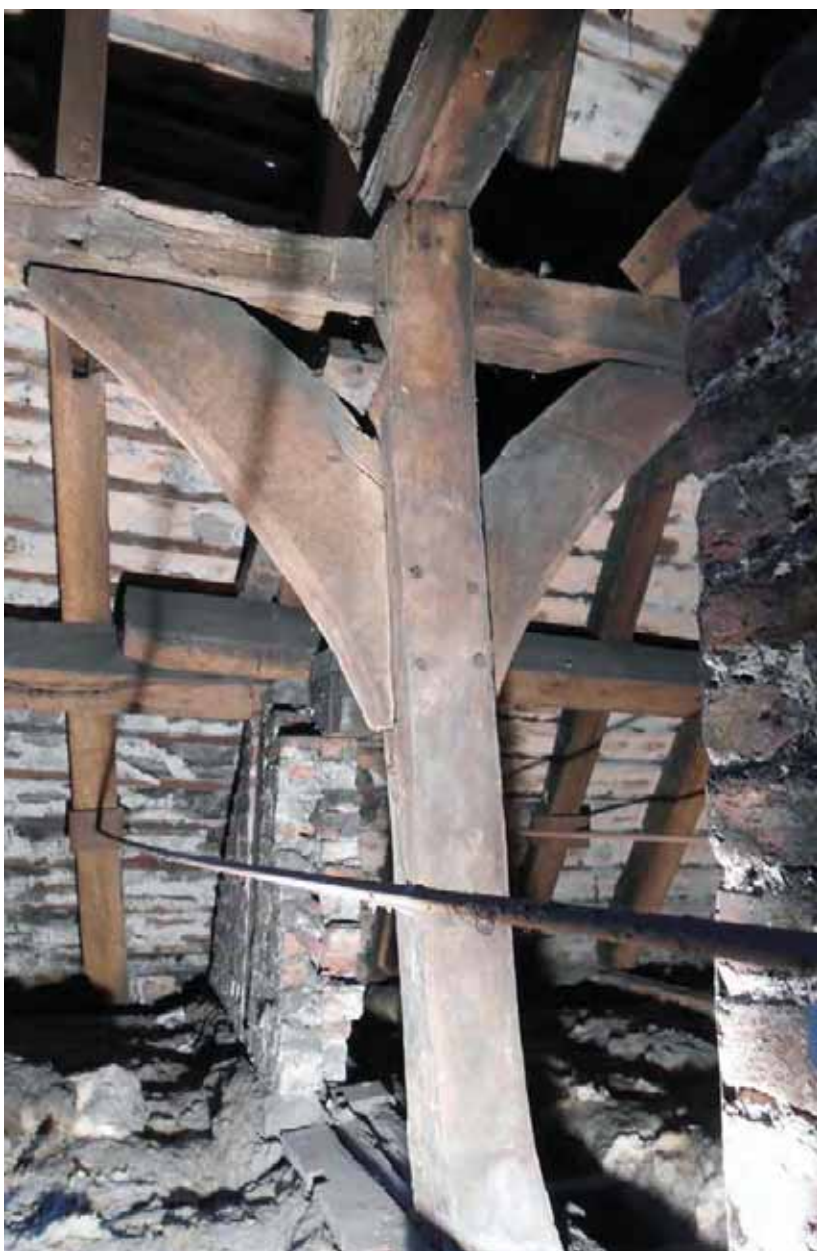
Plate 39. Bay 2, roof space, central crown post, viewed from west.

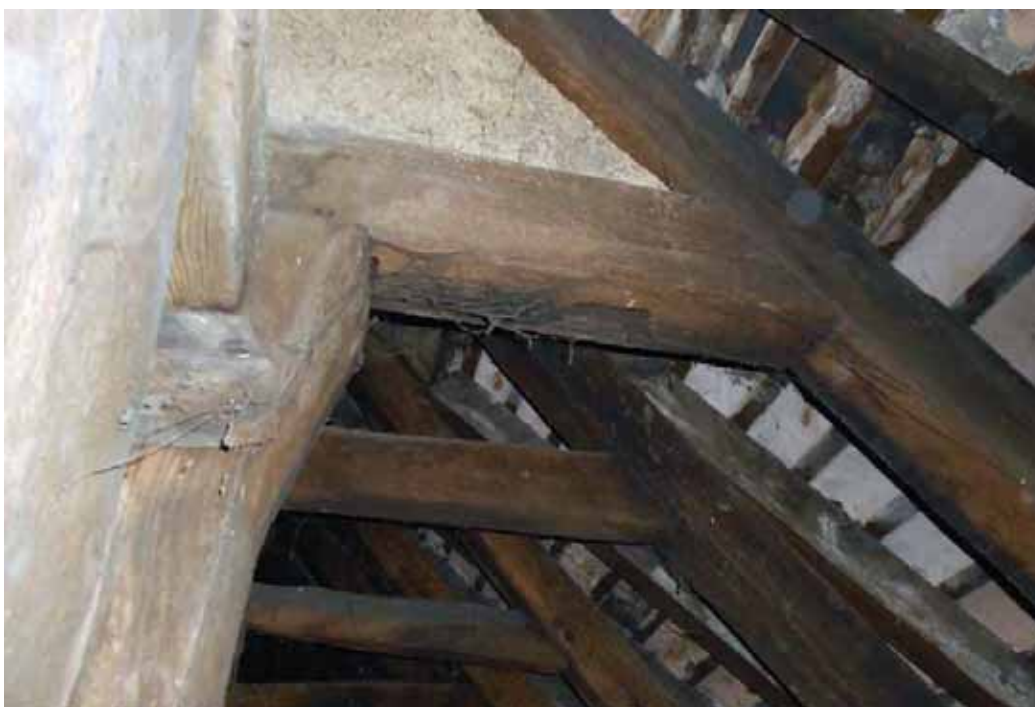
Plate 40. Bay 2, roof space, viewed from north, detail of collar on central truss, showing stave hole in soffit.

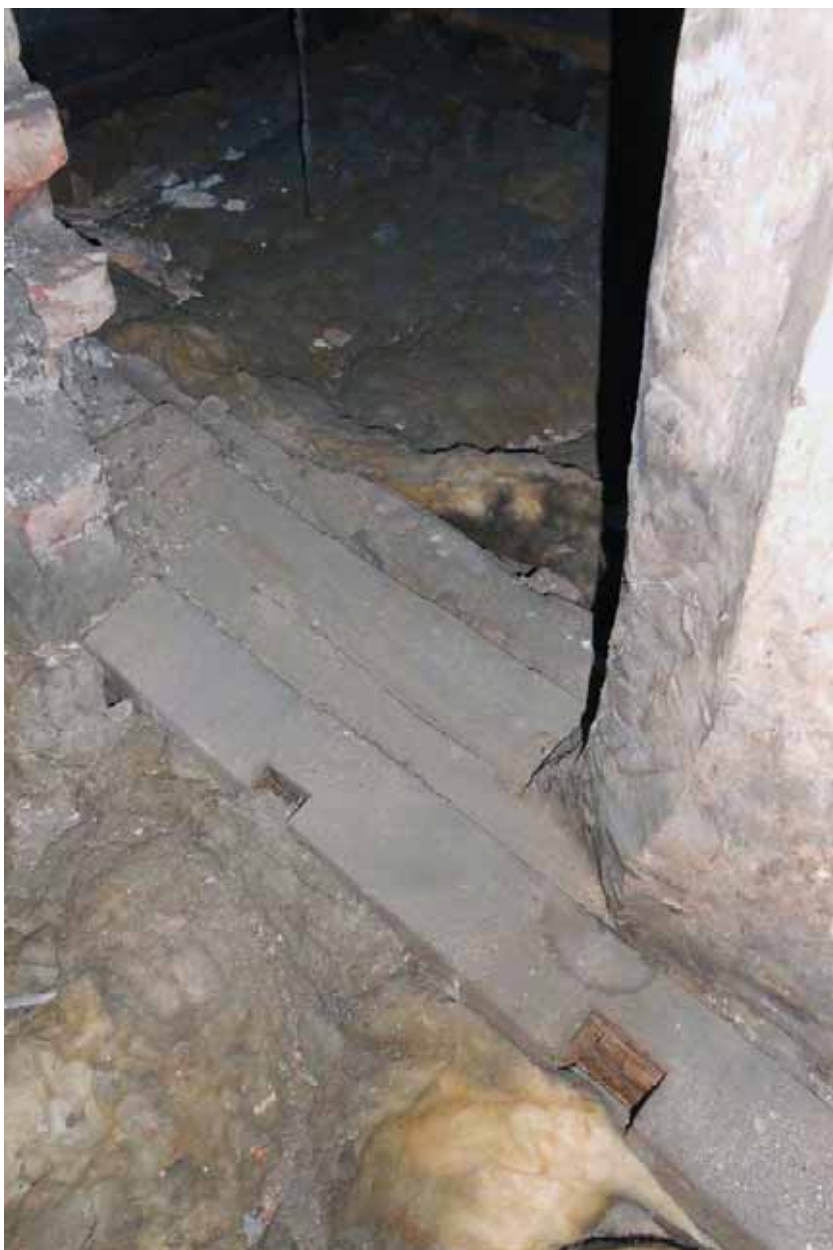
Plate 41. Bay 2, roof space, viewed from north-west, detail of collar (central truss) showing stave groove.

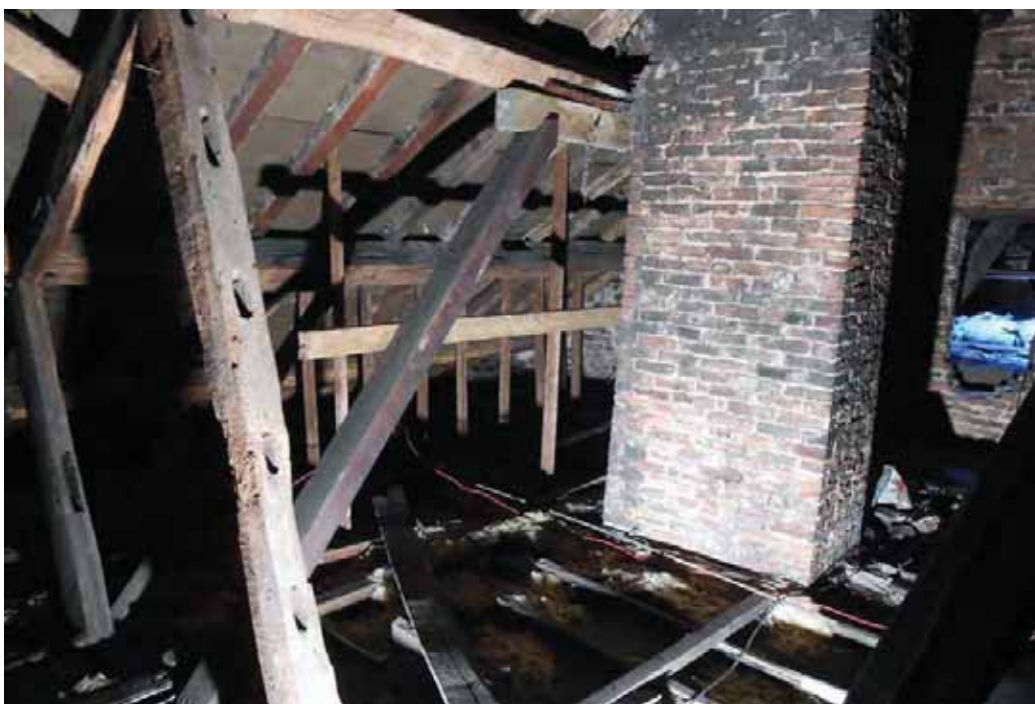
Plate 45. Brick house, bay 3, roof structure and south stack, viewed from north-west.

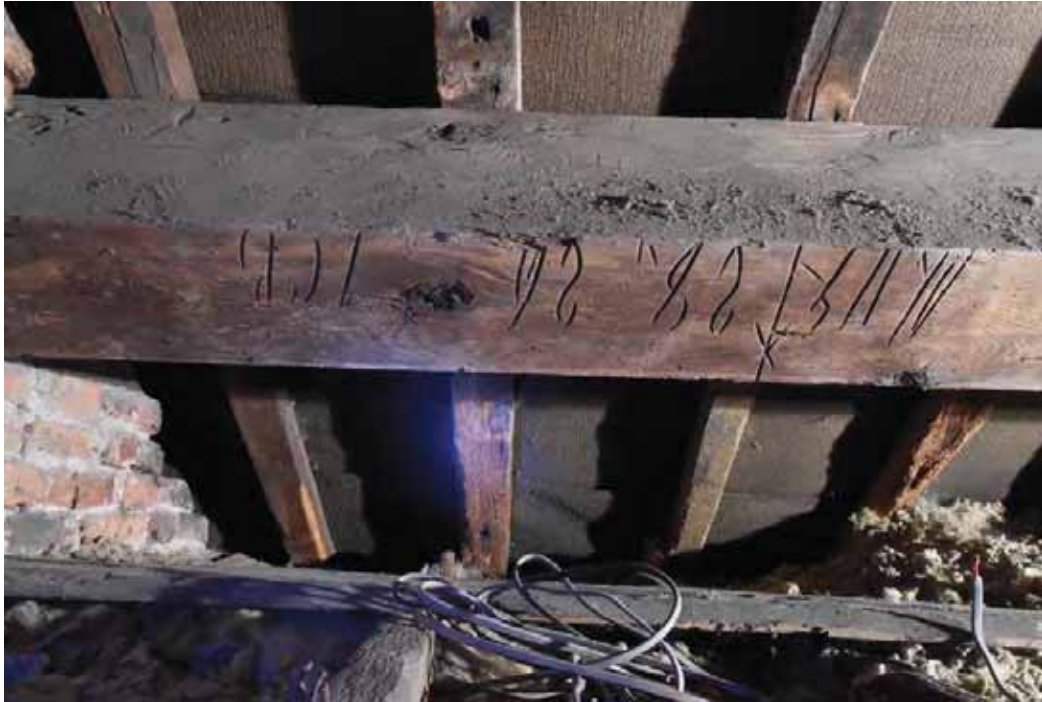
Plate 46. Brick house, bay 4, Baltic timber marks on easternmost purlin.

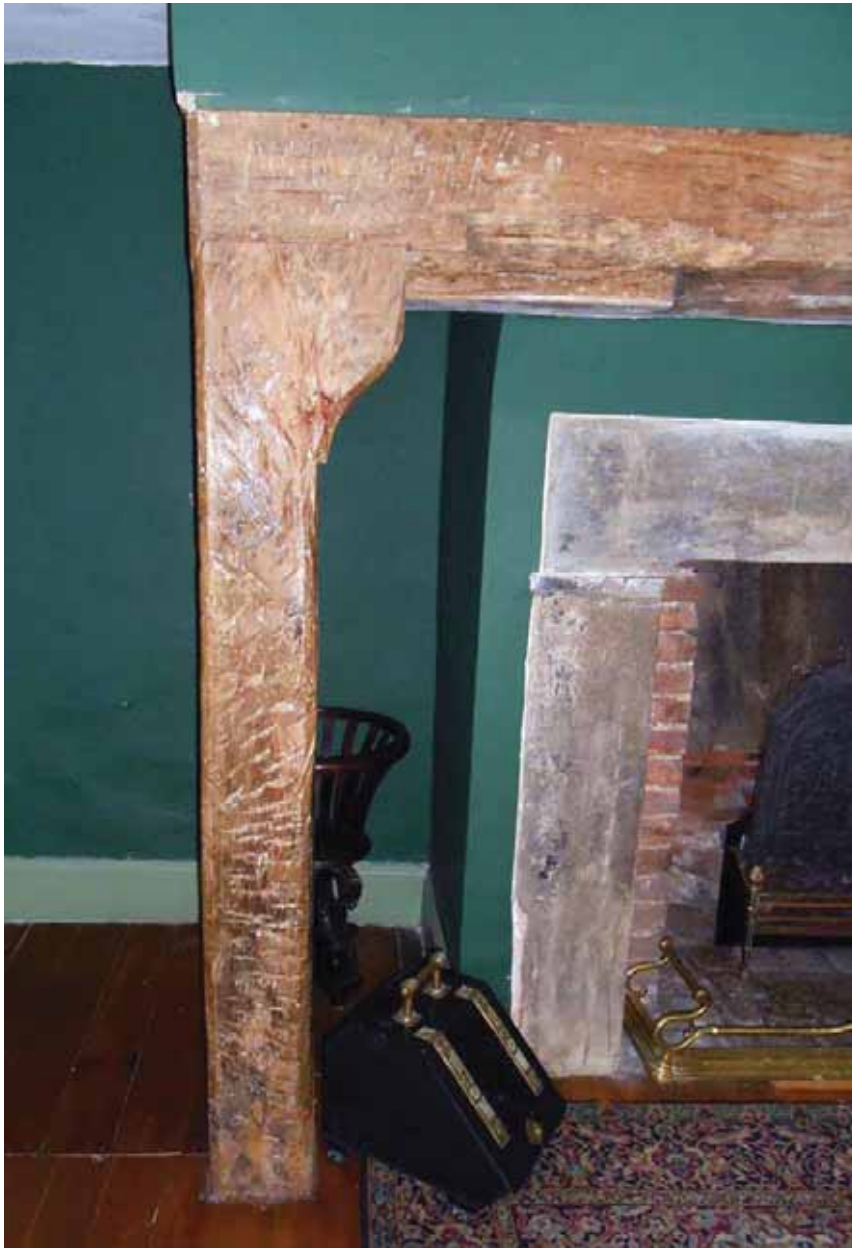
Plate 54. Brick house, ground floor, dining room, heck post, viewed from west.

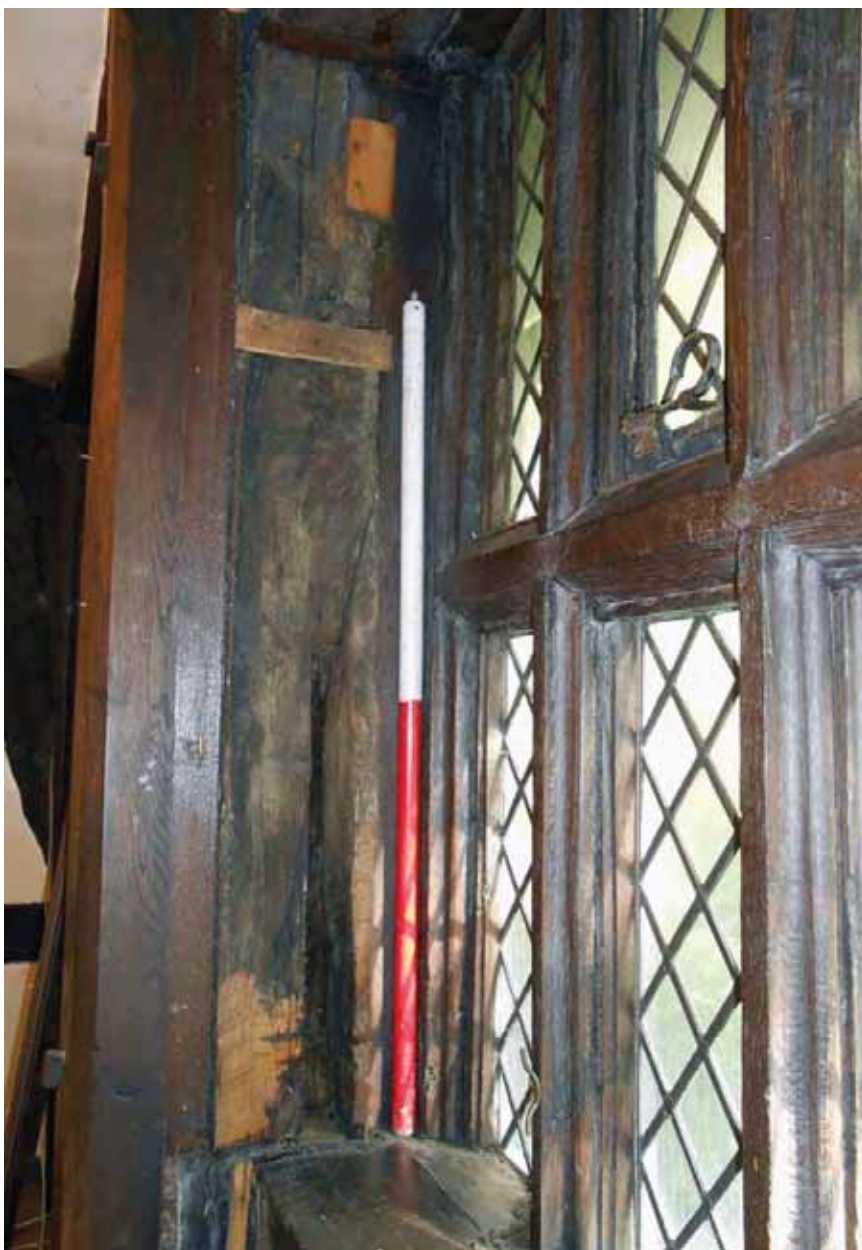
Plate 71. Watching brief, first floor, bedroom 1, east wall, intermediate post, viewed from south.

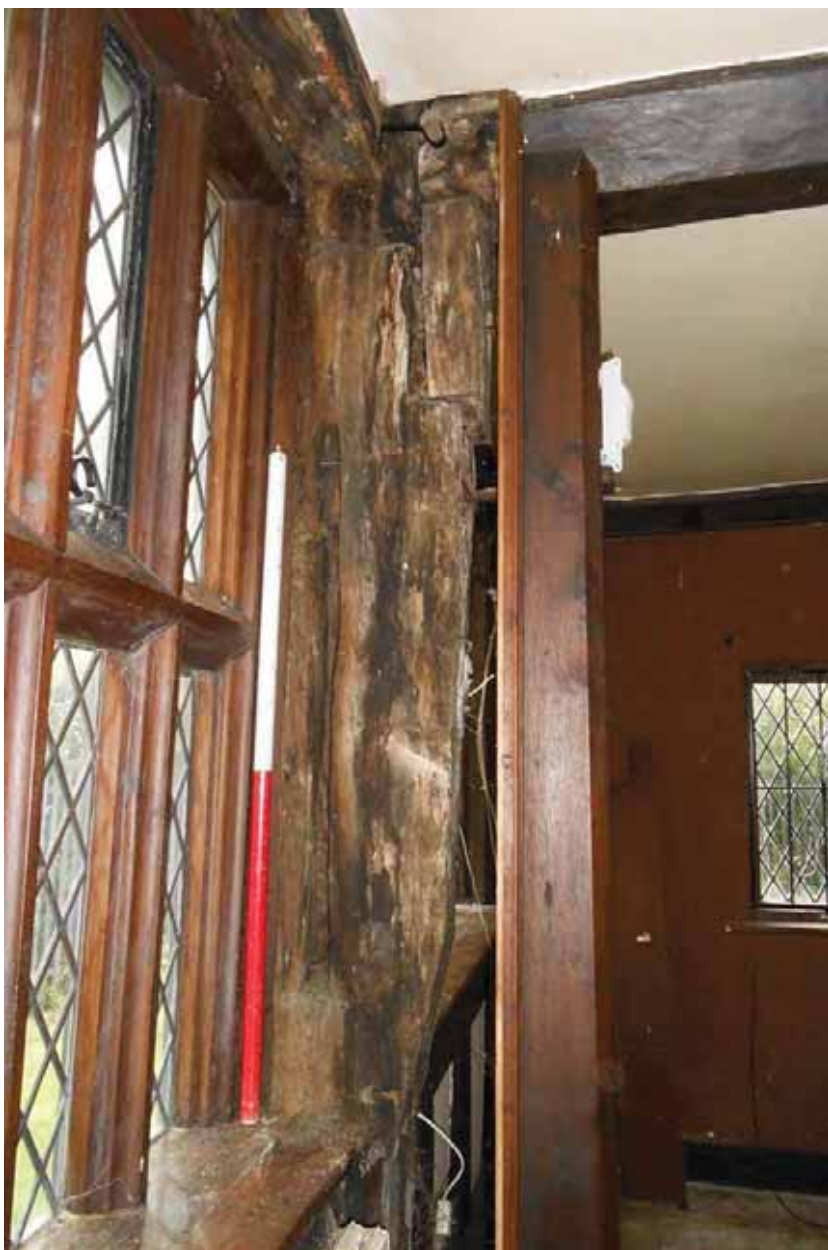
Plate 72. Watching brief, ground floor, bay 1, east wall, intermediate post, viewed from north.

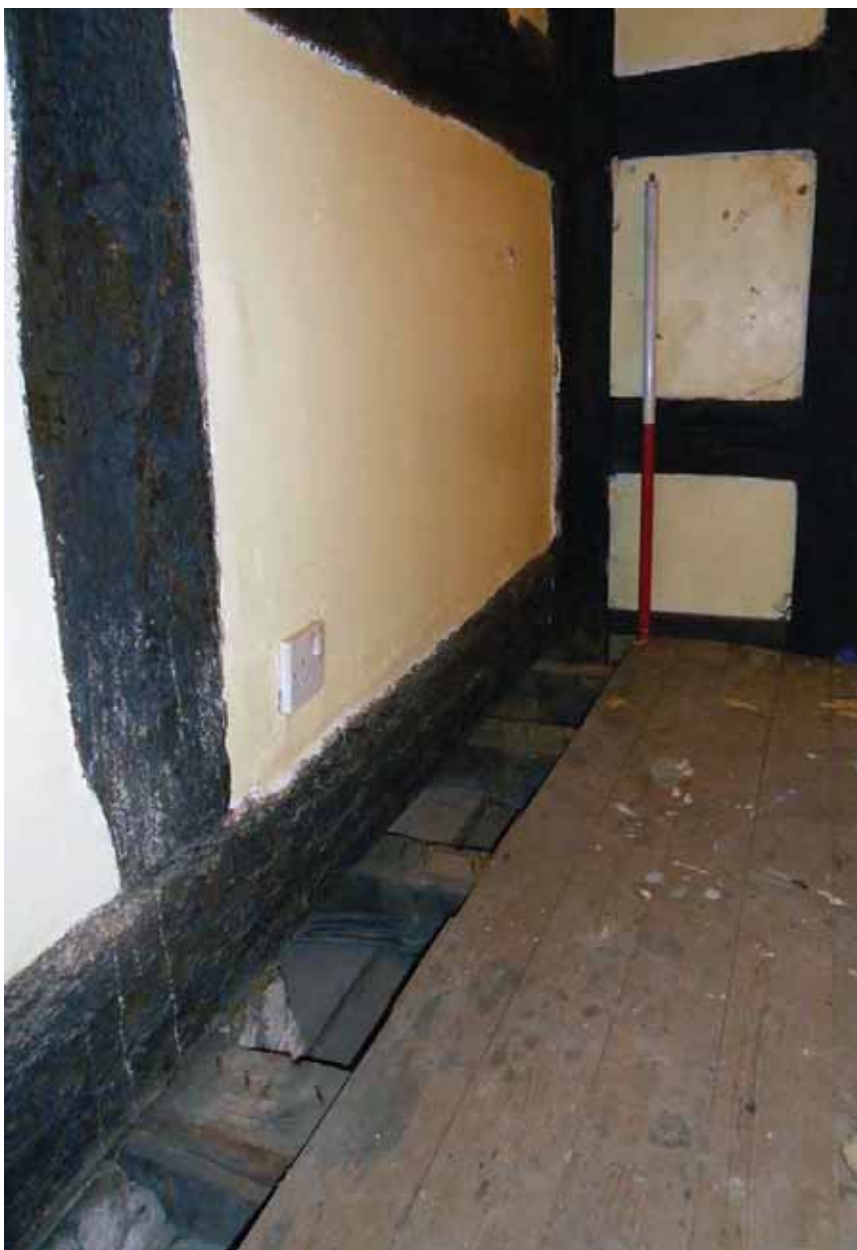
Plate 73. Watching brief, first floor, bedroom 2, north wall, detail of inserted floor.

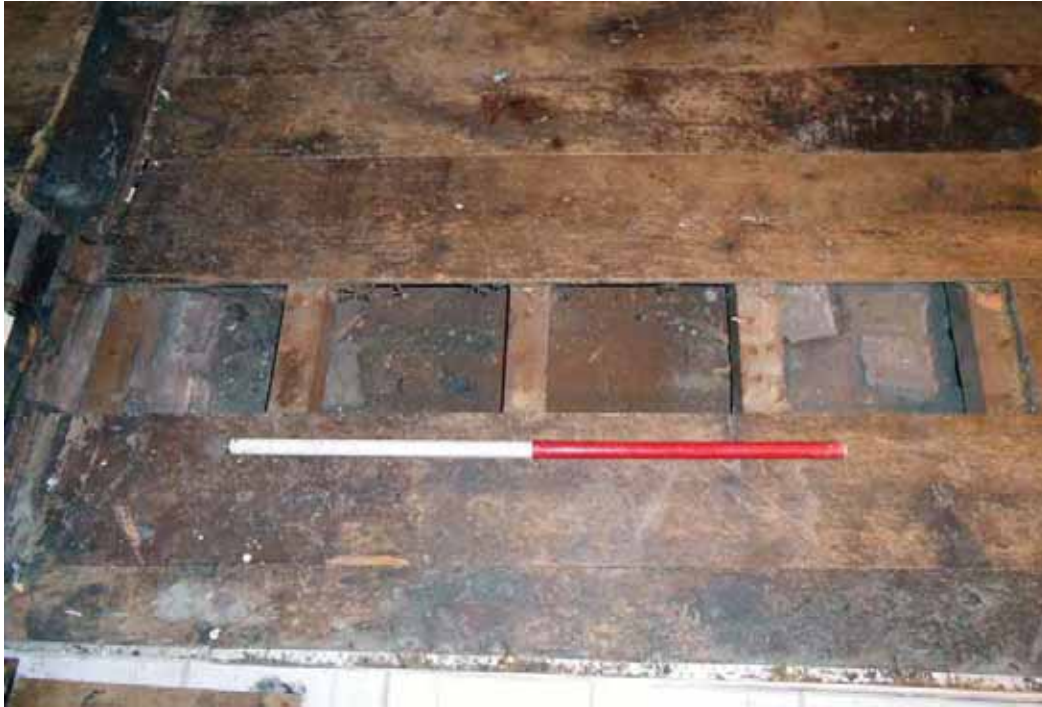
Plate 74. Watching brief, ground floor, bay 2, remains of fireplace below the raised timber floor.

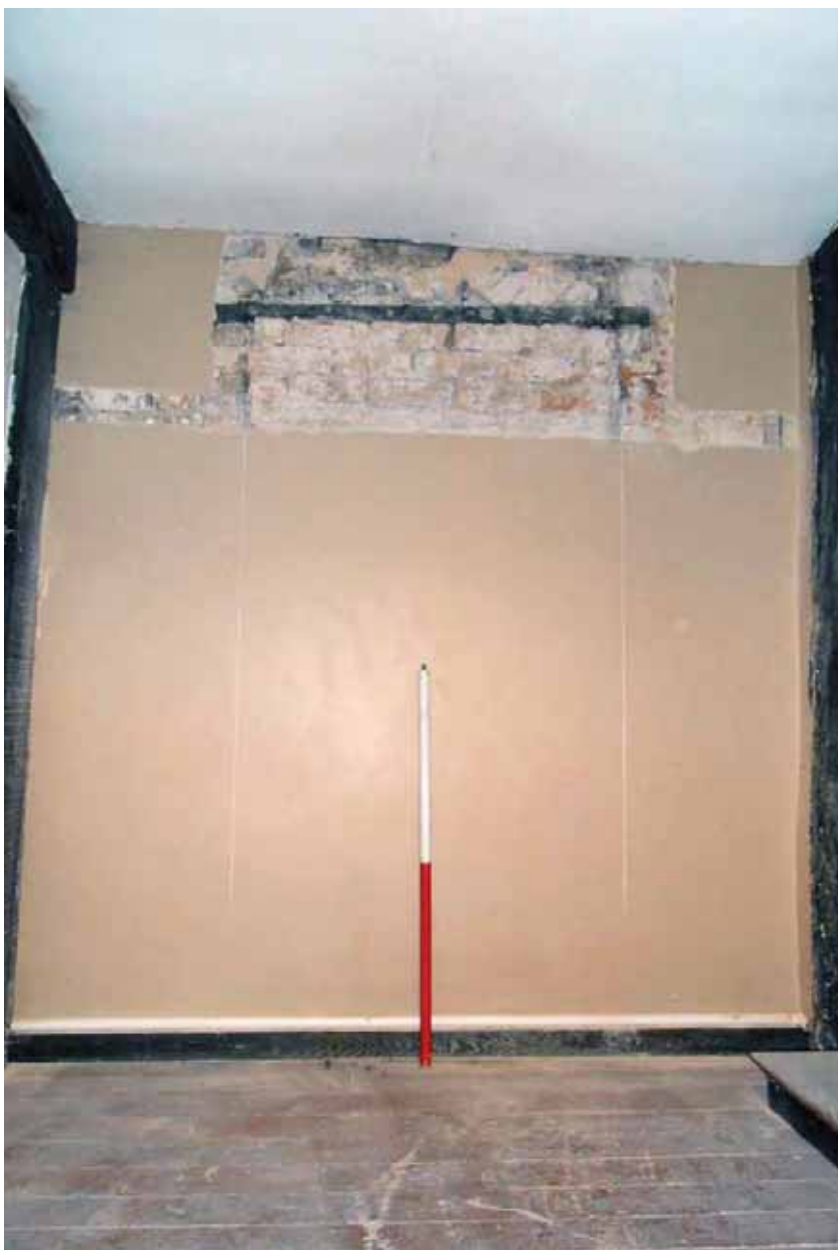
Plate 75. Watching brief, blocked doorway at north end of first floor corridor.

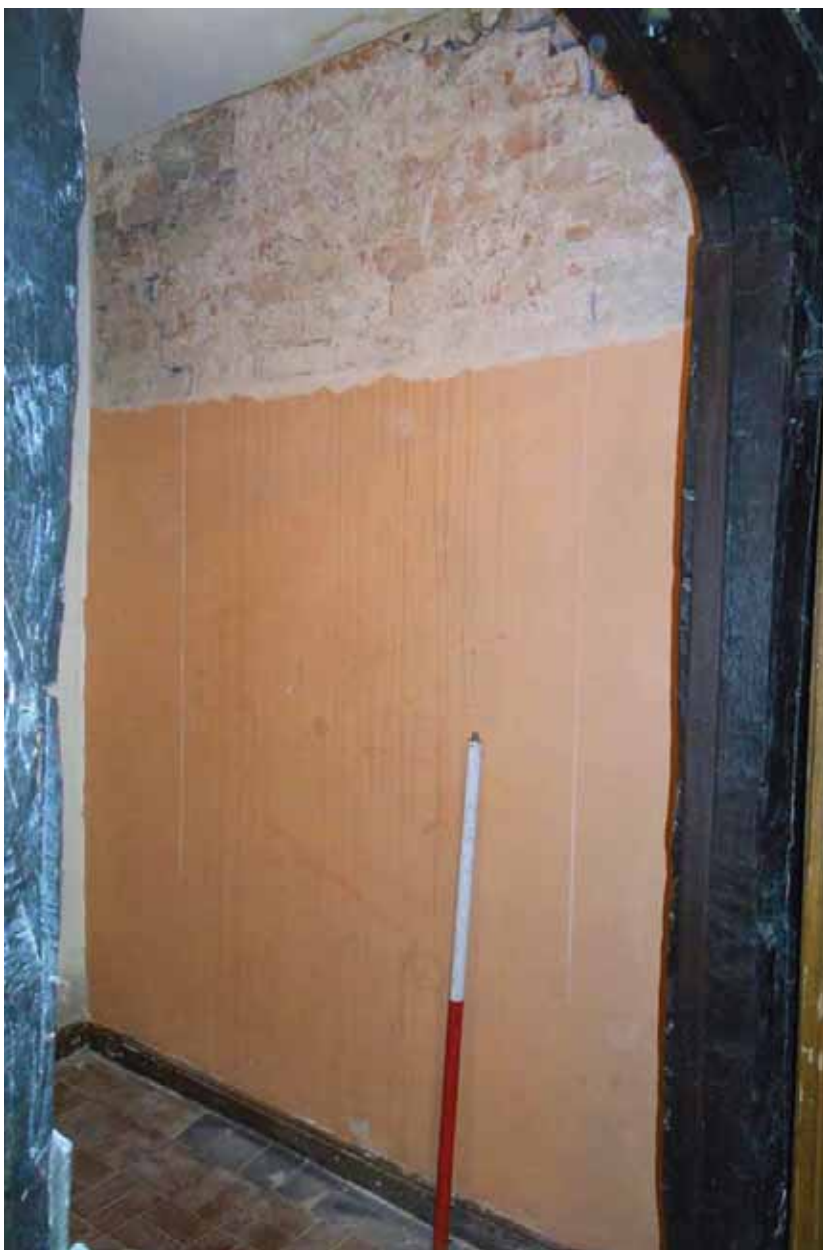
Plate 76. Watching brief, ground floor, blocked doorway in north wall of pantry.

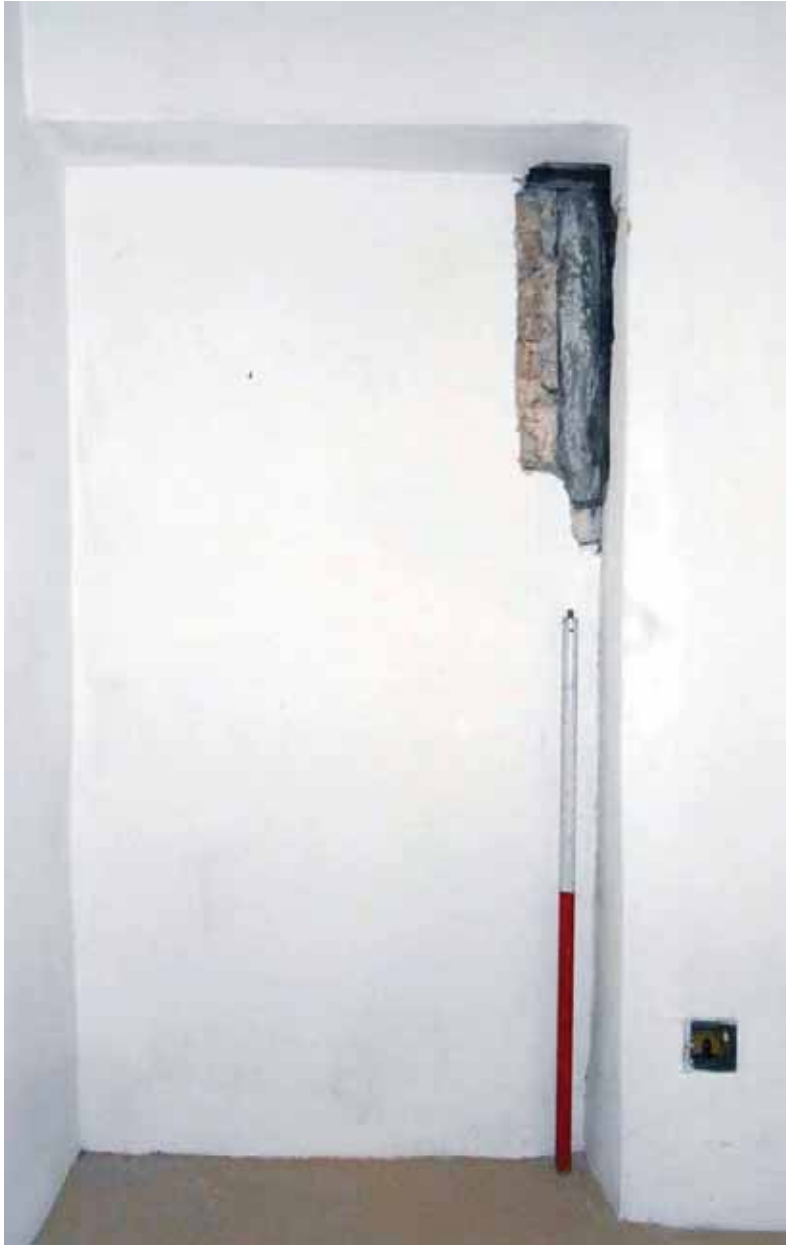
Plate 77. Watching brief, blocked doorway between larder and dining room, in brick house.
