**MOSS LANE EAST, MANCHESTER**

**PRELIMINARY BAT ROOST  
ASSESSMENT**

Report No: RT-MME-158021-02

Date: July 2022

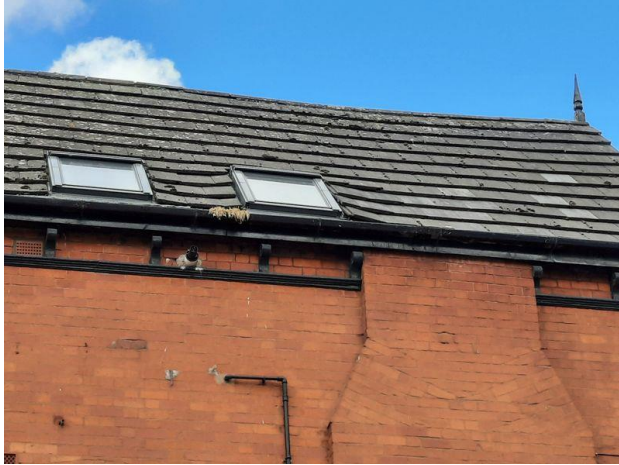
The first building (B1) was a three-story building constructed of red brick with an irregular shaped roof, covered in slate tiles, some of which were broken or dislodged (Plate 1). Windows and doors were noted to

**Plate 1: Dislodged and Warped Tiles Near Skylights**

Building 1 has been identified as having high potential to support roosting bats. Bat Surveys: Good Practice Guidelines published by the Bat Conservation Trust (Collins, 2016) recommends that for structures with high bat roosting potential at least three dusk emergence and/or dawn re-entry surveys be undertaken during the bat emergence/re-entry survey season to determine the presence/absence of roosting bats within the structure. The bat emergence/re-entry survey season extends from May to September. At least two of the surveys should be undertaken during the peak season for emergence/re-entry surveys between May and August and one of the three surveys should be a dawn re-entry survey. If a roost is discovered during these surveys, a Natural England licence application may be required.

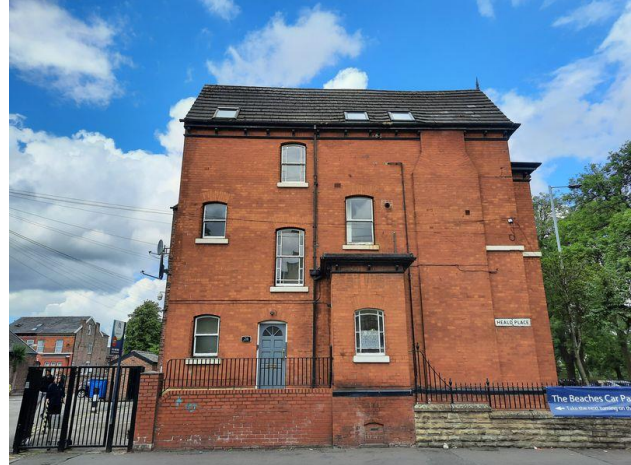
have uPVC frames in places but wooden in other areas (predominantly to the north and east) with brick and concrete window ledges (Plates 2). The front of the building (to the north) had black wooden fascial boards with ornate designs, which were worn in places (Plate 1). The building also had a flat roof porch area to the east, and a converted basement area. Multiple areas of degraded mortar and gaps between the bricks and above windows were noted but were too high to fully inspect (Plate 3 and 4).

**Plate 2: Eastern Elevation of B1.**

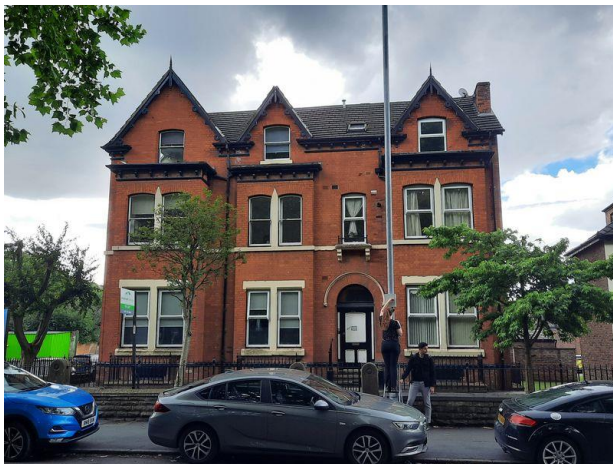
**Plate 3: Ornate Fascia Boards on Southern Elevation**

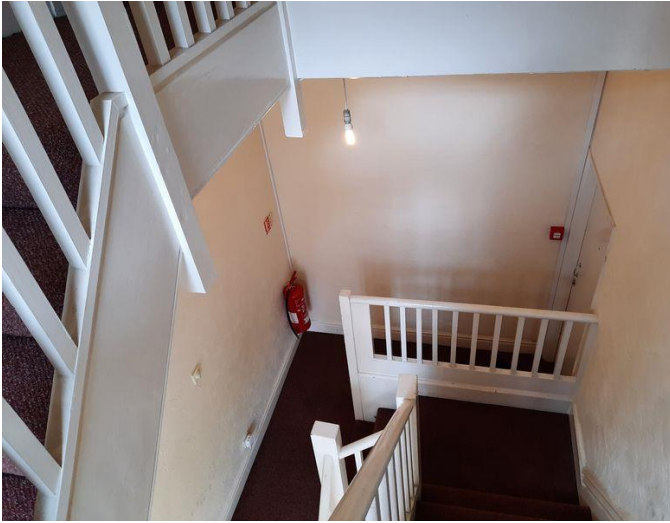
Internally, B1 had been split into flats on every floor, with connecting stairs and corridors (Plate 5). The flats had been converted up into the attic spaces with the addition of skylights and with only a very small area of intact attic that remained accessible within one of the flats (Plate 6).

**Plate 5: Narrow Corridors and Stairwells Leading to Flats**

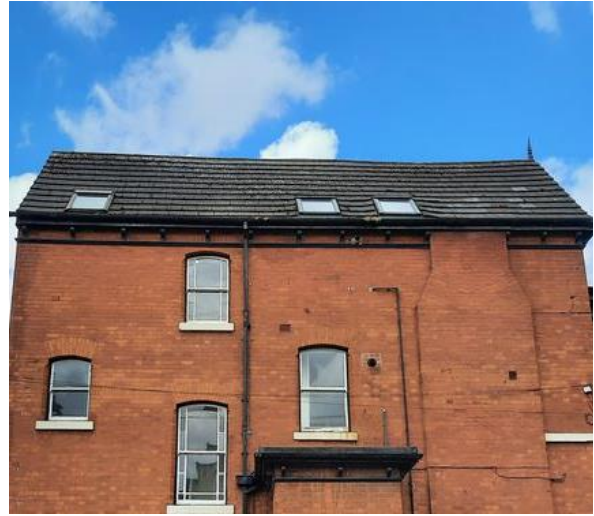
**Plate 6: Skylights Visible From The Outside Of The Building Associated With the Attic Flats**

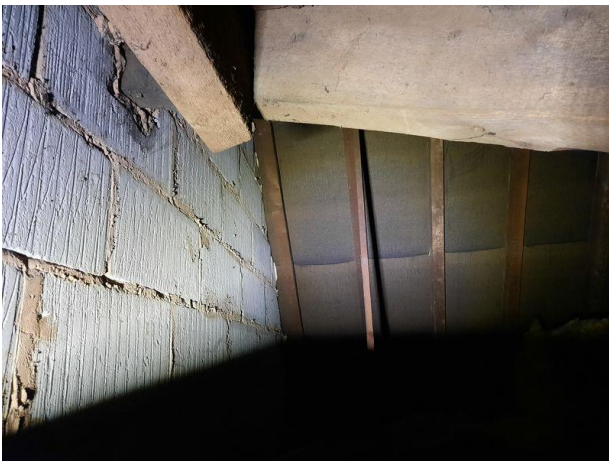
The dimensions of the space was approximately 2m from floor to apex with a steep pitch. The visible areas had wooden floors, wooden beams, and purlins and the loft was sectioned by breezeblock walls. Insulation was noted on the floor to the west but was not consisted across the entire roof space (Plate 7). An area of light was seen to be shining into the attic from the north (Plate 9), and mouse droppings and a disused bird's nest were also noted within the loft space.

**Plate 7: Area within The Attic Space, Separated By Breezeblocks**

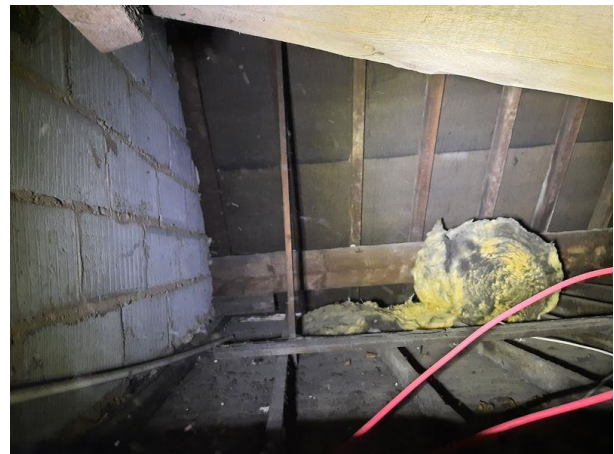
**Plate 8: Some Areas of Insulation within the Roof Space**

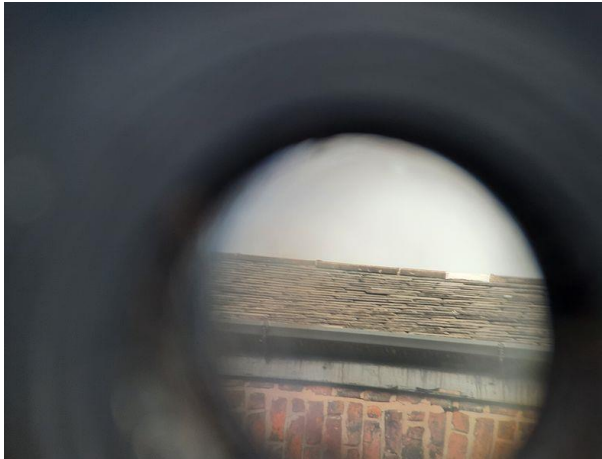
The second building (B2) was also a three-story building constructed of red brick with a Mansard shaped roof which was covered in slate tiles, some of which were broken or dislodged (Plate 10). Windows and doors were noted to have wooden painted frames with brick and concrete window ledges. Gaps were noted around windows and window ledges. The front of the building (to the north) was fronted with white painted stucco on brick extending all the way up to the roof. (Plates 10 to 12).

**Plate 10: Lifted Tiles and Degraded Fascia to the South**

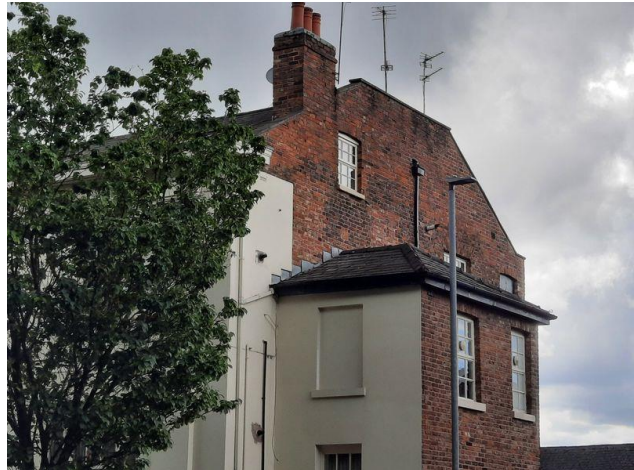
**Plate 11: Mansard Style Roof, Wooden Fascia Boards, and Wooden Framed Windows Consistent Throughout The Building**

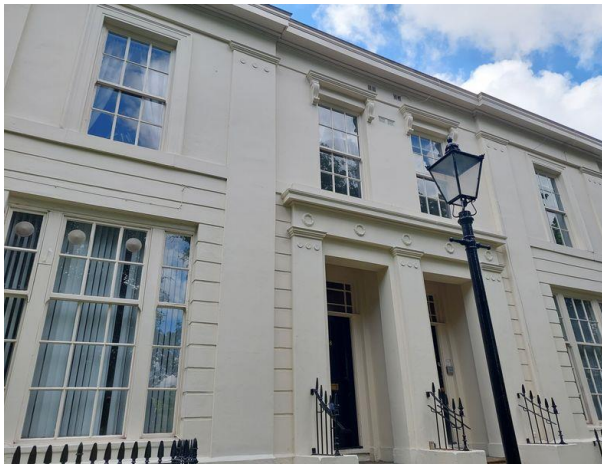
**Plate 12: North Of The Building Entirely Painted up To Roof and in Good Condition**

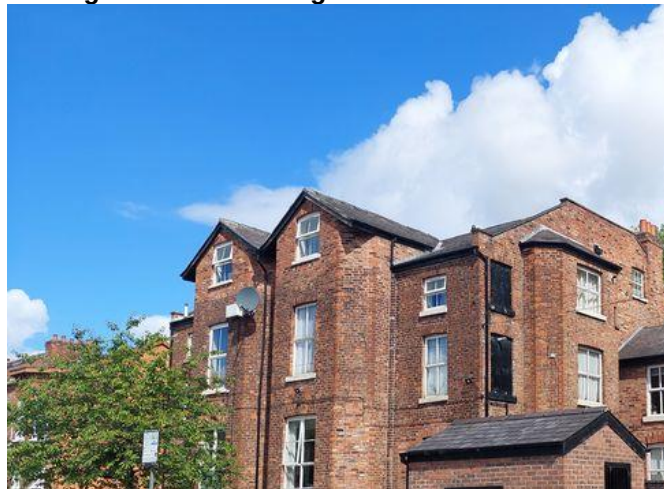
**Plate 13: The South Of The Building with Worn Fascia Boards and Windows**

To the north, the building had exposed red brick, with black fascia's boards that had been worn in areas. Multiple areas of degraded mortar and gaps between the bricks and above windows were noted to the south, east and west but were too high to fully inspect with the endoscope (Plate 13 and 14).

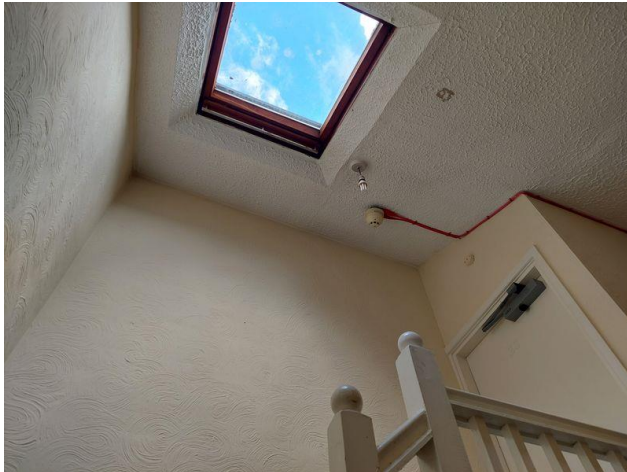
Similarly to B1, the internal of the building had been modified and redeveloped into separate flats with narrow corridors and stairwells (Plate 15). The flats extended all the way into the attic space, apart from one small area within a flat which was accessible. The area was small and was 2 m from floor to apex, with insulation lining the floor (Plate 16 to 17). The area consisted of wooden eaves, purlins and rafters, which had been replaced in places recently. Foil backed roof felting was also recorded along the western side but was not consistent throughout with some exposed slate visible (Plate 17).

**Plate 15: Inside of Building Redeveloped Into Flats with Narrow Corridors and Stairwells**

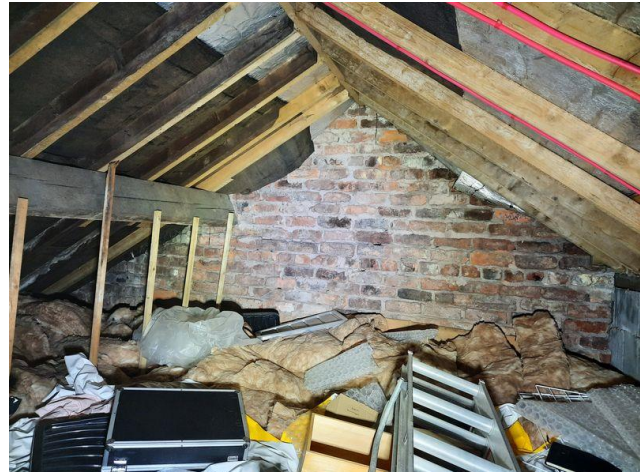
**Plate 16: Inside of the Attic Space with Insulation and Aerial Cables Visible**

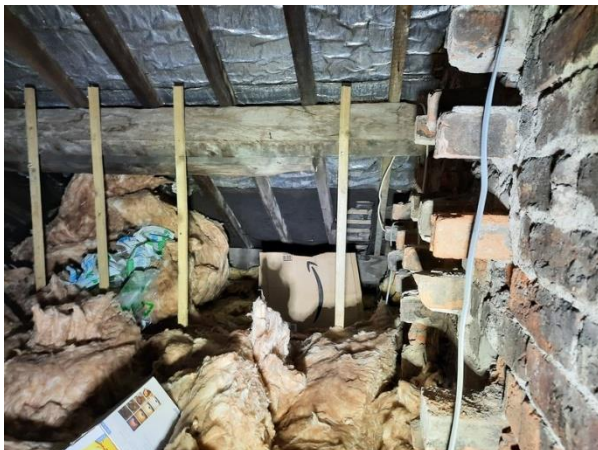
**Plate 17: Foil Lined Roof Felting Visible to the West**

A breezeblock wall was noted to the east and extended up to the eaves. A small gap was noted on an exposed slate, with a small gap between the felt and the tiles. There was also a small hole created for an aerial cable to enter the building. A wasp nest and mouse droppings were noted in this area.

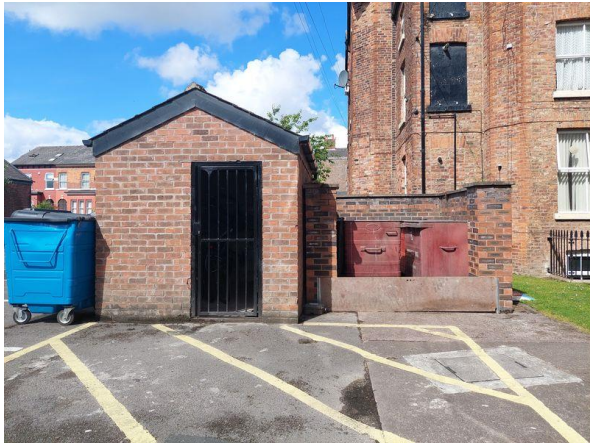
The bike shed was situated to the south of the two buildings next to a refuse area. The structure was small and was constructed of red brick and had a hipped clay tile roof. The doors and windows were open, with metal grating for security (Plate 18). The structure also had black wooden fascia boards in good condition with heavy cobwebbing (Plate 19).

**Plate 18: Small Bike Shed Structure to The South of The Main Buildings**

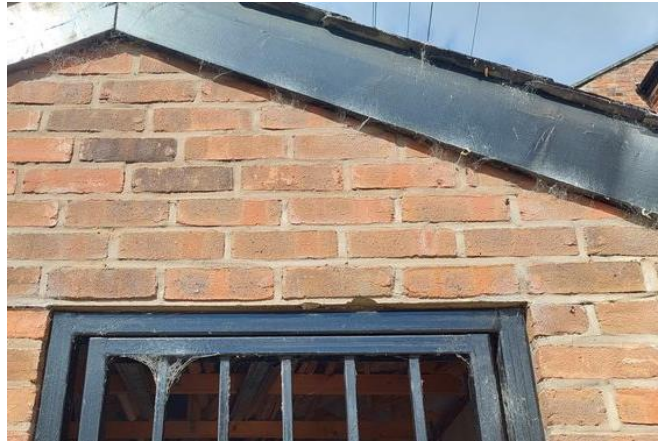
**Plate 19: Cobwebbing along Fascia Boards**
