# Geo-Environmental Investigation & Assessment

**Our Lady's RC High School, Blackley**

**Pozzoni Architecture**

| Report Reference: | 9670G-WML-XX-ZZ RP-G-0001 |

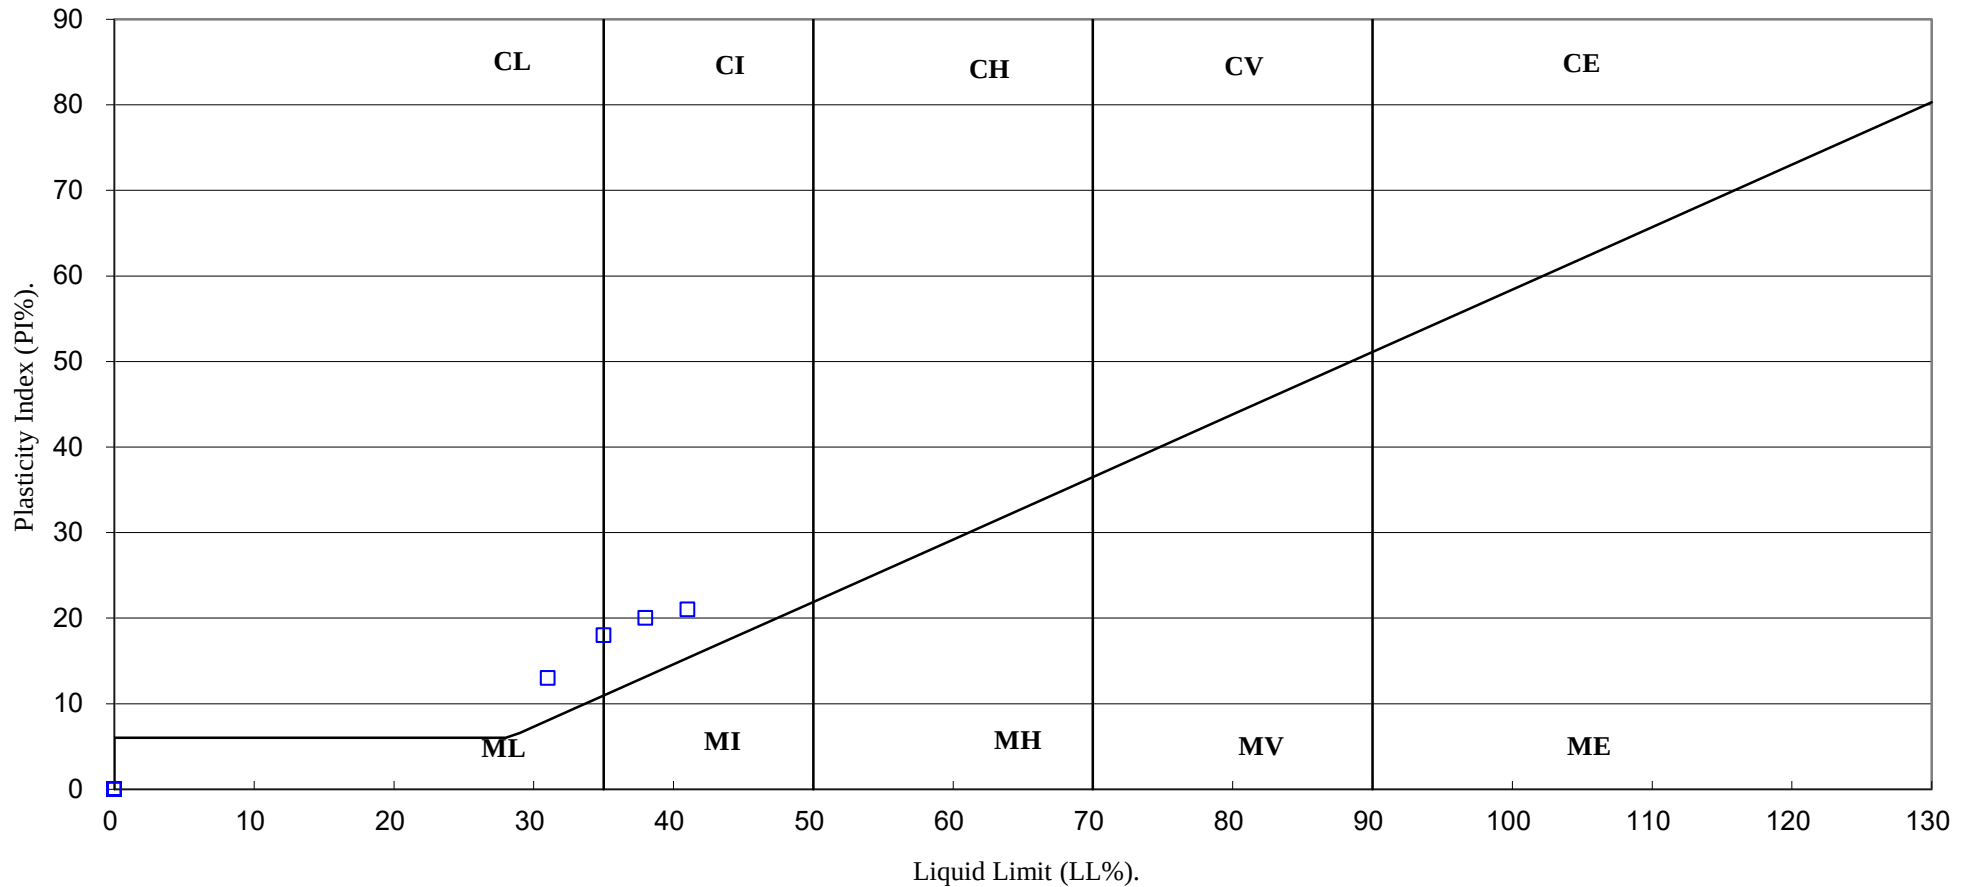
# PLASTICITY CHART FOR CASAGRANDE CLASSIFICATION.

- 5.15 Limited laboratory classification testing on the Glacial Till/re-worked Glacial Till provided natural moisture content values of 17 to 22%. Liquid limits of 31 to 41% with corresponding plasticity indices of 13 to 21% indicate clay of low to intermediate plasticity with plastic limit values of 18 and 20% (modified to 12 to 21%) indicating low to medium volume change potential.

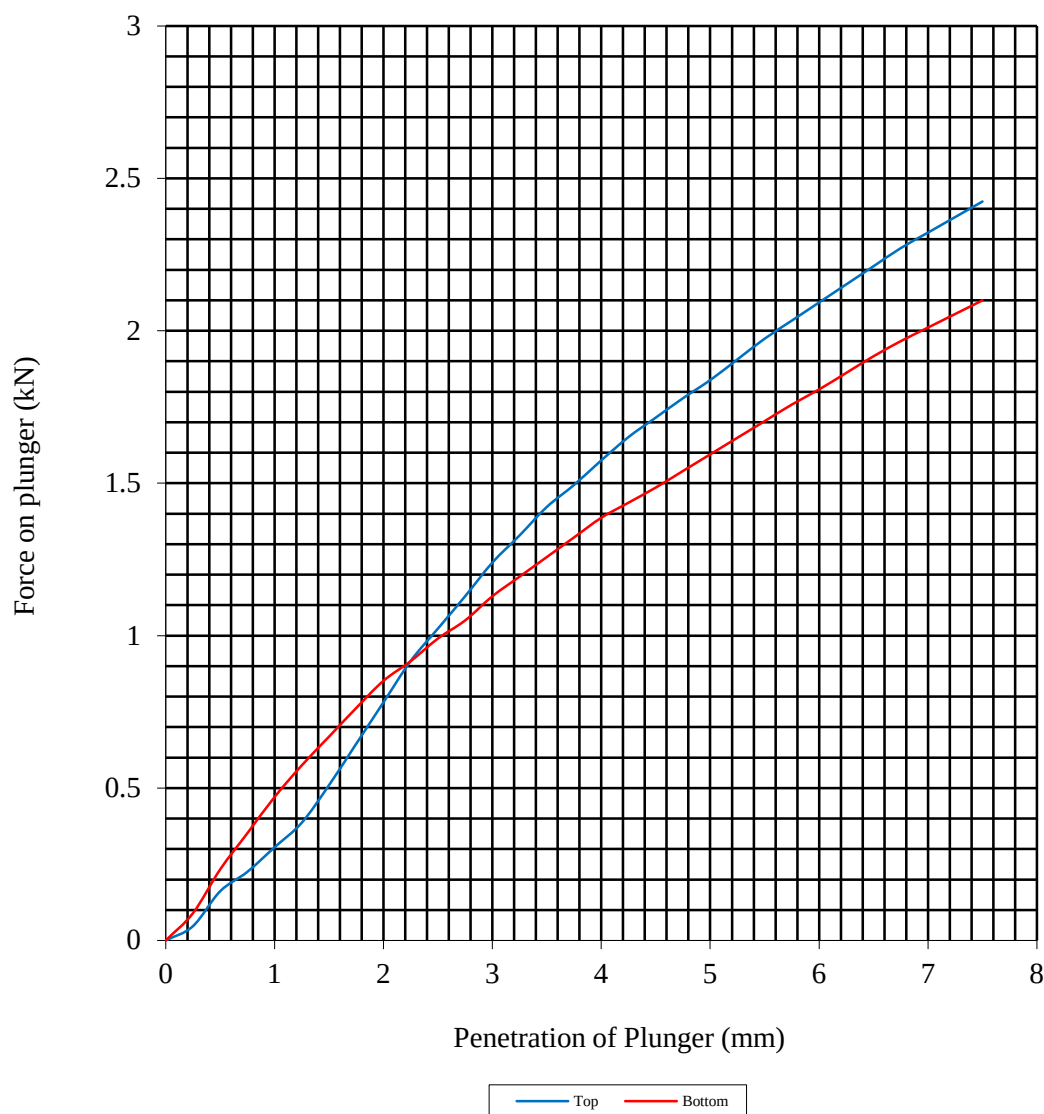
| Initial Sample Conditions | | Sample Preparation | | Final Moisture Content % | | C.B.R. Value % | |
| Moisture Content: | 16 | Surcharge Kg: | 4.20 | Sample Top | 16 | Sample Top | 9.2 |

- 6.16 In consideration of the ground conditions at shallow depth, it is recommended that new road pavement design should be based on a California Bearing Ratio (CBR) value of no more than 3.0% for preliminary purposes.
- 6.17 The CBR will need to be reviewed and confirmed by site inspection and possibly by suitable in-situ testing at formation levels following any earthwork operations and prior to pavement construction.
- 6.18 In any event, all formations should be proof-rolled with any soft, loose or otherwise unsuitable material being removed and replaced with compacted granular fill.

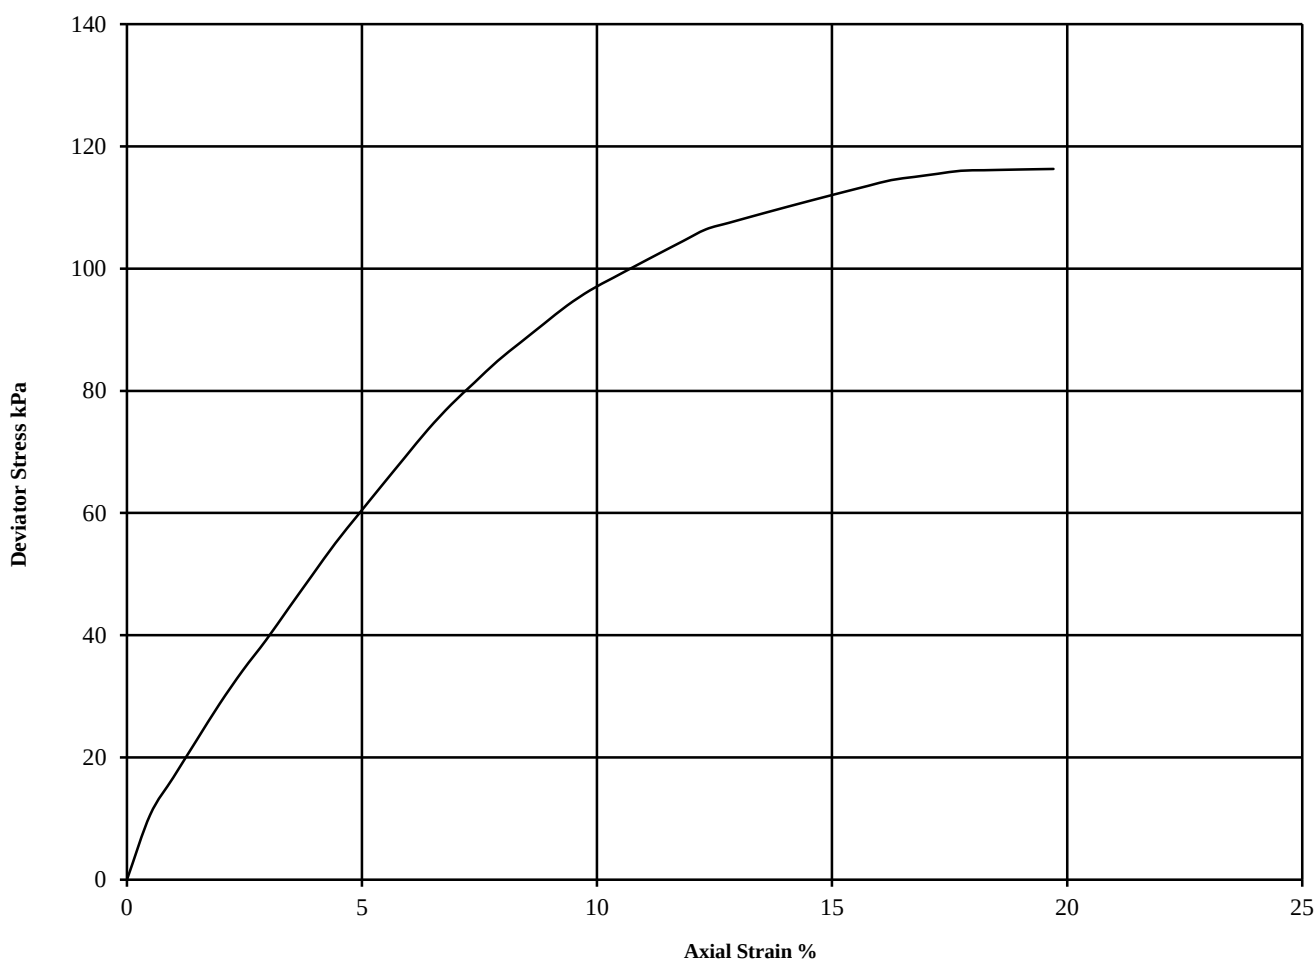
| Diameter (mm): | | 102 | Height (mm): | | 207 | Test: | UU Single Stage | | Remarks: |
| Specimen | Moisture Content (%) | Bulk Density (Mg/m3) | Dry Density (Mg/m3) | Cell Pressure (kPa) | Corr. Max. Deviator Stress (kPa) | Shear Strength Cu (kPa) | Failure Strain (%) | Mode of Failure | Undisturbed Sample<br>Sample taken from top of tube<br>Rate of strain = 2 %/min<br>Latex Membrane used 0.2 mm thick,<br>Correction applied 0.33<br>See summary of soil descriptions |

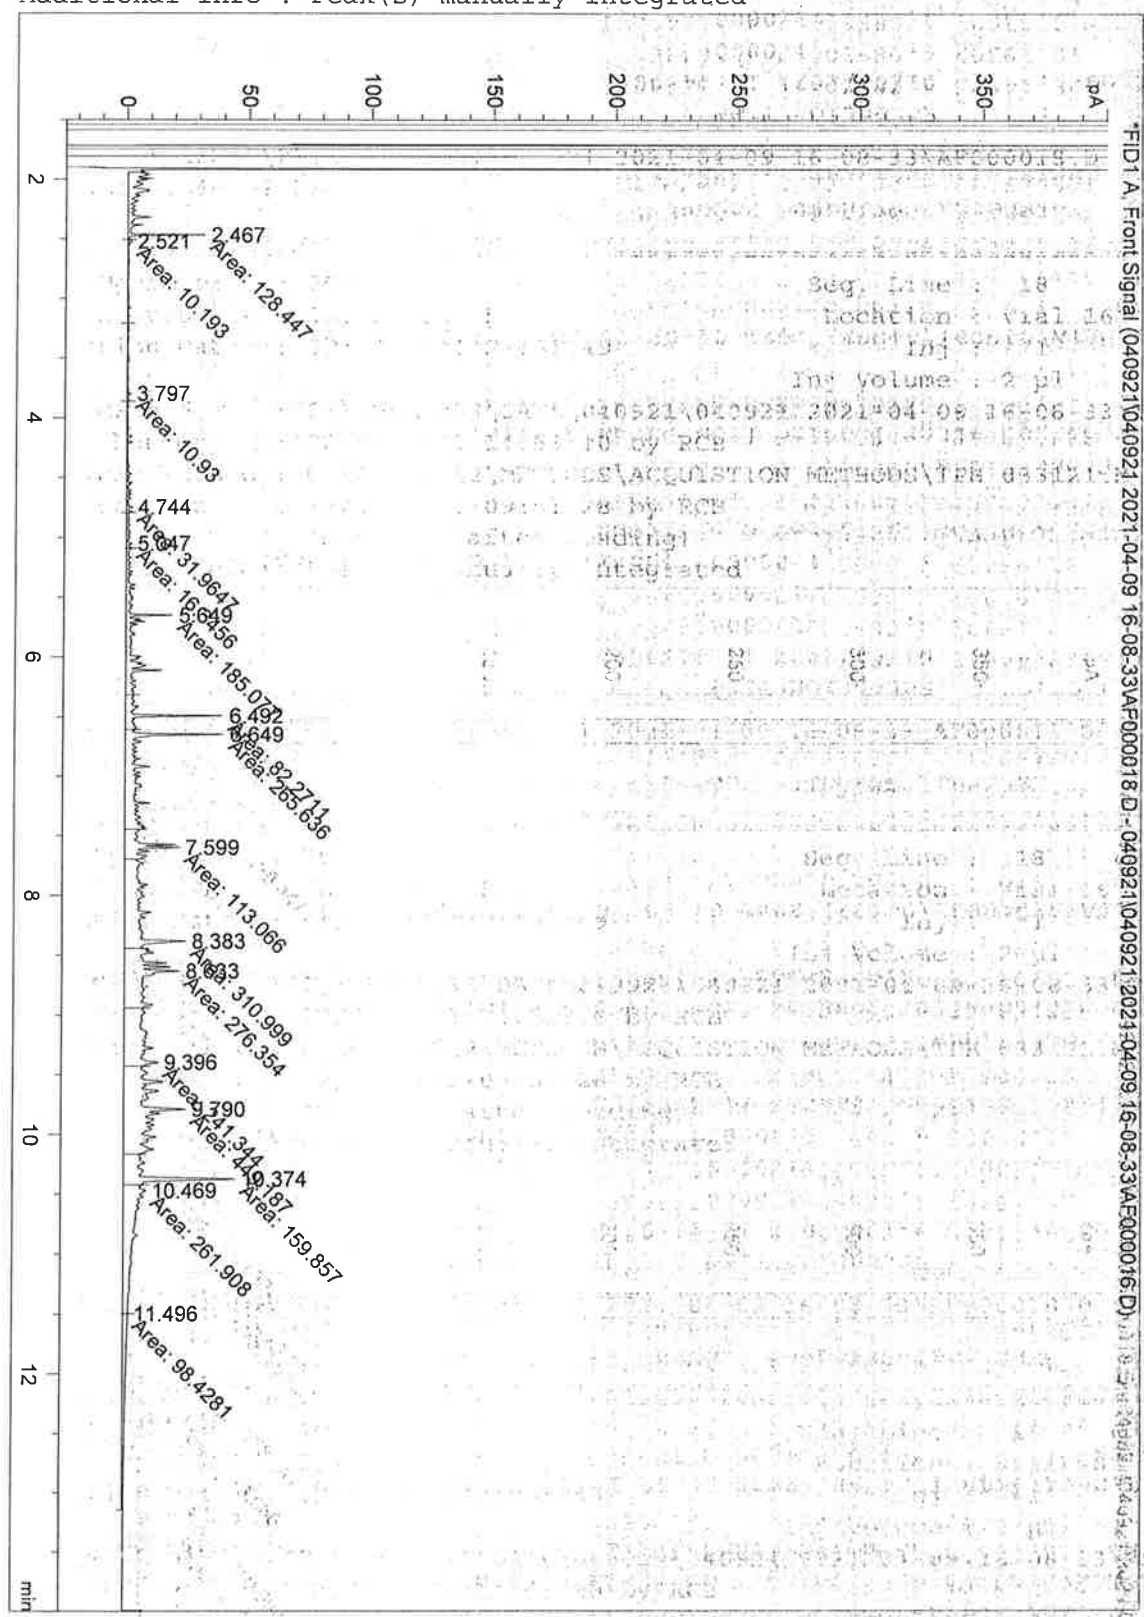
Sample Name: 3444-03 TS

FID1 A Front Signal (040921\040921 2021-04-09 16-08-33\AF000018.D) - 040921\040921 2021-04-09 16-08-33\AF000018.D

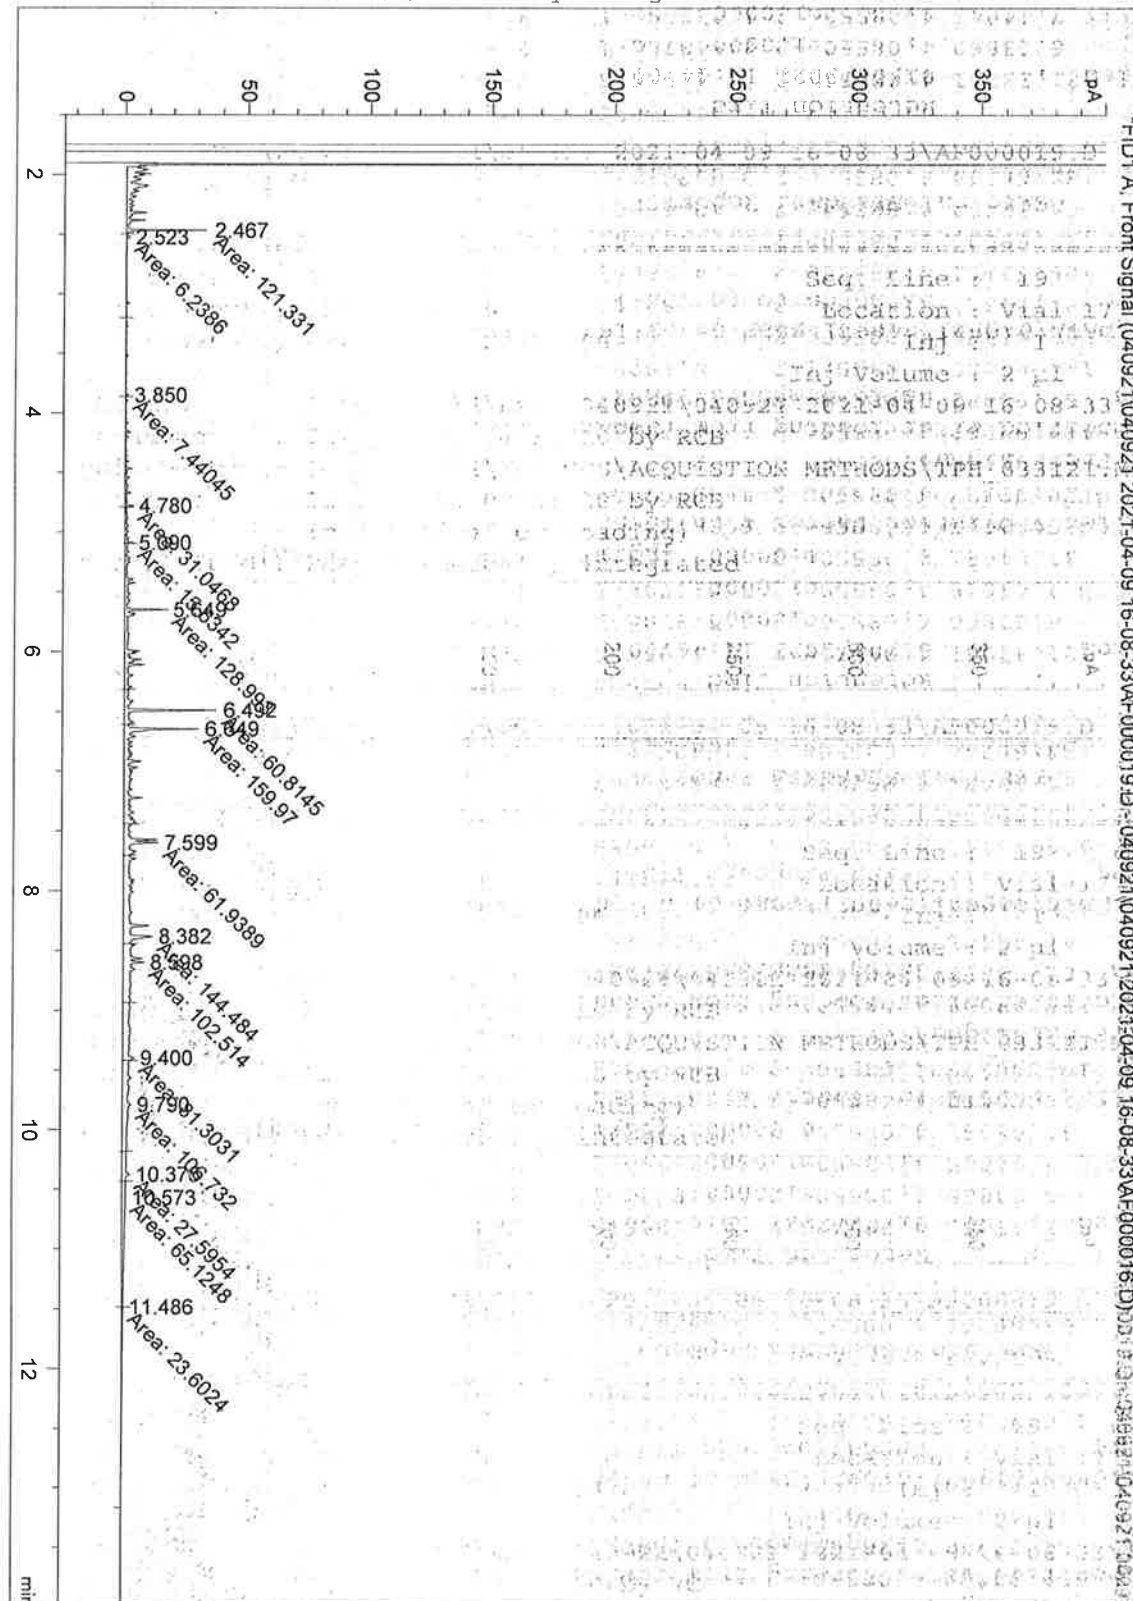
Sample Name: 3444-06 TS

FID1 A, Front Signal (040921\040921 2021-04-09 16-08-33\AF000019.D) 2021-04-09 16-08-33\AF000016.D

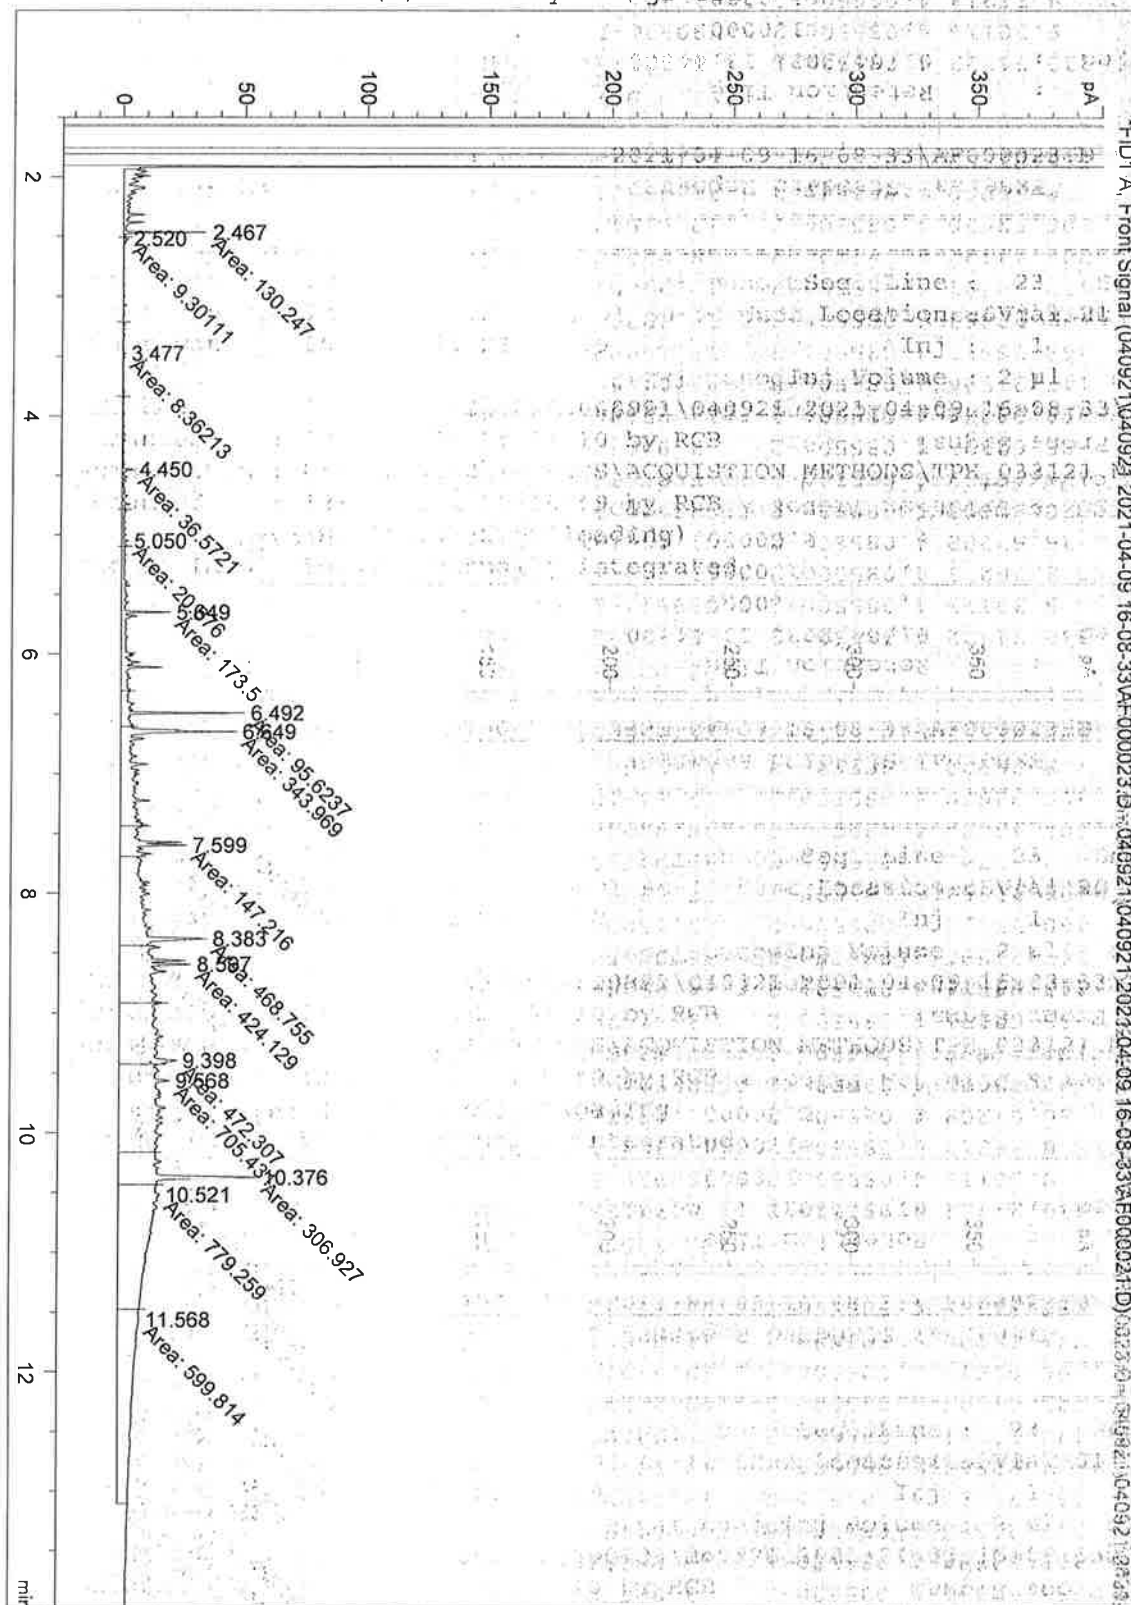
FID1 A, Front Signal (040921\040921-2021-04-09-16-08-33\AF000023.D)
