Phase I Geoenvironmental Site Assessment  
Land off Wilbraham Road, Chorlton, Manchester

Reference: 15-811-R1-5  
Date: November 2022

Phase I Geoenvironmental Site Assessment

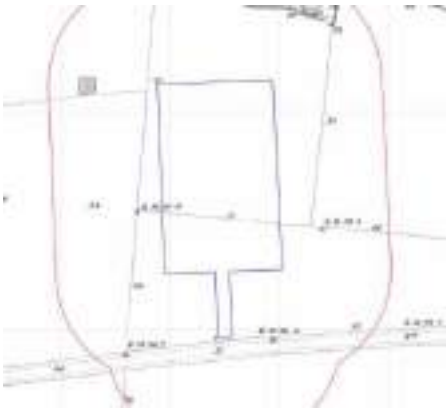
| MAP EDITION | HISTORICAL LAND USE | HISTORICAL MAP EXCERPT |
|---|---|---|
| <b>1881</b><br><b>1:2,500</b> | <p>The site is still recorded as agricultural land. The field boundaries in the north and south of the site are no longer recorded.</p> <p>The three ponds on site are no longer recorded and presumed to have been infilled.</p> | |

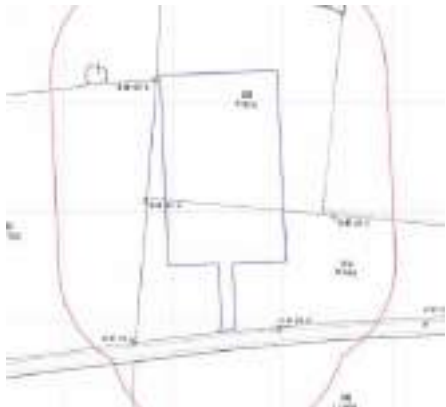
| MAP EDITION | HISTORICAL LAND USE | HISTORICAL MAP EXCERPT |
|---|---|---|
| <b>1894</b><br><b>1:2,500</b> | <p>There are no significant changes to the subject site.</p> | |

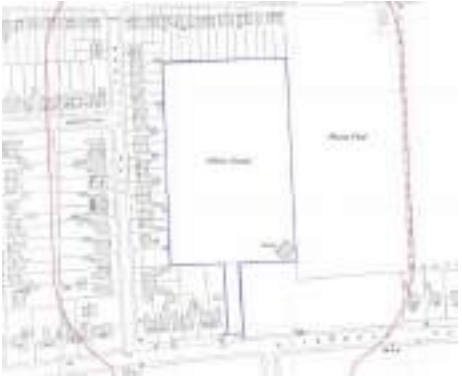
| MAP EDITION | HISTORICAL LAND USE | HISTORICAL MAP EXCERPT |
|---|---|---|
| <b>1950-1954</b><br><b>1:1,250</b> | <p>The site remains an Athletic Ground. The small, unmarked building in the east of the site and the tennis courts in the southwest of the site are no longer recorded.</p> <p>There are no other significant changes to the subject site.</p> | |

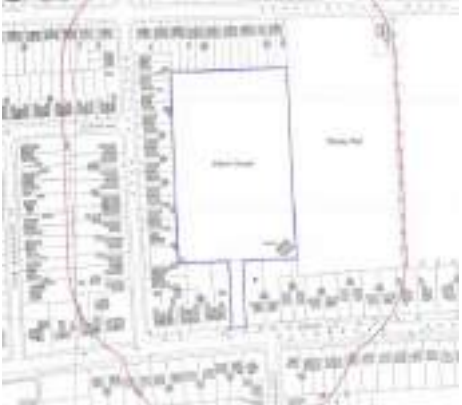
| MAP EDITION | HISTORICAL LAND USE | HISTORICAL MAP EXCERPT |
|---|---|---|
| <b>1964</b><br><b>1:2,500</b> | <p>A relatively small, unmarked structure is located in the southwest corner of the site.</p> <p>There are no other significant changes to the subject site.</p> | |

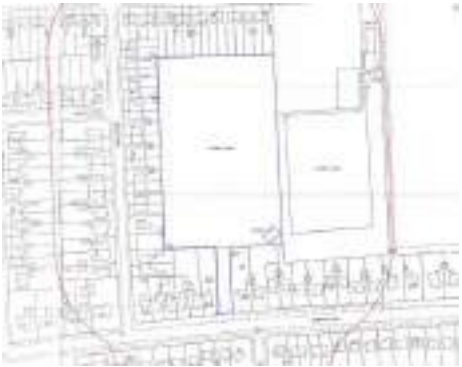
| MAP EDITION | HISTORICAL LAND USE | HISTORICAL MAP EXCERPT |
|---|---|---|
| <b>1992</b><br><b>1:1,250</b> | <p>The site is recorded as Football Ground.</p> <p>There are no other significant changes to the subject site.</p> | |

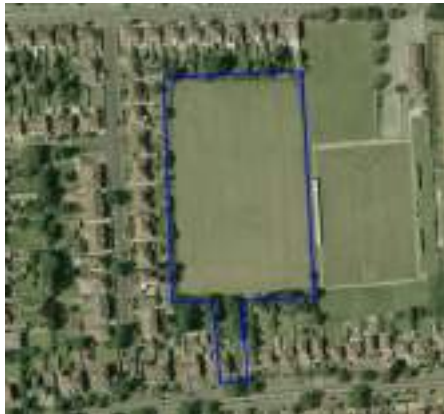
| MAP EDITION | HISTORICAL LAND USE | HISTORICAL MAP EXCERPT |
|---|---|---|
| <p><b>2005</b><br/><b>Ariel Imagery</b></p> | <p>Ariel imagery indicates that the pavilion is no longer present on site and the site comprises grass cover with no other features recorded.</p> <p>There are no other significant changes to the subject site.</p> | |

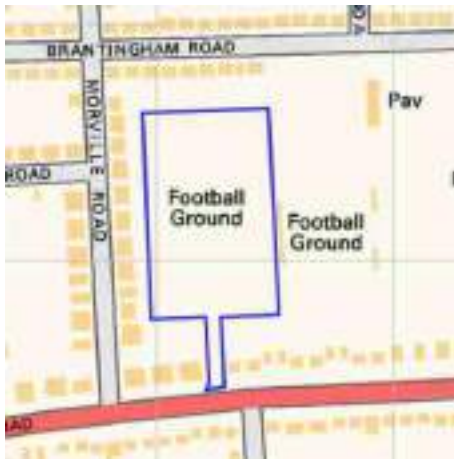
| MAP EDITION | HISTORICAL LAND USE | HISTORICAL MAP EXCERPT |
|---|---|---|
| <p><b>2010</b><br/><b>1:10,000</b></p> | <p>There are no significant changes to the subject site.</p> | |

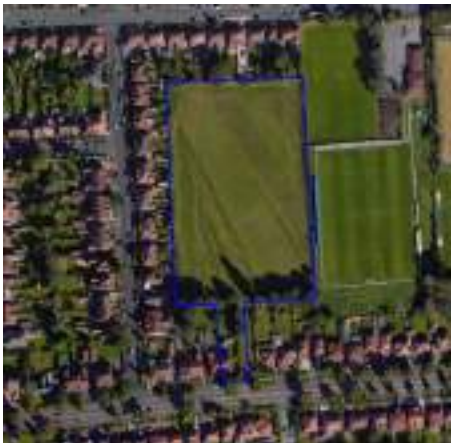
| MAP EDITION | HISTORICAL LAND USE | HISTORICAL MAP EXCERPT |
|---|---|---|
| <b>2016</b><br><b>Ariel Imagery</b> | There are no significant changes to the subject site. | |

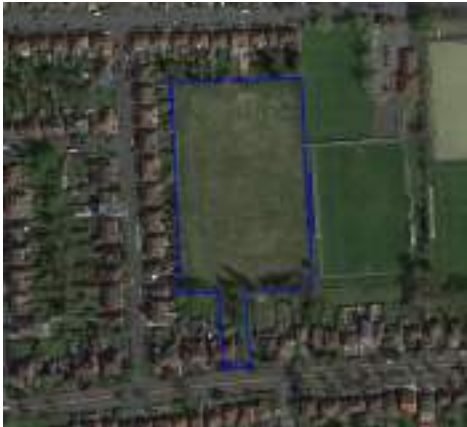
| MAP EDITION | HISTORICAL LAND USE | HISTORICAL MAP EXCERPT |
|---|---|---|
| <b>2022</b><br><b>Aerial Imagery</b> | <p>The site is no longer used as a football ground and appears vacant.</p> <p>The site has remained in this configuration until the present day.</p> | |

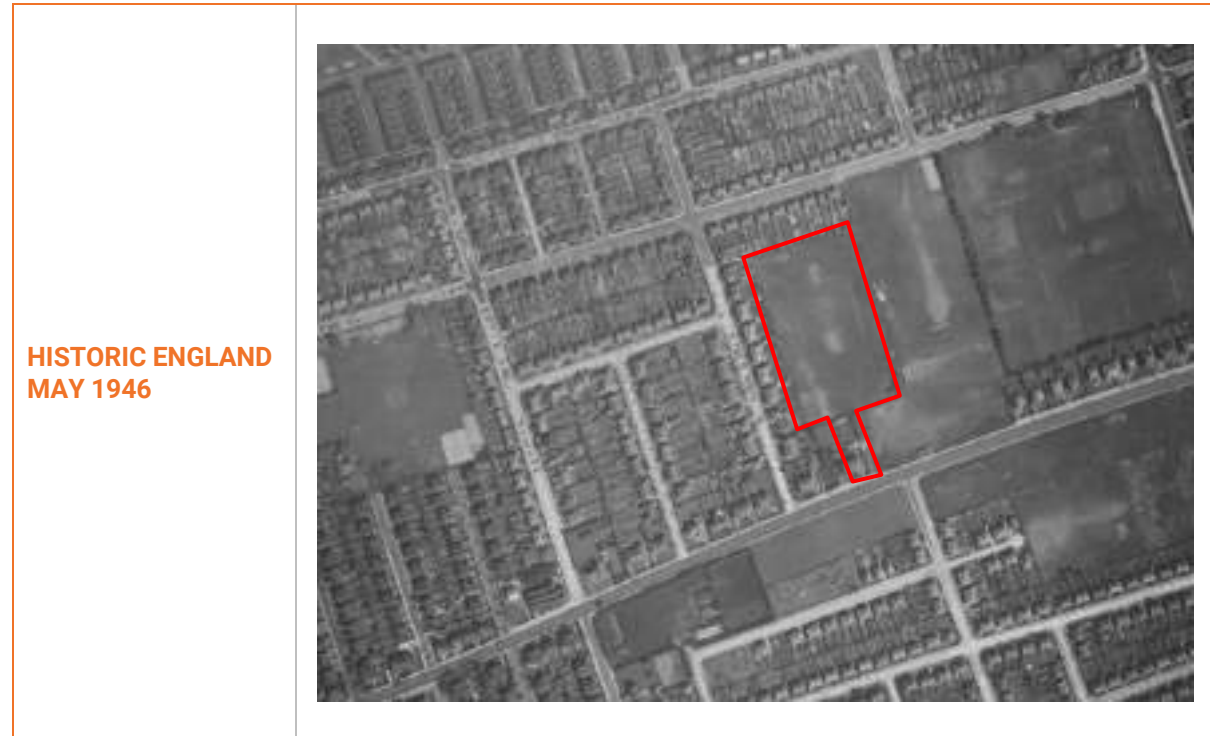
FIGURE 3.1. HISTORIC ENGLAND

The above image shows the site in its former use as a football/athletic ground which correlates with the historic mapping data.

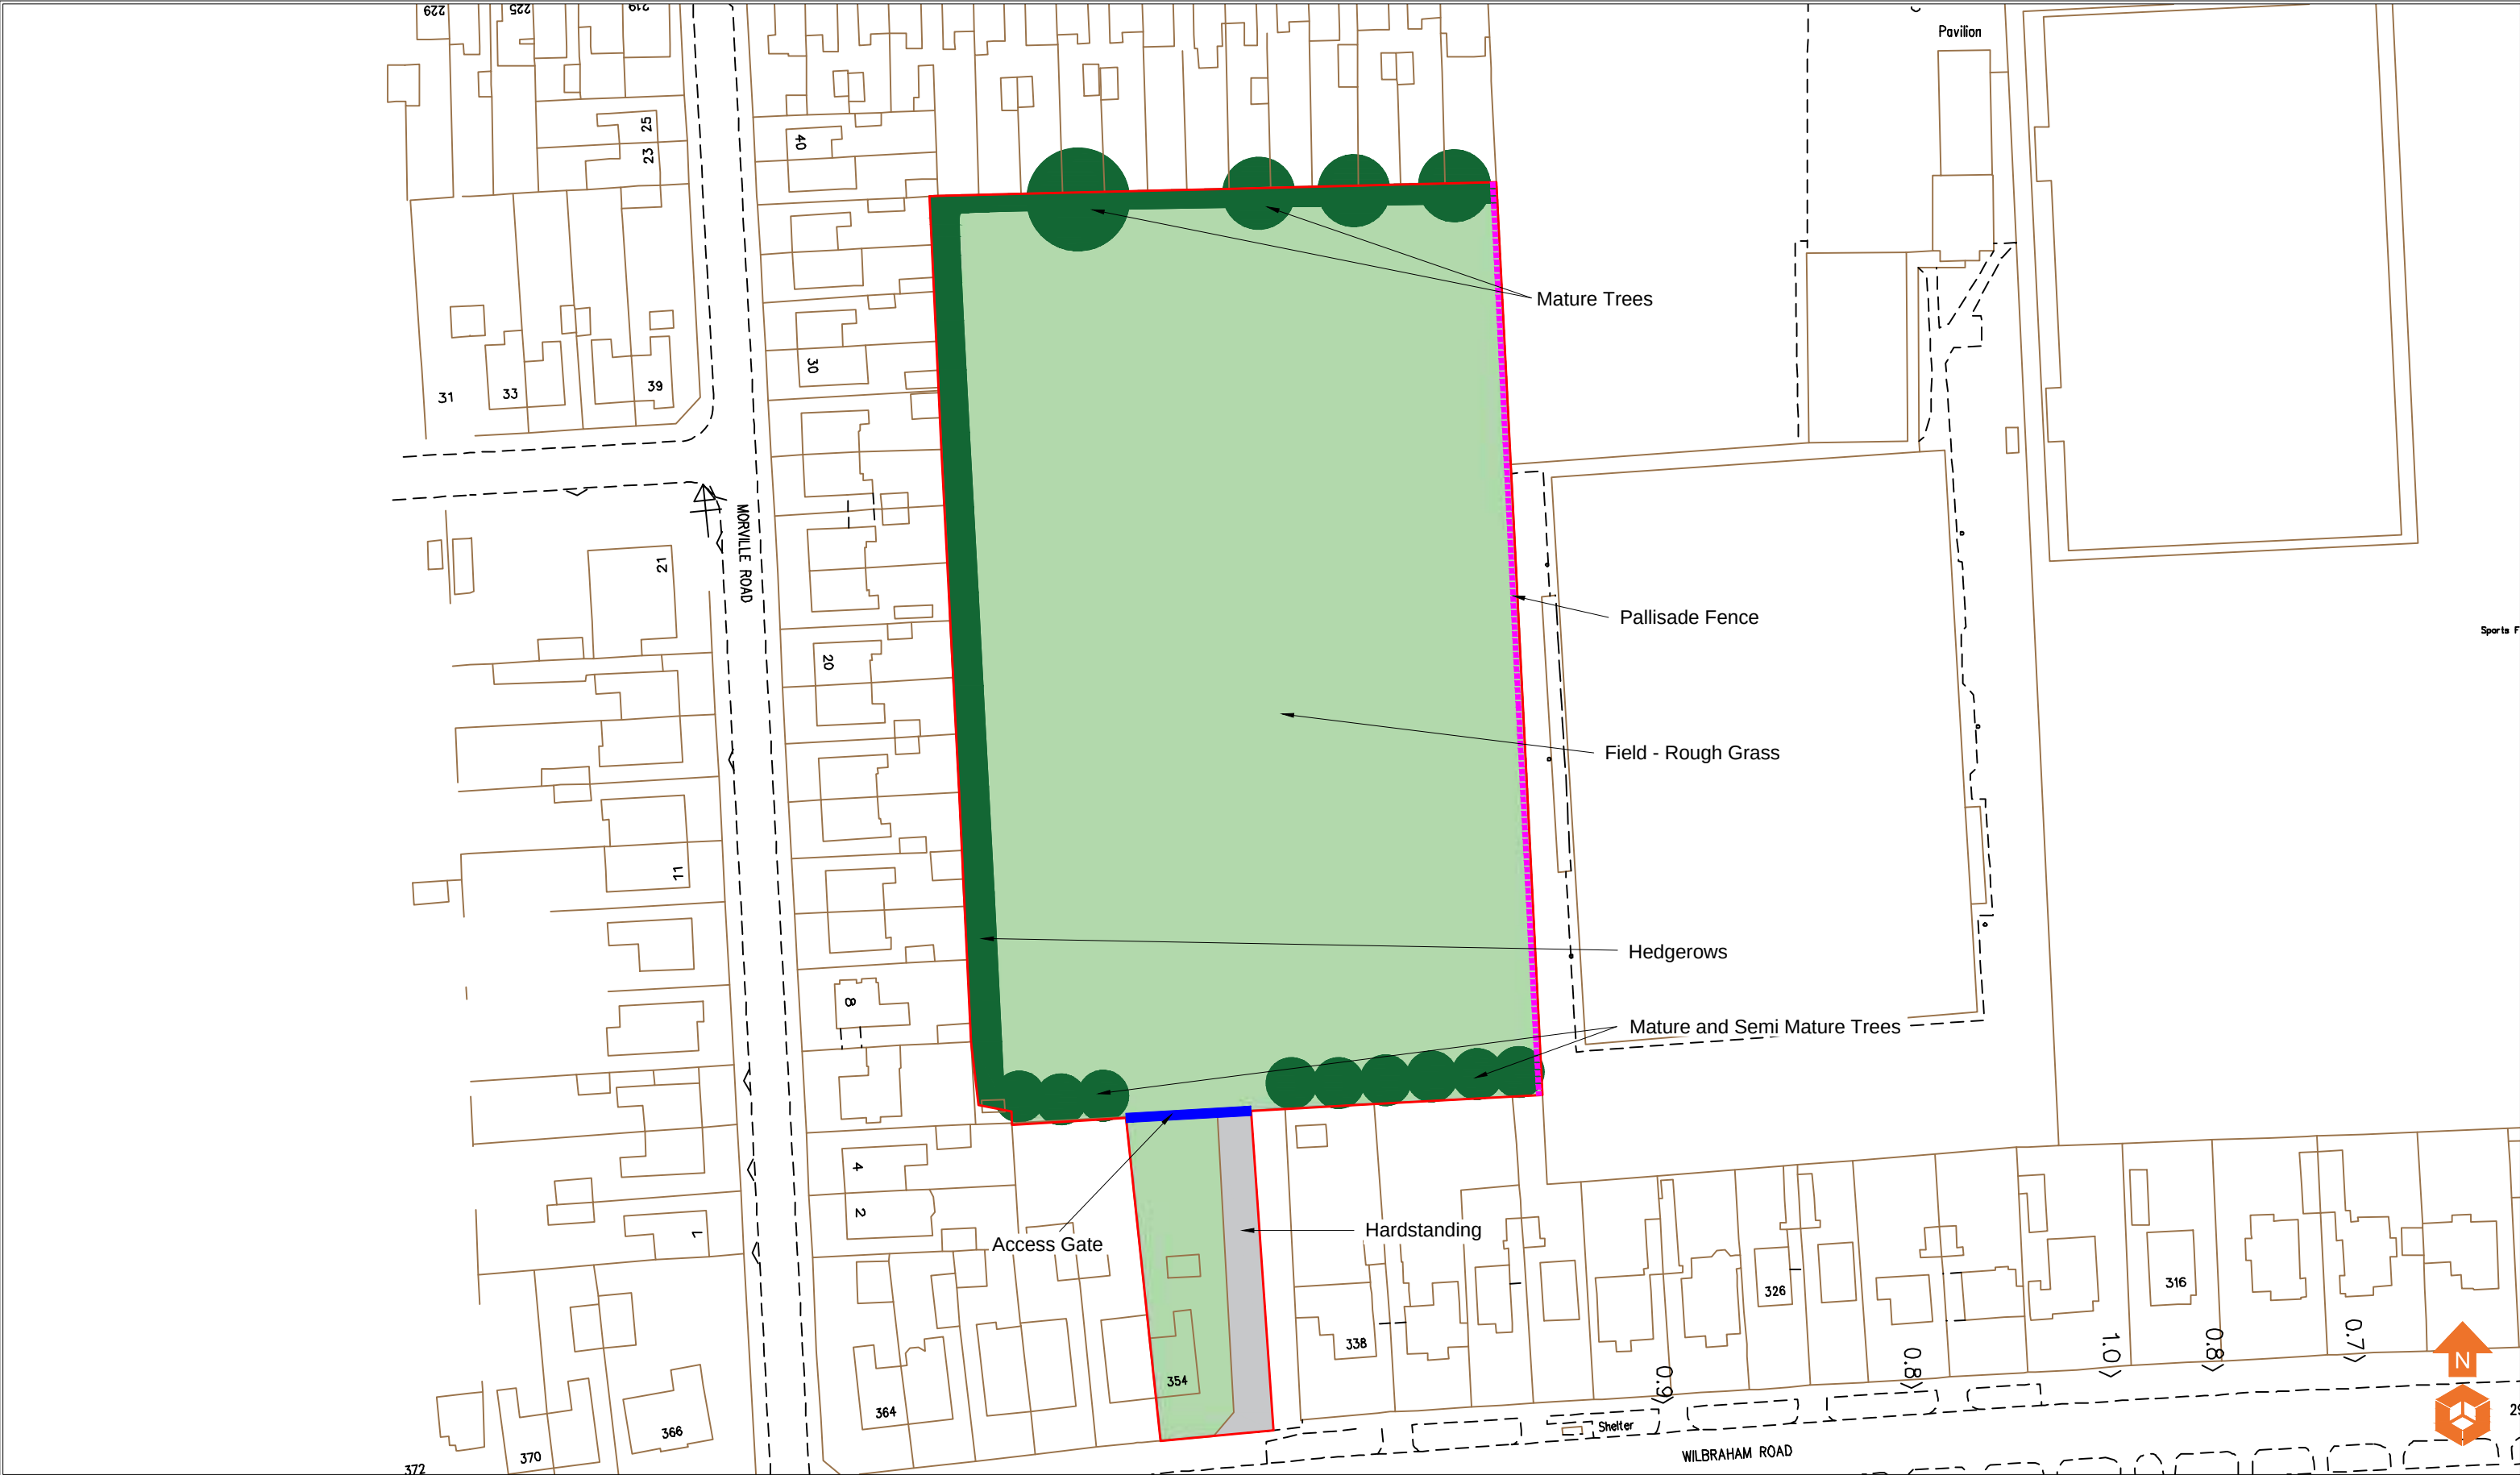
| <div>Site Features</div> <div><div></div>Field - Rough Grass</div> <div><div></div>Access Gate</div> <div><div></div>Hedgerows</div> <div><div></div>Hardstanding</div> <div><div></div>Mature and Semi Mature Trees</div> <div><div></div>Pallisade Fence</div> | <div>Notes:</div> <div></div> | <div>Client:</div> <div>Anwyl Homes</div> | <div>Job No:</div> <div>15-811</div> | <div>Date:</div> <div>31.03.2022</div> | <div><div><div></div></div>e3p</div> <div>Environmental Engineering Partnership Ltd<br/>Taylor Road, Trafford Park<br/>Urmston, Manchester, M41 7JQ<br/>Tel: 0161 707 9612<br/>E-mail: info@e3p.co.uk<br/>Website: www.e3p.co.uk</div> |

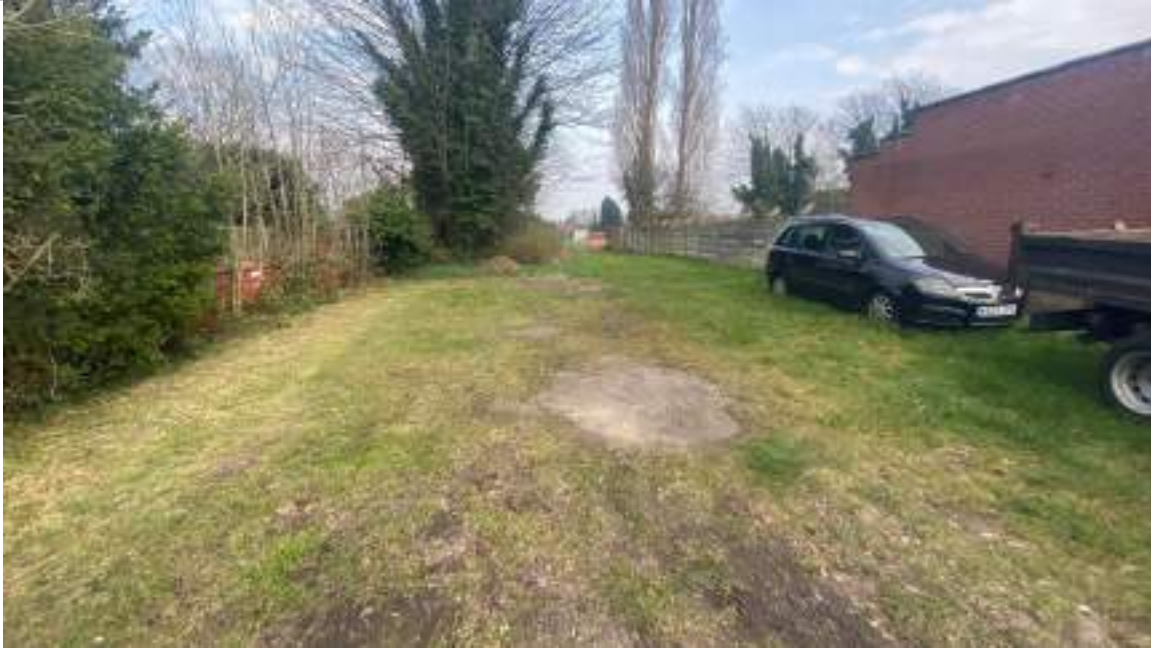
PLATE 1      VIEW OF SITE ACCESS FROM WILBRAHAM ROAD FACING NORTH

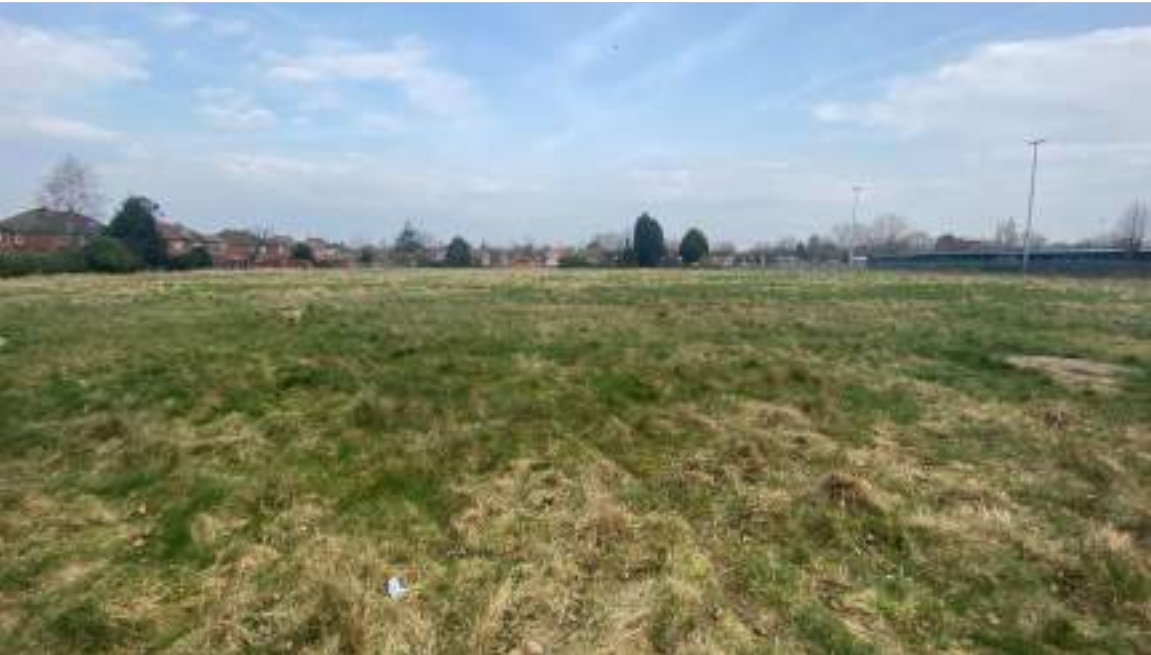
PLATE 2      VIEW OF SITE FACING NORTH

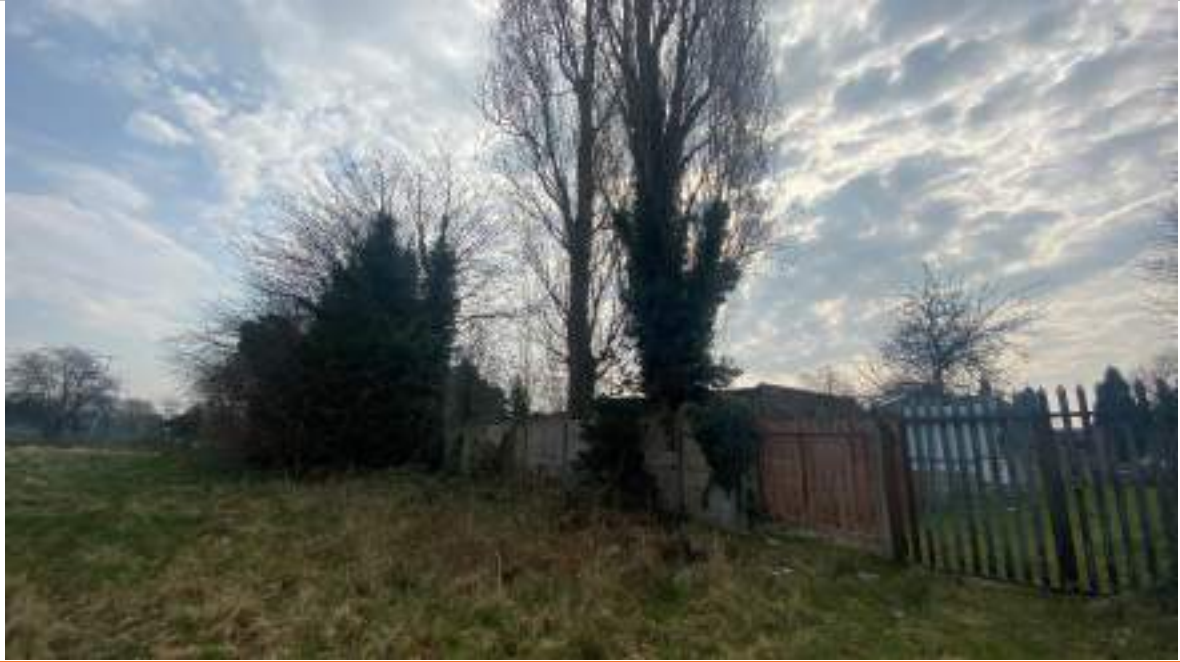
PLATE 3 MATURE AND SEMI-MATURE TREES AROUND THE SOUTHERN PERIPHERY

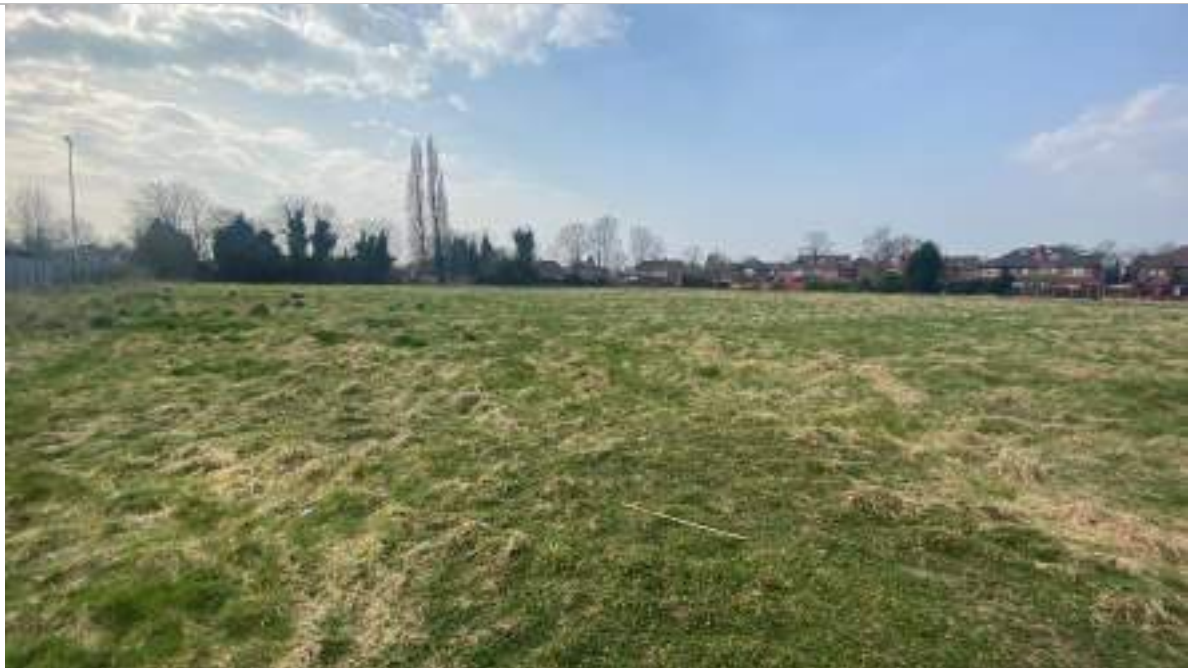
PLATE 4 VIEW OF THE SITE FACING SOUTH
