## **REMEDiation STRATEGY REPORT**

**AT  
OLD MARKET STREET,  
MANCHESTER,  
M9 8HY**

**REPORT NO. 7268B  
REVISION 1  
AUGUST 2022**

**SUB SURFACE NORTH WEST LIMITED**

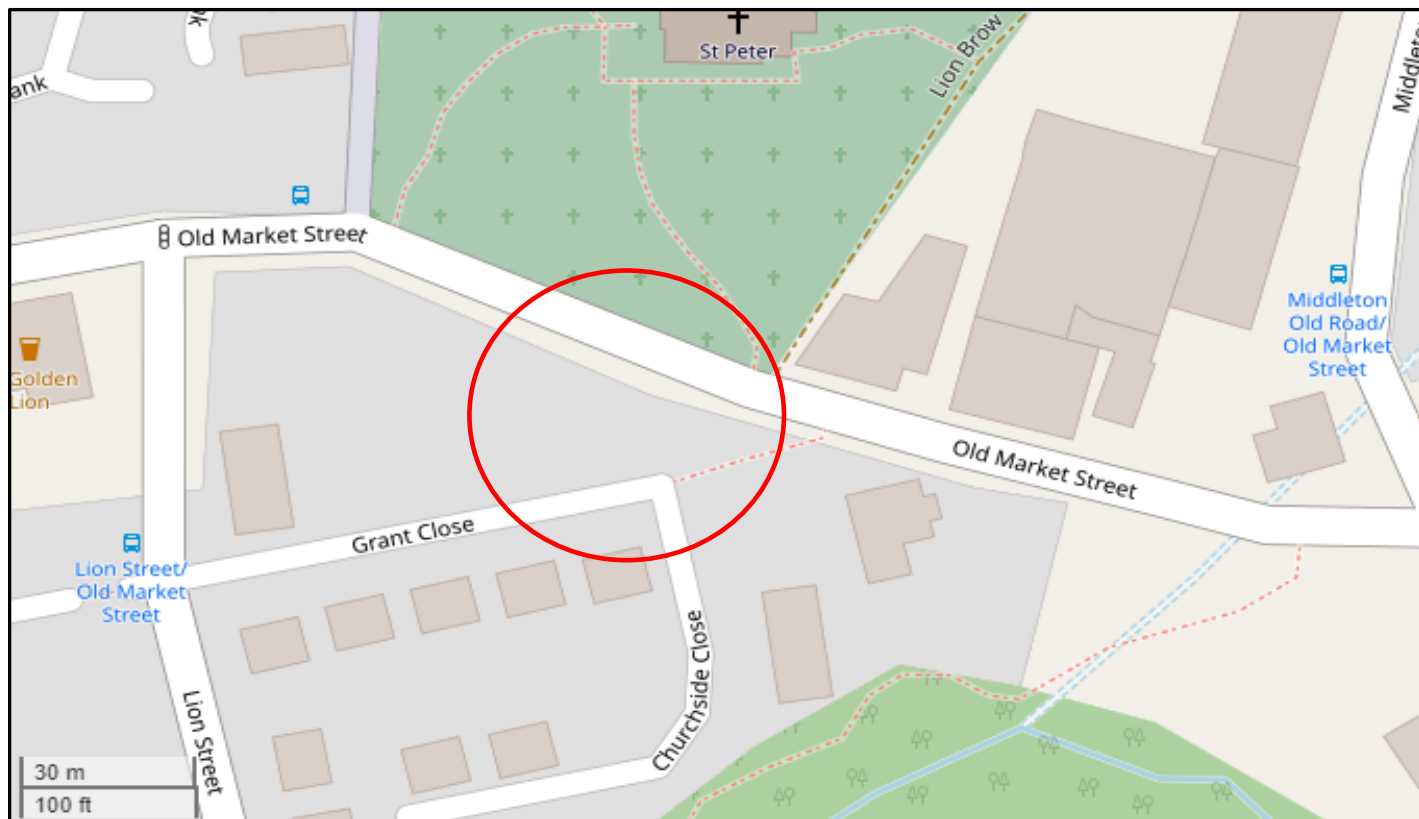
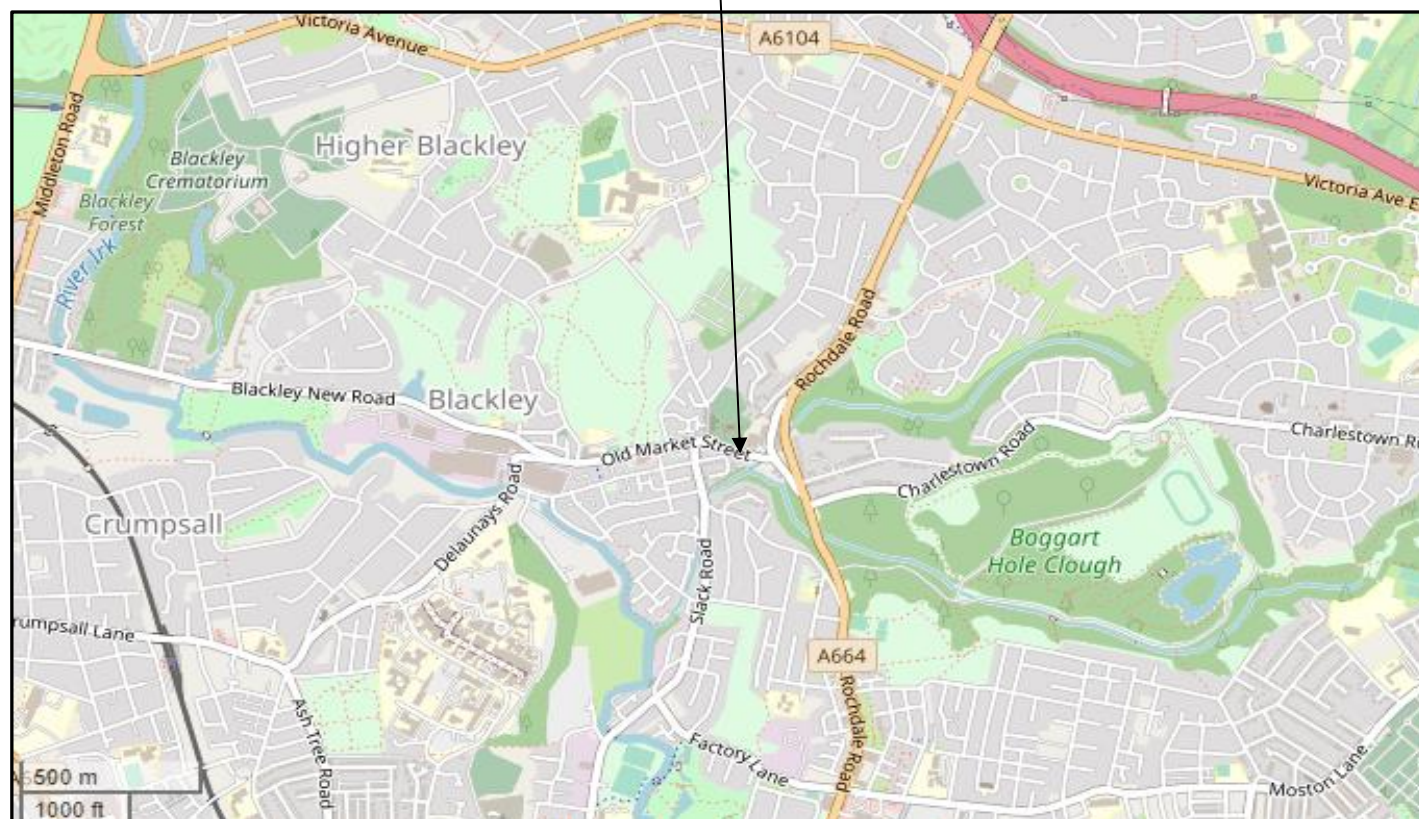
| Client<br>ZAHID KHALID | Drawn By<br>DJ | Checked By | Scale<br>As Shown | Figure No.<br>1 |

The site is located off Old Market Street in the Blackley area of Manchester, as indicated on Figures 1 and 2. The approximate National Grid Reference for the centre of the site is 385642E 402922N.

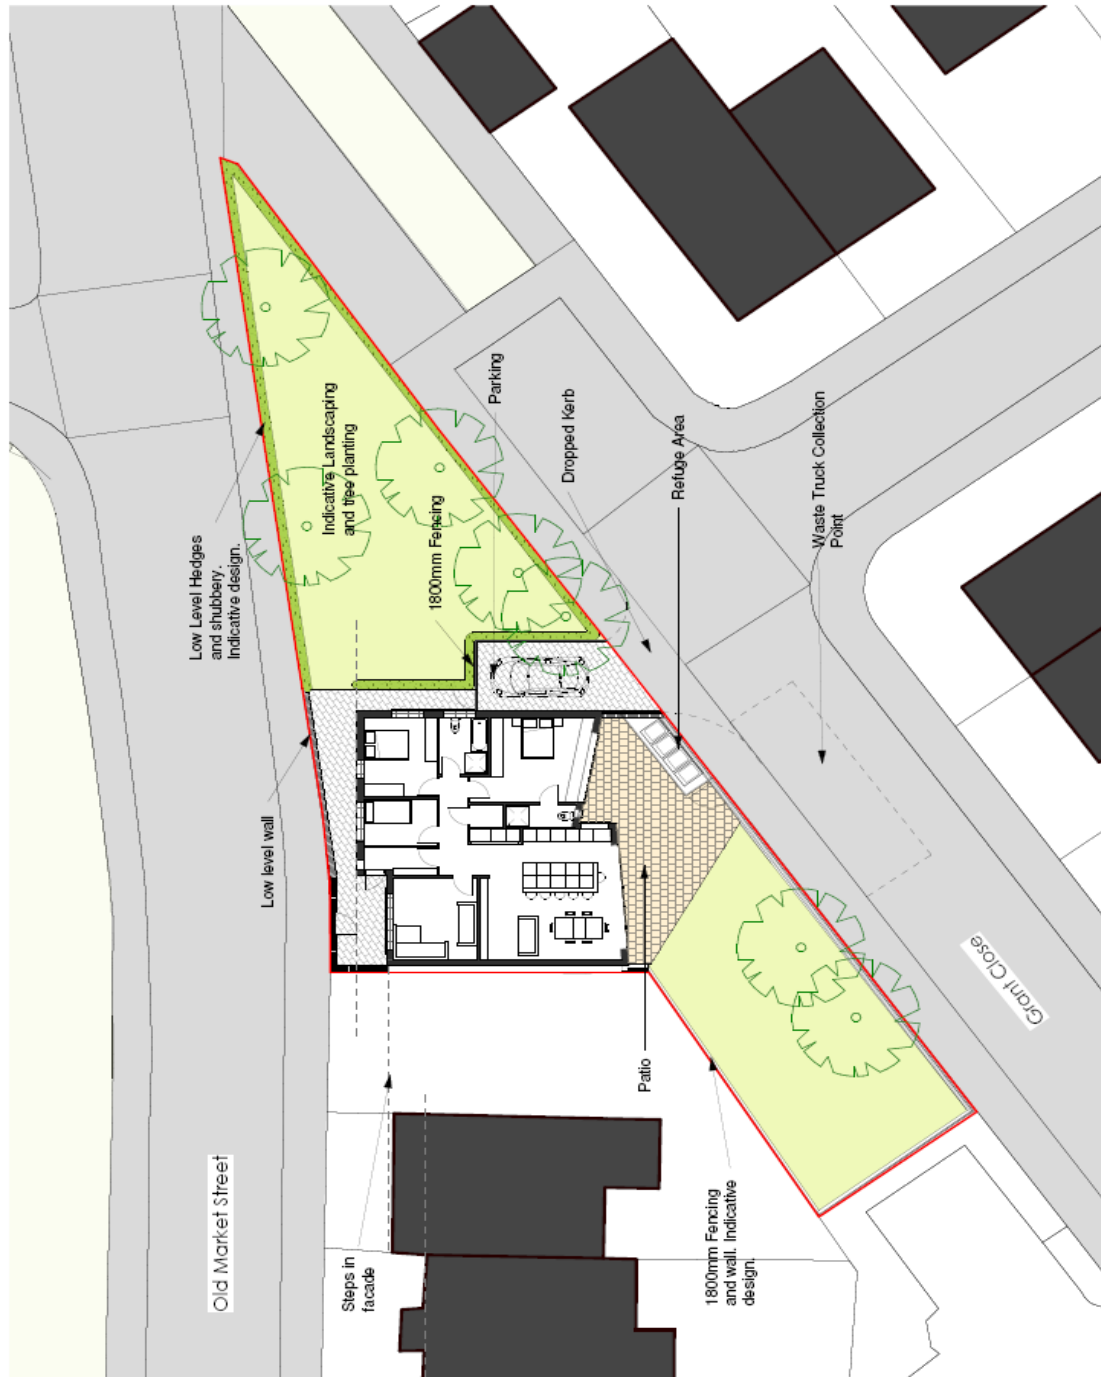
We understand that it is proposed to construct a single residential bungalow with associated car parking and gardens as shown on Figure 3.
