GeoEnvironmental  
Investigation

Old Market Street

FBJ Construction Ltd

**Report Ref: A4932/22/SI  
OCTOBER 2022**

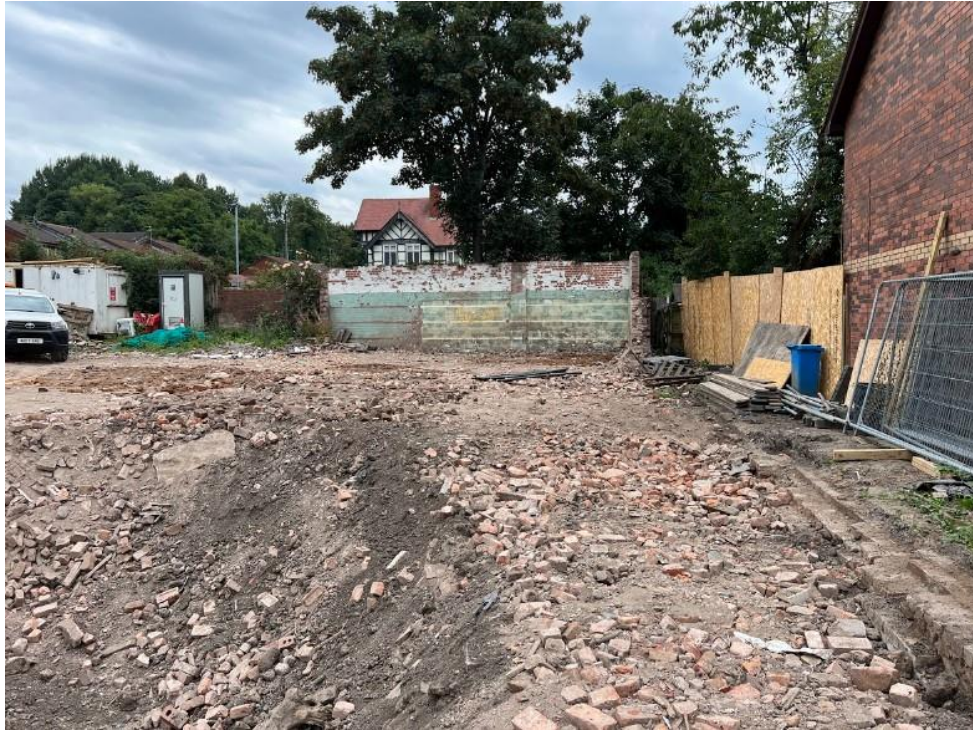
**Figure 2: General Site Photographs**

Photograph taken viewing east showing southern section of the site.

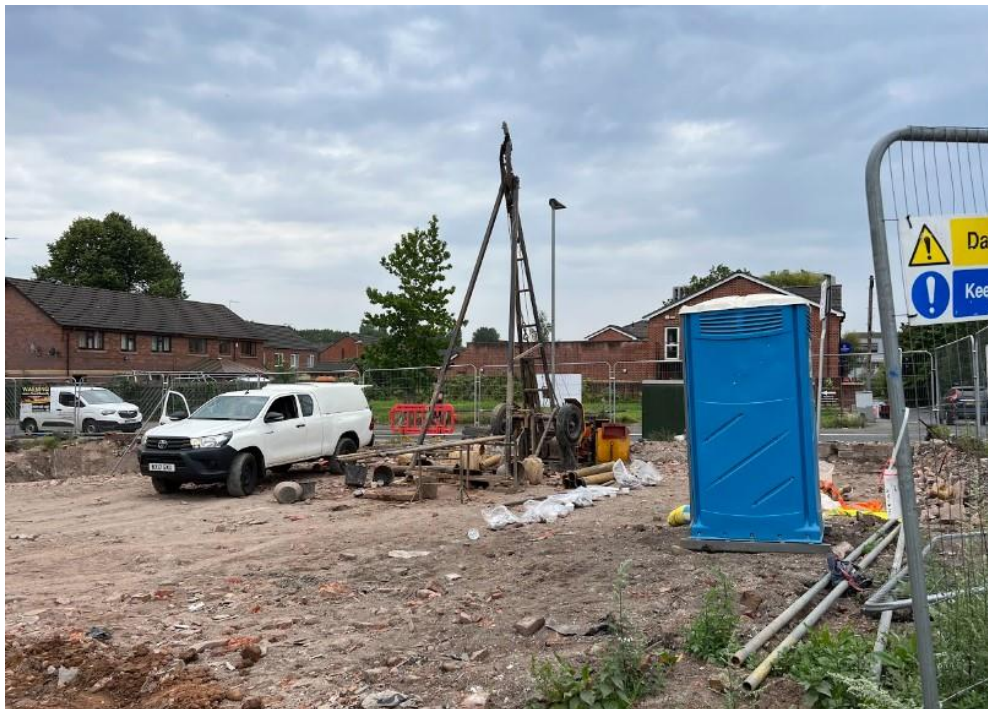
Photograph taken viewing west showing cable percussion rig on BH1.

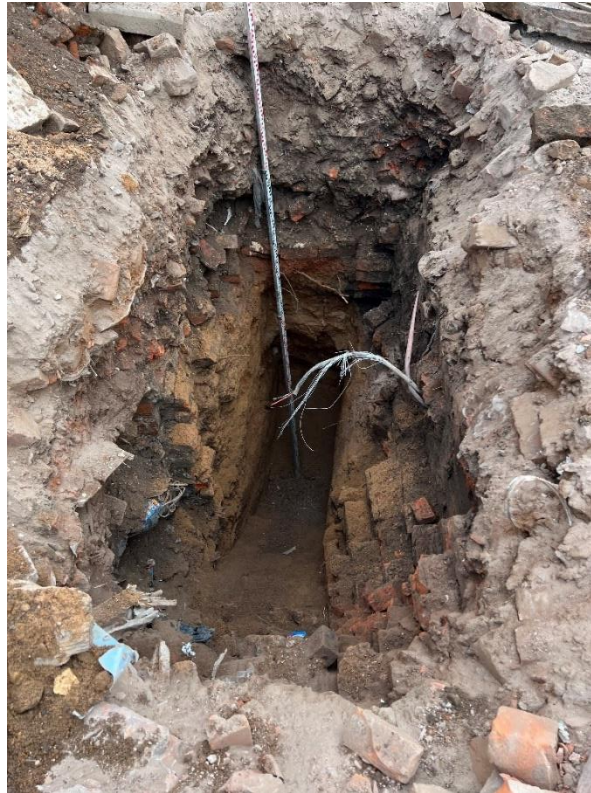
Photograph showing the extent of excavation at TP3

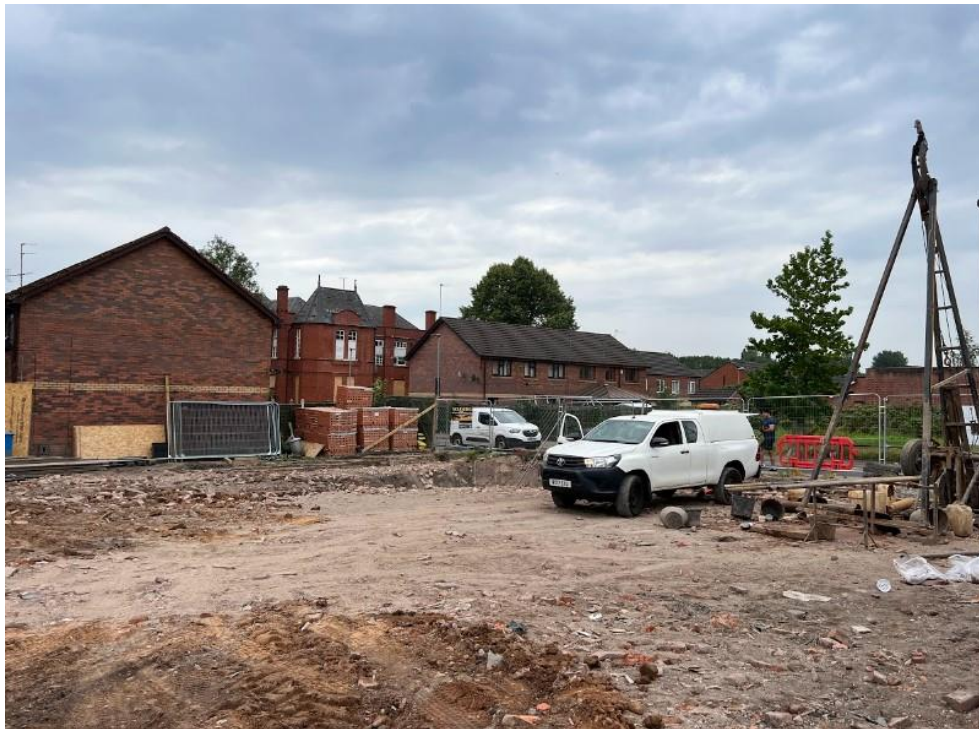
Photograph taken viewing southwest showing general overview of the site. Note large slope in the southwest corner.

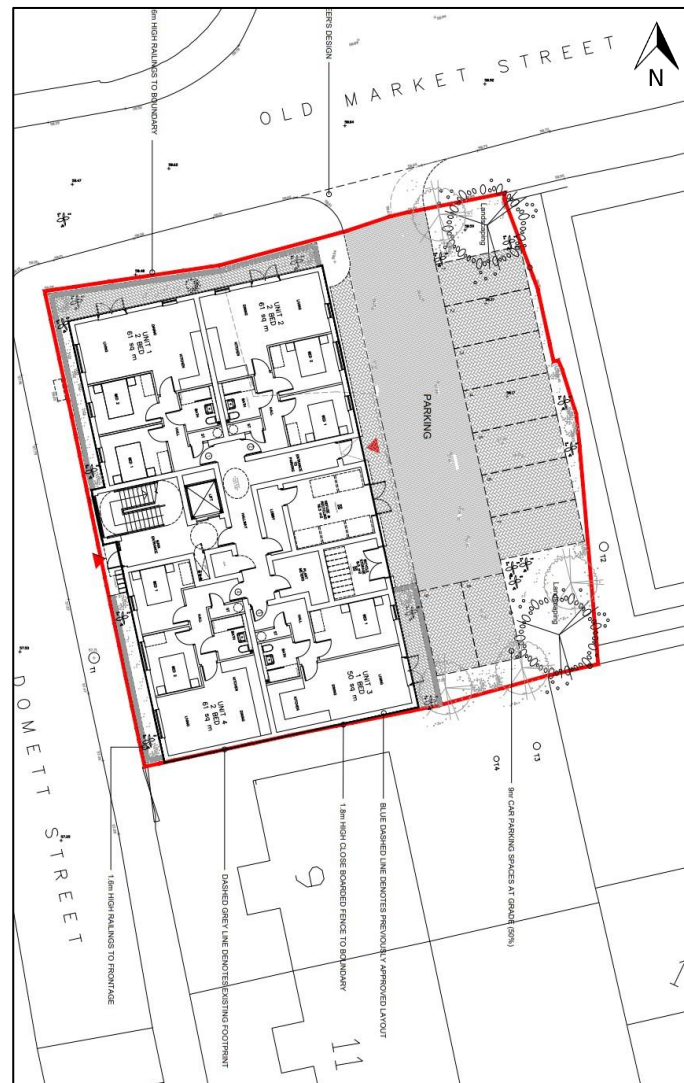
**Figure 3: Proposed Development Plan**

It is understood that the client wishes to construct an apartment building with 12 two bed units and 6 one bed units, with parking and soft landscaping.

The proposed development layout details are shown in Figure 3 below.
