## **PHASE 1: DESK TOP STUDY AND COAL MINING RISK**

### **ASSESSMENT REPORT**

#### **FAIRBRIAR HATBOX LIMITED / SCARBOROUGH DEVELOPMENT GROUP**

#### **BOWLERS YARD**

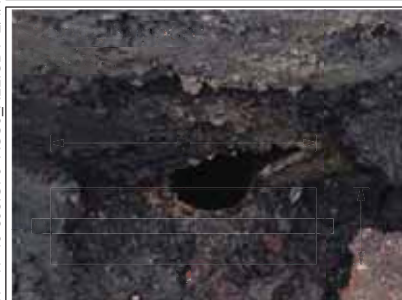
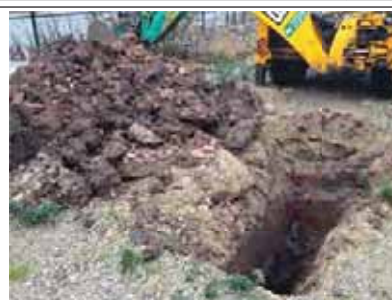
| STRATA | | | SAMPLES & TESTS | | |
|---|---|---|---|---|---|
| 2.40 | | Trial pit terminated at 2.40m due to refusal on concrete in base of pit. Relic brick walls in ends of pit with a c.300mm diameter pot lined 'well' like feature in base / side of pit extending to c.4.20m BGL. Noted as dry. | | | |

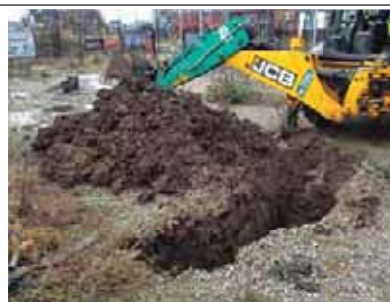
| STRATA | | | SAMPLES & TESTS | | |
|---|---|---|---|---|---|
| 2.50 | | Trial pit terminated at 2.50m. | 2.50 | V | 120kN/m <sup>2</sup> |

WATER: Upon completion, trial pit recorded as dry and open.

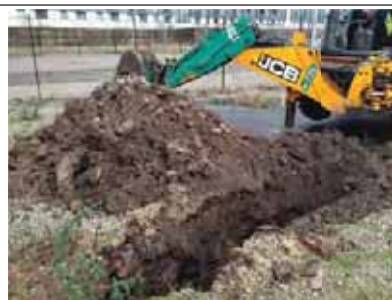
| STRATA | | | SAMPLES & TESTS | | |
|---|---|---|---|---|---|
| | | | 2.50 | V | 120kN/m <sup>2</sup> |

WATER: Upon completion, trial pit recorded as dry and open.

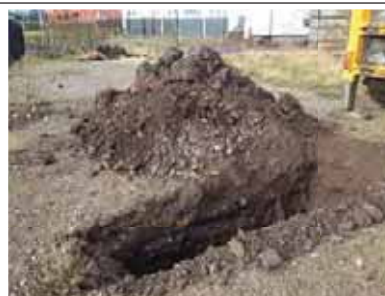
| STRATA | | | SAMPLES & TESTS | | |
|---|---|---|---|---|---|
| | | | 2.50 | V | 120kN/m <sup>2</sup> |

WATER: Upon completion, trial pit recorded as dry and open.

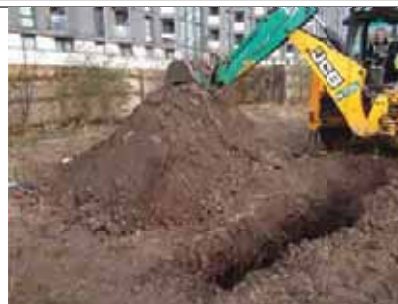
| STRATA | | | SAMPLES & TESTS | | |
|---|---|---|---|---|---|
| 3.00 | | Trial pit terminated at 3.00m. Relic brick walls across pit. | 3.00<br>3.00 | B<br>V | 120kN/m <sup>2</sup> |

WATER: Upon completion, trial pit recorded as dry with slight wall collapse from surface.

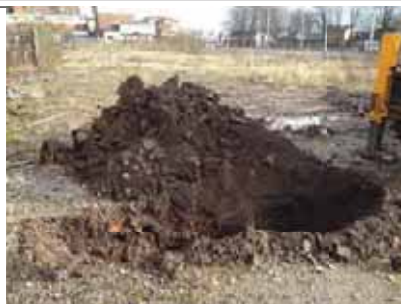
| STRATA | | | SAMPLES & TESTS | | |
|---|---|---|---|---|---|
| 2.50 | | Trial pit terminated at 2.50m. | 2.50 | V | 120kN/m <sup>2</sup> |

WATER: Upon completion, trial pit recorded as dry and open.

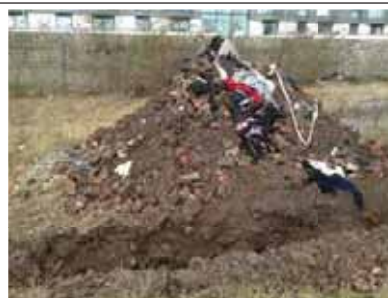
| STRATA | | | SAMPLES & TESTS | | |
|---|---|---|---|---|---|
| 3.20 | | Trial pit terminated at 3.20m due to refusal on possible concrete floor and owing to collapse of side walls. | 2.00 | J/D | |

WATER: Upon completion, trial pit recorded as dry with slight wall collapse from surface.

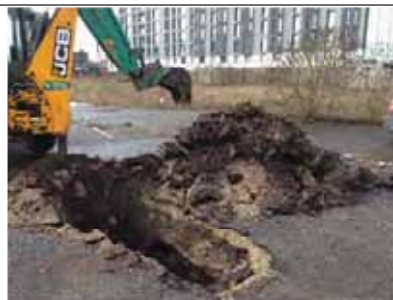
| STRATA | | | SAMPLES & TESTS | | |
|---|---|---|---|---|---|
| | | | 2.50 | V | 120kN/m <sup>2</sup> |

WATER: Upon completion, trial pit recorded as dry and open.

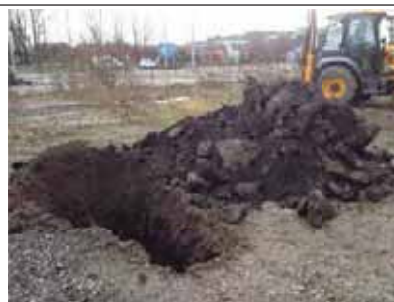
| STRATA | | | SAMPLES & TESTS | | |
|---|---|---|---|---|---|
| 2.50 | | Trial pit terminated at 2.50m. | 2.50 | V | 120kN/m <sup>2</sup> |

WATER: Upon completion, slight water ingress from 1.60m.

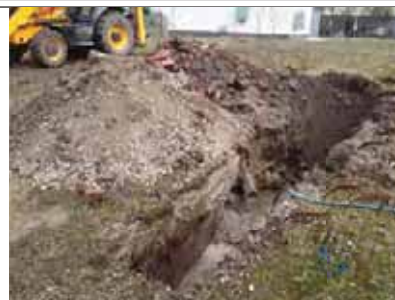
| STRATA | | | SAMPLES & TESTS | | |
|---|---|---|---|---|---|
| 1.20 | | Trial pit terminated at 1.20m due to relic concrete floor. Relic brick walls in ends and side of pit. | | | |

WATER: Upon completion, standing water level recorded at 1.00m.

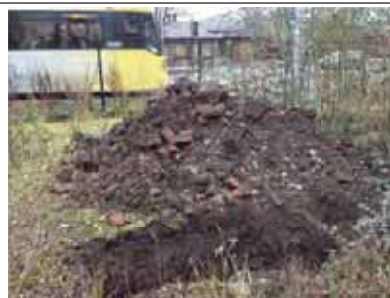
| STRATA | | | SAMPLES & TESTS | | |
|---|---|---|---|---|---|
| 2.80 | | Trial pit terminated at 2.80m. | 2.60<br>2.70 | B<br>V | 120kN/m <sup>2</sup> |

WATER: Upon completion, slight water ingress from 1.20m with slight wall collapse from surface.

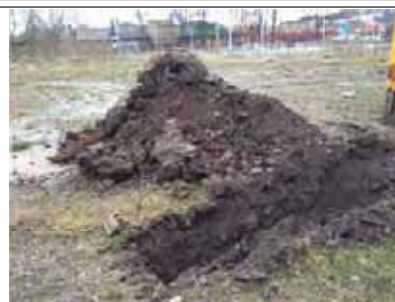
| STRATA | | | SAMPLES & TESTS | | |
|---|---|---|---|---|---|
| 2.70 | | Trial pit terminated at 2.70m. | | | |

WATER: Upon completion, trial pit recorded as dry and open.
