**University of Manchester - Graham and Ewings Halls  
of Residence Re-development  
Bats: Building and Activity Surveys**

**Simply Ecology Limited**

**Ref: SE/GTHQ001/02**

**October 2022**

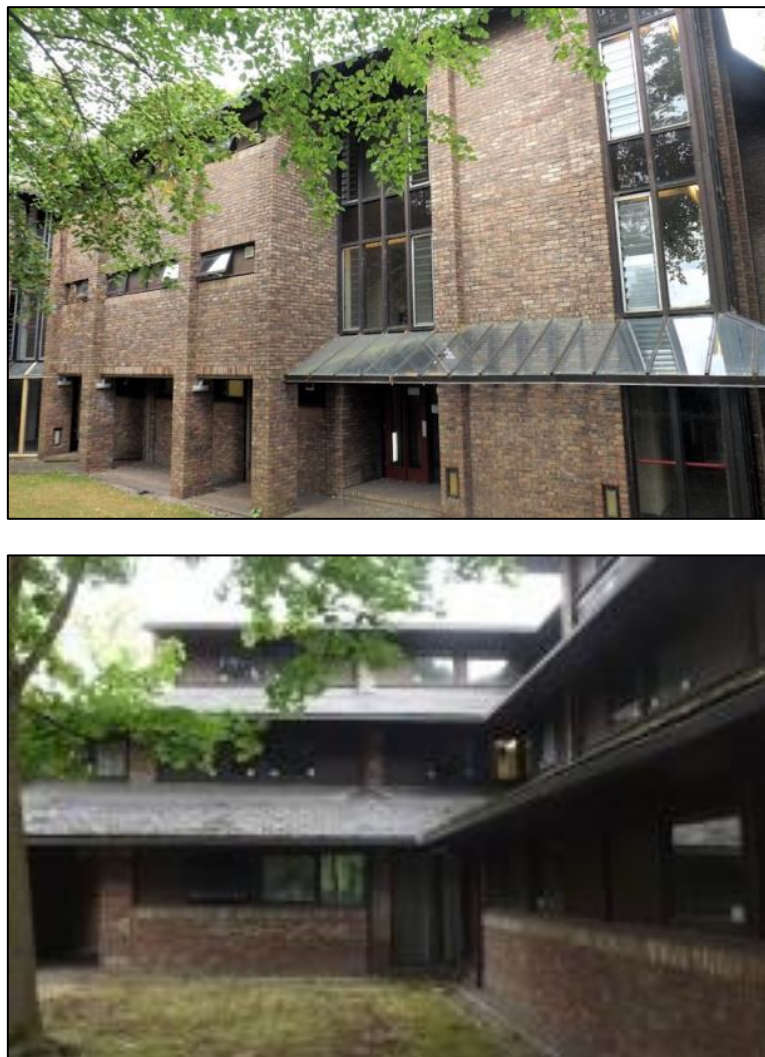
- 3.1.2 The survey began by checking the exterior of the buildings. Both Ewing Hall and Graham Hall were purpose built in the 1980s (see Plate 1). They were constructed from red brick with overlapping tile on pitched roofs. They both appeared to be generally, structurally sound although there was evidence of water damage on some of the soffits.

*Plate 1: General views of Ewing and Graham Hall*

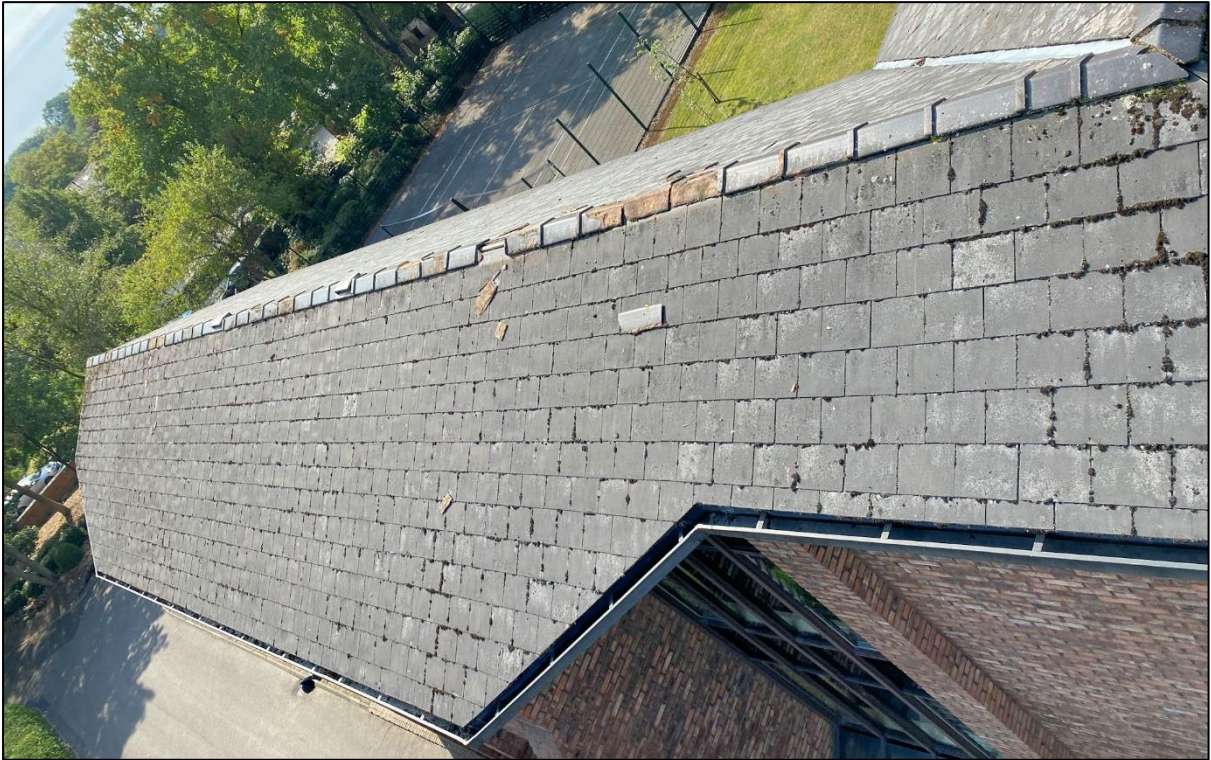
- 3.1.3 The inspection began by checking the roof of the building. The roofs were pitched and of overlapping asbestos cement tiles. Whilst the general condition of the roofs was satisfactory, and with tightly interlocking tiles, there were some missing and broken ridge tiles with gaps

beneath (see Plate 2 & Plate 3). It was clear from the inspection that these gaps and crevices would provide Potential Roost Features (PRFs) for bats (see Plate 4 & Plate 5).

*Plate 2: General roof view from MEWP broken and missing ridge tiles were apparent.*

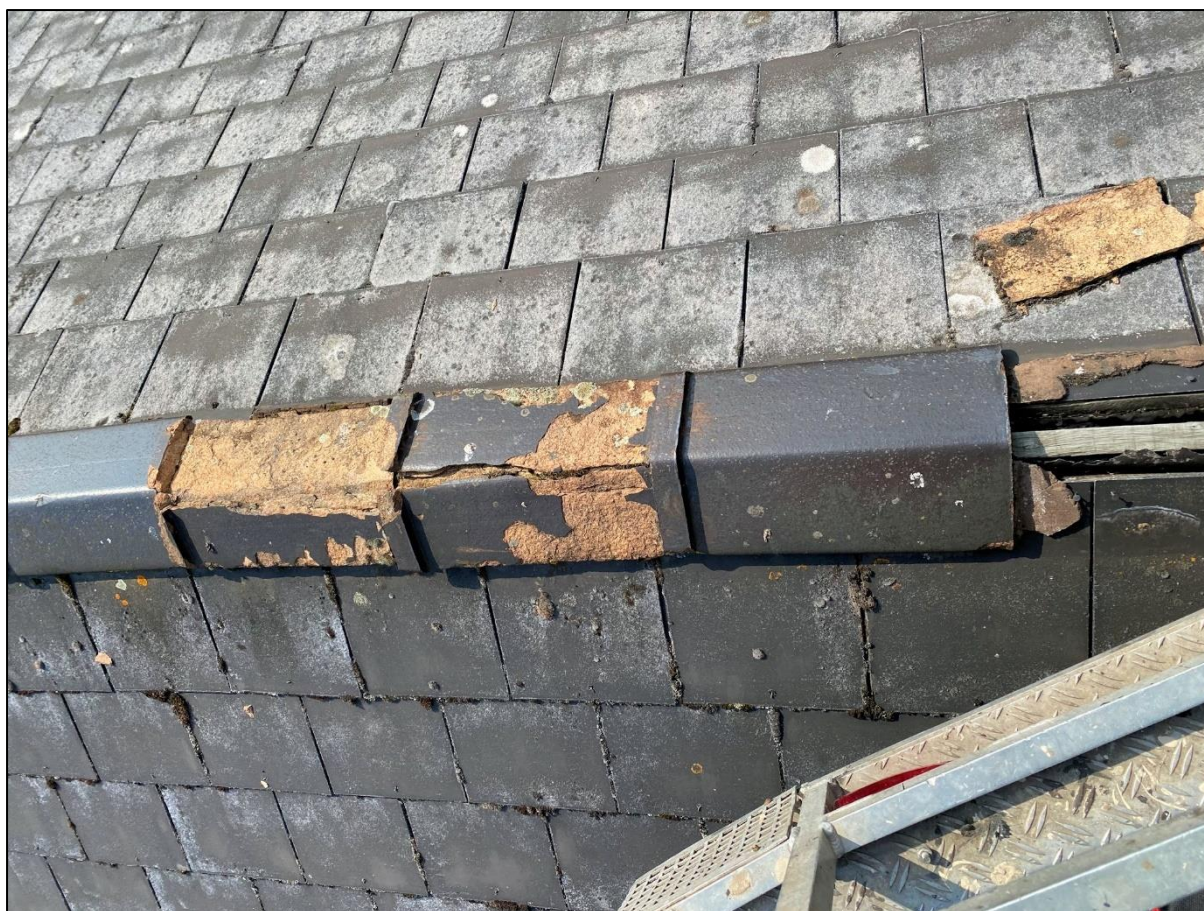
*Plate 3: Missing and broken ridge tiles were apparent across the roofs.*

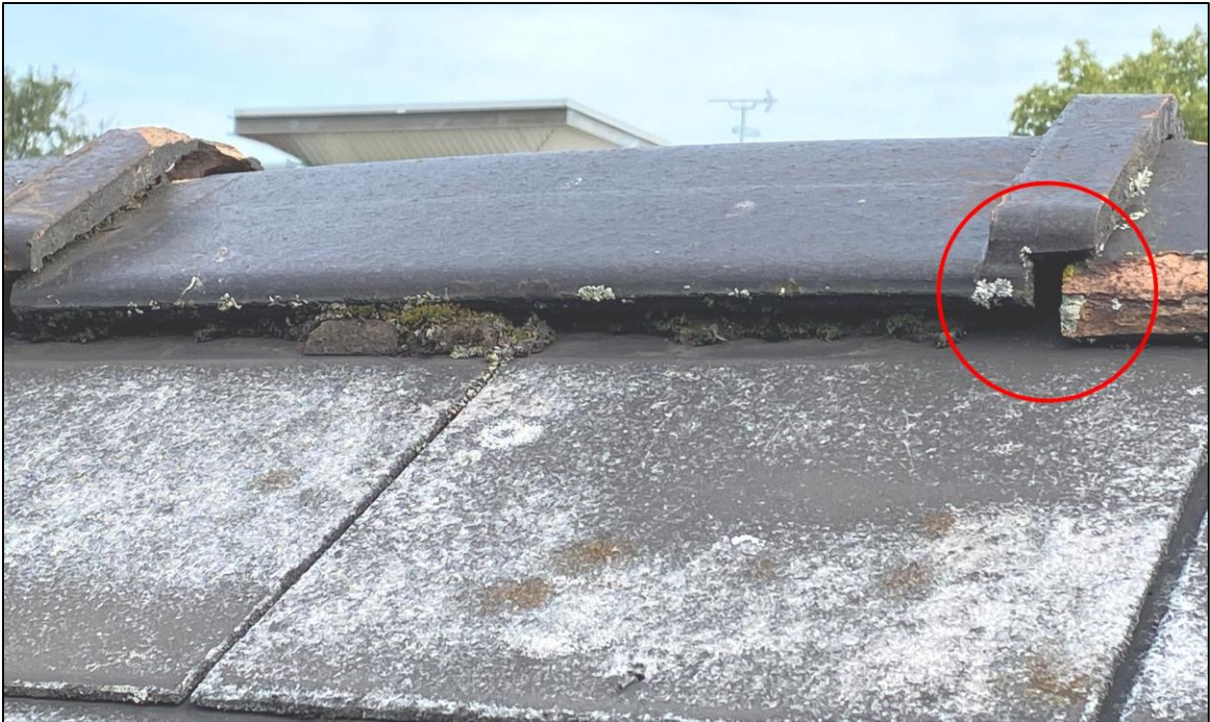
*Plate 5: Even where ridge tiles were intact there were significant gaps beneath them.*

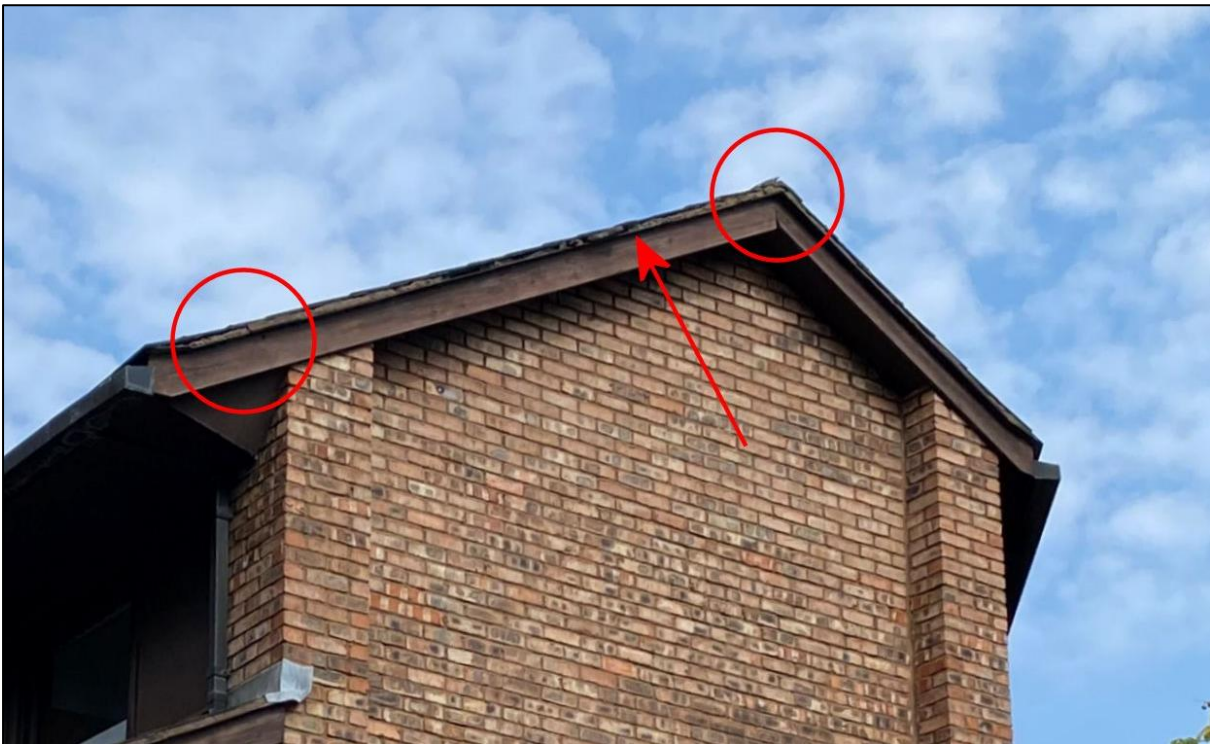
- 3.1.4 The verges were generally intact although there were areas of broken and missing mortar (see Plate 6). These were in typical locations used by bats, and so these areas of missing mortar were considered to be PRFs.

*Plate 6: Numerous gaps were apparent in the verges of the buildings.*

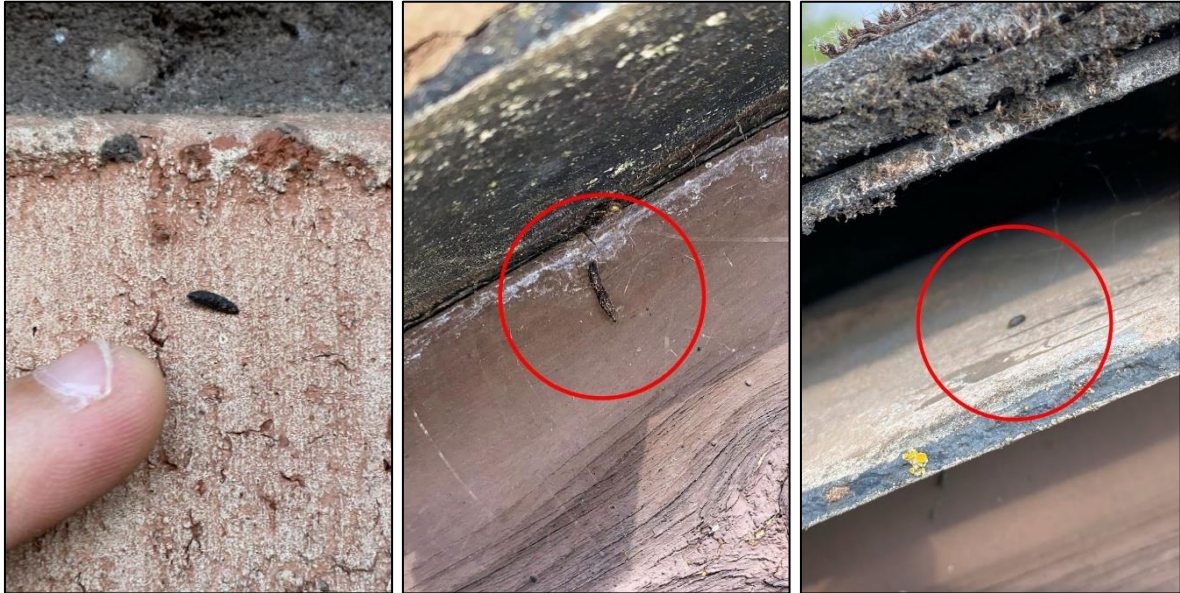
- 3.1.5 Within and below the gaps of the verge on the south face of Ewings were a small number of bat droppings (see Plate 7). The position of these droppings high upon the building were considered likely to be associated with bat roosts.
- 3.1.6 The eaves and soffits were generally in fair condition, although gaps were apparent in the soffits which offered some low bat roost potential (see Plate 8 and Plate 9).

*Plate 7: Droppings were identified within and below the verges of the building.*

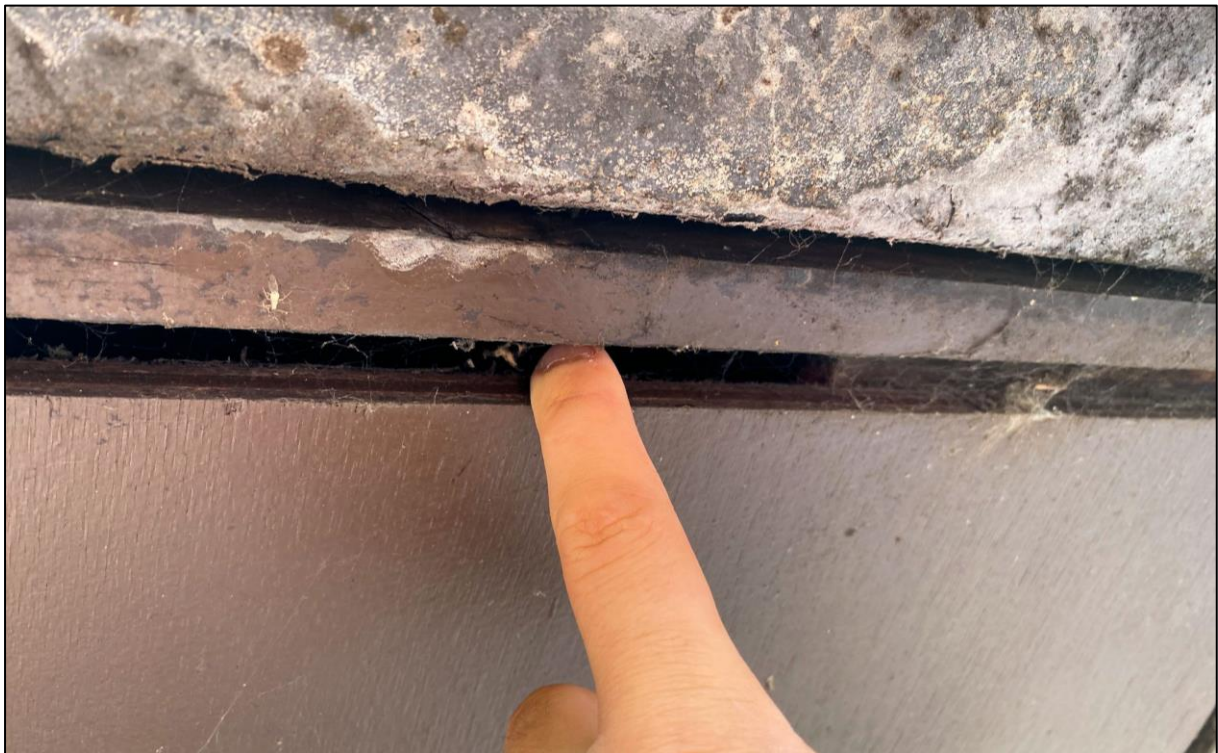
*Plate 8: The soffits were generally intact although they were not well sealed and may offer low level Roosting Potential.*

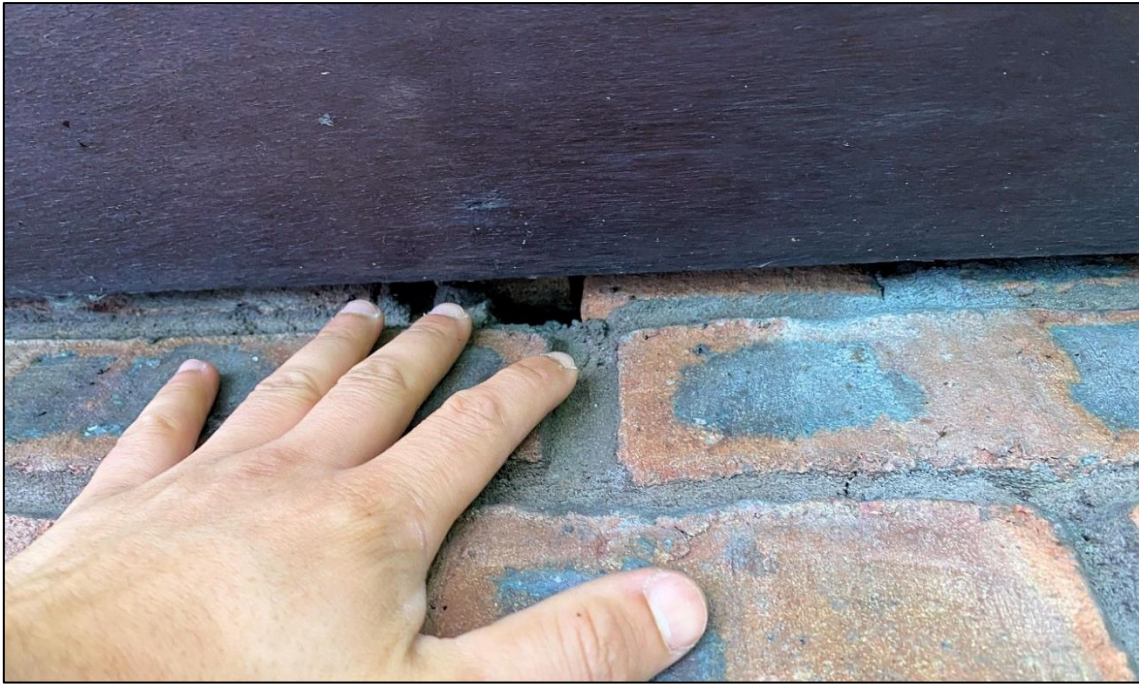
*Plate 9: Gaps were apparent around the soffits providing potential access to internal roosting opportunities.*

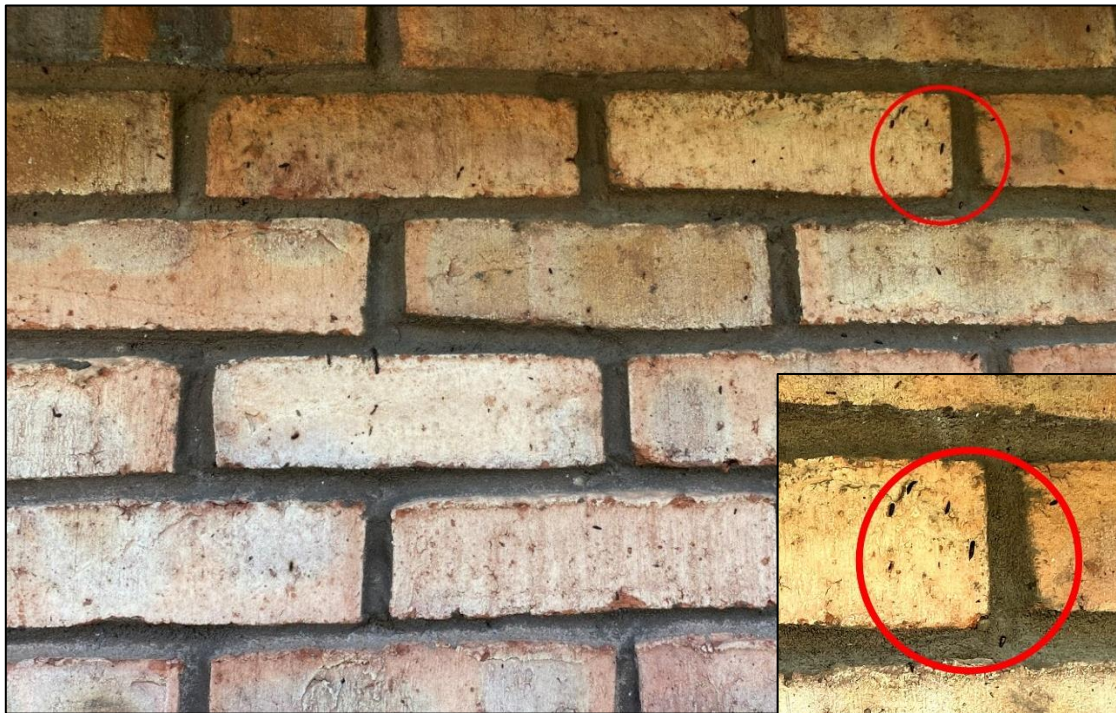
- 3.1.7 The barge boards on the gable ends of Graham were also not well sealed and offered some further low level roosting potential.
- 3.1.8 The external walls of the two halls were examined and evidence of bat activity, in the form of droppings, was found on the external walls of Ewings Hall (see Plate 10) beneath some of the soffit gaps. Again, the location of these were considered likely to be associated with bat roost presence.

*Plate 10: There were numerous bat droppings on a north facing aspect of Ewings (see inset).*

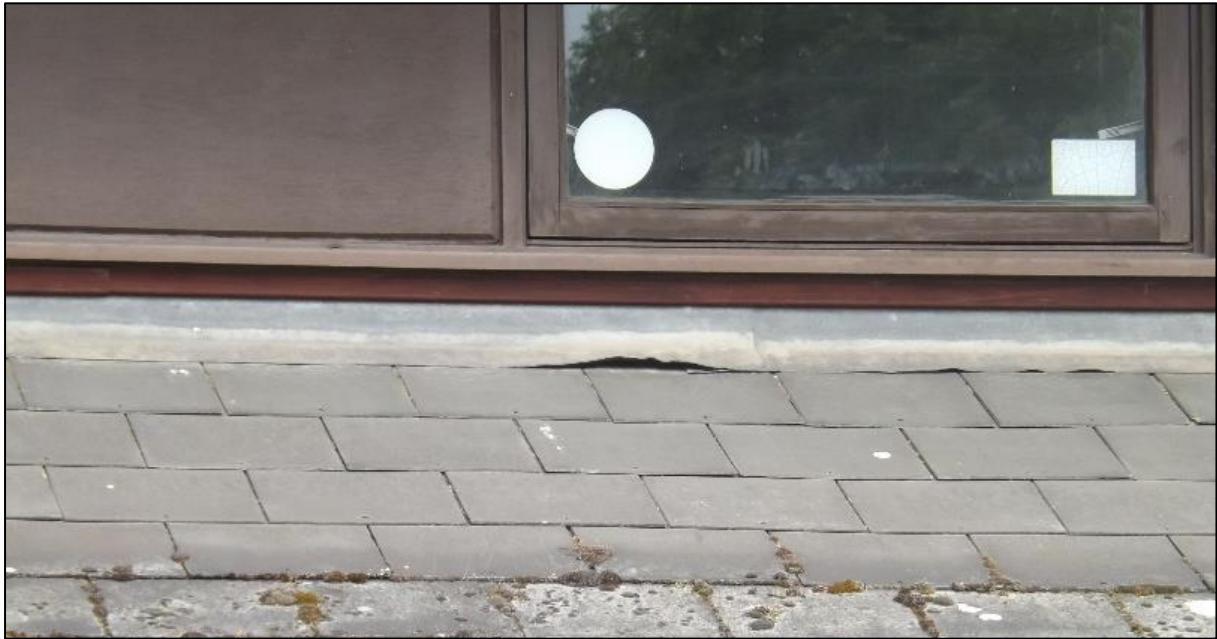
- 3.1.9 Across both buildings, the window and door frames were generally intact with no obvious roost potential. However, the flashing around some of the frames was not flush with the roof tiles (see Plate 11). These might be PRFs.

*Plate 11: The flashing around window frames was not flush in places, leaving Potential Roosting space underneath.*

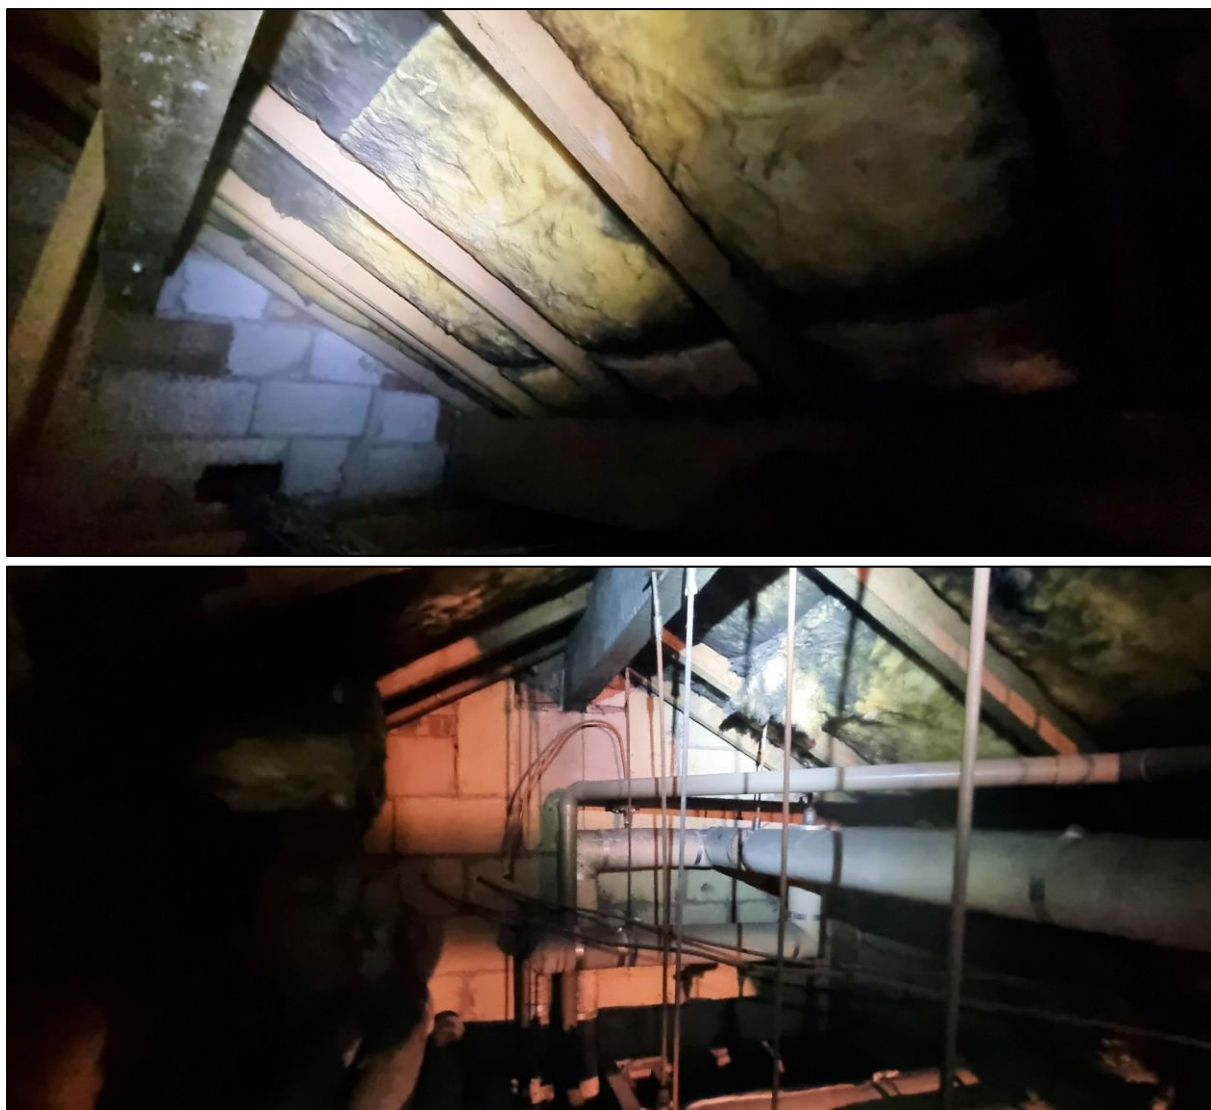
*Plate 13: The roof voids were subdivided into separate spaces that were open to the roofing timbers and insulation.*

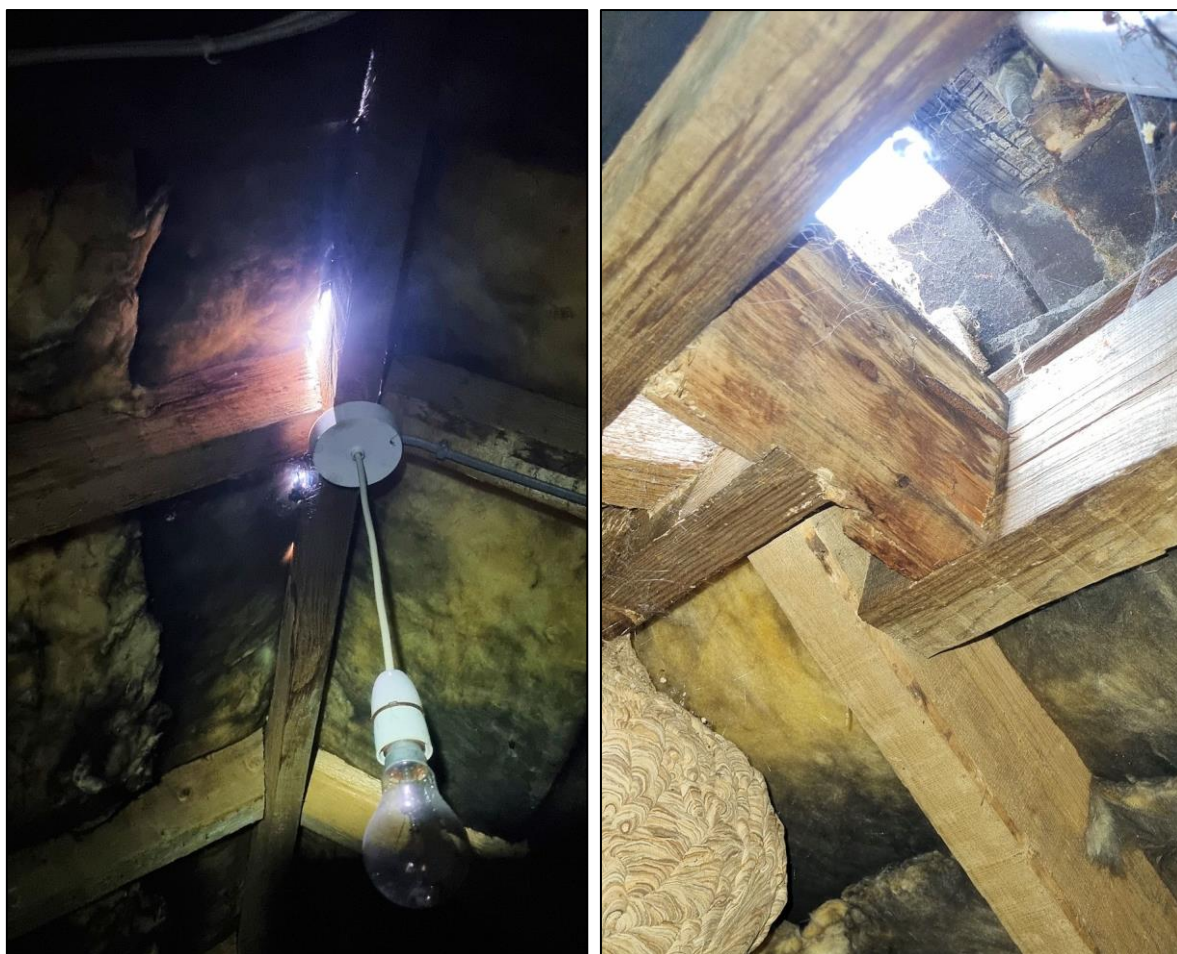
- 3.1.13 Gaps in the roof ridges were apparent that would allow unrestricted access to the internal space (see Plate 14 **Error! Reference source not found.**).

*Plate 14: Gaps in the ridges identified externally allowed potential access to the internal voids.*

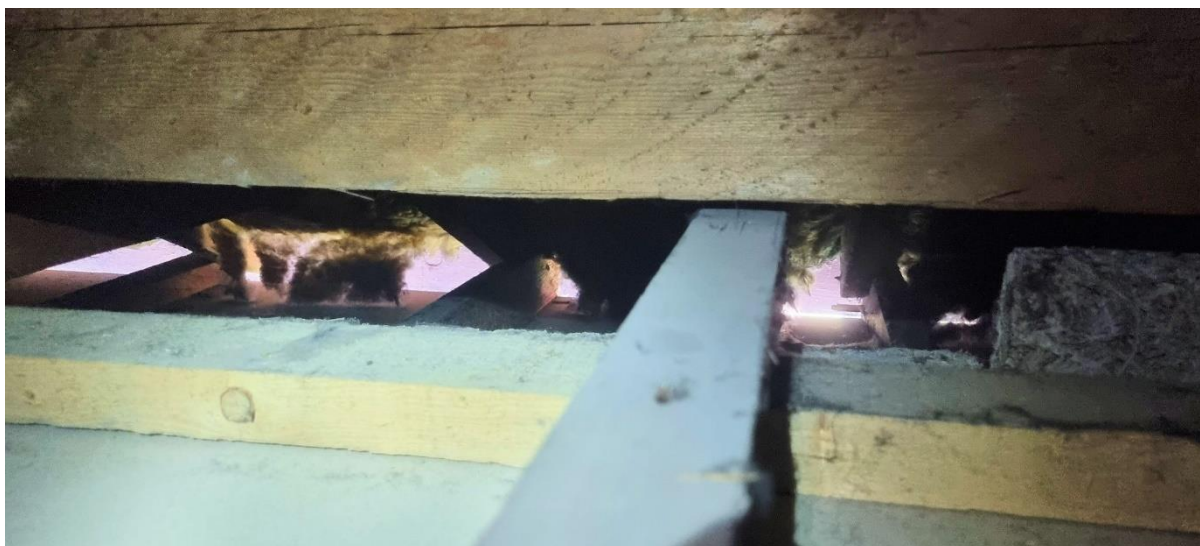
- 3.1.14 Gaps were around the soffits were also apparent in places which allowed further potential access to the internal voids (see Plate 15).
- 3.1.15 Flat surfaces and floors within the void were thoroughly searched for evidence of bat activity. Overall the vast majority of the loft spaces in both buildings did not reveal and evidence of bats or bat activity (e.g., droppings, discarded prey items). However, within Ewings a large collection of droppings were found adjacent to the feature identified externally (see Paragraph 3.1.8 and Plate 16) as well as a small number by the gable wall identified in Paragraph (see Plate 17). This added to the findings of the external survey which found bat

*Plate 15: An internal view of the soffits in Graham.*

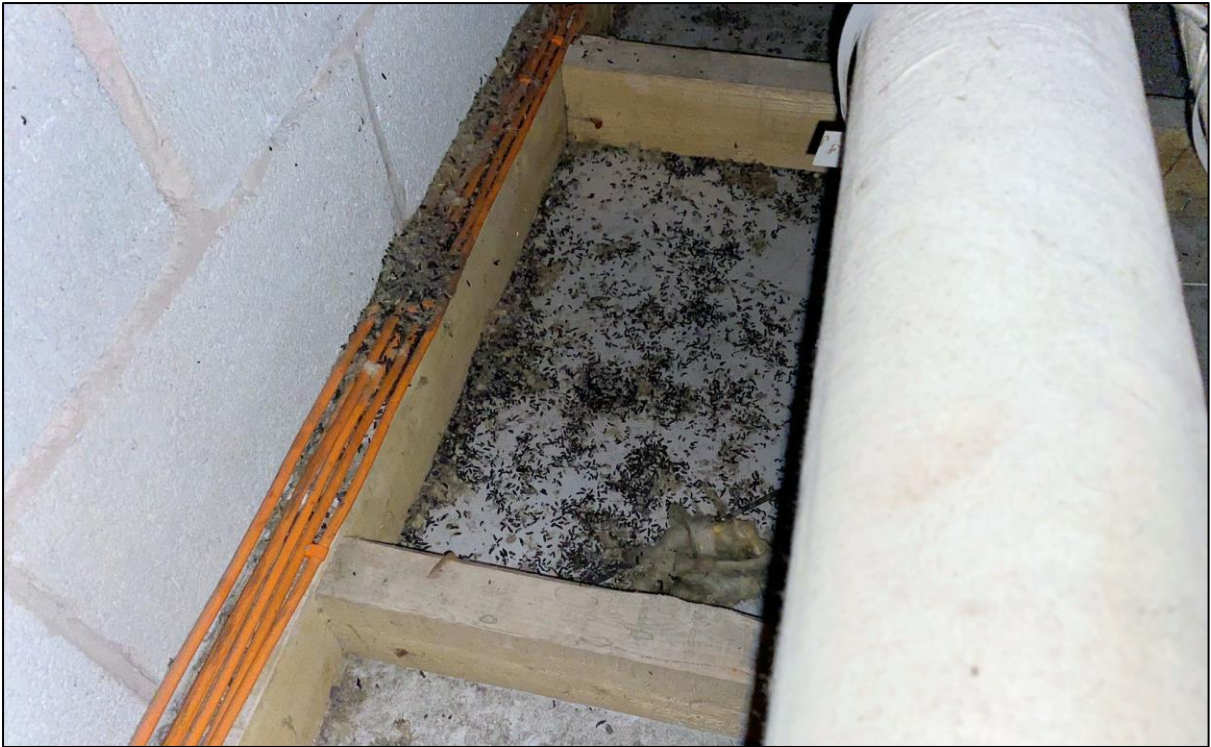
*Plate 16: A large collection of bat droppings was identified in a void in Ewings.*

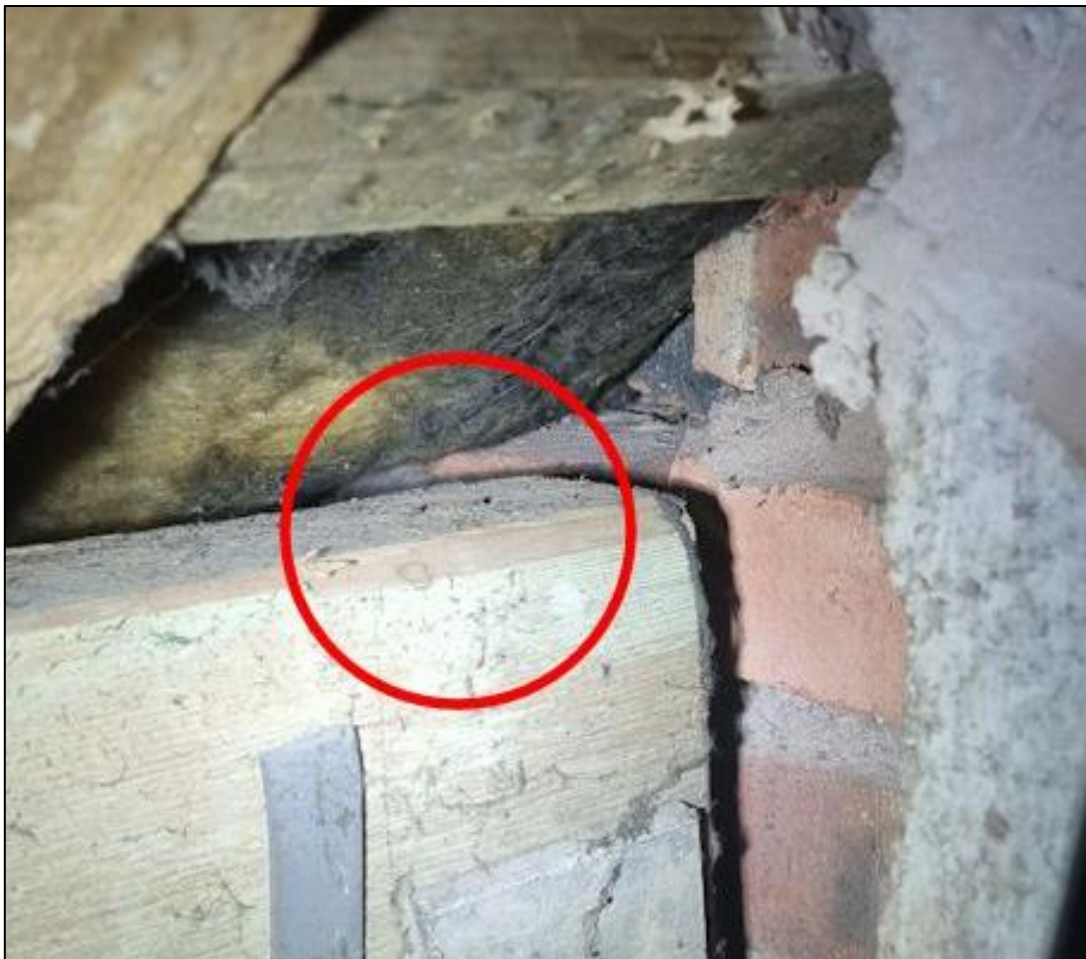
droppings close to the PRFs and the findings of the internal survey confirmed the high likelihood that active bat roosts were present, particularly in Ewings. No evidence of bat roosting was found in Graham.

*Plate 17: Elsewhere there was further evidence of bat activity in the form of droppings by Ewings' gable wall.*

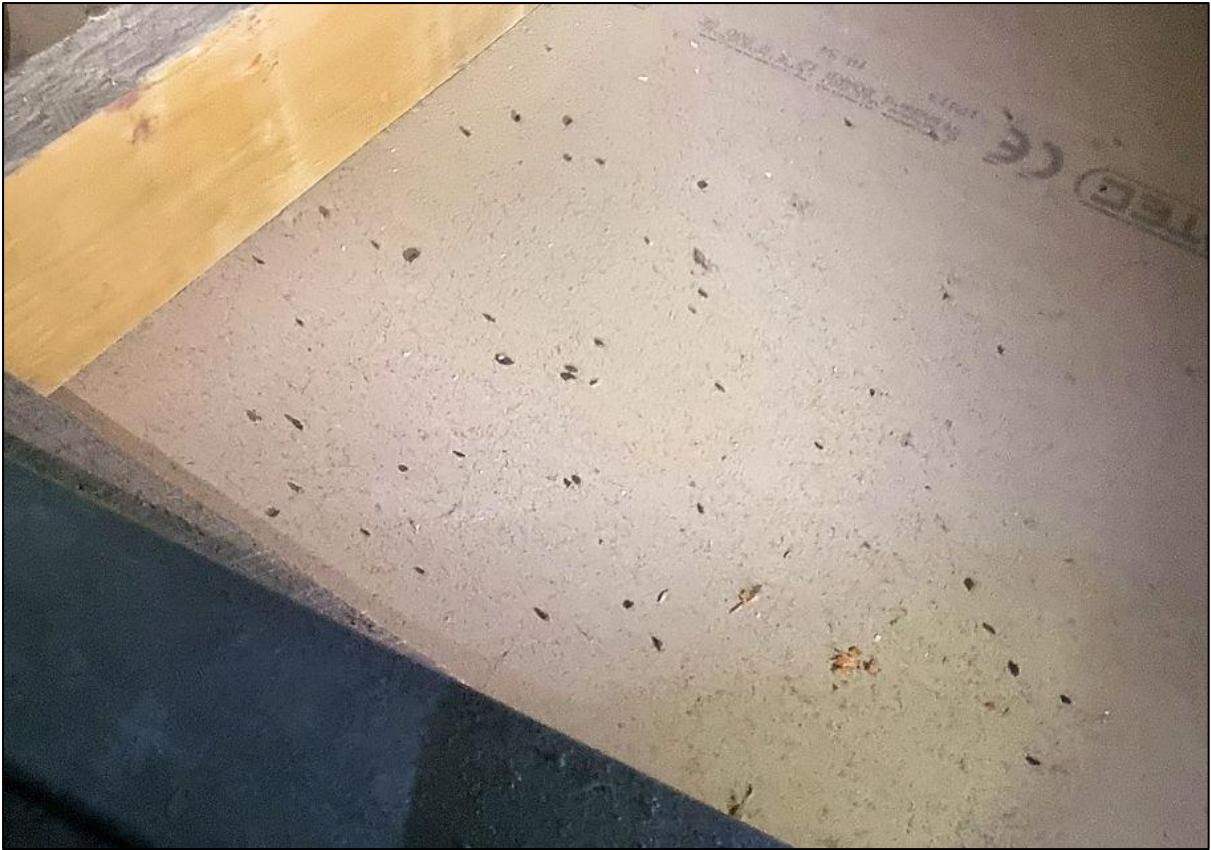
- 3.1.16 In addition, there was significant evidence of mouse activity throughout the roof voids (see Plate 18). In addition some wasps nests were present in the loft voids (see Plate 19).

*Plate 18: There was evidence of mouse activity in the roof void of Graham Hall.*

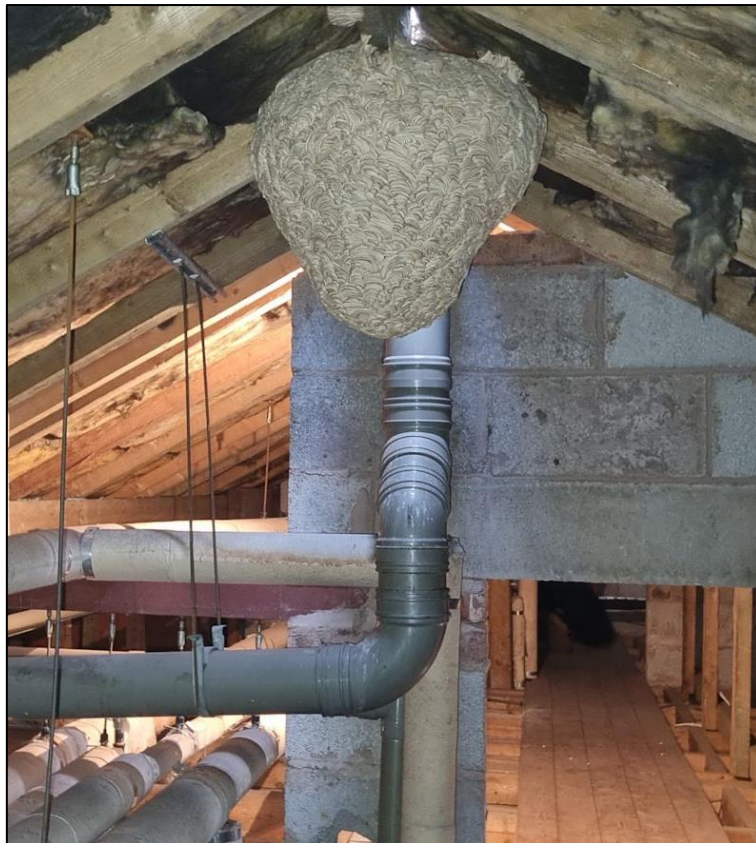
*Plate 19: A number of wasp nests were also identified with a substantial nest in a Ewings roof void*

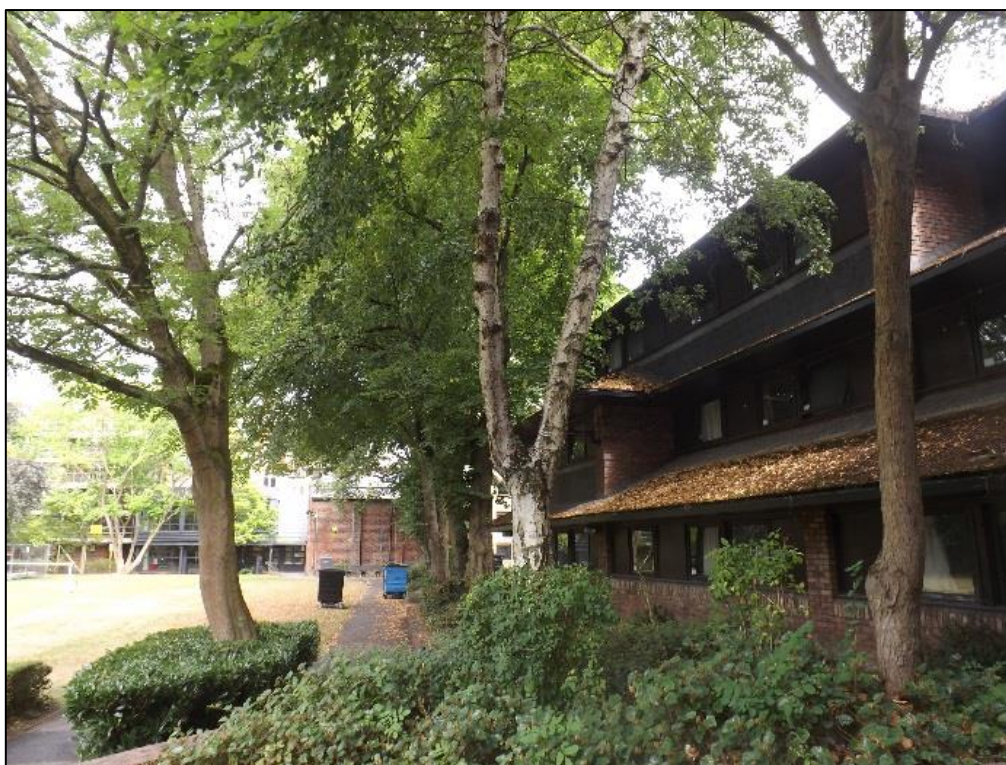
3.2.3 The trees were all large and mature specimens, which were growing in close proximity to the halls. A thorough ground level tree inspection found that the trees which are due to be impacted by the proposed works had no PRFs and there were no signs or presence of features such as knot holes or hazard beams which would have indicated their use by bats (see Plate 20 and Plate 21). As such, all of the trees were categorised as Class 3 trees, with negligible potential to support any bat roosts.

*Plate 20: None of the trees adjacent to Graham Hall had any PRFs.*

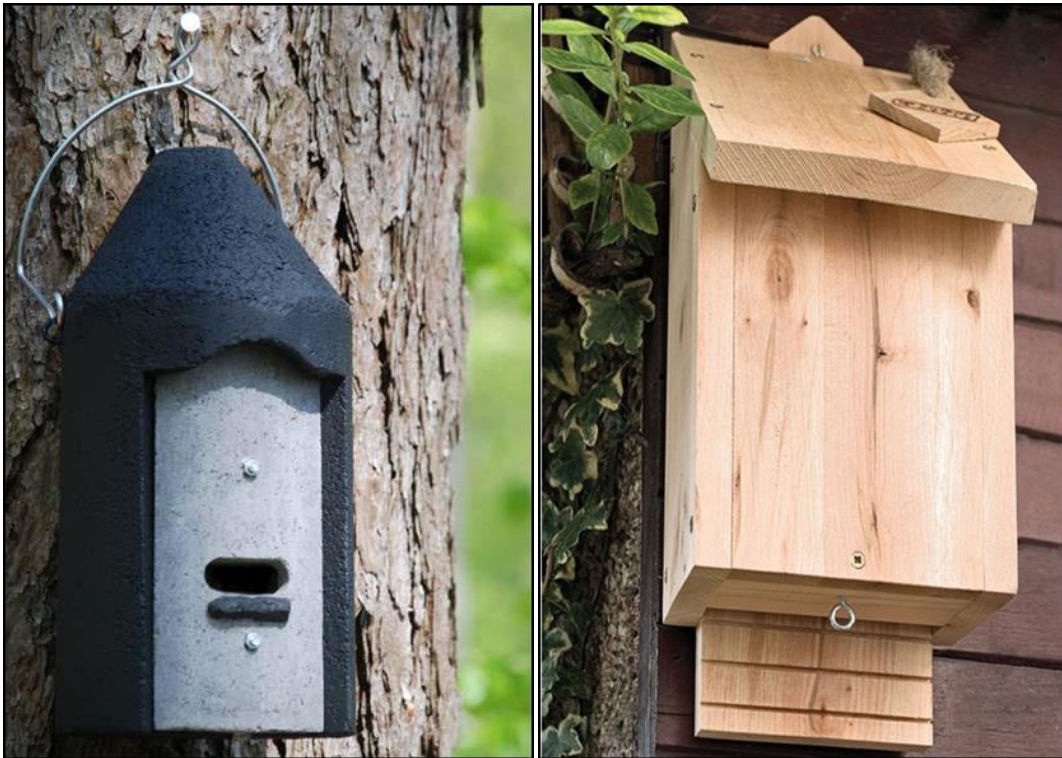
Plate 23: 1 x tree or wall mounted bat box must be installed prior to commencement of work.

- Prior to any works commencing on site, a new semi-permanent roost should be introduced on site. This will ensure that alternative roosting is available at the site prior to roost disturbance and reduce any low impacts during the period of time that the works are taking place. This should be in the form of 1 bat box (e.g. see Plate 23), to be placed in a mature tree nearby. This should be placed high (ideally 4m above ground if possible) and facing either south or south west.

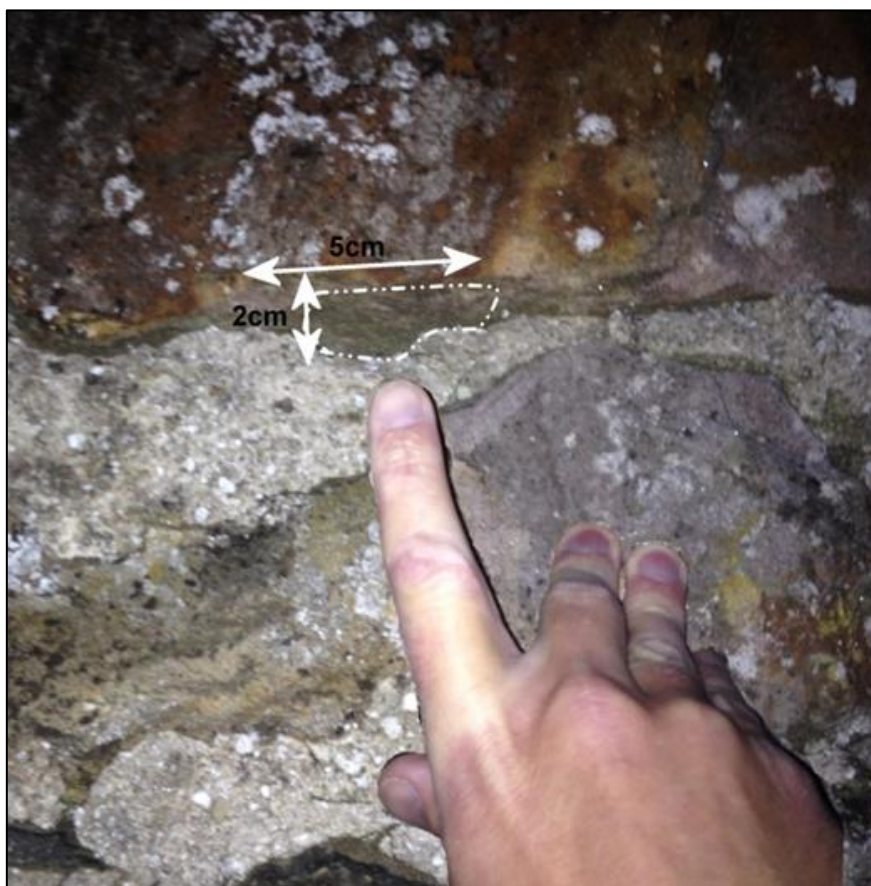
*Plate 24: Example of an existing bat roost entrance (2cm by 5cm crevice).*

suggest creating a new crevice within the verges. The crevice should be created in the mortar; a timber batten or similar should be put in place during the works so that a clear gap is retained. The batten needs to be approx. 2-3cm wide and 5-10cm wide. **The crevice must be no larger than this, otherwise birds will use it for nesting.** This will create crevice access point that is suitable for bat roost access all the way through to the bat brick.

- Once mortaring work is finished, remove the temporary batten. The bat roost is complete (See Plate 24).
