Our Ref: 70101534-12011  
15 September 2022  
CONFIDENTIAL

**Angel Meadows Plots 2 & 3, Manchester  
Letter Report on Remediation Activities**

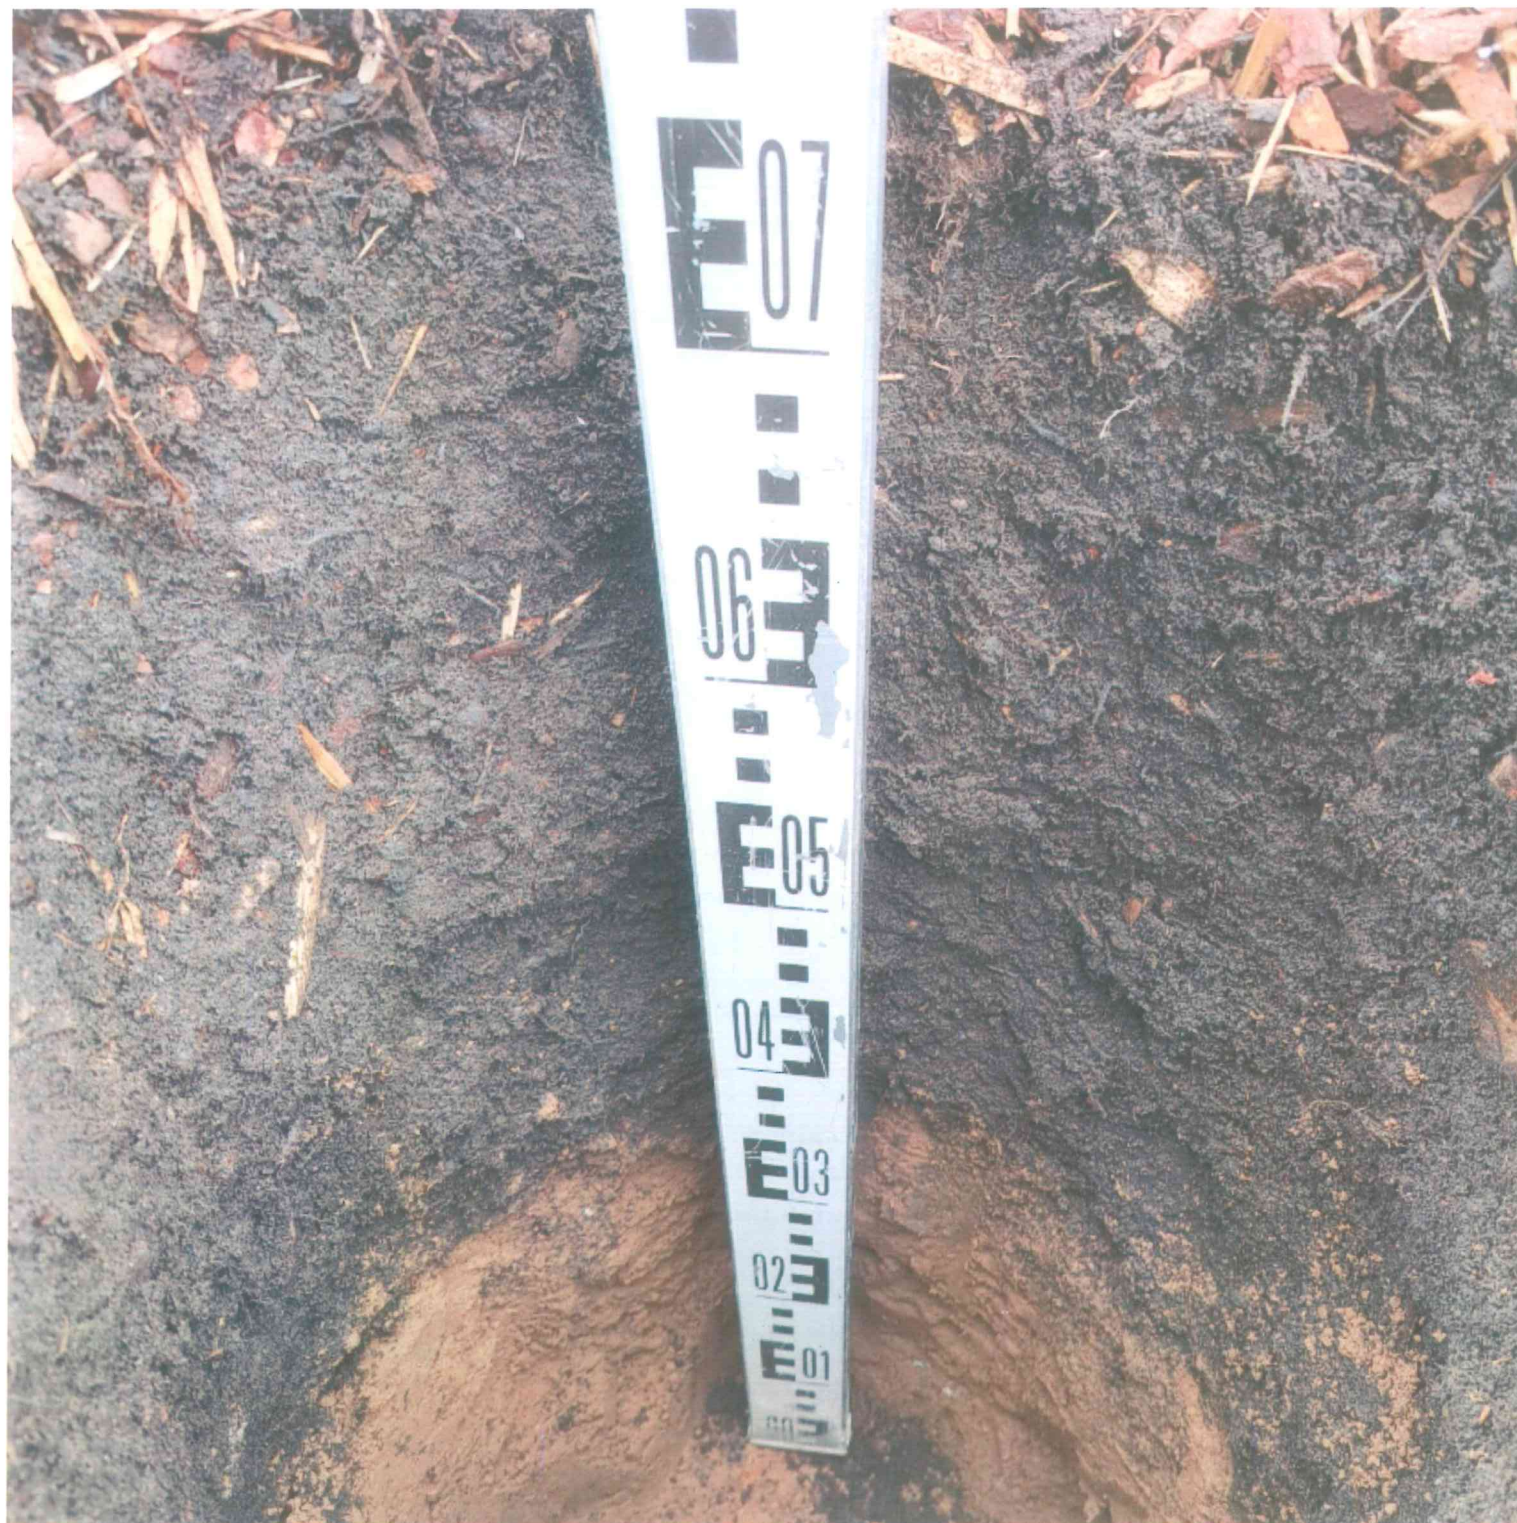
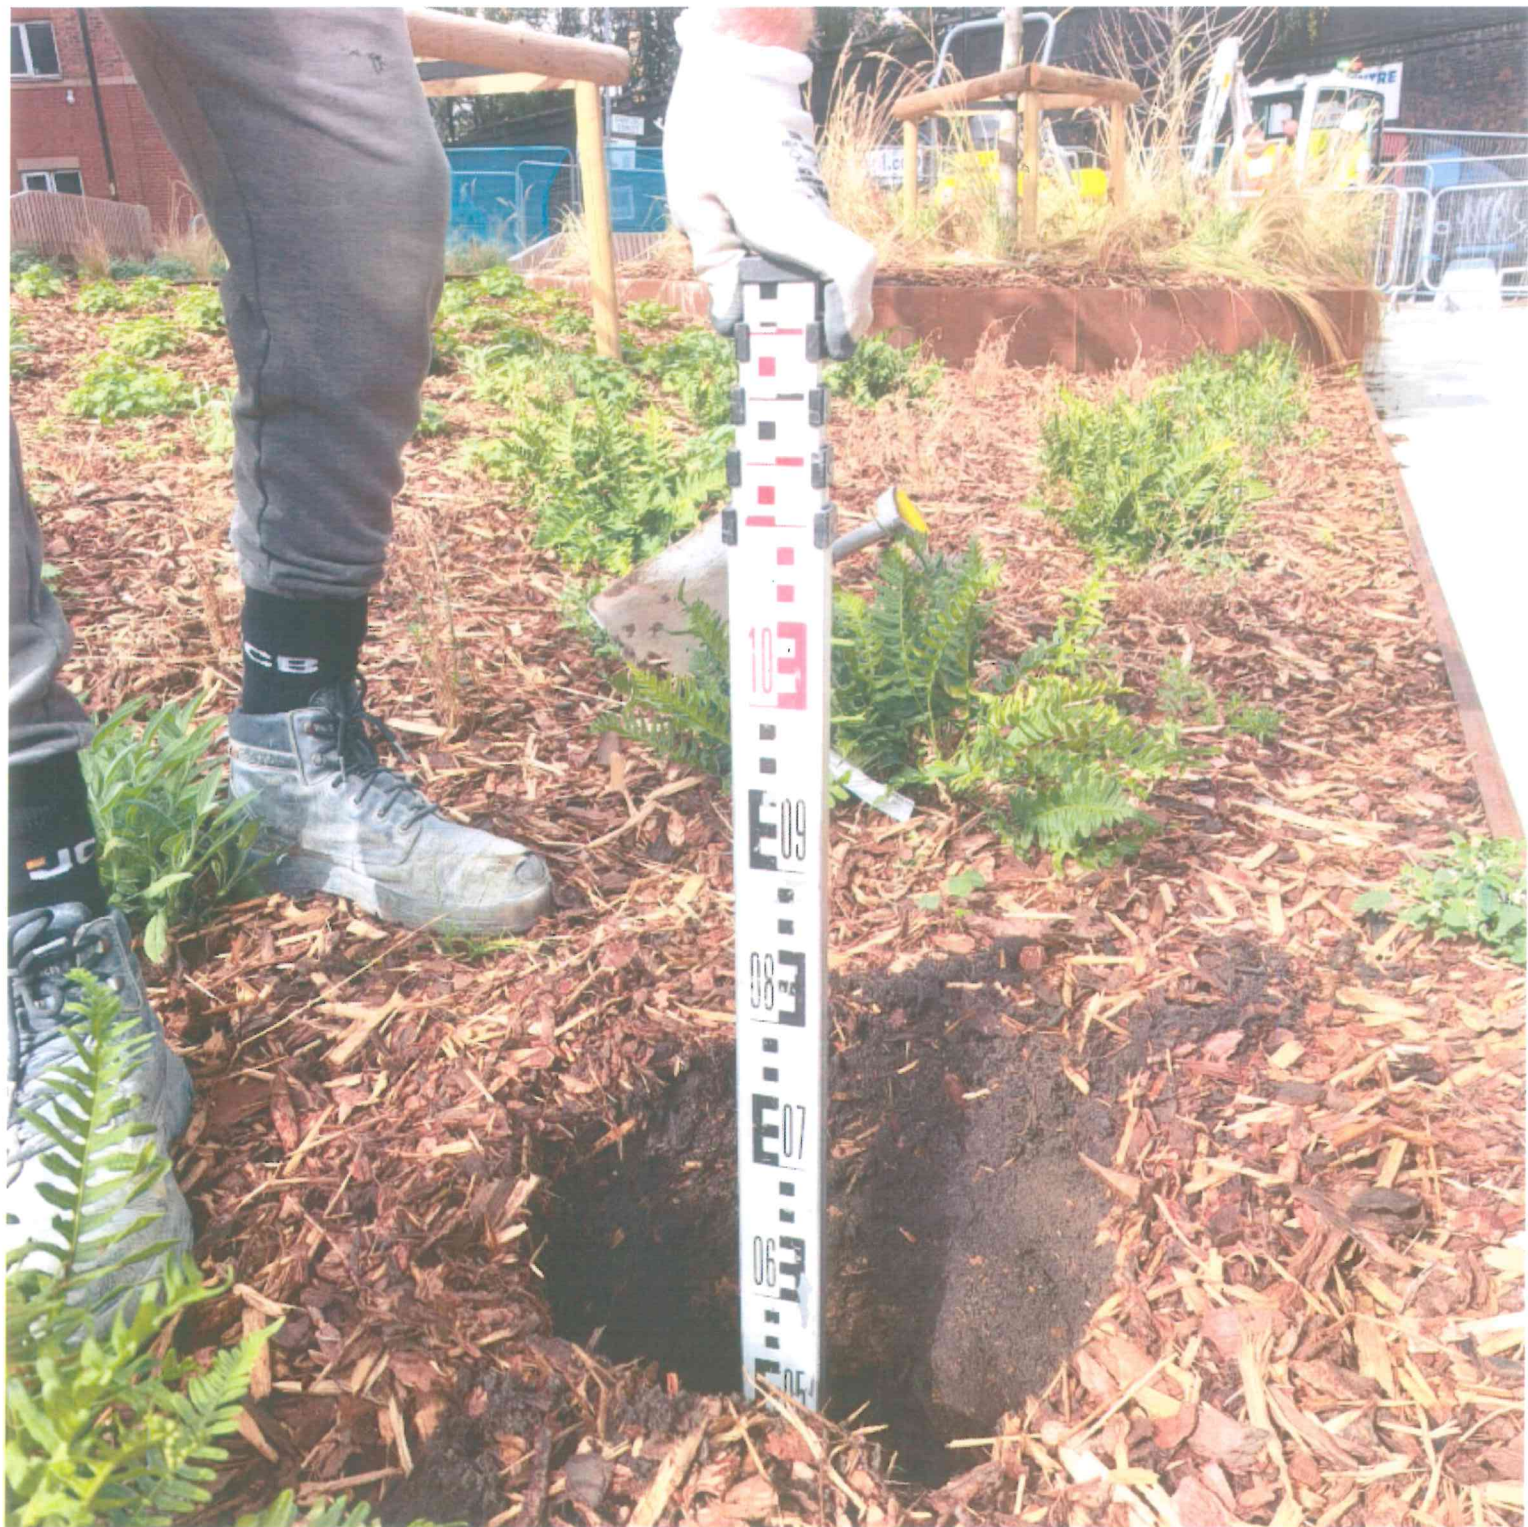
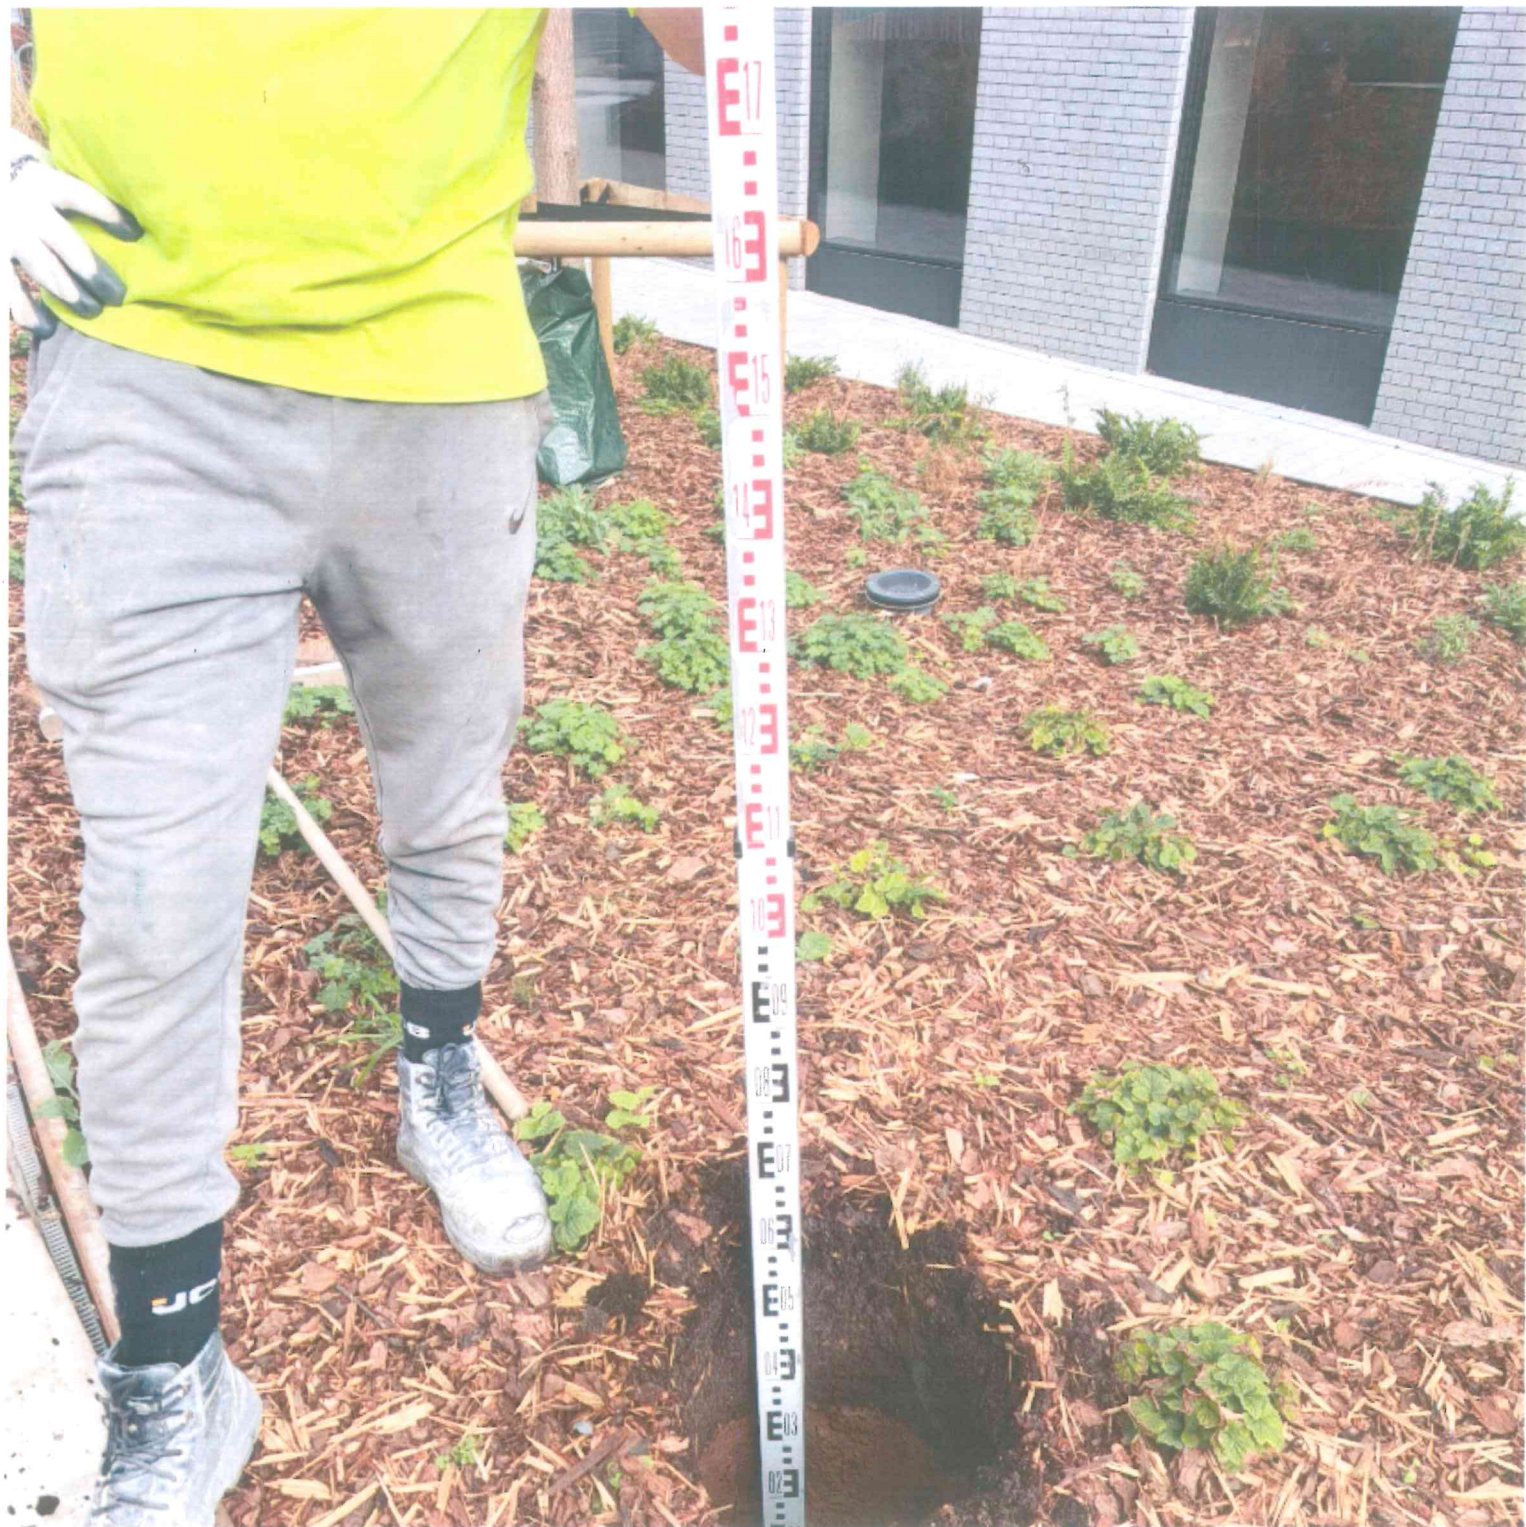
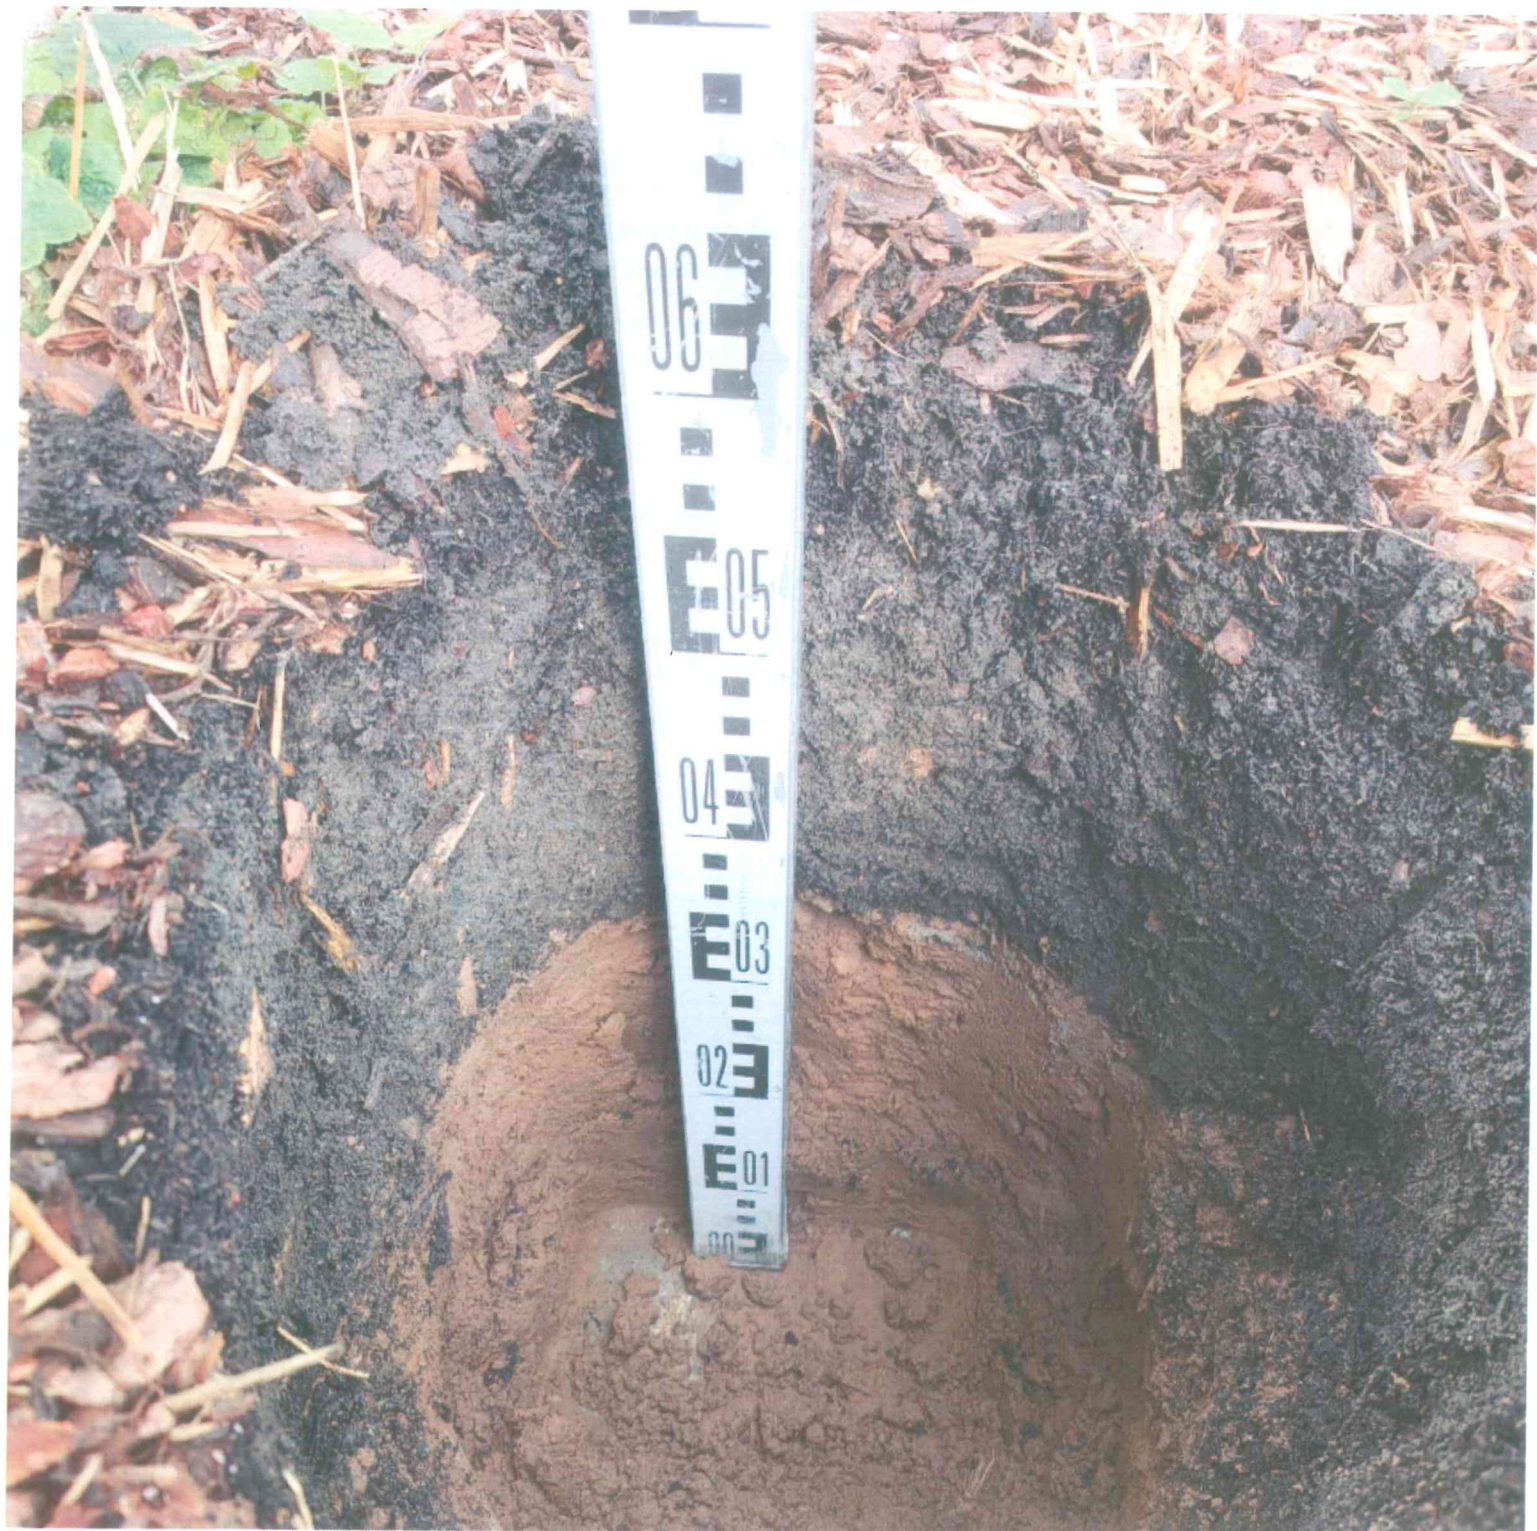
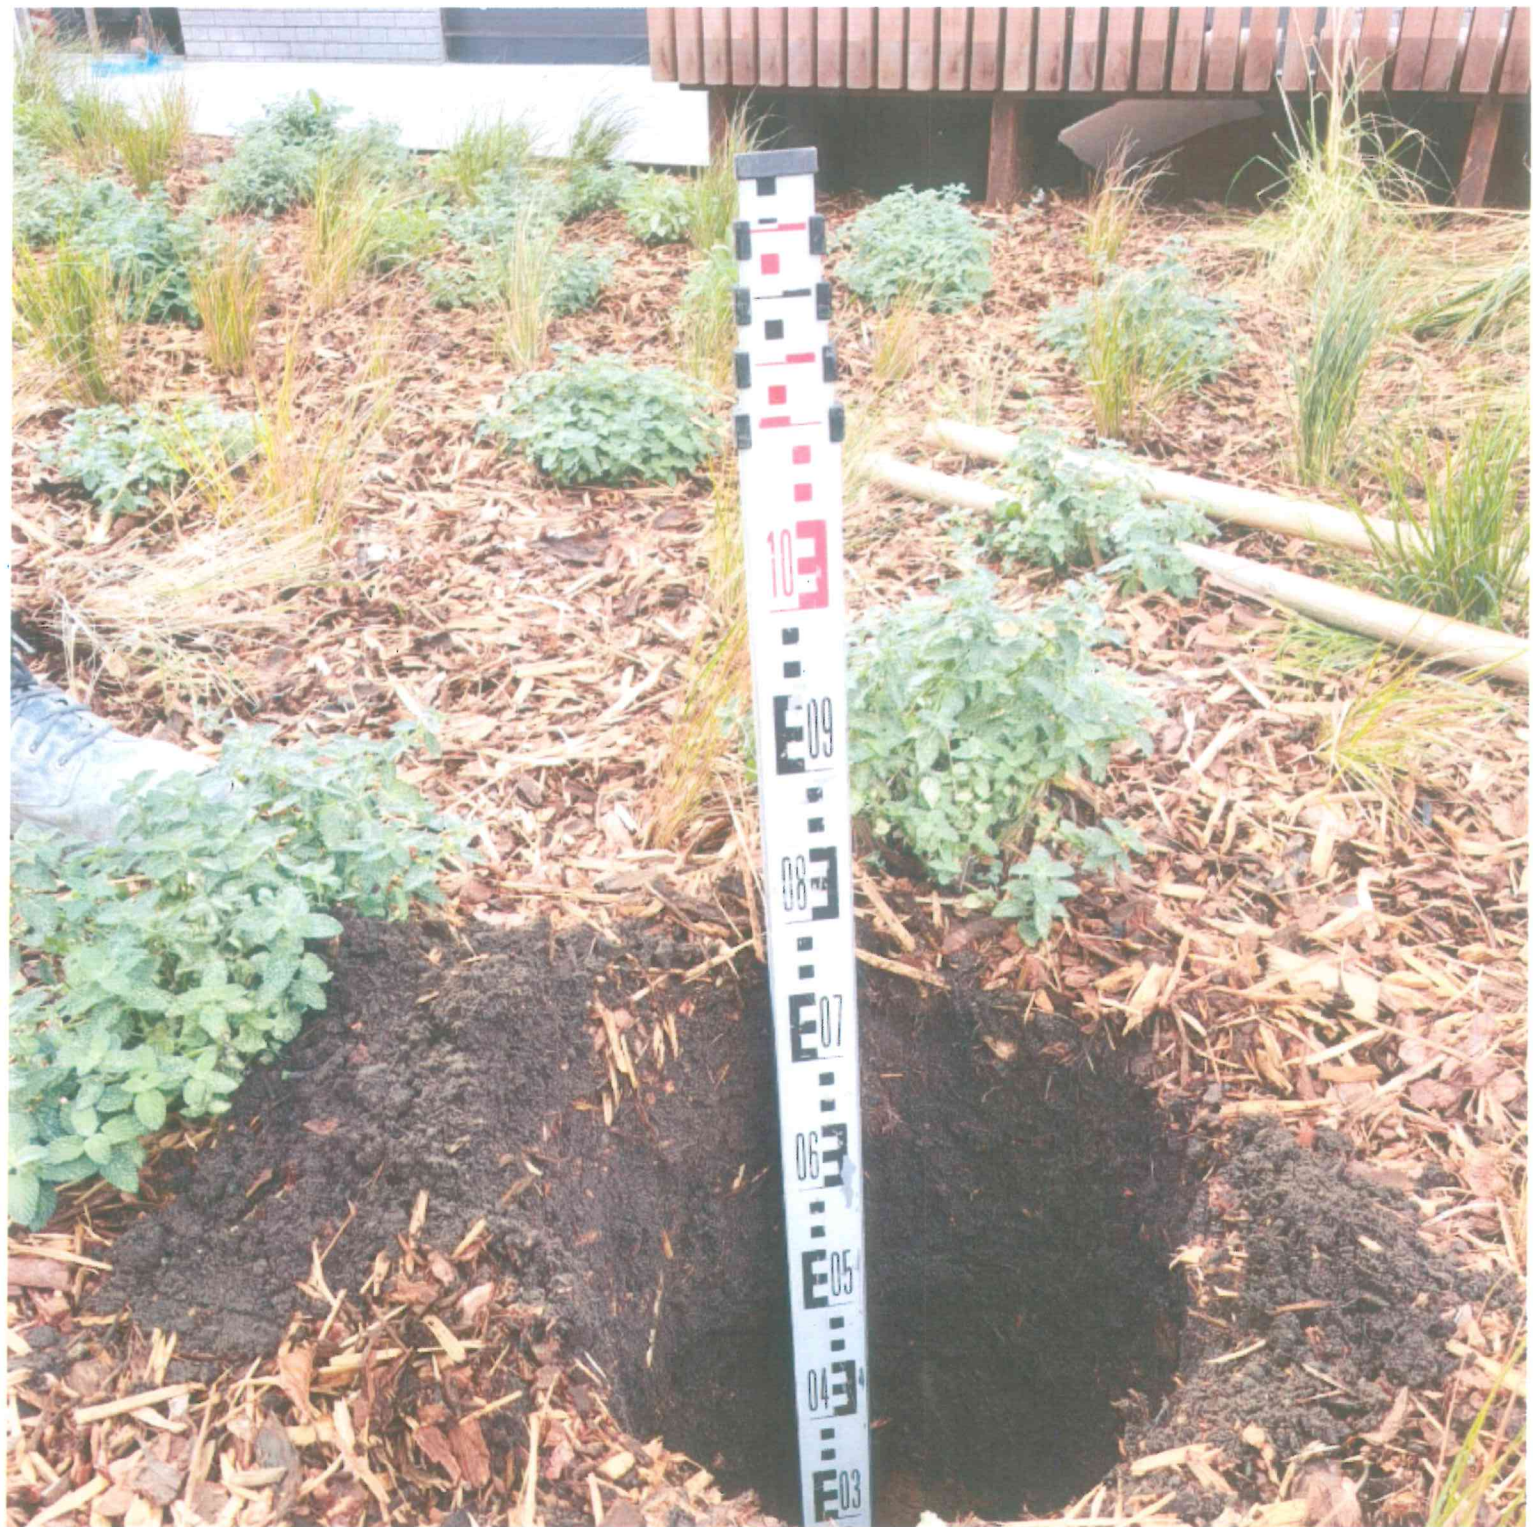
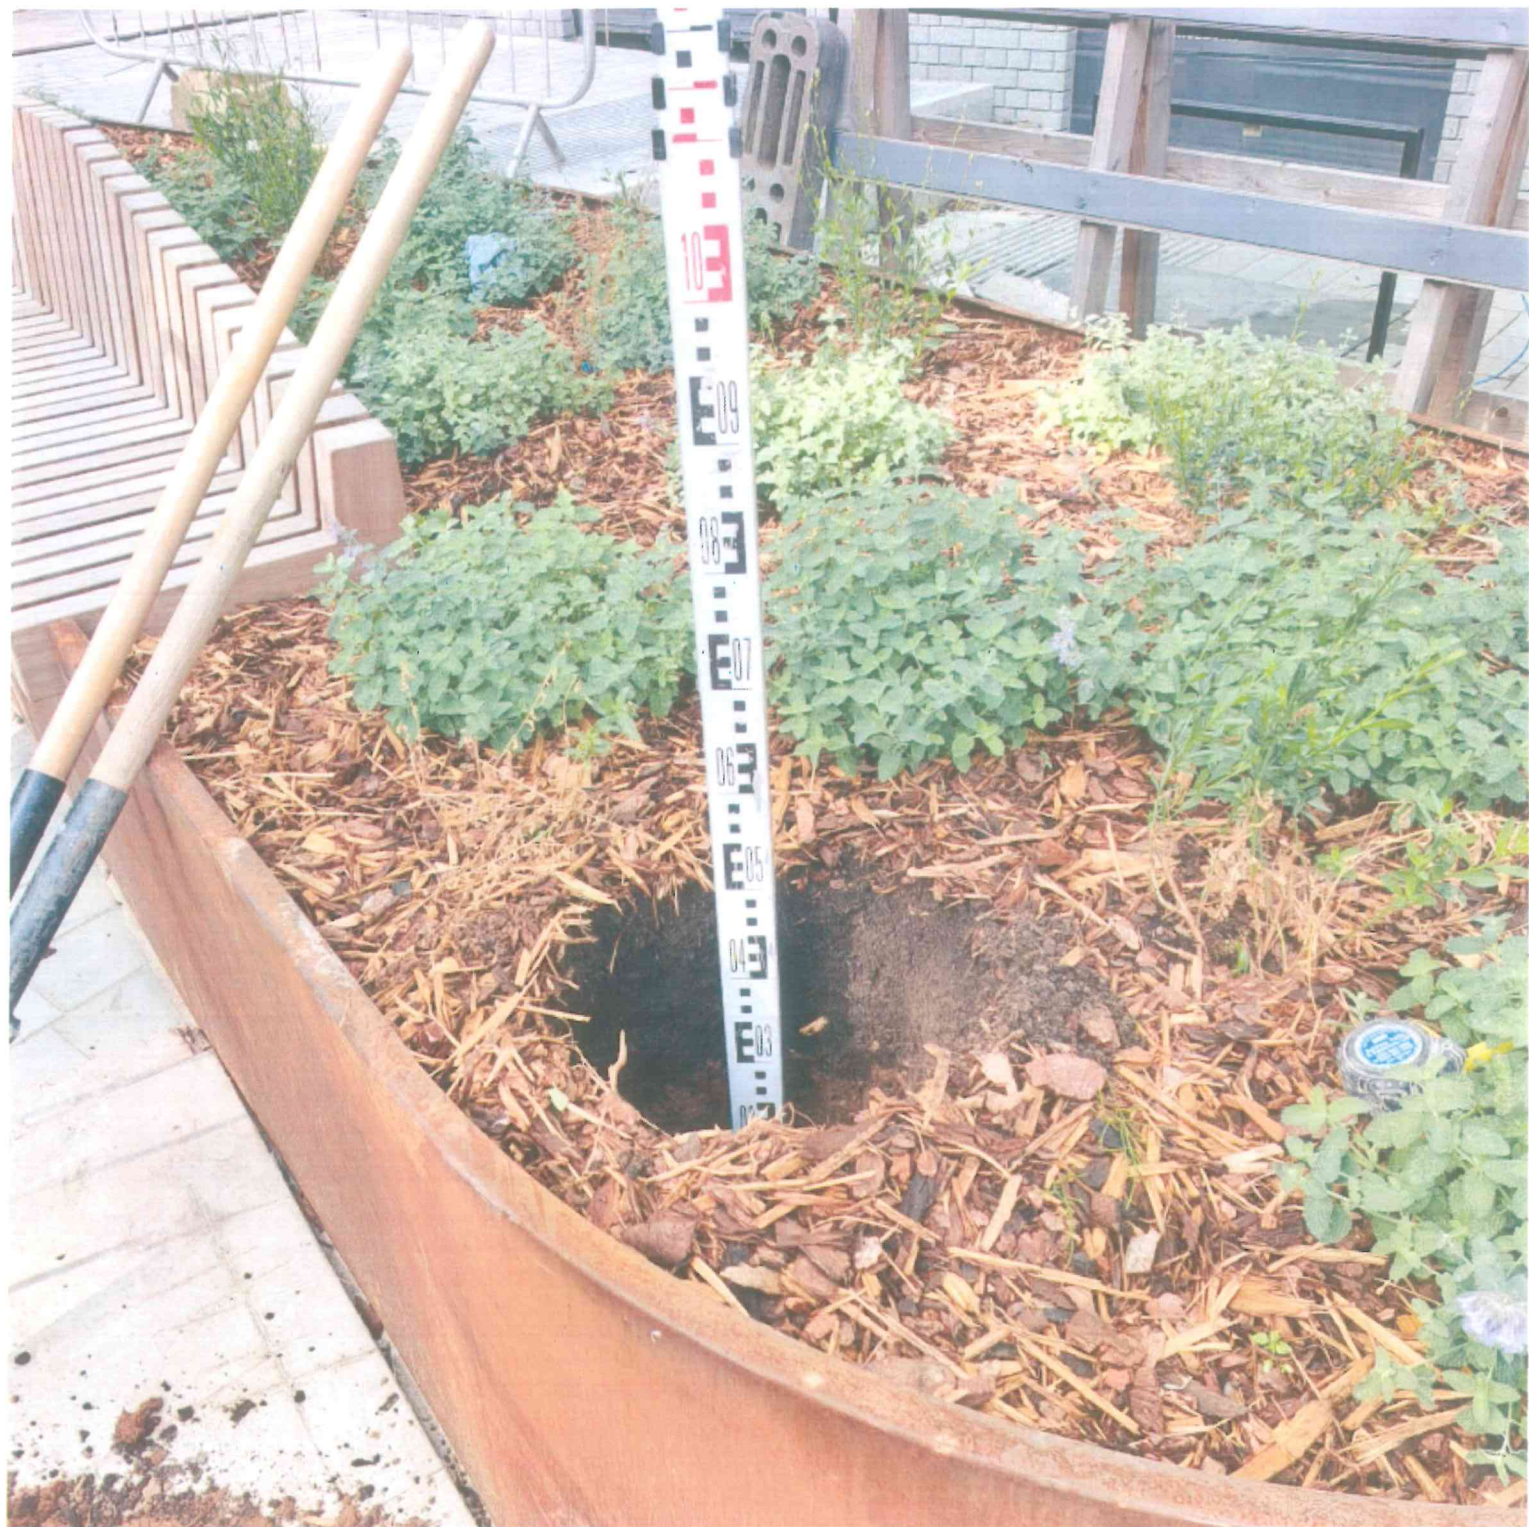
## Photographic record

- Photographic evidence of placement of imported soils in soft landscaping areas (Appendix C). Review of these records indicates that suitable placement of soils has been completed. No thickness of soils was specified in the WSP GIR, however it is considered from the available photographic evidence that thicknesses are suitable to mitigate against any contaminant linkage related to asbestos fibres within Made Ground.
