**149-151 Ladybarn Lane, Manchester M14 6RQ**  
**Bat Survey Report**  
**Manchester Construction**

**August 2022**

Report Title: 149-151 Ladybarn Lane – Bat Survey Report

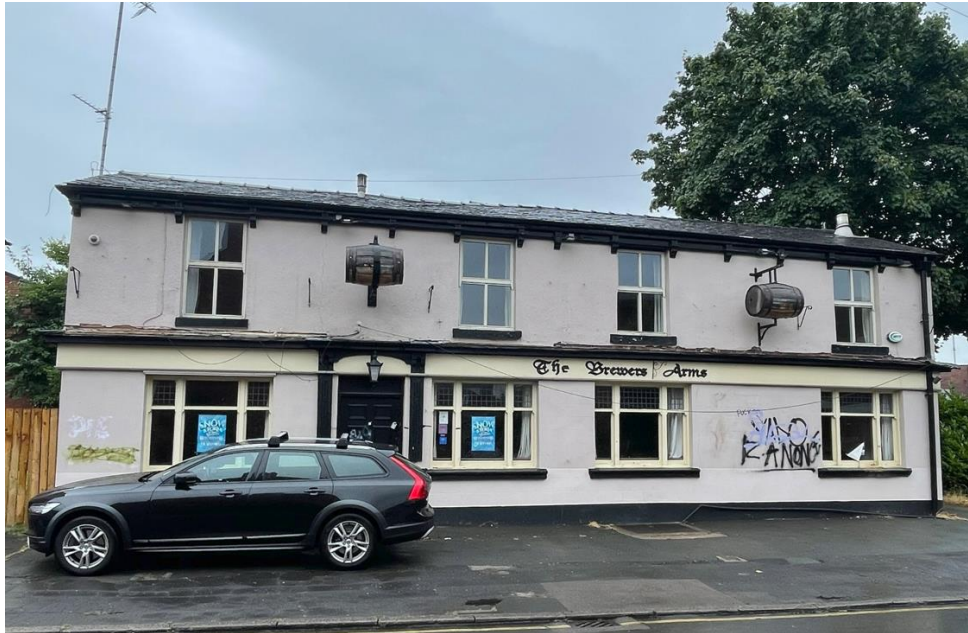
- 3.3.1 The building is a detached two storey rendered structure. The roof consists of wooden rafters directly overlain with a bituminous lining and slate tiles. The internal roof void is open and lagged with insulation. The roof is in fair condition overall but is displaying signs of neglect at the gable ends.
- 3.3.2 The results of the building inspection are presented below in Table 4, with

1. Two-storey, rendered structure in an urban location.

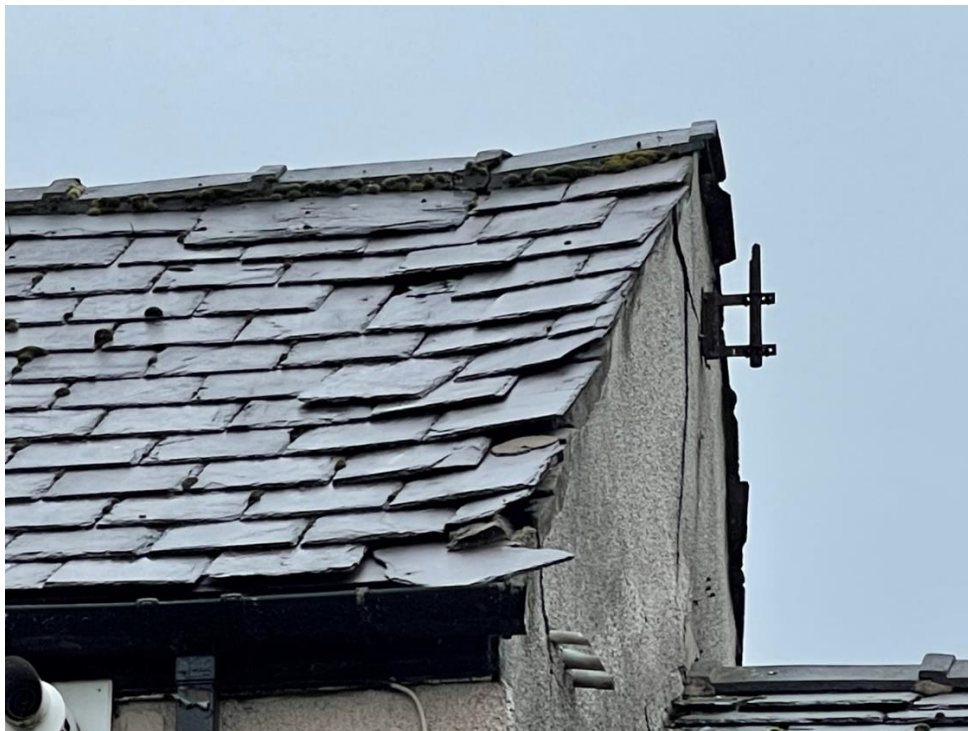
| Building | Description/features | Potential interest to roosting bats |
|---|---|---|
| B1 | <u>External</u><br><br>Slate roof with slipped and missing tiles<br><br><u>Internal</u><br><br>Open roof void with no signs of roosting bats. | <b>Overall:</b><br><br><br><br>Low |

2. Gable end with slipped and missing tiles.

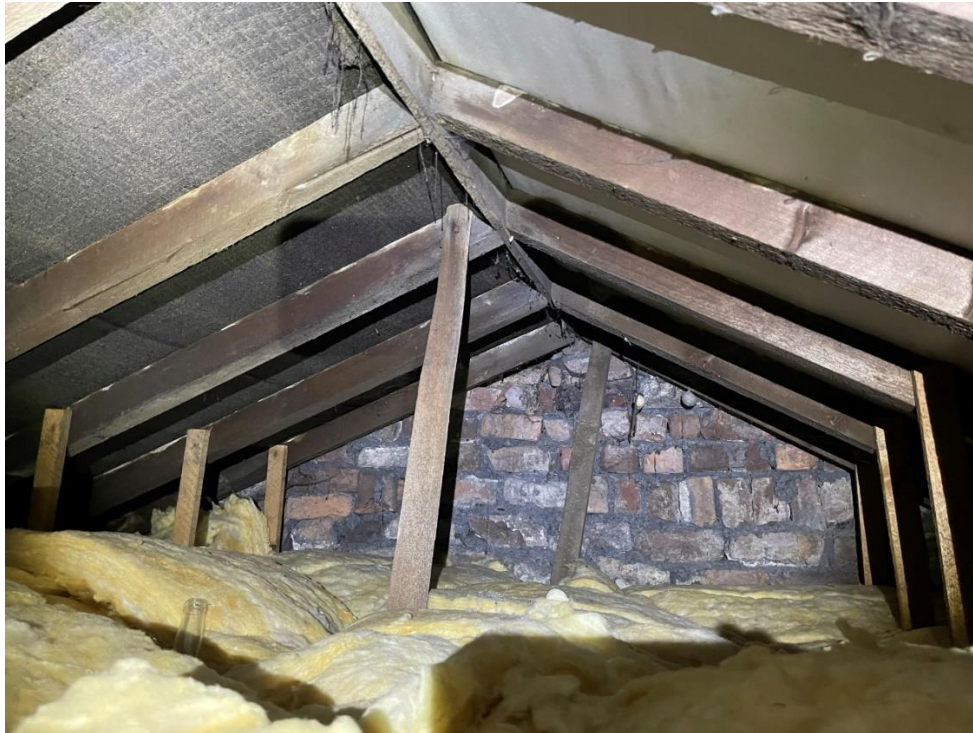
3. Wooden rafters overlain with bituminous felt.

- 5.1.3 Bats are known to frequently become entangled and die in Breathable Roof Membranes (BRMs) due to pilling of the material when subject to frequent passage by bats. As a potential benefit to bats in line with the National Planning Policy Framework (NPPF) aim that “opportunities to incorporate biodiversity in

and around developments should be encouraged" (NPPF, 2012) it is recommended that Type 1F bitumastic roofing felt should be used during construction of the proposed buildings.
