# PHASE 2 SITE INVESTIGATION

Plots O + N, Mayfield

Mayfield Partnership Ltd

| DESCRIPTION | DATE | AUTHOR | REVIEWED BY | APPROVED BY |
|---|---|---|---|---|
| <b>Phase 2 Site Investigation Report</b> | 01/10/20 | Elizabeth Stewart<br> | <b>Liam Daley</b><br> | <b>Alex Smiles</b><br> |

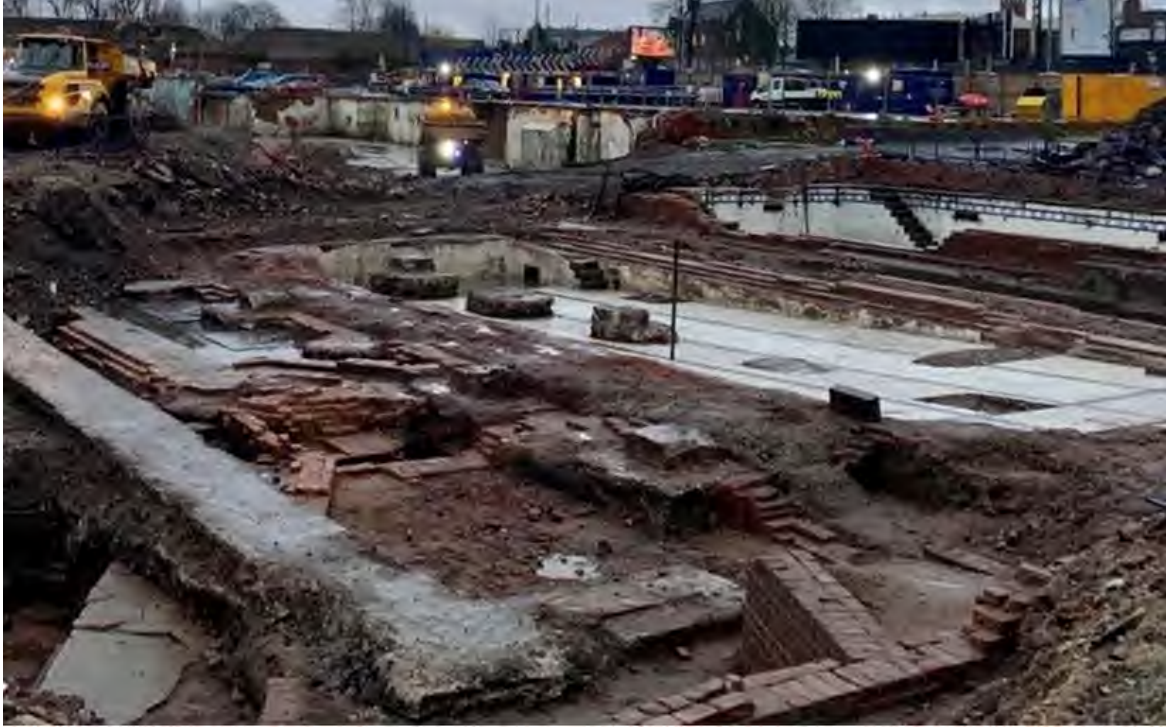
Fig 6.1 : Looking south east from Baring Street across excavated Mayfield Baths site.

- 6.1.6 Figure 6.1 and 6.2 provided overleaf were taken in December 2020 following the complete exaction of the baths by Salford Archaeology.

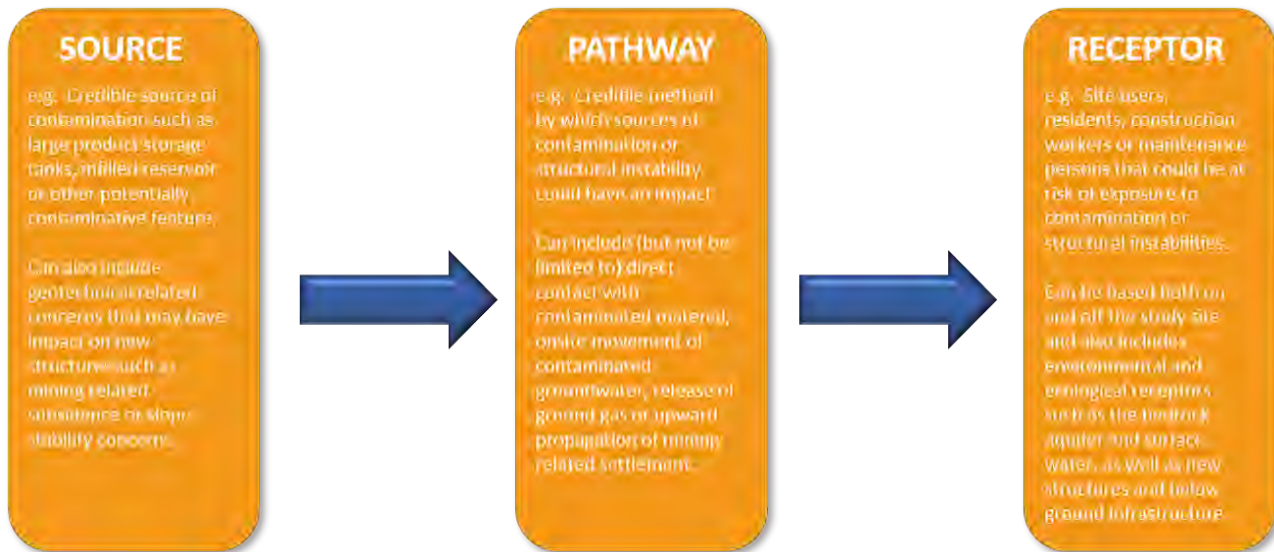
**Figure 8.0 Source Pathway Receptor Diagram**

- 8.0.1 The information obtained during the desk-based study has been reviewed to establish the Preliminary Conceptual Model for the site. This model is based around the Source / Pathway / Receptor methodology as outlined in Figure 8.0.

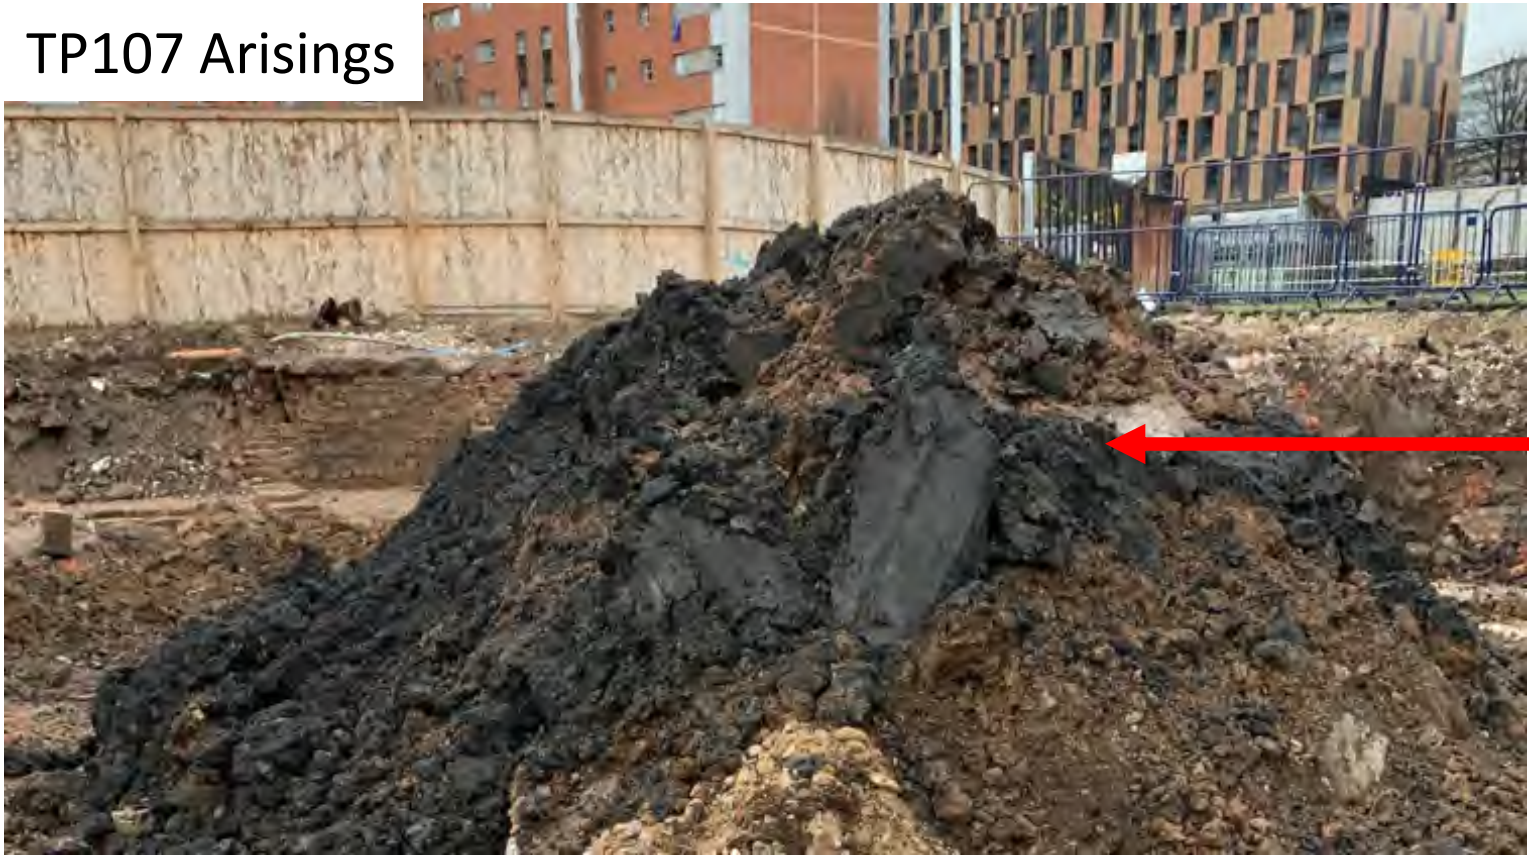
TP107 Arisings

Organic rich clay

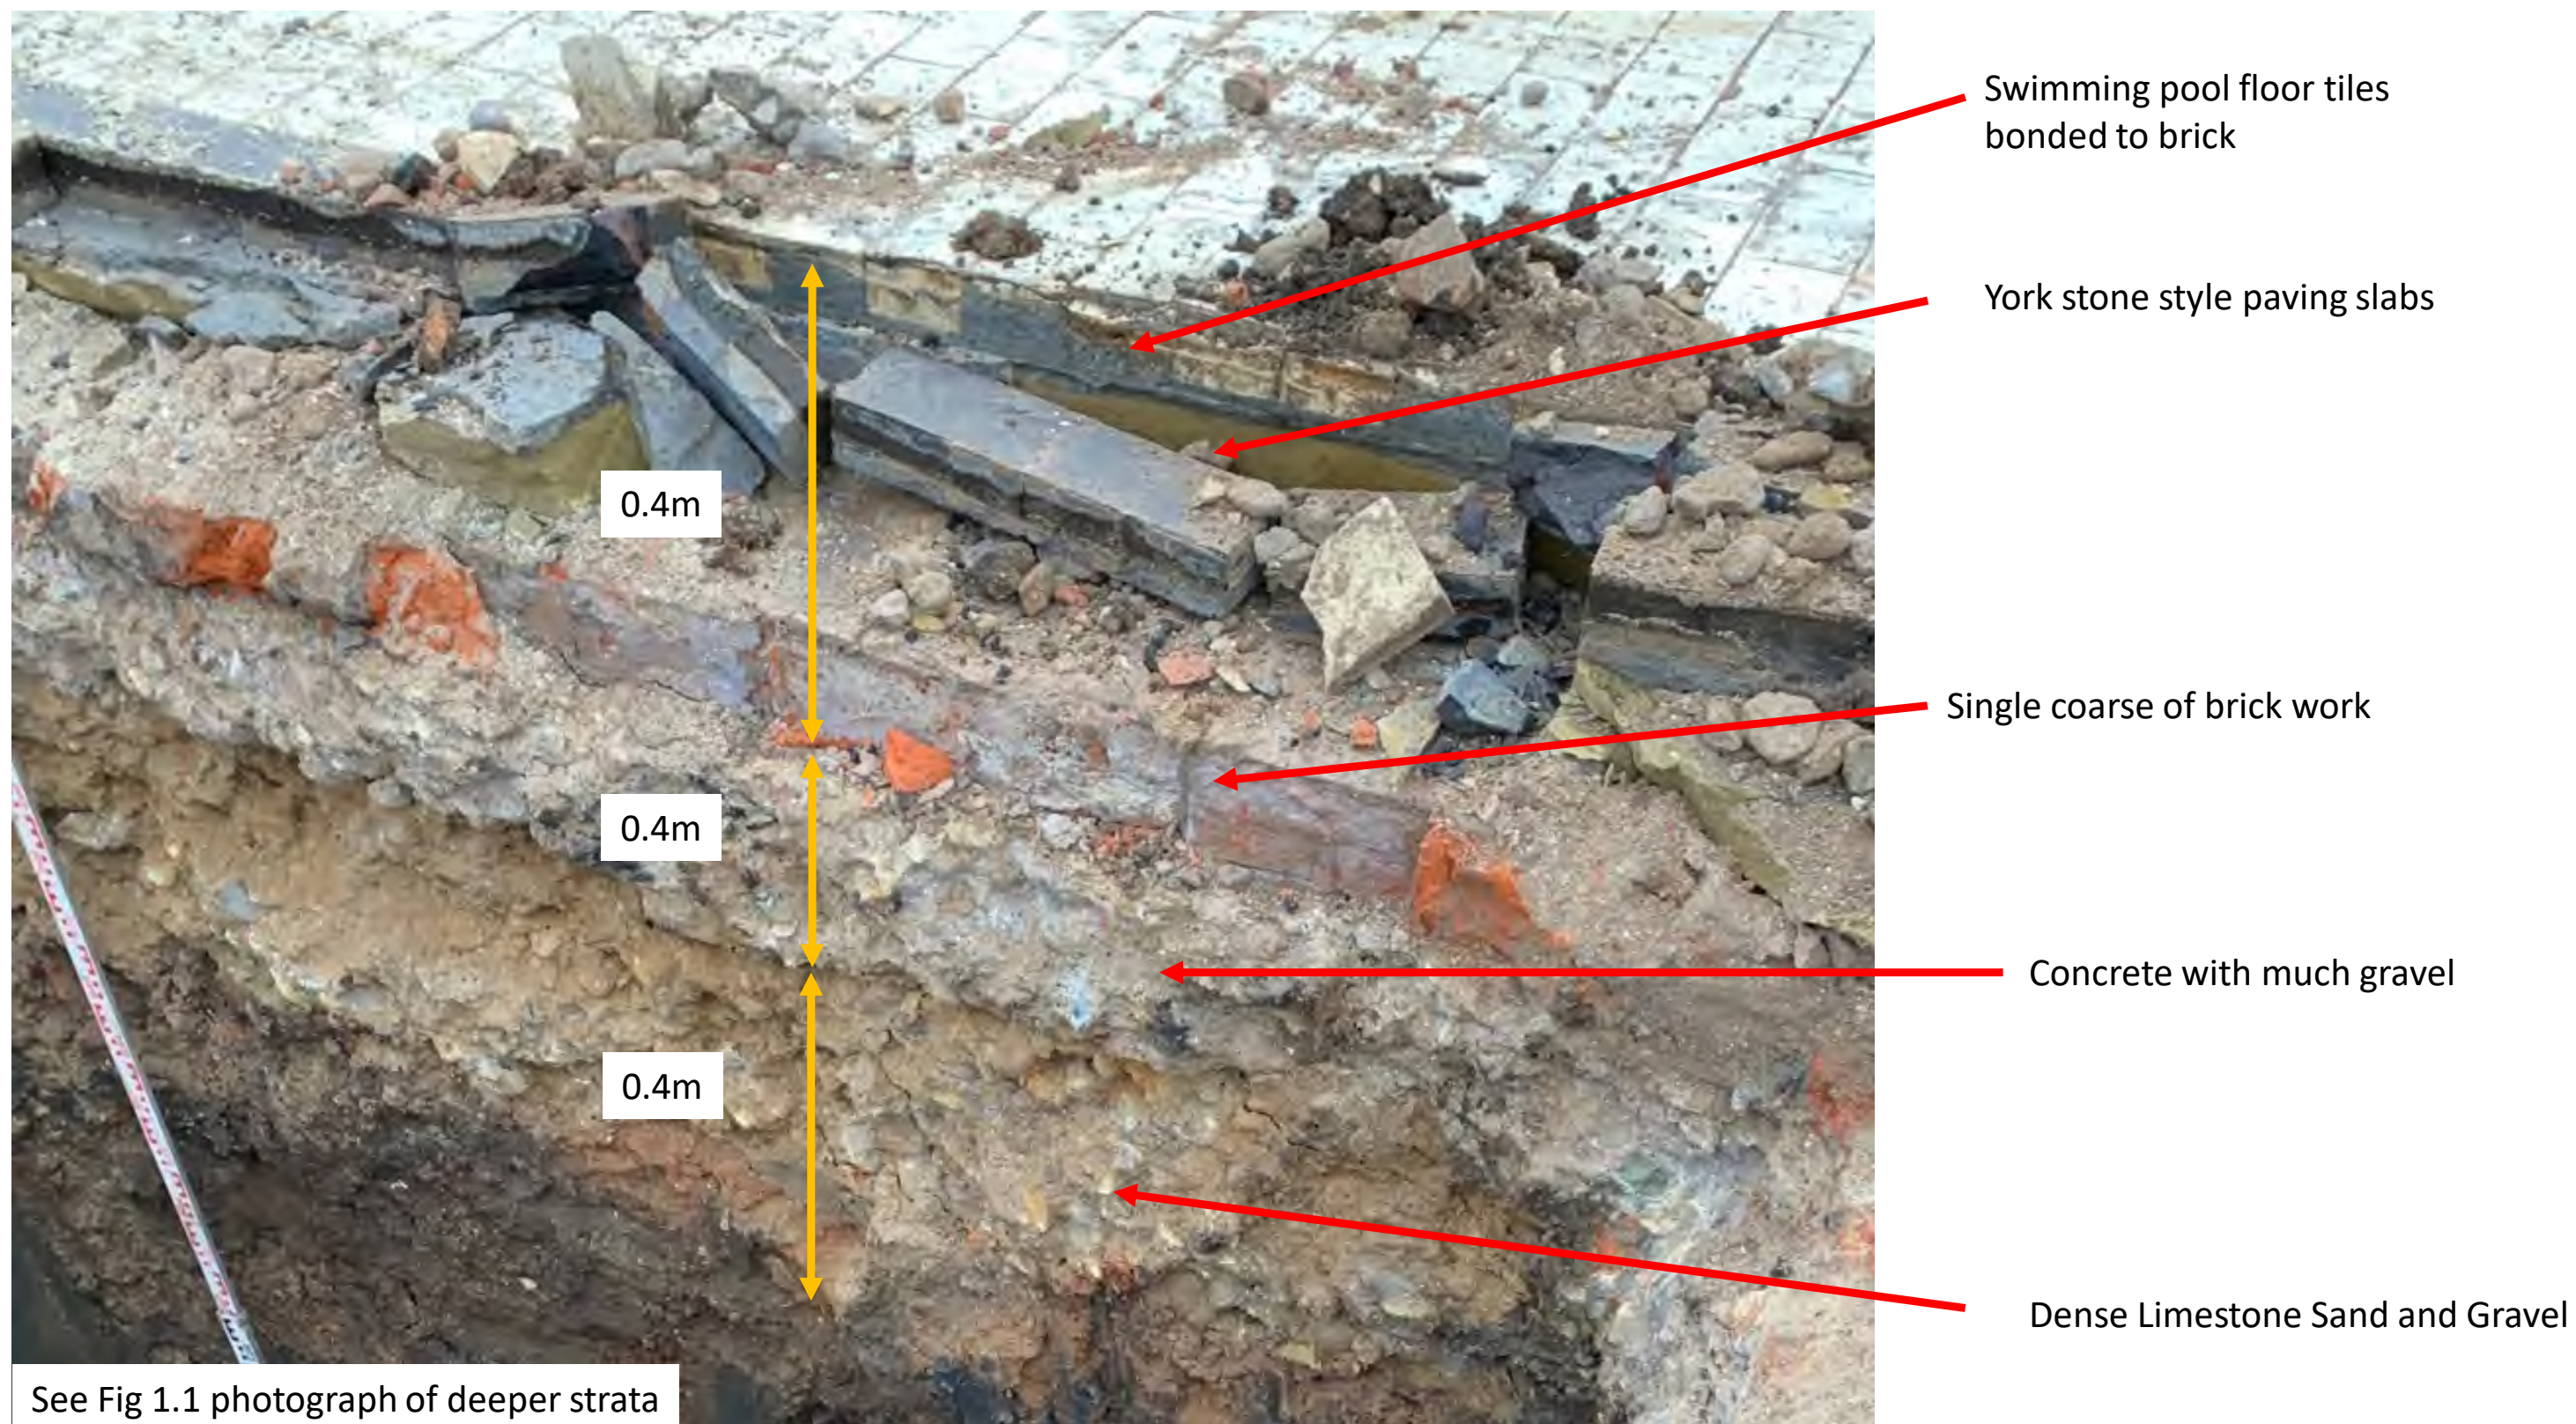
| | PROJECT TITLE | Poulton Additional Trial Holes | SKETCH TITLE | Section through ladies swimming pool | |
