**GEO-ENVIRONMENTAL  
APPRAISAL REPORT**

**2 Didsbury Point  
The Boulevard  
Didsbury  
Manchester  
M20 2EY**

**April 2016**

**Report Ref: 10/0867/001**

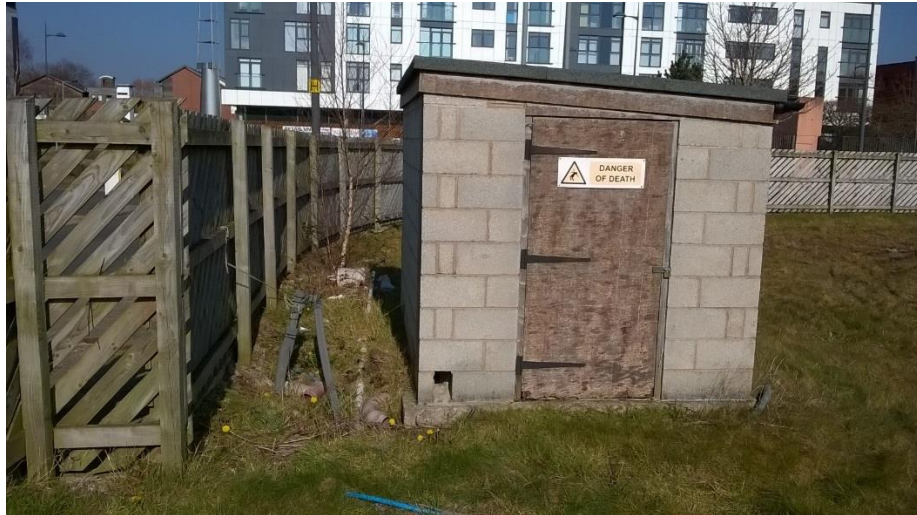
1) Electricity sub station north west corner of the site.

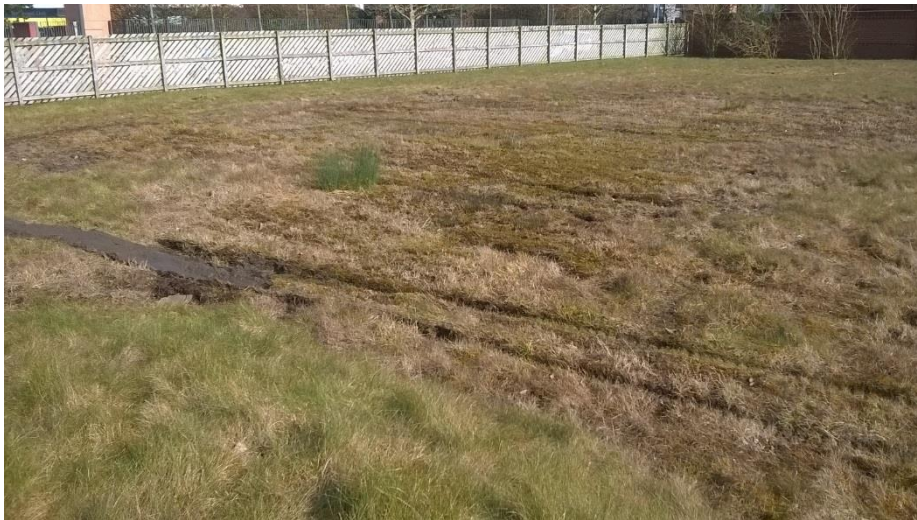
2) Area of soft ground in north west corner of the site.

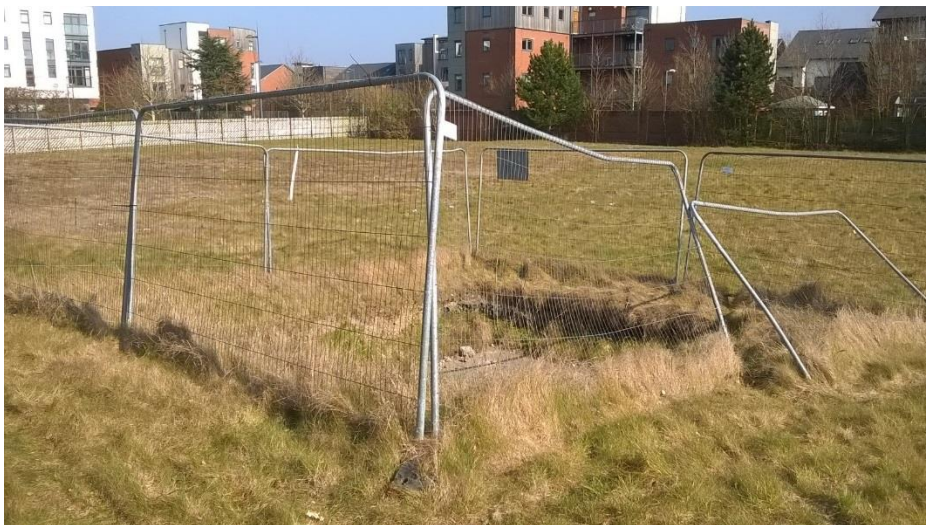
3) Buried slab, view looking north east

| <b>Further Works / Considerations</b> | <p>In summary, based on the findings of this initial investigation we would make the following recommendations for additional works:</p> <p>Drilling of 4No. Cable Percussion boreholes to confirm foundation design.</p> <p>Installation of ground gas monitoring wells and gas monitoring carried out including 4 visits over a 1 month period.</p> <p>Potential provision of gas prevention measures, at present thought to include a carbon dioxide resistant membrane and ventilated void spaces.</p> <p>Provision of a piled foundation solution or possibly vibro ground improvement, though advice should be sought from a specialist vibro contractor regarding suitability of soils.</p> <p>Shoring and dewatering of excavations during construction phase.</p> <p>Grubbing up and removal of relic foundations and floorslabs.</p> |

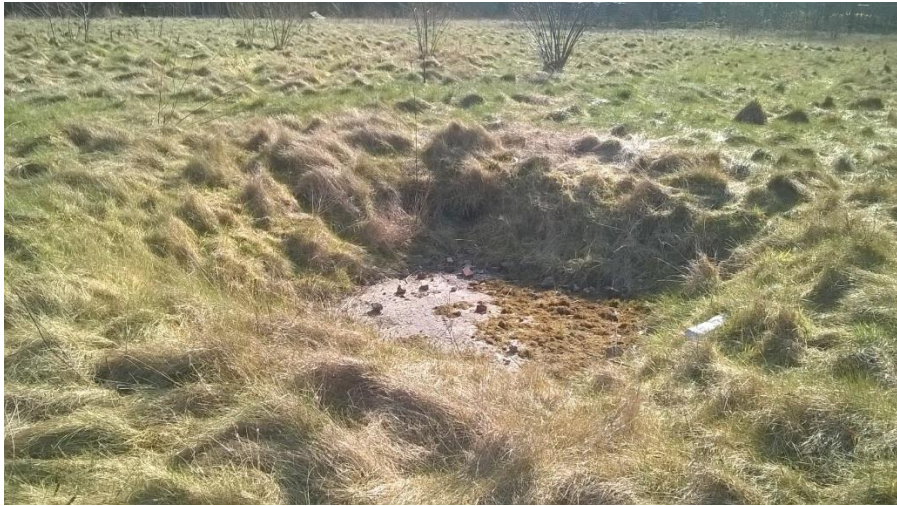
4) Second buried slab

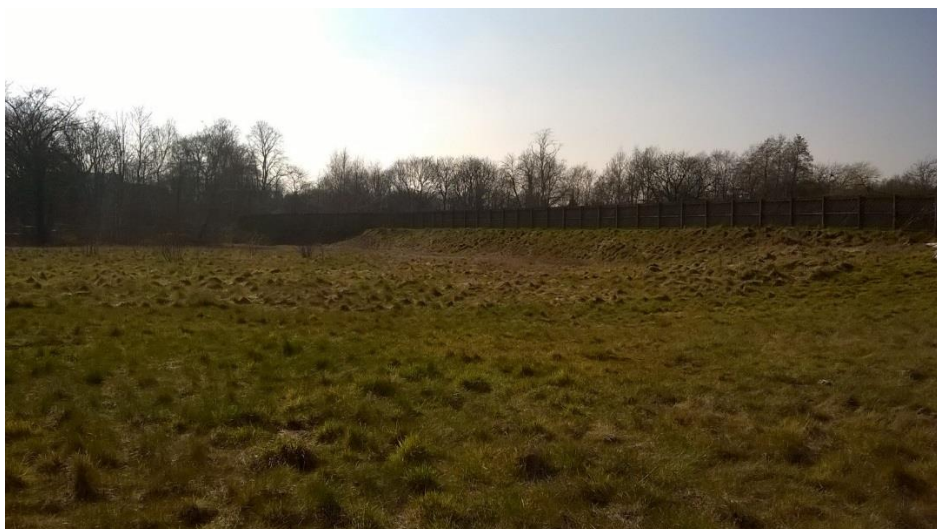
6) View looking south west showing elevated road.
