Phase II Geoenvironmental Site Assessment  
Thompson Street, Manchester

Reference:12-729-R2-1  
Date: November 2020

## PHASE II GEOENVIRONMENTAL SITE ASSESSMENT

Thompson Street  
Manchester  
M4 5FP

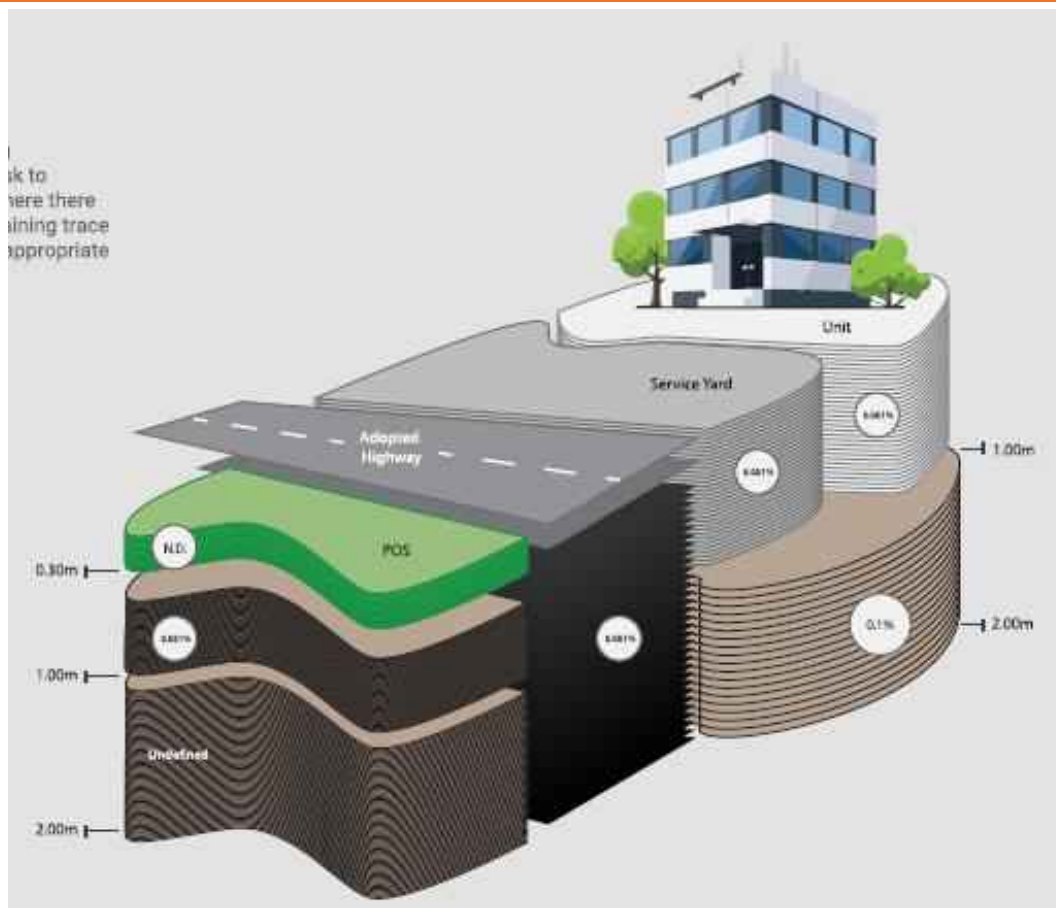
FIGURE 4.1 ASBESTOS RISK MITIGATION CONCEPTUAL SITE MODEL

Asbestos in the form of chrysotile has been identified in the Made Ground in TP104 at 0.70 m bgl. Asbestos quantification confirms that only trace fibres are present, and no visual signs of ACM were encountered during the ground investigation. Impacted soils should be managed according to the asbestos risk mitigation conceptual site model shown in Figure 4.1 below.

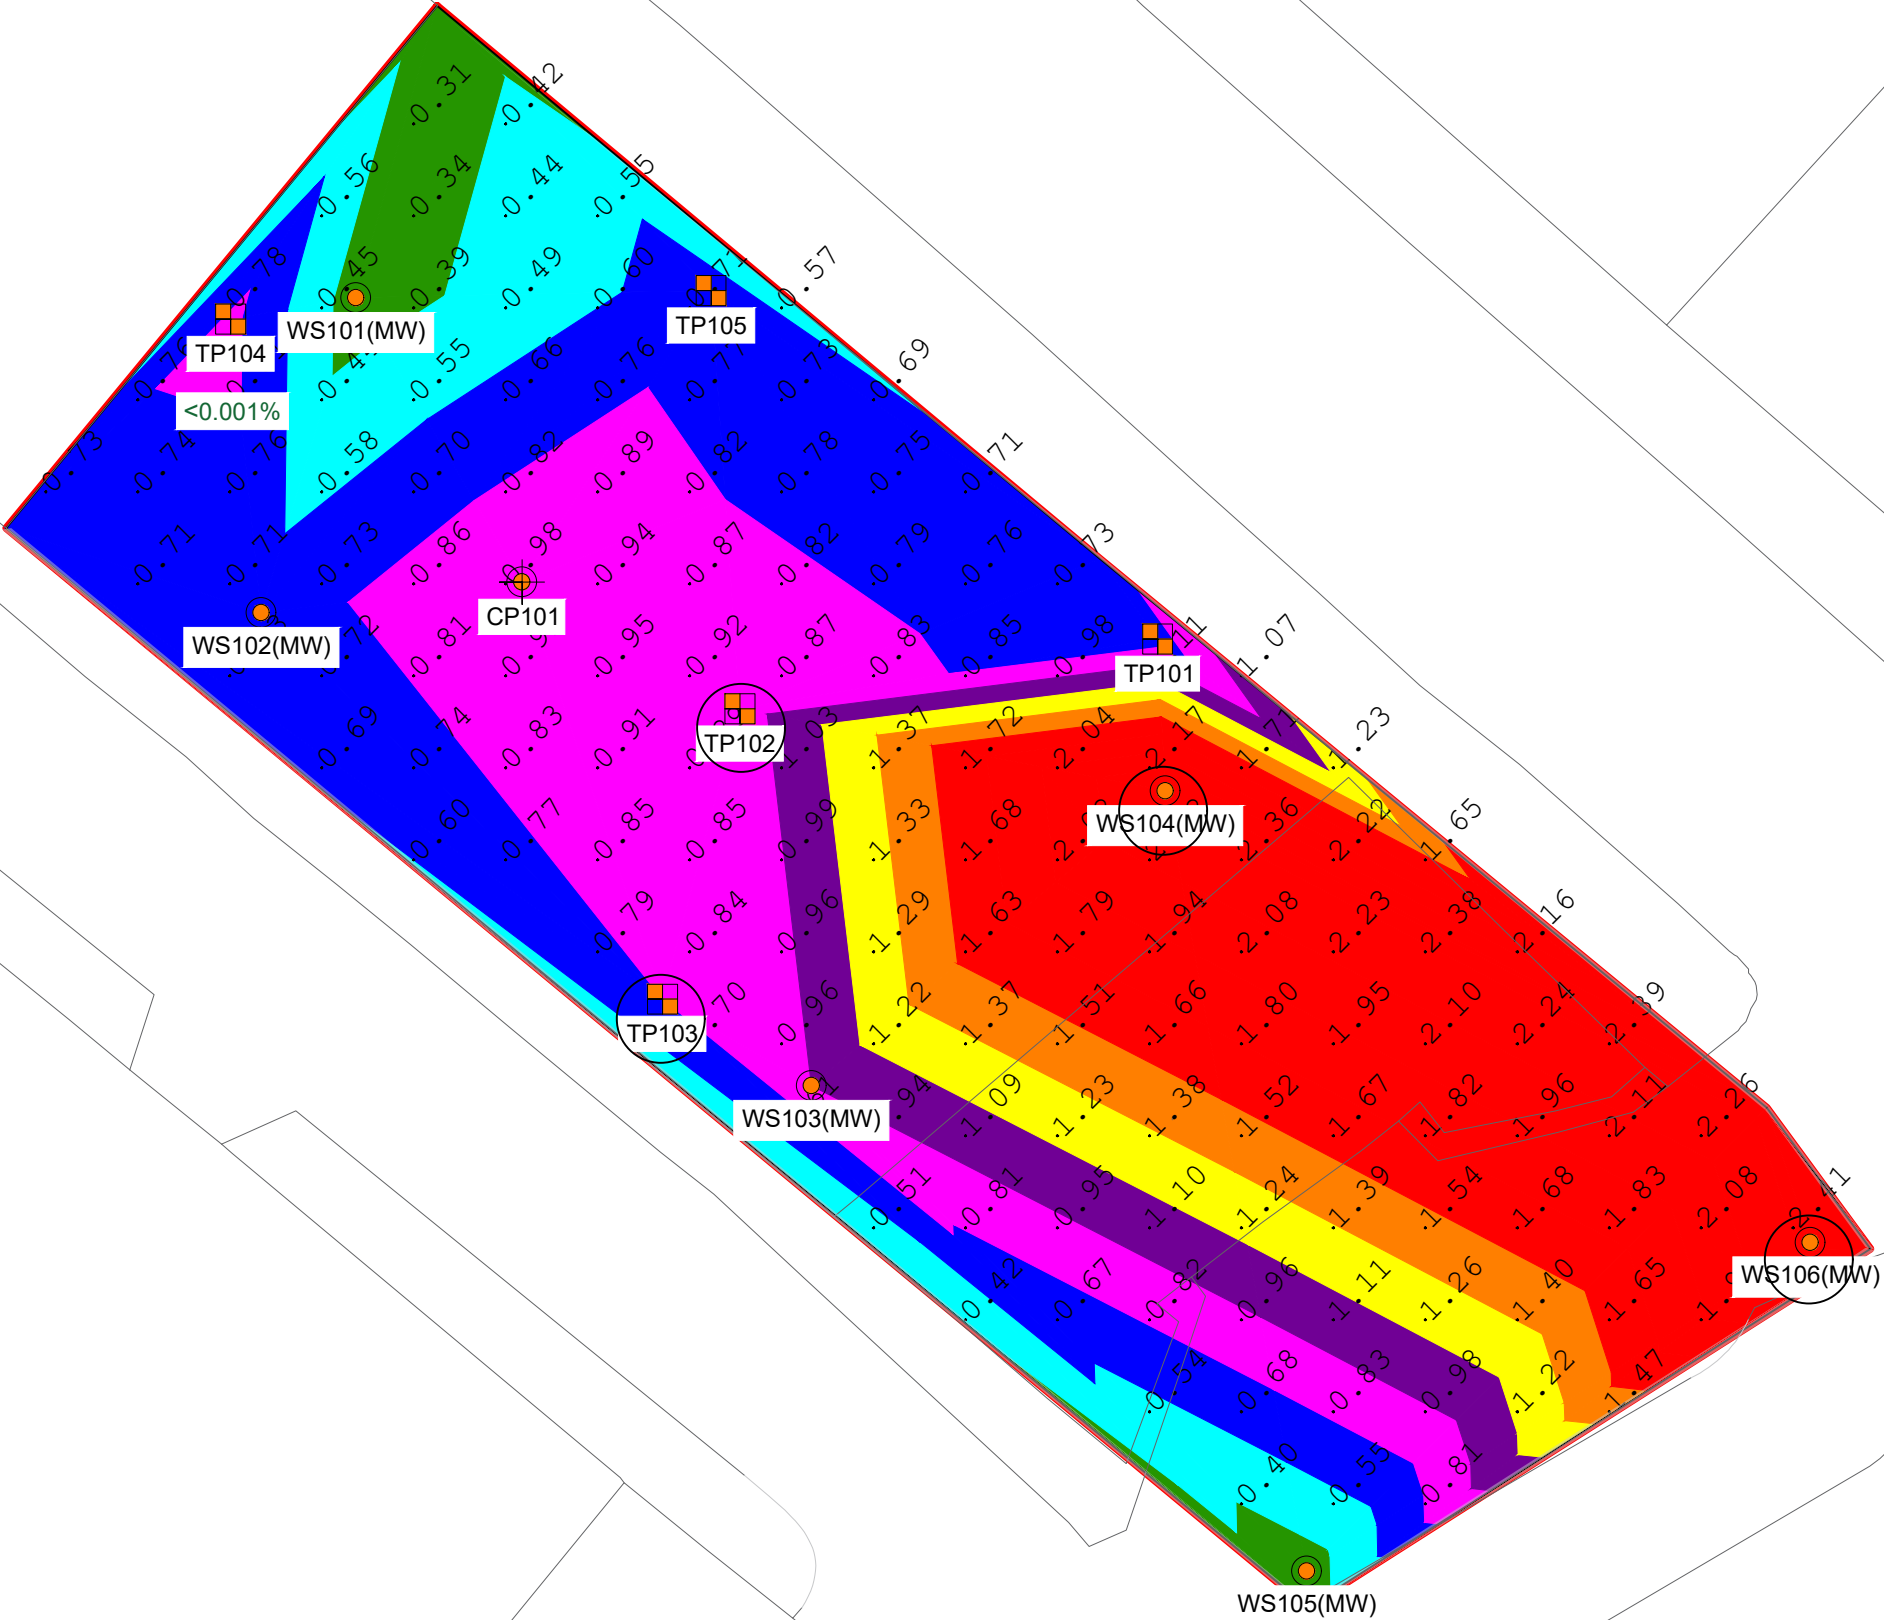
| Depth of Made Ground Plan |

- Made Ground Depth (m)**
- Depth of Made Ground 0.00 - 0.19m
  - Depth of Made Ground 0.20 - 0.39m
  - Depth of Made Ground 0.40 - 0.59m
  - Depth of Made Ground 0.60 - 0.79m
  - Depth of Made Ground 1.00 - 1.19m
  - Depth of Made Ground 1.20 - 1.39m
  - Depth of Made Ground 1.40 - 1.59m
  - Depth of Made Ground 1.60 - 1.79m
  - Depth of Made Ground >1.80m

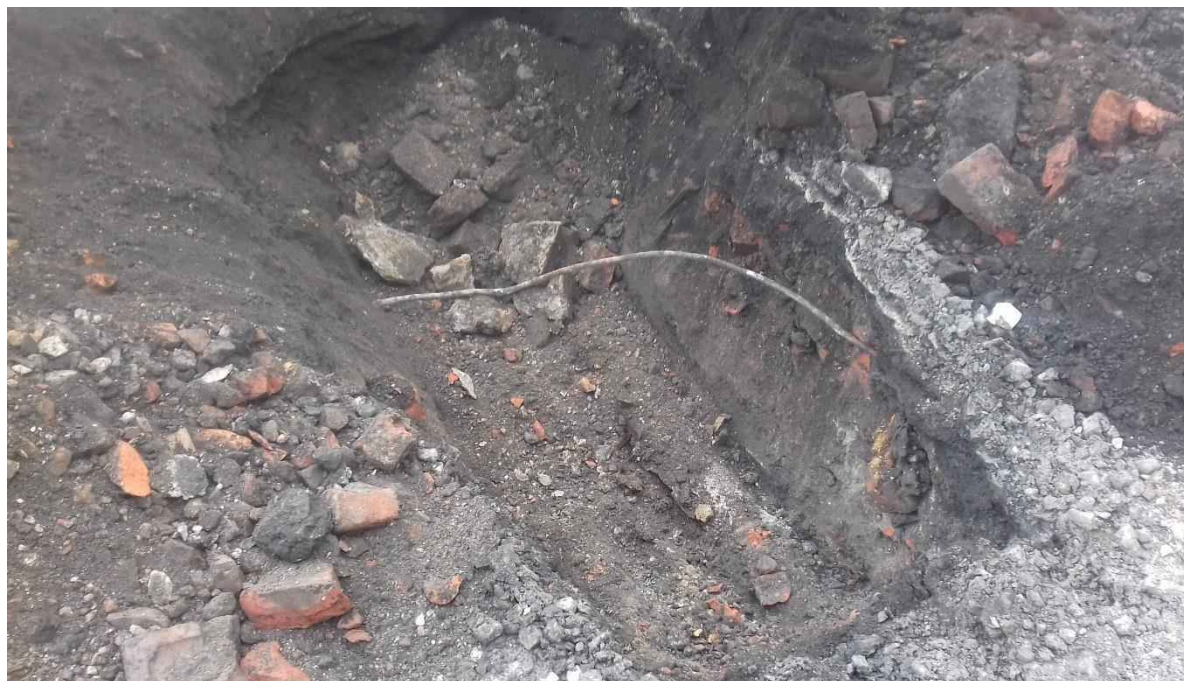
PLATE 4      TP102 EXCAVATION

The presence of brick and concrete cobbles within the Made Ground deposits meant that in certain places, excavation was slow through the Made Ground and in some places, Made Ground could not be fully penetrated. Concrete obstructions were noted in TP102 and TP103.

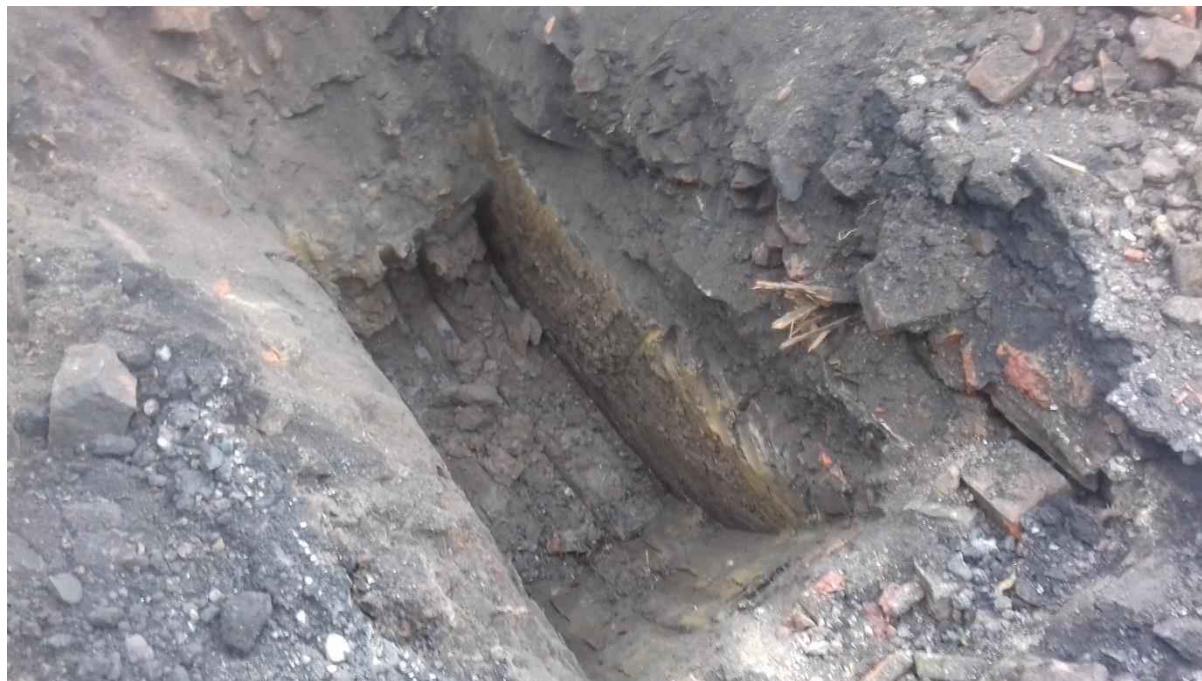
PLATE 6 TP104 EXCAVATION

Asbestos in the form of loose chrysotile fibres (<0.001 %) has been identified in the natural clay drift deposits in TP104 at 0.70 m bgl.

| POLLUTANT LINKAGE | CONTAMINANT (SOURCE) | PATHWAY | RECEPTOR | PROBABILITY | CURRENT RISK | RESIDUAL RISK AFTER MITIGATION |
|---|---|---|---|---|---|---|
| <p><b>Assessment:</b><br/>Trace fibres of asbestos (&lt;0.001 %) have been identified in the Made Ground in TP104, however asbestos fibres must be assumed to be present throughout the Made Ground.</p> <p><b>Recommendation:</b><br/>Placement of impact soils beneath hardstand or cover system in landscaped areas in accordance the asbestos CSM will prevent exposure to future site users. Construction works completed with PPE and provision of welfare.</p> | | | | | | |

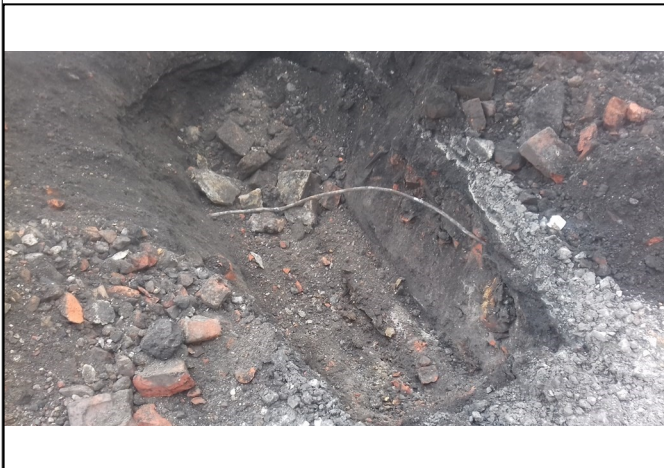
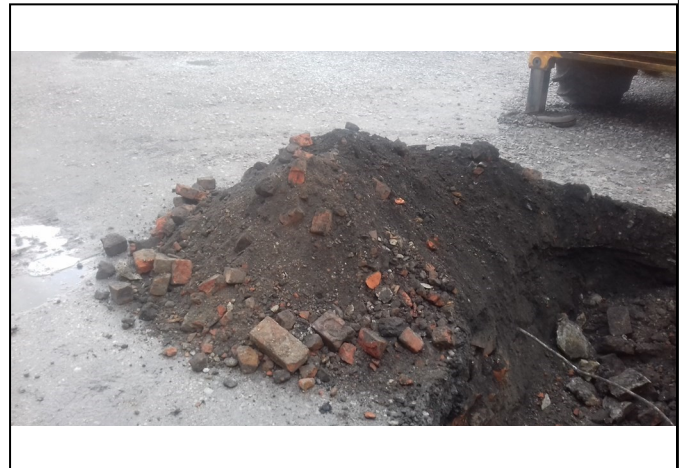
Trial Pit 102

Remarks: Terminated on concrete obstruction.
