## Bowes Street

### Phase 2 Ground Investigation & Assessment

March 2017

| <b>Project</b> | Bowes Street, Manchester | | |

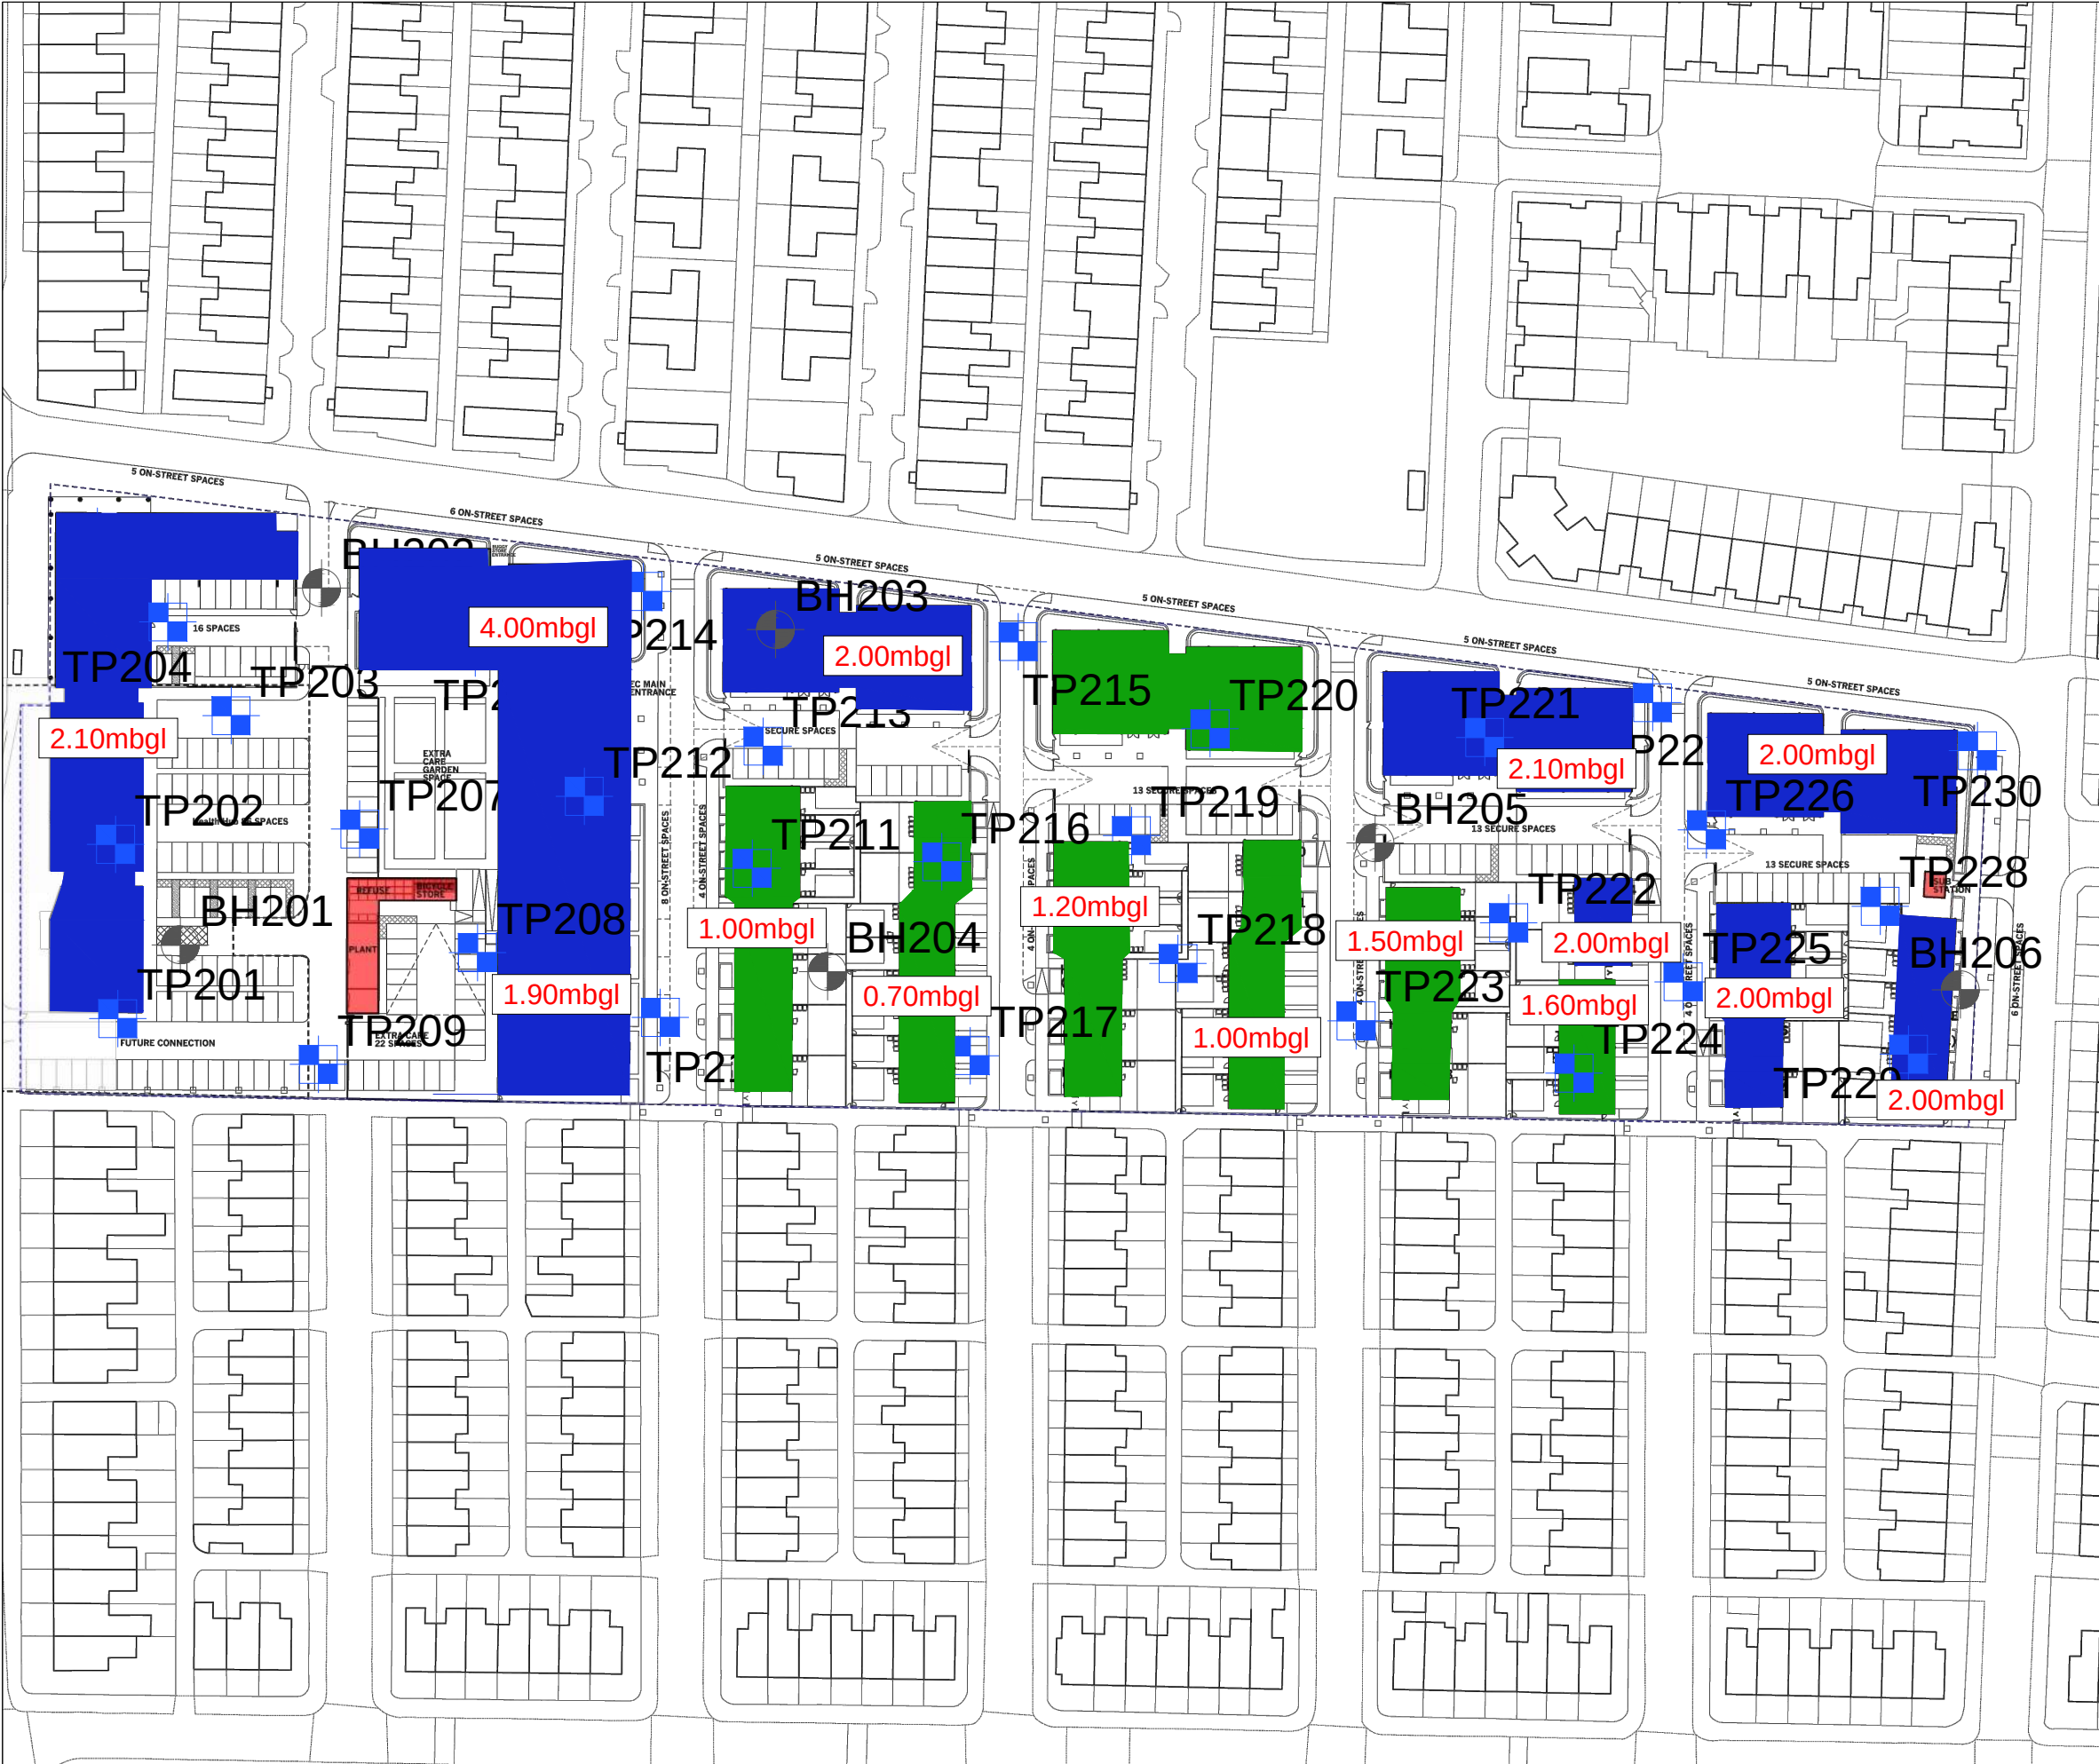
| Rev | Date | Revision | By | Checked | Authorised |
|---|---|---|---|---|---|
| Title:<br>INDICATIVE<br>FOUNDATION<br>ZONING<br>PLAN | | | | | |

- Borehole Location
- Trial Pit Location
- Founding Strata Greater than 1.80mbgl
- Founding Strata Less than 1.80mbgl
- Indicative Depth to Top of Founding Strata

- 9.3.1 Given the variable thickness of the Made Ground deposits and the competence of the natural strata across the site, a combination of foundation solutions should be considered for the subject site. In areas of Made Ground less than 1.80mbgl shallow spread foundations may be considered as a suitable founding option. According to the SPT 'N' values observed at the subject site, the suitable founding strata will be either firm to very stiff clay or weathered sandstone bedrock of the Chester Pebble Beds. The uppermost cohesive Glacial Till deposits can be conservatively expected to provide a bearing capacity ranging from 80-150kN/m<sup>2</sup> depending on the stiffness of the strata. The depth to competent founding strata across the site varies significantly. An indicative foundation depth zoning plan is presented in Appendix A.
