Northenden Campus, Sale Road M23 0DD

## UPDATED BAT ACTIVITY SURVEY AND ASSESSMENT

August 2022

[ERAP (Consultant Ecologists) Ltd ref: 2020-272g]

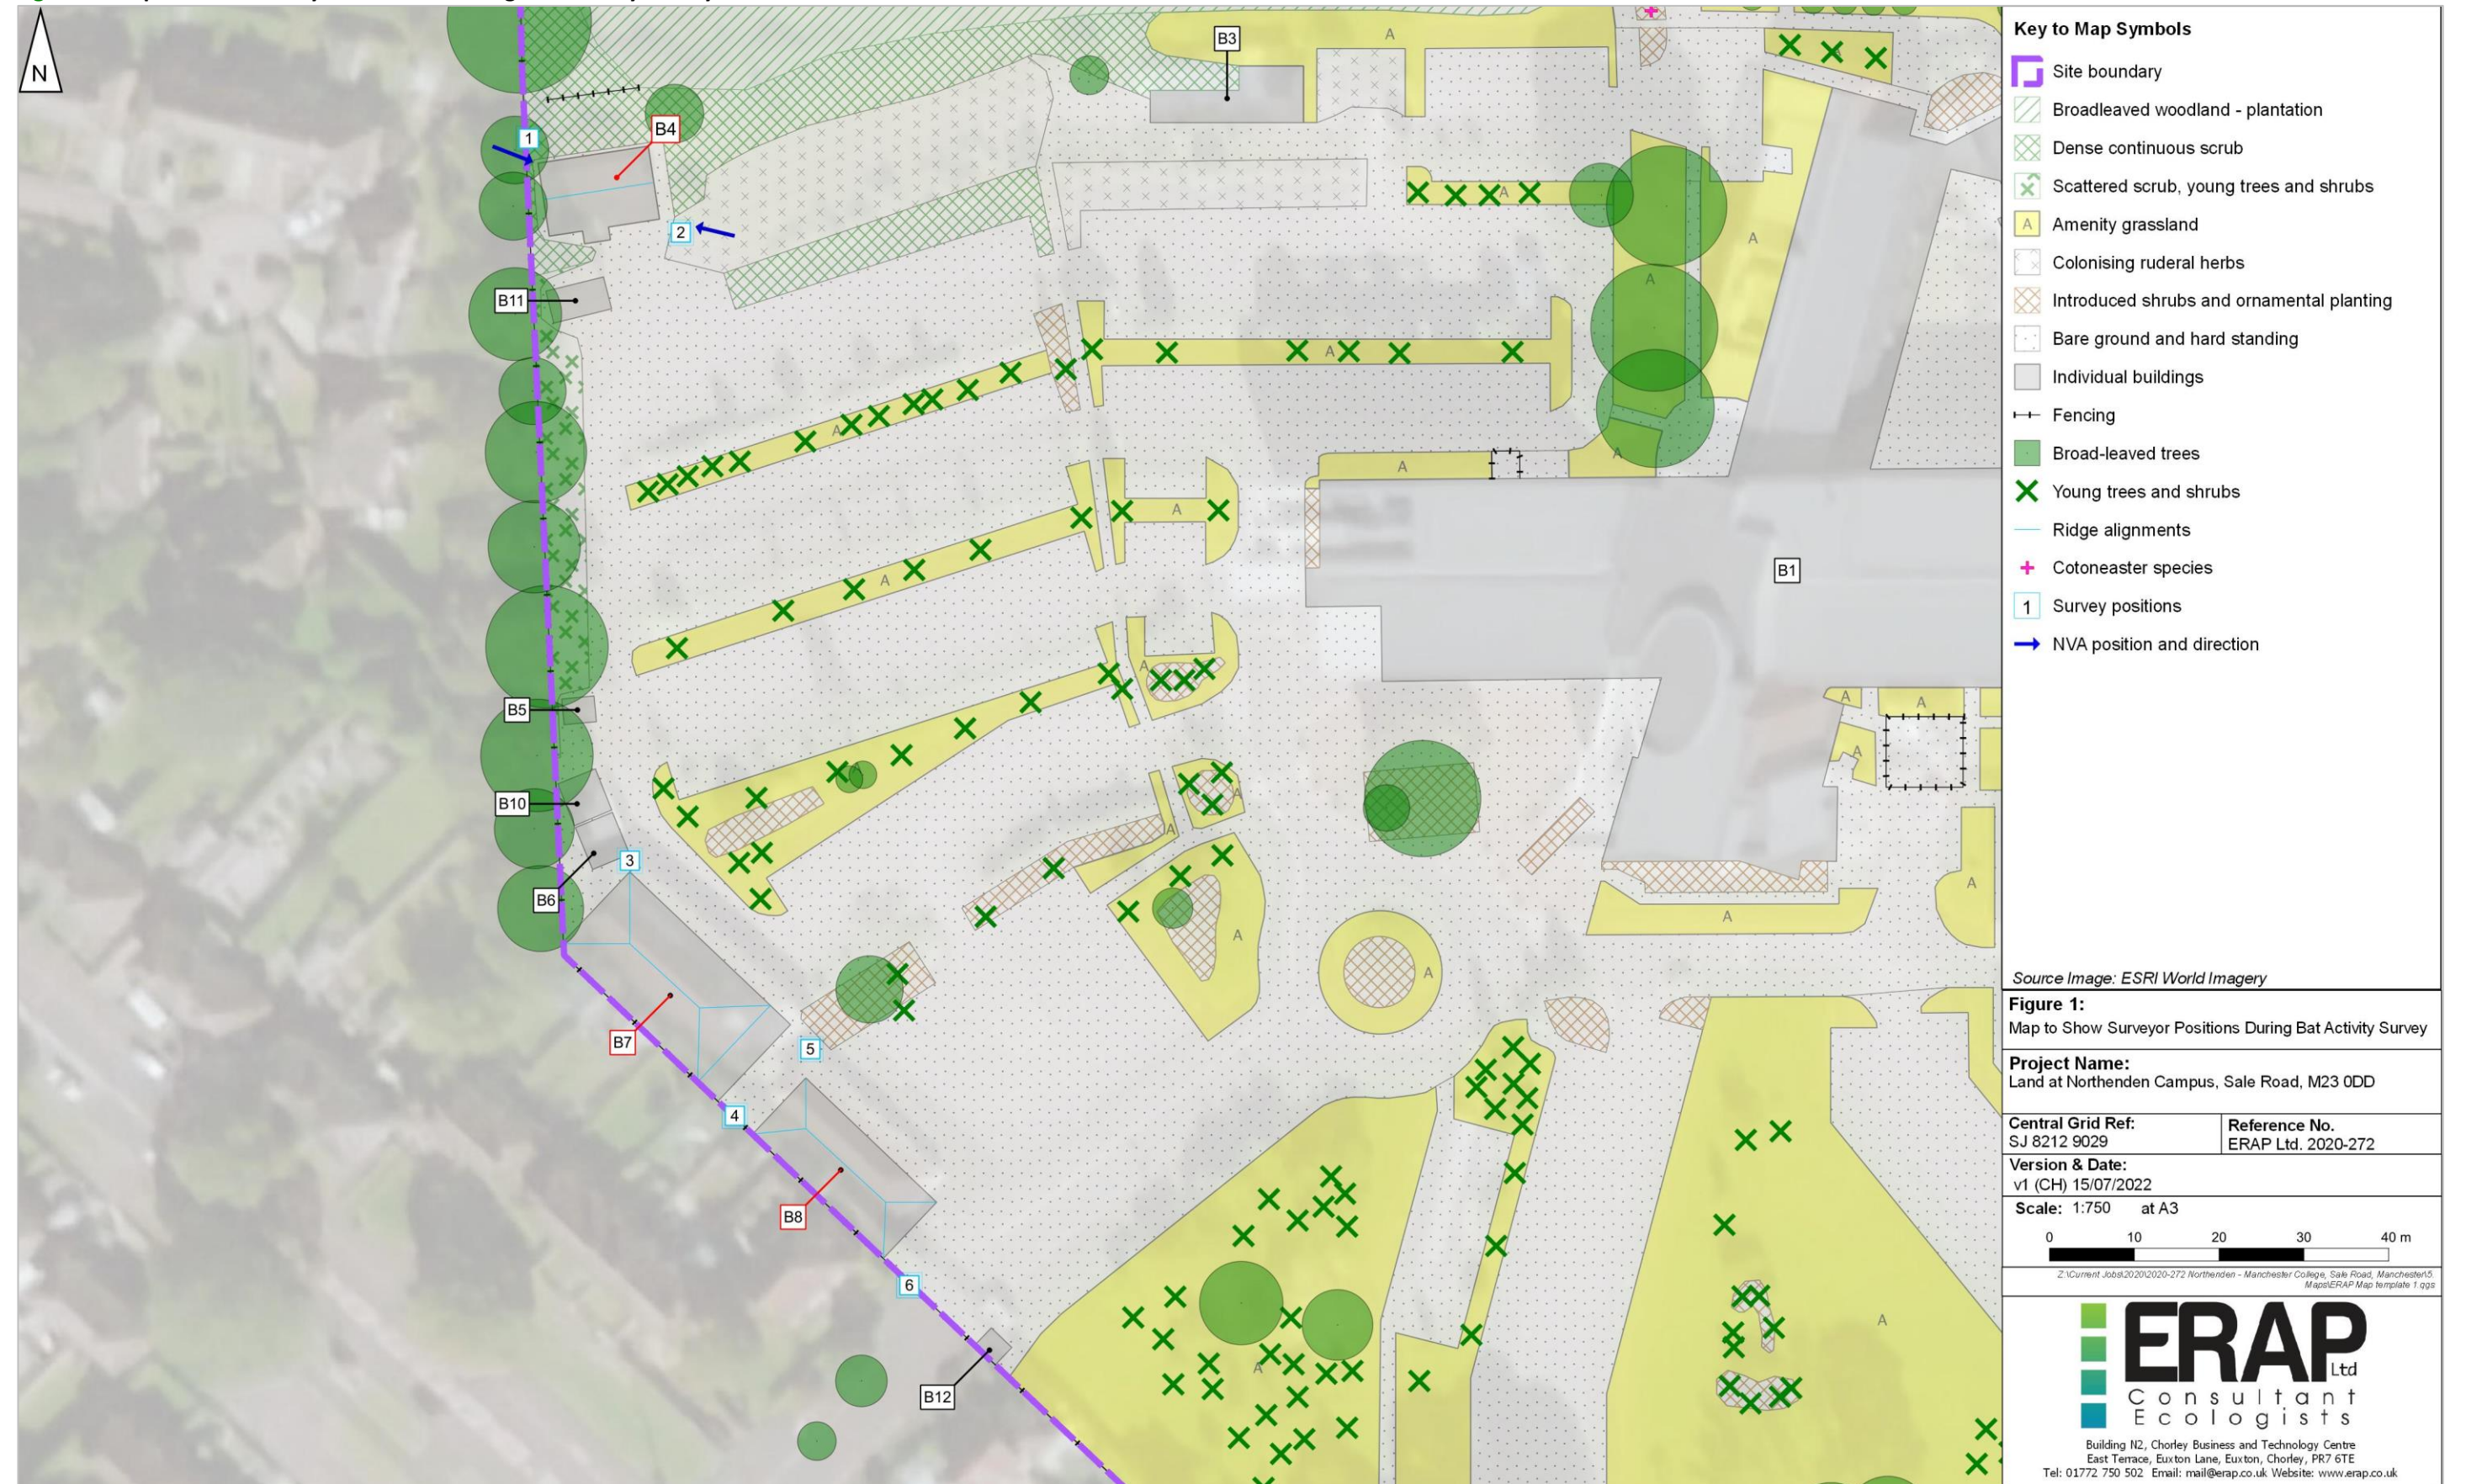
**Figure 1: Map to Show Surveyor Positions During Bat Activity Survey**

2.1.1 The survey area comprised buildings B4, B7 and B8 within the wider site (refer to **Figure 1**).

- 2.2.2 Six surveyors experienced in conducting bat surveys, were positioned at suitable locations to maximise the coverage of buildings B4, B7 and B8 and the identified potential roost features to determine any entry or exit at the buildings by roosting bats. Surveyor positions are annotated at **Figure 1** (appended).

- 2.2.4 Night vision aids (NVAs) comprising a SANNCE CCTV system (comprising 1080N Digital Video Recorder and one KKmoon 1080P AHD Bullet CCTV camera) were used at the positions annotated on **Figure 1** as a supplementary survey technique. Footage was subsequently reviewed using VLC Media Player to determine any emergence / re-entry at B4 later in the survey period.
