| Project Name: Miles Platting | Project No. 13887 | Co-ords: 386281.00 - 399455.00<br>Level: | Date<br>28/09/2021 |
| Location: Manchester | Dimensions (m): <input type="text"/> | | Scale<br>1:30 |
| Client: Engie | Depth<br>2.50 | | Logged<br>G. Calvert |

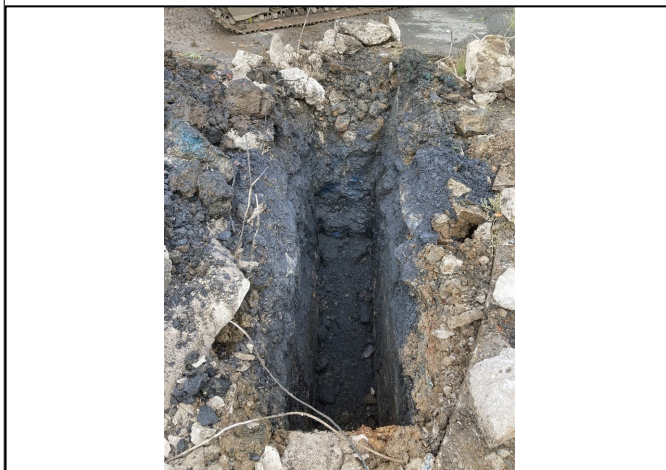
TP813

| Water Strike | Samples & In Situ Testing | | | Depth (m) | Level (m) | Legend | Stratum Description | |
|---|---|---|---|---|---|---|---|---|
| | 0.60 | B | | 0.20 | | | MADE GROUND: Concrete reinforced with rebar. | |
| | | | | 0.80 | | | MADE GROUND: Brown clayey gravel with rare blue staining. Gravel is fine to coarse angular to subrounded of brick, concrete and mudstone. | 1 |
| | 2.00 | L | | | | | MADE GROUND: Dark blue to black oily sheen very gravelly clay. Gravel is fine to coarse angular to subangular of brick and mudstone. (Strong hydrocarbon odour) | 2 |
| | | | | 2.50 | | | End of Pit at 2.50m | 3 |

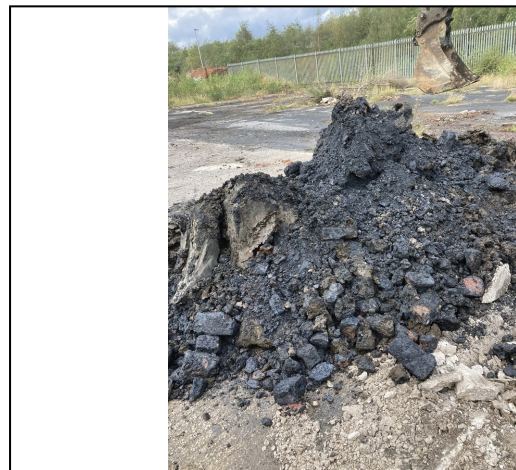
TP813 Spoil

Remarks: 1. Complete.

Stability: Stable.

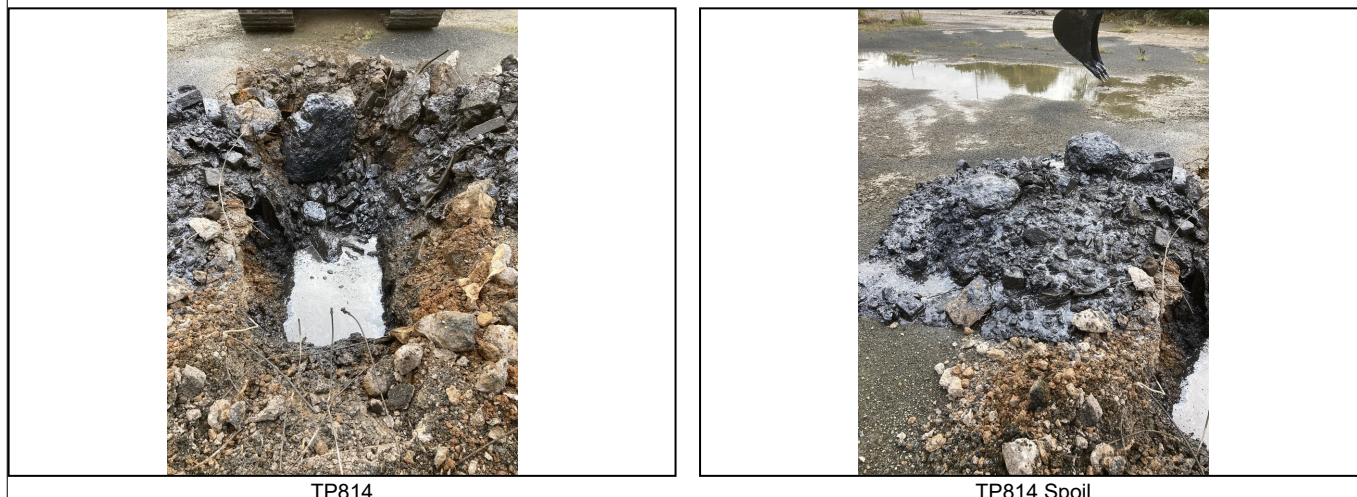
| Water<br>Strike | Samples & In Situ Testing | | | Depth<br>(m) | Level<br>(m) | Legend | Stratum Description | |
|---|---|---|---|---|---|---|---|---|
| <br>0.40 | 0.30 | B<br>ES | | 0.20 | | | MADE GROUND: Concrete reinforced with rebar and plastic sheeting. | |
| | 0.40 | | | | | MADE GROUND: Black oily gravel with frequent cobbles. Gravel is fine to coarse angular to subangular. Cobbles are angular (Strong hydrocarbon odour). | | |

Remarks: 1. Terminated due to water ingress. 2. Water strike encountered at 0.40m bgl, fast ingress, black with an oily sheen and a strong hydrocarbon odour.

Stability: Stable.

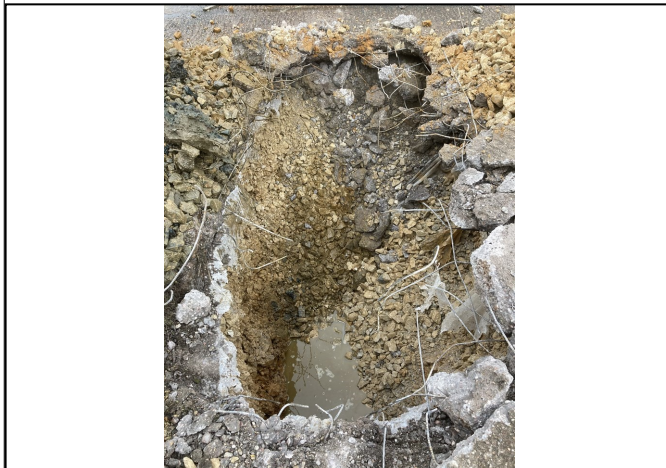
TP815

| Water Strike | Samples & In Situ Testing | | | Depth (m) | Level (m) | Legend | Stratum Description | |
|---|---|---|---|---|---|---|---|---|
| | 0.50 | ES | | 0.20 | | | MADE GROUND: Concrete reinforced with rebar and plastic sheeting. | |
| | | | | | | | MADE GROUND: Yellow gravel. Gravel is coarse angular to subangular of sandstone. | 1 |
| | 1.90 | ES | | 1.70 | | | MADE GROUND: Brown gravelly clay with an oily sheen and green staining. Gravel is fine to medium angular to subrounded of brick and mudstone. | 2 |

Remarks: 1. Complete. 2. Water strike encountered, orange in colour.

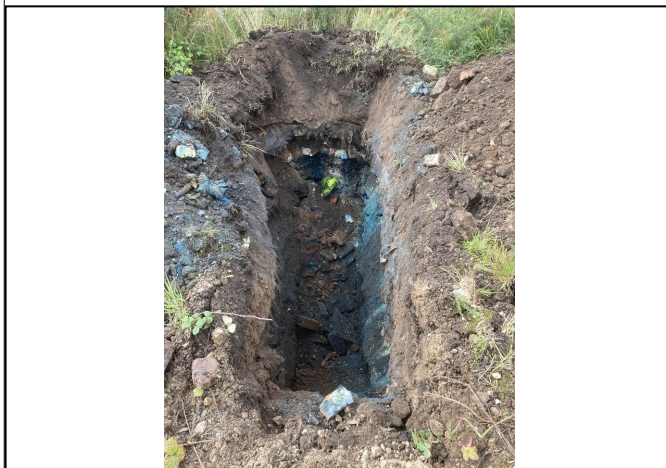
TP816

| Water Strike | Samples & In Situ Testing | | | Depth (m) | Level (m) | Legend | Stratum Description | |
|---|---|---|---|---|---|---|---|---|
| | 0.20<br>0.20 | B<br>ES | | 0.30<br>0.35 | | | MADE GROUND: Brown gravelly fine to medium sand with frequent rootlets. Gravel is fine to coarse angular to subangular of brick and mudstone. | |
| | | | | | | | MADE GROUND: Geotextile | |
| | | | | | | | MADE GROUND: Dark brown with blue staining gravelly fine to medium sand with frequent cobbles. Gravel is fine to coarse angular to subangular of brick, ash, mudstone, ceramic, plastic wire, timber, rag and plastic bag. Cobbles are angular of brick. | 1 |
| | | | | 2.70 | | | Firm grey mottled brown slightly gravelly sandy CLAY. Gravel is fine to medium angular to subrounded of mudstone. | 3 |

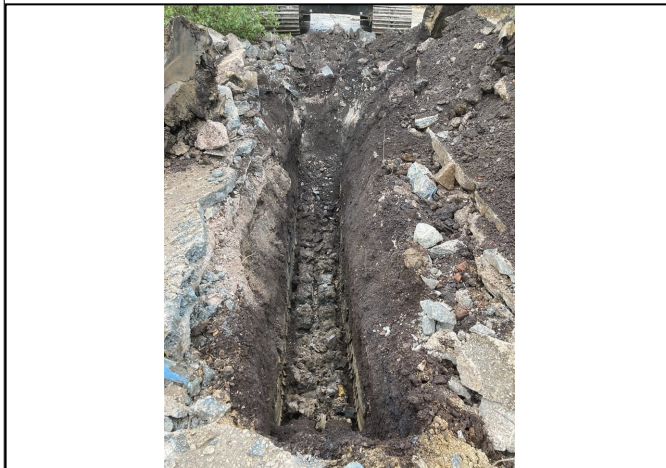
TT801

| Water Strike | Samples & In Situ Testing | | | Depth (m) | Level (m) | Legend | Stratum Description | |
|---|---|---|---|---|---|---|---|---|
| | | | | 0.30 | | | MADE GROUND: Concrete reinforced with rebar and plastic sheeting. | |
| | | | | 1.50 | | | MADE GROUND: Black sandy gravel with some blue staining throughout. Gravel is fine to coarse angular to subangular of brick, limestone, concrete and ash. | 1 |
| | | | | 1.90 | | | Firm brown mottled grey sandy CLAY. | |

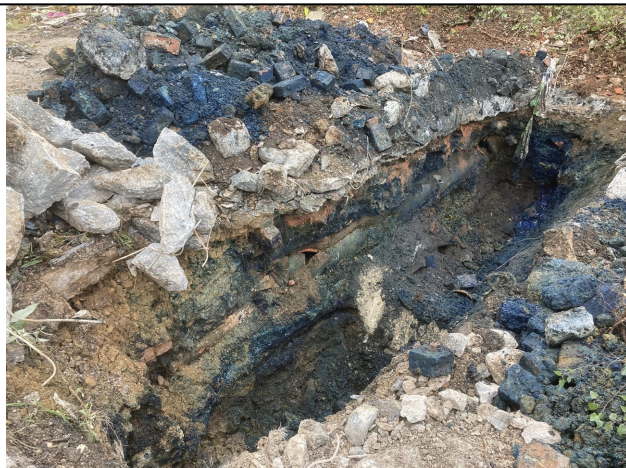
TT802

| Water<br>Strike | Samples & In Situ Testing | | | Depth<br>(m) | Level<br>(m) | Legend | Stratum Description | |
|---|---|---|---|---|---|---|---|---|
| | | | | 0.20 | | | MADE GROUND: Concrete reinforced with rebar. | |
| | | | | | | | MADE GROUND: Brown sandy gravel with occasional cobbles and blue staining throughout. Gravel is fine to coarse angular to subangular of brick, mudstone and concrete. Cobbles are angular of brick | |
| | | | | 0.80 | | | MADE GROUND: Brick structure. | 1 |
| | 1.20 | ES | | 1.10 | | | MADE GROUND: Blue gravel. Gravel is fine to coarse angular to subangular. | |

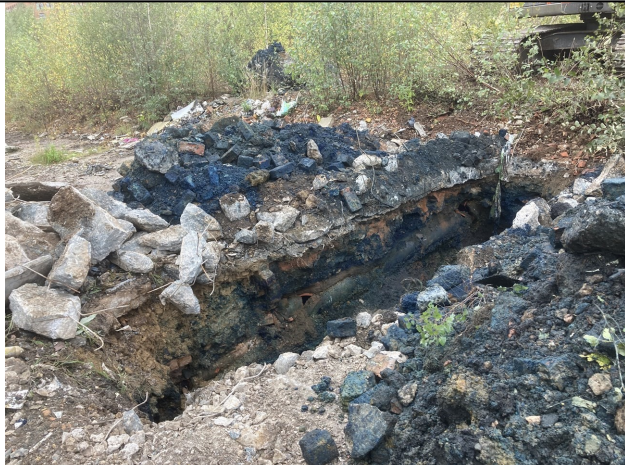
TT803

| Water Strike | Samples & In Situ Testing | | | Depth (m) | Level (m) | Legend | Stratum Description | |
|---|---|---|---|---|---|---|---|---|
| | 0.40 | ES | | 0.30 | | | MADE GROUND: Concrete. | |
| | | | | 0.60 | | | MADE GROUND: Brown sandy gravel with occasional cobbles and blue staining throughout. Gravel is fine to coarse angular to subangular of brick, mudstone and concrete. Cobbles are angular of brick | |
| | | | | | | | MADE GROUND: Black clayey gravel. Gravel is fine to coarse angular to subrounded of brick, clinker, mudstone, plastic and metal wire. (Hydrocarbon odour) | 1 |
| | | | | 2.40 | | | Very soft grey gravelly CLAY. Gravel is fine to medium subangular to subrounded of mudstone. | |

Remarks: 1. Terminated due to instability.

Stability: Unstable.

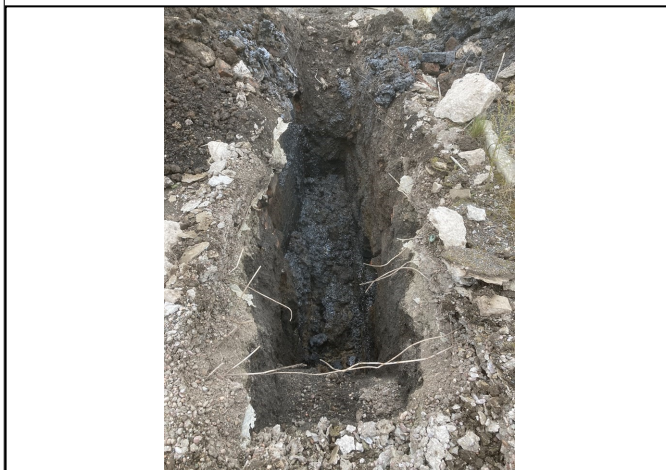
TT804

| Water Strike | Samples & In Situ Testing | | | Depth (m) | Level (m) | Legend | Stratum Description | |
|---|---|---|---|---|---|---|---|---|
| <br>2.10 | 0.50 | ES | | 0.30 | | | MADE GROUND: Concrete. | |
| | | | | | | | MADE GROUND: Black clayey gravel. Gravel is fine to coarse angular to subrounded of brick, clinker, mudstone, plastic and metal wire. | 1 |
| | 1.80 | ES | | 1.80 | | | MADE GROUND: Black oily sheen clayey gravel. Gravel is fine to coarse angular to subangular. | 2 |
| | | | | 2.10 | | | Firm brown mottled grey sandy clay. | |

Remarks: 1. Complete. 2. Water strike encountered at 2.10m bgl, seeage, black in colour with a strong hydrocarbon odour.

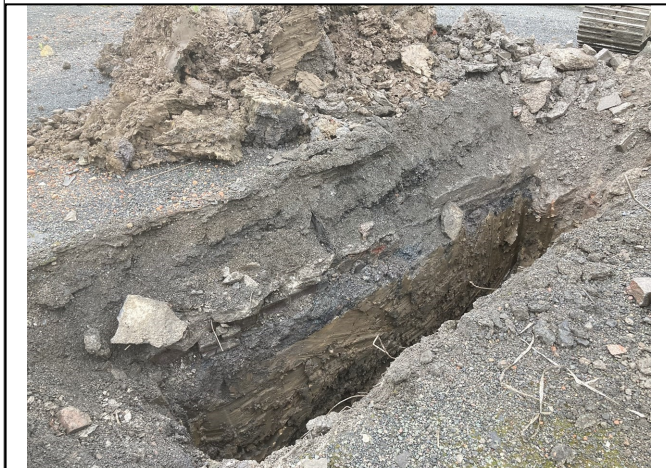
TT805

| Water Strike | Samples & In Situ Testing | | | Depth (m) | Level (m) | Legend | Stratum Description | |
|---|---|---|---|---|---|---|---|---|
| | | | | 0.60 | | | MADE GROUND: Asphalt | |
| | | | | 0.80 | | | MADE GROUND: Concrete reinforced with rebar. | |
| | 1.00 | ES | | | | | MADE GROUND: Grey gravel with occasional cobbles. Gravel is fine to coarse angular to subrounded of concrete, brick, limestone and mudstone. Cobbles are angular of brick. | 1 |
| | 1.70 | ES | | 1.50 | | | Firm brown mottled grey very gravelly CLAY. Gravel is fine to medium angular to subrounded of mudstone. | 2 |
