MAYFIELD, MANCHESTER

BAT INSPECTION AND EMERGENCE  
SURVEY REPORT -  
BUILDING B2 AND CULVERTS B24/B26

November 2018

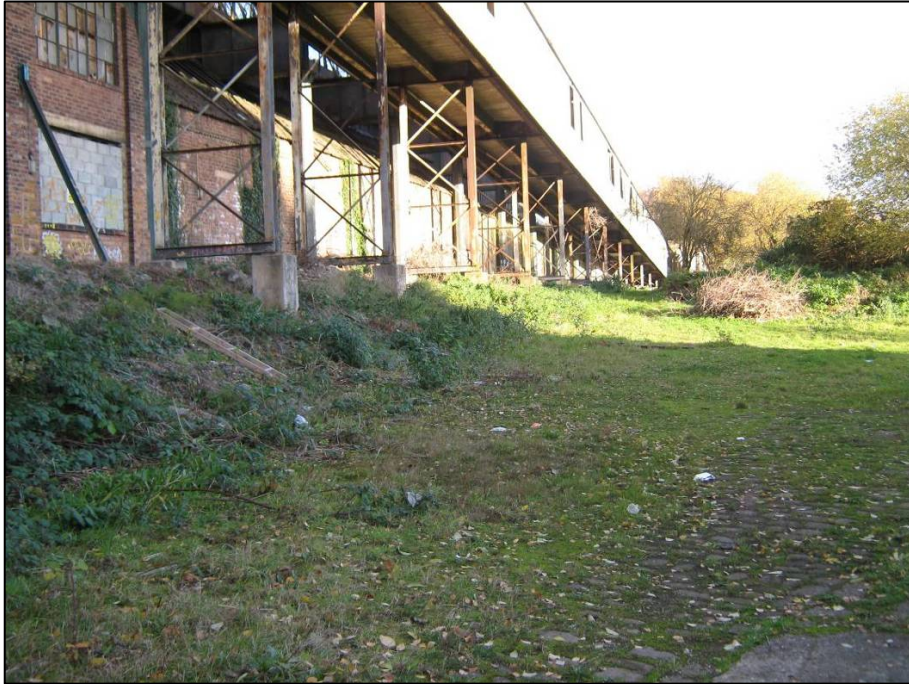
- 2.9 There was a narrow corridor of accessible land between the base of the building and a wire fence. Beyond the fence the area was well-vegetated and fell sharply towards the River Medlock. It was not possible, therefore, to step away and view the building more fully and surveyors were confined to making observations from close to the building walls. Visibility was further inhibited by the former pedestrian ramp walkway, which partially blocks the view of the building (see Plates 1 and 2).

Plate 1 Southern side of B2 – roost entrance identified towards end of ramp during earlier survey work undertaken by other consultants during 2014

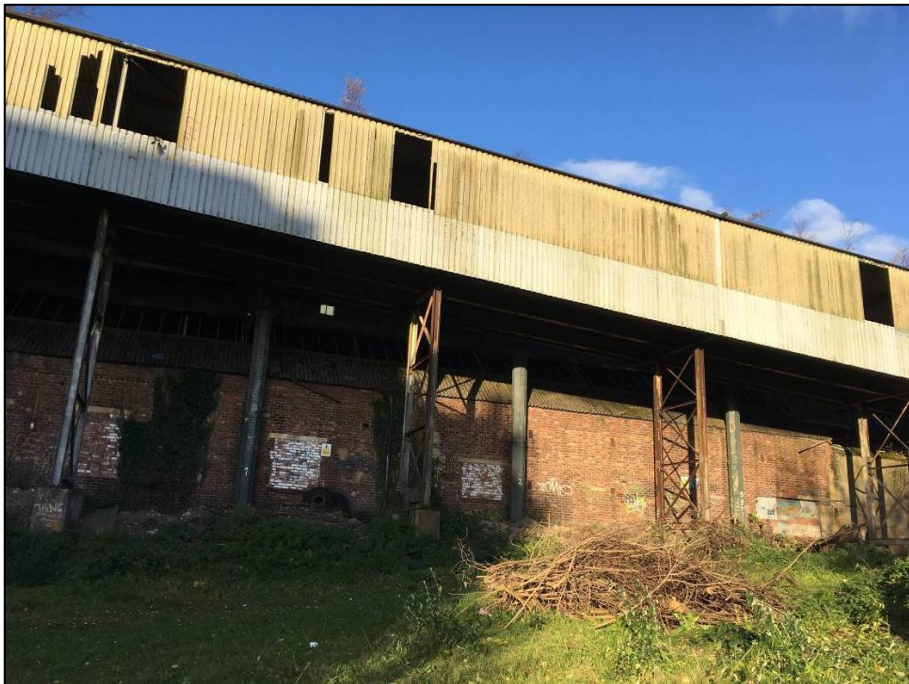
Emergence surveys corroborated evidence for a bat roost on B2 near the ramp, but the exact location could not be determined as the roost site may be hidden by the depot ramp which occupies much of the southern wall. Together with previous data for this part of B2, the survey results confirm the presence of a regularly-used, non-breeding summer day roost of up to four common pipistrelle bats in this area.

Plate 2 Three to four bats seen close to building at sunset during dusk surveys, considered likely to be roosting but exact roost feature not identified

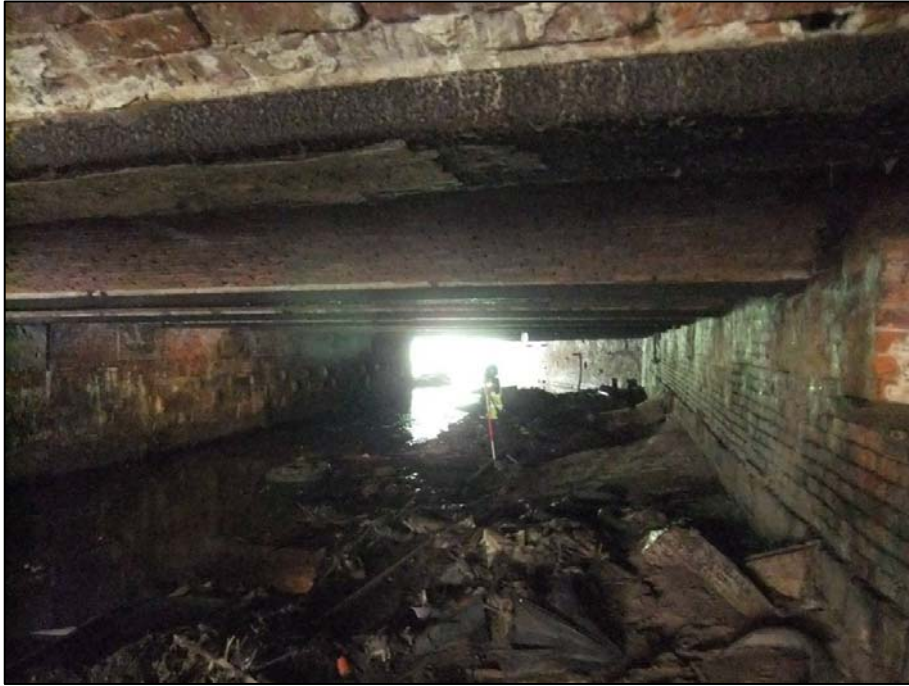
- 3.6 Culvert B24 was surveyed from the upstream end, entering the river via the B4 warehouse off Baring Street and walking downstream through the tunnel. The stream channel was accessible throughout but a lot of debris, including tyres, fabric and construction materials, was present within the channel. The culvert itself was box-section (Plate 3), with metal girders supporting brick arches perpendicular to the stream (Plate 4). The culvert walls were mainly brick with sections of stone and concrete (Plate 5). The walls appeared to have been modified considerably since construction. No maintenance has been undertaken recently and there were many cracks and crevices that bats could access, particularly in the junction between the walls and the roof (Plate 6), although relatively few were more than superficial. Occasional resting moths were noted and spiders (including old cobwebs) were abundant in more sheltered cavities in the roof, indicating that waters rarely reach these levels.

Plate 3 Culvert B24 box section culvert over River Medlock

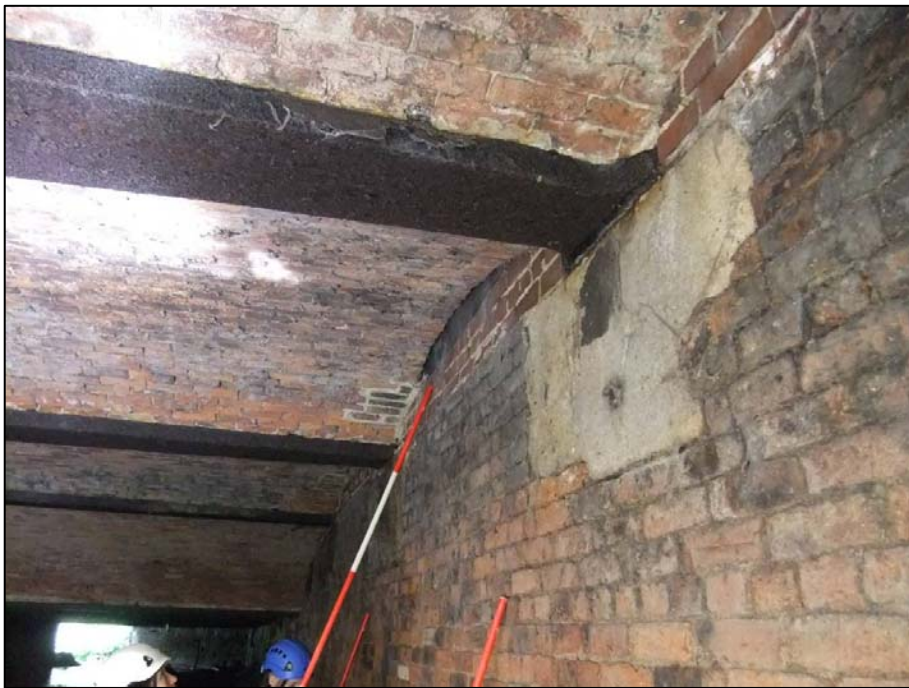
- 3.7 Culvert B24 contained many crevices that bats could use singly or in pairs for shelter and several locations where cavities extended further into the structure. All larger cavities were searched using a torch and endoscope and no evidence of bats was found. It has to be noted that roosts over a river will not be marked by droppings, a feature which often provides a clue to bats' whereabouts. The presence of moths and spiders (including old cobwebs) indicate that the culvert rarely fills, making it more suited to bat roosting. The evidence from emergence surveys is that bats roost within the culvert, and potential for bats to roost here was certainly

Plate 4 Culvert B24 showing gaps at junction between wall and roof

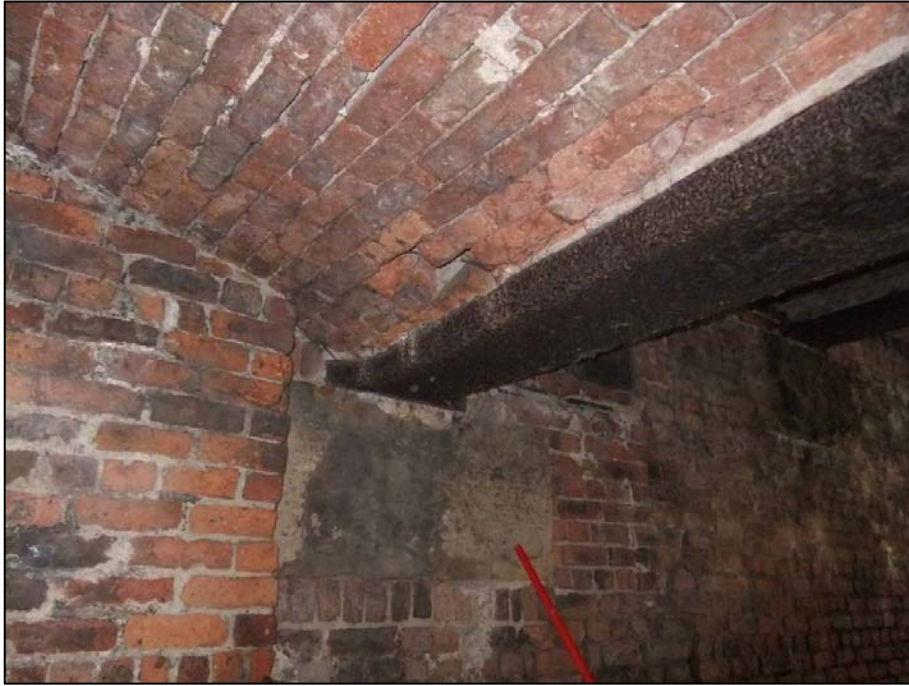
Plate 5 Culvert B24 wall of mixed materials

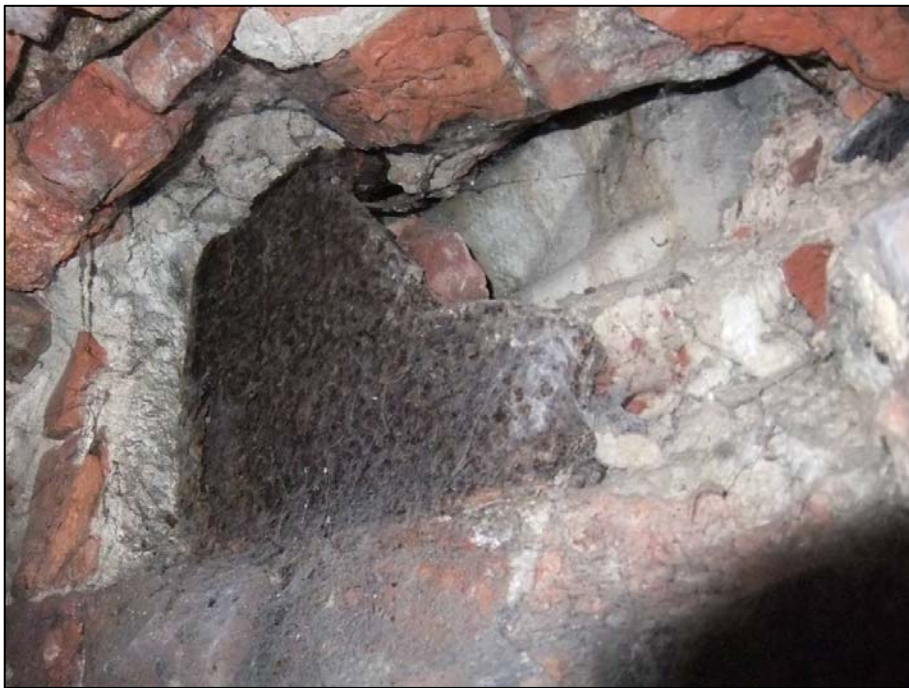
Plate 6 Culvert B24 example crevice at join between wall and roof with bat roost potential but no evidence

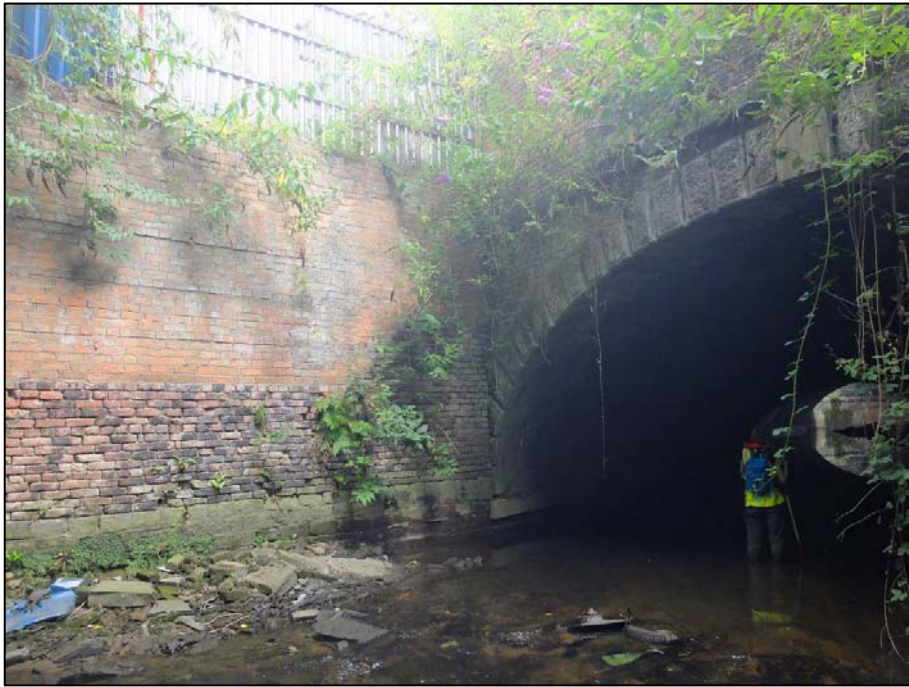
- 3.8 Safe access to the river at culvert B26 was not possible on the day of the survey. The River Medlock Survey (PAA 2017b) commenced at the downstream end of the B26 culvert, but photographs taken at the time show an arched structure with dressed stone lintel and brick interior and headwall. Sidewalls are also of brick. Some opportunities for bat roosts are apparent in gaps in the headwall at the downstream end (Plate 7).

Plate 7 Culvert B26 downstream end, left bank looking upstream showing stone lintel and brick head and sidewalls

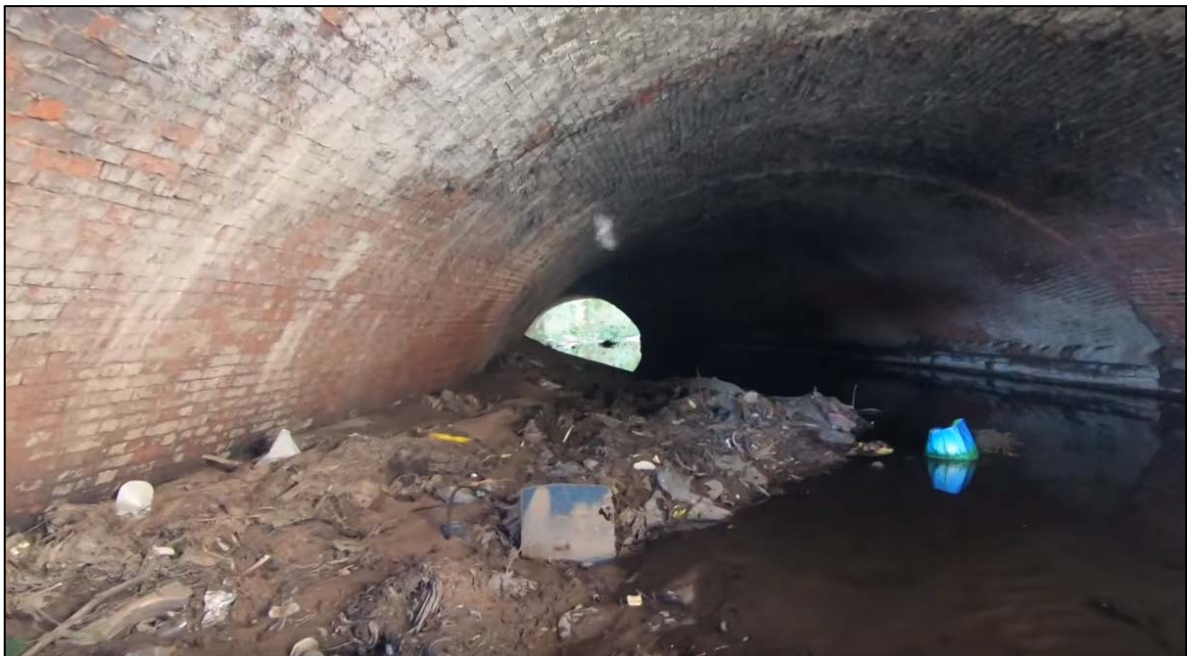
- 3.9 Video information available online<sup>3</sup> shows some views of the inside of the culvert, which is connected to a longer section under the railway lines into Piccadilly Station, north of Temperance Street. Here the culvert is arched (Plate 8) and constructed entirely of brick. Brickwork appears intact throughout and in good condition. Roost sites would be hard to identify as evidence would be likely to fall into the river and wash away. Photographs appear to indicate that the interior of culvert B26 would not be very suitable for bat roosts as the condition of the brick is good and crevices are few. It is considered more likely that bat roosts would be located in headwalls or at the junctions between culvert and external walls.

Plate 8 Culvert B26 interior looking downstream, showing brick-built arched structure (Martin Zero 2018)

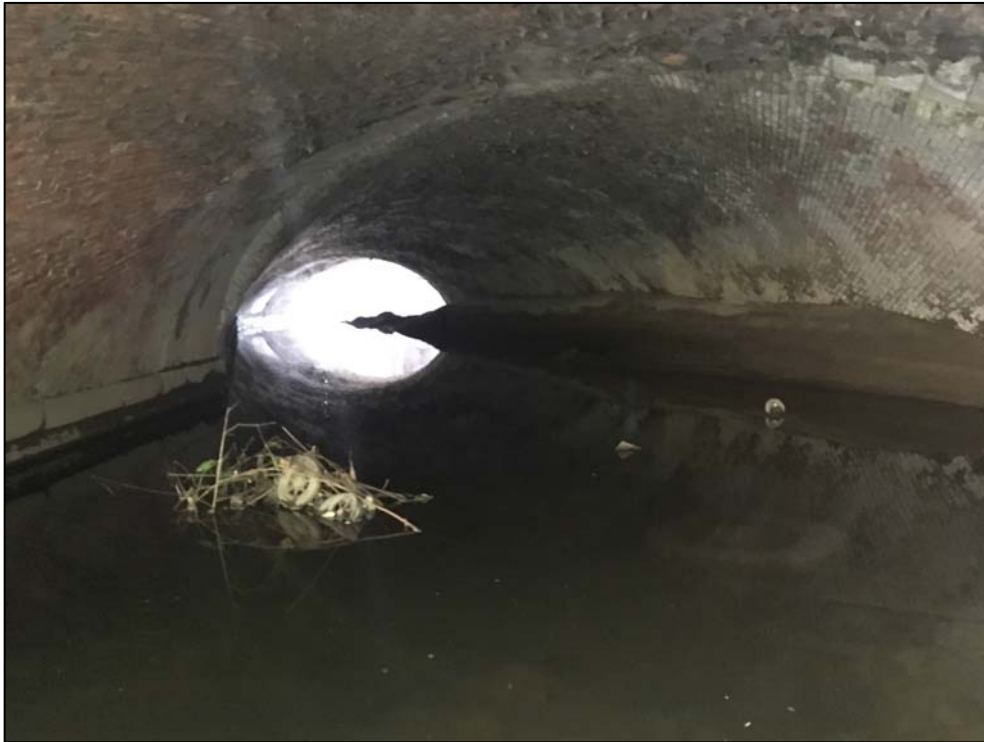
Plate 9 Culvert B26 looking upstream. Brickwork largely intact with few crevices (July 2017)
