## NON-TECHNICAL SUMMARY OF DRAFT EPSL BAT LICENCE FOR BUILDINGS B2, B6 AND B24

## Bats – Method Statement template to support a licence application

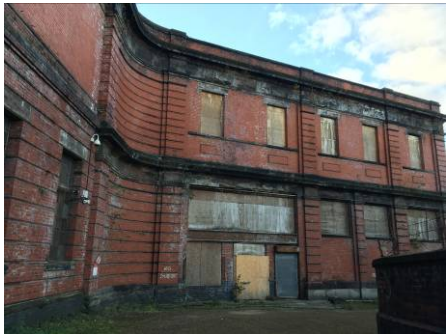
| Reference | Picture | Description | Potential Bat Roost Features and Evidence of Roosting | Assessed Roost Status |
|---|---|---|---|---|
| B1 | | <p>Former Mayfield Station. Brick façade with stone parapet and stone lintels to windows.</p> <p>Large decoratively tiled stairwell and offices/warehouse at ground floor, offices and station concourse at second floor. No roof structure remaining.</p> <p>All windows and doors boarded up.</p> <p><b>No access to interior due to presence of asbestos &amp; lead paint.</b></p> | <p>Damaged wooden fascia boards on external façade providing access to cavity behind. Small crevices in brickwork and around stone lintels on external façade. Unglazed window into stairwell providing potential bat access to internal rooms.</p> | High Potential |

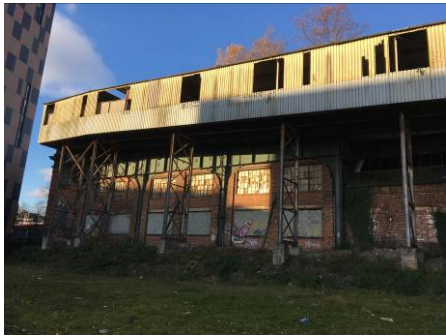
| Reference | Picture | Description | Potential Bat Roost Features and Evidence of Roosting | Assessed Roost Status |
|---|---|---|---|---|
| B2a | | <p>Former station platforms and warehouses. Brick façade with two large internal warehouses. Concrete floor, flat roof supported by concrete pillars.</p> <p>Narrow enclosed ramp from ground level to platforms on southern elevation, supported by metal framework and covered with corrugated sheets. Open ramp on northern elevation.</p> <p>Series of large brick arches beneath platforms at eastern end, each enclosed with wooden boarding and used as warehouse/industrial units.</p> | <p>Crevices on the external façade. Broken windows and gaps around roller shutter doors providing access to internal warehouses. Very limited roost potential within these rooms but considered likely to be used as sheltered foraging site during poor weather conditions.</p> <p>Existing record of pipistrelle roost on northern side, potentially on external façade or at platform level.</p> | Confirmed Roost<br><br>High Potential on rest of structure |

B2 – removal of the metal ramp structure has the potential to permanently damage or destroy a small day roost for up to 5 common pipistrelle bats. Because the exact location of the roost is not known on this large structure, the worst case scenario has been assumed – i.e. permanent destruction of the roost. There is also potential for temporary disturbance of bats during the removal of the ramp, and the possibility of injury to bats during the works.

B2 - removal of metal ramp structure and possible destruction of roost area. The ramp is unsafe and unsuitable for future uses of the building. It must be removed to facilitate redevelopment in line with the SRF and local planning policy. Therefore specific mitigation will comprise:

- Pre-demolition inspection (if possible to safely access the general area where the roost is located) using endoscope to examine potential roost cracks and crevices at ramp level.
- Exclusion where bats are found using a feature that will be destroyed as part of the ramp removal operations. Exclusion to follow standard methods (e.g. Mitchell-Jones and McLeish (2004)).
- Watched demolition of any features identified as hosting the bat roost or having high potential for roosting that are to be destroyed during the works.
- Retention and protection of roost feature if found and not needing to be destroyed as part of the ramp removal works.
- Capture and release of any accessible bats following best practice guidance (E2.2)

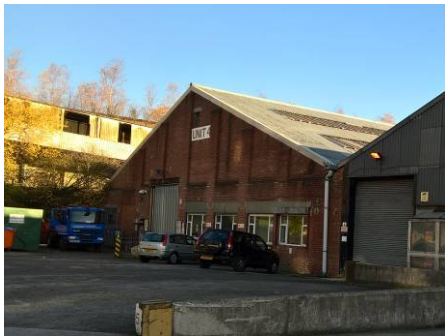
| Reference | Picture | Description | Potential Bat Roost Features and Evidence of Roosting | Assessed Roost Status |
|---|---|---|---|---|
| B3 | | <p>Industrial unit occupied as warehouse.</p> <p>Brick walls with pitched roof covered with corrugated asbestos cement sheets and numerous plastic skylights.</p> <p>Roof supported by metal framework, open to ridge with no roof voids. Concrete floor.</p> | None | Negligible Potential |

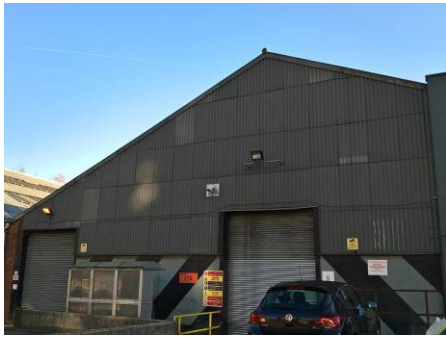
| B4 | | <p>Industrial unit occupied by Fedex as warehouse and distribution centre.</p> <p>Brick walls with corrugated metal sheets on front elevation. Pitched roof of corrugated asbestos sheets with numerous plastic skylights.</p> <p>Open to ridge with no roof void.</p> | None | Negligible Potential |

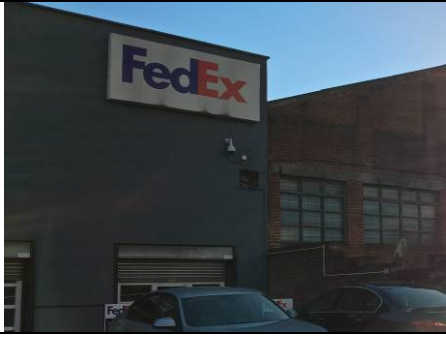
| B5 | | <p>Office unit of warehouse complex occupied by Fedex.</p> <p>Metal sheet walls to front elevation, brick walls with pitched roof of corrugated sheets to rest of building.</p> <p>No roof voids.</p> | None | Negligible Potential |

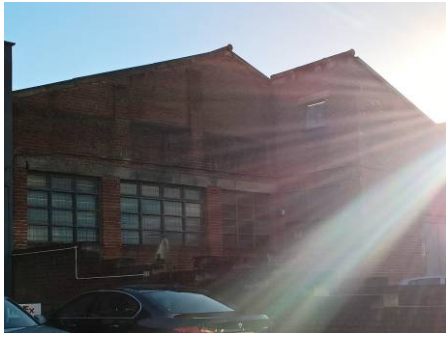
| B6 | | <p>Industrial unit used as storage warehouse together with B9 and B10b.</p> <p>Brick with pitched roof covered with asbestos cement sheets.</p> <p>Roof supported by metal framework, open to ridge with no roof voids.</p> <p>Concrete floor.</p> <p>Large basement, also used for storage.</p> | <p>Crevices on brickwork on northern elevation above River Medlock.</p> <p>Basement provided no obvious crevice features and was too light and disturbed for potential hibernation use.</p> | High Potential |

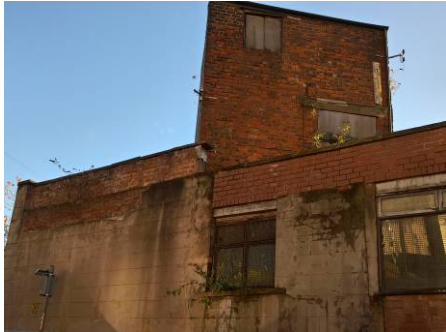
| B7a | | <p>Disused industrial units, part of former Towbar and Trailer Centre.</p> <p>Two-storey section, brick with pitched slate roof, clay ridge tiles and wooden bargeboards at gable ends. Underside visible from interior - open to ridge and appeared to be lined with wooden or metal boards.</p> <p>Two-storey section at SE corner, brick with pitched roof covered with bitumen felt. <b>No access for internal inspection on this section, potentially a roof void present.</b></p> <p>Single storey section with flat bitumen felt roof.</p> <p>Concrete floors throughout and single glazed windows boarded up or secured with wire mesh.</p> | <p>Numerous crevices in brickwork.</p> <p>Crevices around windows providing bat access to interior of two storey sections. Crevices beneath barge boards, potentially providing access to space between slates and lining beneath.</p> <p>Dilapidated fascia boards at eaves on single storey section.</p> | Moderate Potential |

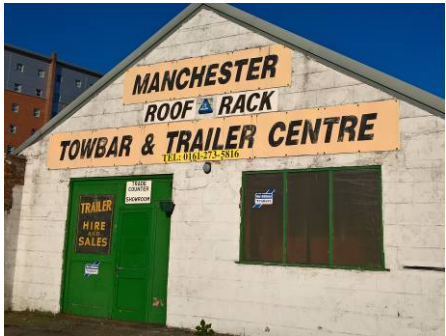
| B7b | | <p>Disused industrial units, part of former Towbar and Trailer Centre.</p> <p>Brick walls with pitched roof covered with metal sheets.</p> <p>Wooden ceiling with roof void above – no obvious hatches to provide access for inspection.</p> <p>Underside of roof partially visible at rear of building (adjacent to two-storey section visible in photo for B7a), supported by wooden rafters and fully lined with membrane.</p> <p>Underground basement.</p> | <p>Basement provided no obvious crevice features but was dark and likely to provide relatively stable temperature conditions.</p> <p>In use until relatively recently and therefore likely to have been too disturbed for hibernation use; however, could potentially be used in future now that the building is disused.</p> | Negligible Potential |

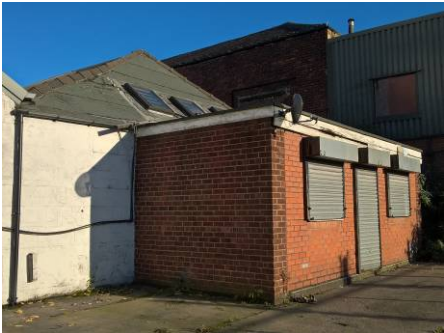
| B7c | | <p>Industrial unit, occupied as religious premises.</p> <p>Brick walls with pitched roof covered with bitumen felt and clay ridge and hip tiles. Skylights on roof suggesting no roof void present.</p> <p>Small section at front with flat roof covered with bitumen felt and narrow wooden fascia boards at eaves.</p> <p><b>No access permission for inspection.</b></p> | None apparent from areas visible. | Full inspection required. |

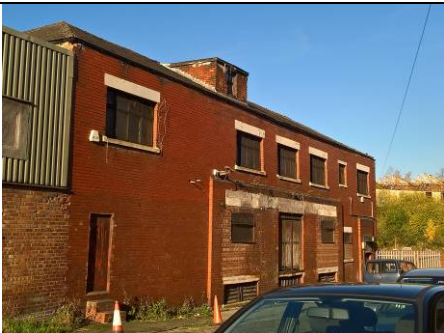
| B8a | | <p>Industrial/office units.</p> <p>Two-storey brick building, two separate pitched slate roofs with hipped gables.</p> <p><b>No access permission for internal inspection.</b></p> | <p>Potentially two roof voids.</p> <p>Crevices on external brickwork.</p> | <p>Moderate Potential</p> <p>Full inspection required</p> |

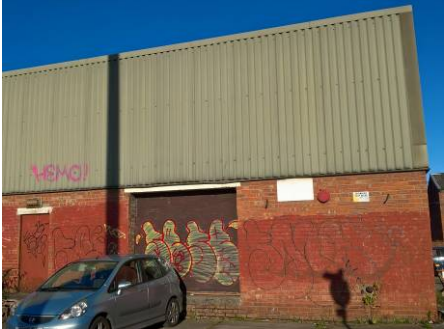
| B8b | | <p>Industrial units.</p> <p>Two-storey flat roofed building with brick walls with metal sheeting at upper level.</p> <p><b>No access permission for internal inspection.</b></p> | <p>Unlikely to be any roof void.</p> <p>No obvious crevices on external façade.</p> | Negligible Potential |

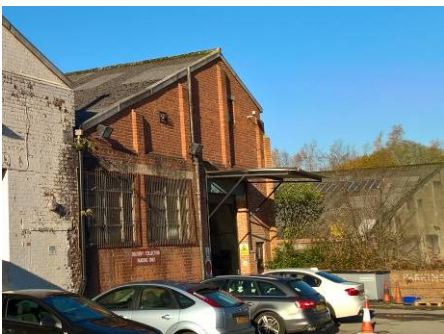
| B9 | | <p>Industrial unit occupied as factory and storage warehouse, together with B10b and B6.</p> <p>Brick with pitched roof of asbestos cement sheets.</p> <p>Roof supported by metal framework, open to ridge with no roof voids.</p> <p>Concrete floor.</p> <p>Large basement beneath, used for storage.</p> | <p>No roof void.</p> <p>Basement provided no obvious crevice features and was too light and disturbed for potential hibernation use.</p> | Negligible Potential |

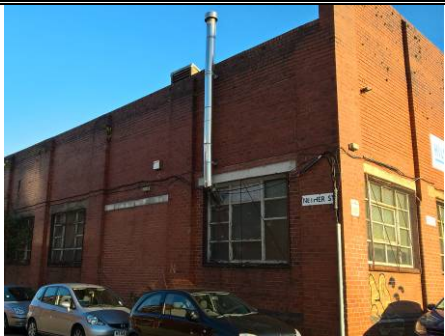
| B10a | | <p>Two-storey brick building with brick parapet at front elevation.</p> <p>Four ridges to the roof, covered with slates and clay ridge tiles.</p> | No access for internal inspection | <p>Moderate Potential</p> <p>Full inspection required</p> |

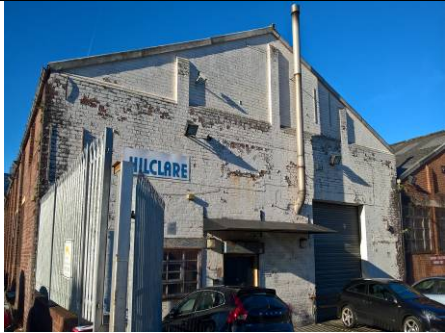
| B10b | | <p>Industrial unit occupied as factory and storage warehouse, together with B9 and B6.</p> <p>Brick with pitched roof of asbestos cement sheets.</p> <p>Open to ridge with no roof void.</p> | None | Negligible Potential |

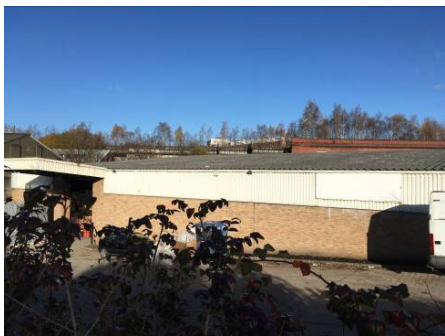
| B12 | | <p>Industrial unit used as a storage/distribution warehouse.</p> <p>Brick walls with corrugated metal sheeting towards roof level.</p> <p>Shallow pitched roof covered with corrugated sheets, open to ridge with no roof void.</p> | None | Negligible Potential |

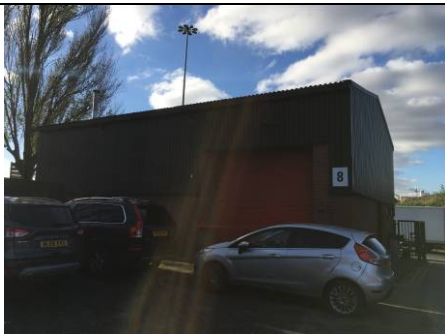
| B13 | | <p>Industrial unit.</p> <p>Two-storey building with brick walls at ground level and metal sheeting at first floor level.</p> <p>Shallow pitched roof covered with metal sheets.</p> | None | Negligible Potential |

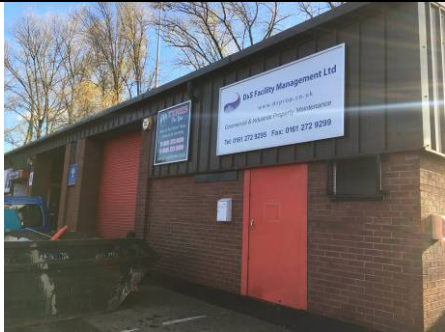
| B14 | | <p>Industrial unit.</p> <p>Two-storey building with brick walls at ground level and metal sheeting at first floor level.</p> <p>Shallow pitched roof covered with metal sheets.</p> | None | Negligible Potential |

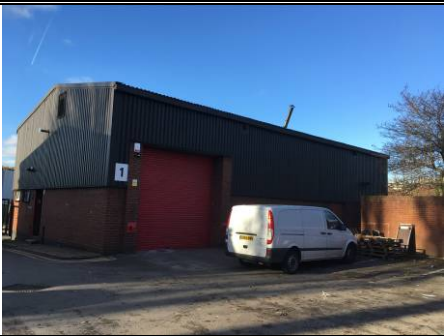
| B15 | | <p>Industrial unit.</p> <p>Two-storey building with brick walls at ground level and metal sheeting at first floor level.</p> <p>Shallow pitched roof covered with metal sheets.</p> | None | Negligible Potential |

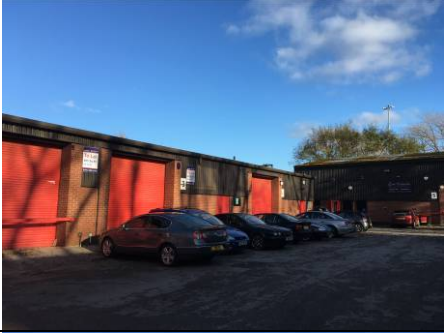
| B16 | | <p>Industrial units.</p> <p>Single-storey building with brick walls at ground level and metal sheeting towards roof level.</p> <p>Shallow pitched roof covered with metal sheets.</p> | None | Negligible Potential |

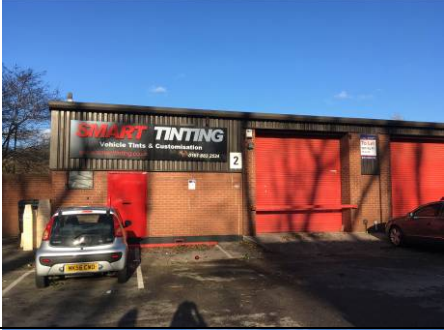
| B17 | | <p>Industrial unit.</p> <p>Brick walls at ground level and metal sheeting towards roof level.</p> <p>Shallow pitched roof covered with metal sheets.</p> | None | Negligible Potential |

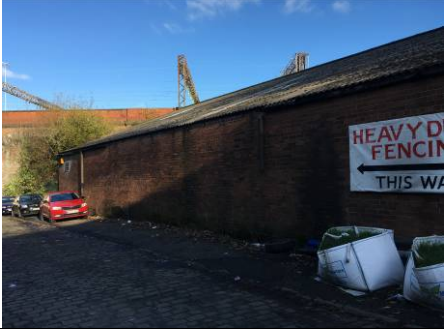
| B18 | | <p>Warehouse/industrial unit, used as storage and recycling facility.</p> <p>Brick walls with pitched roof of asbestos cement sheets, open to the ridge with no roof void.</p> <p>Interior very cluttered.</p> | None | Negligible Potential |

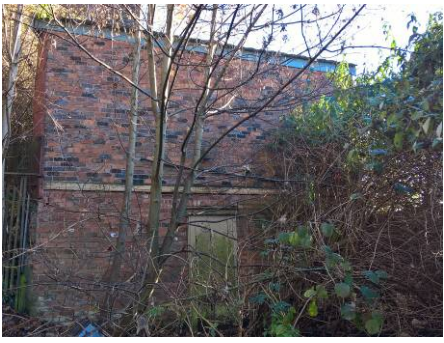
| B20 | | <p>Two-storey brick structure with sloping roof covered with corrugated sheets.</p> <p>Unlikely to have roof void.</p> <p>Narrow wooden fascia board at eaves.</p> <p><b>No access permission for inspection.</b></p> | None apparent from visible areas | Negligible potential |

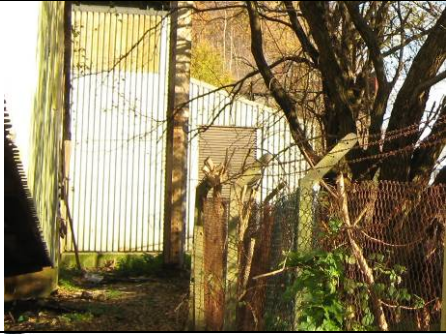
| B21 | | Small lean-to structure adjoined to B2. Corrugated metal walls with roller shutter door and sloping metal roof. | None | Negligible Potential |

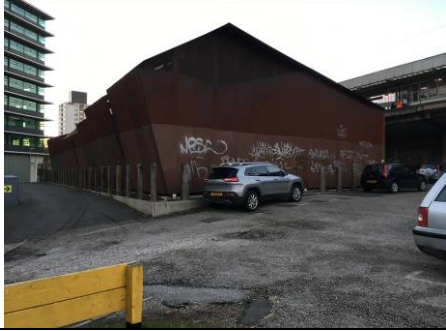
| B22 | | Electricity substation.<br><br>Metal walls.<br><br>Pitched roof with metal sheet covering. | None | Negligible Potential |

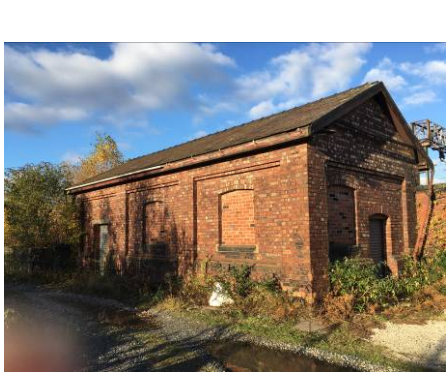
| B23 | | Single-storey brick building. Pitched slate roof with clay ridge tiles and overhanging eaves with wooden soffit and bargeboards at gable ends.<br>Metal roller shutter door (locked) on southern elevation, door and window on eastern gable end boarded up.<br><br>No access permission for internal inspection. | Gaps between brickwork and soffit providing potential access to cavity within soffit and/or interior of building.<br><br>Gap beneath end ridge tile at eastern gable end.<br><br>Gap above roller shutter door. | High Potential |

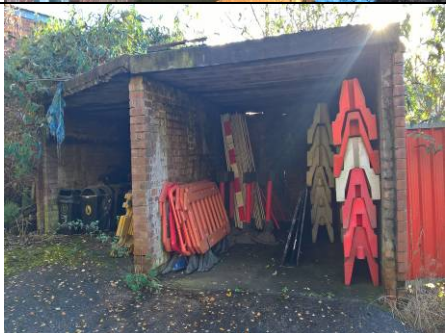
| B25 | | Pair of open fronted garages with brick walls and flat concrete roof.<br><br>Used for storage but appeared relatively undisturbed. | None | Negligible Potential |

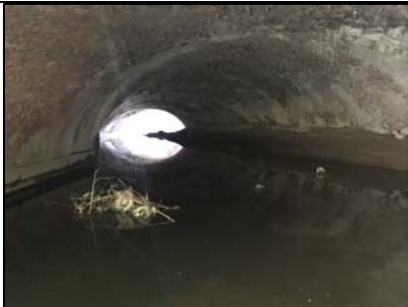
| B26 | | <p>Culverted section of the River Medlock at east of site.<br/>Length approx. 60m within the site and extending for at least the same distance beyond the site boundary.</p> <p><b>Poor visibility for assessment.</b></p> | Bats known to roost in a similar culvert on another nearby site in Manchester. | High Potential |

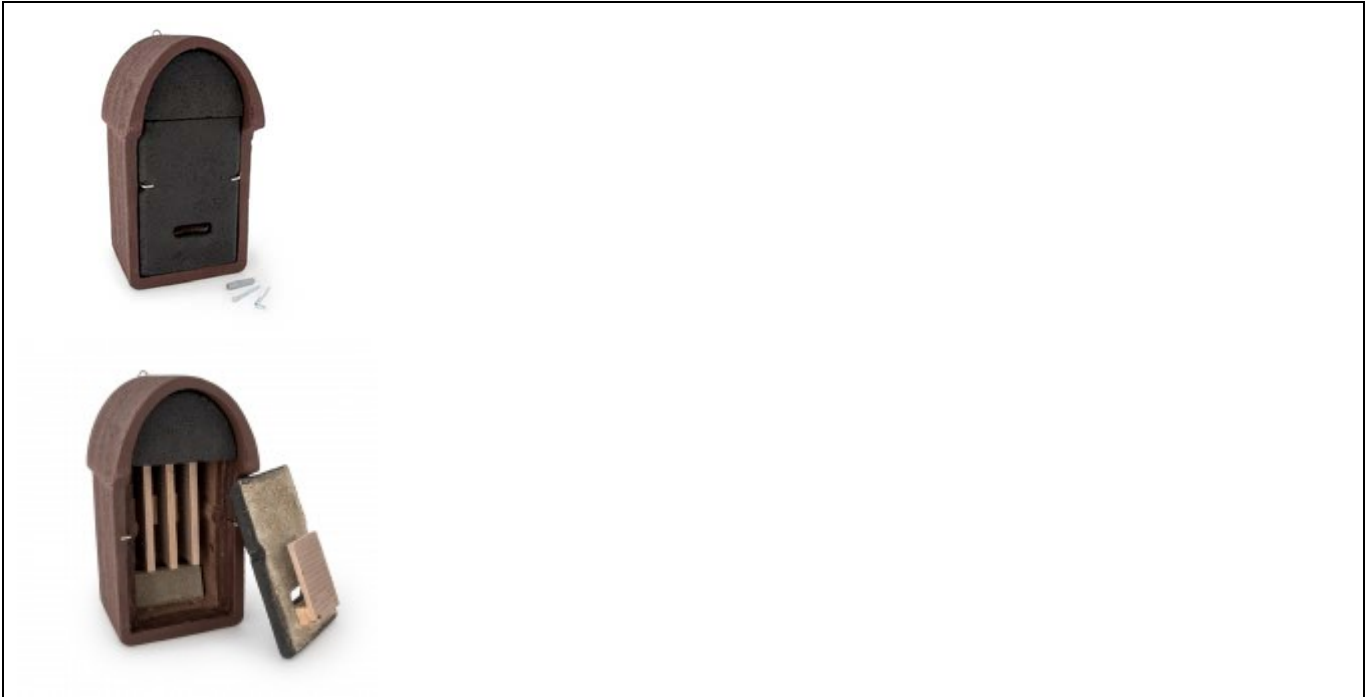
**Figure E1 Example of suitable bat box type for crevice-dwelling species such as common pipistrelle**  
(<https://www.wildcare.co.uk/large-multi-chamber-woodstone-bat-box.html>)
