## Geo-Environmental Factual Report

Premier Inn, Deansgate

Whitbread PLC

MAN.160.001.GE.R.001.A

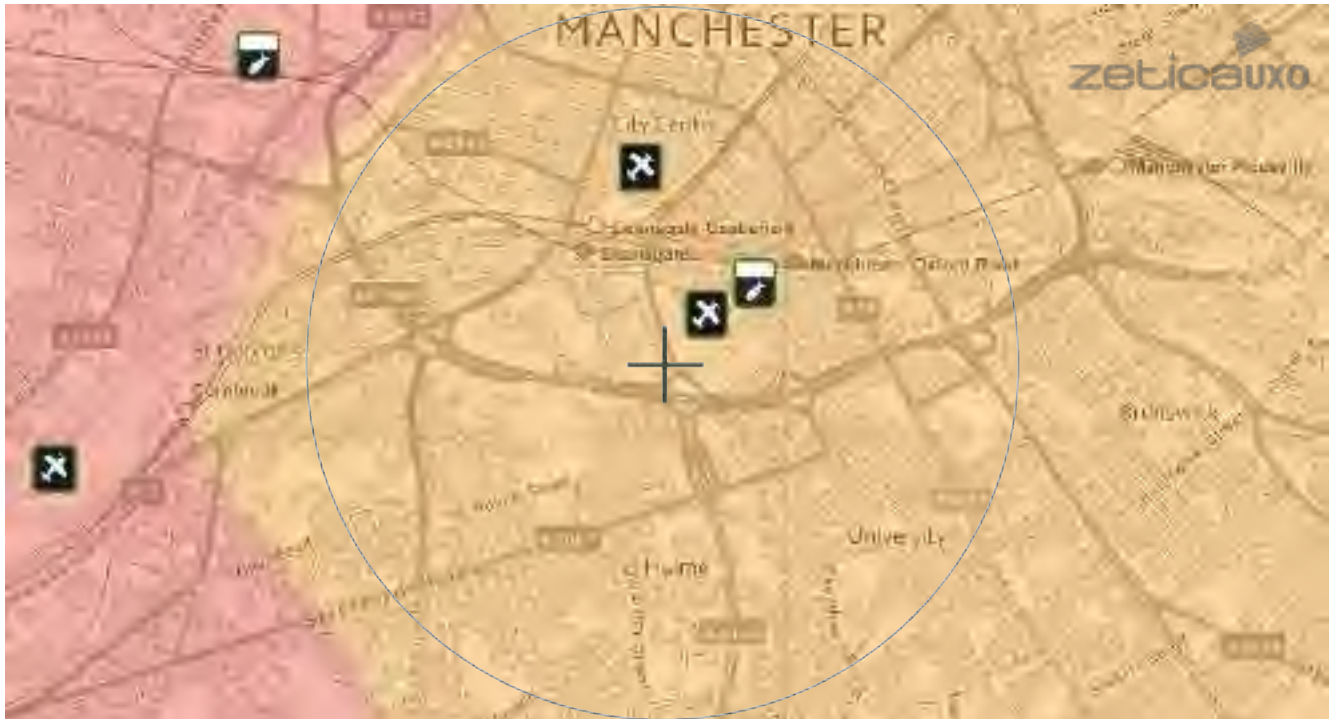
- High:** Areas indicated as having a bombing density of 50 bombs per 1000acre or higher.
- Moderate:** Areas indicated as having a bombing density of 15 to 49 bombs per 1000acre.
- Low:** Areas indicated as having 15 bombs per 1000acre or less.

Generally, we recommend that a detailed UXO desk study and risk assessment is undertaken for sites in a moderate or high UXB risk area.
