## Phase 1 GeoEnvironmental Desk Study

Queens Road

Manchester

**Report No. A5027/22**

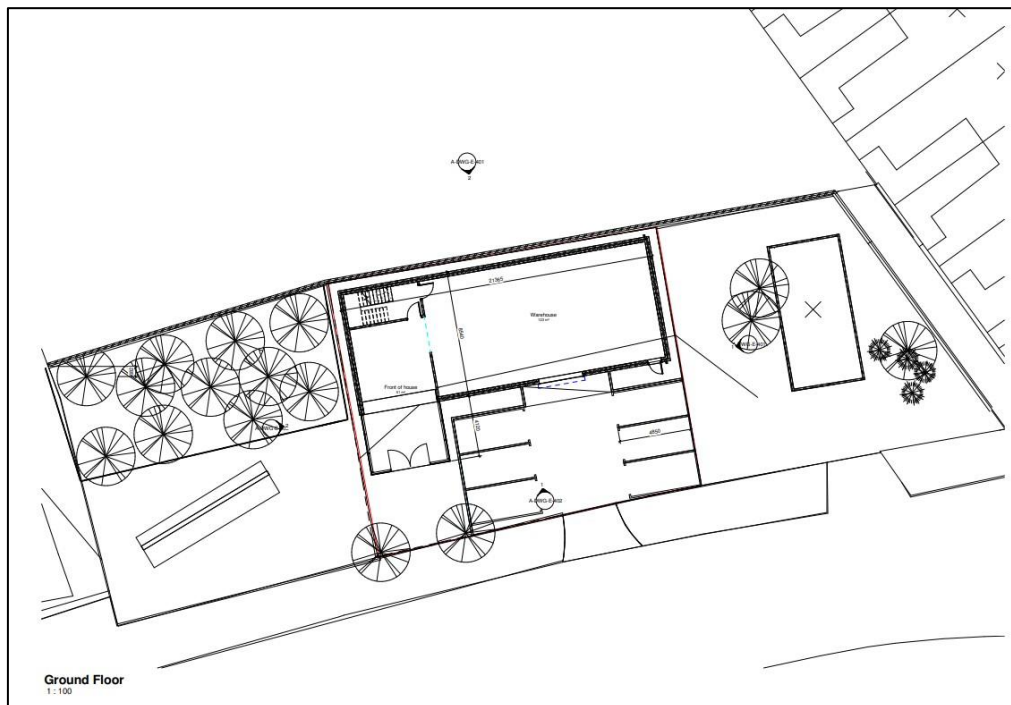
**Figure 1 Proposed Development Plan**

- 1.1 Earth Environmental & Geotechnical Ltd has been commissioned by SEED Architects Ltd on behalf of Skyview Construction Ltd (the Client) to undertake a Phase I GeoEnvironmental Desk Study for the proposed development on the land at Queens Road, Manchester.
- 1.2 It is understood that the Client wishes to construct a warehouse building with associated car park.
- 1.3 Vehicle access will be gained from Queens Road to the south of the site.
- 1.4 A proposed development plan for the site is shown in Figure 1 below.

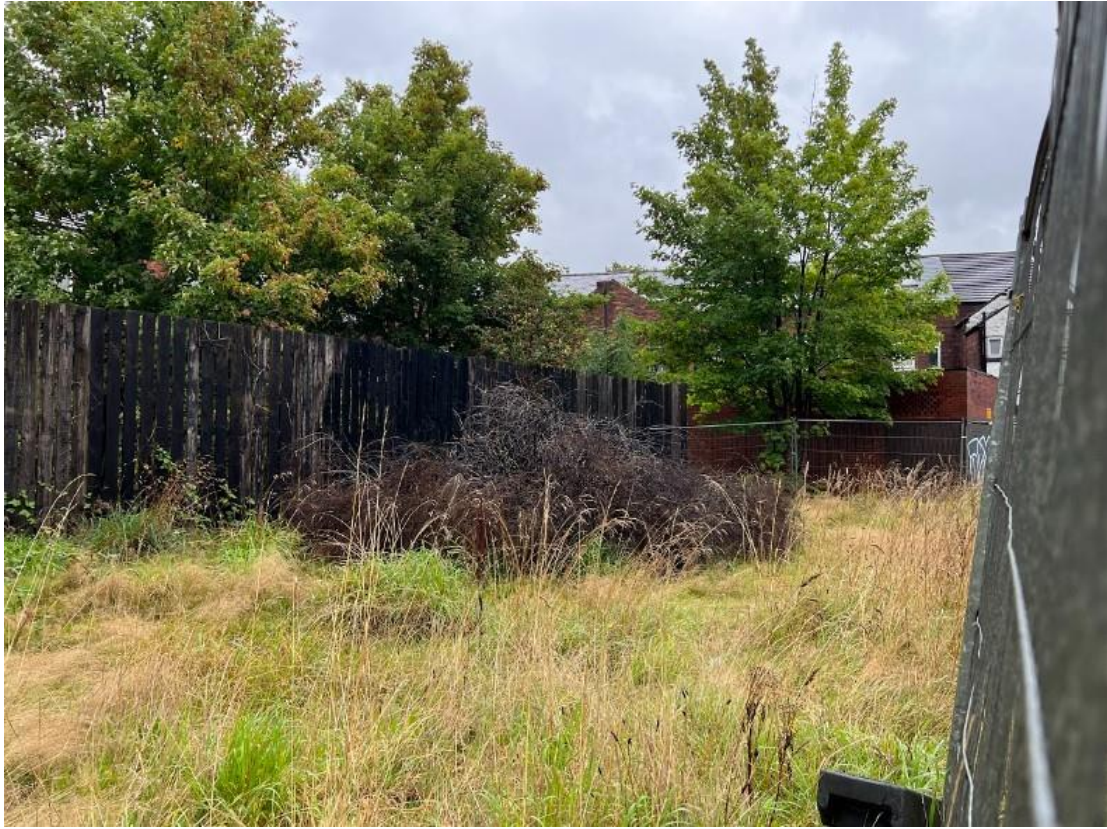
**Figure 3 Site Photograph**

- 2.1 The site is located in Smedley, Greater Manchester approximately 1.9km from Manchester City Centre. The approximate National Grid Reference for the centre of the site is SD 85090 00646 (X: 385090, Y: 400646) with the closest postcode being M8 0JL.
- 2.2 The site is a rectangular shaped parcel of land with current access via Queens Road to the south of the site. The maximum dimensions of the proposed site are 19m north to south and 25m west to east. The site occupies an area of approximately 0.04 hectares.
- 2.3 The site is currently vacant with a wooden fence running through the centre of the site.
- 2.4 The general surrounding area comprises predominantly of residential dwellings, with a railway line situated 40m to the west of the site.
- 2.5 A location plan is shown below as Figure 2, together with a recent site photograph as Figure 3 (overleaf).

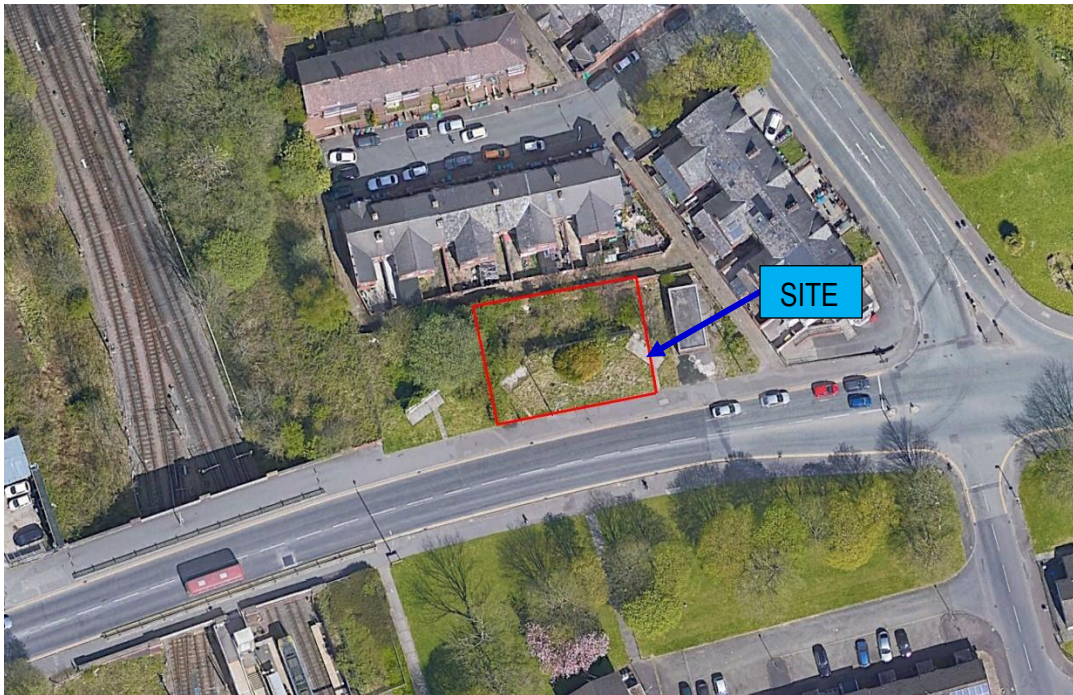
Figure 8 Aerial Photograph 2021

| Date | On-Site History | Surrounding Land Use History |
|---|---|---|
| <p>2022<br/>1:10,000</p> <p>2021<br/>Aerial</p> | The northern boundary of the site is largely overgrown with trees and shrubs. | No significant change. |

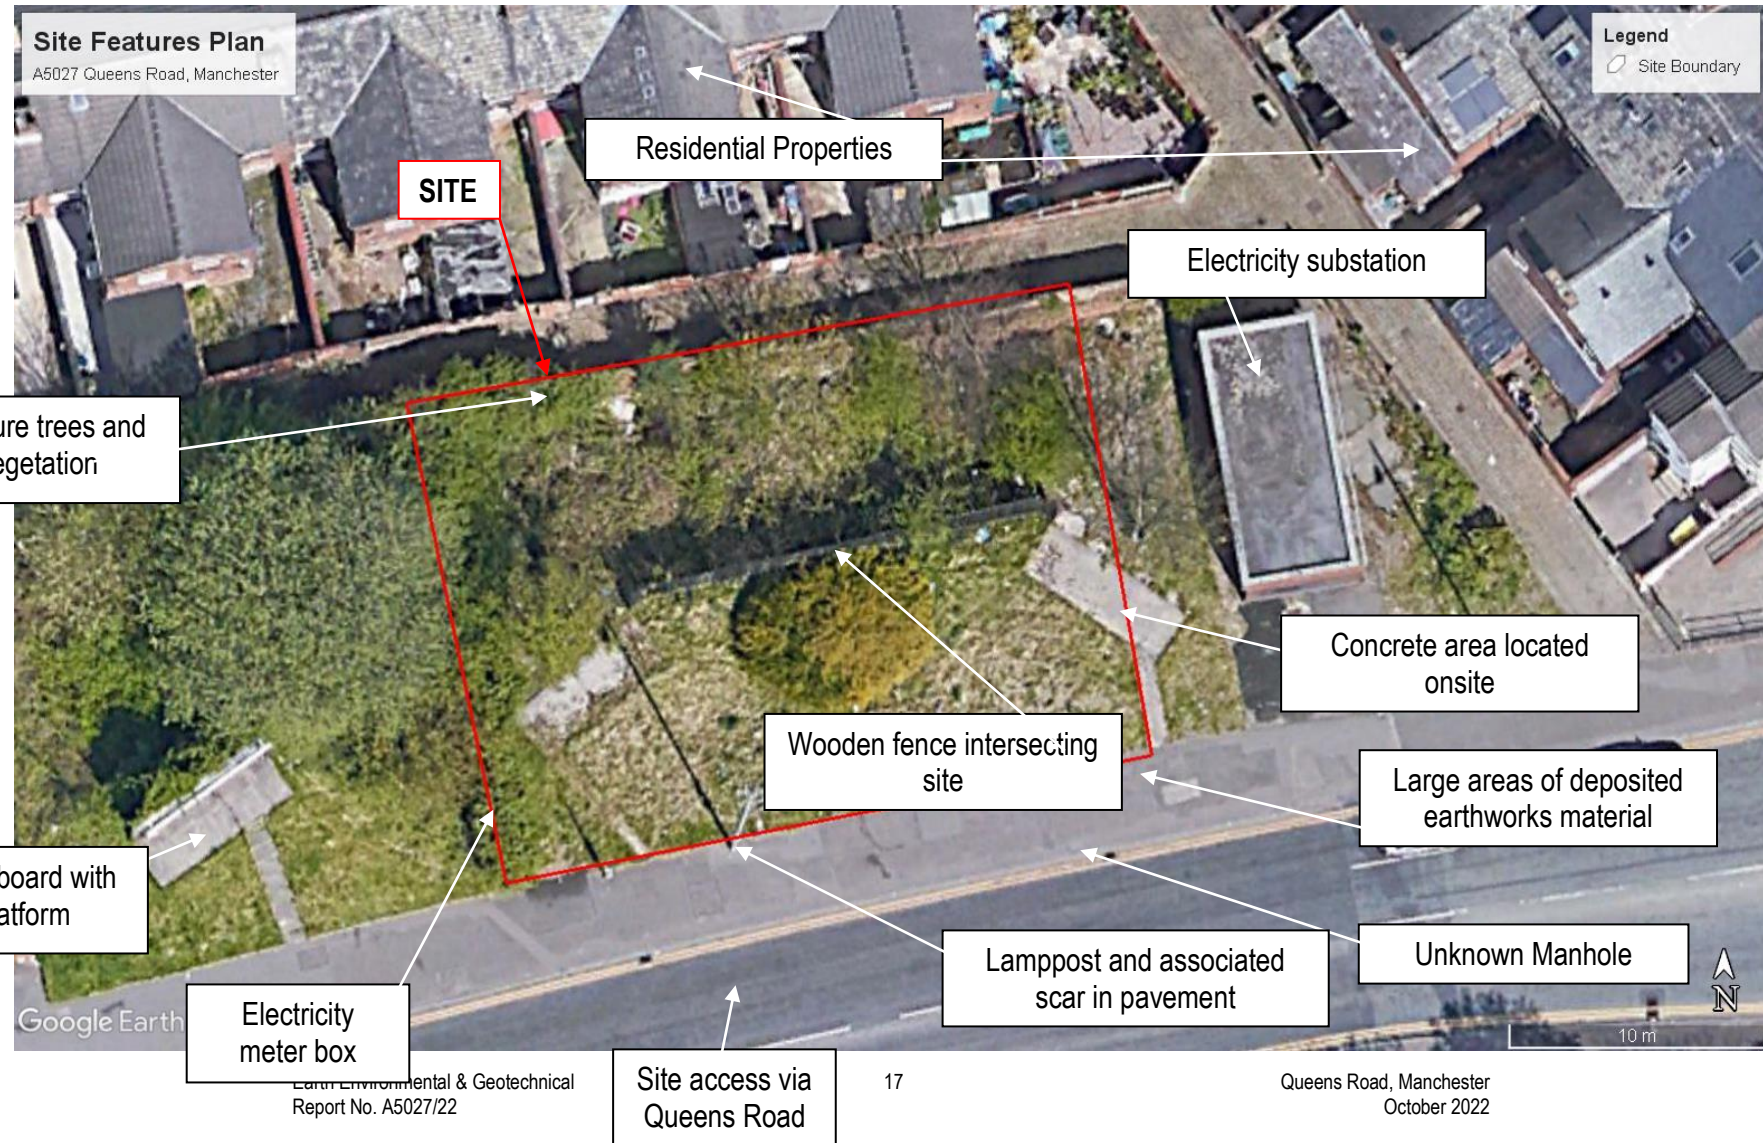
Figure 9 Site Features Plan

- 5.1 A walkover survey was completed on 30<sup>th</sup> September 2022. The photographs and notes from this survey are appended to this report as Appendix 2 and Appendix 3, respectively.
- 5.2 The site is currently accessed via Queens Road to the south of the site.
- 5.3 The site is currently vacant land with a wooden fence intersecting the site and significant amount of vegetation present north of the fence. The southern site boundary is also demarked by heras fencing.
- 5.4 The site lies flat throughout with a slight undulating surface along the vegetation.
- 5.5 There are no overhead cables on the site.
- 5.6 The site is surrounded by residential properties including an electricity substation located adjacent to the eastern site boundary.
- 5.7 A site features plan is presented as Figure 9 overleaf.

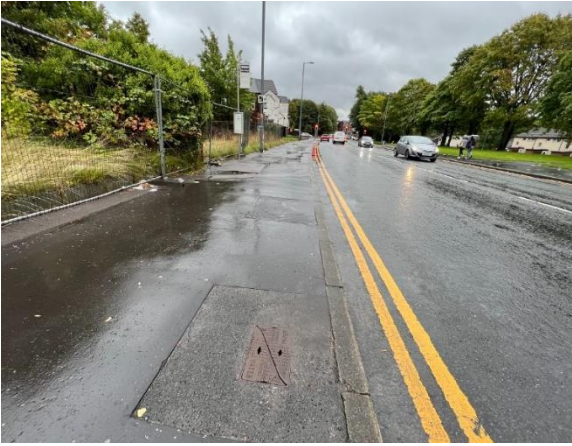
| <p><b>Plate 1 Viewing east showing access to the site via Queens Road. Note potential water supply located along the road/</b></p> | <p><b>Plate 2 Viewing northwest showing railway line located 40m west of the site.</b></p> |

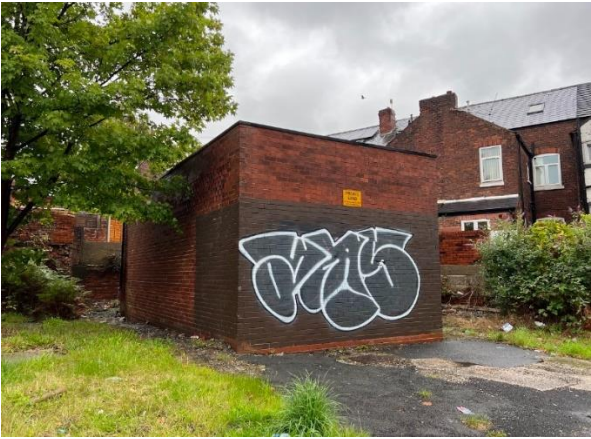
- Polychlorinated biphenyls (PCBs) associated with electricity substation
  - Leaks and spillages of fuels and oils associated with on site development

| <p><b>Plate 3 Viewing north showing the electricity substation located adjacent to the eastern site boundary.</b></p> | <p><b>Plate 4 Viewing west showing heras fencing located around the northern and eastern site boundaries.</b></p> |

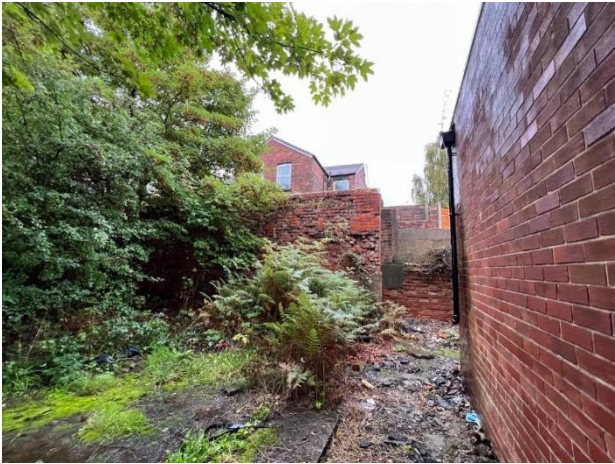
| Geotechnical Design Considerations | |
|---|---|
| Retaining Walls | A brick retaining wall is present along the northern boundary, although it is in poor condition. |

| <p><b>Plate 5 Viewing north showing retaining wall located along the northern site boundary.</b></p> | <p><b>Plate 6 Viewing northwest showing mature trees and shrubs located along the northern section of the site.</b></p> |

- 8.11 An intrusive investigation should be undertaken to ensure the most up to date geotechnical parameters for the design foundations, floor slabs and pavement construction for the proposed new structures and surrounding area are gained.
- 8.12 As part of the geotechnical investigation, it is recommended that the samples of soil and groundwater are recovered for contamination testing and to confirm whether these are still any potential risks.
- 8.13 As part of the site investigation a ground gas assessment should be carried out.

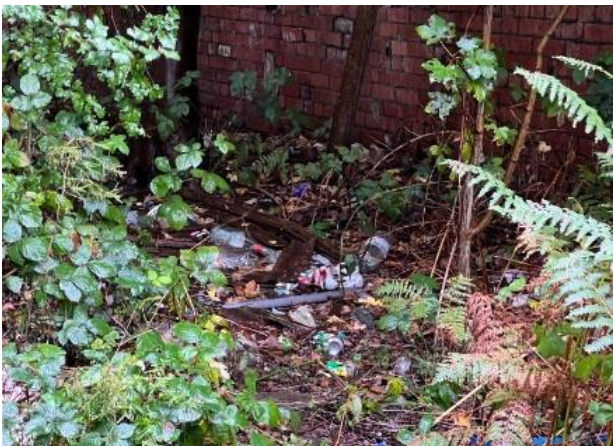
| <p><b>Plate 7 Viewing north showing areas of litter located around the site.</b></p> | <p><b>Plate 8 Viewing northeast showing wooden fencing intersecting the centre of the site.</b></p> |
