# GEOTECHNICAL REPORT

## Report on a Geotechnical Investigation

Location: 48 & 50 Wilton Road  
Crumpsall, Manchester M8 4EL

Report No. C2491/22/E/4020

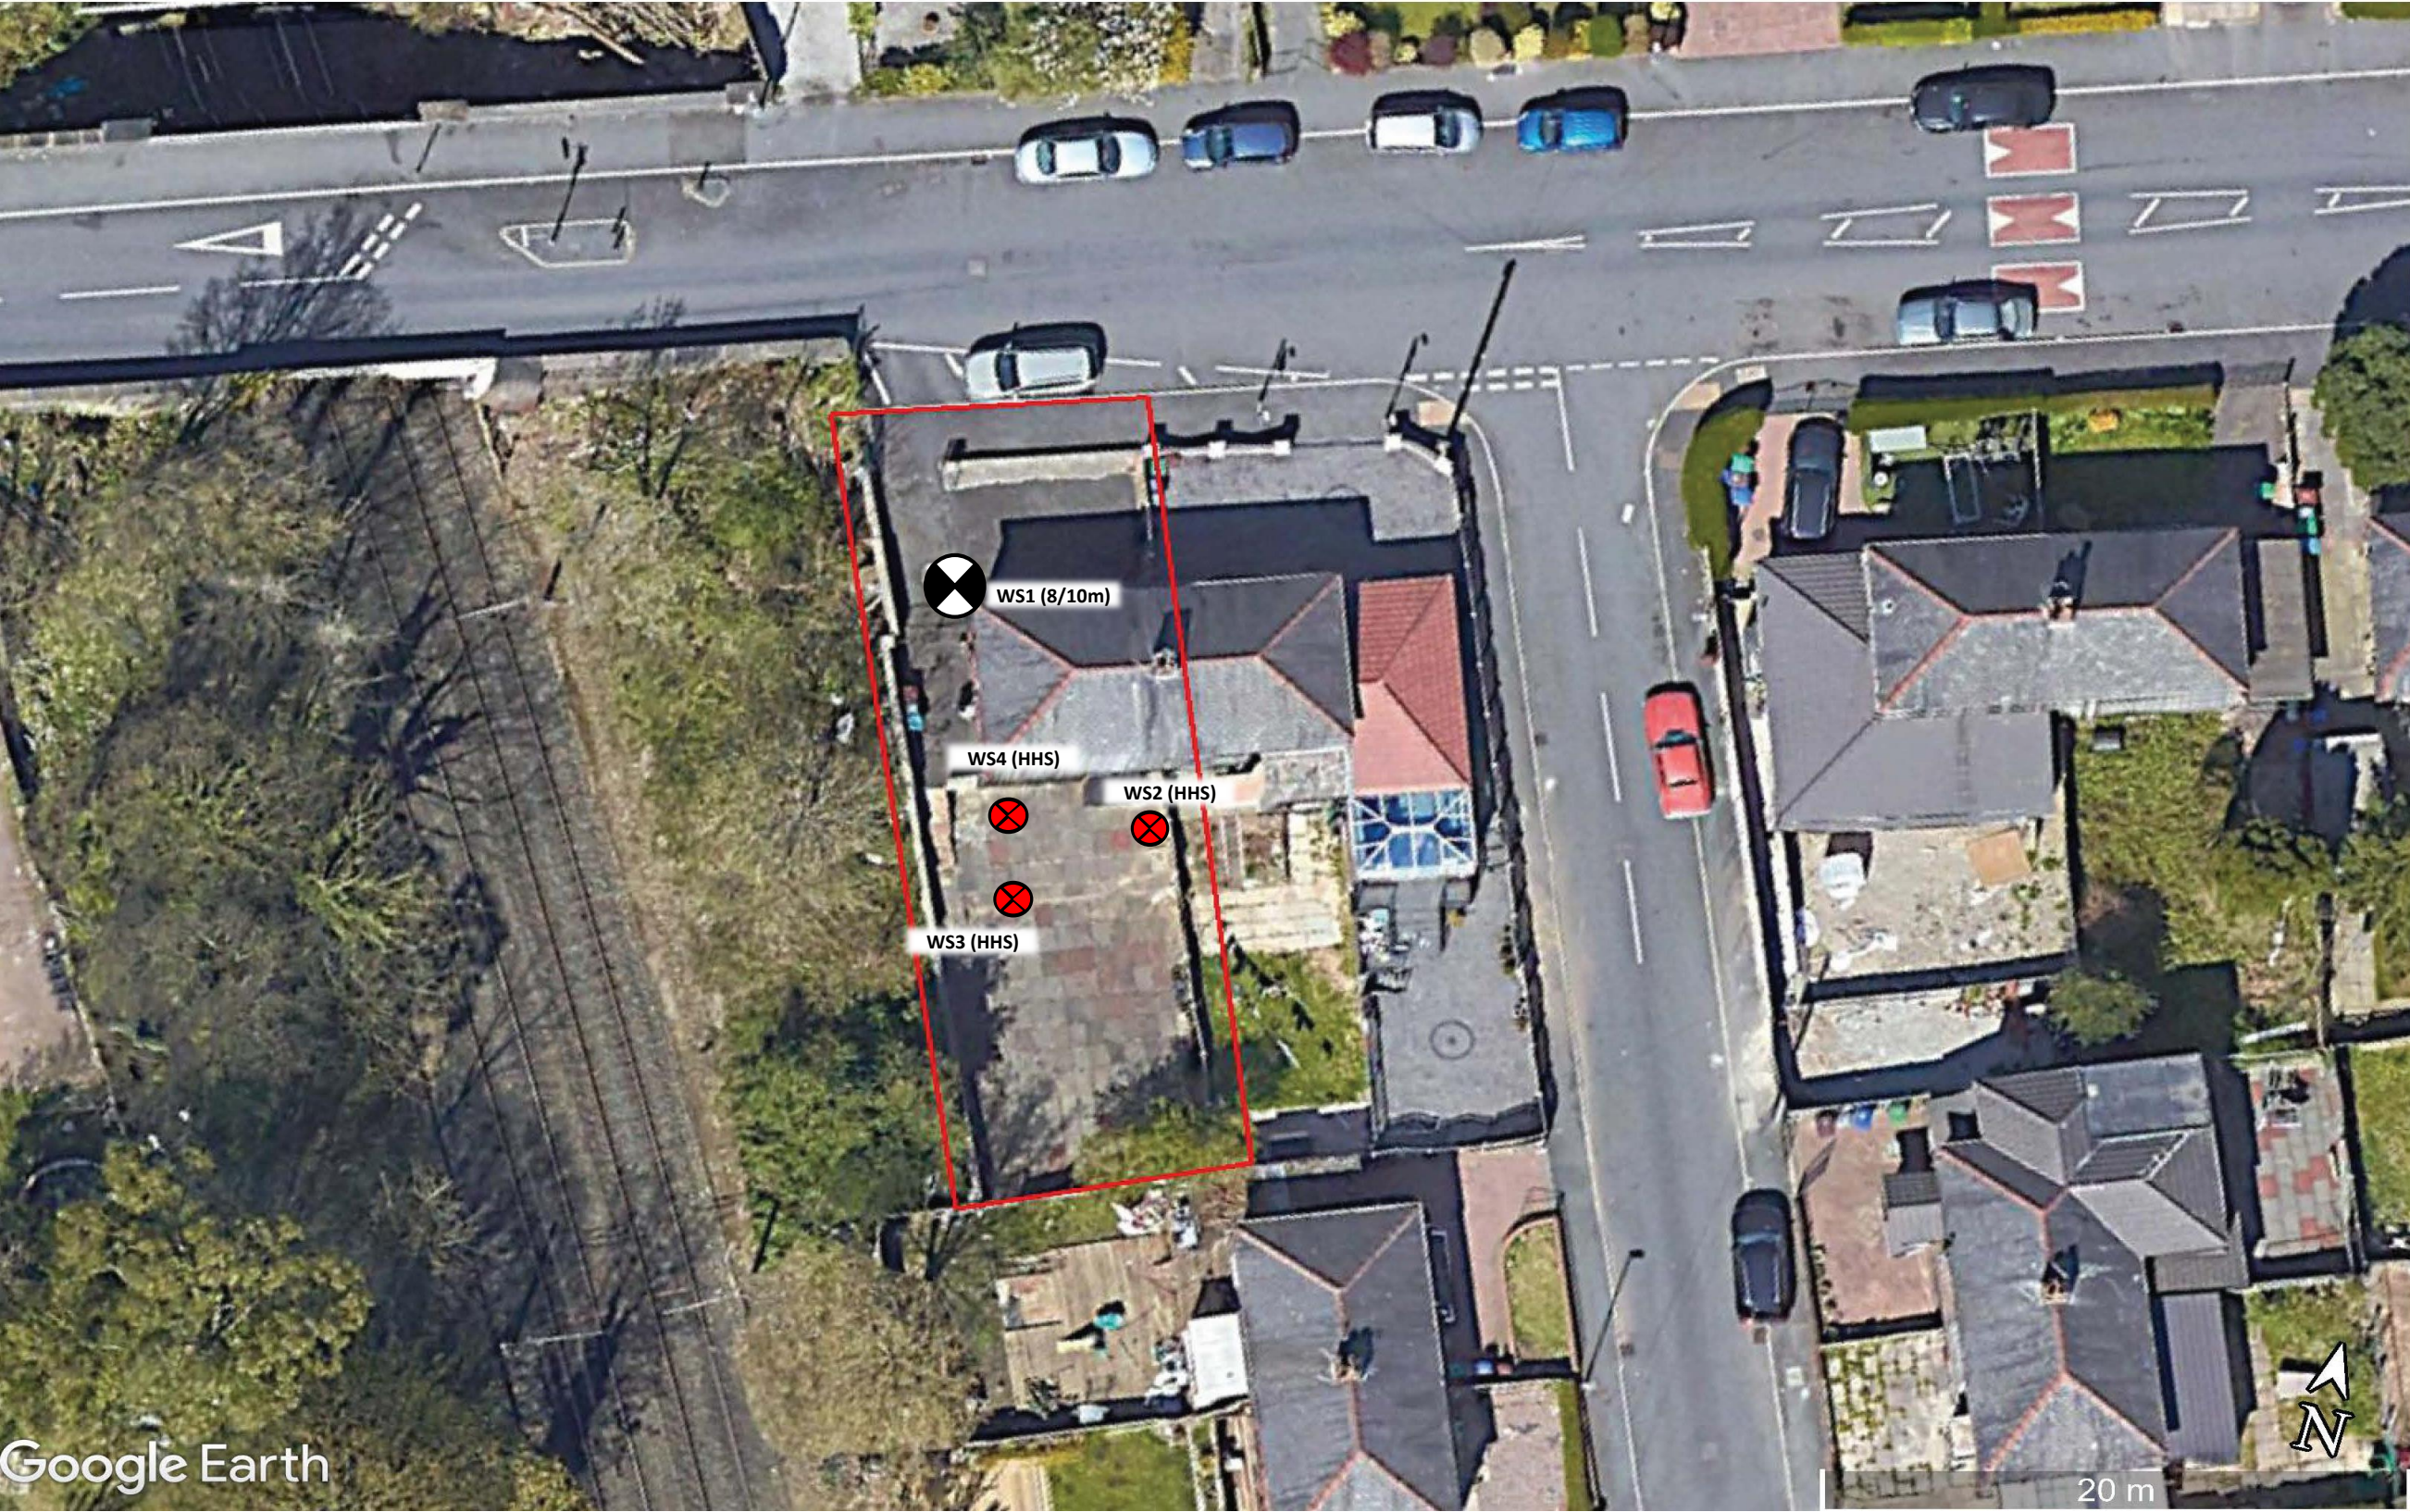
### Site Plan

**Notes:**  
Investigation positions approximated from site operative's notes.

The investigatory locations are shown on the site plan which is presented in Appendix 1 to this report. It should be appreciated that due to the access constraints, hand-held windowless sampling equipment was utilised at the rear of the property, as the drilling rig was unable to reach this location. Nonetheless,

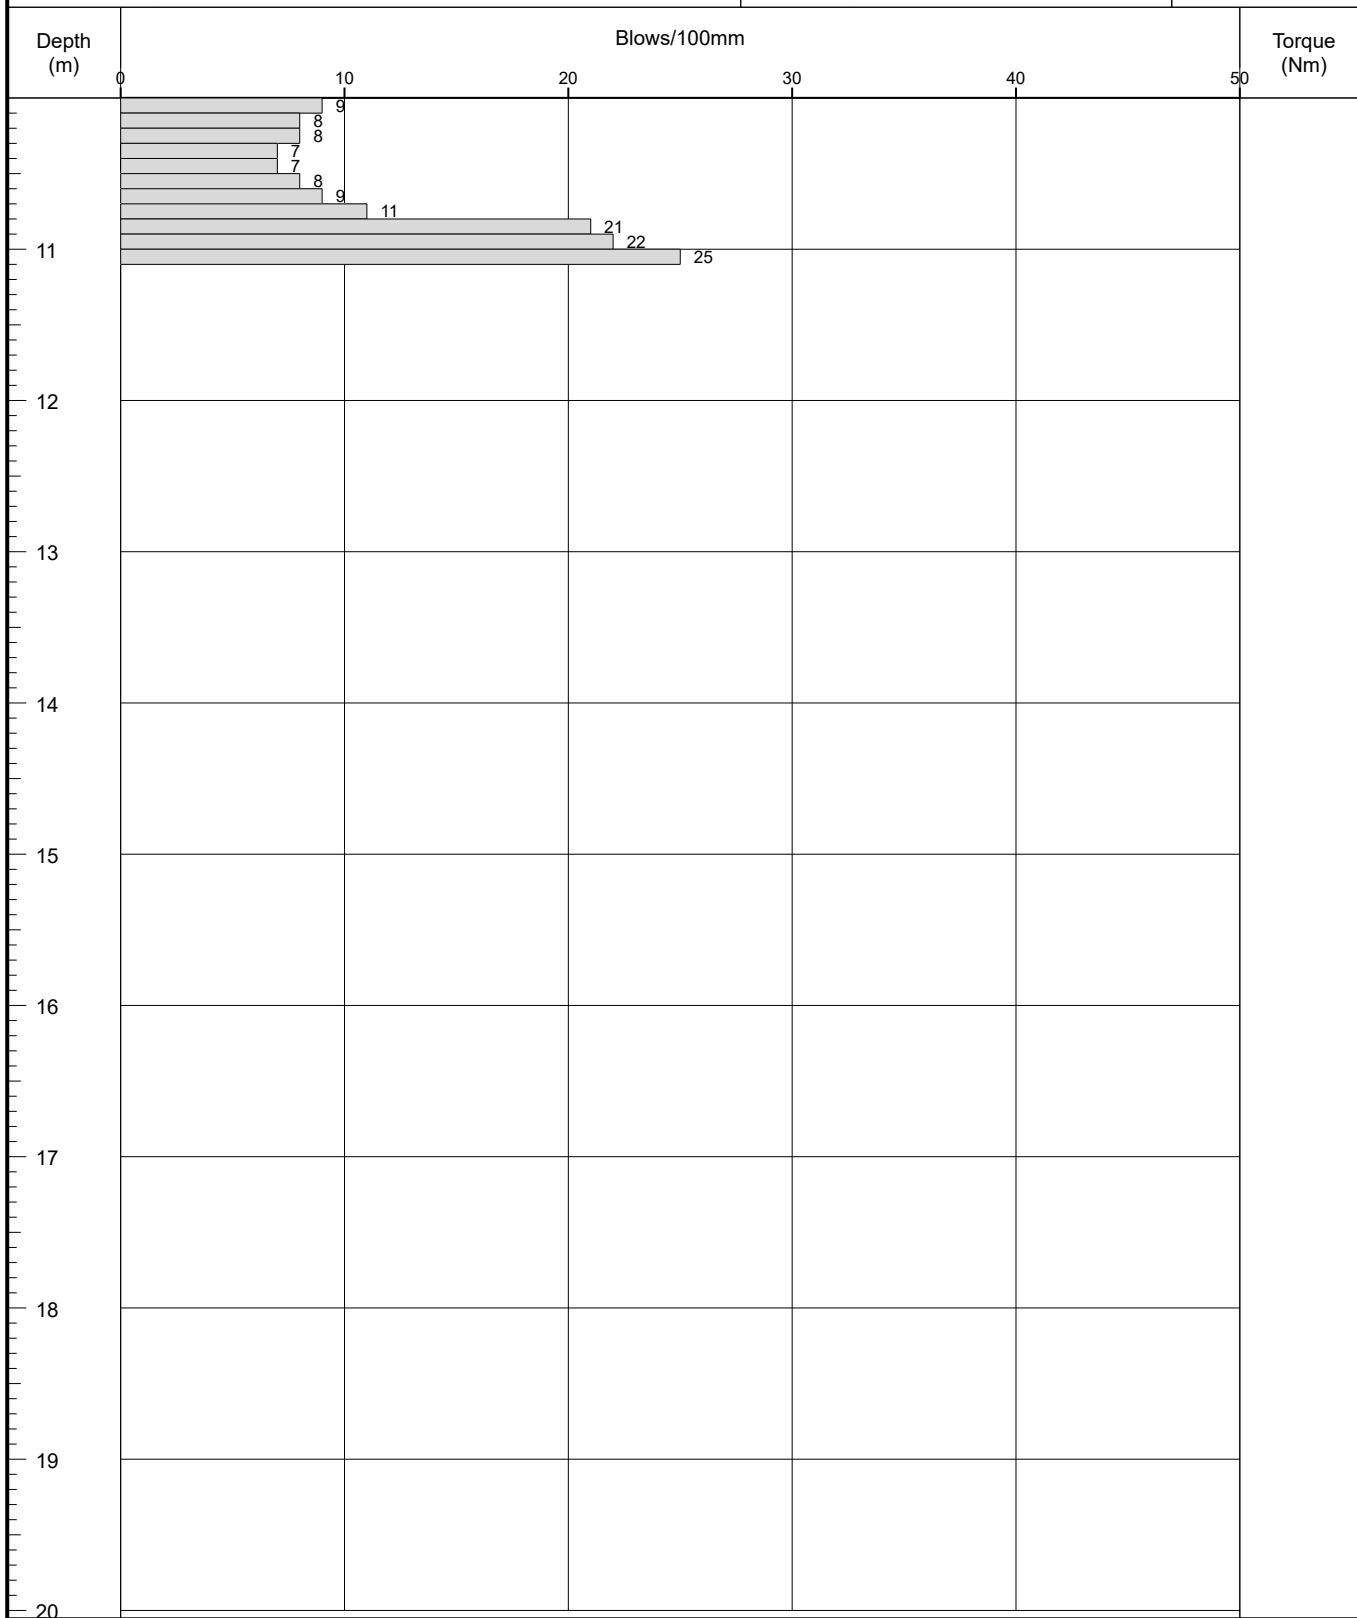
Commenced from base of WS01 (8m depth).

A dynamic penetration test was undertaken through the base of WS01 and a summary of the results is presented below:

| Table 4: Summary of Dynamic Penetration Tests | | | | | |
|---|---|---|---|---|---|
| DP01 | 8.3<br>9.6 | 8.9<br>10.7 | 11.1 | Effective | Commenced from 8m. Medium dense and<br>dense material recorded from 9.6m (granular<br>stratum assumed based on published data and<br>observed ground conditions).<br>Effective refusal at 11.1m. |

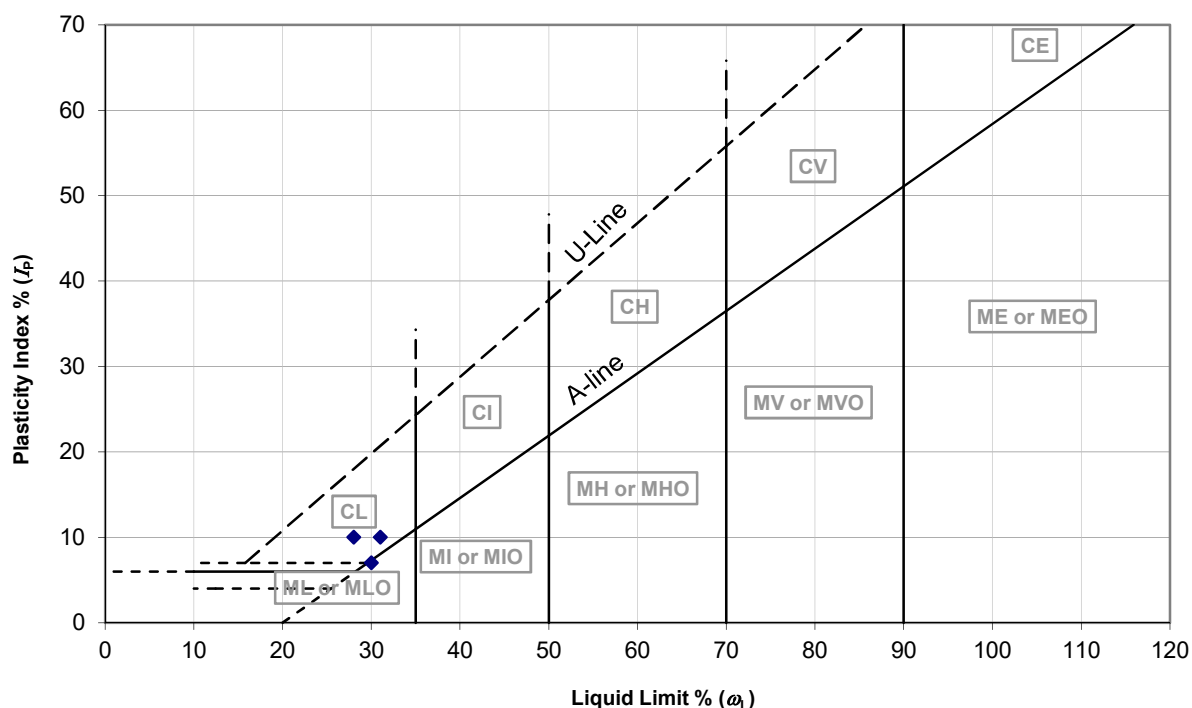
| Location | Depth<br>(m) | Moisture<br>Content<br>(w)<br>(%) | Liquid<br>Limit<br>(wL)<br>(%) | Plastic<br>Limit<br>(wP)<br>(%) | Plasticity<br>Index (IP)<br>(%) | Retained<br>by<br>0.425mm<br>(%) | Modified<br>(w)<br>(w')<br>(%) | Modified<br>(IP)<br>(IP')<br>(%) | Liquidity/<br>Consistency | | Casagrande<br>Class | N.H.B.C<br>Class<br>(%) |
|---|---|---|---|---|---|---|---|---|---|---|---|---|
| WS01 | 2.60 | 30.4 | 30 | 23 | 7 | 5 | 32 | 7 | 1.1 | -0.1 | M L | * |
| WS02 | 0.80 | 35.3 | 31 | 21 | 10 | 3 | 36 | 10 | 1.4 | -0.4 | C L | * |

| <b>Table 5: Summary of Geotechnical Test Results</b> | | | | |
|---|---|---|---|---|
| Moisture content determinations | 3 | 17% to 35% | | Clay (Till) – MC very close, or above to the LL. |
| Index properties (1 Point) | 3 | LL | 28% to 31% | Clay/silt of low plasticity. |

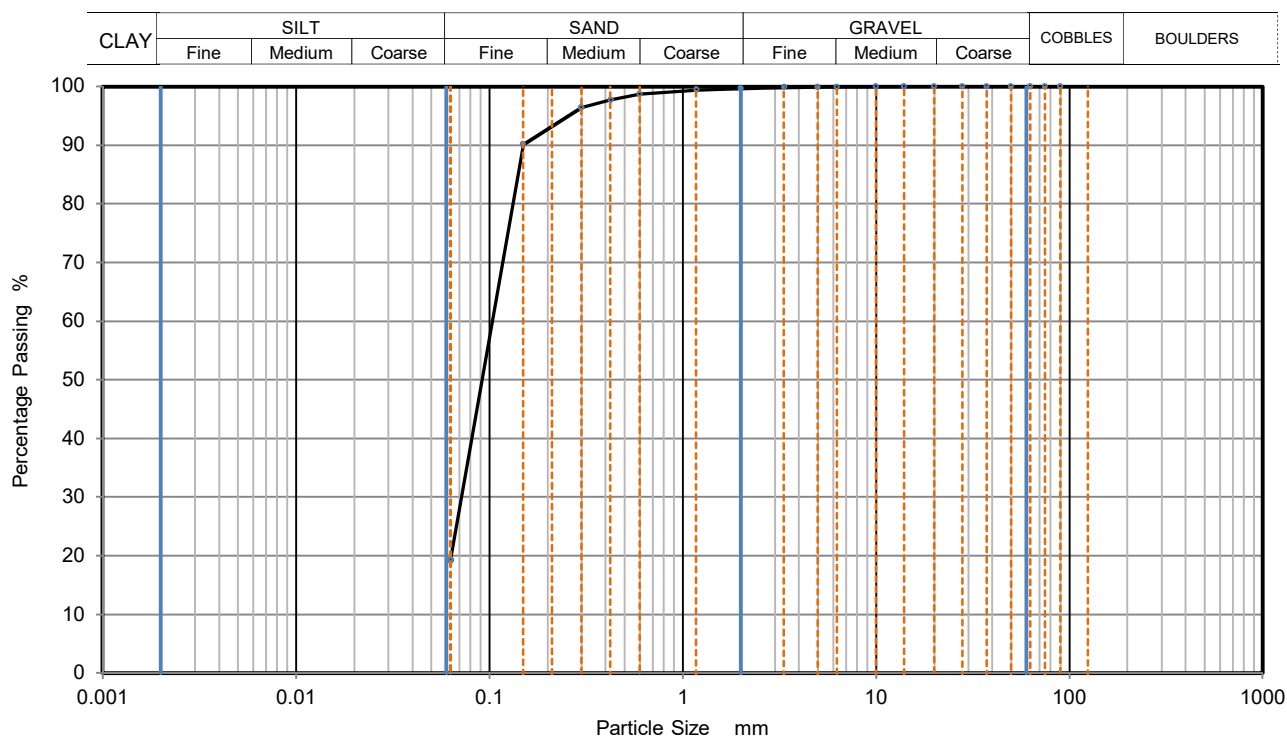
KeyLAB ID RGS\_202205092

Test Method ISO 17892 -4, by sieving on pre-dried or dry sample

| <b>Table 5: Summary of Geotechnical Test Results</b> | | | | |
|---|---|---|---|---|
| Particle size distribution (Dry sieve) | 6 | Gravel | 0% to 5% | Silty SAND. Locally slightly gravelly. |

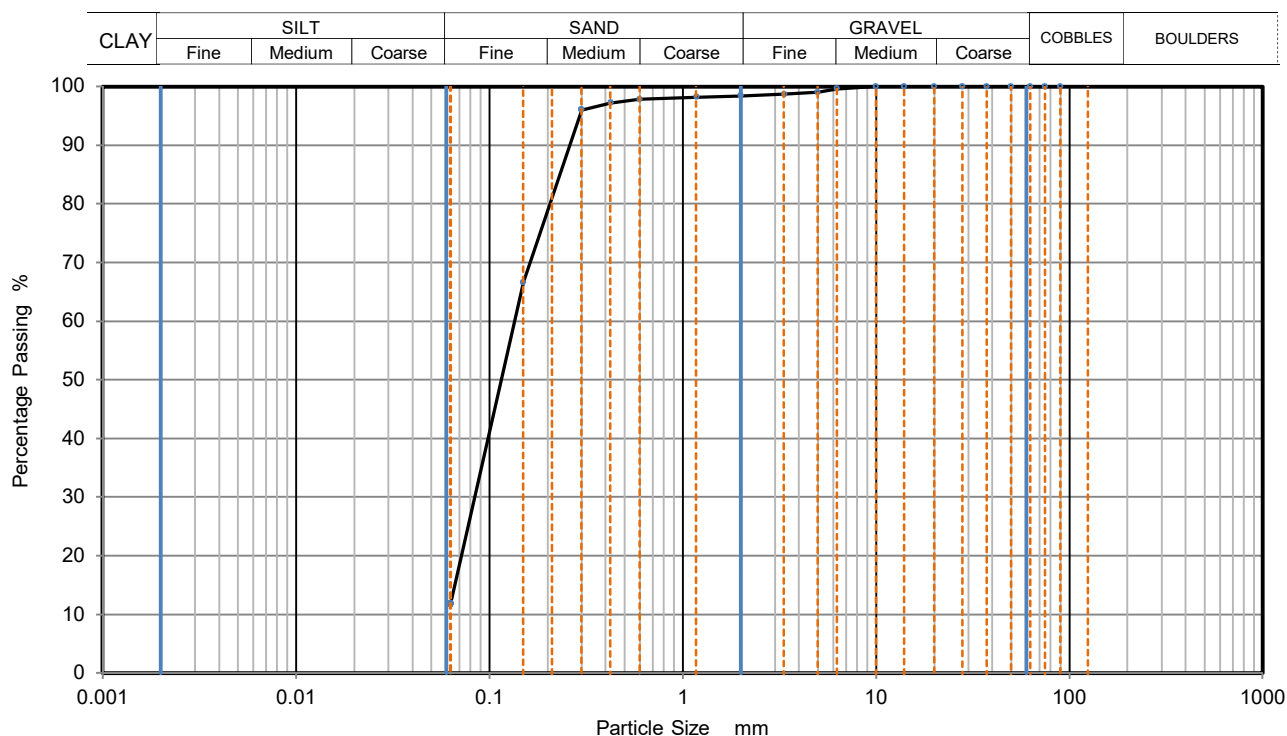
KeyLAB ID RGS\_202205093

Test Method ISO 17892 -4, by sieving on pre-dried or dry sample

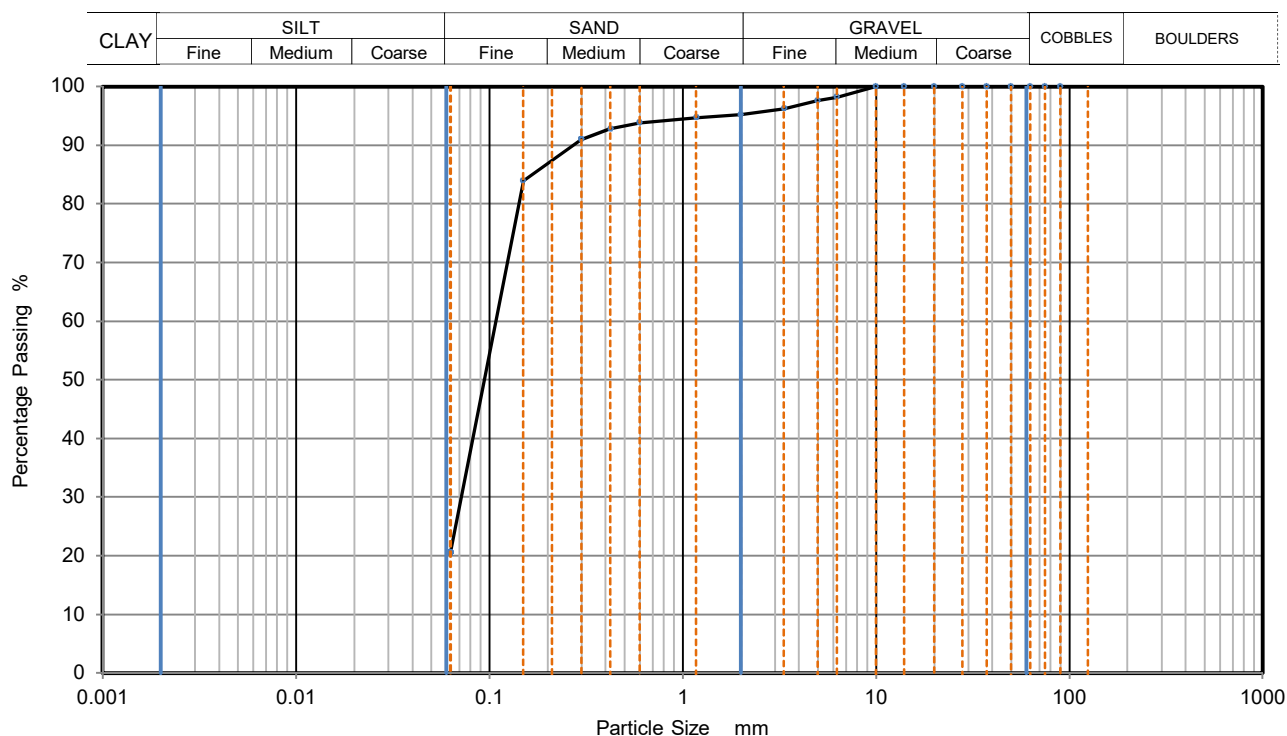
KeyLAB ID RGS\_202205097

Test Method ISO 17892 -4, by sieving on pre-dried or dry sample

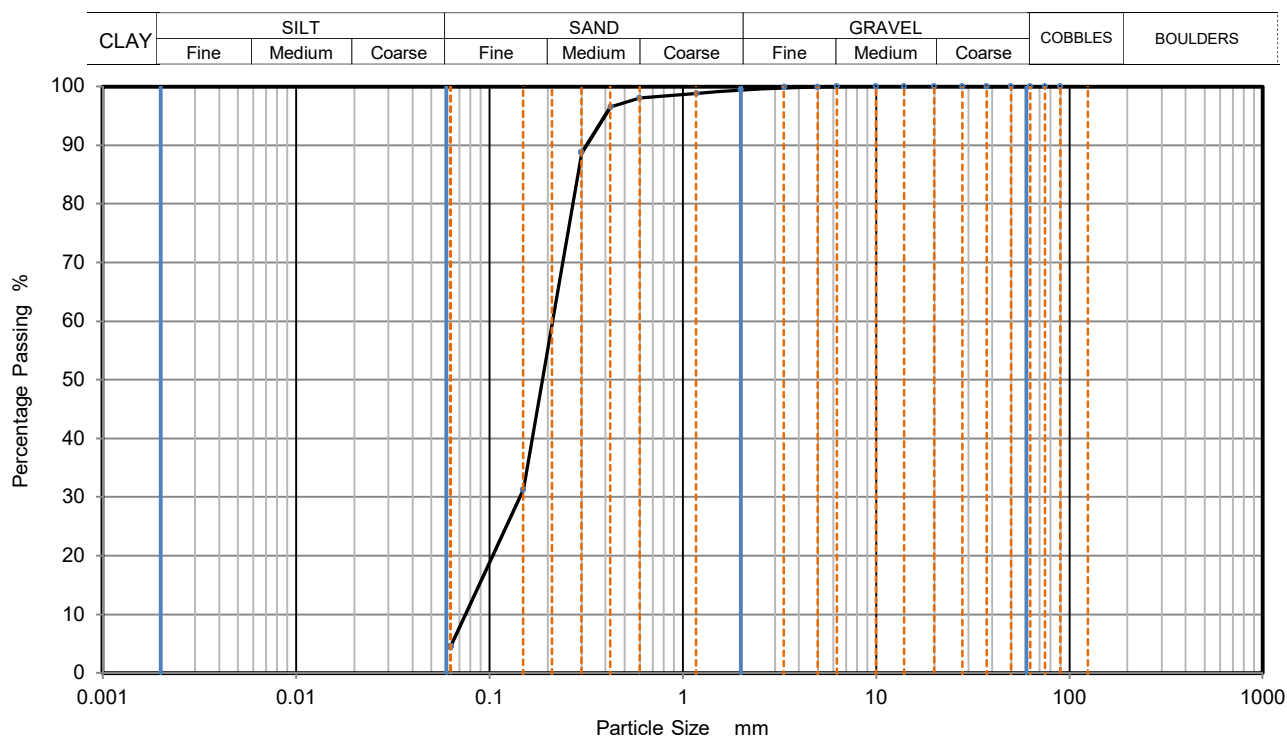
KeyLAB ID RGS\_202205098

Test Method ISO 17892 -4, by sieving on pre-dried or dry sample
