| PROJECT NO: | 5287 | | ISSUE DATE: | 31 AUG 22' |
| PROJECT TITLE | LUCKY CAT, MANCHESTER | | | |
| AREAS: | BASEMENT, GROUND FLOOR, MEZZANINE & FACADE | | | |
| REQUEST FOR RESTORATION SCHEDULE | | | | |

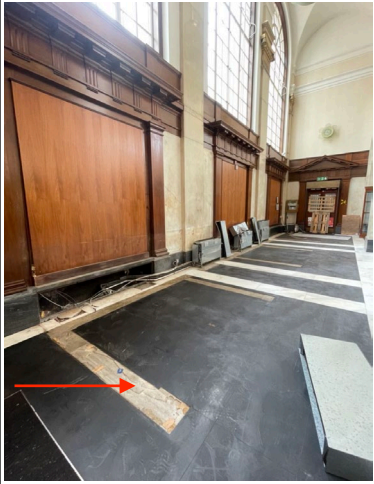
| 1 | Floor marble to be repaired/ re-installed where there is a missing tile or cracked marble | | LHS Entrance | 28/7/22 |

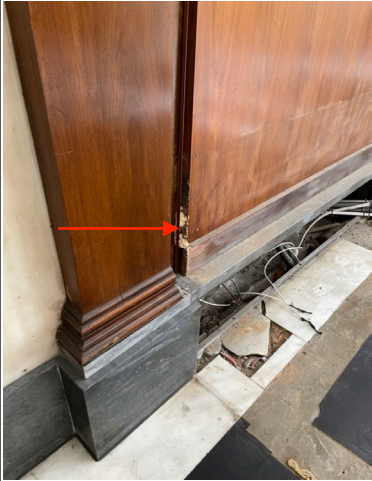
| 2 | Timber wall panels to be made good or repaired as close to original as possible, remove all tapes, markings and scratches | | General | 28/7/22 |

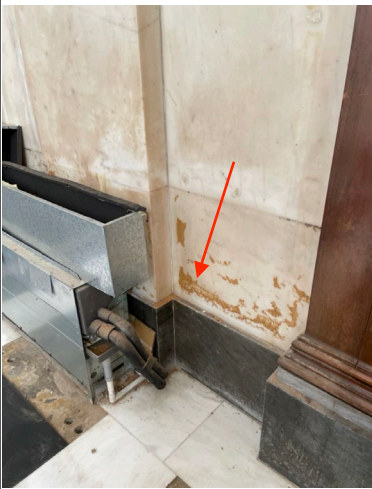
| 3 | Existing marble walls to be strip clean and repaired where chipped, scratched and/ or cracked | | General | 28/7/22 |

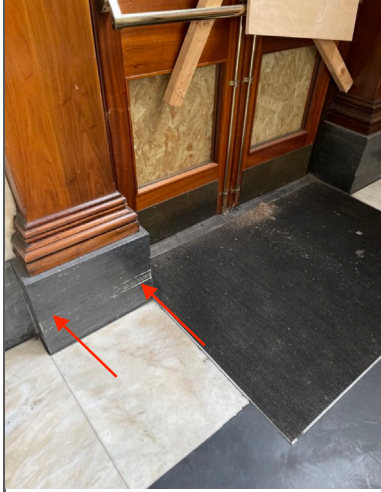
| 4 | Existing marble walls to be strip clean and repaired where chipped, scratched and/ or cracked | | LHS Doorway | 28/7/22 |

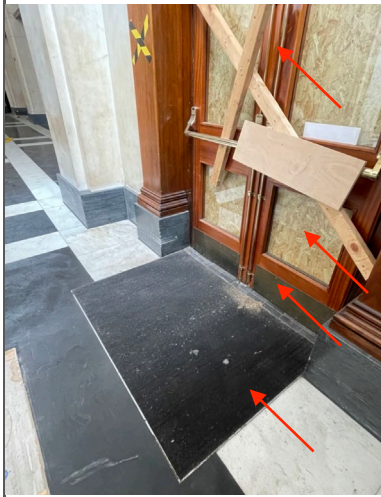
| 5 | Doormat to be replaced; All material on door panels and door gears to be inspected and made good where necessary | | LHS Doorway | 28/7/22 |

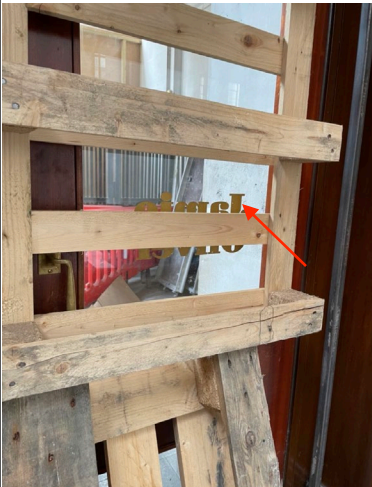
| 6 | <p>Jamie Italian's branding to be carefully removed on RHS entrance door; replace clear glass panel if necessary while maintaining all door gear and heritage element on panel</p> | | RHS Doorway | 28/7/22 |

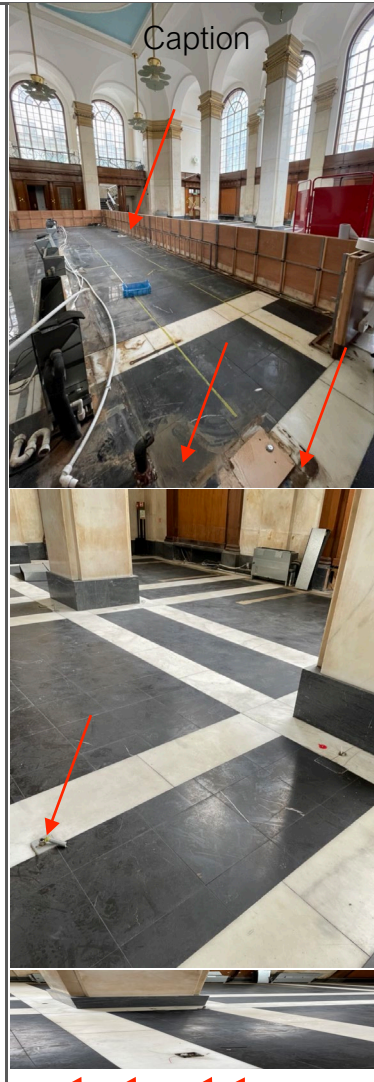
Main Hall

Marble floor to be cleaned and make good as close to original as possible; remove any unused floor mounted floor boxes and close holes on floor where possible

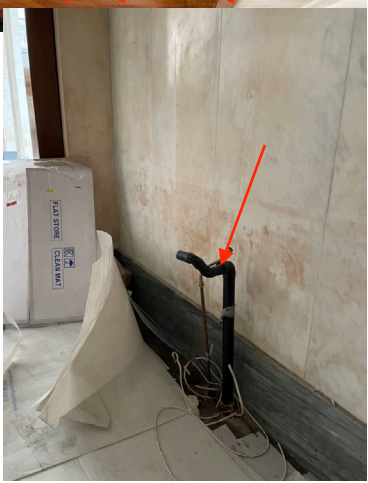
| 8 | Unknown pipe; MC to inspect and check whether it can be removed to allow more room for new booth seat and close hole on floor after | | Room next to RHS entrance under Mezzanine | 28/7/22 |

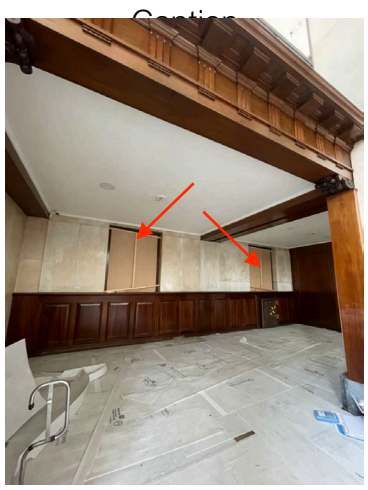
| 9 | Remove timber panels in front of windows; MC to make good window frame and sill behind | | Room next to RHS entrance under Mezzanine | 28/7/22 |

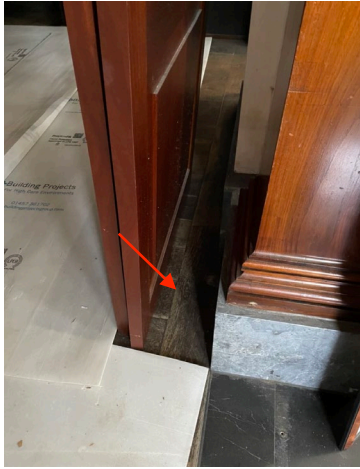
| 10 | Unable to inspect heritage timber flooring below; MC to inspect and make good flooring to match as close as original as possible and ensure it is free of stains, scratches and repair if necessary | | Room next to RHS entrance under Mezzanine | 28/7/22 |

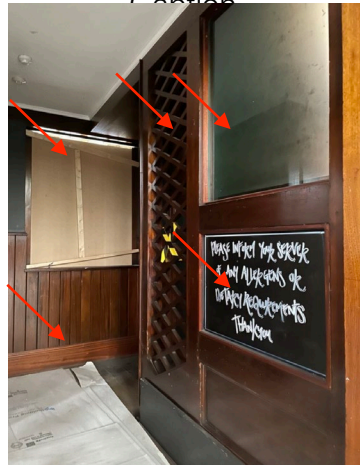
| 11 | MC to check feasibility to remove blackboard; clean & make good adjacent glass and timber feature panel to match original as much as possible; Remove timber panels in front of windows; MC to make good window frame and sill behind | | Room next to RHS entrance under Mezzanine | 28/7/22 |

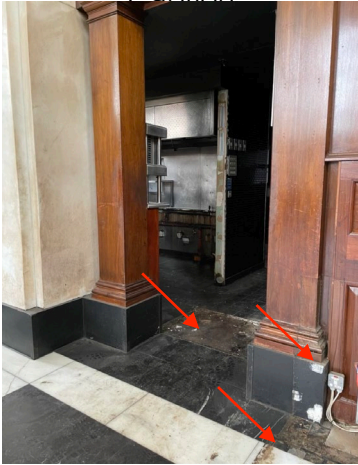
| 12 | MC to clean, make good and repair heritage materials; install new tile to match existing where necessary | <p>Caption</p> <p>The photograph shows a narrow archway leading into a kitchen. On either side of the archway are tall, dark wood pillars. The floor is made of dark, square tiles. Three red arrows point to the base of the pillars and the floor area, indicating the work to be done. A white electrical outlet is visible on the right pillar.</p> | Archway into kitchen | 28/7/22 |

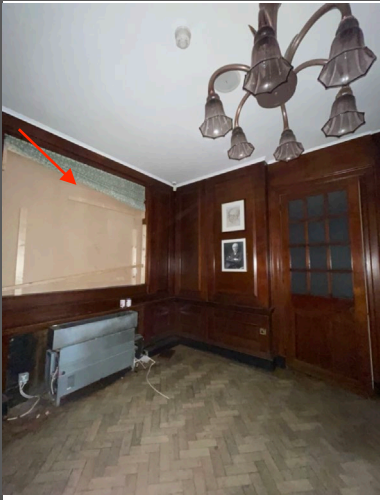
| 13 | MC to remove timber panel in front of windows and make good windows and sill behind. | <p>The photograph shows a room with wood-paneled walls and a patterned tile floor. A large window is on the left, and a door is on the right. A red arrow points to the top of the window frame, indicating the area to be worked on. A small, dark object is visible on the wall above the door.</p> | PDR 3 | 28/7/22 |

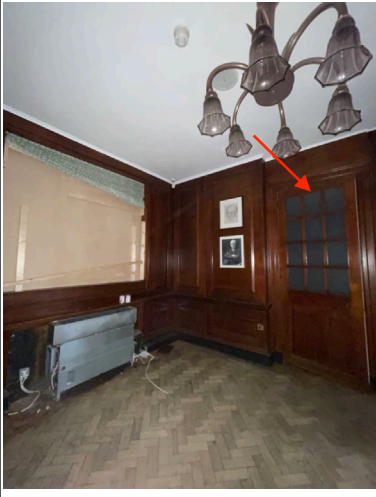
| 14 | MC to carefully remove panel (behind heritage door) between PDRs without damaging heritage timber wall panelling | | PDR 3 | 28/7/22 |

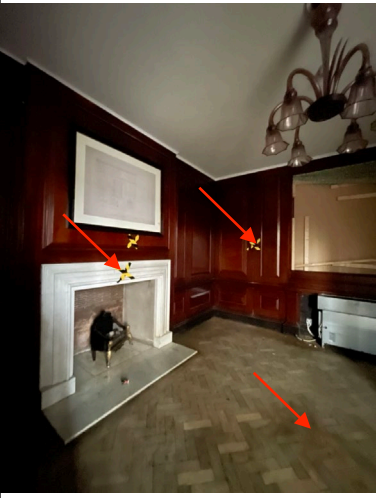
| 15 | MC to remove all tapes and markings, clean and make good, as close to original as possible heritage fireplace, timber floor finishes and timber wall panels | | PDR 3 | 28/7/22 |

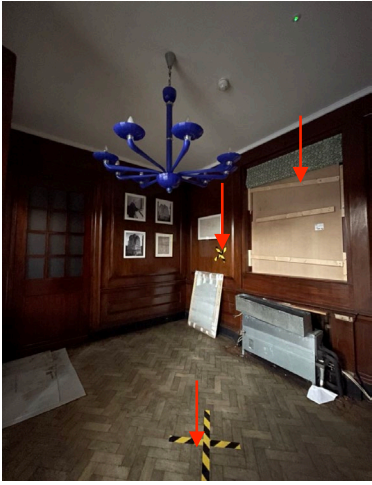
| 16 | MC to remove all tapes and markings, clean and make good, as close to original as possible heritage fireplace, timber floor finishes and timber wall panels | | PDR 2 | 28/7/22 |

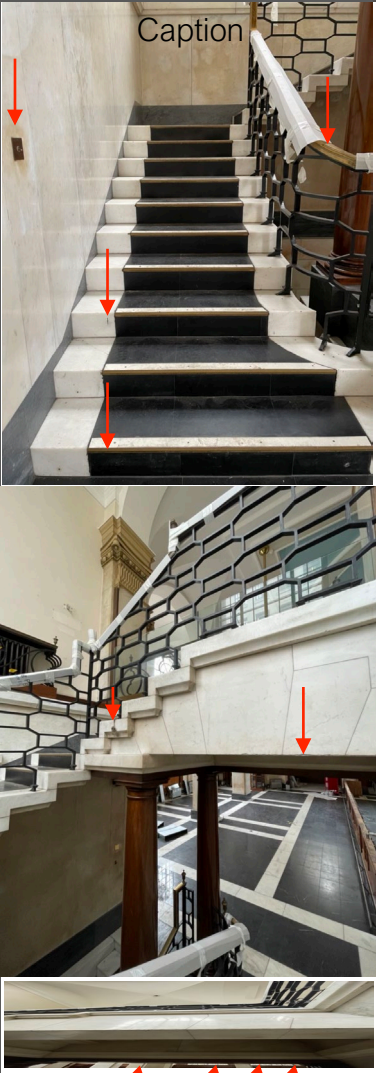
| 17 | <p>MC to clean and make good all risers, treads, step nosings, railings and marble walls as close to original as possible. All cracked and/ or chipped marble to be repaired</p> | <p>Caption</p> | LHS Stairwell to Mezzanine | 28/7/22 |

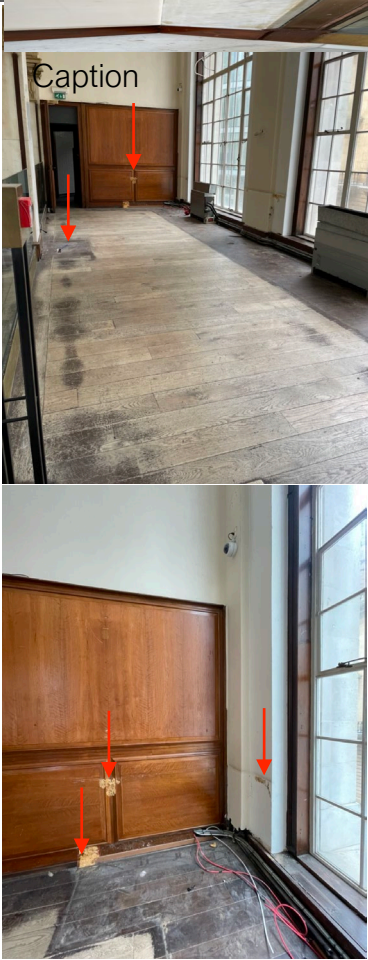
| 18 | <p>MC to clean and make good heritage timber flooring and wall panelling as much as possible to match original</p> | <p>The top photograph shows a long, narrow room with wooden flooring and wall panelling. Red arrows point to specific areas on the floor and wall. The bottom photograph shows a corner of the room with wooden wall panelling and a window. Red arrows point to specific areas on the wall and floor.</p> | LHS<br>Mezzanine | 28/7/22 |

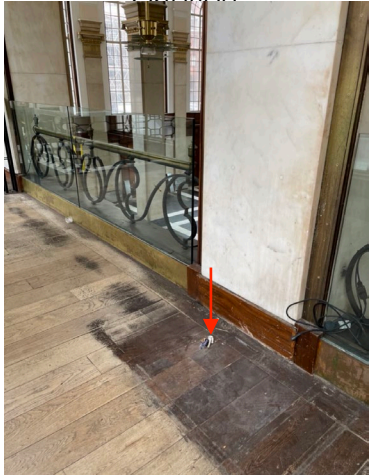
| 19 | MC to inspect whether exposed wire can be removed and close and make good any floor holes after | | LHS Mezzanine | 28/7/22 |

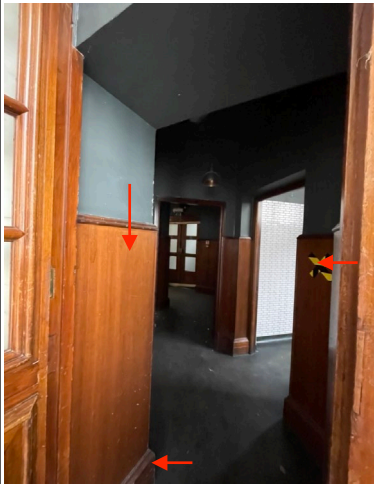
| 20 | MC to clean and make good all timber panels as close to original as possible | | Doorway to BOH corridors | 28/7/22 |

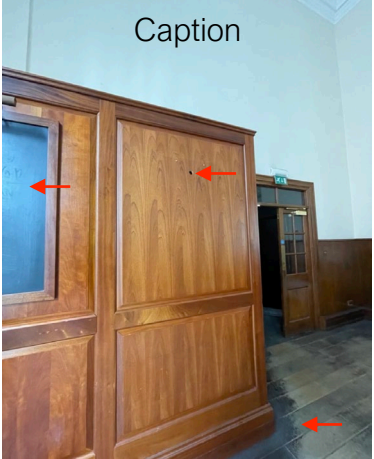
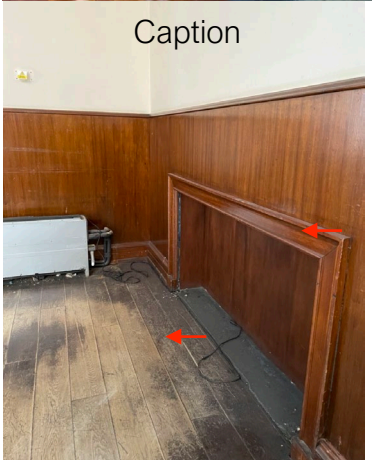
| 21 | <p>MC to clean and make good all timber panels, floor finish, fire place, close hole on panel, remove black board and finish as close to original as possible</p> | <p>Caption</p> <p>Caption</p> | Central<br>Mezzanine | 28/7/22 |

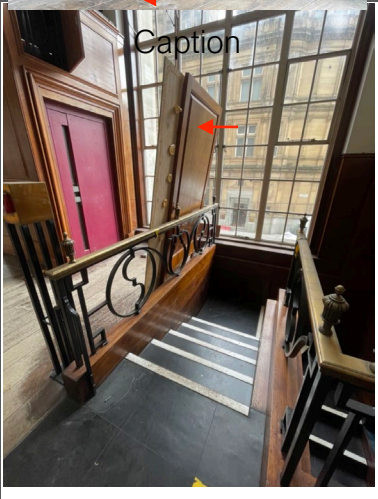
| 22 | MC to clean and make good all timber panels, fix lift door panel and inspect if the lift can be operable | | RHS<br>Mezzanine | 28/7/22 |

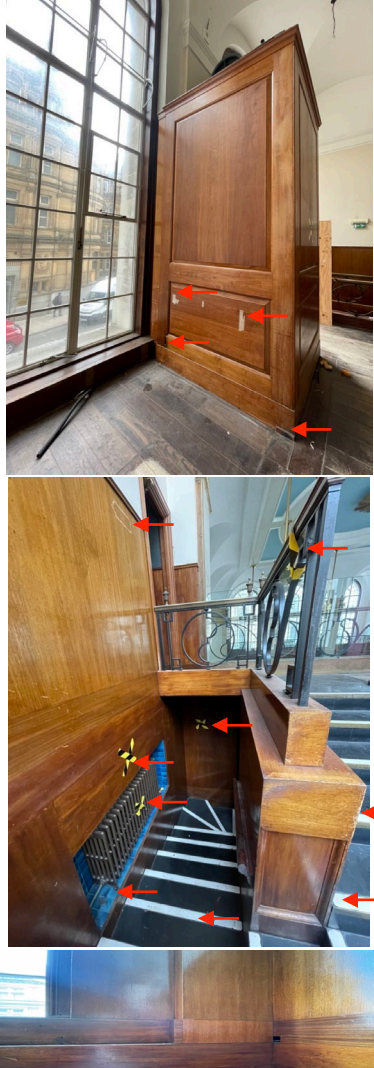
| 23 | <p>MC to clean, repair and make good all timber panels, floor finish, treads, tread nosings, risers, radiator (and tiling around) and railing as close to original as possible</p> | | RHS Stairwell<br>to Mezzanine | 28/7/22 |

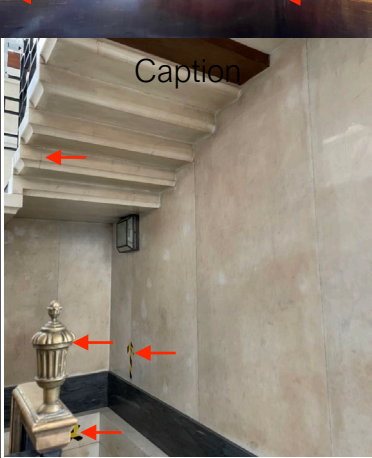
| 24 | MC to clean and make good all risers, treads, step nosings, railings and marble walls as close to original as possible. All cracked and/ or chipped marble to be repaired | <p>Caption</p> <p>Caption</p> | LHS Stairwell to Basement | 28/7/22 |

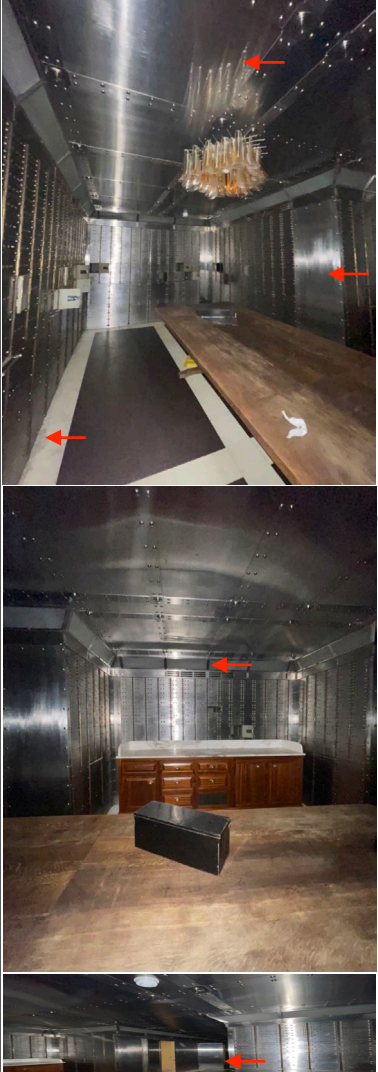
| 25 | <p>MC to clean and make good internal finishes on ceiling, floor and wall in vault room; MC to inspect if light strip detail above deposit boxes are functioning, re-lamp per lighting consultant's specifications</p> | | <p>tion</p> <p>Basement<br/>Vault Room</p> | 28/7/22 |

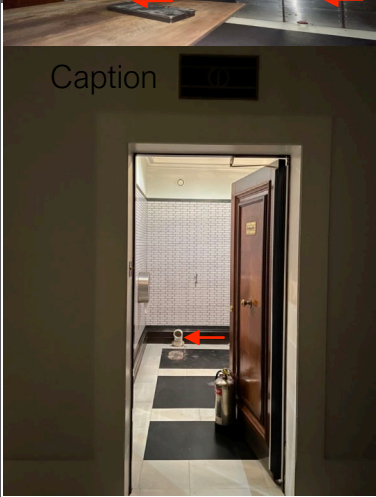
| 26 | Missing loo in WC #1 | <p>Caption</p> | Basement<br>WCs | 28/7/22 |

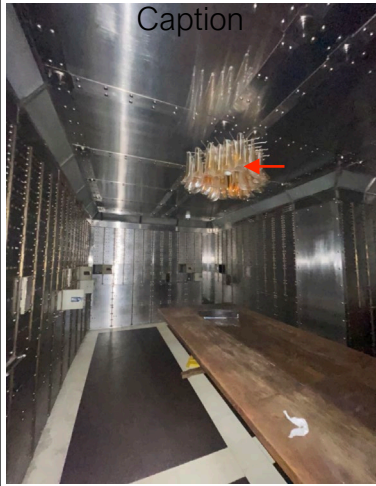
| 27 | Pendant to be removed, retain existing wiring & fixing and connect to PL-02 | <p>Caption</p> | Basement<br>Vault Room | 28/7/22 |

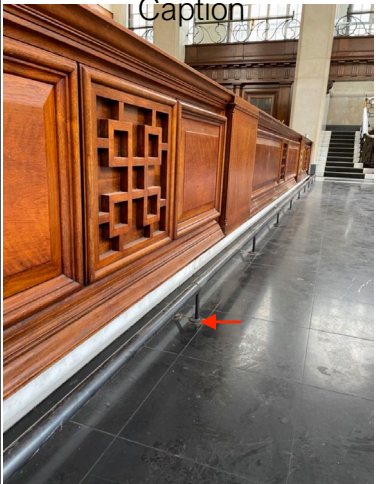
| 28 | Foot rail in front of ground floor bar panels to be removed and install new foot rail in brass, MT-01 | <p>Caption</p> | Ground Floor Bar | 28/7/22 |

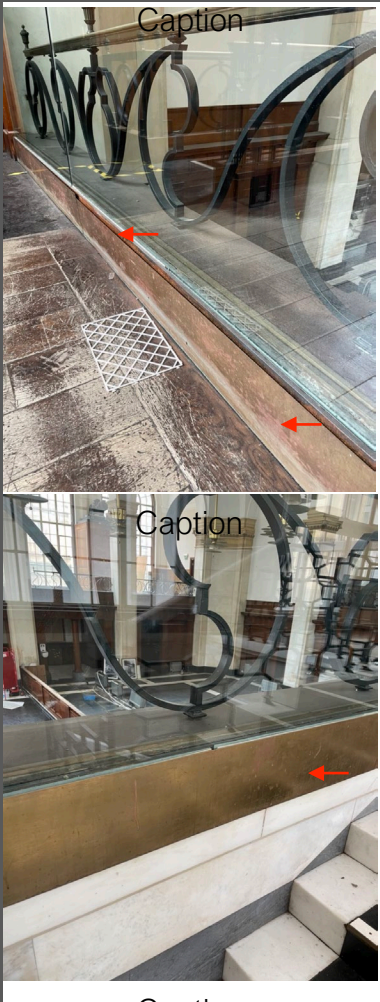
| 29 | Existing brass skirtings are loose; MC to ensure all skirting to be secured, cleaned and made good | <p>Two photographs of the Mezzanine Balustrade. The top photo shows a close-up of the brass skirting on a wooden floor, with two red arrows pointing to loose areas. The bottom photo shows a wider view of the balustrade with a red arrow pointing to a loose section of the brass skirting.</p> | Mezzanine<br>Balustrade | 28/7/22 |

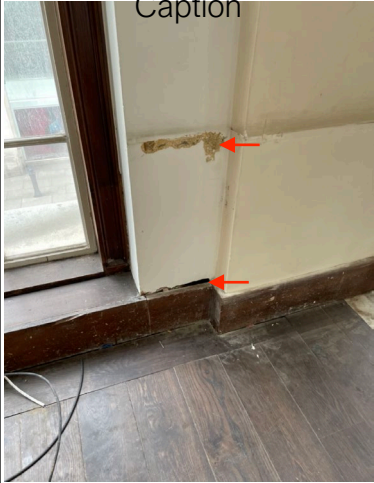
| 30 | Drywalls to be repaired and re-painted in new paint colour | | Mezzaline drywalls | 28/7/22 |

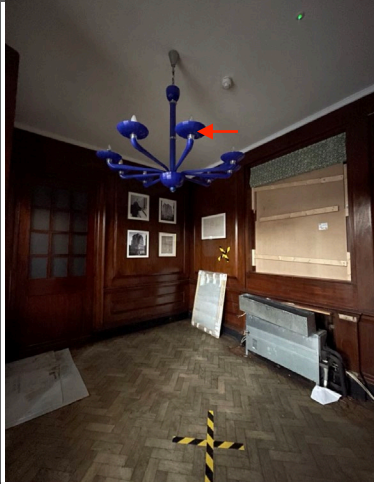
| 31 | Existing pendant to be removed; Retain all wiring, fixings and install new ceiling fitting | | PDR 2 | 28/7/22 |

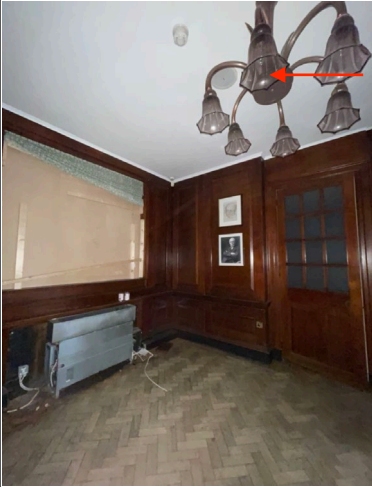
| 32 | Existing pendant to be removed; Retain all wiring, fixings and install new ceiling fitting | | PDR 3 | 28/7/22 |

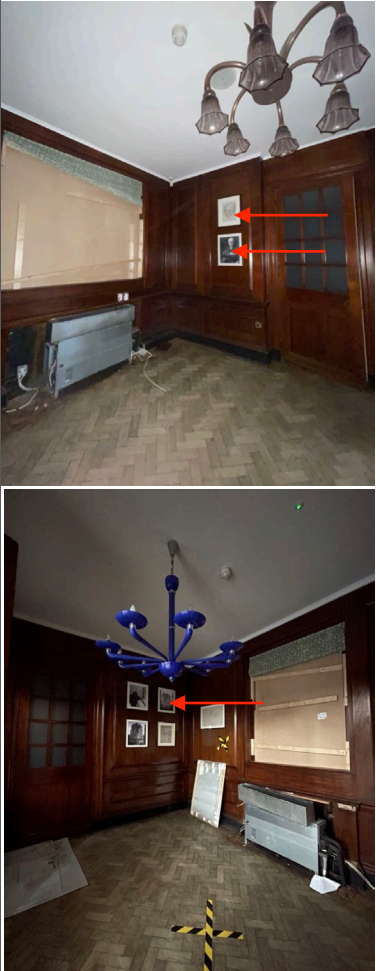
| 33 | <p>All existing framed artwork to be removed, wall behind to be made good as close to original as possible</p> | | PDRs | 28/7/22 |

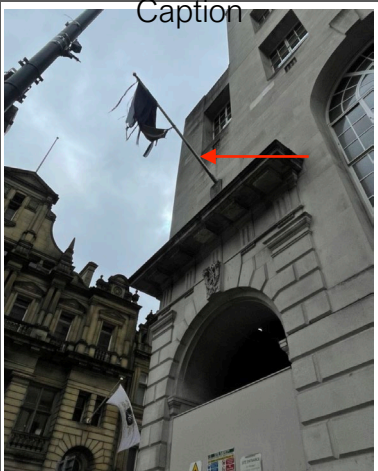
| 34 | Remove existing flags and allow for new flags | <p>Caption</p> <p>Caption</p> | On facade above both entrances facing King Street | 28/7/22 |

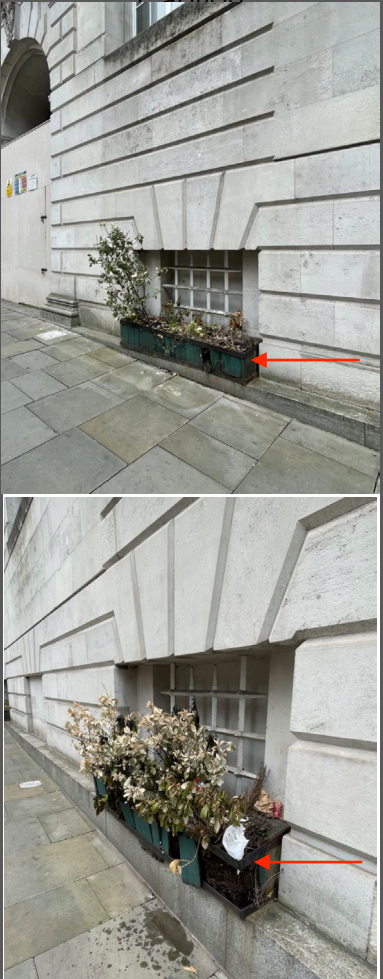
| 35 | Remove existing flags and allow for new flags | | On niches facing King Street | 28/7/22 |
