# DAYTIME BAT SURVEY

SWALLOW STREET,  
LEVENSHULME, GREATER  
MANCHESTER

APRIL 2022

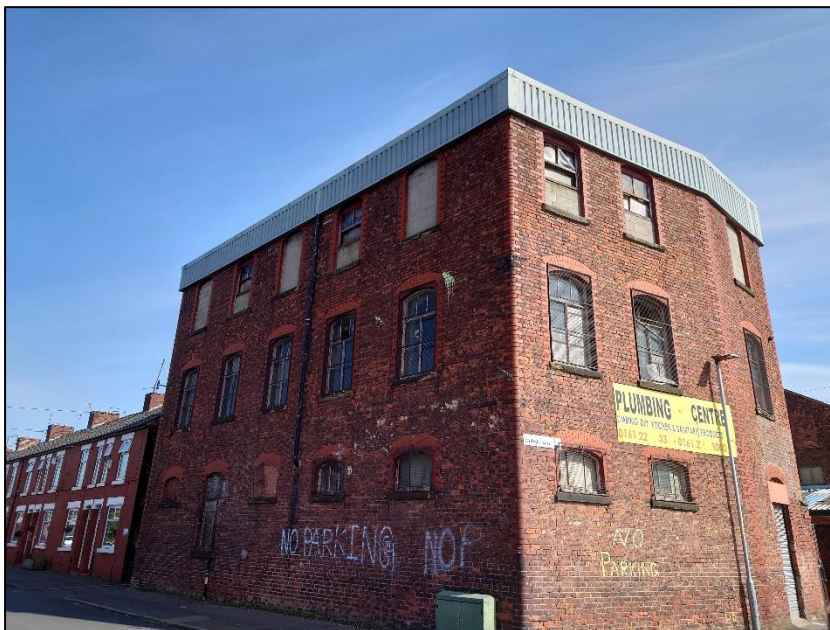
- 3.2 The external brickwork is in good condition with no significantly damaged bricks or recessed mortar cavities (see Photographs 1 and 2). The window and door frames are flush to the surrounding masonry (see Photograph 3). Some of the windows are boarded, with metal grills in position over the ground floor and second floor windows. The brick window lintels are intact, offering no gaps.

*Photograph 1 showing the exterior of the property*

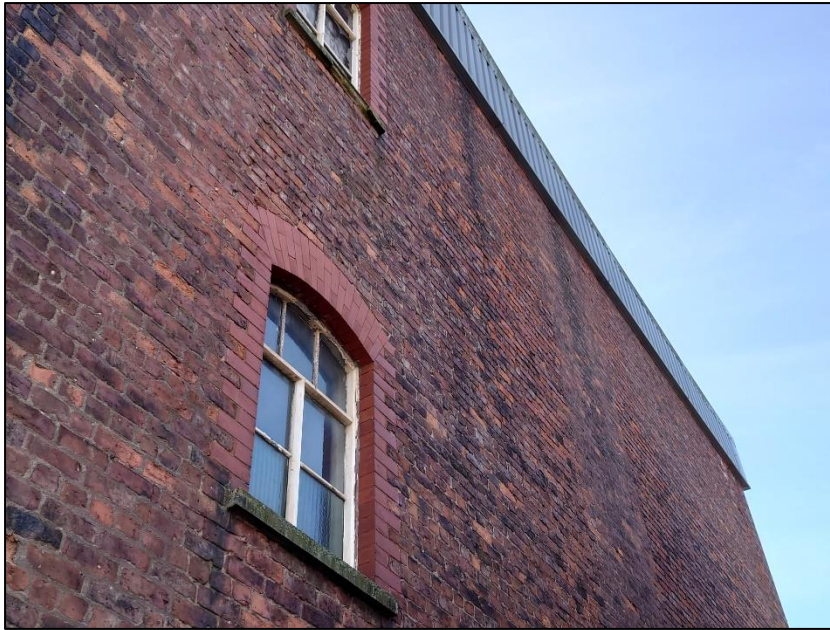
*Photograph 2 showing the rear elevation of the property*

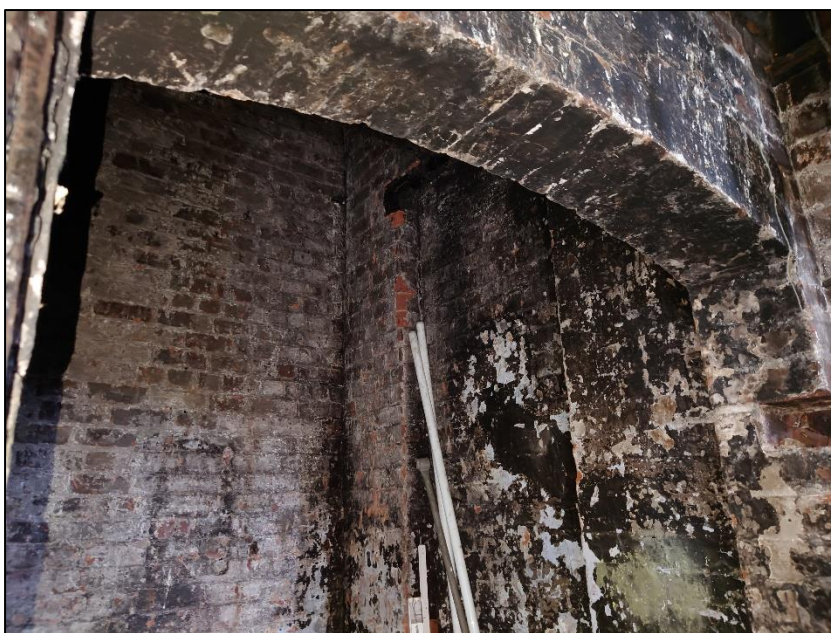
- 3.4 The interior of the building is used for storage only. The building is currently unoccupied. The upper floor is built up to the roof, and has no separate roof void (see Photograph 5). The steel beams are complete and intact, offering no cavities for bats to exploit. The roof is unlined. The internal brickwork is complete and intact, offering no damaged bricks or recessed mortar (see Photograph 6). The interior is well-lit. No evidence of bat activity was found inside the building.

*Photograph 6 showing the internal brickwork*

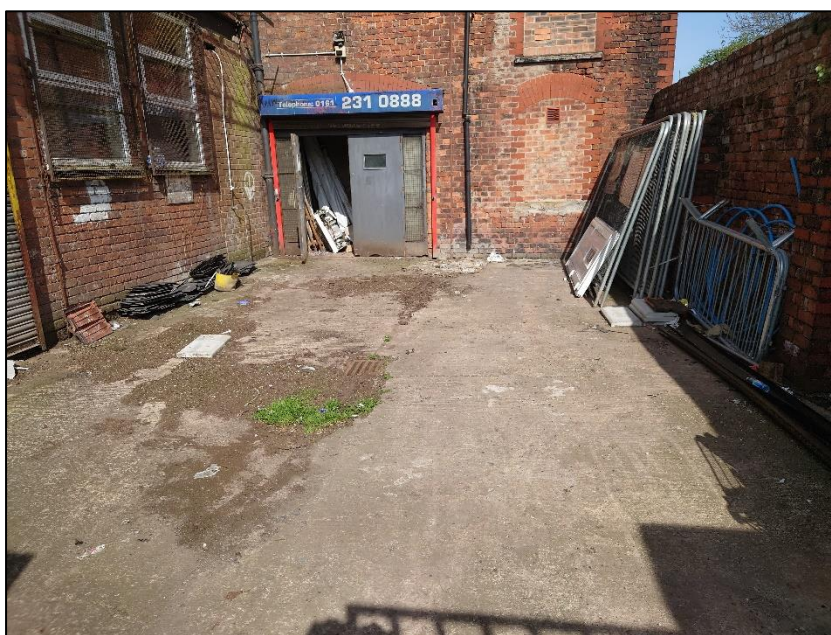
- 3.5 The property is enclosed entirely by hardstanding, with a small yard present on the front elevation (see Photograph 7). No evidence of other protected species could be found on the site.

*Photograph 7 showing the small yard on the site*
