| CLIENT | Historic England |
| PROJECT | Baguley Hall |
| TITLE | Fabric Repairs Elevations 3 of 3 |
| NUMBER | BGH-SEV-XX-ZZ-DR-A-3002 |

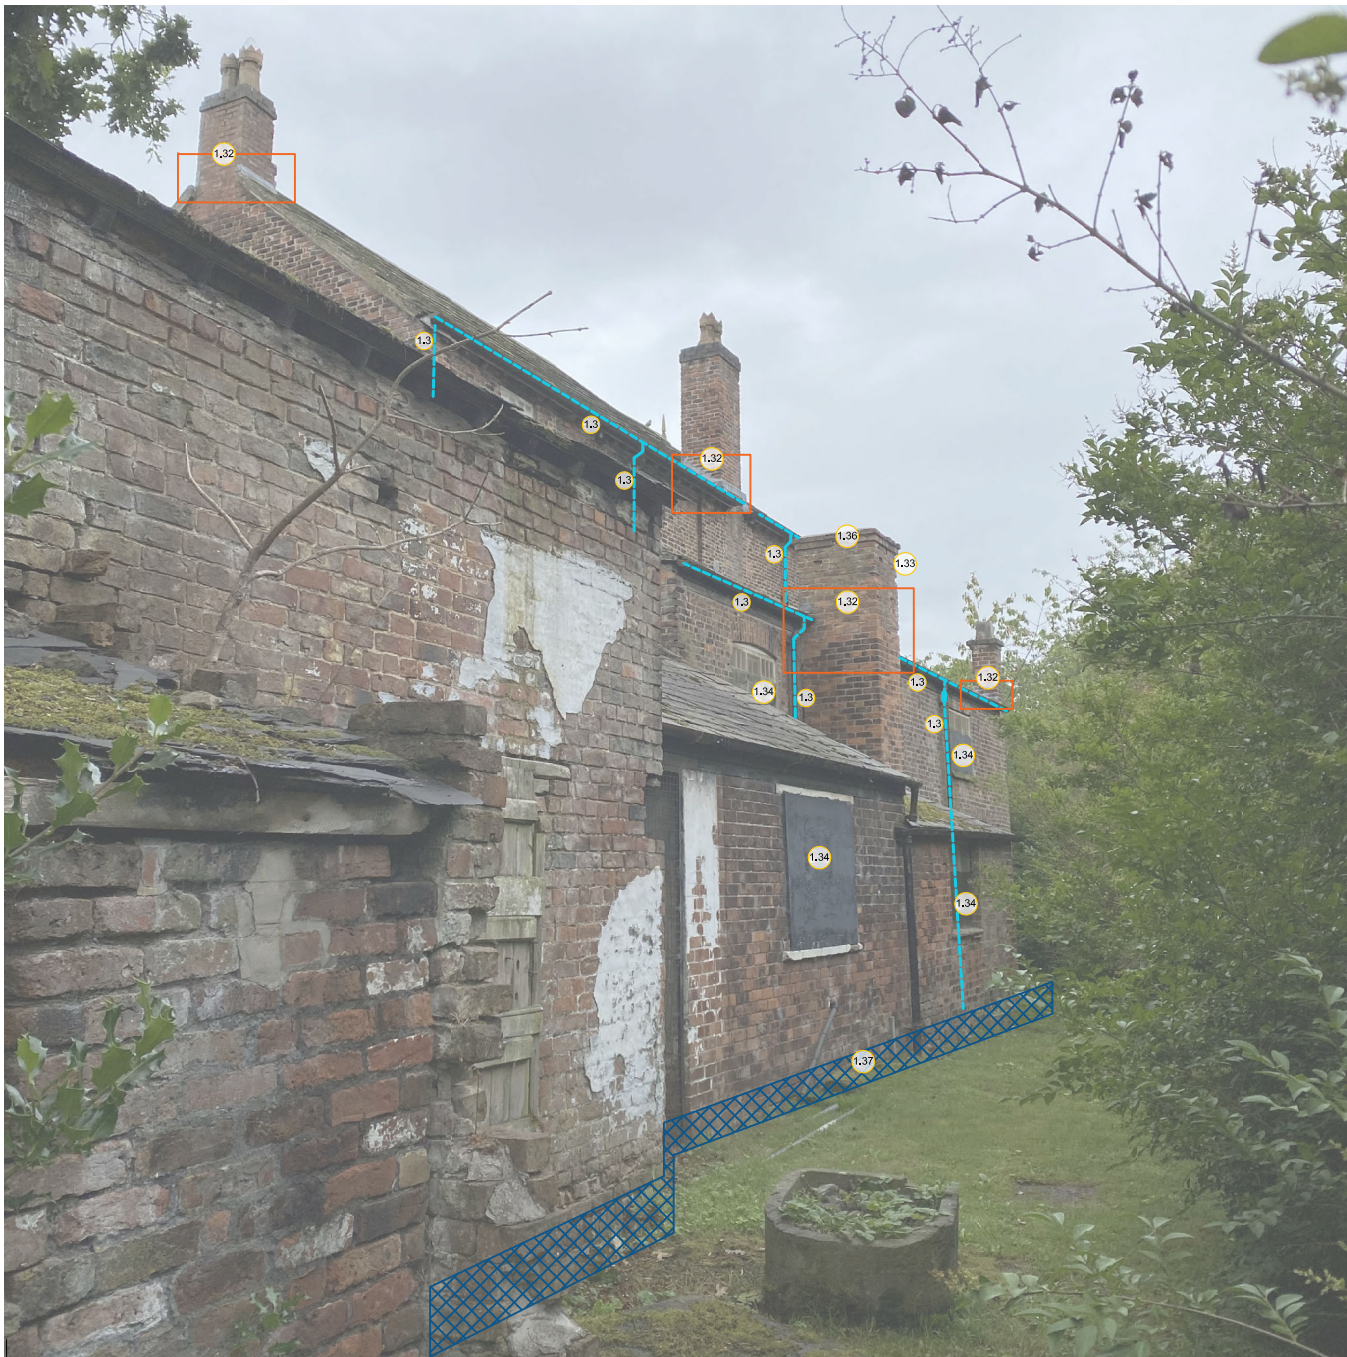
North Elevation 01

- Refix approximately 6no slipped slates with copper pegs.
- Replace existing plywood with plywood painted white on the inside with an image of the window externally.
- Repointing at low level. Allow for 3 courses around the perimeter of the building.
- Carefully cut out brickwork and replace with reclaimed brick as per specification. Repoint in a Hot Lime mix to match existing mortar colour and texture.
- Replace lead flashing.
- Renew rainwater goods throughout and increase sizes to 6inch.
- Replace valley gutter as per detail...
