# BAGULEY HALL CONSERVATION PLAN

WYTHENSHAW  
GREATER MANCHESTER

## VOLUME 1 UNDERSTANDING THE SITE

DECEMBER 2004

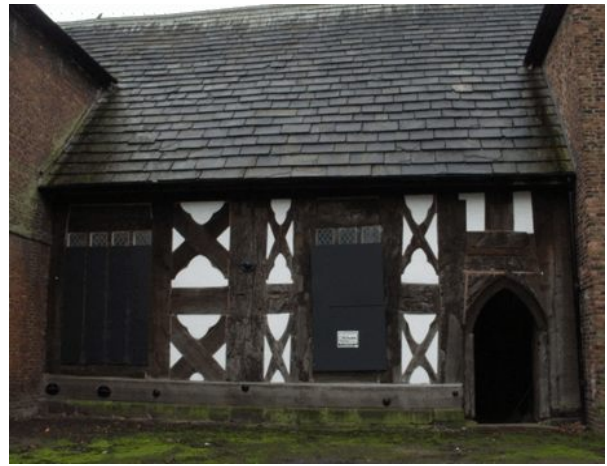
**Plate 3** East external elevation showing massive plank construction

wall reaches 1.27m across) (Dixon *et al* 1989, 391). These timbers are arranged into square framing divided by a mid-rail, as was typical of the western school of carpentry. The panels are further subdivided by cusped braces, forming a ‘St Andrew’s cross’ design (Plate 3) (Dixon *et al* 1989, 391). In the north wall of the hall, this design is more elaborate, with moulded trefoil panels below the wall plate. Above, flanking the queen post, are two large quatrefoils, also formed by cusped bracing.

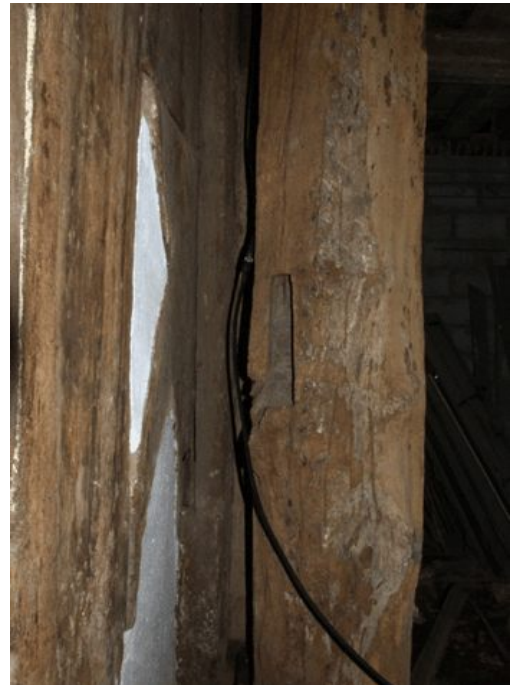
**Plate 4** Empty mortice in Room 0/15

Further discussion focusses on the form of empty mortices positioned to take mid-rails (Plate 4). These rails would have blocked the openings into the hall at ground-floor level. There are several solutions for this, two of which were presented by the recent excavation report (Dixon 1989, Fig.11). One suggests that the mortices were designed to take upward braces, rather than rails. With the absence of a cross-beam, this is hard to verify, and with the mortices cut at a right-angles to the vertical face of the timbers, it seems somewhat unlikely. A second interpretation surrounds the subdivision of the building as part of joint occupation. As already noted, there is documentary evidence to suggest such arrangements taking place from the end

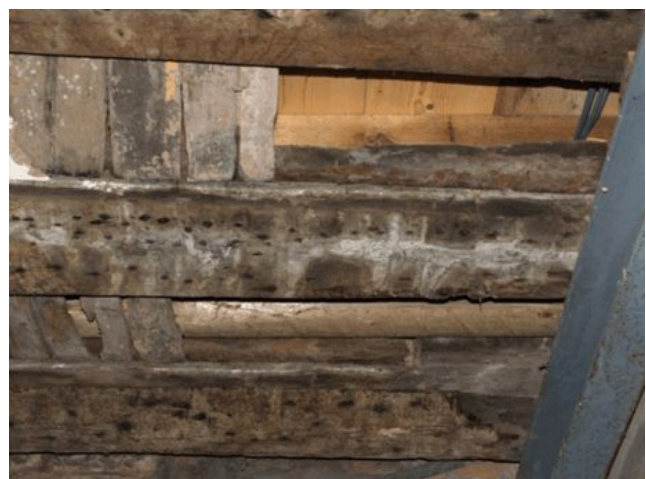
**Plate 5** Elaborate ceiling construction in Room 0/09

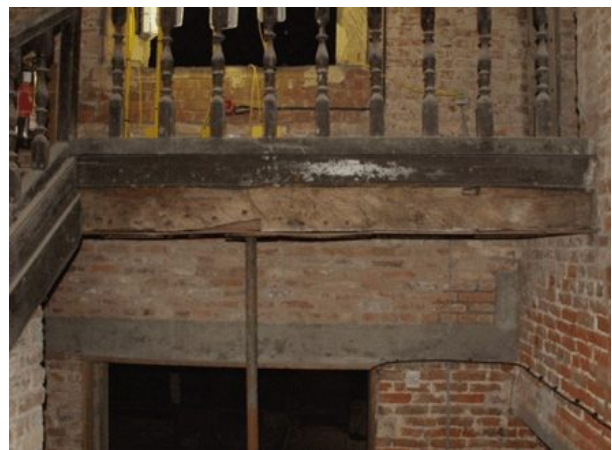
**Plate 6** Re-used timber in the stair of Room 0/21

Various reused medieval timbers survive within the present wing, but these may originate from either the north or south wing. Dixon *et al* (1989, 401) identified a 15th century roof truss, assuming it to have come from the earlier north wing, although it be a survival from an earlier structure to the south. Two large uprights have also been reused in the construction of the later stair (Plate 6). These reveal a complicated arrangement of wall plates and braces, similar to those found *in situ* to

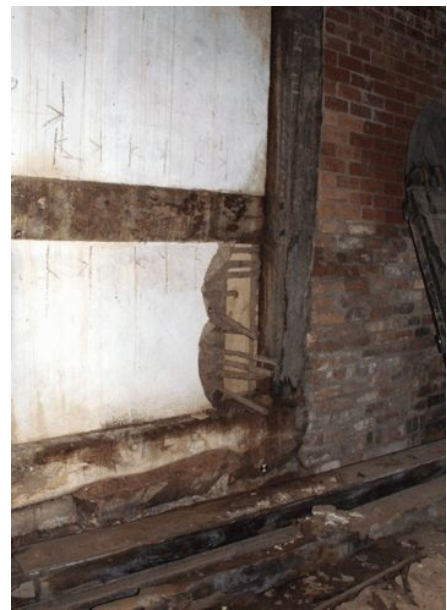
**Plate 7** Evidence for the extension of Room 0/15

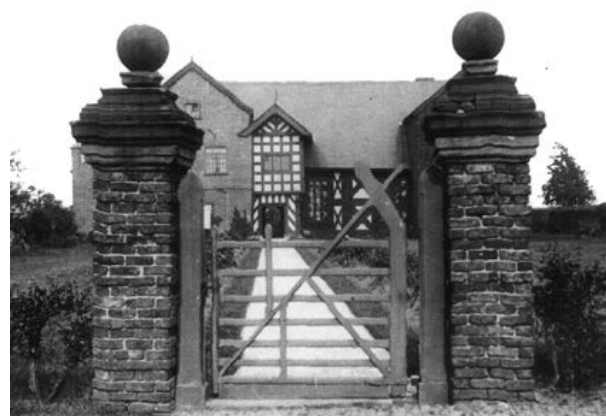
**Plate 19** Photograph of 1900 showing the brick gate piers leading to the Hall, since removed

Surviving images from the late 19th and early 20th centuries show the Hall to be in good condition, with carefully manicured gardens to the west, approached through stately gate piers (Plate 19). However, by 1932, the building was beginning to suffer and, when the Mayers left in 1949, the imposing entrance had been lost and the gardens abandoned. The Hall was suffering a similar fate, being deemed uninhabitable and reserved for the storage of timber. The logic of this move was somewhat misguided, as the Hall was already under attack from deathwatch beetle (Manchester Evening Chronicle 9/9/49). In 1950, the estimated cost of renovation was only £20,000; put into perspective by the £500,000 later spent on repairs in the 1980s (Manchester Evening News 25/02/99).

Formal gardens are identified in the documentary sources as early as 1578. They are also noted in the 1838 tithe, but do not appear on the map evidence until 1898. Historic photographs of the area show carefully manicured lawns and hedges, reflecting the present arrangement. They also show grand ornamental gate piers, leading up to the garden path. These are constructed from brick and defined by a series of bands which mirror the floor band on the brick wings. This suggests that the garden was formalised in the early 18th century, when the brick wings were added.

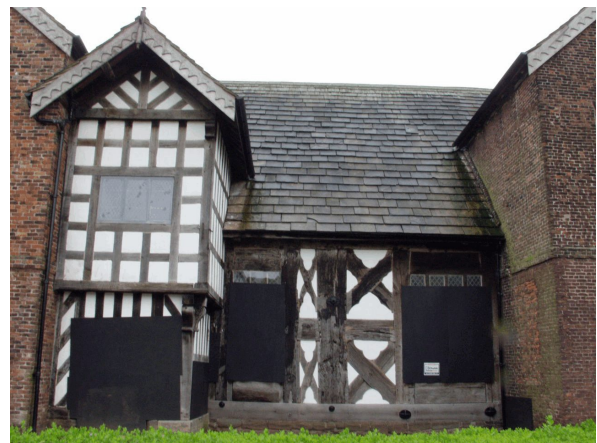
**Plate 20** Baguley Hall west facade

The present hall is of two bays, with a one third bay at the north end forming a cross-passage. The bays are divided by an arch-brace open truss to the south and spere truss to the north, separating off the cross-passage. Each bay is defined by an opening in the east and west elevations. Within the northern bay are two doorways, with later replacement doors. Within the hall proper are large timber mullioned windows, those to the south being slightly larger four-light openings, in contrast to the three-

Each bay of the hall is flanked by tall, mullioned windows, with deep, moulded sills (Plate 2). Those to the south are slightly larger, being of four lights, while on the remaining two windows there is some evidence of shutters being placed across the lower portion. The windows are presently filled with leaded glass, but it is possible that they originally held stained glass, a large amount of which was removed from the hall during the second world war (Wythenshawe County Express 20/05/65). However, it is the construction of the hall which makes it a remarkable example of its type. The building was built using massive pieces of timber, some measuring over 1.00m in width (the queen post of the north

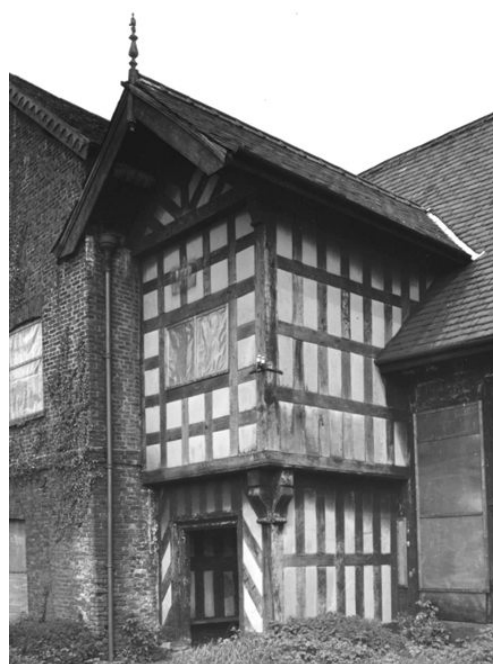
**Plate 23** The 20th century two-storey porch to the northwest of the hall

Projecting from the northwest corner of the hall is a two-storey timber porch (Plate 23). This represents a 20th century replacement of a 19th century rebuild of an earlier, possibly 16th century structure. Very little survives of the original structure except within Room 1/09, where a single post in the southeast corner rises above the roof level of the hall.

The present structure is of post and rail construction, forming close-studding on the south elevation. The regularly spaced mortices in the surviving post, outlined above, suggest that this reflects the earlier arrangement. This has been altered on the west elevation to create smaller square panels, into which has been inserted a three-light timber window at first-floor level. The porch is also jettied at this level, being supported by carved brackets rather than the more typical dragon post arrangement. The main doorway is in the west elevation, forming a continuation of the cross-passage; to each side it is flanked by diagonal bracing. The

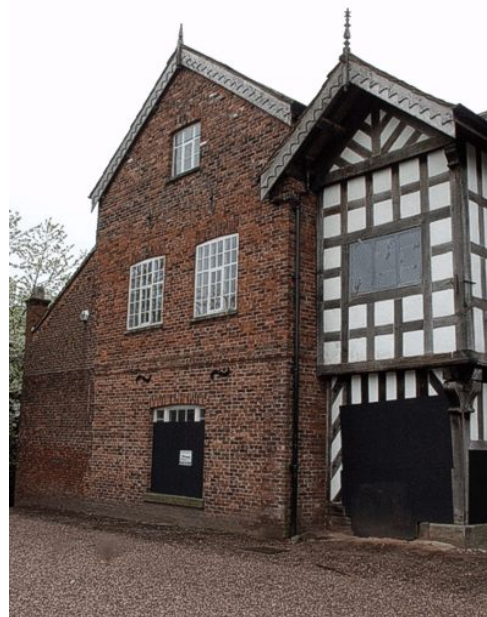
**Plate 24** The brick facade of the north wing

The standing remains of the north wing represent several successive phases of building. A service wing is known have existed when the *circa* 1400 hall was built, as evidenced by the three doorways in the north elevation of the hall; however, none of this structure has survived *in situ*. The archaeological excavations identified a cobbled surface within Room 0/09, thought to be associated with the earlier building (Dixon *et al* 1989, 411). Some timber elements are visible in the present wing and these have been dendrochronologically dated to 1443-78, suggesting that a new service wing was constructed in the late 15th century to replace the earlier structure. There is evidence within Room 0/15 that the range was extended to the west at a later date, possibly in the late 16th century, as will be discussed below. In the early 18th century, the wing was encased in brick, with a added second floor to match the new south wing (Plate 24). However, there is evidence to suggest that much of the existing timber frame was retained, only being removed in the 19th century. This is highlighted by straight joints in the east external and north internal elevations, which indicate the removal of posts, and subsequent infilling. This event is probably contemporary with the extension of the building to the north in the early 19th century.

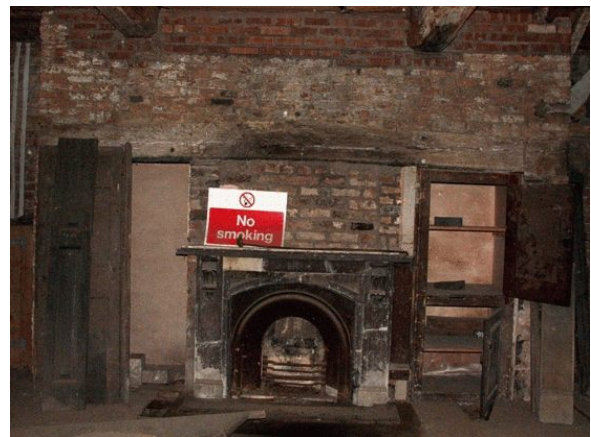
**Plate 28** Fireplace in Room 0/15

The cast iron fire surround and integrated cupboard relate to the conversion of the room into a living space. This may have occurred with the extension of the wing in the 19th century, when a new kitchen was added. At this time the room was divided off from the hall with brick infill, with the only access being provided through Room 0/14. The window in the west wall relates to the recent restoration programme, but old photographs show it to be a faithful replica of the 19th century hung sash. During these works, the west wall was also rebuilt internally using breeze blocks.

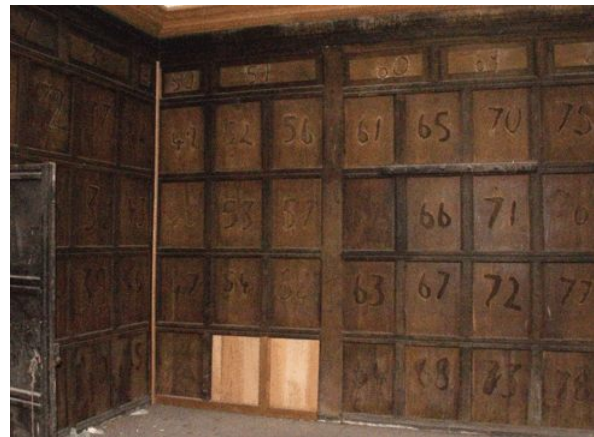
**Plate 29** Panelling in Room 1/02

Room 1/02 is situated at first-floor level, to the east. The present proportions follow those of Room 0/09 below, suggesting that it retains its original 15th century scale. The panelling is early 17th century in style, but was introduced into this room at a later date (Plate 29). Evidence for this surrounds the introduction of horizontal panels on the uppermost course, in an attempt to fit the room. The cornice is also later, with the mouldings suggesting an early to mid-18th century date, corresponding to the dating of the hob grate fireplace. It is also important to note the absence of panelling along the east wall, perhaps suggesting that this has been rebuilt at a later date, and two large hung-sash windows inserted.

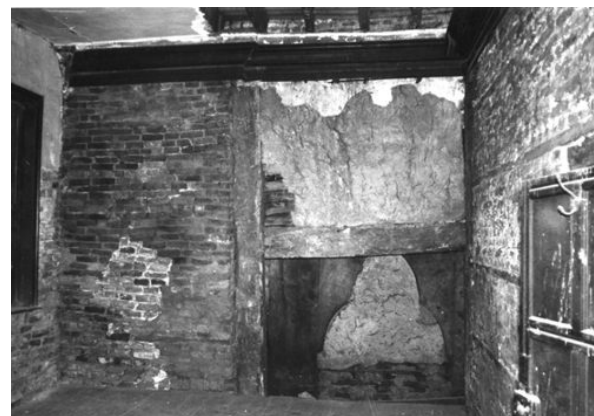
**Plate 30** Timber-framing revealed by restoration

Removal of the panelling for restoration in the 1970s revealed the north elevation of the hall, superseded by the timber-framing of the late 15th century wing (Plate 30). A wall post survives *in situ* in the southwest corner, as a continuation of that identified in Room 0/09 and dated to c.1470 (Nayling 2004). To the east of this is a lath and plaster partition, divided by a timber midrail, adjoining a second post. To the east of this post, the wall has been infilled with brick. In 1621, the room was most likely in use as ‘Mr Richard Leigh’s Chamber’, although it probably functioned more as a study than a bedchamber, with the head of the household sleeping in the adjoining chapel chamber (CRO: WS1621).

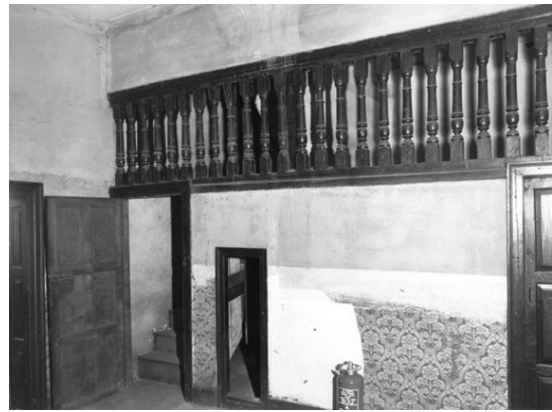
**Plate 31** Photograph taken in the 1960s, showing forming subdivision of Rooms 1/05 and 1/06

The subsequent subdivision to create Room 1/06 probably occurred with the rebuilding of the wing and the creation of a second storey. A photograph from the 1960s shows the position of a stair, rising from the east and returning west, following the north elevation of the hall (Plate 31). The balustrade divide not only formed a decorative partition, but also provided light to the stairwell. The area below this (Room 1/06) was reserved as storage space. This staircase, and much of the dividing wall, was removed during the late 20th century restorations, revealing evidence of the late 15th century structure. Both the east and west walls correspond to surviving wall posts, both of which have been dated to *c.* 1470 (Nayling 2004). The presence of mortices highlight the existence of a midrail, suggesting that the south wall was divided from the hall elevation, leaving a void between the two structures (Plate 32).

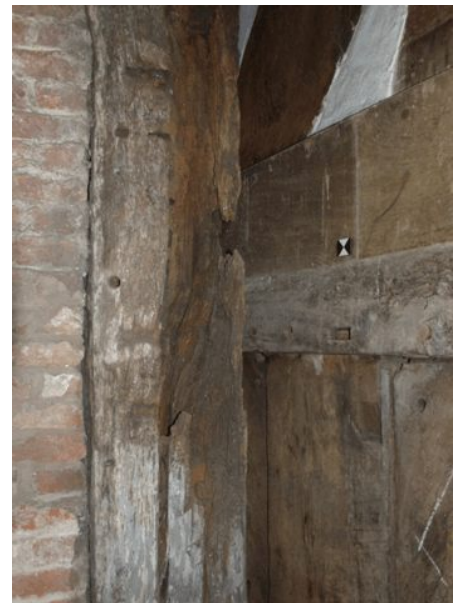
**Plate 32** Surviving late 15th century post in Room 1/06

Extension of the room is visible in the south elevation, parallelling the situation below (Room 0/15). In the southeast corner survives a late 15th century wall post; however, the original corner post to the west has been replaced with a post of smaller scantling. The area between these has been much altered, but evidence of two midrails survives in the form of empty mortices. A photograph from the 1970s shows the area to have been infilled with close studding. To the west of the inserted post is a doorway, providing access to the upper level of the porch. This was probably added as part of the Victorian rebuilding of the structure. The space was formerly occupied by a window, highlighted by a series of voids in the underside of the horizontal timber above the door. These correspond to the regular placing of mullions. Any additional evidence has been lost with the insertion of

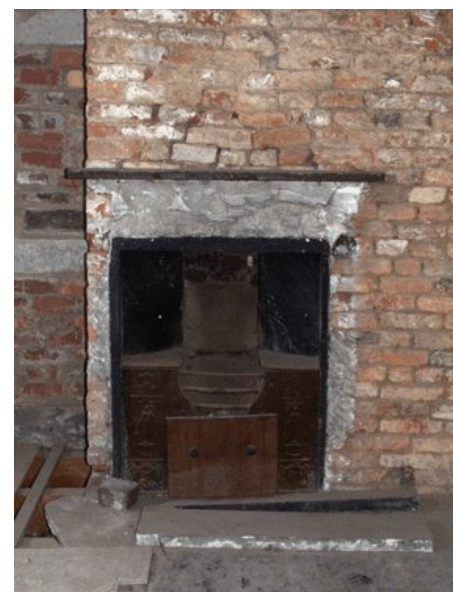
**Plate 33** Fireplace in the north wall of Room 1/08

To the north, the elevation is dominated by a large flue, as a continuation of the large kitchen range below (Plate 33). The fireplace is a later insertion of the 18th century, contemporary with the thirty-pane casements to the east. To the east of the flue is a straight joint running the full height of the elevation. This may relate to the rebuilding of the north wing in brick in the early 18th century.

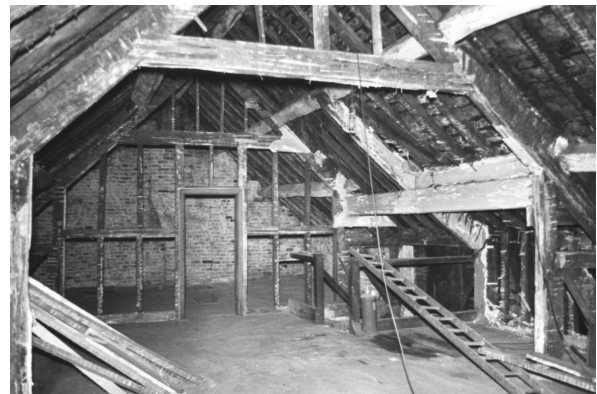
**Plate 34** Rooms 2/01 and 2/02

A stair formerly provided access to the second floor from Room 1/06 rising to the north. This was removed during the general strip-out of the building, but the aperture for the stair remains in the south wall of Room 2/02. The second floor of north wing consists of two rooms (2/01 and 2/02) divided by a stud wall (Plate 34). A further stud wall that divided 2/02 from the stair landing might also have existed; this had certainly been removed by 1971. Other than the 19th century roof structure, consisting of principal rafters and purlins, there are few features of note. The absence of fireplaces and the relatively austere appearance of the rooms would suggest that they were intended either as very low status accommodation or storage.

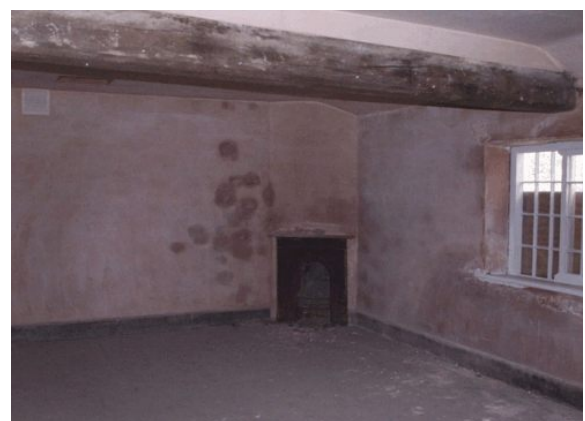
**Plate 35** First-floor living accommodation in the northern extension (Room 1/04)

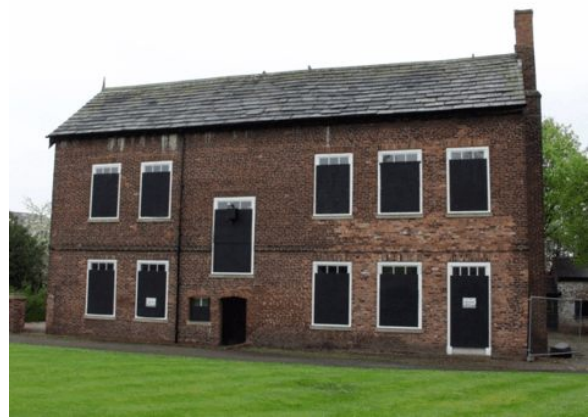
**Plate 36** South elevation of the south wing

The south wing was completely reconstructed in the early 18th century (Plate 36). However, it was built to replace an existing structure on the site. The earliest evidence for building to the south of the hall was identified during excavations. These revealed evidence of a timber wing within Room 0/18, pre-dating the *circa* 1400 hall, but post-dating the aisled building (Dixon *et al* 1989). During the 15th century, the north wing was constructed and there is evidence to suggest that a new south wing was built at the same time, also causing the truncation of the hall. Some timber-framed elements do survive, most notably in the roof and the inserted stairwell, and it may be possible to have these dendrochronologically dated. The surviving inventories for the 17th century provide a reconstructed floor plan for the earlier wing, suggesting a plan similar to that to the north. However, these rooms were reserved for the principle living quarters, including the parlour and great chamber, consistent with increased social segregation.

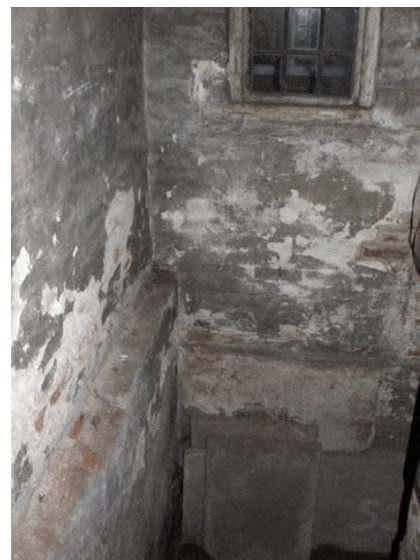
**Plate 37** Inserted stair down to basement

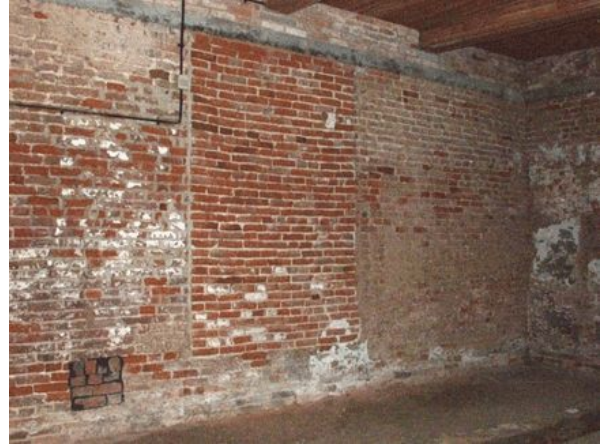
**Plate 38** Blocked opening in the north elevation of Room 0/18

Flanking the central stairwell are two rooms of similar proportions. To the east is Room 0/18. The walls have been stripped of plaster during the most recent restoration programme, revealing a complex arrangement of blocked and inserted openings. The windows and door in the south elevation were also inserted during these works, and reflect only one fenestration scheme. It is apparent from the structural evidence that these were not replicas of the original windows which were much larger in. The original windows reached almost to ground level, suggesting that they may have been grand bay windows, consistent with the early 18th century date, and with the use of the room as a principle living and entertaining room, heated by a fireplace in the east wall. A similar window was located in the north wall, close to the east elevation of the hall (Plate 38). This appears to have been blocked at an early date, shown by the use of small, red, hand-made bricks. The blocking of this window may have been a result of the strengthening of the window tax in 1749, suggesting that the wing was built closer to 1700.

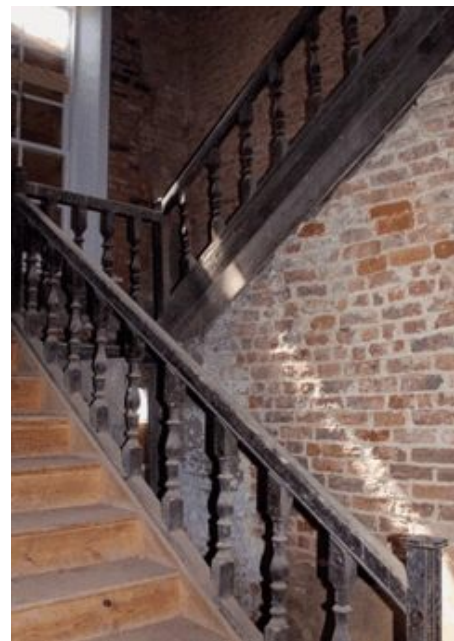
**Plate 39** Stair in Room 0/21

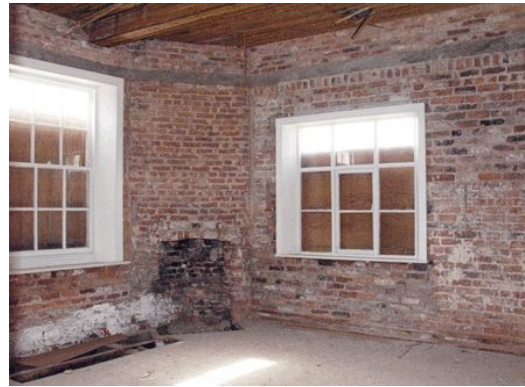
**Plate 40** Room 0/23 looking southwest

Room 0/23 is situated to the west of the central stairwell (Plate 40). It is constructed on a slightly smaller scale than 0/18, but appears to have repeated its arrangement of large windows in the north and south elevations. There is further evidence of similar openings in the west wall, suggesting an extensive provision of light into the room. The door is situated in the east elevation, with a second, blocked opening to the south which provided access into Room 0/22. The corner fireplace is a later addition, but it is unclear where the original flue was situated. The south wall appears to have been largely rebuilt and it is possible that the fireplace was located along this elevation. A room of this size and status would certainly have been heated.

The present windows are recent insertions, with concrete strengthening added along the two external elevations. The ceiling has also been reconstructed, obscuring any evidence of its original arrangement.

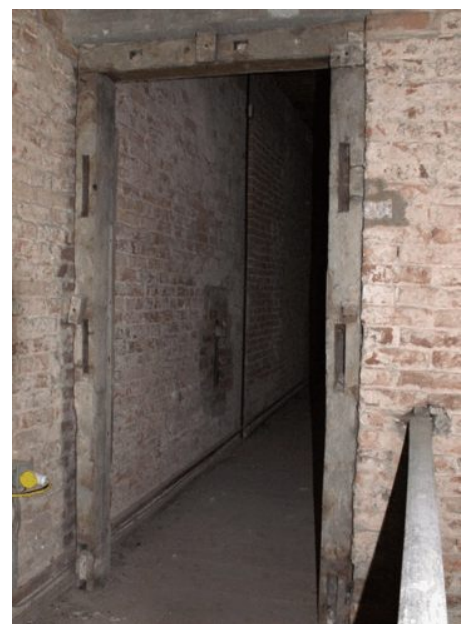
**Plate 41** Re-used timber in the door surround of Room 1/10

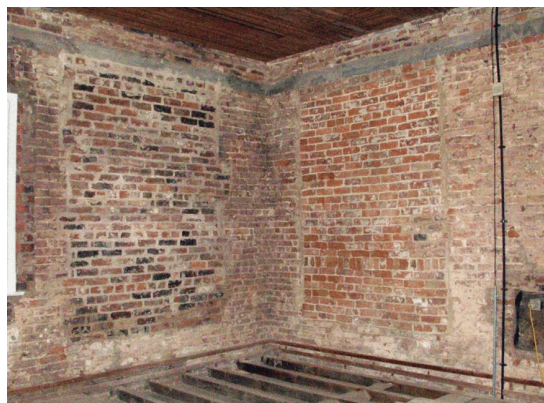
**Plate 42** Room 1/12 looking northwest

external walls. Two large blocked openings are visible in the north and west elevations, suggesting a repeat of the large windows identified at ground-floor level (Plate 42). Evidence in the south wall has been lost due to the recent renovations. These may have also obscured evidence of the original fireplace, that in the southwest corner being a later addition.
