## Phase 1: Desk Study

**68-70 Oldham Street & 61 Spear Street, Manchester**

**Cumming Group**

**Job No. S220723**

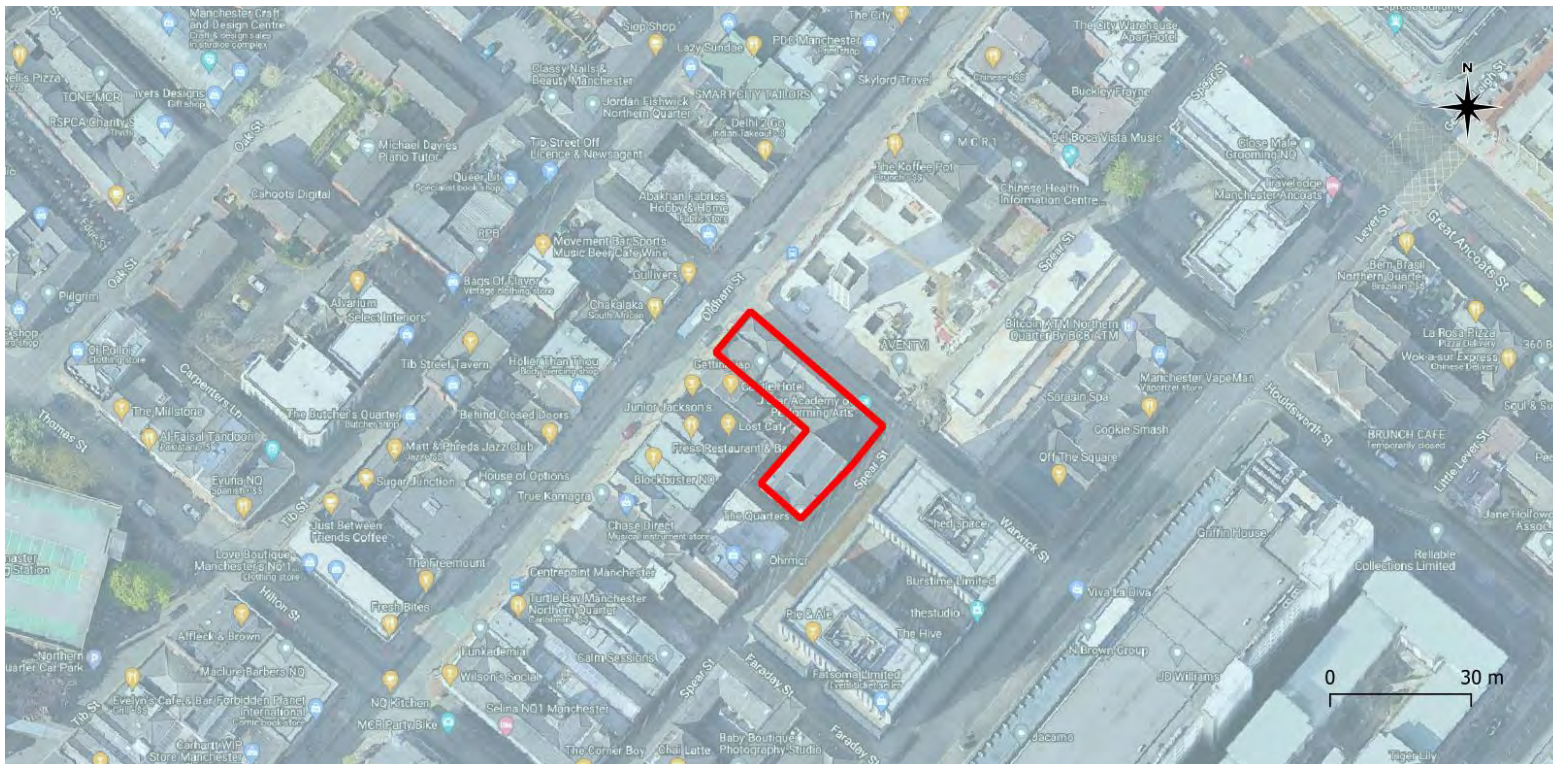
| <i>Geology</i> | The solid geology beneath the site is likely to mostly comprise Chester Formation of sandstone and gravels. The drift deposits on site are likely to comprise of silty, sandy and gravelly Glacial Till. |

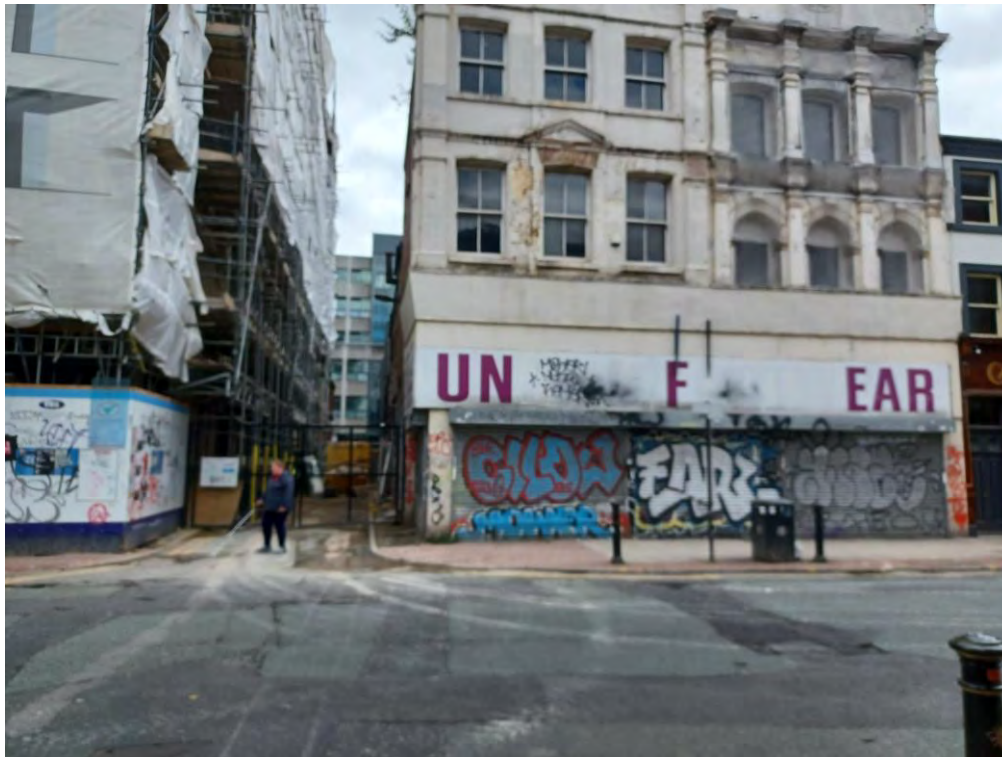
Photo 1: Photo taken at the north corner looking south east across site.

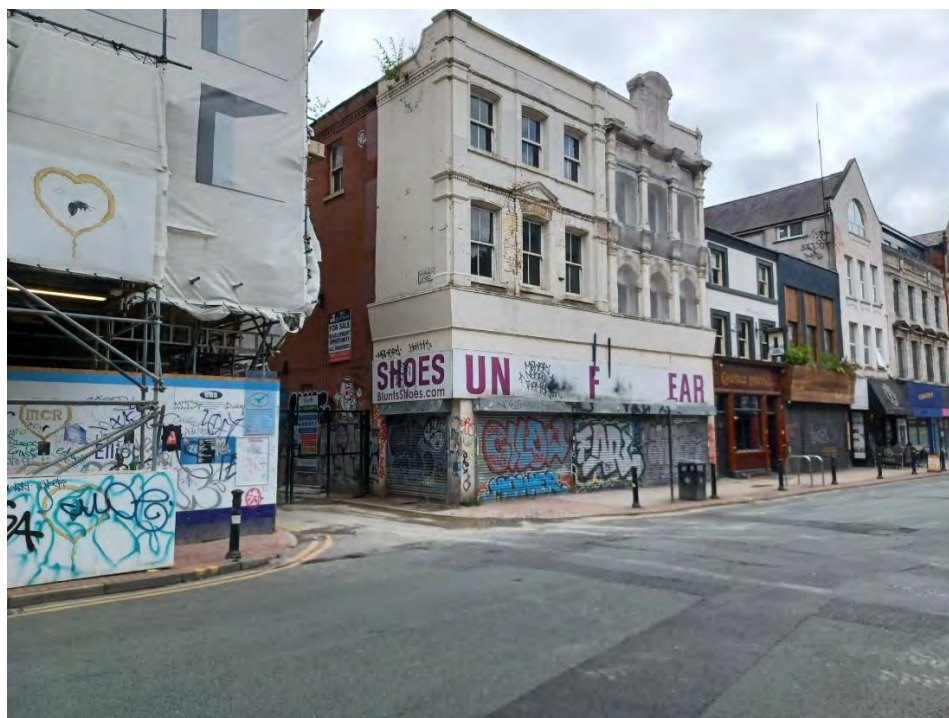
Photo 2: Photo taken looking south across site.

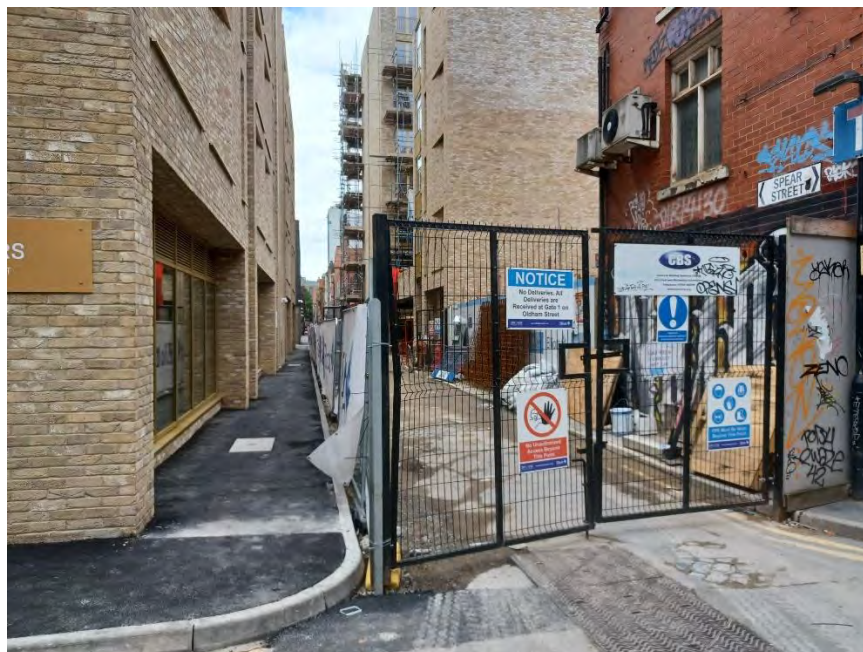
Photo 4: Photo taken east access road looking south west across site.

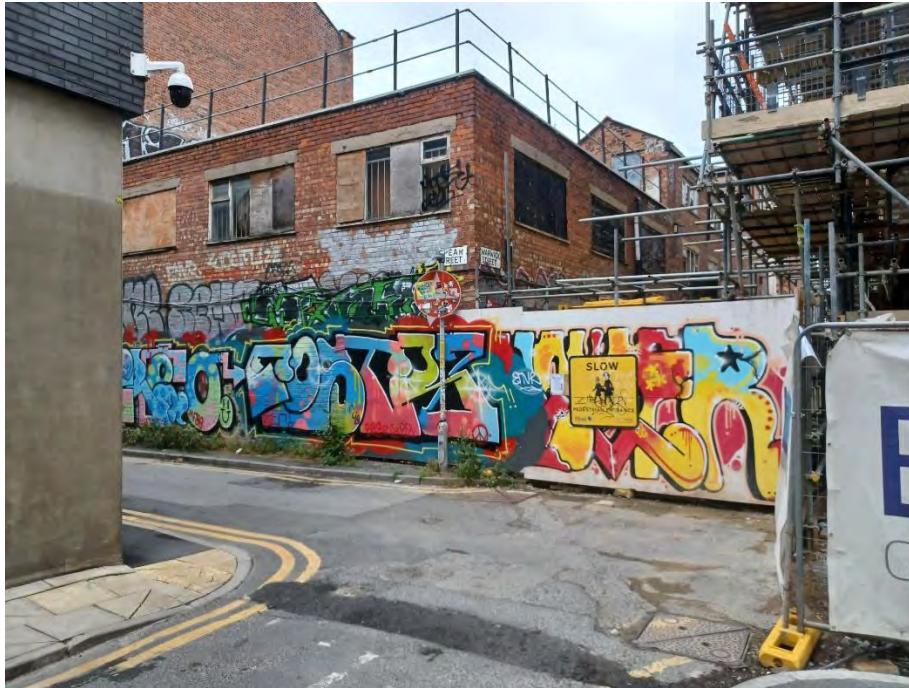
Photo 5: Photo taken at the east corner looking north west across site.

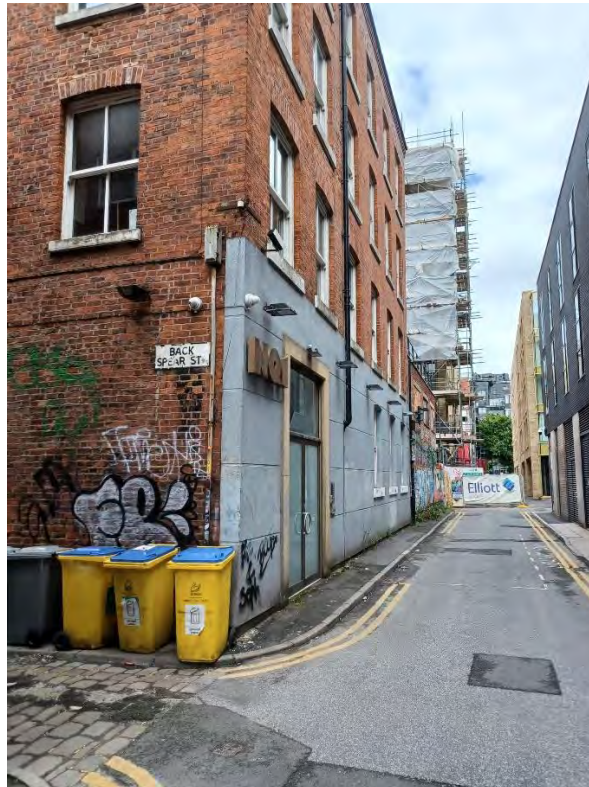
Photo 6: Photo taken at the south corner looking North across site.
