## 5. BUILDING DESCRIPTION & DEVELOPMENT

### 5.1 Introduction

### 5.1.1 Building description - Former “Hulme Place” townhouses – Exterior

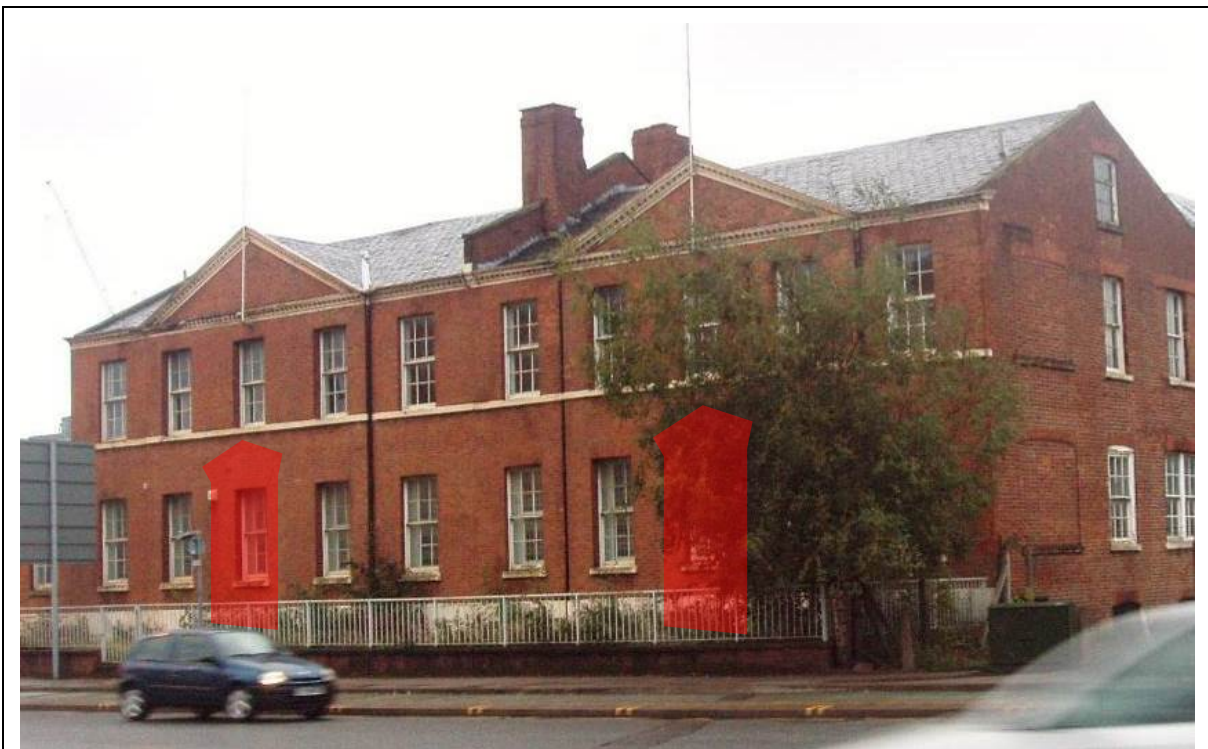
**Figure 35:** The north elevation as seen in 2007, showing the location of the original front entrances into both dwellings shaded red. (Source: SLHA 2007 – Note the current condition of the building has since worsened)

As previously stated, the two dwellings were not originally connected internally. Both houses were originally entered via an entrance door located to the centre of each house to the front, north elevation fronting Chester Road (**Figure 35**). The original front entrances would have formed either stone or timber door cases in a classical style, with pilasters either side and a pointed pediment, accessed from a short flight of stone steps. Although there is no visual evidence for these doors, their former ghosted outline can be seen in subsequent photographs taken in the 1960s/70s (**See Figures 24-25**).

The two entrances survived until being removed at some time between 1883 and 1891 by the Site's new owners; the Bridgewater Navigation Company Ltd, when the residential uses of the dwellings ceased, and the buildings became part of the wider offices, and the two doors were subsequently replaced by sash windows. Internally, the dimensions of the original wide entrance hall into the western dwelling survives, whilst the original entrance hall to the eastern dwelling was redesigned to form a large new board room (Room G04).

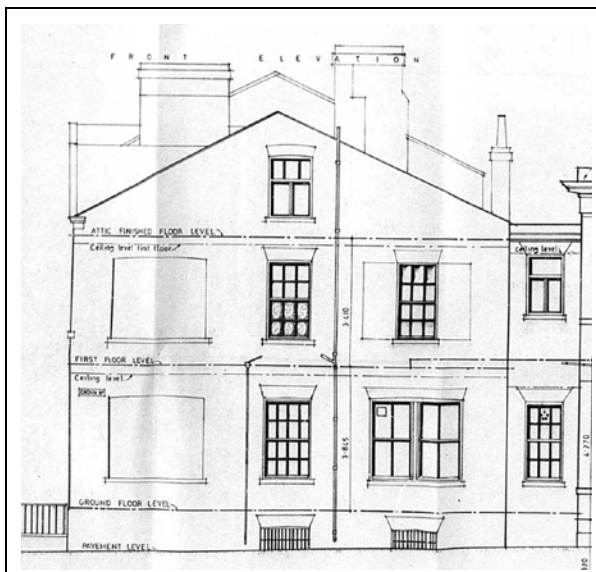
**Figure 36:** Existing west (Crown Street) elevation of the western dwelling 1977. (Source Manchester City Council)

On Crown Street, the west elevation of the western dwelling contains an unusual design of fenestration, with four, large window openings to the ground and first floor levels. The two openings to the north were designed to be blind as these have chimney breasts directly behind them. The two openings to the south originally contained two pairs of six-over-six sash windows, with the first floor opening subsequently altered to contain a single sash window in a reduced opening, whilst the bottom opening retains its original dimensions and contains two replaced/restored multi-pane sash windows inserted in 1977 (**Figures 36-37**). To the attic level is a single window opening containing a window also replaced in 1977.

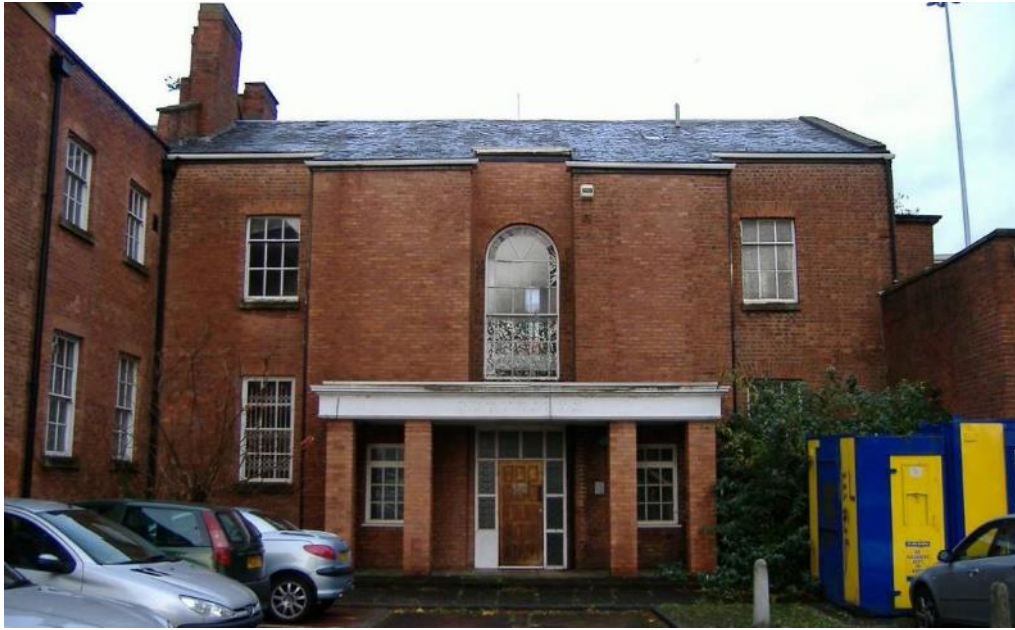
**Figure 38:** The south (rear) elevation of the eastern dwelling as seen in 2007, showing the alterations undertaken in 1977. (Source: SLHA 2007 – Note the current condition of the building has since worsened)

The south elevation of the 18<sup>th</sup> century east dwelling (**Figure 38**) originally contained a short, central projecting outrigger, which was likely to have been a rear entrance porch at ground floor level (**Figure 39**). In the c1850s a similarly dimensioned outrigger was constructed to the western side of this central porch, which provided a WC accessed from the mid-landing level of the main staircase, and a further WC at ground level. At some time after (and before 1879) the matching outrigger to the east was constructed to provide a service staircase from basement to attic level, with ground floor external access also provided.

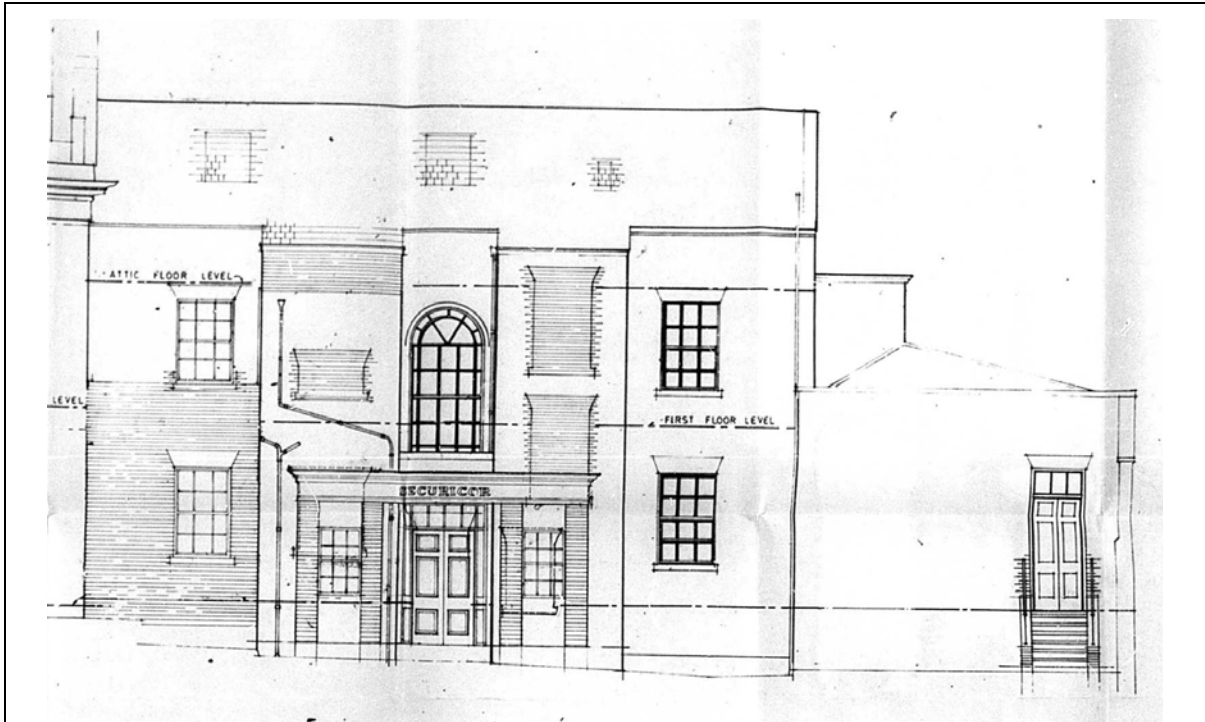
**Figure 40:** The proposed November 1976 southern elevation of the eastern dwelling, showing the alterations undertaken by Securicor Ltd, including the infilling of outrigger windows, the removal of a later glazed lean-to and restoration of original window openings, the construction of a rear canopy and double doors, the removal of three dormers/skylight and the conversion of a window into a door (right). (Source: Manchester City Council)

This elevation was substantially altered in 1977 with the alteration of the central outriggers, including the removal, filling and insertion of window openings, and the extension of the west outrigger up to roof level to provide a room at first floor level (**Figure 40**).

The late-19<sup>th</sup> century glazed lean-to was removed from the west of the elevation, and this part of the elevation was restored back to its original appearance. The alterations were finished with a new projecting canopy supported on square brick columns and landscaping of the car park area.

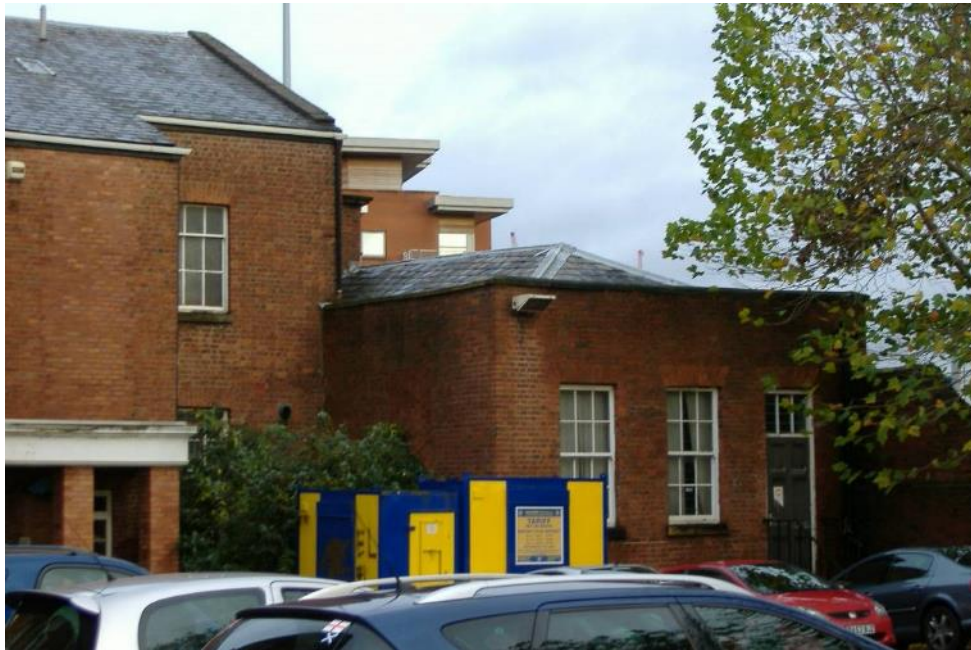
**Figure 41:** The southern aspect of the mid-to-late 19<sup>th</sup> century single-storey extension, which formed the "Porch Office". The door to the single storey wing was inserted in 1977, whilst the two window openings were inserted in 1985. (Source: SLHA 2007 – Note the current condition of the building has since worsened)

To the east of the eastern dwelling is a mid-to-late 19<sup>th</sup> century single-storey extension, which was historically known as the “Porch Office”. This building utilised the original 18<sup>th</sup> century garden wall to the east (fronting Great Jackson Street).

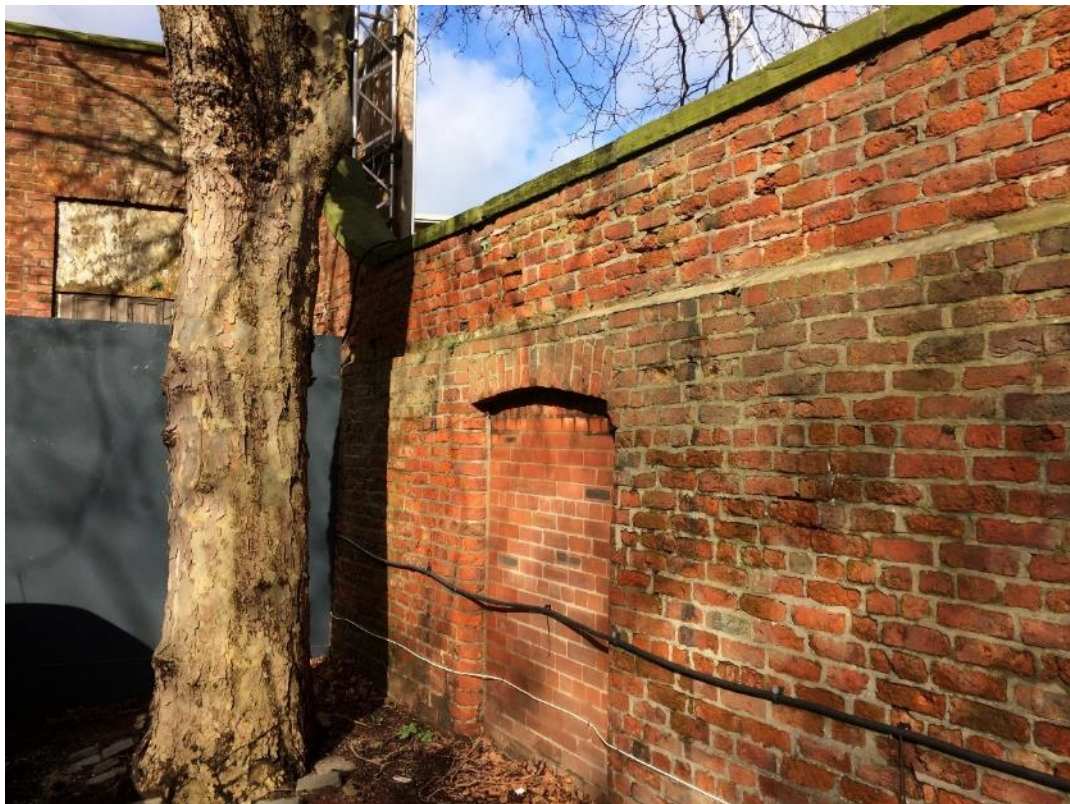
**Figure 44:** The remains of the original garden boundary wall from the eastern dwelling onto Great Jackson Street. (Source SLHA 2007).

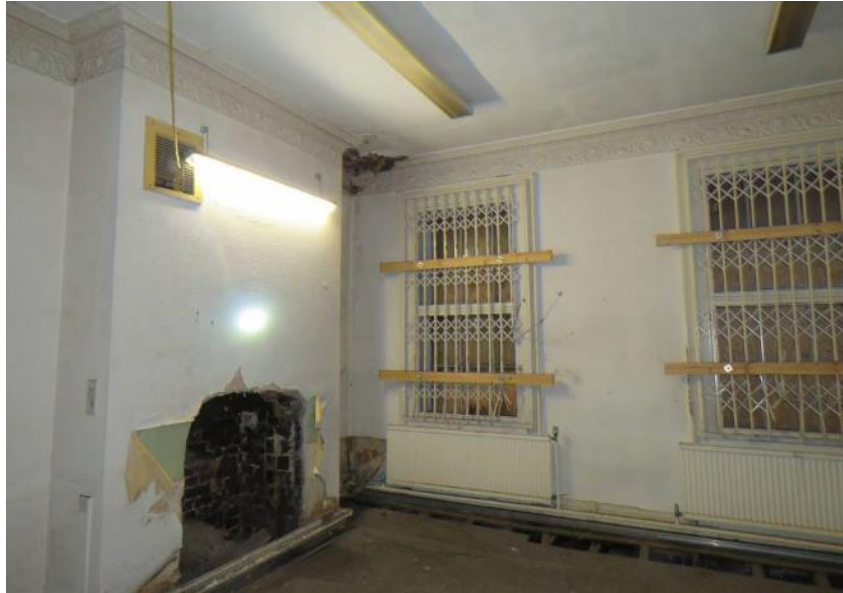
**Figure 46:** Room G11 (looking north) – Formally one of two reception rooms within the western dwelling, the room retains all its 18<sup>th</sup> century plaster cornice of urns and wreaths. (Source: SLHA 2017)

The ground floor level of both dwellings retain several examples of original cornicing. This cornice is of very high quality and includes highly decorative and figural plaster cornice, featuring classical urns

and cherubs faces, particularly in Rooms G10, G11, G12 and F16. The ground floor windows retain original panelled shutters to the ground floor windows, which have been painted shut and partially concealed with c1970s security bars.

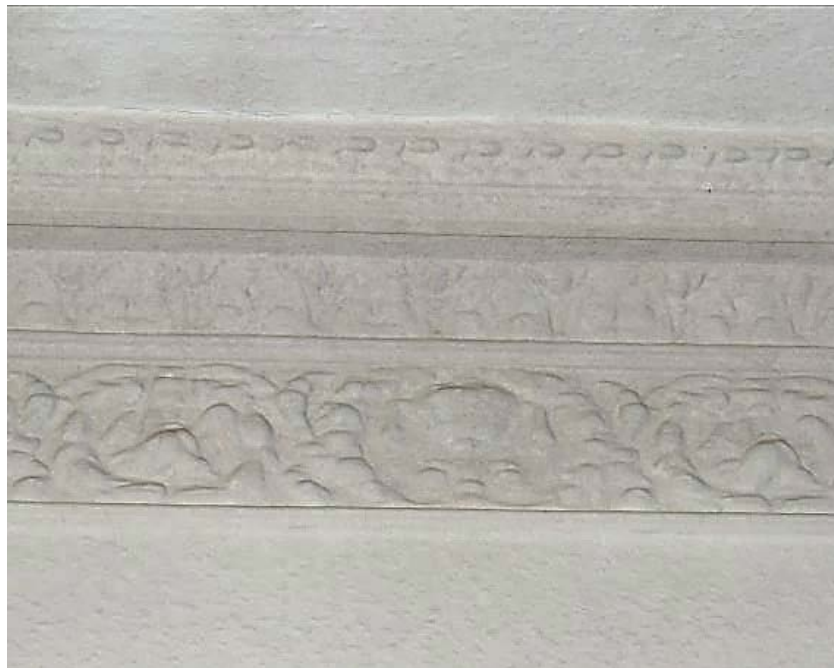
**Figure 46a:** A detail of the 18<sup>th</sup> century cornice in Room G11. (Source: SLHA 2017)

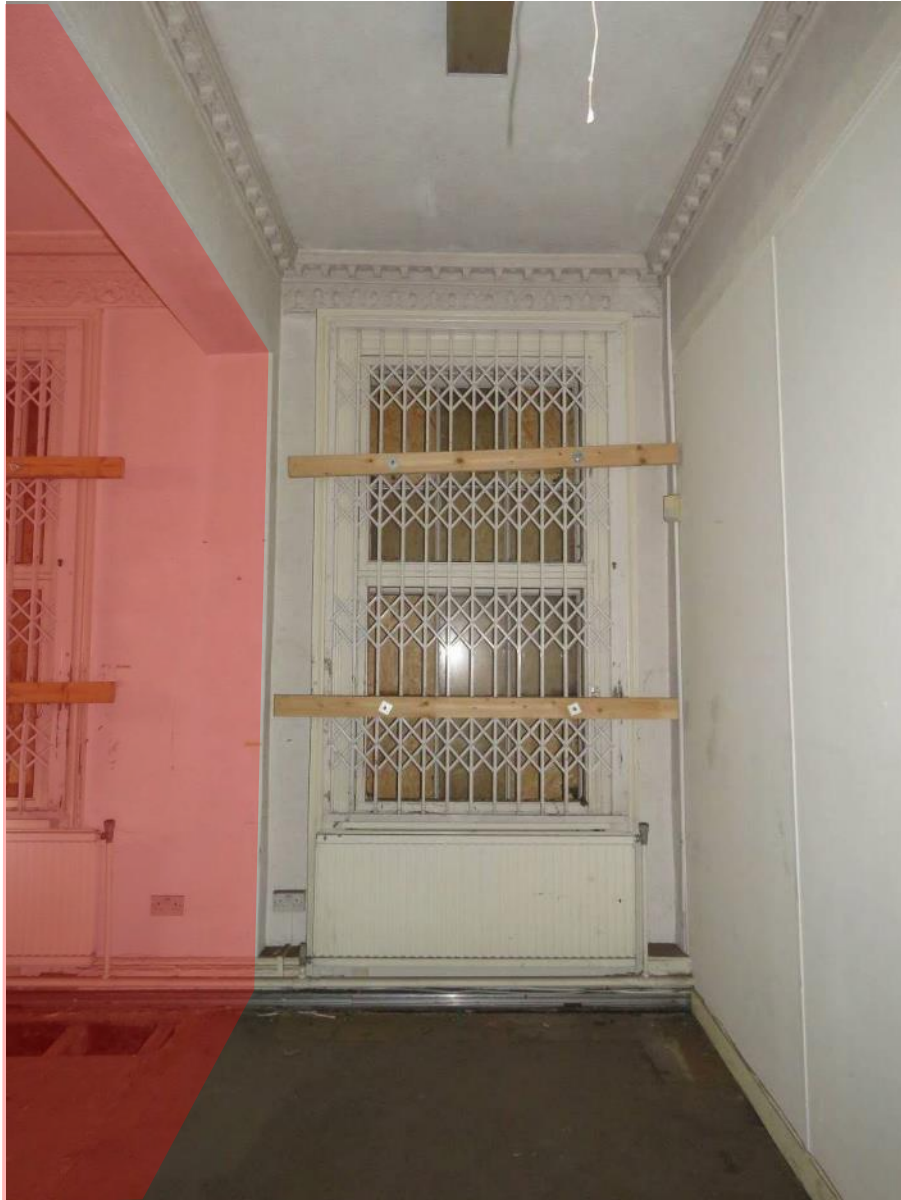
**Figure 47:** Room G11 (looking north) – This room was the original entrance hall and was originally divided from the room pictured above by a dividing wall (indicated by red shading). The window was inserted following the removal of the front entrance door in the late-19<sup>th</sup> century.

This room retains most of its original plaster cornice featuring urns, which is of a different design to the western part of the room, and which matches the cornice found in the adjacent former hallway (Room G12) which originally formed an extension of this room (See Figures 48-50) (Source: SLHA 2017)

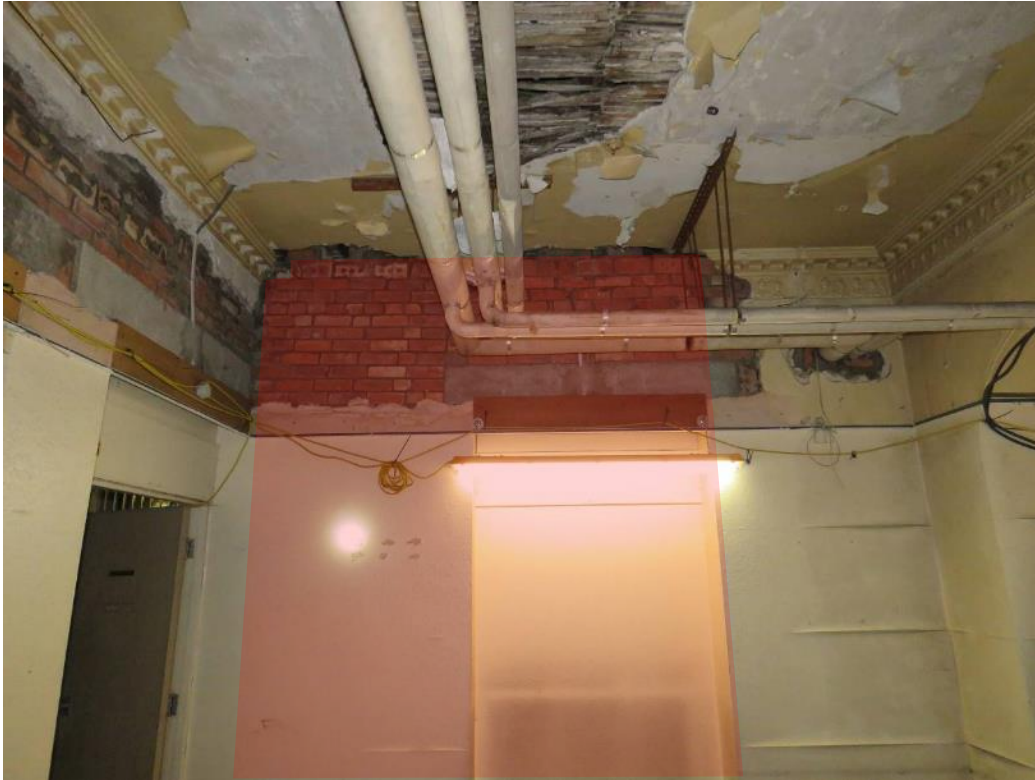
**Figure 48:** Room G12 (looking north) – This room was the original 18<sup>th</sup> century hallway for the western dwelling, which opened out into the entrance hall shown in Figure 47 above. To the south was originally a now demolished separate staircase hall. The room retains parts of its 18<sup>th</sup> century cornice, which features urns, laurel leaves and brackets with indentations from former, now removed plaster rosettes, surviving examples of these can still be seen in Room G11 (see Figures 49-50) (Source: SLHA 2017)

Due to the survival of original flagstone floors and original decorative 18<sup>th</sup> century plaster cornicing in this former entrance hall (Room G12), it demonstrates that the staircase was not located within the room itself, but within an adjacent room to the south which has since been demolished.

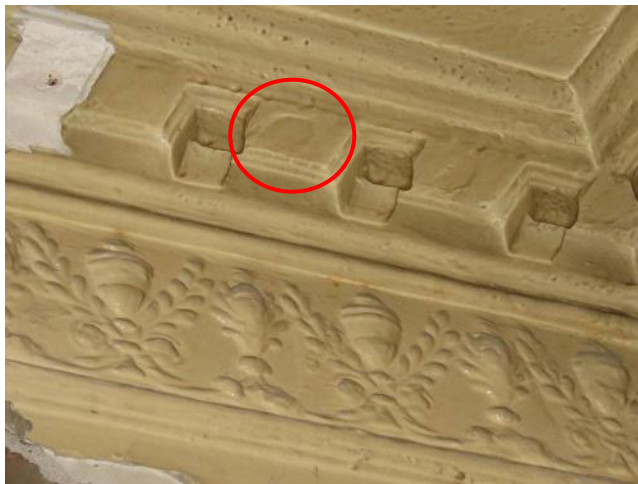
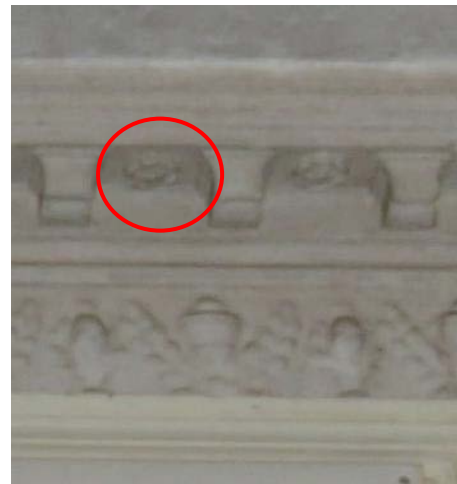
**Figure 49 & 50:** The original cornice surviving in Room G12 showing missing rosettes (left), and surviving cornice with rosettes within the adjacent Room G11 (right) (Source: SLHA 2017)
