Our reference: 065782-CUR-00-XX-RP-GE-0004-P03

## **Re: Remediation Validation at Circle Square Plots 2, 3 and 4**

### **1.0 Introduction and Background**

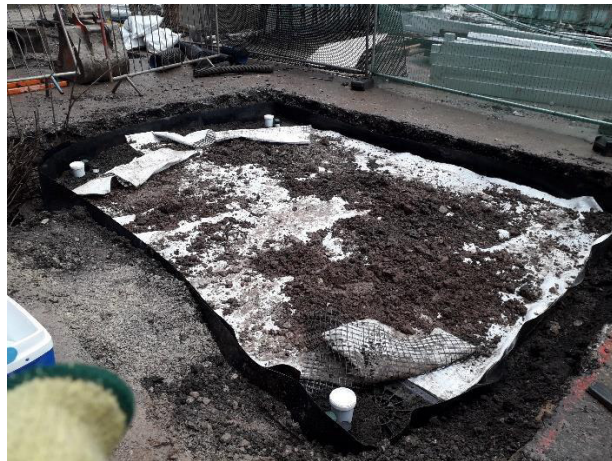
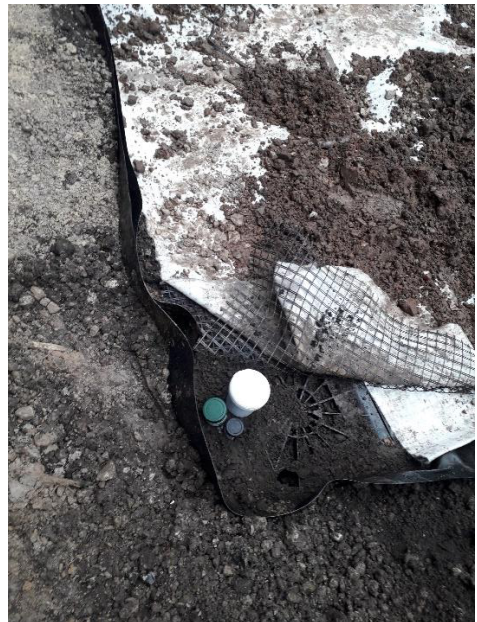
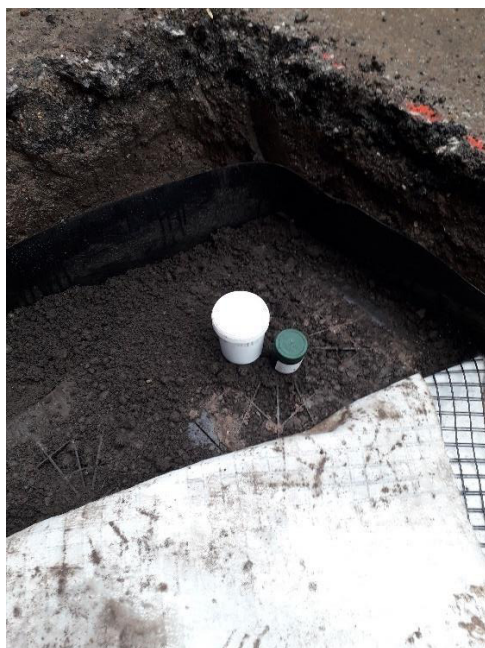
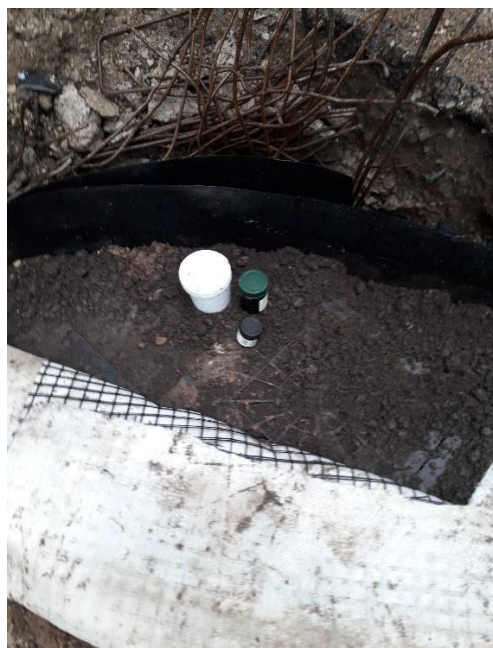
| Photo of location TS01 – TS03 | | Excavation Location – TS01 | | |

Three samples (TS01-TS03) were obtained for testing on the 13<sup>th</sup> October 2020 from one of the tree pits where soils had already been deposited. Curtins drawing ref. 065782-CUR-00-XX-DR-GE-00002-V02 and Curtins photo enclosed shows the locations from which the samples were obtained. Samples were tested for the greenfield/manufactured environmental chemistry analysis suite recommended in Curtins Remediation Strategy (Table 5.2). Envirolab testing results (ref. 20-08744 enclosed) were compared against 'Residential without Home grown Produce' Generic Assessment Criteria for 2.5% SOM. No exceedances were recorded however asbestos was identified in one location, sample ref. TS1 ES1 at 0.05m bgl, identified as Chrysotile board. Quantification was undertaken and identified a percentage of 0.01% of asbestos in soil mass tested.

| Initial topsoil sampling TS01, TS02 and TS03 from a tree pit between Building 4 and Area 3a. | | | | |

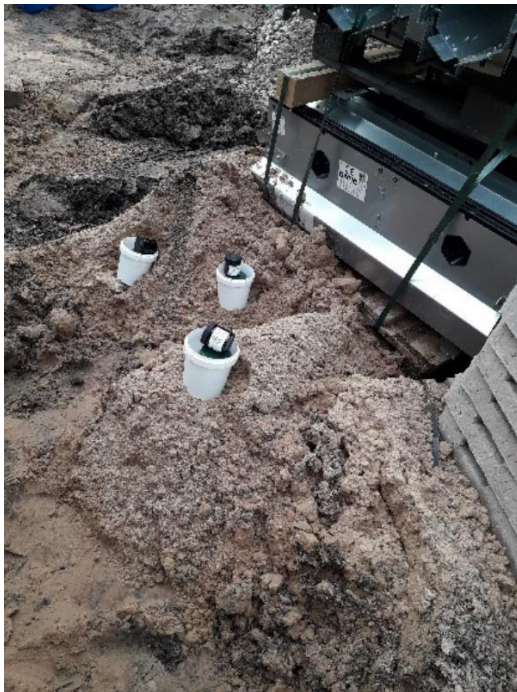
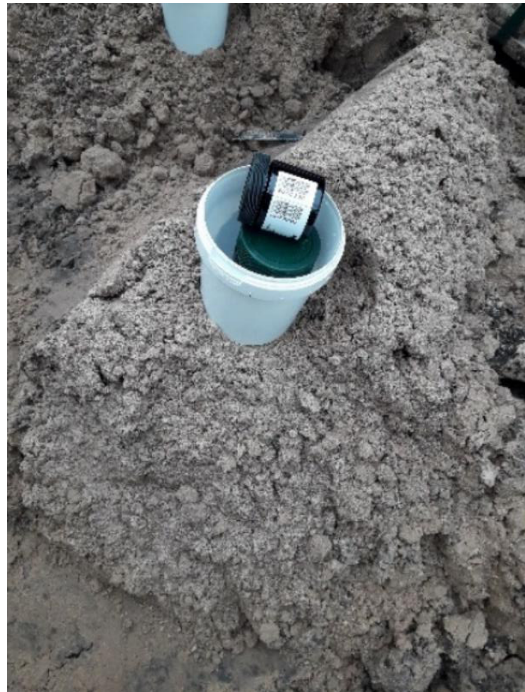
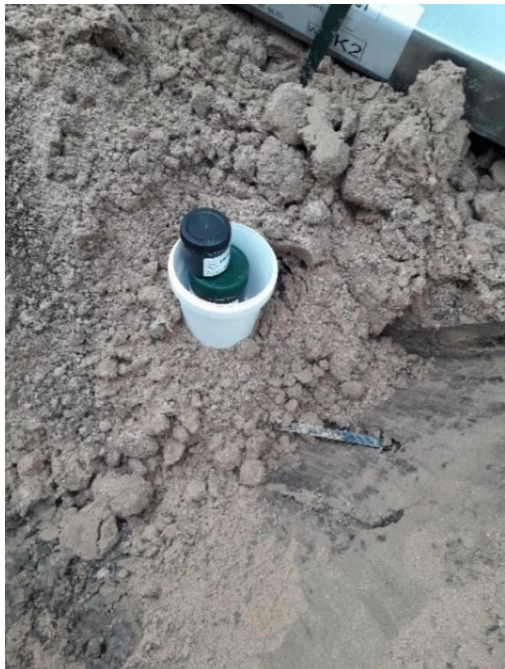
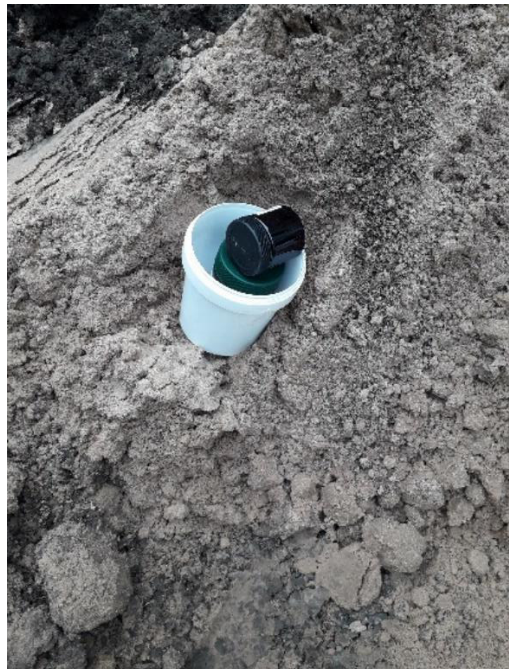
| Photo of location SS01 – SS03 | | Excavation Location – SS01 | | |

Three samples were subsequently obtained for testing from a stockpile of the imported subsoil stored on the adjacent Circle Square Plot 12 site on 28<sup>th</sup> October 2020. Curtins drawing ref. 065782-CUR-00-XX-DR-GE-00002-V01 and Curtins photographic record enclosed shows the locations from which the samples were obtained. Samples were tested for the greenfield/manufactured environmental chemistry analysis suite recommended in Curtins Remediation Strategy (Table 5.2). Envirolab testing results (enclosed report ref. 20/09272/1 for samples SS1-SS3) were again compared against 'Residential without Home grown Produce' Generic Assessment Criteria for 1% SOM. No exceedances were recorded and therefore the subsoil may be considered 'clean' and 'suitable for use'.

| Subsoil sampling SS01, SS02 and SS03 from stockpile located onsite within Building area 12. | | | | |

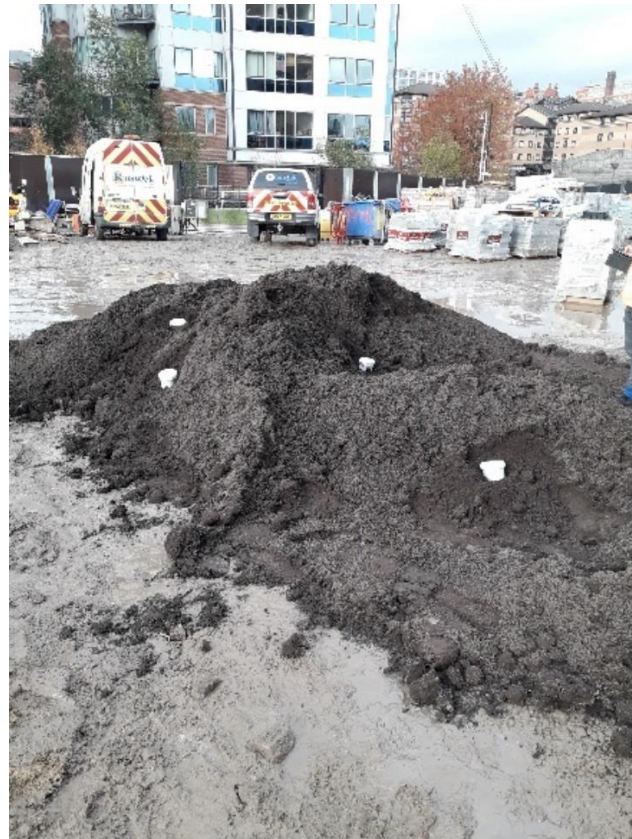
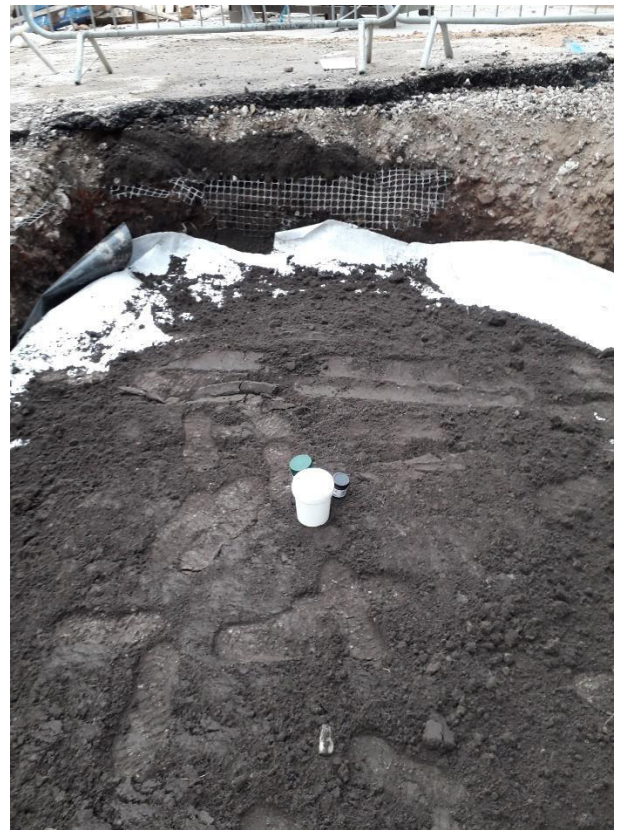
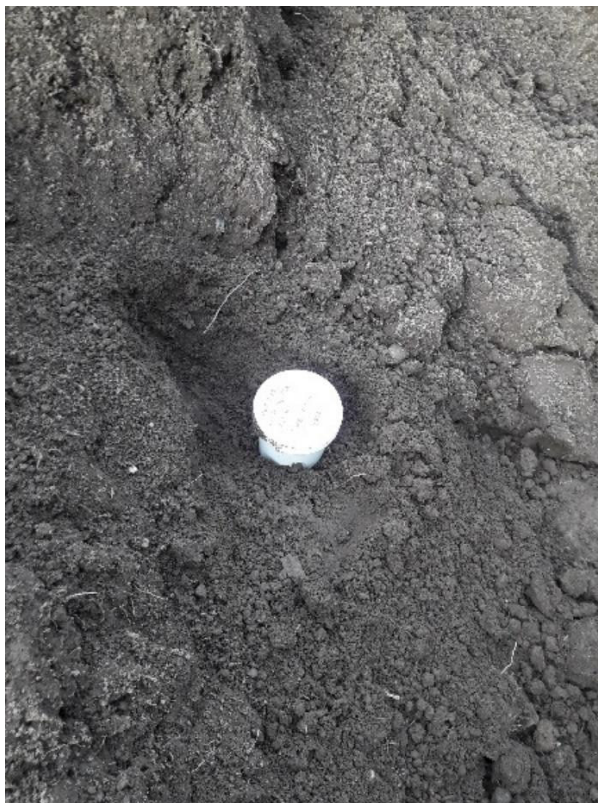
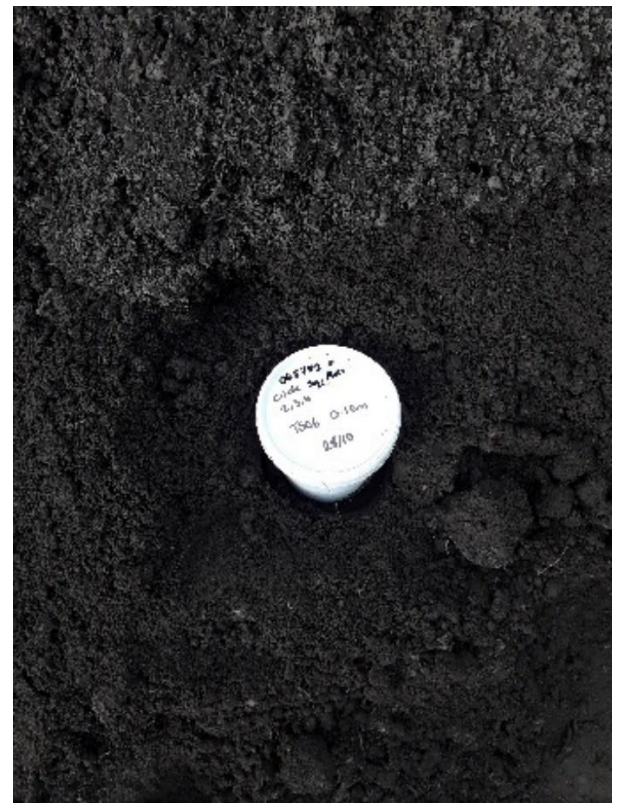
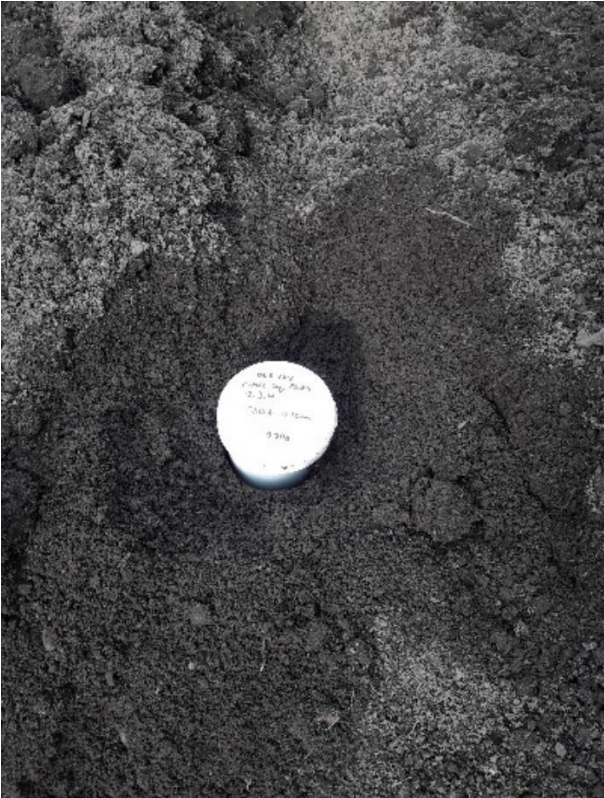
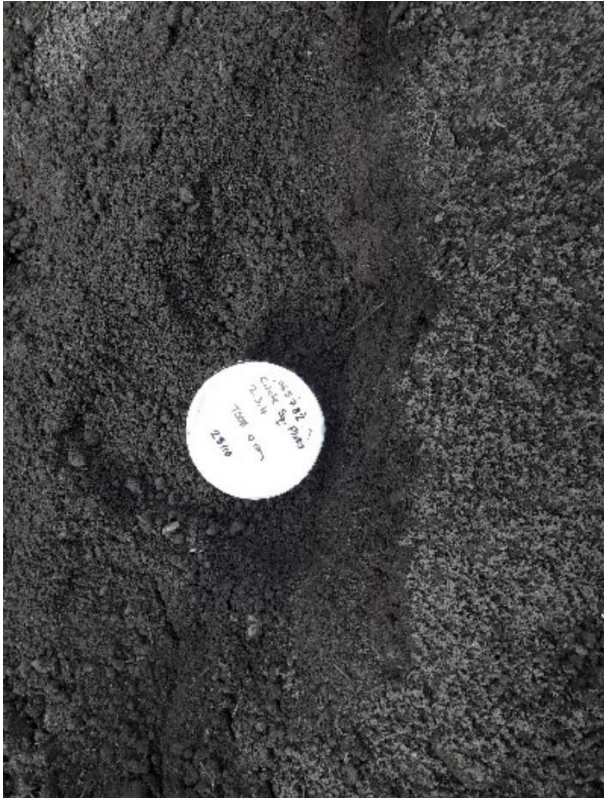
**Photo of location TS05 – TS08**

Further testing was recommended across the site to understand if this is an isolated occurrence. An additional five samples were obtained 28<sup>th</sup> October 2020 for testing (enclosed report ref. 20/09272/1) from the locations shown in Curtins drawing ref. 065782-CUR-00-XX-DR-GE-00002-V01. Sample ref. TS04 was taken from another tree pit and tested for the same greenfield/manufactured environmental testing suite. Samples ref. TS05-TS08 were taken from a stockpile of the soils stored on the adjacent Circle Square Plot 12 site and were screened for asbestos only. No exceedances of 'Residential without Home grown Produce' Generic Assessment Criteria were identified in TS04 and no asbestos was identified in any sample.

| Sample Location – TS07 | Sample Location – TS08 |
|---|---|
| <p><b>Additional topsoil sampling TS04, TS05, TS06, TS07 and TS08. TS04 obtained from tree pit on site and TS05-TS08 from stockpile on Plot 12.</b></p> | |

Given asbestos chrysotile board has been encountered in only one location it appears to be an isolated occurrence. Furthermore, it was encountered within a tree pit referenced 'D6-Tree Pit in Hard' by landscape architects Planit I.E Limited. Planit I.E Drawing ref. CS-PLA-ZZ-XX-DR-L-1402 S3 C02

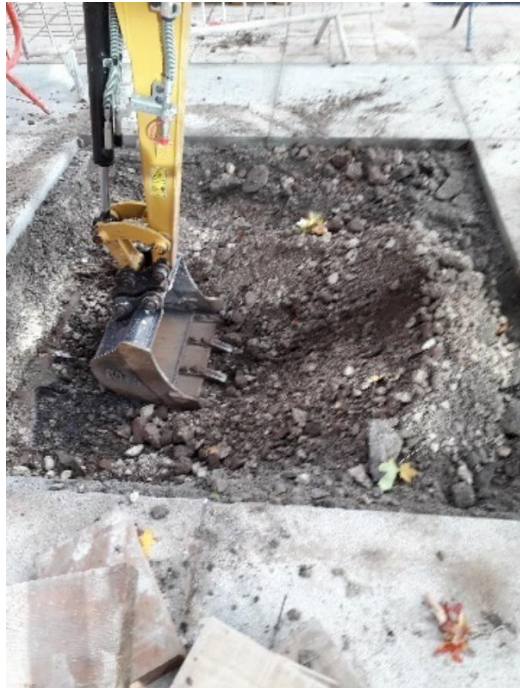
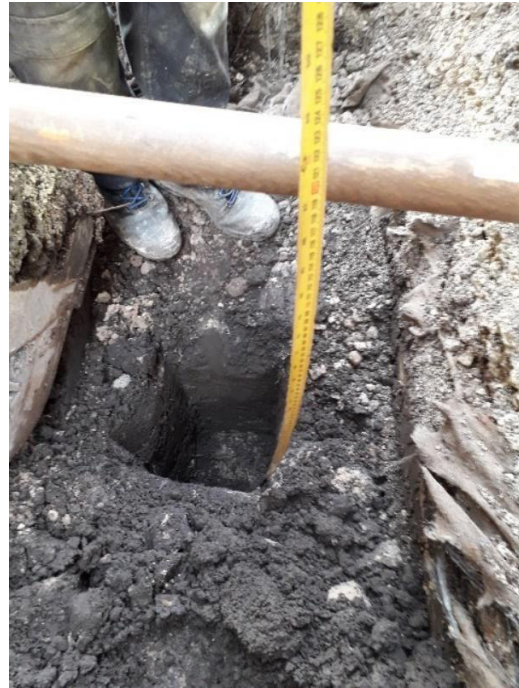
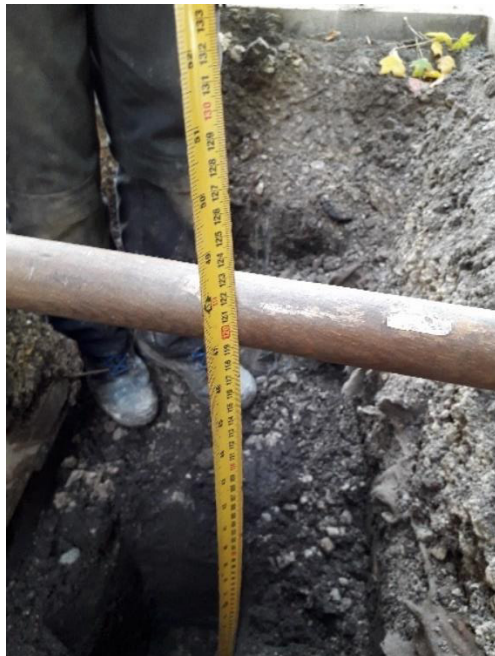
| Excavation of tree pit location HD201, located between Building 2 and Building 4 area, recording a reduced level dig depth of 1200mm for construction of clean capping with tree pit. | | | | |

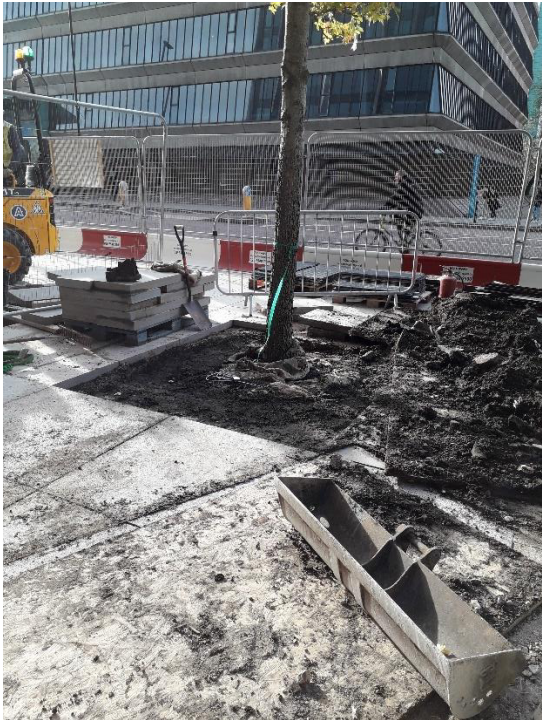
| <i>Photo of location of Tree next to HD201</i> | <i>Description</i> |

| <i>Photo of location of Tree next to HD201</i> | <i>Description</i> |
|---|---|
| | <p>Tree completed on arrival. Located next to HD201.</p> |

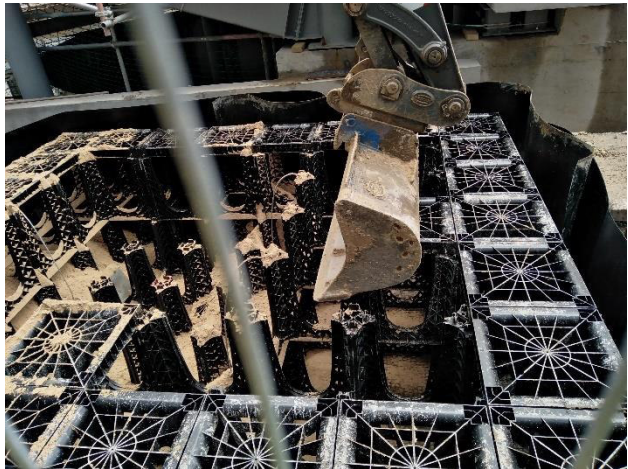
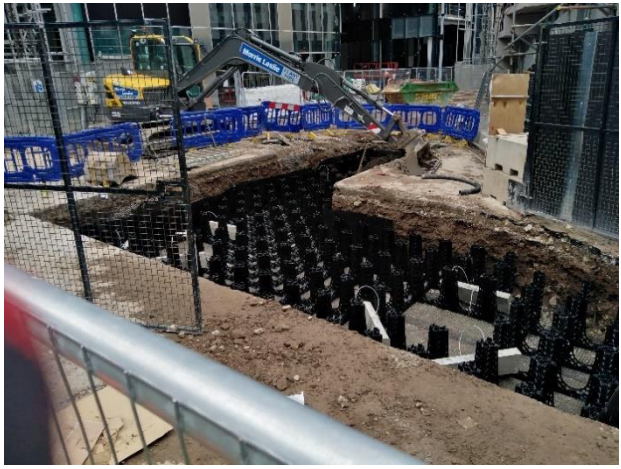
| <i>Photo of location of Tree next to HD201</i> | <i>Description</i> |
|---|---|
| <i>Photo of location near TS04</i> | <i>Photo of location near TS04</i> |

| <i>Photo of location of Tree next to HD201</i> | <i>Description</i> |
|---|---|
| <p>Photos of tree pit installation above received from Sisk located within the public open space between Building 2 and Building 7/8 near TS04.</p> | |

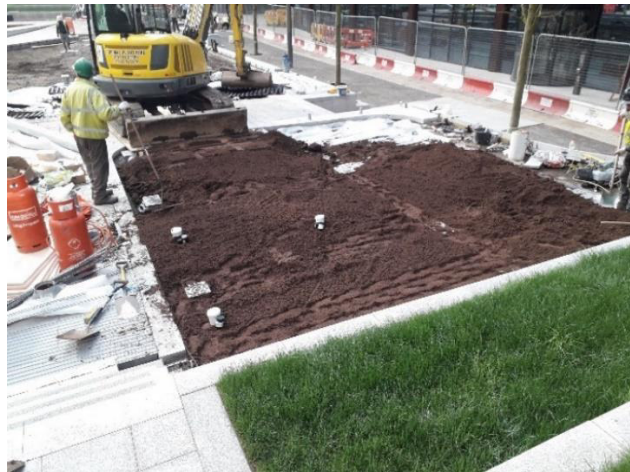
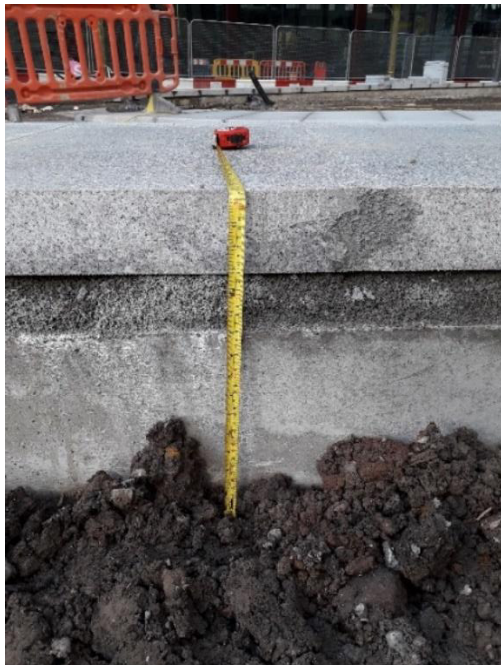
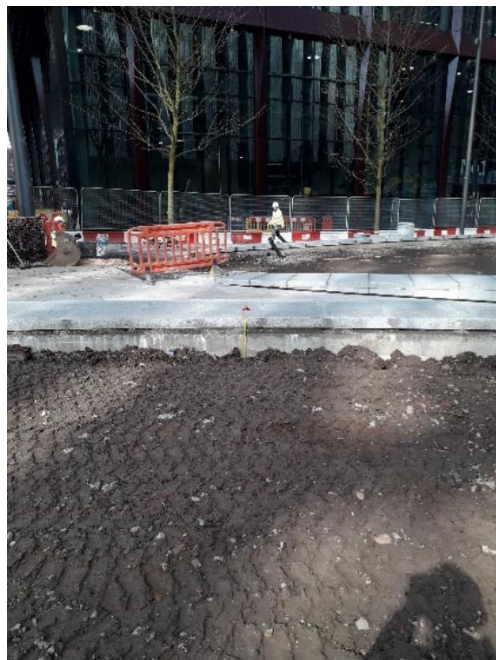
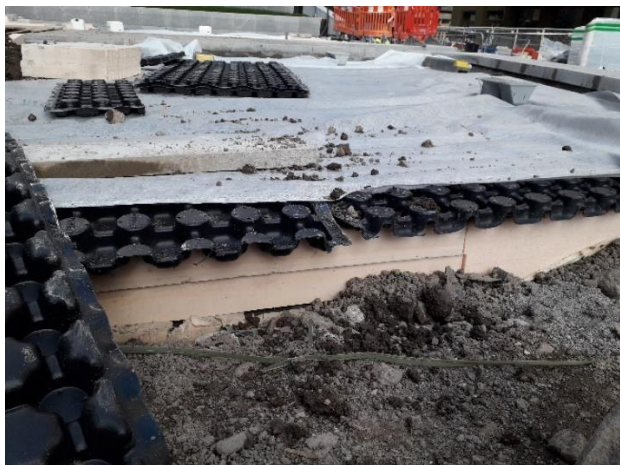
Curtins visited site in March 2021 to collect samples of the topsoil to be deposited in the central lawn and terrace areas. The topsoil in the central lawn area had not been deposited at this time but from the reduced level dig it was evident that 450mm clean soil would not be included as specified, with thicknesses of around 330-420mm anticipated. At the base of the reduced level dig was either; plastic crating and insulation in areas above the basement areas, or in areas outside of the basements a grey clayey gravel was observed with gravel including concrete and brick. This material was an imported 6F5 material but no source testing results were available.

Thicknesses of 380-450mm of dark brown topsoil were observed overlying >100mm grey clayey gravel. Although some deviation from the agreed Remediation Strategy has been observed, as the grey clayey gravel at the base of the 6F5 has also been proven to be clean and suitable for use, this acts as a subsoil material and a sufficient capping thickness is therefore achieved.

| <p>Topsoil samples taken representative of new source (Astley), TS09, TS10 and TS11. Central lawn reduced level dig depth was inspected which allowed for an anticipated thickness of topsoil overlying was between 330mm to 420mm.</p> <p>Photo showing the membrane and plastic crates over the basement in terrace areas and part of lawn which would break any S-P-R linkage to end users and maintenance workers.</p> | | | | |

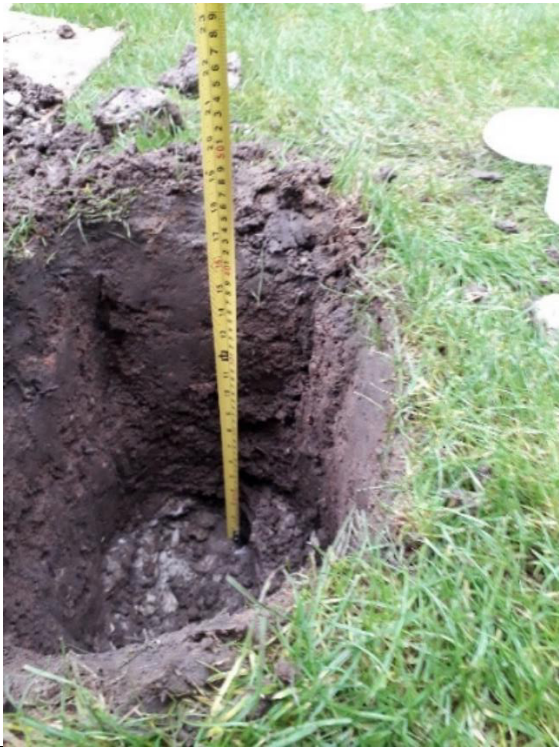
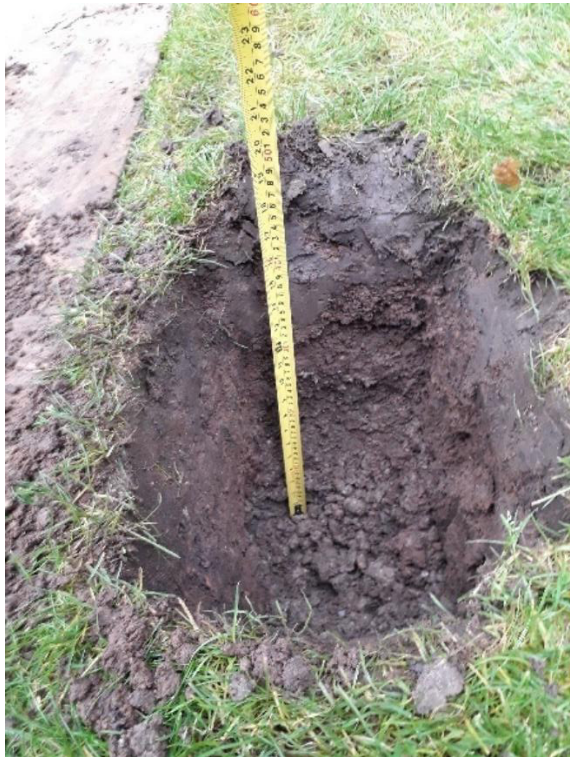
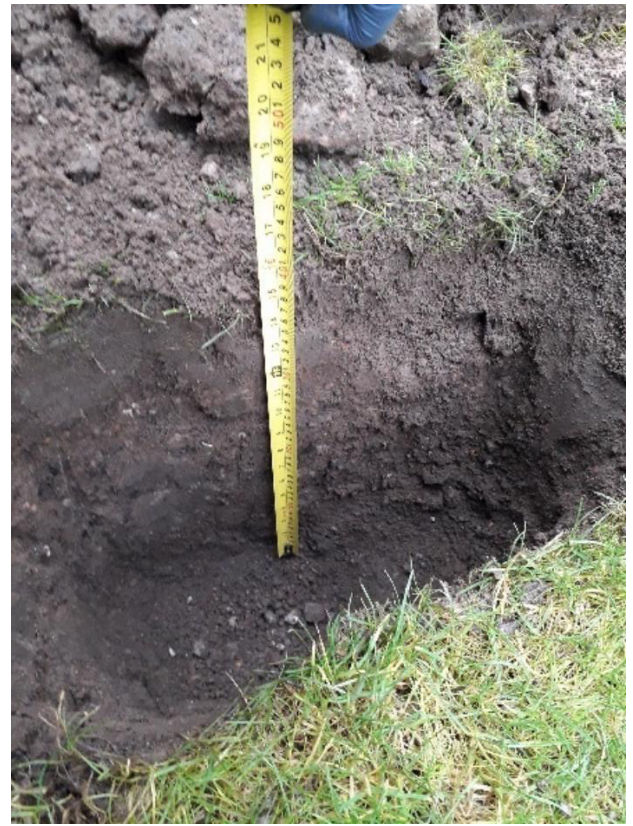
| <b>Photo of location HD301</b> | | <b>Excavation Location – HD301</b> | | |

Six samples (HD301-HD306) were tested for the brownfield/unknown environmental chemistry analysis suite recommended in Curtins Remediation Strategy (Table 5.2). Curtins drawing ref. 065782-CUR-00-XX-DR-GE-00002-V02 and Curtins Photographic record enclosed shows the locations from which the samples were obtained. Envirolab's testing results (ref. 21-13656 enclosed) were compared against 'Residential without Home grown Produce' Generic Assessment Criteria for 2.5% SOM. No exceedances were recorded and therefore this source is considered suitable for use.

| 6F5 in HD306 | Description |
|---|---|
| | <p>Hand excavated pits within central lawn area/area 3a and 3b. Soft landscaping recorded clean capping depths of between 380mm to 450mm. 6F5 was recorded underneath the topsoil. A sample of this strata was taken to confirm if clean due to the slight shortfall in capping thickness.</p> |

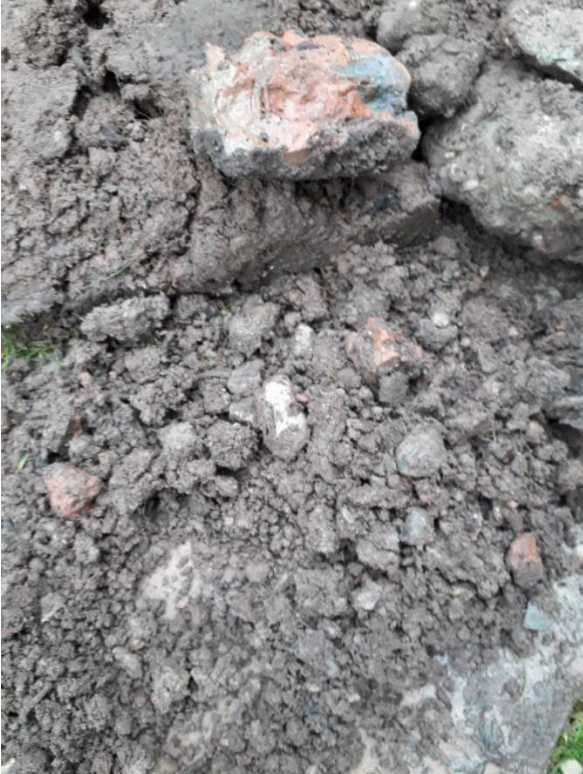
- In the central lawn area only 380-450mm topsoil was identified overlying a >100mm grey clayey gravel (imported 6F5 material). Although some deviation from the agreed Remediation Strategy has been observed, as the grey clayey gravel at the base of the 6F5 has also been proven to be clean and suitable, this acts as a subsoil material and a sufficient capping thickness is therefore achieved.
