## Museum of Science & Industry Fire Door Survey Report Station Building

## **Fire Doors Report**

Museum of Science and Industry Manchester

Station Building

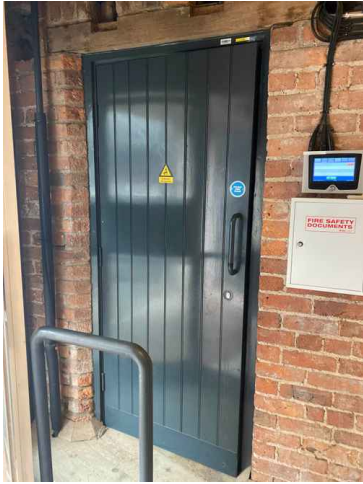
Door details  
1 of 2

| <b>Are the seals free from damage?:</b> | No |

| <b>Are the hinges free of metal fragment and oil leakage, which shows signs of wear?:</b> | No |

| <b>Action required - Seals:</b> | Arrange for replacement intumescent seals/smoke seals FD60 20mm |
| <b>Action required - Ironmongery:</b> | Arrange for hinge repairs or replacement due to wear & tear, Install minimum of 3 hinges with all the screws fitted. Use ironmongery stamped with CE stamp or BSEN 1935 grade 13 (or equivalent) |
| <b>Recommended actions:</b> | Doorset can be upgraded to a notional standard Service Pack B - Single doorset |

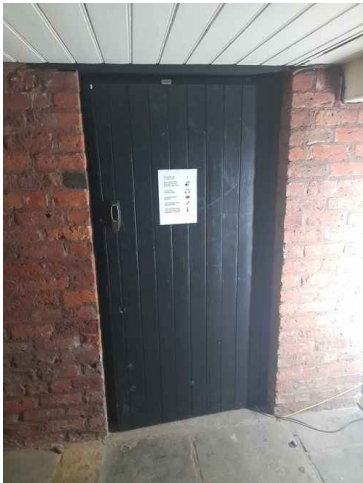
Door details  
1 of 2

| <b>Is the door leaf free from damage affecting its fire integrity?:</b> | No |

| <b>Action required - Door Leaf:</b> | Arrange for replacement compliant full door set |

| Action required - Ironmongery: | Install minimum of 3 hinges with all the screws fitted. Use ironmongery stamped with CE stamp or BSEN 1935 grade 13 (or equivalent), Replace lock/latch with a CE certified tested set |
| Action required - Door Closers: | Replace with a CE marked certified closer - Single Door |
| Recommended actions: | Doorset is not compliant and cannot be repaired or upgraded to meet a satisfactory standard - Replacement Required Single Doorset |

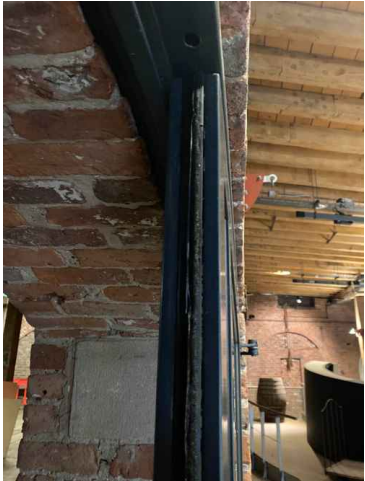
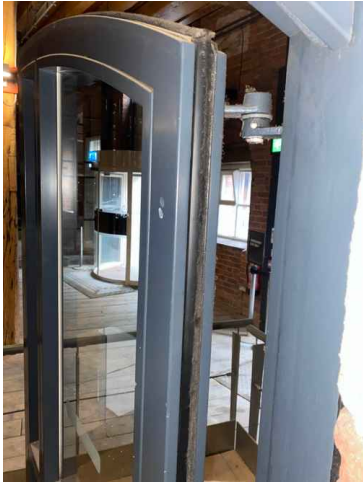
| <b>Are the seals free from damage?:</b> | No |

| <b>Action required - Seals:</b> | Arrange for replacement intumescent seals/smoke seals FD60 20mm |

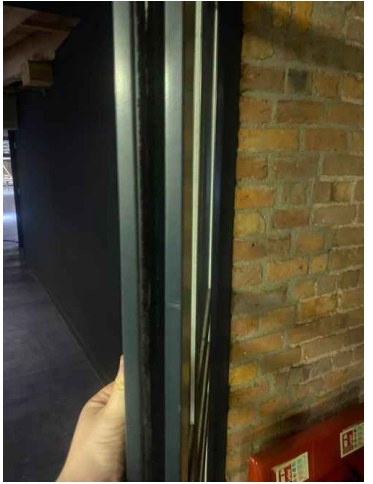
Seals  
1 of 1

| <b>Are the seals free from damage?:</b> | No |

| <b>Action required - Seals:</b> | Arrange for replacement intumescent seals/smoke seals FD60 20mm |

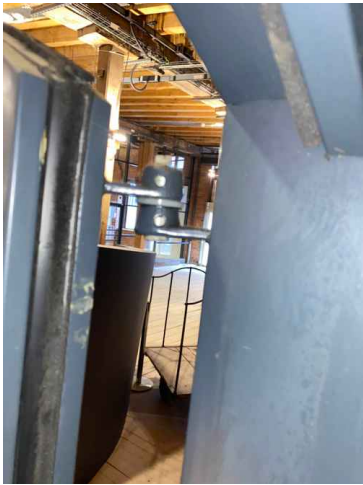
Seals  
1 of 1

| <b>Are the seals free from damage?:</b> | No |

| <b>Action required - Seals:</b> | Arrange for replacement intumescent seals/smoke seals FD60 20mm |

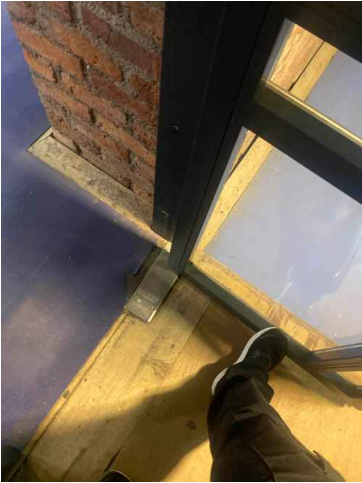
Seals  
1 of 1

| <b>Are the seals free from damage?:</b> | Yes |

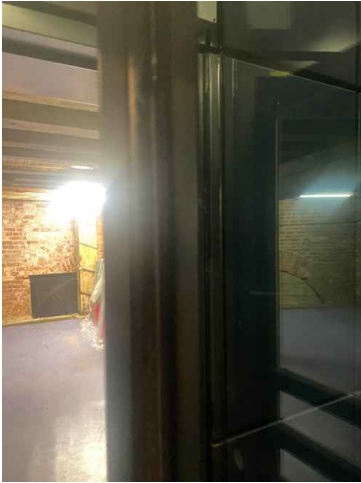
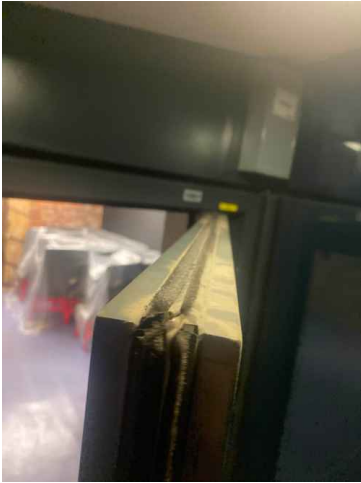
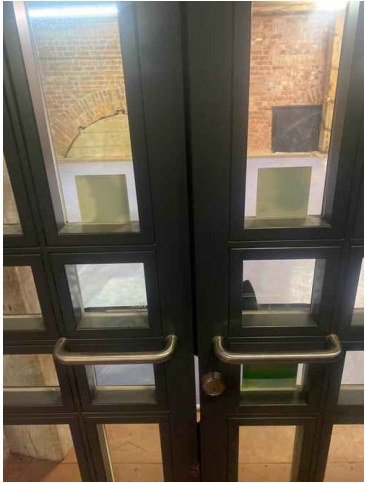
Seals  
1 of 3

| <b>Are the seals free from damage?:</b> | Yes |

| <b>Action required - Seals:</b> | Arrange for replacement intumescent seals/smoke seals FD60 20mm |

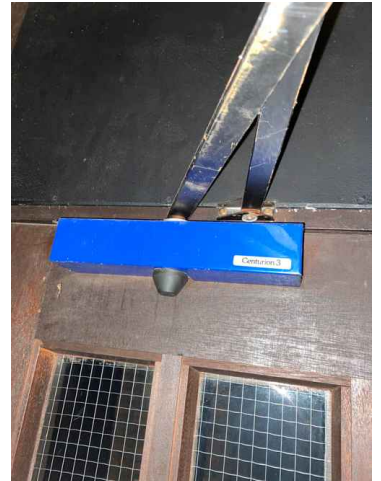
Door closers  
1 of 1

| Is the closer free from damage and not leaking?: | Yes |

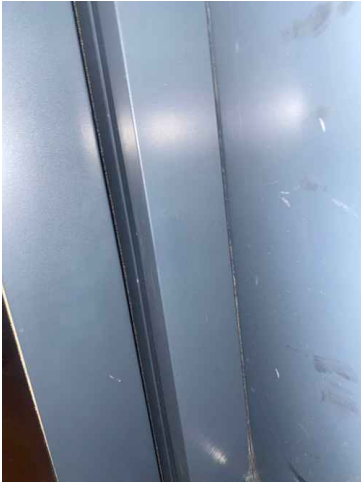
Door frame  
1 of 1

| <b>Is the door frame free from damage affecting its fire integrity?:</b> | Yes |
| <b>Action required - Door Frame:</b> | Risk of damage to decorative finishes (frames / architrave's) prevented inspection from being performed - Intrusive inspection required |

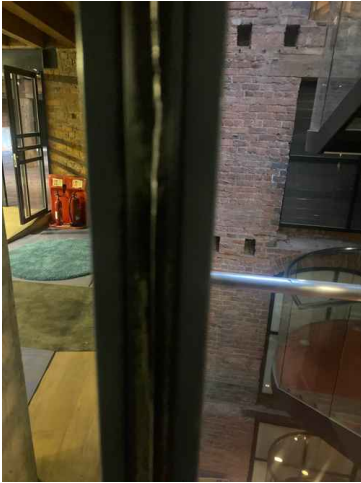
Seals  
1 of 1

| <b>Are the seals free from damage?:</b> | Yes |

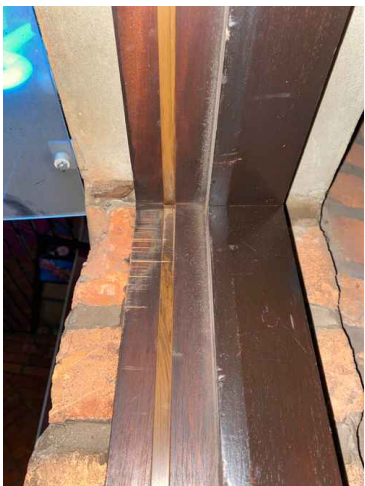
Seals  
1 of 1

| <b>Are the seals free from damage?:</b> | Yes |

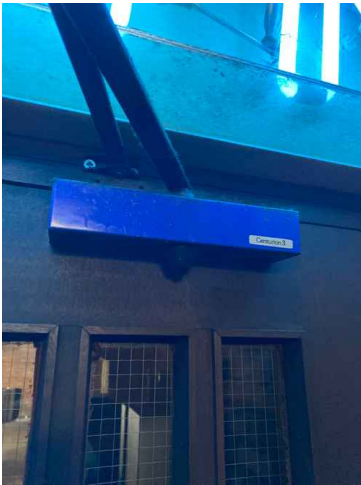
Door closers  
1 of 1

| Is the closer free from damage and not leaking?: | Yes |

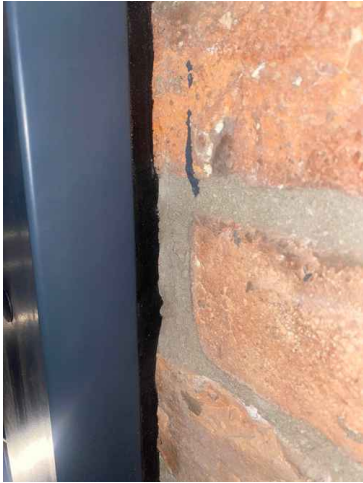
Door frame  
1 of 1

| Door details | |
|---|---|
| Action required - Door Frame: | Risk of damage to decorative finishes (frames / architrave's) prevented inspection from being performed - Intrusive inspection required |

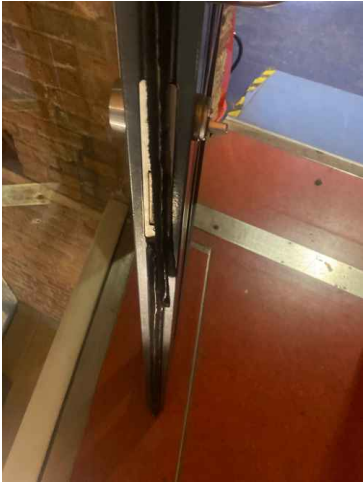
Seals  
1 of 1

| Door details | |
|---|---|
| Are the seals free from damage?: | No |

| Door details | |
|---|---|
| Action required - Seals: | Arrange for replacement intumescent seals/smoke seals FD60 20mm |

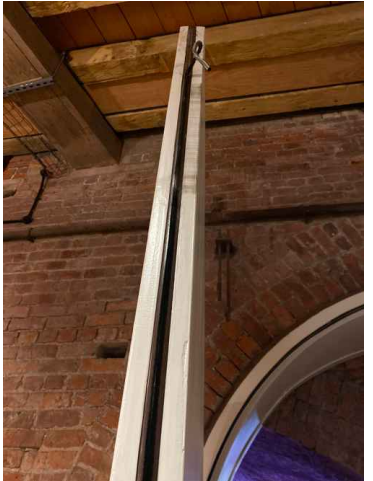
Seals  
1 of 1

| <b>Are the seals free from damage?:</b> | No |

| <b>Action required - Seals:</b> | Arrange for replacement intumescent seals/smoke seals FD60 20mm |

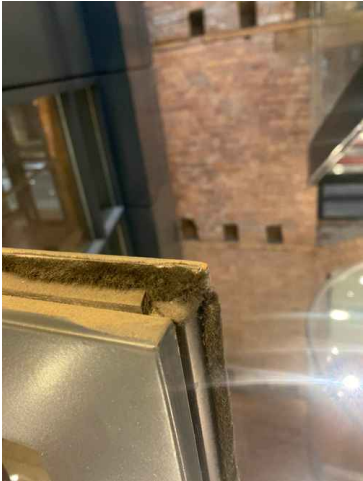
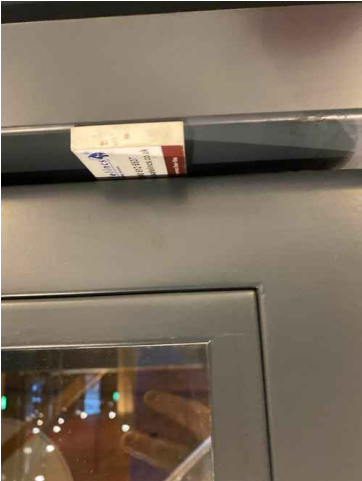
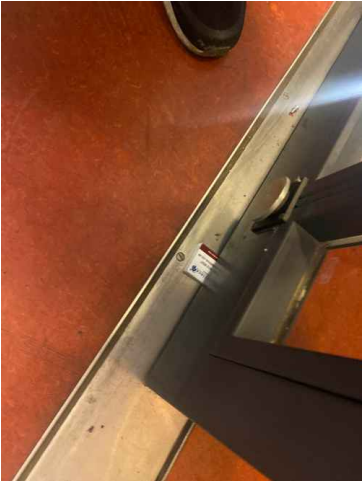
Door leaf  
1 of 3

| <b>Is the door leaf free from damage affecting its fire integrity?:</b> | Yes |

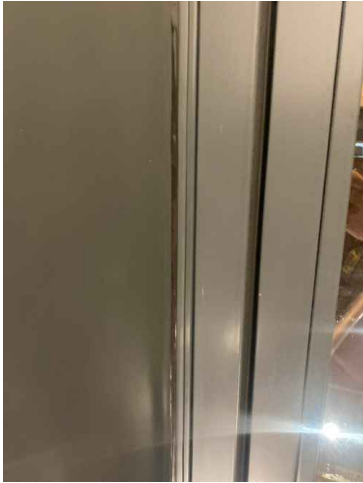
Door frame  
1 of 1

| <b>Is the door frame free from damage affecting its fire integrity?:</b> | Yes |
| <b>Action required - Door Frame:</b> | Risk of damage to decorative finishes (frames / architrave's) prevented inspection from being performed - Intrusive inspection required |

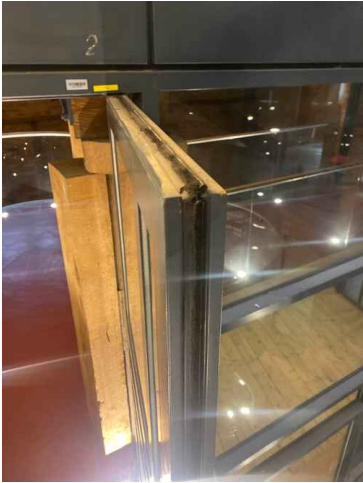
Seals  
1 of 1

| <b>Are the seals free from damage?:</b> | Yes |

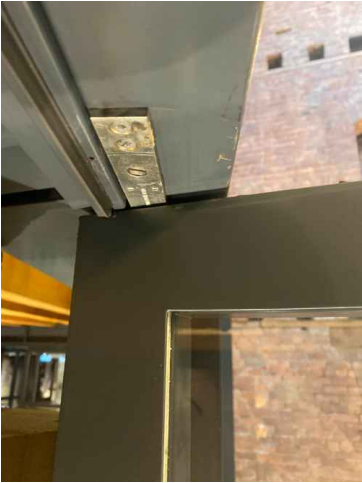
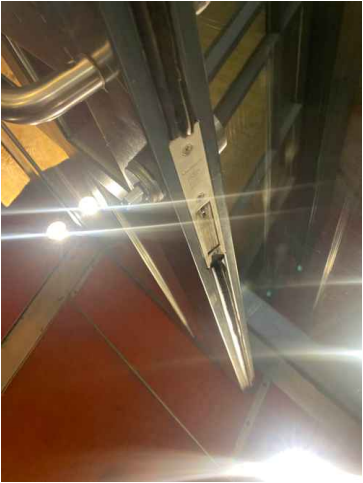
Ironmongery  
1 of 2

| Are the hinges free of metal fragment and oil leakage, which shows signs of wear?: | Yes |
| Is all ironmongery free from damage and correctly operating?: | Yes |

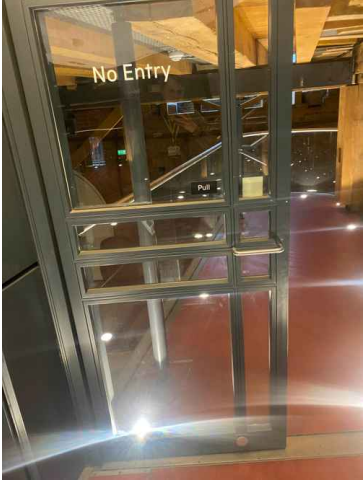
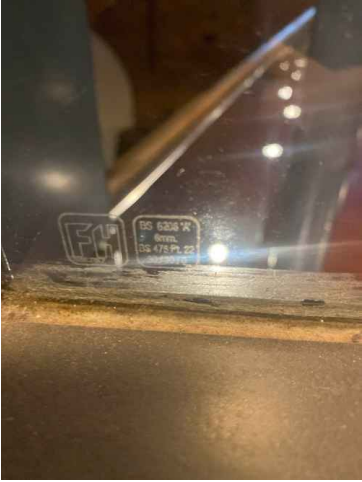
Glazing and Glass  
1 of 2

| Are the glazing beads correctly attached to the frame from both sides and free from damage?: | Yes |
| Is the glass free from damage and cracking?: | Yes |

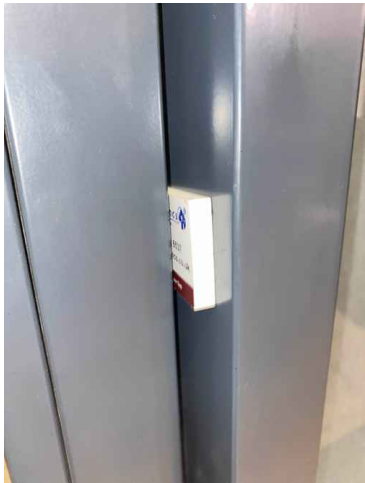
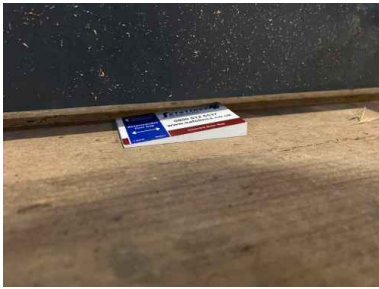
Door leaf  
1 of 2

| <b>Is the door leaf free from damage affecting its fire integrity?:</b> | Yes |

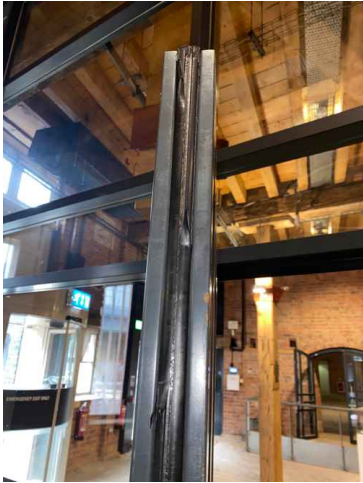
Seals  
1 of 1

| <b>Are the seals free from damage?:</b> | No |

| <b>Action required - Seals:</b> | Arrange for replacement intumescent seals/smoke seals FD30 10mm |

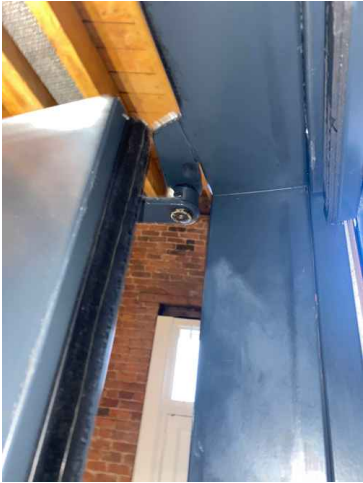
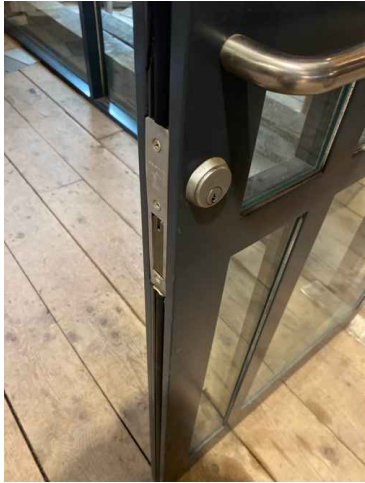
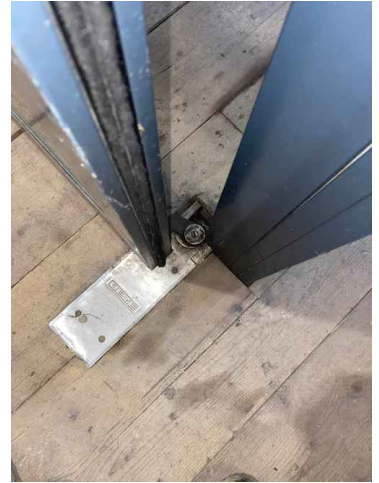
Ironmongery  
1 of 3

| <b>Is all ironmongery free from damage and correctly operating?:</b> | Yes |

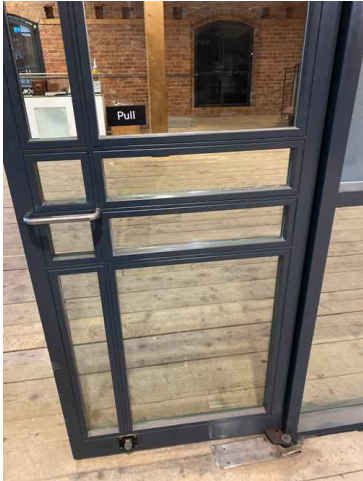
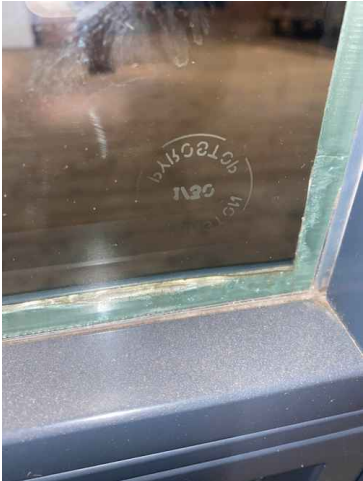
Glazing and Glass  
1 of 2

| <b>Are the glazing beads correctly attached to the frame from both sides and free from damage?:</b> | Yes |
| <b>Is the glass free from damage and cracking?:</b> | Yes |

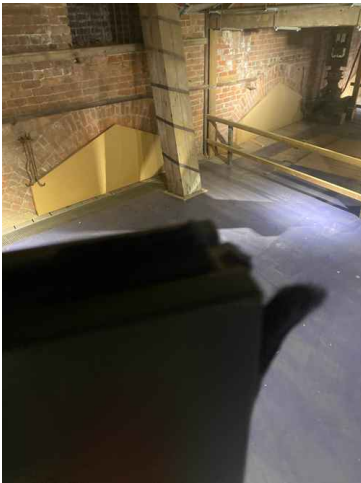
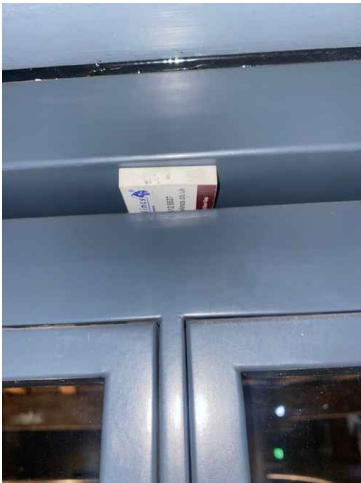
Door leaf  
1 of 3

| <b>Is the door leaf free from damage affecting its fire integrity?:</b> | Yes |

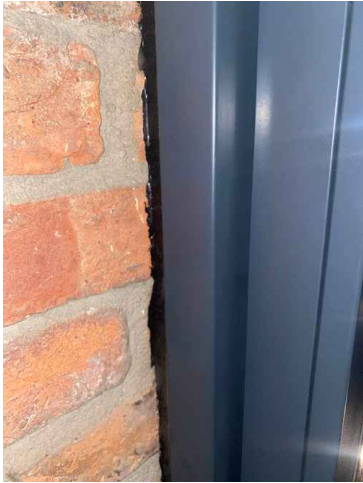
Door frame  
1 of 1

| <b>Is the door frame free from damage affecting its fire integrity?:</b> | Yes |
| <b>Action required - Door Frame:</b> | Risk of damage to decorative finishes (frames / architrave's) prevented inspection from being performed - Intrusive inspection required |

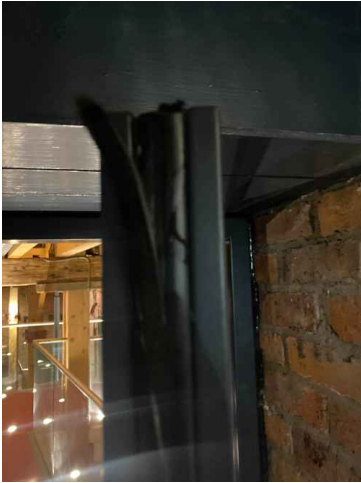
Seals  
1 of 1

| <b>Are the seals free from damage?:</b> | No |

| <b>Action required - Seals:</b> | Arrange for replacement intumescent seals/smoke seals FD60 20mm |

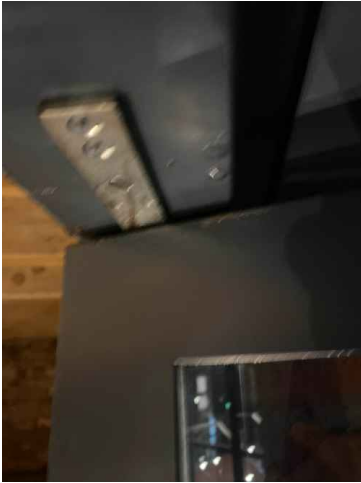
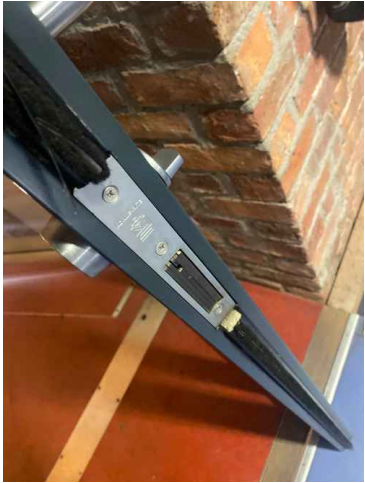
Ironmongery  
1 of 2

| <b>Is all ironmongery free from damage and correctly operating?:</b> | Yes |

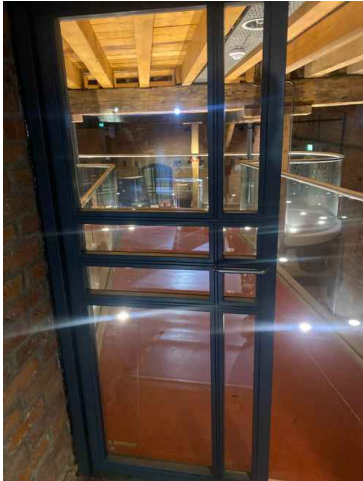
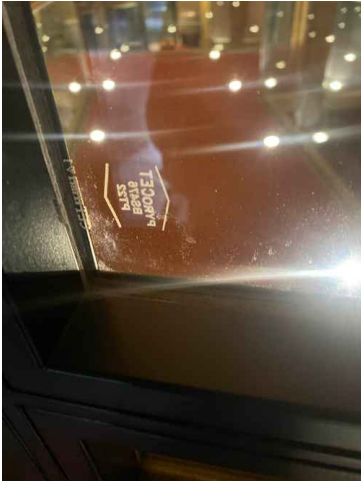
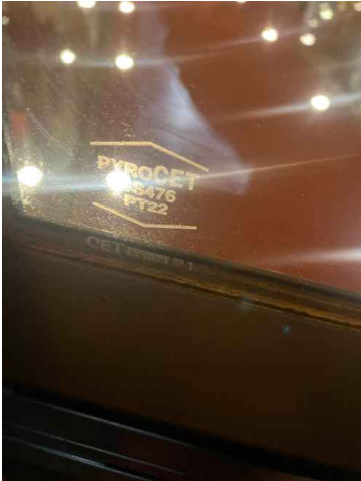
Glazing and Glass  
1 of 3

| <b>Are the glazing beads correctly attached to the frame from both sides and free from damage?:</b> | Yes |
| <b>Is the glass free from damage and cracking?:</b> | Yes |

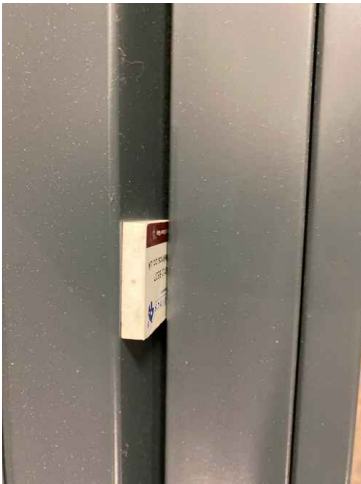
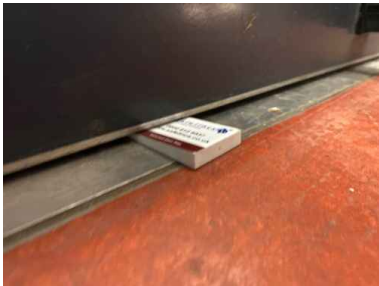
Door leaf  
1 of 2

| Door details | |
|---|---|
| Is the door leaf free from damage affecting its fire integrity?: | Yes |

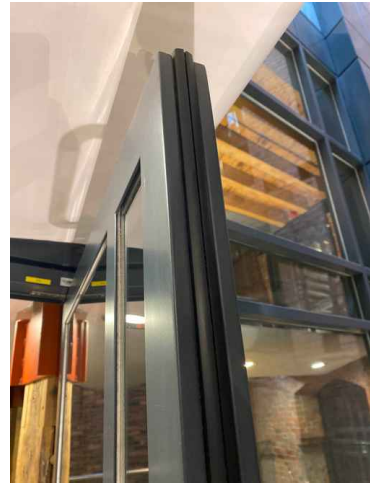
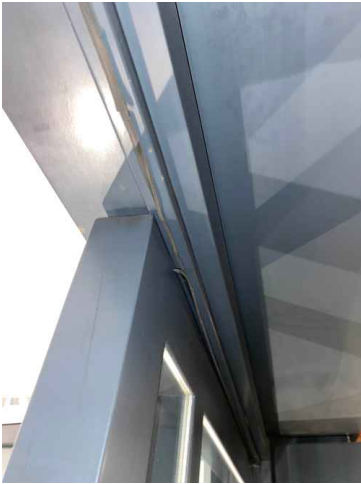
Seals  
1 of 2

| Door details | |
|---|---|
| Are the seals free from damage?: | No |

| Action required - Seals: | Arrange for replacement intumescent seals/smoke seals FD30 10mm |

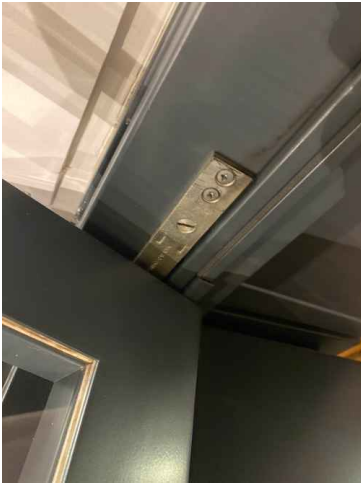
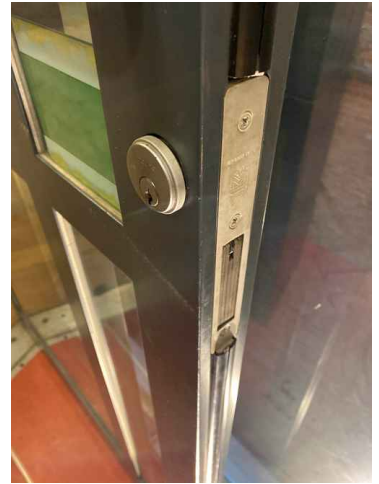
Ironmongery  
1 of 2

| Is all ironmongery free from damage and correctly operating?: | Yes |

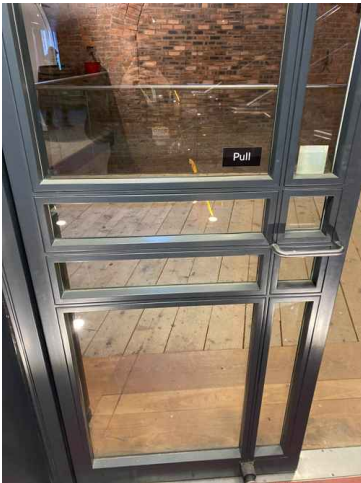
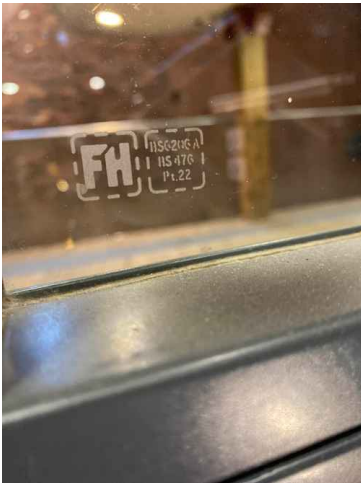
Glazing and Glass  
1 of 2

| Are the glazing beads correctly attached to the frame from both sides and free from damage?: | Yes |
| Is the glass free from damage and cracking?: | Yes |

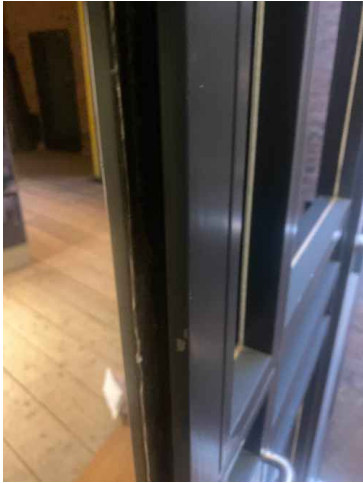
Seals  
1 of 1

| <b>Are the seals free from damage?:</b> | Yes |

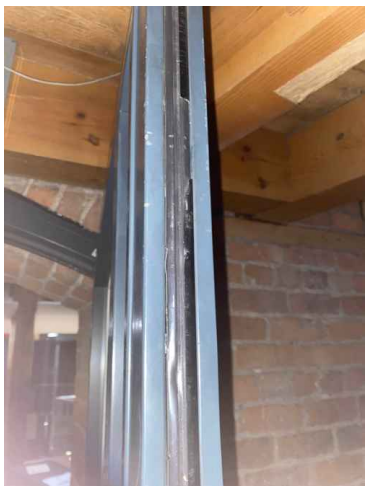
Seals  
1 of 1

| <b>Are the seals free from damage?:</b> | No |

| <b>Action required - Seals:</b> | Arrange for replacement intumescent seals/smoke seals FD30 10mm |

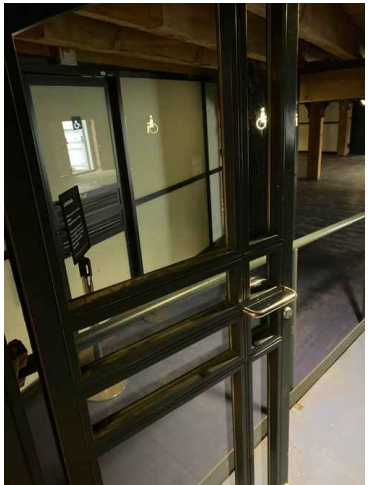
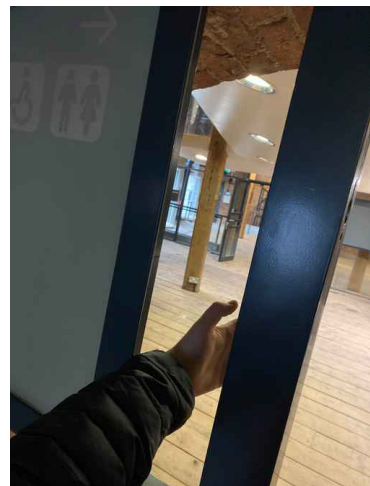
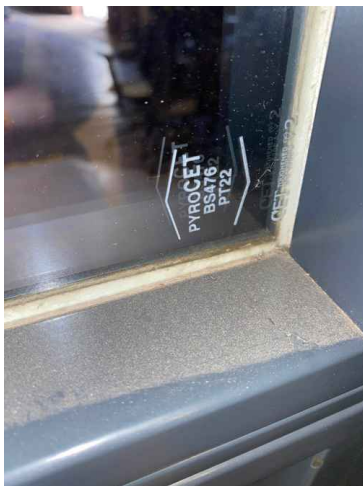
Glazing and Glass  
1 of 3

| <b>Is the glass free from damage and cracking?:</b> | No |
| One of the glass panels is missing from doorset. | |

| <b>Action required - Glazing And Glass:</b> | Install/repair correct fire rated safety glass to the door |
| This needs to be replaced. | |

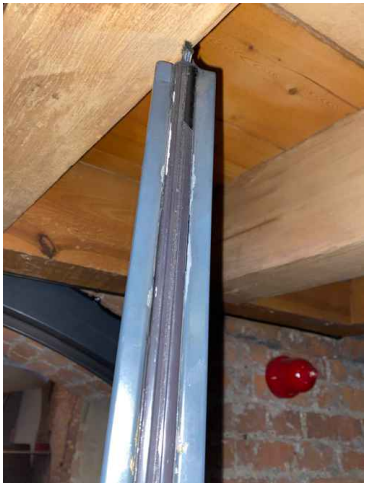
Seals  
1 of 1

| <b>Are the seals free from damage?:</b> | No |

| <b>Action required - Seals:</b> | Arrange for replacement intumescent seals/smoke seals FD30 10mm |

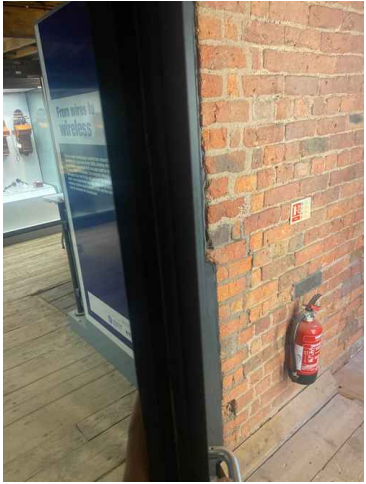
Seals  
1 of 1

| <b>Are the seals free from damage?:</b> | No |

| <b>Action required - Seals:</b> | Arrange for replacement intumescent seals/smoke seals FD60 20mm |

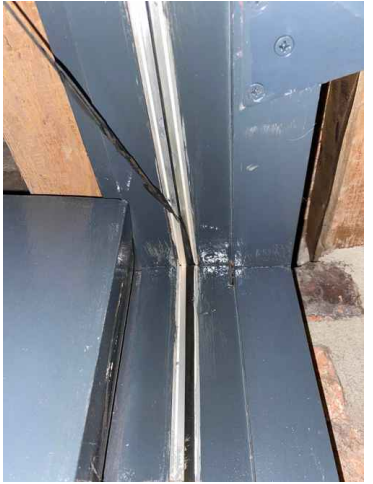
Seals  
1 of 1

| Door details | |
|---|---|
| Are the seals free from damage?: | No |

| Door details | |
|---|---|
| Action required - Seals: | Arrange for replacement intumescent seals/smoke seals FD60 20mm |

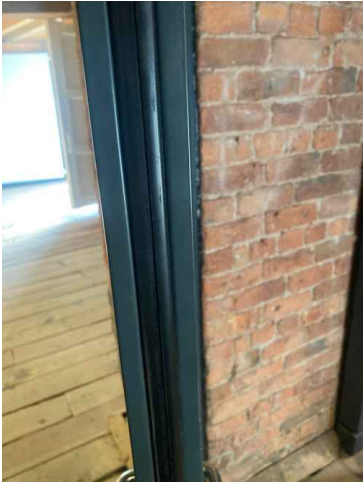
Seals  
1 of 1

| <b>Are the seals free from damage?:</b> | No |

| <b>Action required - Seals:</b> | Arrange for replacement intumescent seals/smoke seals FD30 10mm |

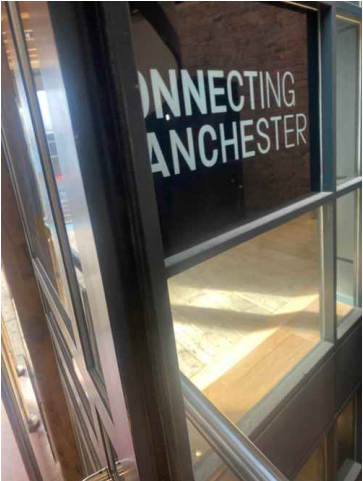
Seals  
1 of 2

| <b>Are the seals free from damage?:</b> | No |

| Action required - Seals: | Arrange for replacement intumescent seals/smoke seals FD30 10mm |

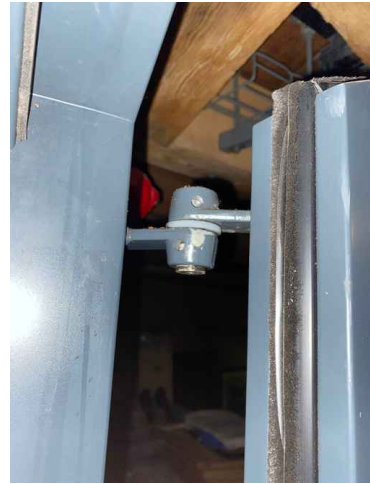
Seals  
1 of 1

| <b>Are the seals free from damage?:</b> | No |

| <b>Action required - Seals:</b> | Arrange for replacement intumescent seals/smoke seals FD60 20mm |

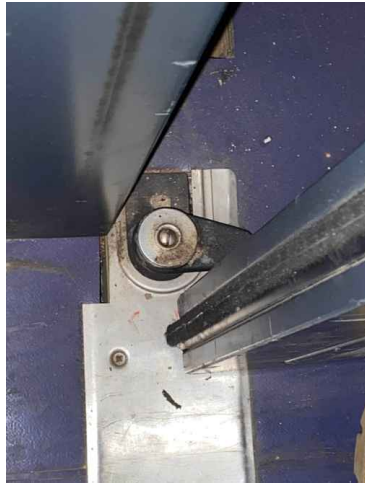
Ironmongery  
1 of 3

| <b>Is all ironmongery free from damage and correctly operating?:</b> | Yes |

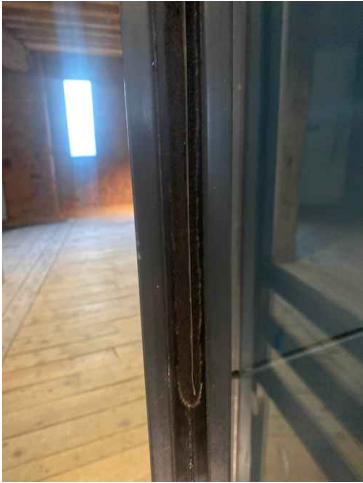
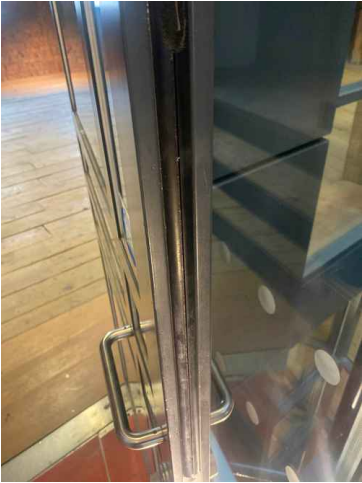
Seals  
1 of 2

| <b>Are the seals free from damage?:</b> | Yes |

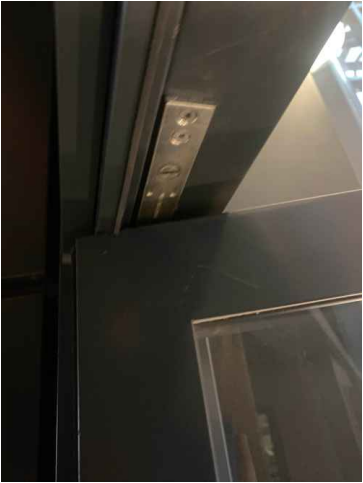
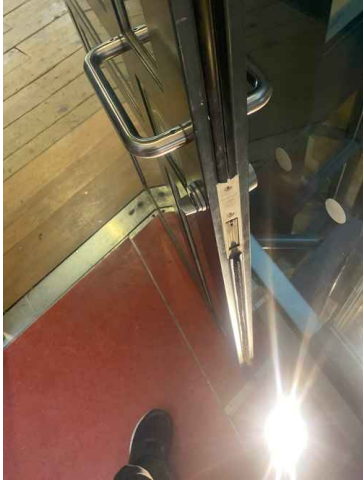
Ironmongery  
1 of 2

| Is all ironmongery free from damage and correctly operating?: | Yes |

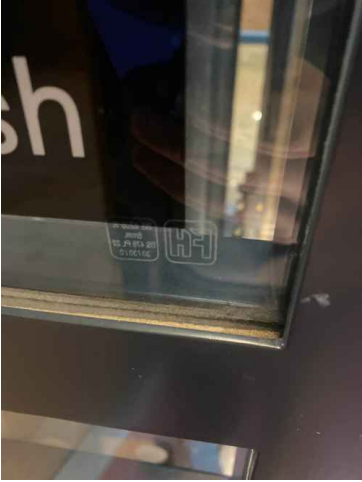
Glazing and Glass  
1 of 1

| Are the glazing beads correctly attached to the frame from both sides and free from damage?: | Yes |
| Is the glass free from damage and cracking?: | Yes |

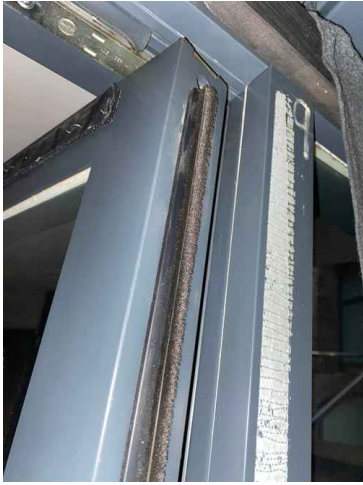
Seals  
1 of 1

| <b>Are the seals free from damage?:</b> | No |

| <b>Action required - Seals:</b> | Arrange for replacement intumescent seals/smoke seals FD60 20mm |

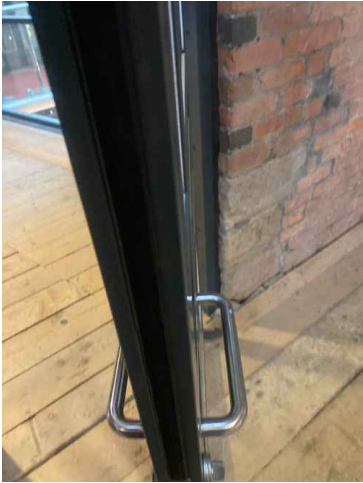
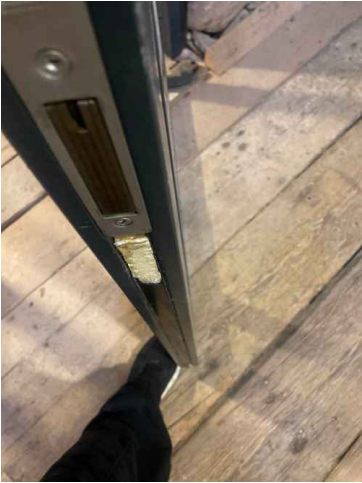
Seals  
1 of 2

| Door details | |
|---|---|
| Are the seals free from damage?: | No |

| Action required - Seals: | Arrange for replacement intumescent seals/smoke seals FD30 10mm |

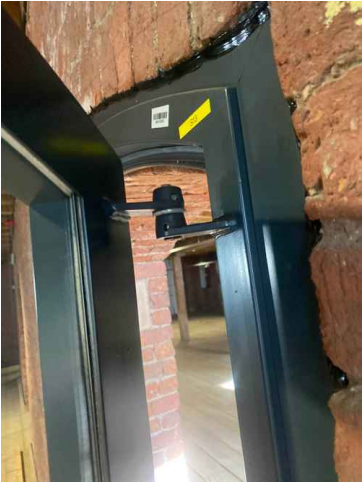
Ironmongery  
1 of 2

| Are the hinges free of metal fragment and oil leakage, which shows signs of wear?: | No |

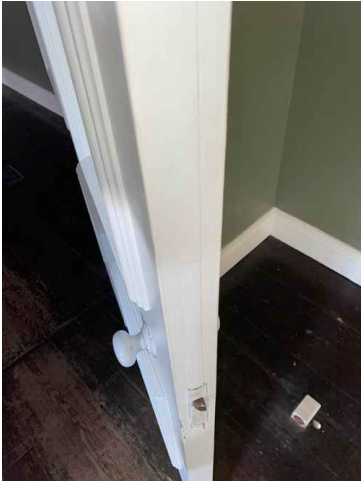
Seals  
1 of 1

| Door details | |
|---|---|
| Are the seals free from damage?: | No |

| Action required - Seals: | Arrange for replacement intumescent seals/smoke seals FD30 10mm |

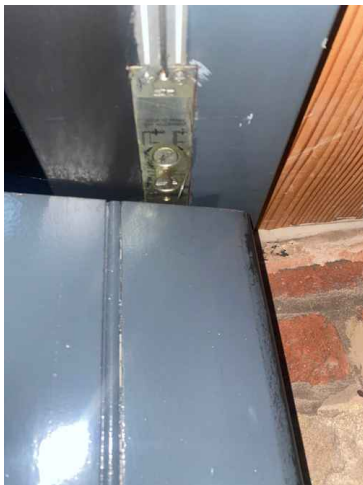
Ironmongery  
1 of 1

| Door details | |
|---|---|
| Replacement required with an FD30 compliant doorset. | |

| Door details | |
|---|---|
| Recommended actions: | Doorset is not compliant and cannot be repaired or upgraded to meet a satisfactory standard - Replacement Required Single Doorset |

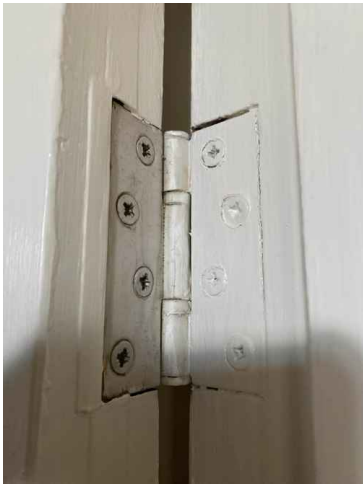
Ironmongery  
1 of 2

| <b>Are the hinges free of metal fragment and oil leakage, which shows signs of wear?:</b> | No |

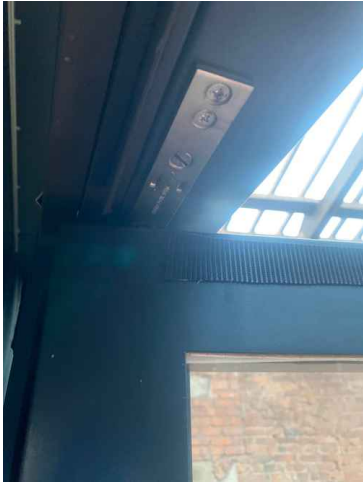
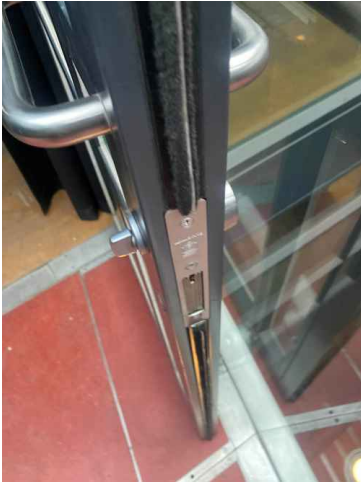
Ironmongery  
1 of 2

| Door details | |
|---|---|
| Is all ironmongery free from damage and correctly operating?: | Yes |

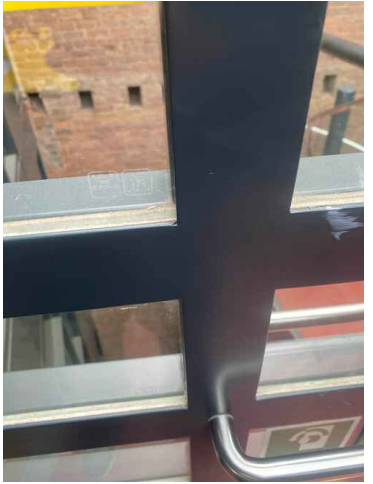
Glazing and Glass  
1 of 1

| <b>Are the glazing beads correctly attached to the frame from both sides and free from damage?:</b> | Yes |
| <b>Is the glass free from damage and cracking?:</b> | Yes |

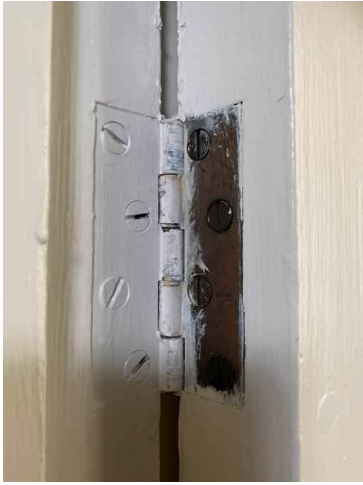
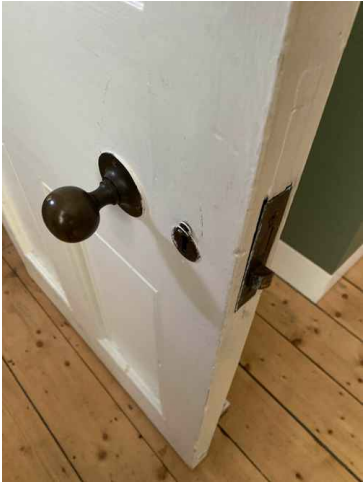
Ironmongery  
1 of 2

| <b>Are the hinges free of metal fragment and oil leakage, which shows signs of wear?:</b> | No |

| Is all ironmongery free from damage and correctly operating?: | Yes |

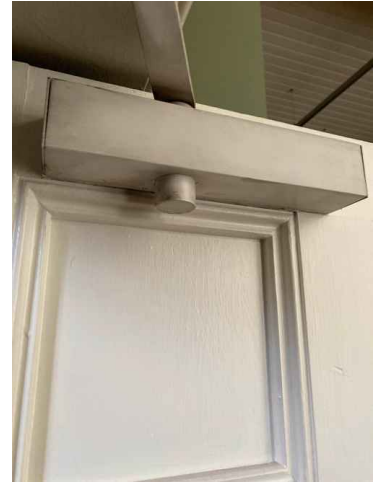
Door closers  
1 of 1

| Is the closer free from damage and not leaking?: | Yes |

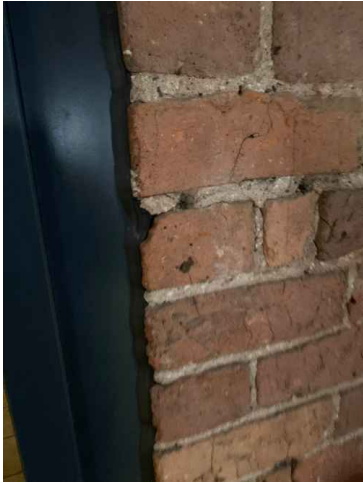
Door frame  
1 of 1

| Door details | |
|---|---|
| Action required - Door Frame: | Risk of damage to decorative finishes (frames / architrave's) prevented inspection from being performed - Intrusive inspection required |

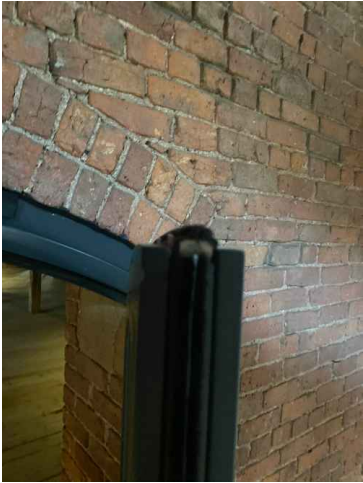
Seals  
1 of 1

| Door details | |
|---|---|
| Are the seals free from damage?: | Yes |

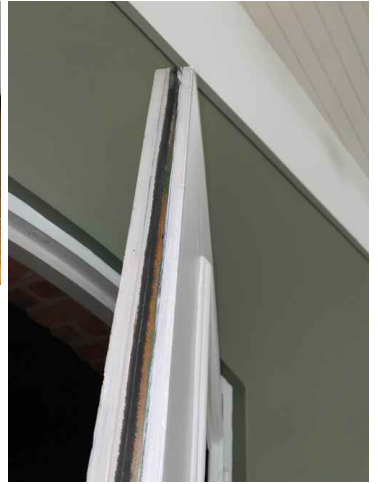
Seals  
1 of 1

| Door details | |
|---|---|
| Are the seals free from damage?: | No |

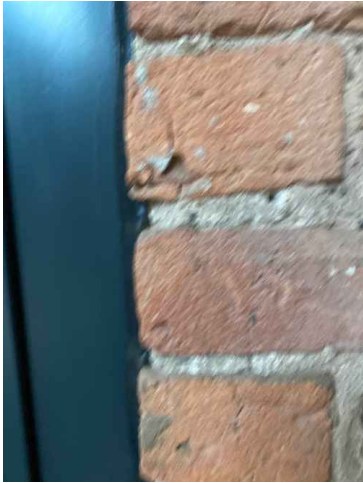
Door frame  
1 of 1

| <b>Action required - Door Frame:</b> | Risk of damage to decorative finishes (frames / architrave's) prevented inspection from being performed - Intrusive inspection required |

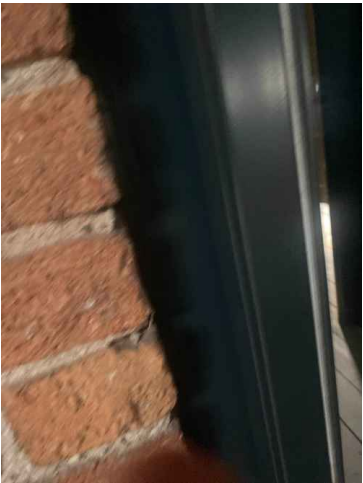
Door frame  
1 of 1

| Door details | |
|---|---|
| Action required - Door Frame: | Risk of damage to decorative finishes (frames / architrave's) prevented inspection from being performed - Intrusive inspection required |

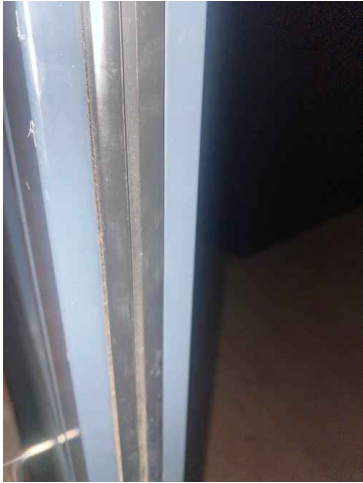
Seals  
1 of 1

| Door details | |
|---|---|
| Are the seals free from damage?: | No |

| Door details | |
|---|---|
| Action required - Seals: | Arrange for replacement intumescent seals/smoke seals FD60 20mm |

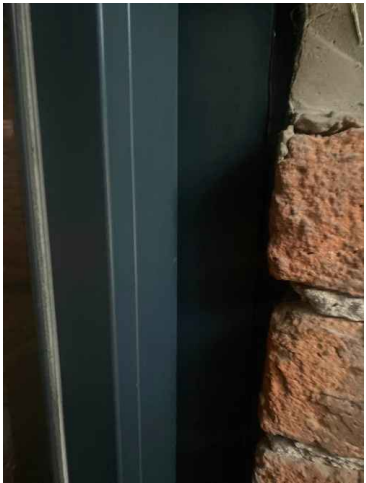
Door frame  
1 of 1

| <b>Action required - Door Frame:</b> | Risk of damage to decorative finishes (frames / architrave's) prevented inspection from being performed - Intrusive inspection required |

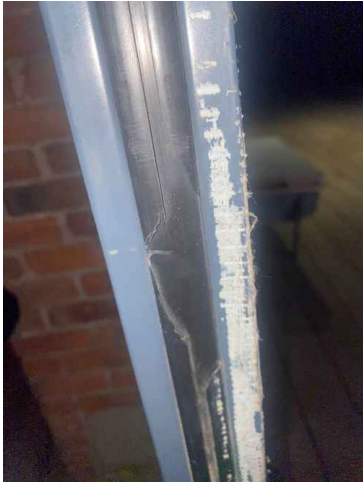
Seals  
1 of 1

| <b>Are the seals free from damage?:</b> | No |

| <b>Action required - Seals:</b> | Arrange for replacement intumescent seals/smoke seals FD60 20mm |

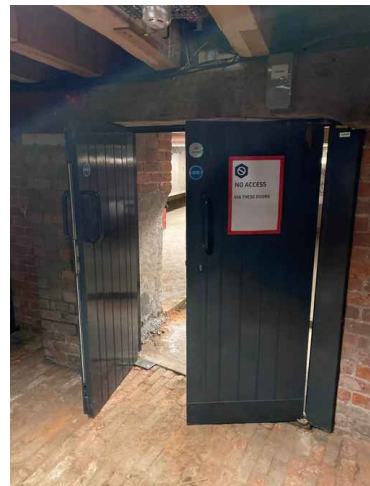
Door details  
1 of 2

| Door details | |
|---|---|
| Door is damaged beyond economical repair. Pivot hinges also in need of adjustment or replacement. | |

| Door details | |
|---|---|
| Recommended actions: | Doorset is not compliant and cannot be repaired or upgraded to meet a satisfactory standard - Replacement Required Double Doorset |

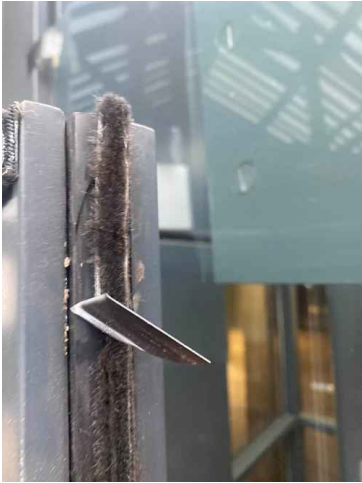
Seals  
1 of 1

| <b>Are the seals free from damage?:</b> | No |

| <b>Action required - Seals:</b> | Arrange for replacement intumescent seals/smoke seals FD60 20mm |

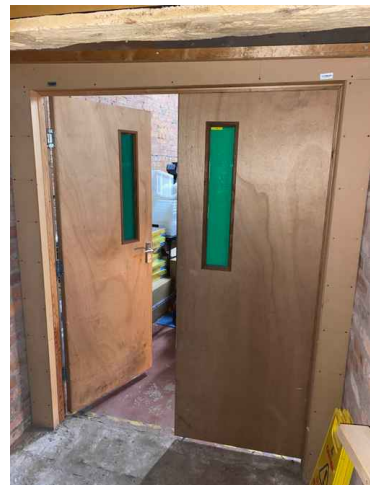
Door details  
1 of 1

| Door is located on 60 minute fire line but only has 30 minute fire resistance. Replacement is required with an FD60 door. | |

| Recommended actions: | Doorset is not compliant and cannot be repaired or upgraded to meet a satisfactory standard - Replacement Required Double Doorset |

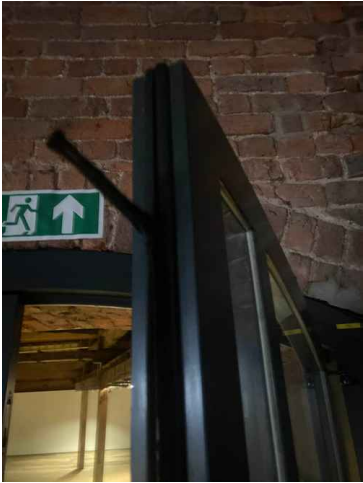
Seals  
1 of 1

| <b>Are the seals free from damage?:</b> | No |

| <b>Action required - Seals:</b> | Arrange for replacement intumescent seals/smoke seals FD60 20mm |

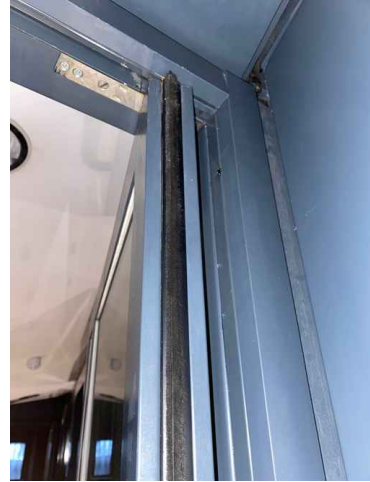
Seals  
1 of 1

| <b>Are the seals free from damage?:</b> | Yes |

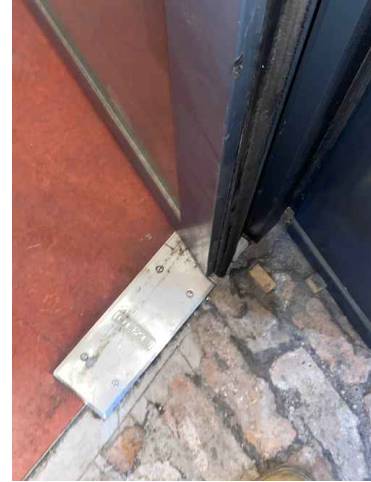
Ironmongery  
1 of 2

| Is all ironmongery free from damage and correctly operating?: | N/A |

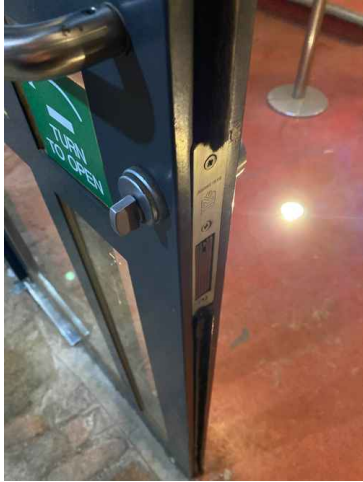
Ironmongery  
2 of 2

| Are the hinges free of metal fragment and oil leakage, which shows signs of wear?: | N/A |

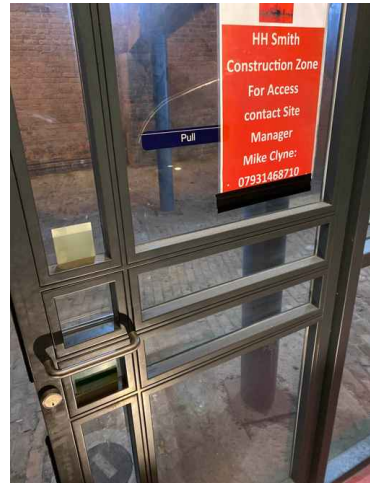
Glazing and Glass  
1 of 2

| Are the glazing beads correctly attached to the frame from both sides and free from damage?: | Yes |
| Is the glass free from damage and cracking?: | Yes |

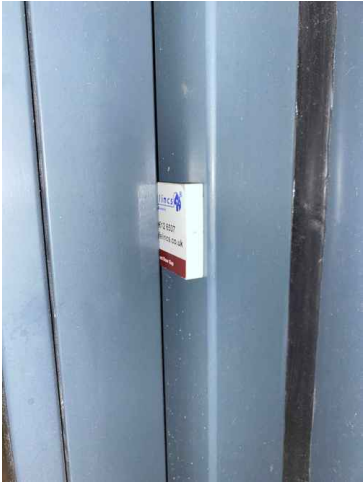
Door leaf  
1 of 2

| <b>Is the door leaf free from damage affecting its fire integrity?:</b> | Yes |

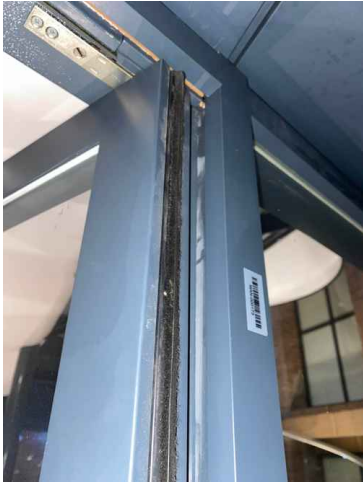
Seals  
1 of 1

| <b>Are the seals free from damage?:</b> | Yes |

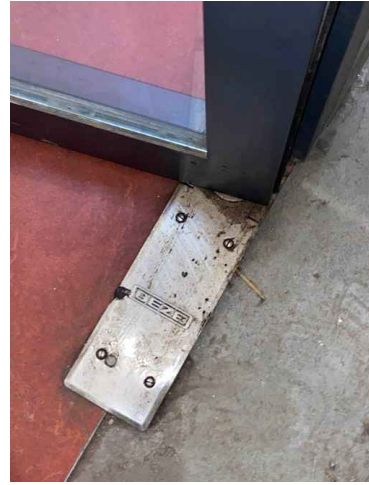
Ironmongery  
1 of 2

| Is all ironmongery free from damage and correctly operating?: | Yes |

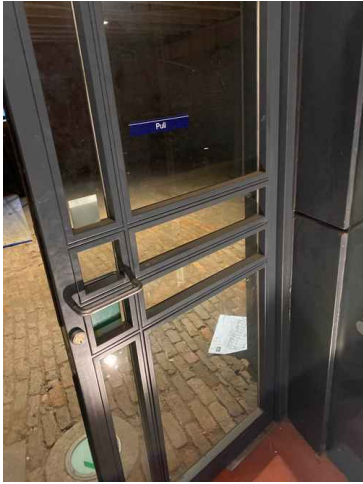
Glazing and Glass  
1 of 2

| Are the glazing beads correctly attached to the frame from both sides and free from damage?: | Yes |
| Is the glass free from damage and cracking?: | Yes |

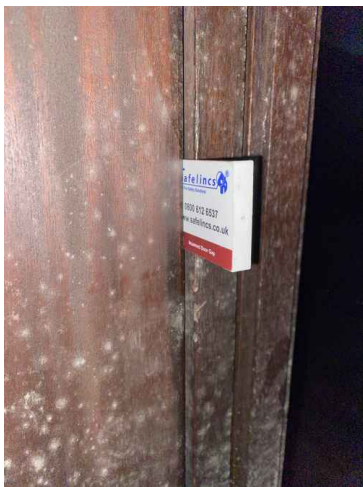
Door leaf  
1 of 2

| <b>Is the door leaf free from damage affecting its fire integrity?:</b> | Yes |

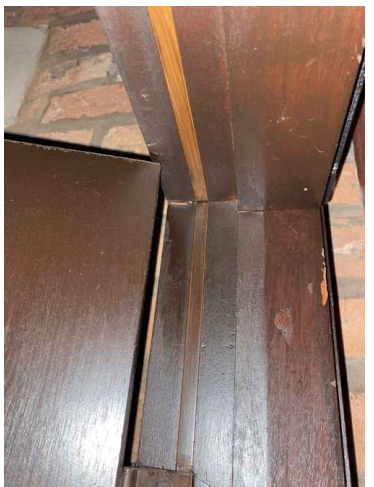
Seals  
1 of 1

| <b>Are the seals free from damage?:</b> | Yes |

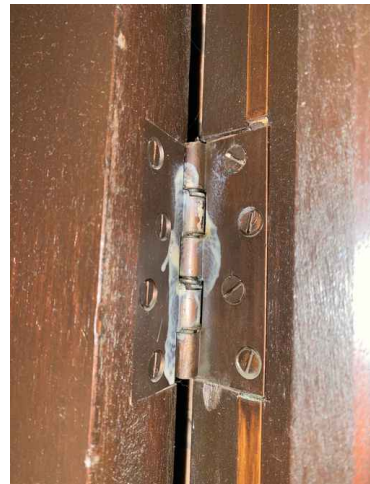
Ironmongery  
1 of 1

| Are the hinges free of metal fragment and oil leakage, which shows signs of wear?: | No |
| Is all ironmongery free from damage and correctly operating?: | Yes |

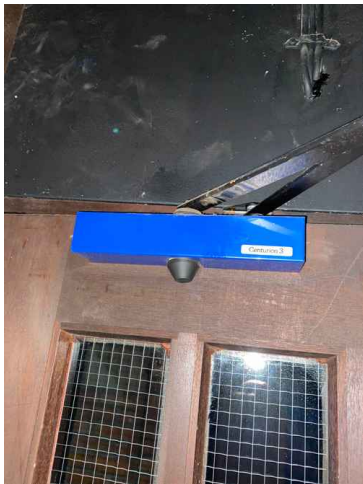
Door closers  
1 of 1

| Is the closer free from damage and not leaking?: | Yes |

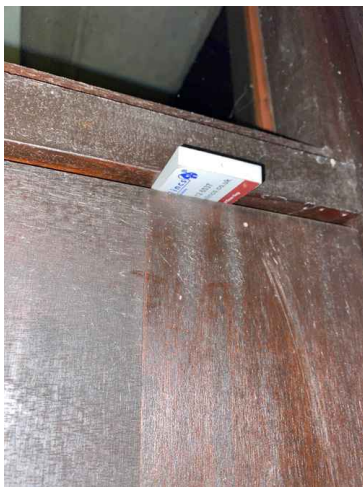
Door leaf  
1 of 2

| <b>Is the door leaf free from damage affecting its fire integrity?:</b> | Yes |

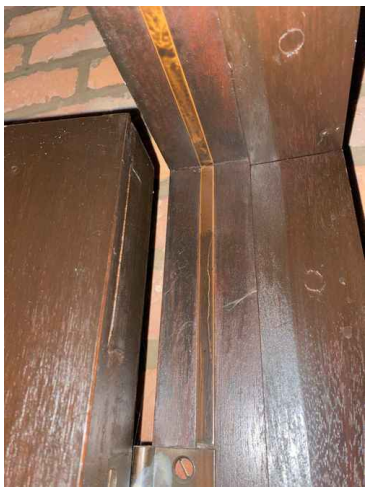
Seals  
1 of 1

| <b>Are the seals free from damage?:</b> | Yes |
