## Museum of Science & Industry Fire Door Survey Report Station Building

## **Fire Doors Report**

Museum of Science and Industry Manchester

Station Building

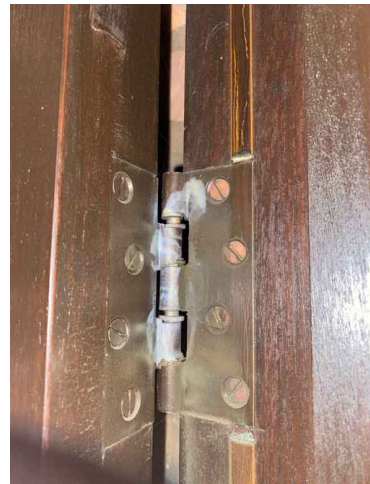
Ironmongery  
1 of 1

| Are the hinges free of metal fragment and oil leakage, which shows signs of wear?: | No |
| Is all ironmongery free from damage and correctly operating?: | Yes |

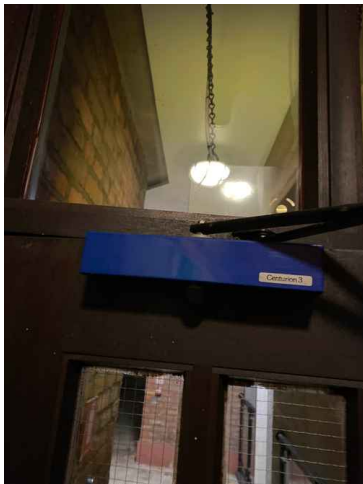
Door closers  
1 of 1

| Is the closer free from damage and not leaking?: | Yes |

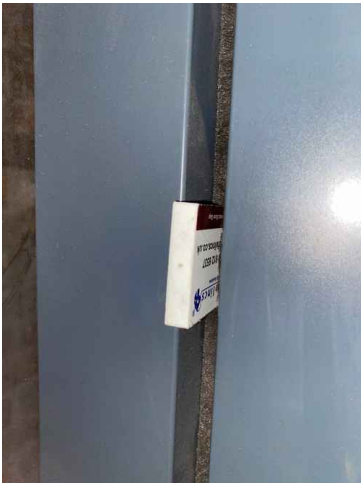
Door leaf  
1 of 2

| Door details | |
|---|---|
| Is the door leaf free from damage affecting its fire integrity?: | Yes |

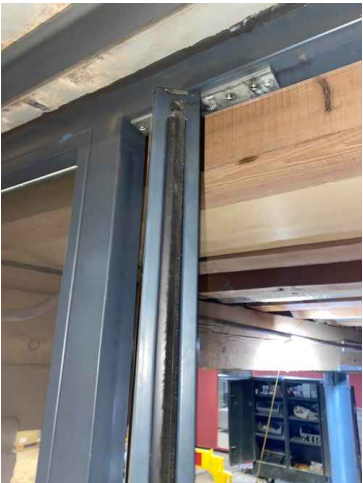
Seals  
1 of 1

| Door details | |
|---|---|
| Are the seals free from damage?: | Yes |

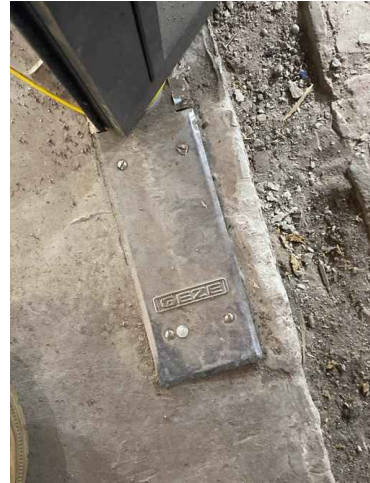
Ironmongery  
1 of 2

| Is all ironmongery free from damage and correctly operating?: | Yes |

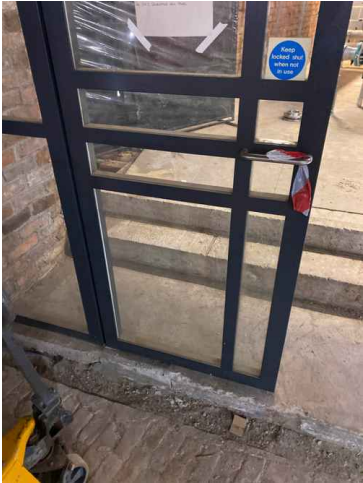
Glazing and Glass  
1 of 2

| Are the glazing beads correctly attached to the frame from both sides and free from damage?: | Yes |
| Is the glass free from damage and cracking?: | Yes |

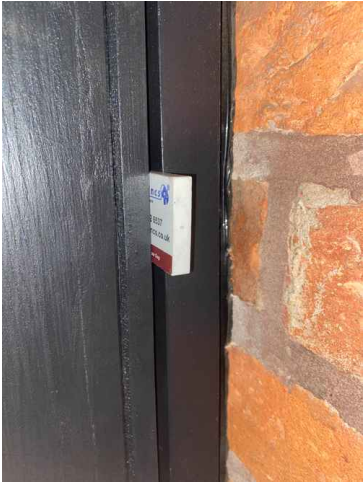
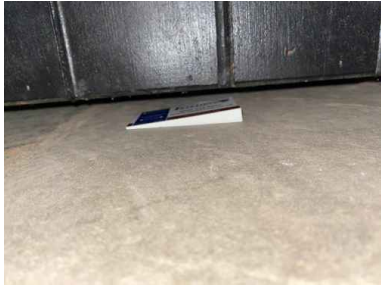
Door leaf  
1 of 2

| <b>Is the door leaf free from damage affecting its fire integrity?:</b> | Yes |

| Recommended actions: | Doorset can be upgraded to a notional standard Service Pack B - Single doorset |

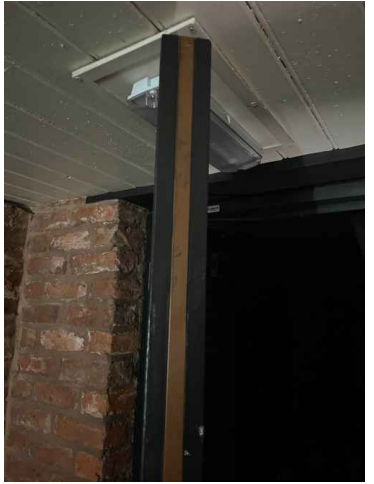
Seals  
1 of 1

| <b>Are the seals free from damage?:</b> | Yes |

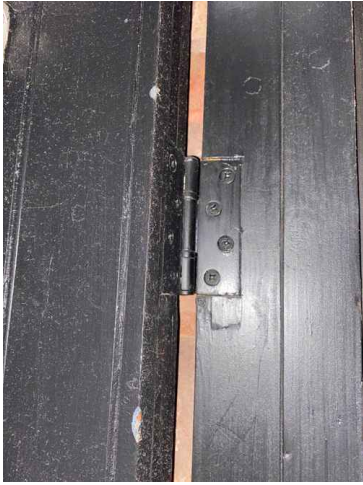
Ironmongery  
1 of 1

| Are the hinges free of metal fragment and oil leakage, which shows signs of wear?: | No |
| Is all ironmongery free from damage and correctly operating?: | Yes |

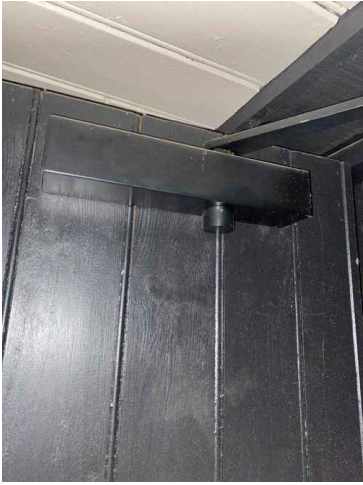
Door closers  
1 of 1

| Is the closer free from damage and not leaking?: | Yes |

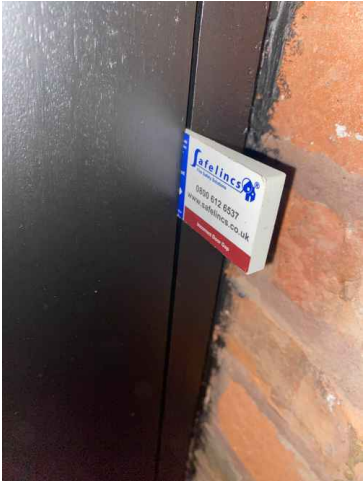
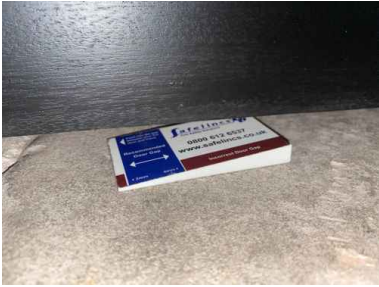
Door leaf  
1 of 2

| <b>Is the door leaf free from damage affecting its fire integrity?:</b> | Yes |

| Recommended actions: | Doorset can be upgraded to a notional standard Service Pack B - Double Doorset |

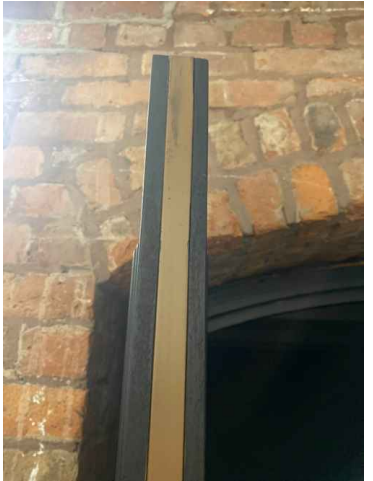
Seals  
1 of 1

| <b>Are the seals free from damage?:</b> | Yes |

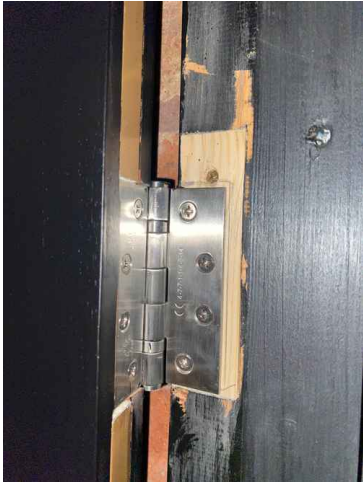
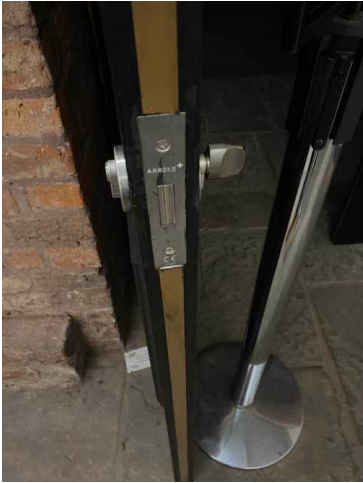
Ironmongery  
1 of 2

| Are the hinges free of metal fragment and oil leakage, which shows signs of wear?: | No |
| Is all ironmongery free from damage and correctly operating?: | Yes |

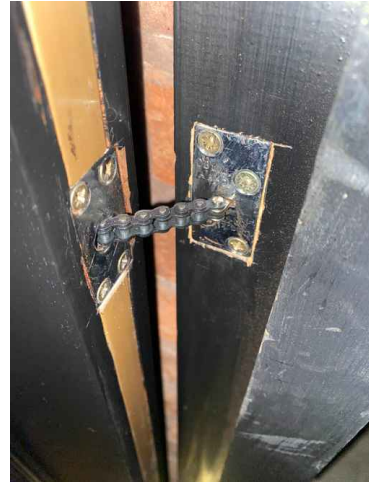
Door closers  
1 of 1

| Is the closer free from damage and not leaking?: | Yes |

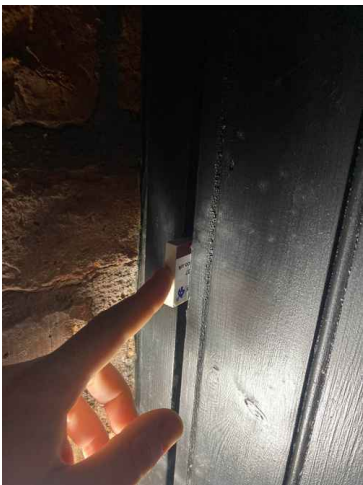
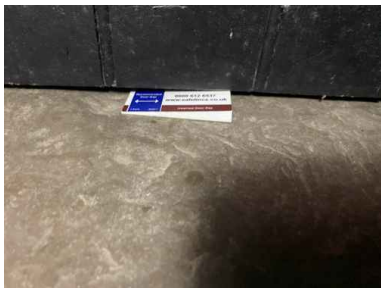
Door leaf  
1 of 2

| <b>Is the door leaf free from damage affecting its fire integrity?:</b> | Yes |

| Recommended actions: | Doorset can be upgraded to a notional standard Service Pack B - Single doorset |

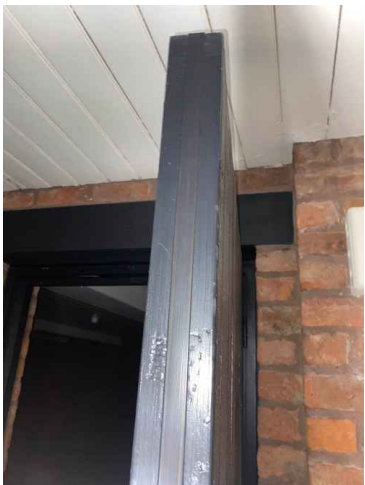
Seals  
1 of 1

| <b>Are the seals free from damage?:</b> | Yes |

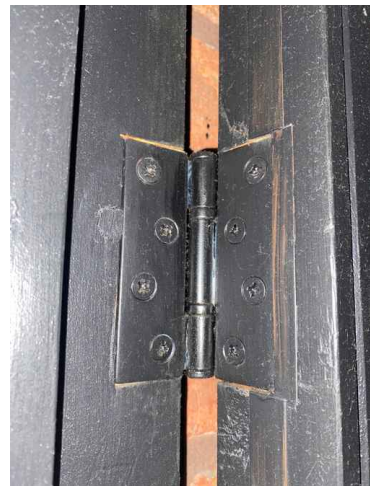
Ironmongery  
1 of 1

| Are the hinges free of metal fragment and oil leakage, which shows signs of wear?: | No |
| Is all ironmongery free from damage and correctly operating?: | Yes |

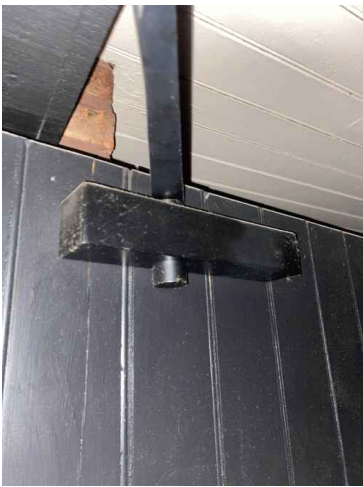
Door closers  
1 of 1

| Is the closer free from damage and not leaking?: | Yes |

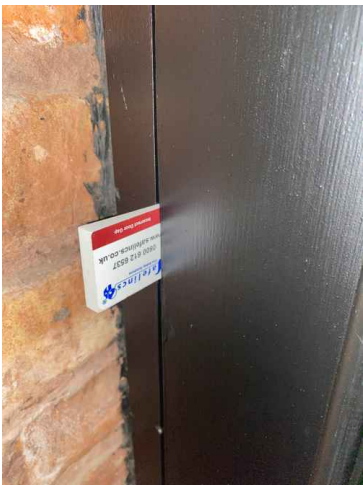
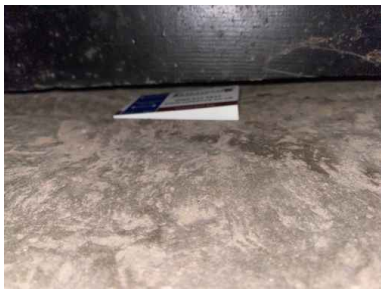
Door leaf  
1 of 2

| <b>Is the door leaf free from damage affecting its fire integrity?:</b> | Yes |

| <b>Recommended actions:</b> | Doorset can be upgraded to a notional standard Service Pack B - Double Doorset |

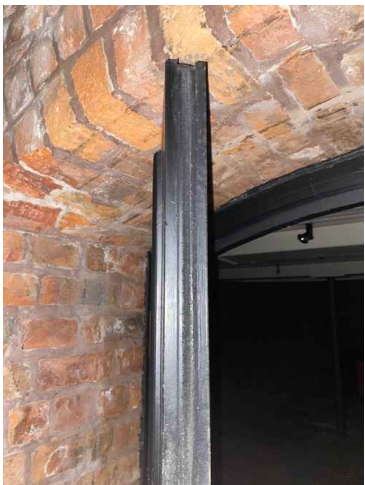
Seals  
1 of 1

| <b>Are the seals free from damage?:</b> | No |

| <b>Action required - Seals:</b> | Arrange for replacement intumescent seals/smoke seals FD30 10mm |

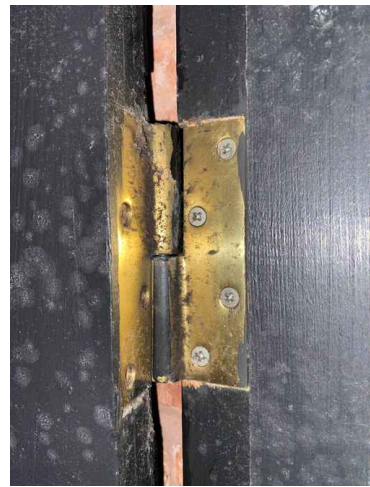
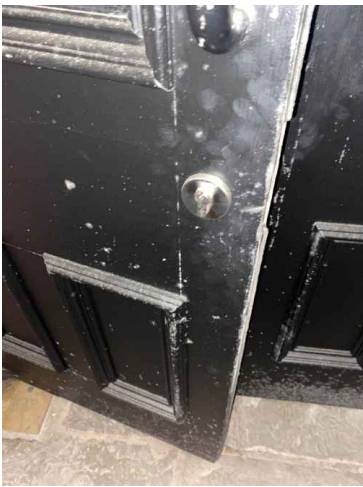
Ironmongery  
1 of 2

| <b>Are the hinges free of metal fragment and oil leakage, which shows signs of wear?:</b> | No |
| <b>Is all ironmongery free from damage and correctly operating?:</b> | Yes |

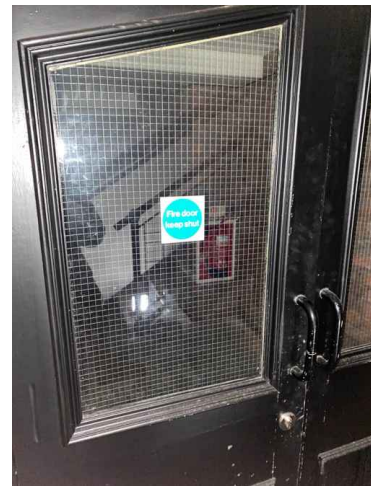
Glazing and Glass  
1 of 1

| <b>Are the glazing beads correctly attached to the frame from both sides and free from damage?:</b> | Yes |
| <b>Is the glass free from damage and cracking?:</b> | Yes |

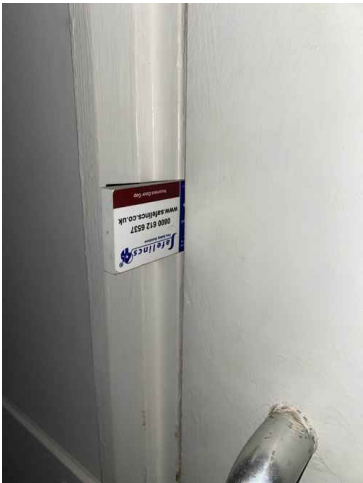
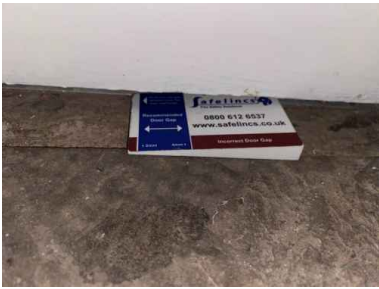
Door leaf  
1 of 2

| <b>Is the door leaf free from damage affecting its fire integrity?:</b> | Yes |

| Recommended actions: | Doorset can be upgraded to a notional standard Service Pack B - Single doorset |

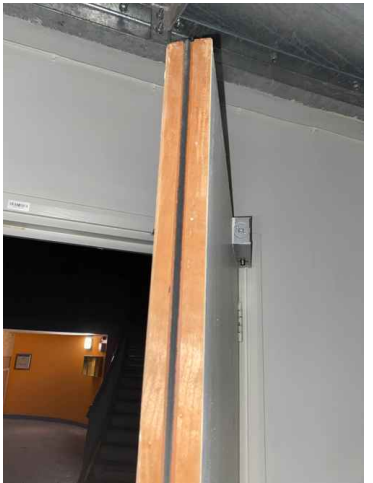
Seals  
1 of 1

| <b>Are the seals free from damage?:</b> | Yes |

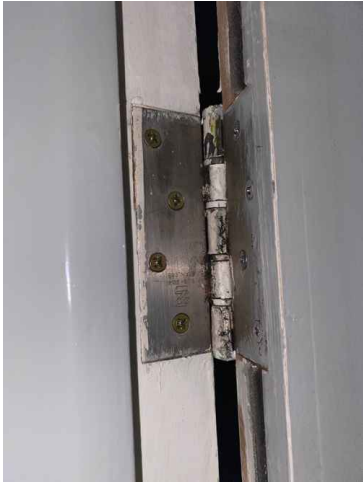
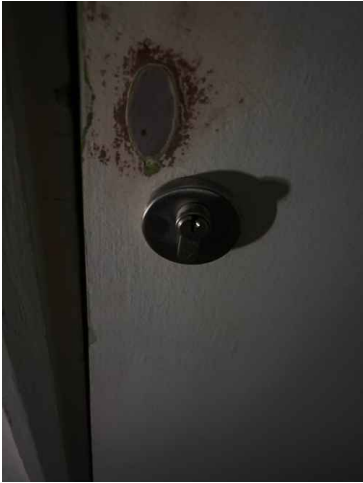
Ironmongery  
1 of 2

| Are the hinges free of metal fragment and oil leakage, which shows signs of wear?: | No |
| Is all ironmongery free from damage and correctly operating?: | Yes |

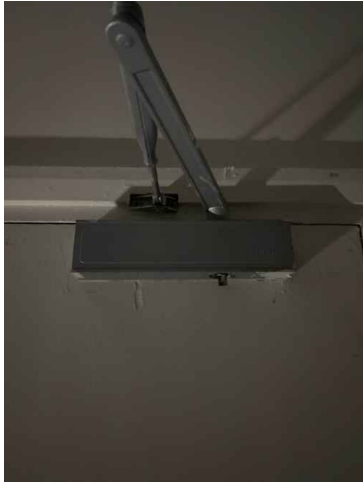
Door closers  
1 of 1

| Is the closer free from damage and not leaking?: | Yes |

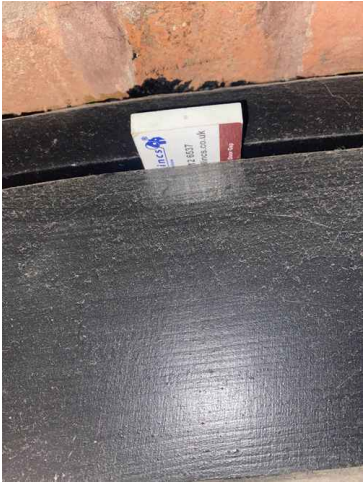
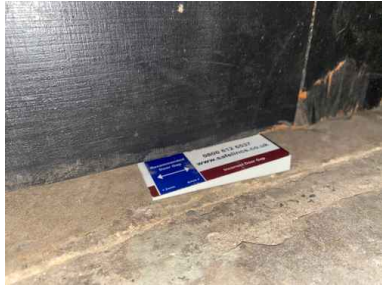
Door leaf  
1 of 2

| Door details | |
|---|---|
| Is the door leaf free from damage affecting its fire integrity?: | Yes |

| Recommended actions: | Doorset can be upgraded to a notional standard Service Pack B - Double Doorset |

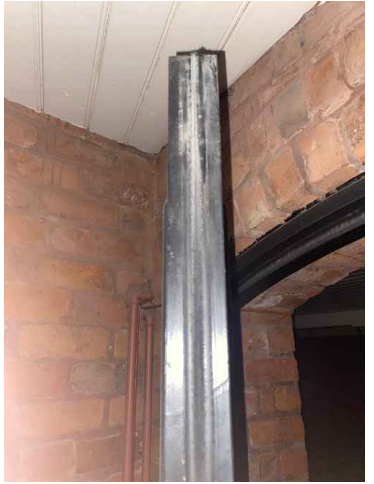
Seals  
1 of 1

| Door details | |
|---|---|
| Are the seals free from damage?: | Yes |

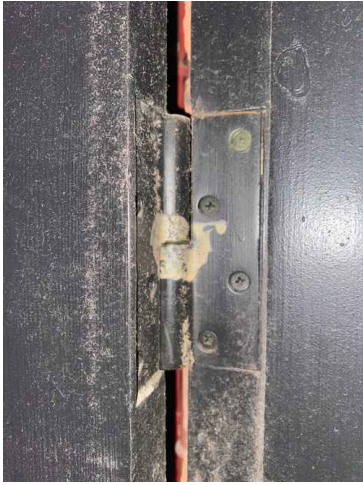
Ironmongery  
1 of 1

| Is all ironmongery free from damage and correctly operating?: | Yes |

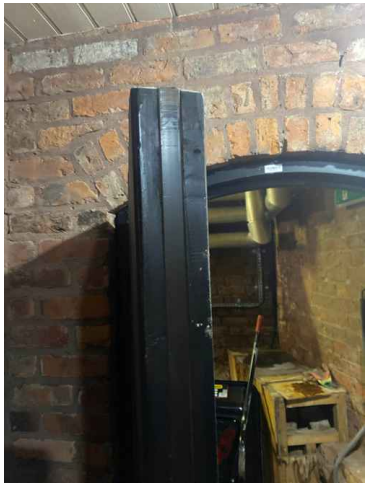
Seals  
1 of 1

| <b>Are the seals free from damage?:</b> | Yes |

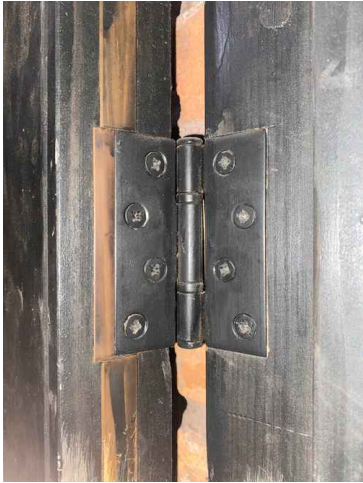
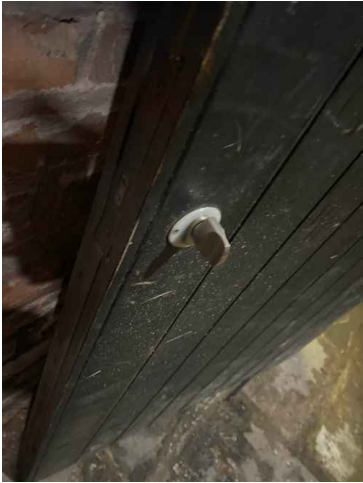
Ironmongery  
1 of 2

| Is all ironmongery free from damage and correctly operating?: | Yes |

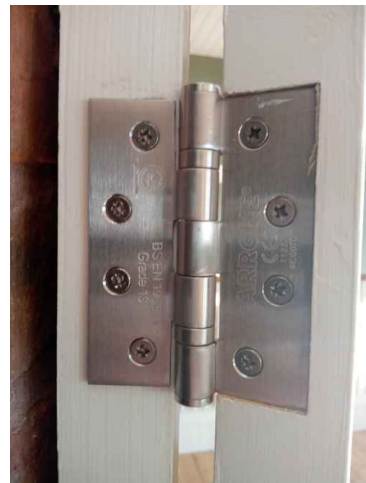
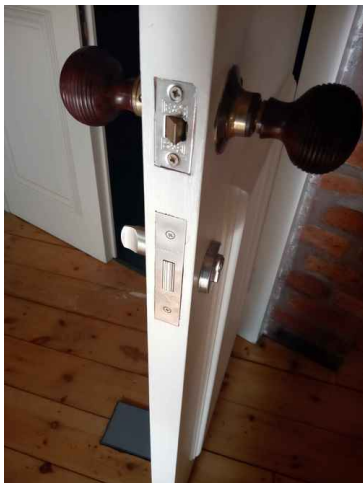
Ironmongery  
1 of 2

| Are the hinges free of metal fragment and oil leakage, which shows signs of wear?: | No |
| Is all ironmongery free from damage and correctly operating?: | Yes |

| Action required - Ironmongery: | Arrange for hinge repairs or replacement due to wear & tear, Install minimum of 3 hinges with all the screws fitted. Use ironmongery stamped with CE stamp or BSEN 1935 grade 13 (or equivalent) |

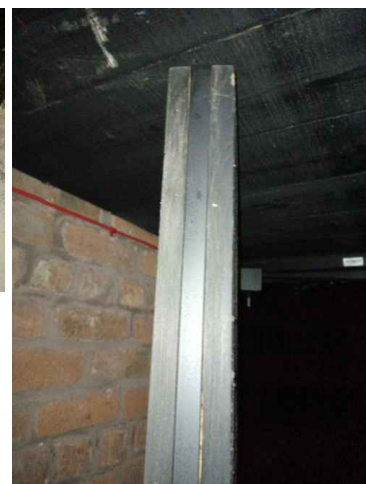
Seals  
1 of 1

| <b>Are the seals free from damage?:</b> | Yes |

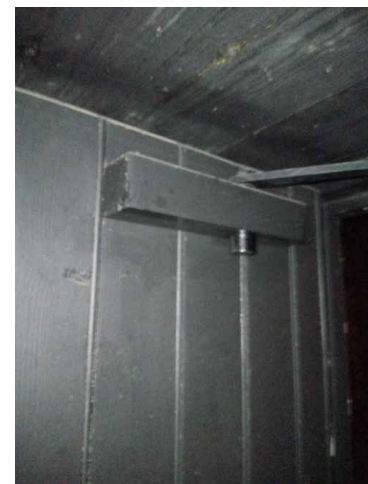
Door closers  
1 of 1

| Is the closer free from damage and not leaking?: | Yes |

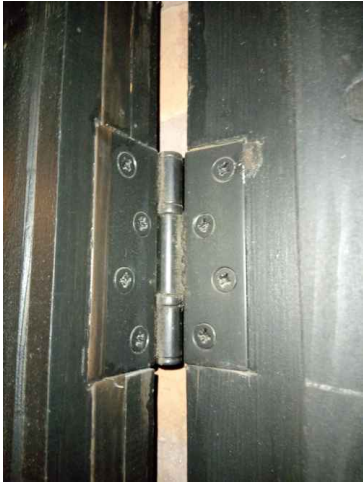
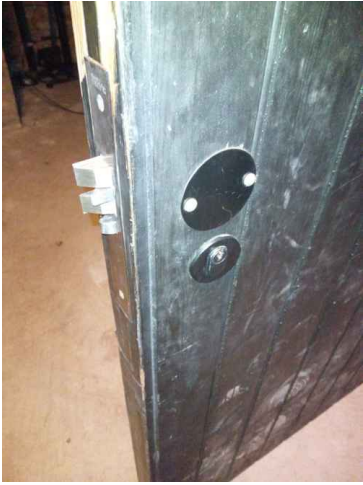
Ironmongery  
1 of 2

| Are the hinges free of metal fragment and oil leakage, which shows signs of wear?: | No |
| Is all ironmongery free from damage and correctly operating?: | Yes |

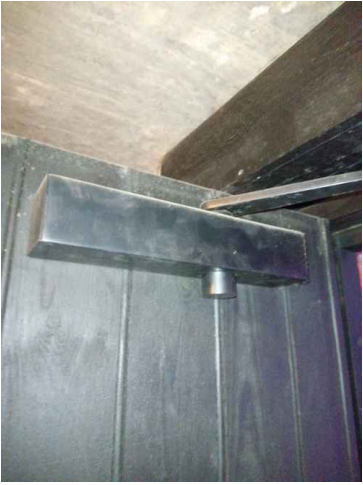
Door closers  
1 of 1

| Is the closer free from damage and not leaking?: | Yes |

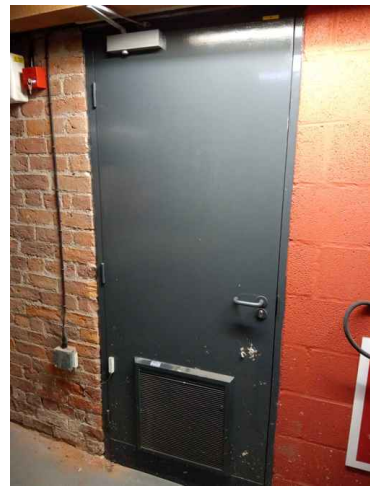
Door details  
1 of 1

| Door details | |
|---|---|
| Door is located on 60 minute fire line but only provides 30 minutes resistance. Replacement with a FD60 door is required. | |

| Door details | |
|---|---|
| Recommended actions: | Doorset is not compliant and cannot be repaired or upgraded to meet a satisfactory standard - Replacement Required Single Doorset |

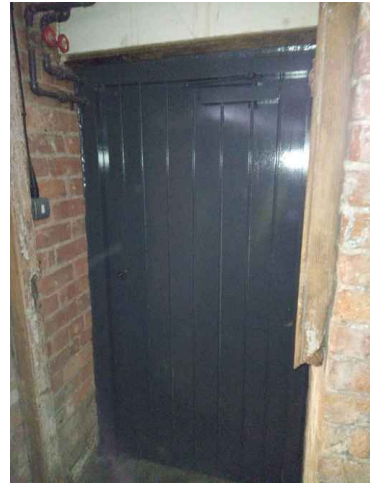
Door details  
1 of 1

| Door details | |
|---|---|
| Door could not be properly surveyed as nobody has key for it. Lock is presumed to be broken and the estates team cannot access it either. Replacement doorset is recommended. | |

| Door details | |
|---|---|
| Recommended actions: | Doorset is not compliant and cannot be repaired or upgraded to meet a satisfactory standard - Replacement Required Single Doorset |

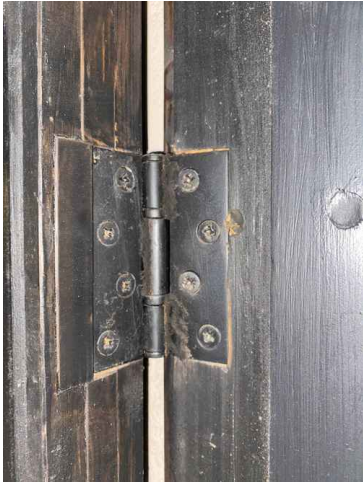
Ironmongery  
1 of 2

| Are the hinges free of metal fragment and oil leakage, which shows signs of wear?: | No |

| Action required - Ironmongery: | Arrange for hinge repairs or replacement due to wear & tear |

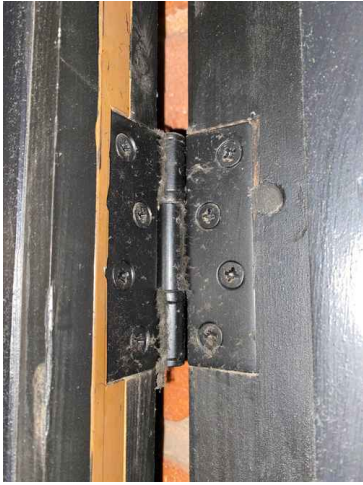
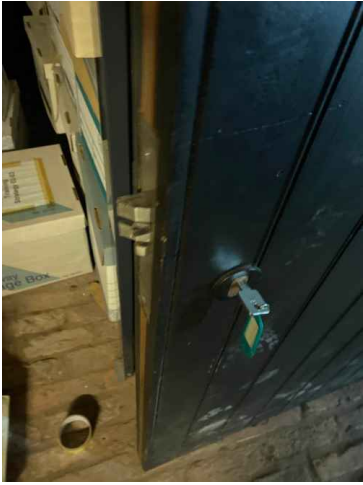
Ironmongery  
1 of 2

| Are the hinges free of metal fragment and oil leakage, which shows signs of wear?: | No |

| Action required - Ironmongery: | Arrange for hinge repairs or replacement due to wear & tear |

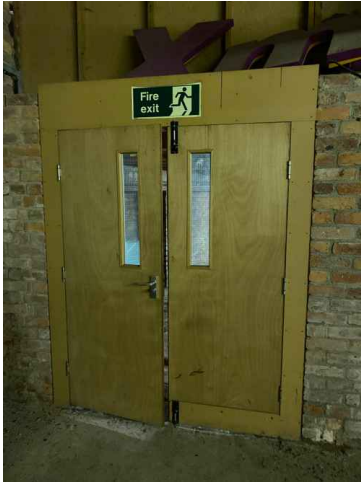
Door details  
1 of 1

| Door is located on 60 minute line but only provides 30 minutes resistance. Replacement Required. | |

| Recommended actions: | Doorset is not compliant and cannot be repaired or upgraded to meet a satisfactory standard - Replacement Required Double Doorset |

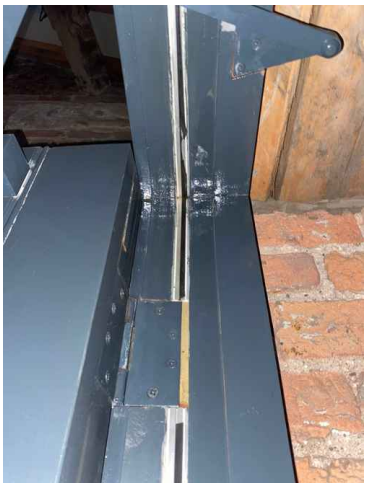
Seals  
1 of 1

| <b>Are the seals free from damage?:</b> | No |

| Action required - Seals: | Arrange for replacement intumescent seals/smoke seals FD60 20mm |

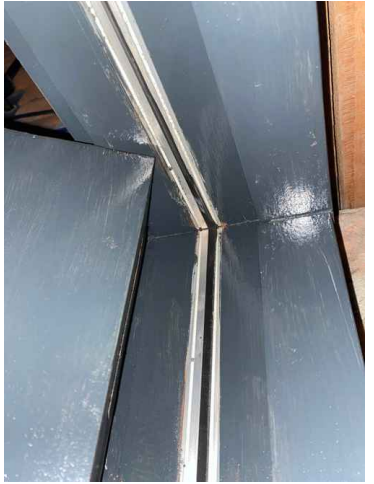
Seals  
1 of 1

| <b>Are the seals free from damage?:</b> | No |

| Action required - Seals: | Arrange for replacement intumescent seals/smoke seals FD60 20mm |

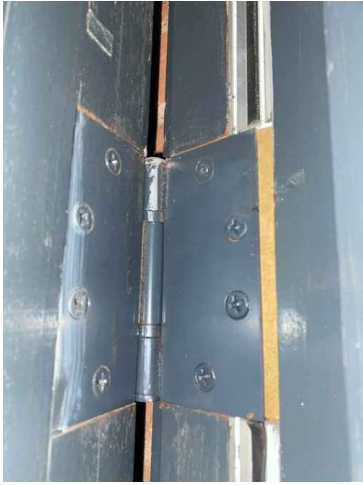
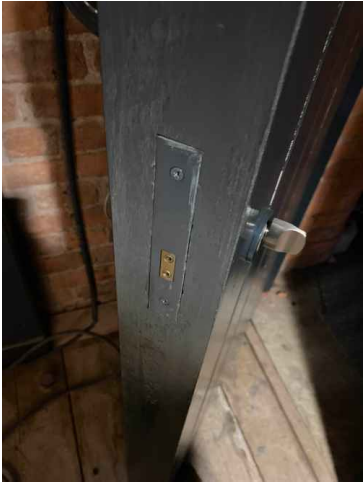
Ironmongery  
1 of 2

| Are the hinges free of metal fragment and oil leakage, which shows signs of wear?: | No |

| Action required - Ironmongery: | Arrange for hinge repairs or replacement due to wear & tear, Install minimum of 3 hinges with all the screws fitted. Use ironmongery stamped with CE stamp or BSEN 1935 grade 13 (or equivalent) |

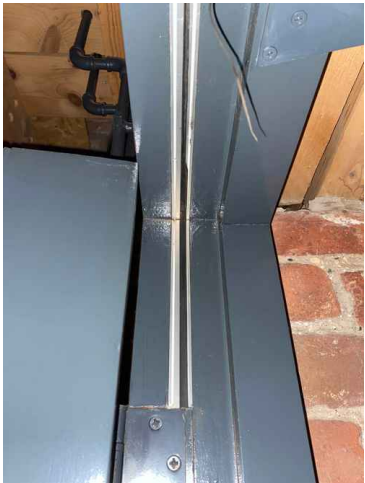
Seals  
1 of 1

| <b>Are the seals free from damage?:</b> | No |

| Action required - Seals: | Arrange for replacement intumescent seals/smoke seals FD60 20mm |

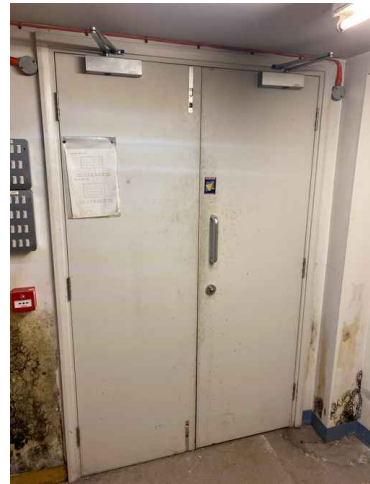
Door details  
1 of 1

| Door details | |
|---|---|
| Recommended actions: | Doorset is not compliant and cannot be repaired or upgraded to meet a satisfactory standard - Replacement Required Single Doorset |

| Door details | |
|---|---|
| Priority: | Urgent |

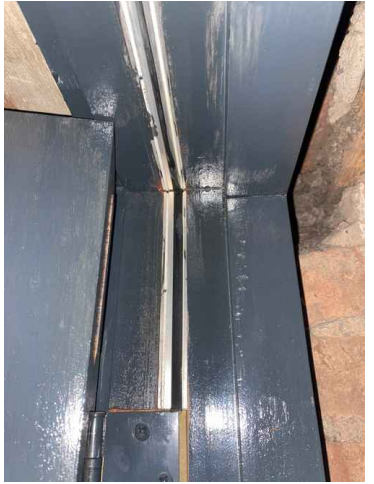
Seals  
1 of 1

| <b>Are the seals free from damage?:</b> | No |

| Action required - Seals: | Arrange for replacement intumescent seals/smoke seals FD60 20mm |

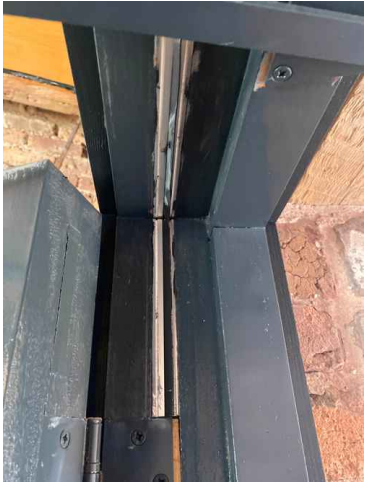
Seals  
1 of 1

| <b>Are the seals free from damage?:</b> | No |

| Action required - Seals: | Arrange for replacement intumescent seals/smoke seals FD60 20mm |

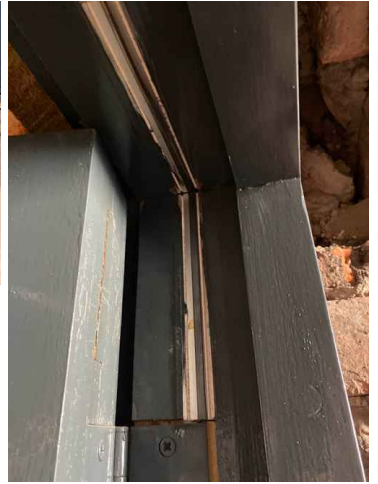
Seals  
1 of 1

| Door details | |
|---|---|
| Are the seals free from damage?: | No |

| Action required - Seals: | Arrange for replacement intumescent seals/smoke seals FD60 20mm |

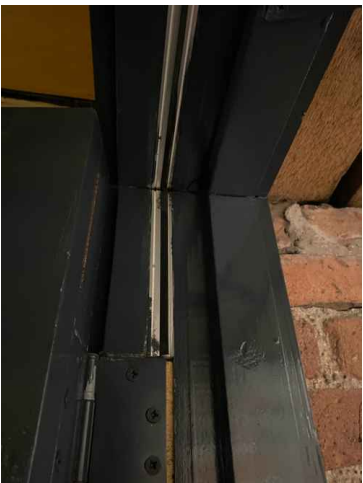
Seals  
1 of 1

| <b>Are the seals free from damage?:</b> | No |

| Action required - Seals: | Arrange for replacement intumescent seals/smoke seals FD60 20mm |

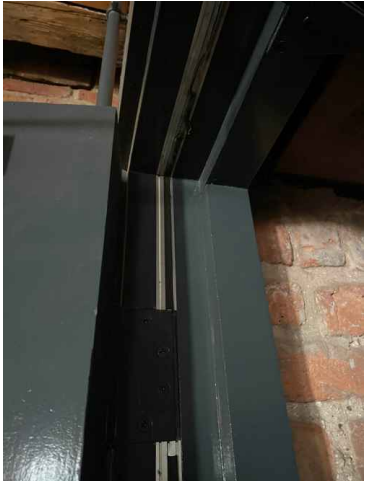
Seals  
1 of 1

| Door details | |
|---|---|
| Are the seals free from damage?: | No |

| Action required - Seals: | Arrange for replacement intumescent seals/smoke seals FD60 20mm |

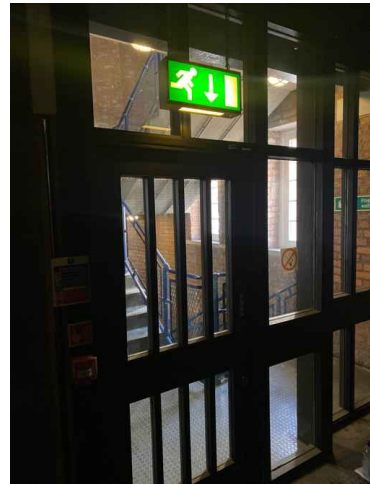
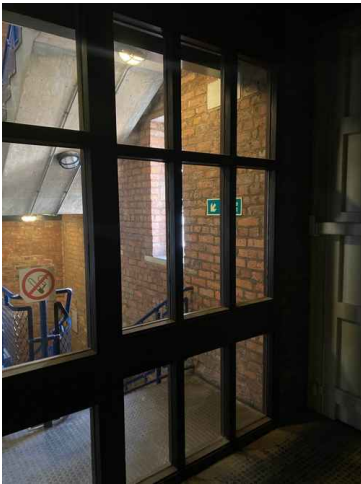
Door details  
1 of 2

| Door details | |
|---|---|
| Door is warped. Replacement required. | |

| Recommended actions: | Doorset is not compliant and cannot be repaired or upgraded to meet a satisfactory standard - Replacement Required Single Doorset |
| Priority: | Urgent |

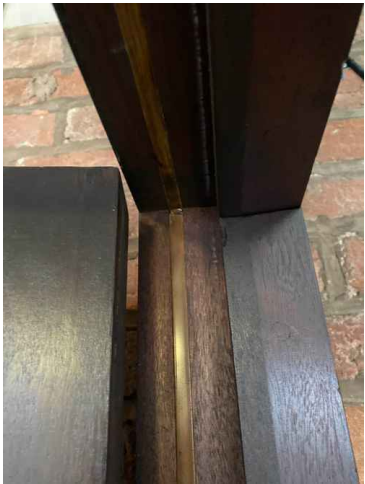
Seals  
1 of 1

| Are the seals free from damage?: | Yes |

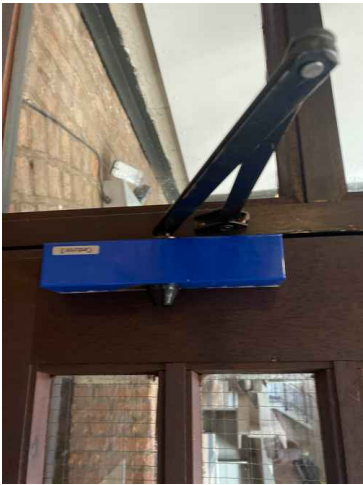
Door closers  
1 of 1

| Is the closer free from damage and not leaking?: | Yes |

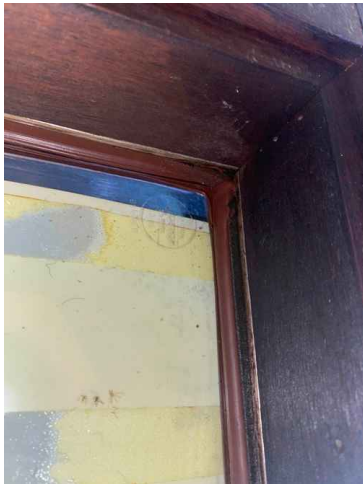
Glazing and Glass  
1 of 1

| Are the glazing beads correctly attached to the frame from both sides and free from damage?: | Yes |
| Is the glass free from damage and cracking?: | Yes |

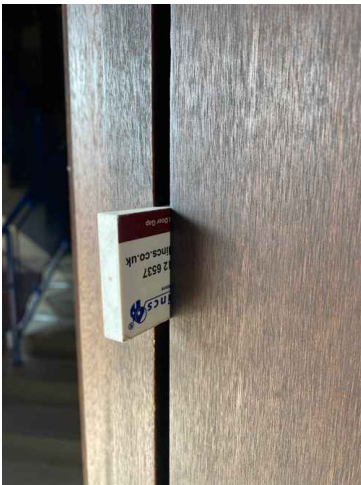
Door leaf  
1 of 2

| <b>Is the door leaf free from damage affecting its fire integrity?:</b> | Yes |

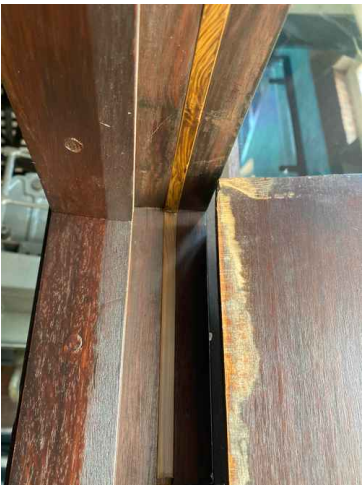
Seals  
1 of 1

| <b>Are the seals free from damage?:</b> | Yes |

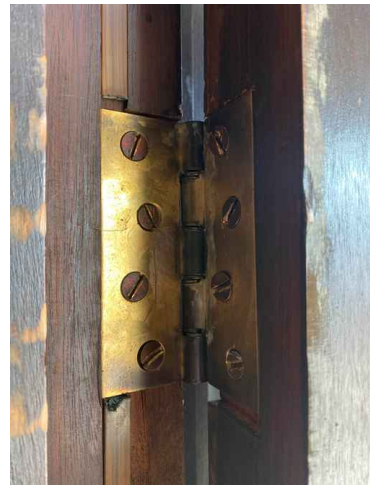
Ironmongery  
1 of 1

| Are the hinges free of metal fragment and oil leakage, which shows signs of wear?: | No |
| Is all ironmongery free from damage and correctly operating?: | Yes |

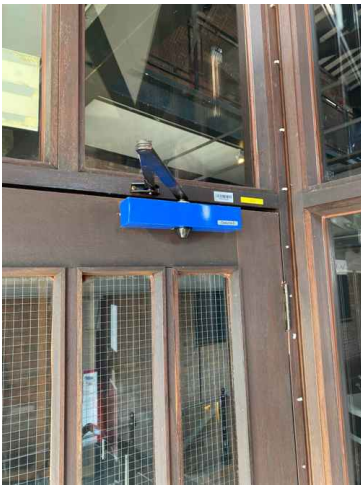
Door closers  
1 of 1

| Is the closer free from damage and not leaking?: | Yes |

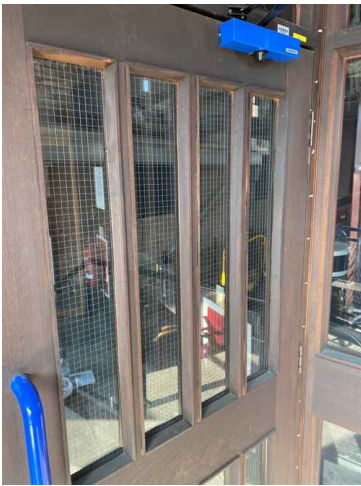
Glazing and Glass  
1 of 1

| Are the glazing beads correctly attached to the frame from both sides and free from damage?: | Yes |
| Is the glass free from damage and cracking?: | Yes |
