Amazon House  
Internal works to Basement,  
Floor 1 and Floor 2

Heritage Statement

Date: July 2022  
Job: 1978

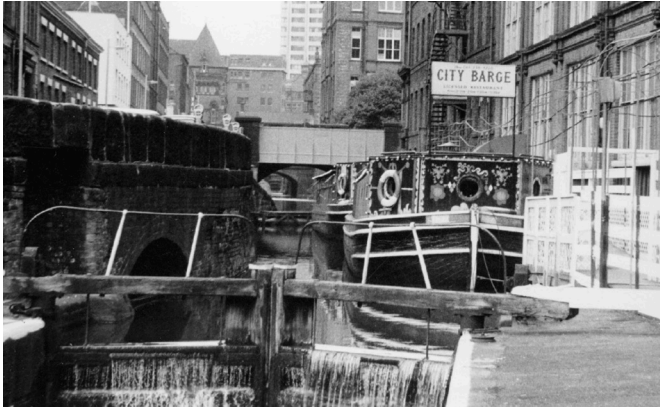
Image 01: Photograph showing the Rochdale Canal side of the building in the early 1970s, with barge moored to side. Amazon House can be identified by the attached fire escape stair. Image taken from Manchester Archives.

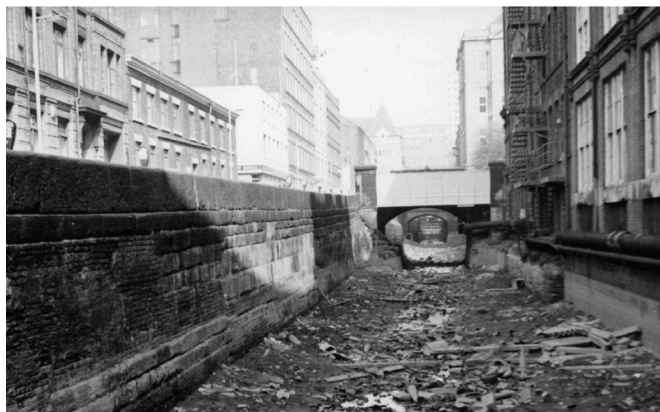
Image 02: Photograph of Rochdale Canal side in 1973, with Amazon House identified by fire escape stair. No platform is present externally at this time. Image taken from Manchester Archives.

The basement has a raised internal timber platform to the canal-side. This serves as access to the external decking, which now links to the footbridge. The age of this internal raised area is uncertain. As it enables a link with the waterway, it is possible some kind of decking was originally located in this area but notwithstanding that supposition, it has clearly been altered to a great extent as the presence of concrete to support the outside deck and modern blockwork is situated underneath the decking, indicating it has been rebuilt likely in the mid-1990s when the outside deck and footbridge were constructed. It is basic in construction and its significance is limited given evidence of its rebuilding.

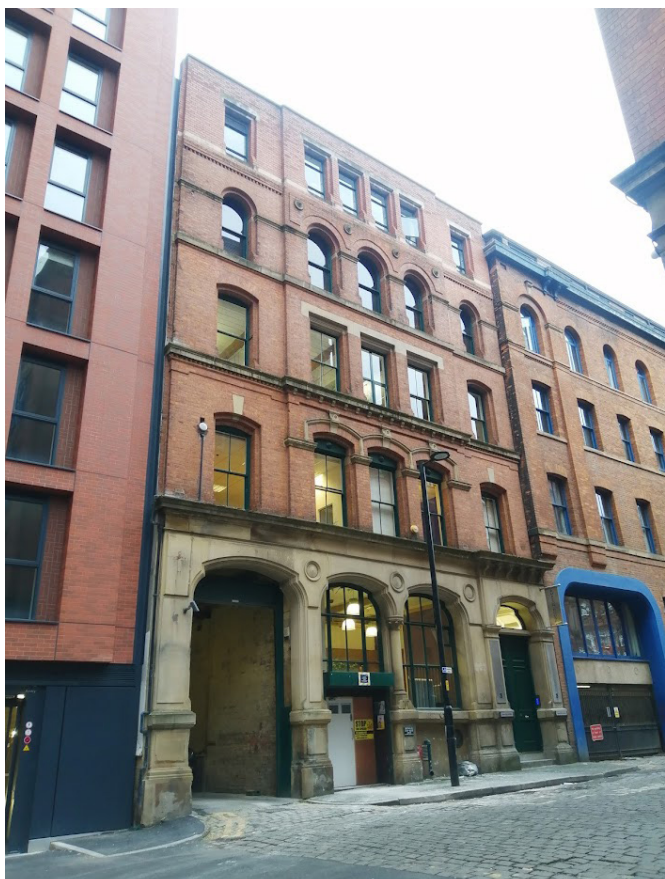
Image 03: Contemporary photograph showing Brazil Street elevation of Amazon House.

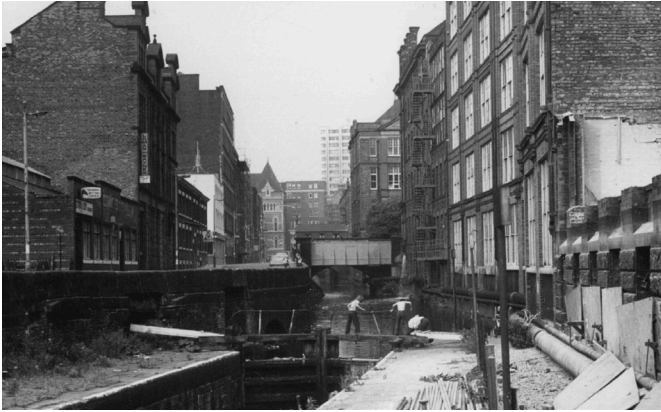
Image 4: Photograph showing Rochdale Canal side of building with lock, 1973. Taken from Manchester Archives.

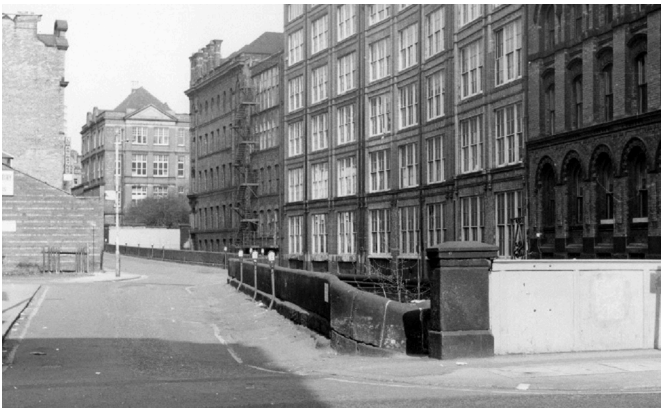
Image 5: Photograph showing view of Amazon House from canal-side, 1970s. Taken from Manchester Archives.

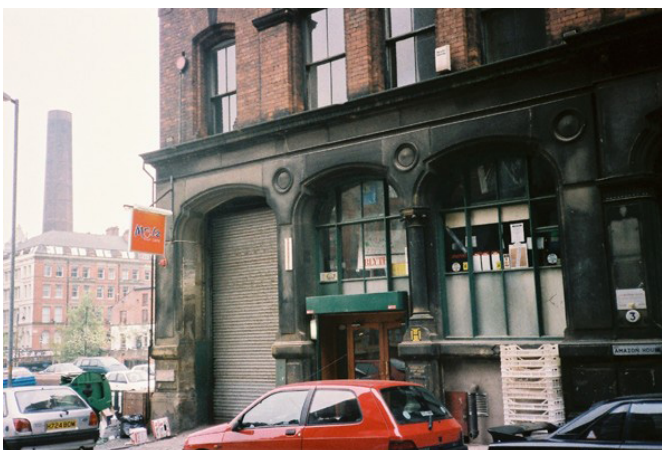
Image 6: Photograph of exterior of Amazon House, taken in the 1990s from Brazil Street side. The former art shop can be seen at ground floor level.

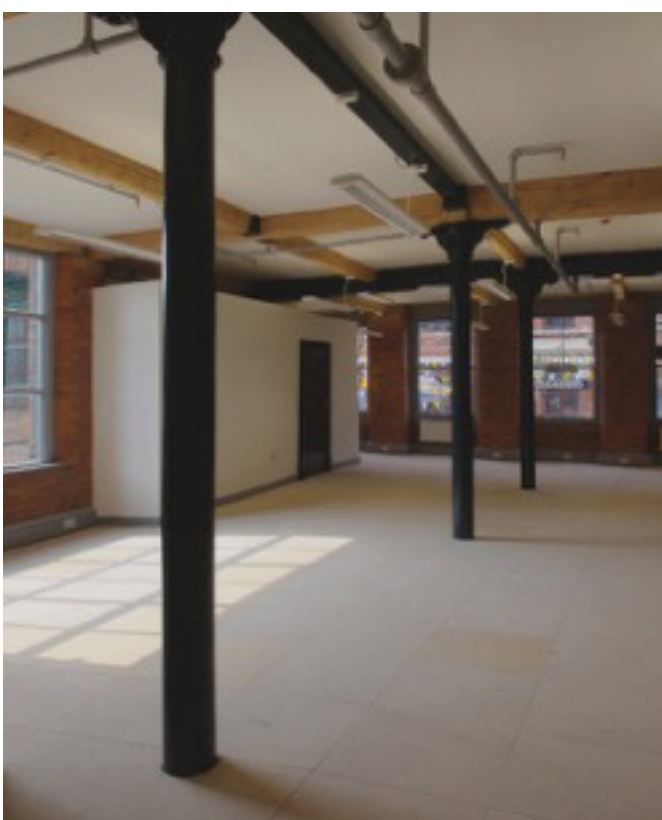
Image 7: Photograph showing typical interior of office spaces with exposed columns and beams.

Internal walls are a mixture of plastered surfaces and exposed brick. They display few features, being standard wall structure, but have value as part of the original fabric. Original cast iron columns, timber floors and exposed beams are typical construction elements for the building type and age. They can be found throughout the floors of Amazon House and have medium evidential and historical significance.

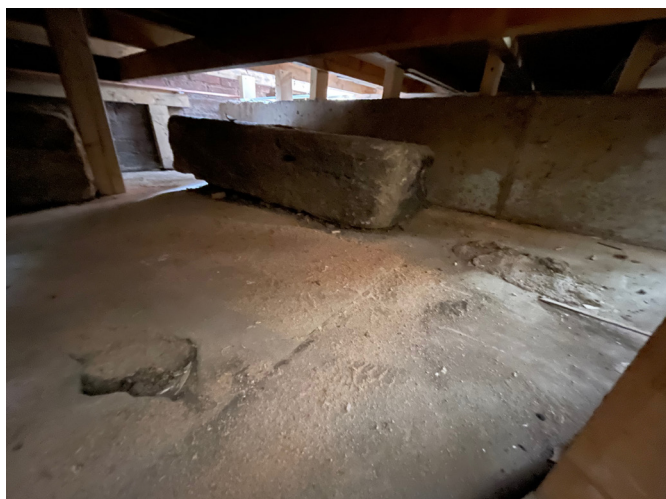
Image 7: Photograph of underside of internal deck showing modern concrete, supporting the external deck, which was added in 1994.

Within the basement there is a desire to re-use the internal platform area as meeting space. In order to create a useable area, the proposal is to add a small portion of additional deck within the angled corner; forming a continuous line. This is a very limited portion of infill and is considered to cause no harm to the form, evidential or aesthetic value of the building, given the clear indications this platform is non-original.
