Bat Survey Report

Francis Road, Withington

Reference: 80-615-R1-4

Date: May 2022

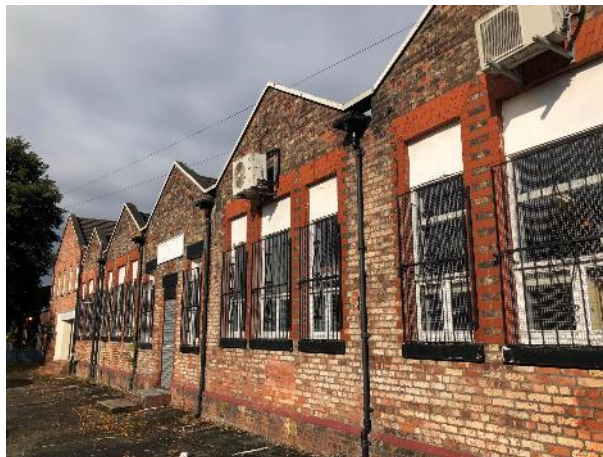
PLATE 1      SHOWING SOUTH-EASTERN ASPECT OF BUILDING

The building comprised a vacant, medium sized industrial building made from red brick. The south-eastern aspect of the building contained the front of the building looking onto Francis Road. The brickwork along this section was in good condition, with evidence of repair work in places. A series of drainpipes and windows were present along south-eastern aspect with small gaps present where the drainpipe leaves the building, which could be used by crevice dwelling bat species on an occasional basis.

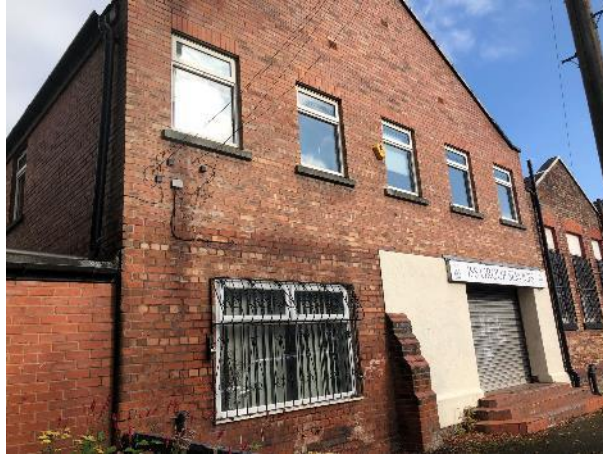
PLATE 2      SHOWING MODERN EXTENSION

The roof of the building comprised a series of joined pitched roofs lined with black tiles. Large sections of the roof could not be viewed from the ground, so a precautionary approach has been adopted. A modern extension to the main building was present at the south-western corner of the building which contained the main entrance and reception area for the building. This section was in good condition and did not provide any potential roost features for bats.

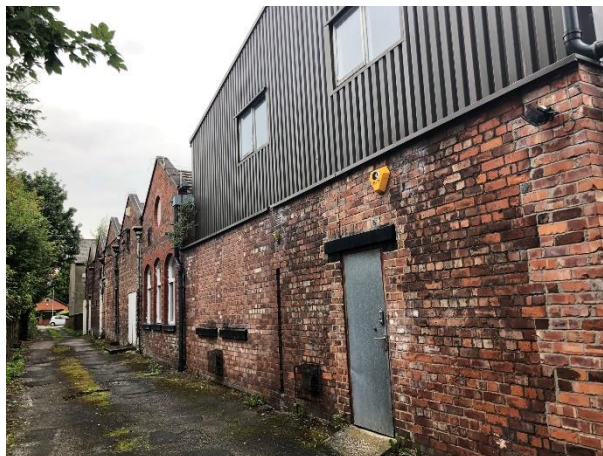
PLATE 3      SHOWING NORTH-WESTERN ASPECT OF BUILDING

The north-western aspect of the building was located next to an access track leading into the car park for the building. The access track was lined with overhanging trees located in the adjacent gardens to the north. The brickwork along this section of the building was in poorer condition than the front of the building, with multiple gaps and holes present which could be used by crevice dwelling bat species on an occasional basis.

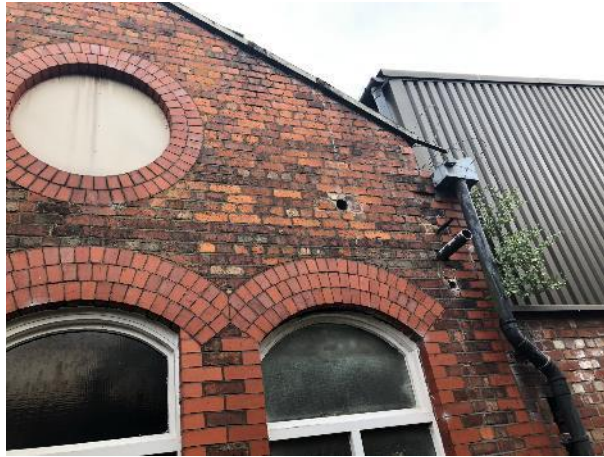
PLATE 4      SHOWING HOLES PRESENT ALONG NORTH-WESTERN ASPECT

Small holes, gaps in brickwork and missing bricks were present in small sections along the north-western aspect of the building. The gaps in the brickwork could provide suitable roost features for crevice dwelling bat species on an occasional basis.

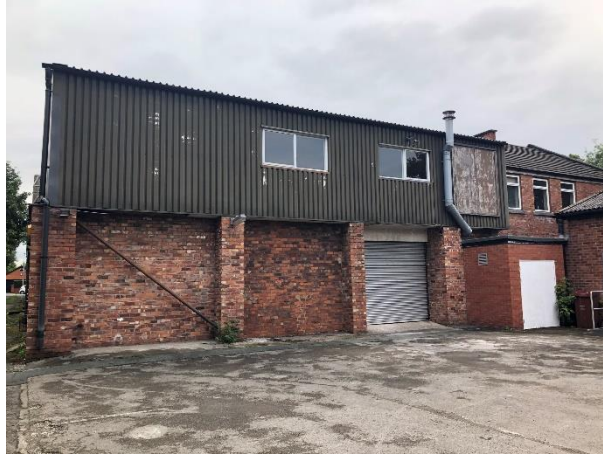
PLATE 6      SHOWING SOUTH-WESTERN ASPECT OF BUILDING

The south-western aspect of the building comprised a brick wall, with the top half of the wall overlain by corrugated metal sheeting. The brick wall was in good condition, with no potential roost features observed. The overhanging corrugated metal sheeting contained small gaps at the base which could be used by crevice dwelling bat species on an occasional basis.

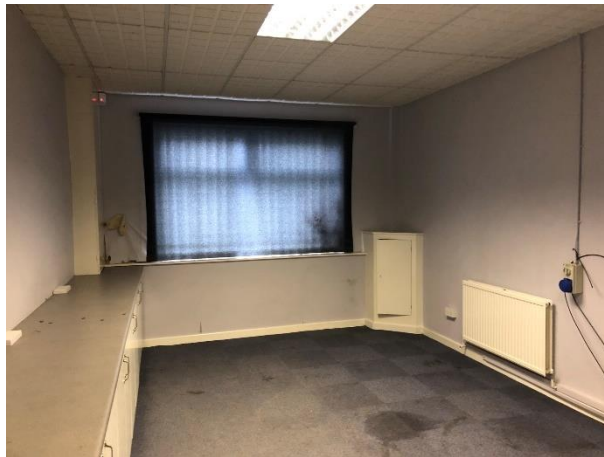
PLATE 9      SHOWING ONE OF THE FORMER OFFICE ROOMS

In addition to the open floor spaces, a series of small rooms formerly used as offices, welfare facilities and storage rooms were located across two floors. These rooms were modern and in good condition and appeared to be in use up until recently. No entry points for bats or any features that could support crevice dwelling bat species were observed.
