## **BAT PRESENCE / ABSENCE SURVEY**

### **Slade Lane Neighbourhood Centre**

642 Stockport Road  
Longsight  
Manchester  
M13 0RZ

| UES reference: | UES03593/02 |

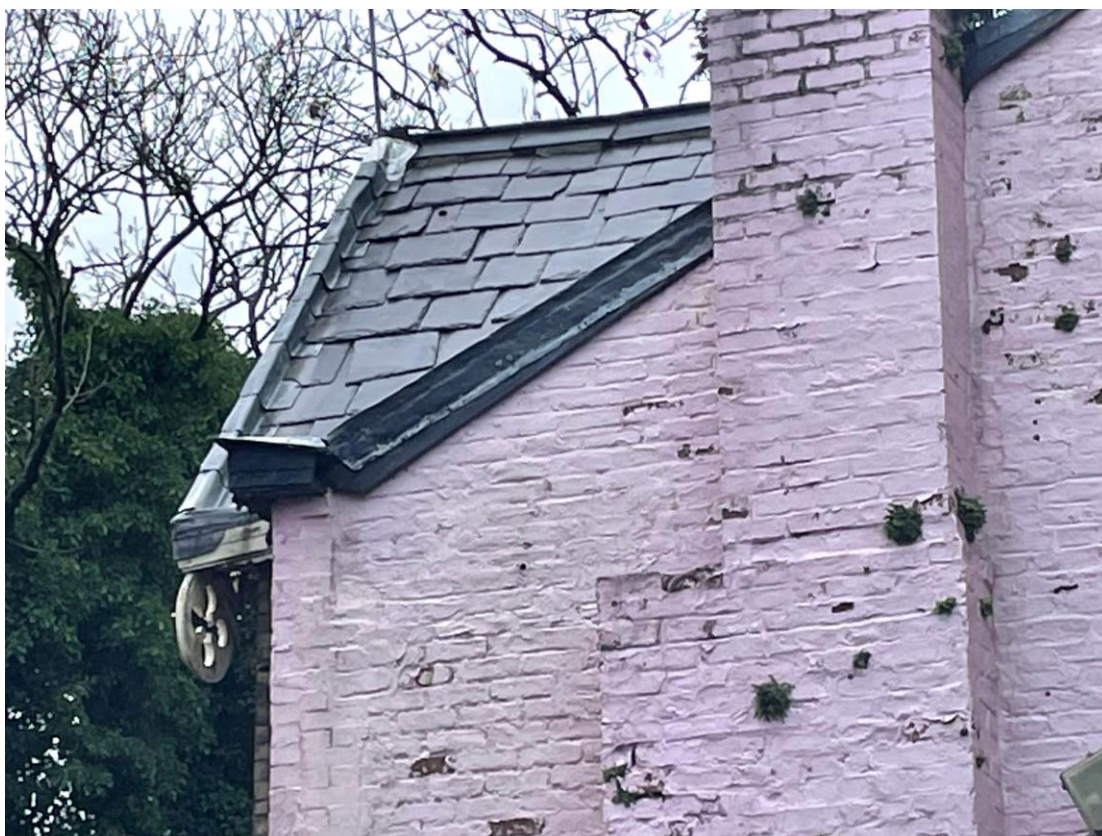
Photograph 1 – The building's south-western aspect, with raised lead flashing and barge boards, loose roof tiles, gaps present under the ridge tiles and the box soffit.

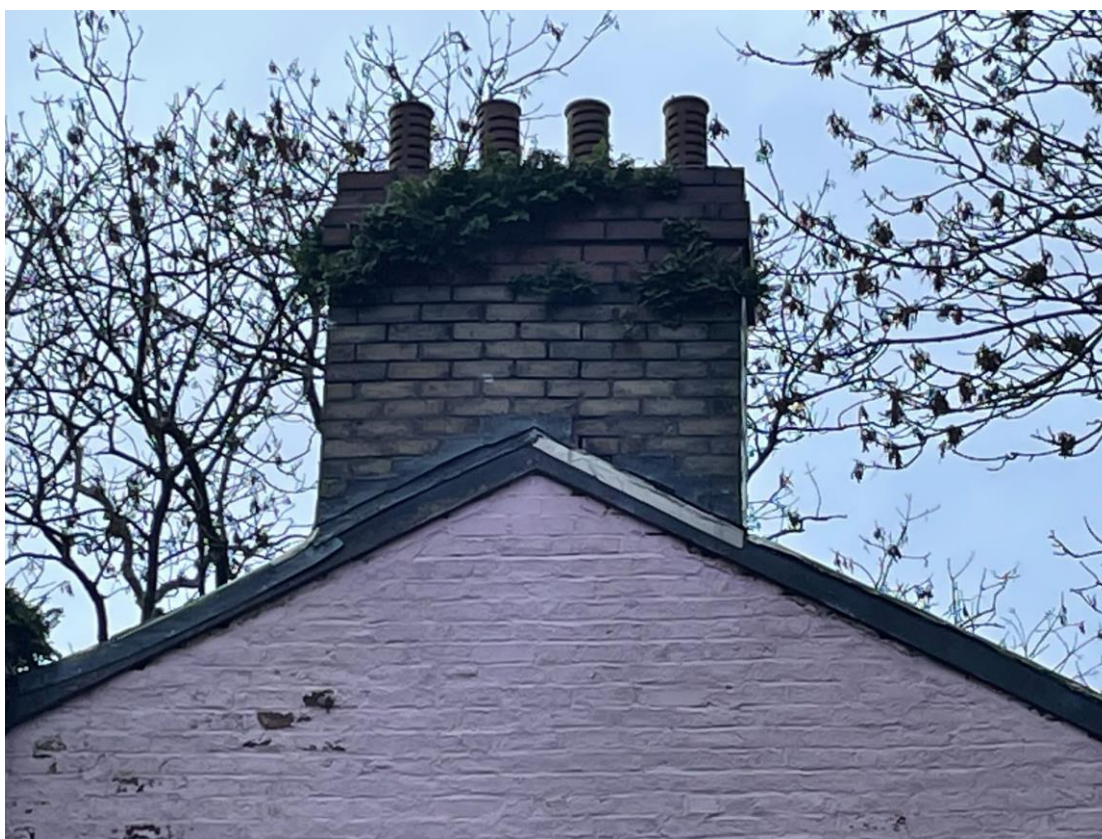
Photograph 2 – South-western aspect with established vegetation on the brick chimney, missing lead flashing, and gaps between bricks and the barge board.

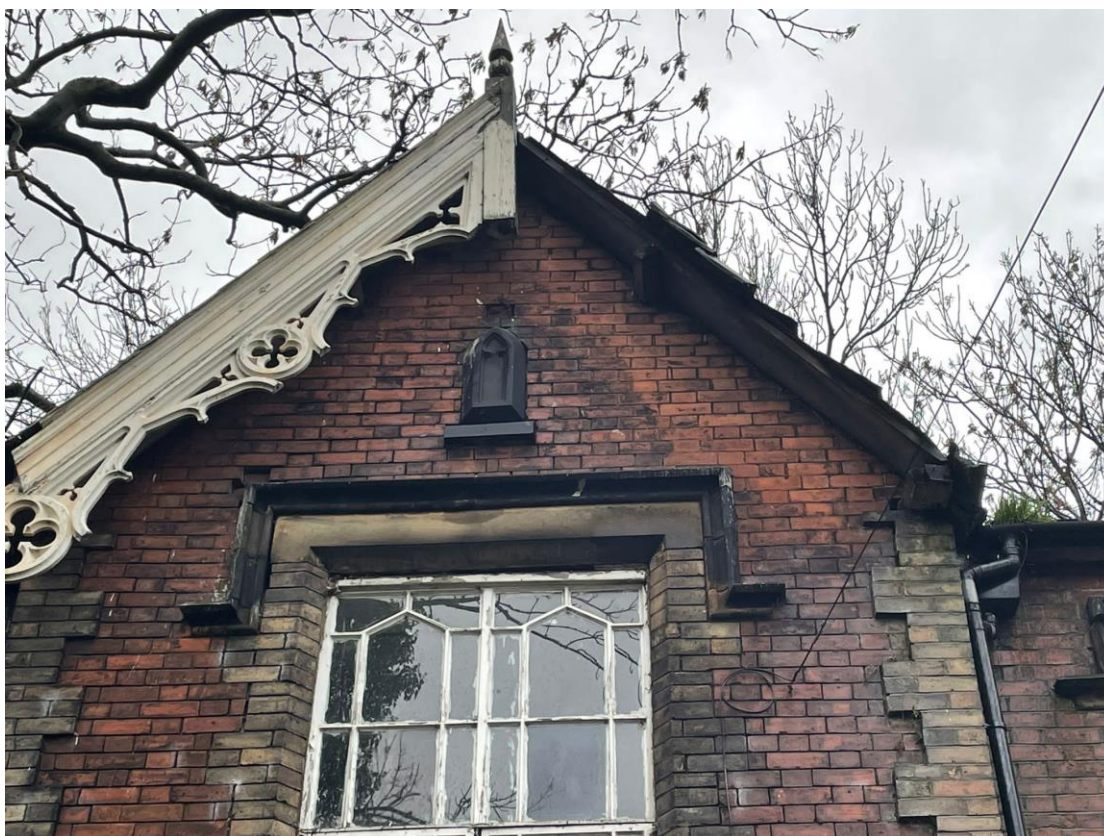
Photograph 3 – North-western aspect, where the barge board is partially missing from the gable end, with gaps present between the eaves, brickwork and lintels.

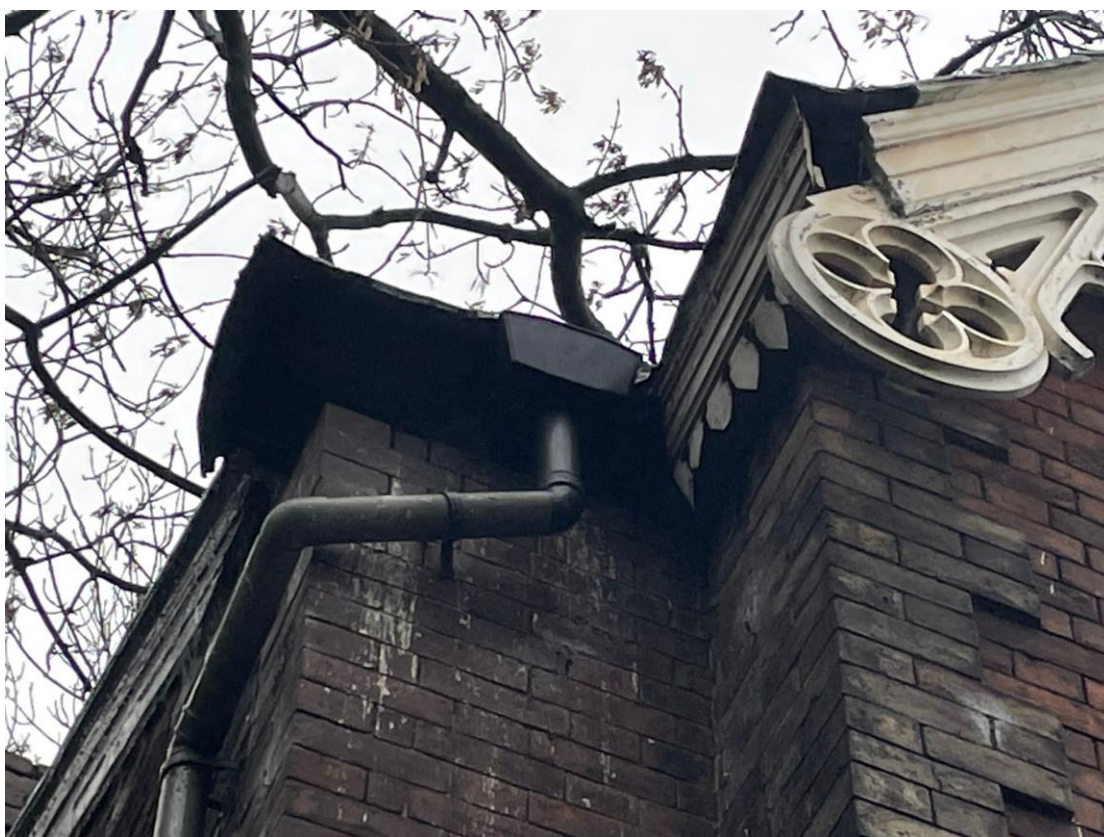
Photograph 4 – Northern aspect where access to the wall plate is granted by gaps in the fascia and barge board.

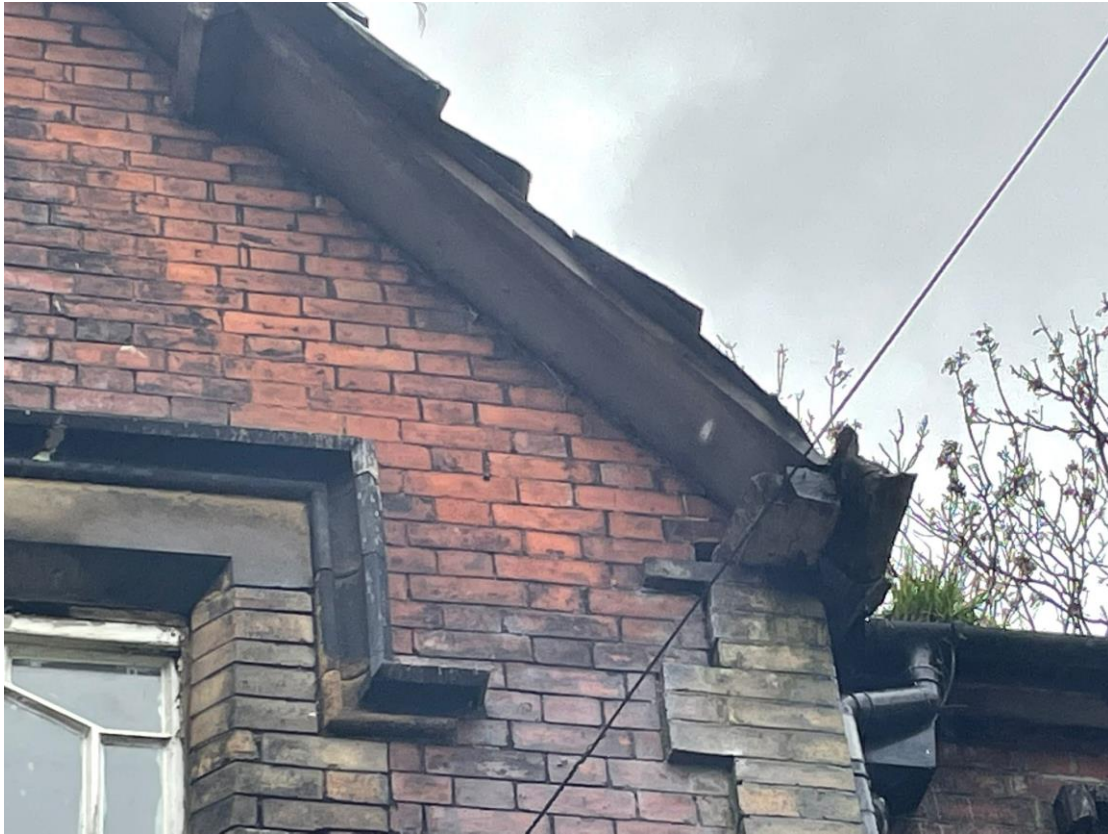
Photograph 5 – Gable-end at the north-western aspect with large gaps present under the eaves and where bricks are damaged.

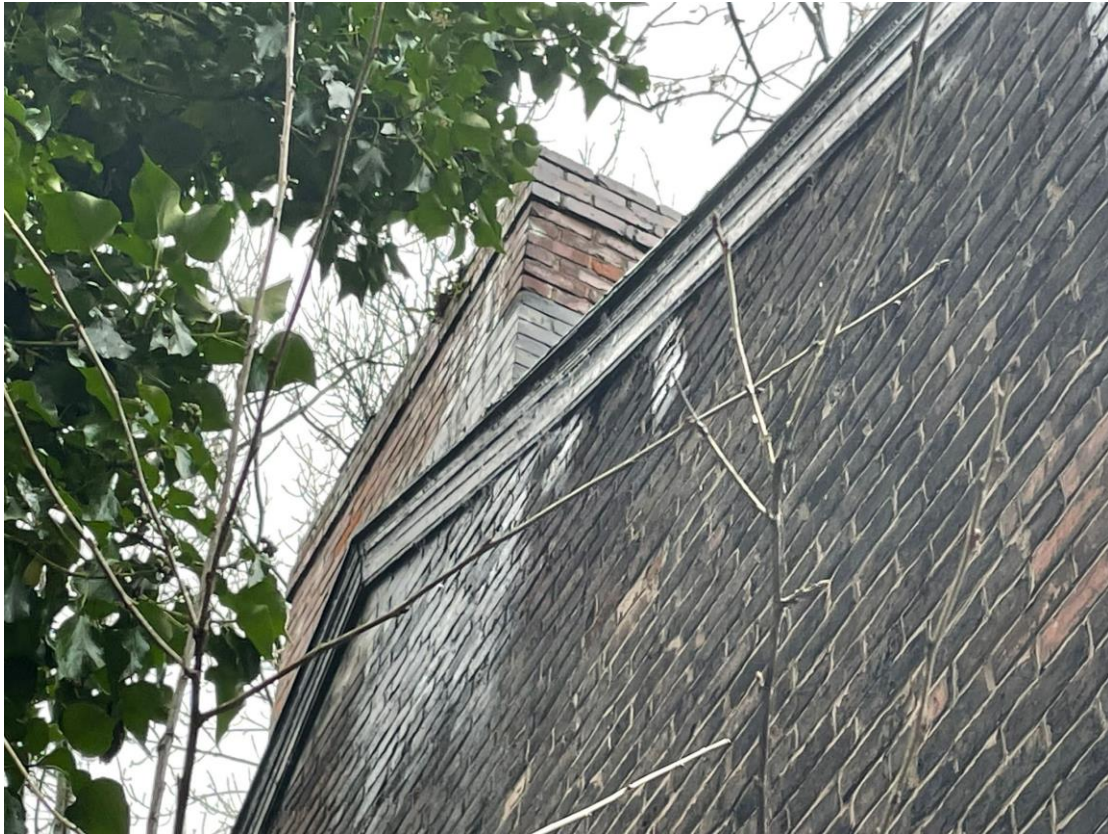
The brickwork of the Slade Land Neighbourhood Centre is generally in poor condition, as there are several instances where damaged brickwork presents PRFs for bats (see Photograph 6). Missing mortar between bricks at the south-western aspect has created gaps, but it was not possible to determine whether these gaps were superficial or suitable for bats (see Photograph 7). Damaged brickwork with multiple examples of sunken and protruding bricks are present at the north-western and north-eastern aspects (see Photograph 8).

Photograph 6 – North-eastern aspect where barge boards have lifted from the brickwork.

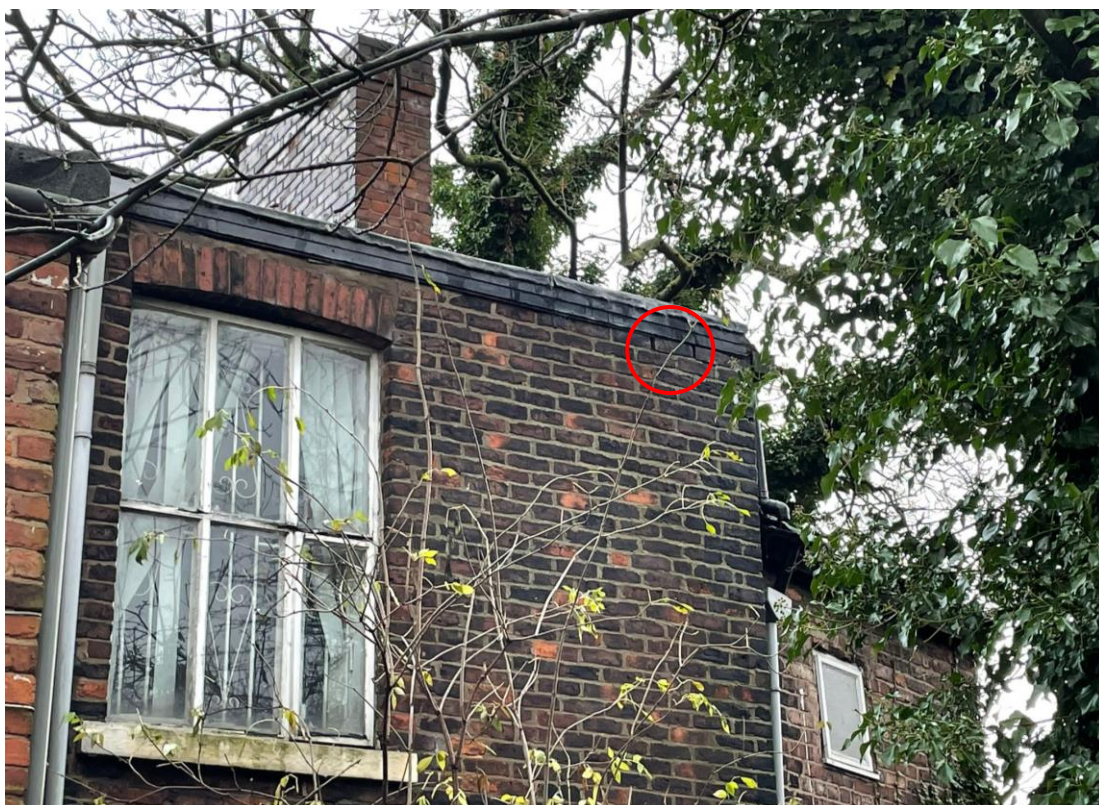
Photograph 7 – South-eastern aspect with lifted lead flashing and missing mortar between bricks.

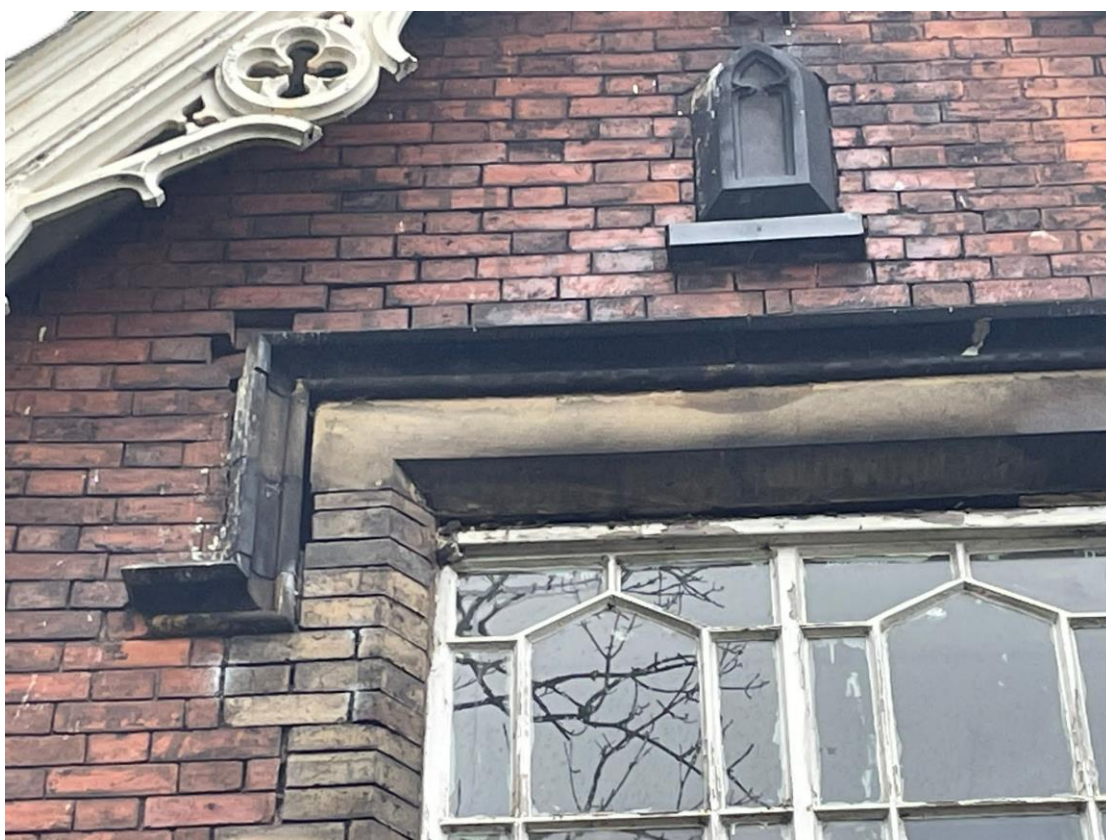
Photograph 8 – Damaged bricks and numerous gaps between the lintels, brickwork and rotten window frames.

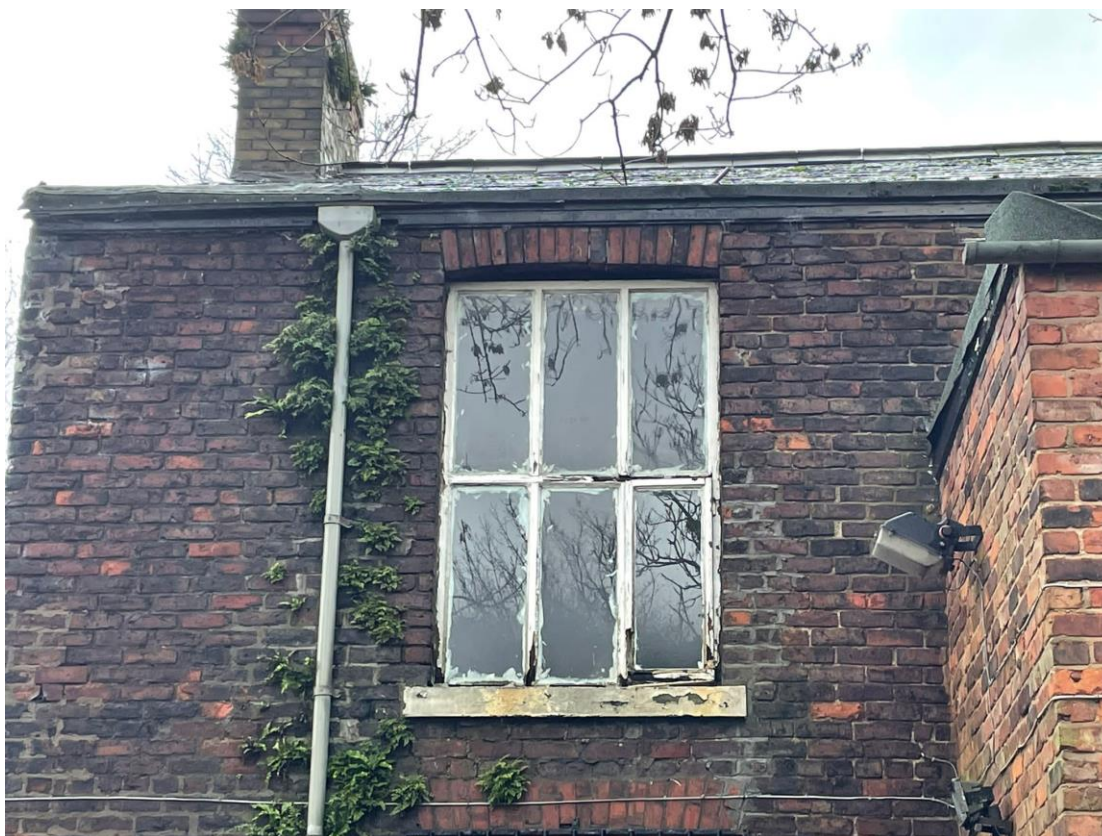
A mix of brick and stone lintels house windows in timber frames that vary in condition. The brick lintels at the south-eastern aspect are in good condition throughout and present no PRFs for bats (see Photograph 9). However, the second-storey stone lintels located on the north-western aspect have gaps between the stone lintel and ornamental features, with additional gaps where the lintel meets the window frame. The timber window frames at the north-western and south-eastern aspects are rotten with gaps present between the frames and brickwork.

Photograph 9 – South-eastern aspect with rotten timber window frames housed by brick lintels and lifted bitumen roof felt of the southern brick extension.

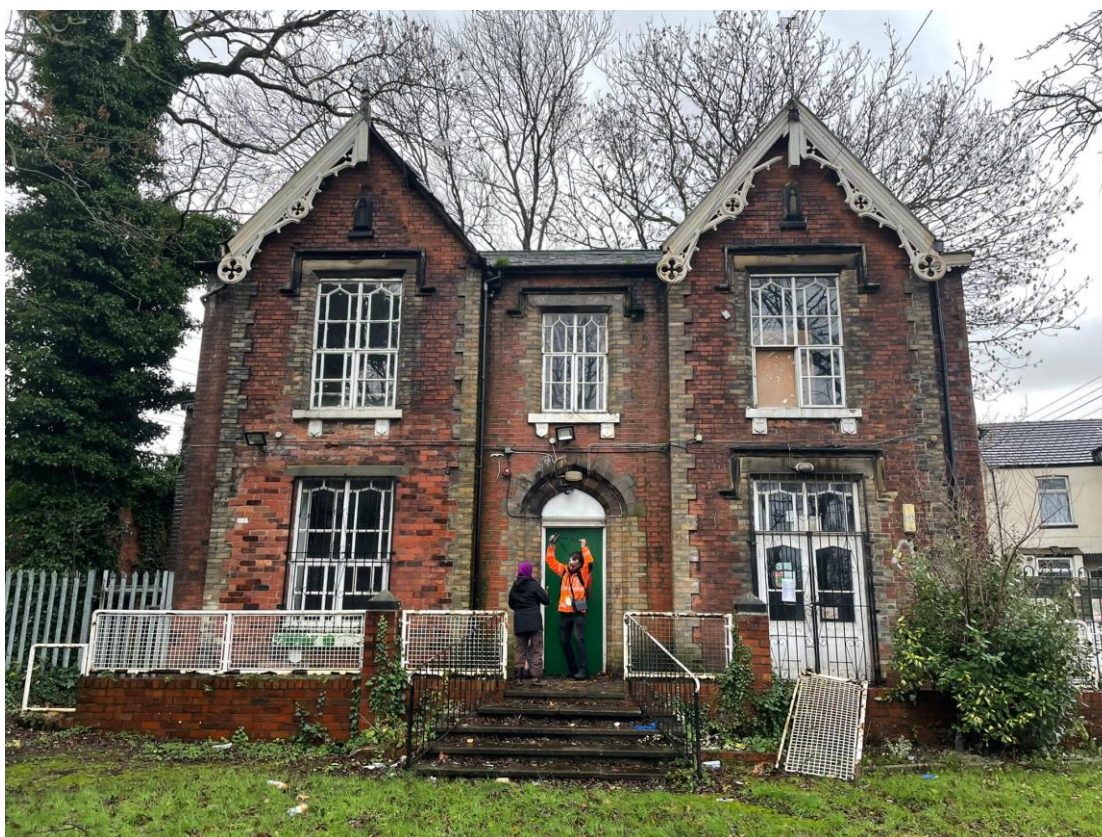
Photograph 10 – North-western aspect of Slade Lane Neighbourhood Centre twin gable ends, with damaged barge boards, several large windows and arched doorway.

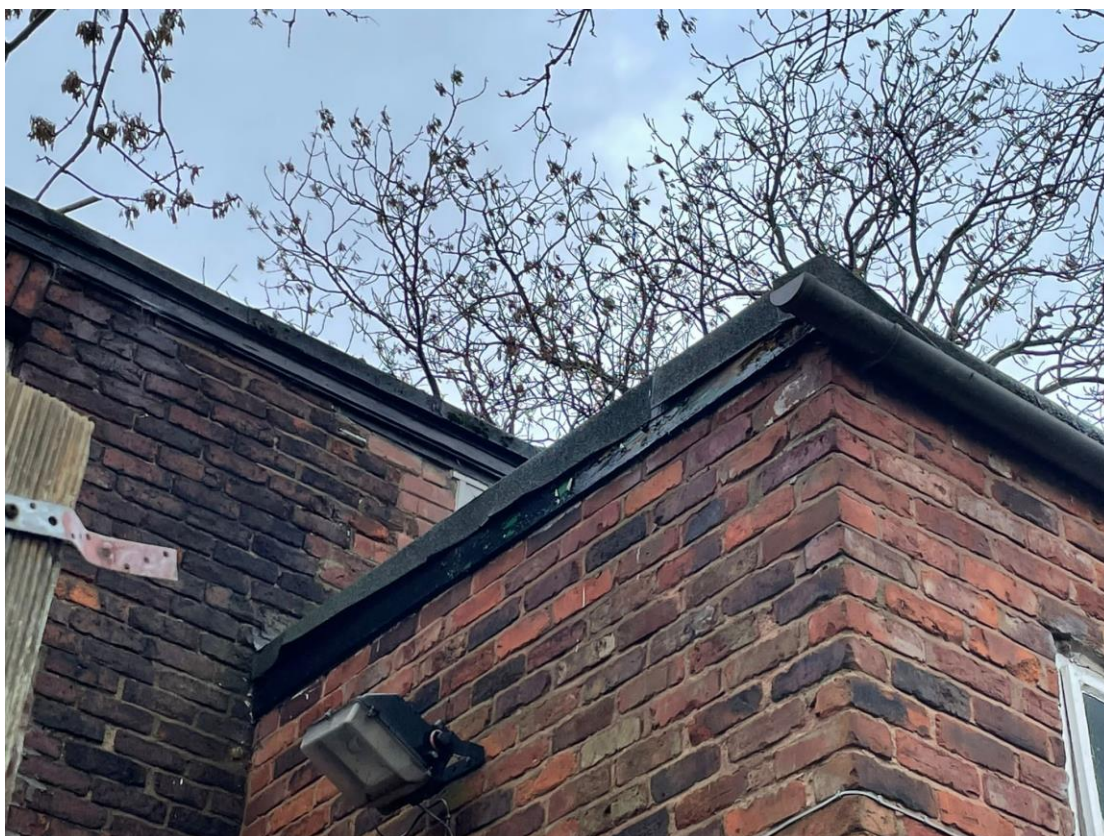
Photograph 11 – The south-eastern extension displaying the bitumen roof felt that has lifted from the flat roof, with the bonded red brick structure and timber window frame.

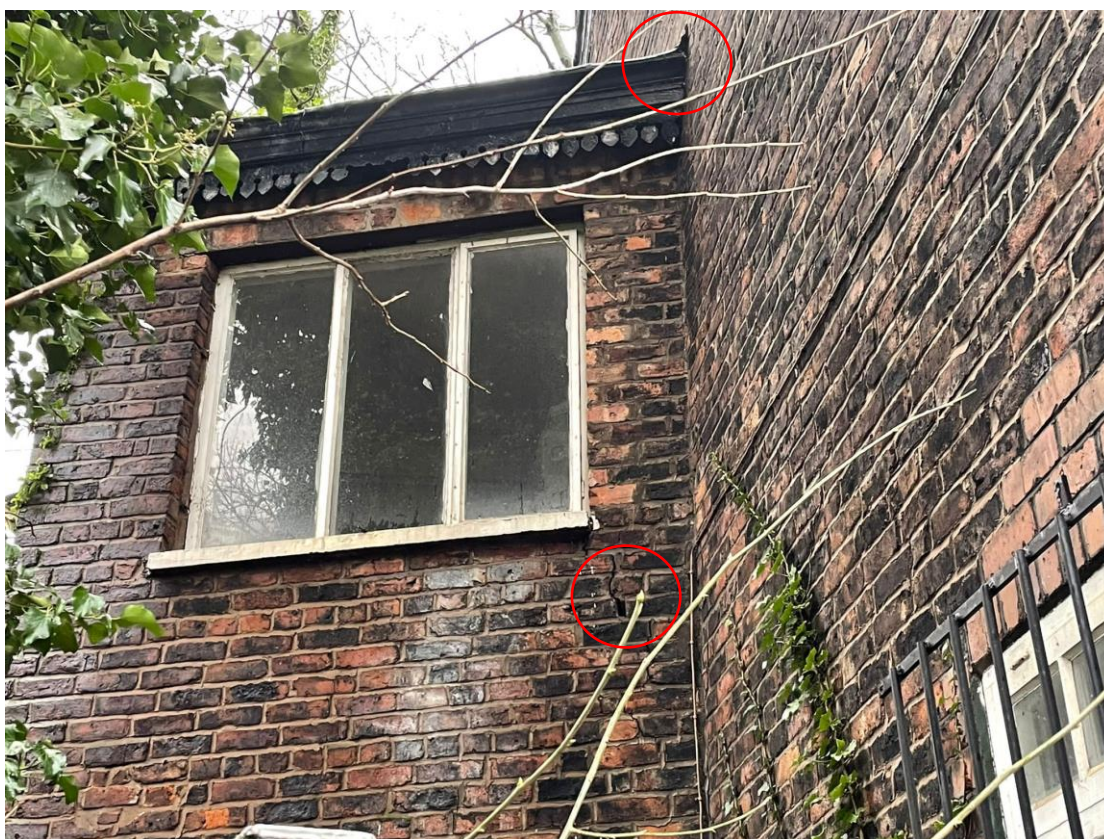
Photograph 12 – North-eastern flat-roofed extension with damaged fascia's, lifted lead flashing, timber window frame in good condition, and gaps in brickwork.

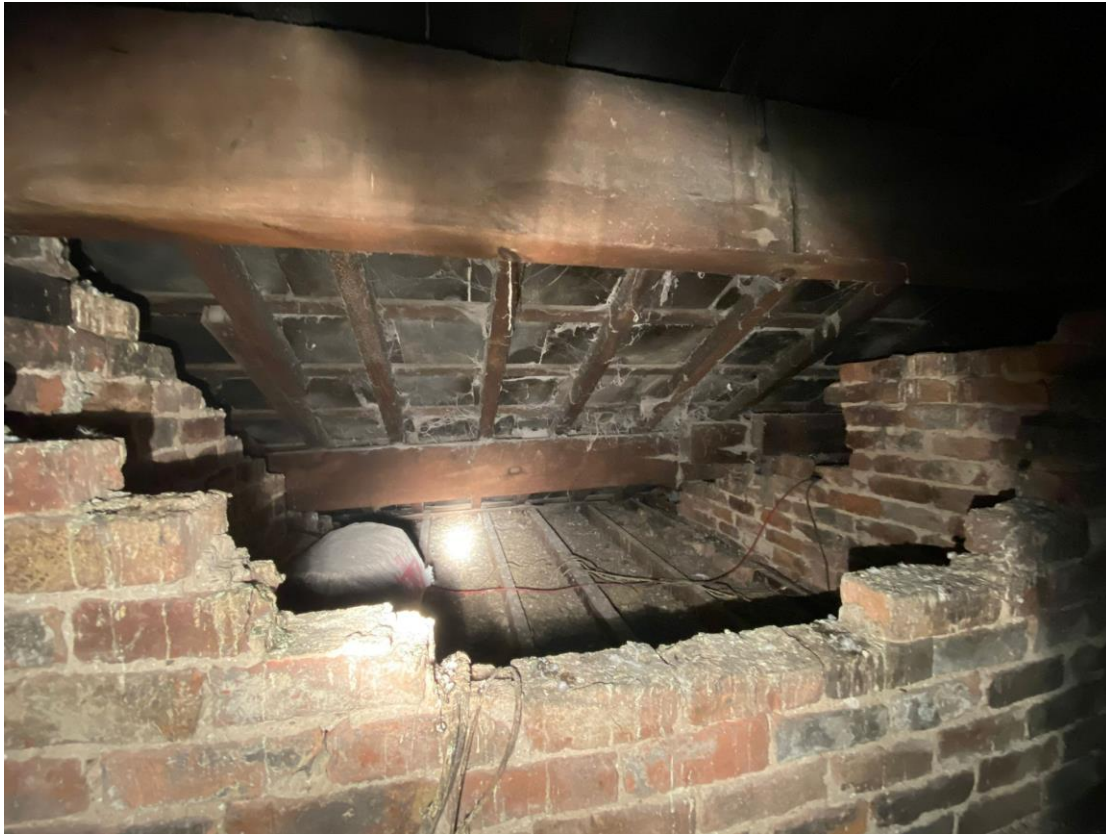
Section 1 has a floor to ceiling height of approximately 1.9m. Partial brick walls divide the loft space into multiple open sections (see Photograph 13). There is no membrane roof lining in Section 1 and the mortar between the roof tiles is in poor condition. Access into the loft is possible through the gaps beneath the roof tiles in multiple areas of the roof. All sections were fully inspected and no evidence of use by bats was found.

Photograph 13 – Open brick sectioned section located within section 1 of the loft void, with timber purlin rafters and bitumen lining.

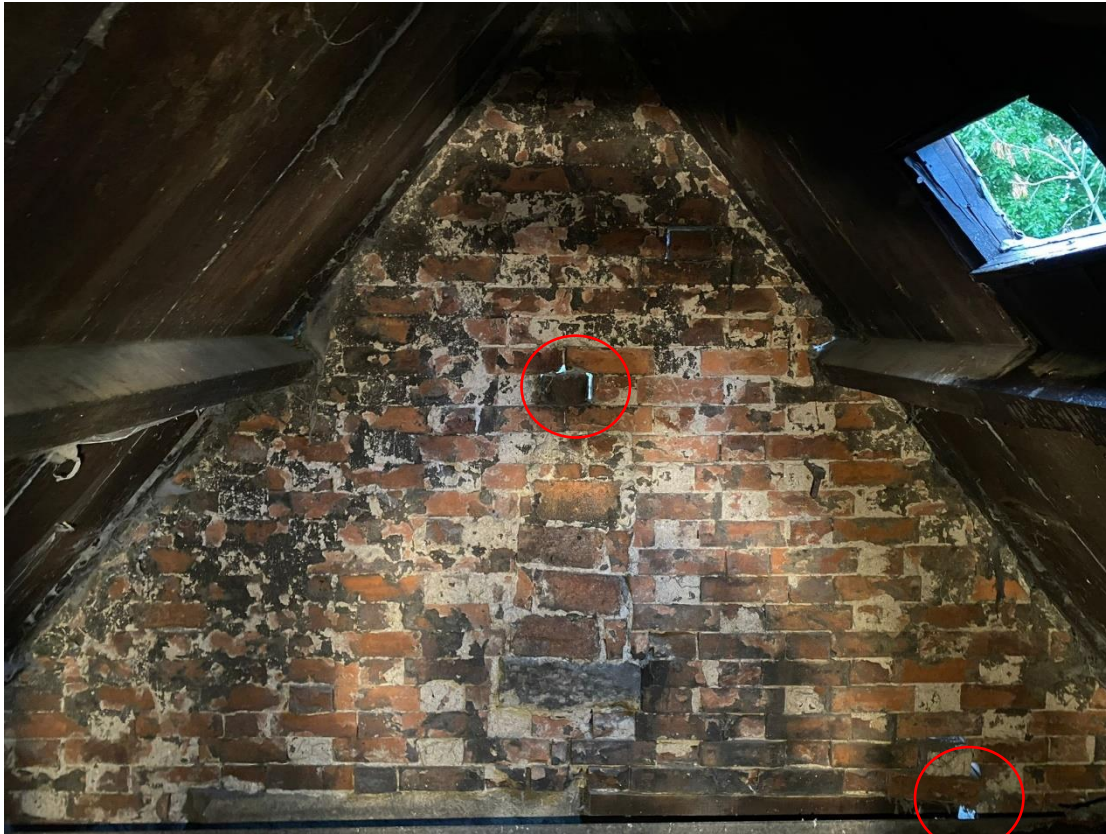
Photograph 14 – North-western gable end in section 2, with timber rafters lined with sarking boards, skylight lacking windowpane, and light entering through brick wall in poor condition.

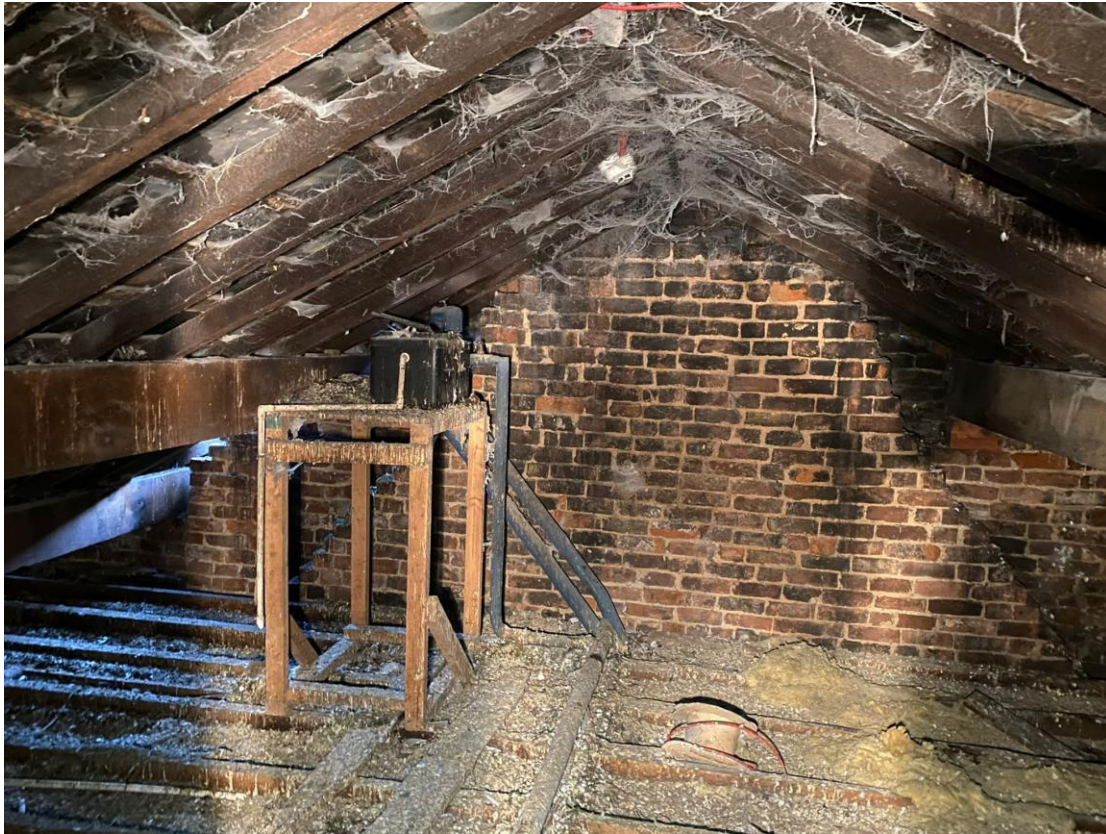
Photograph 15 – Section 1 with traditional purlin timber rafters, lined with bitumen roof felt, dense cobwebs, brick gable ends in poor condition, and guano covered insulation.

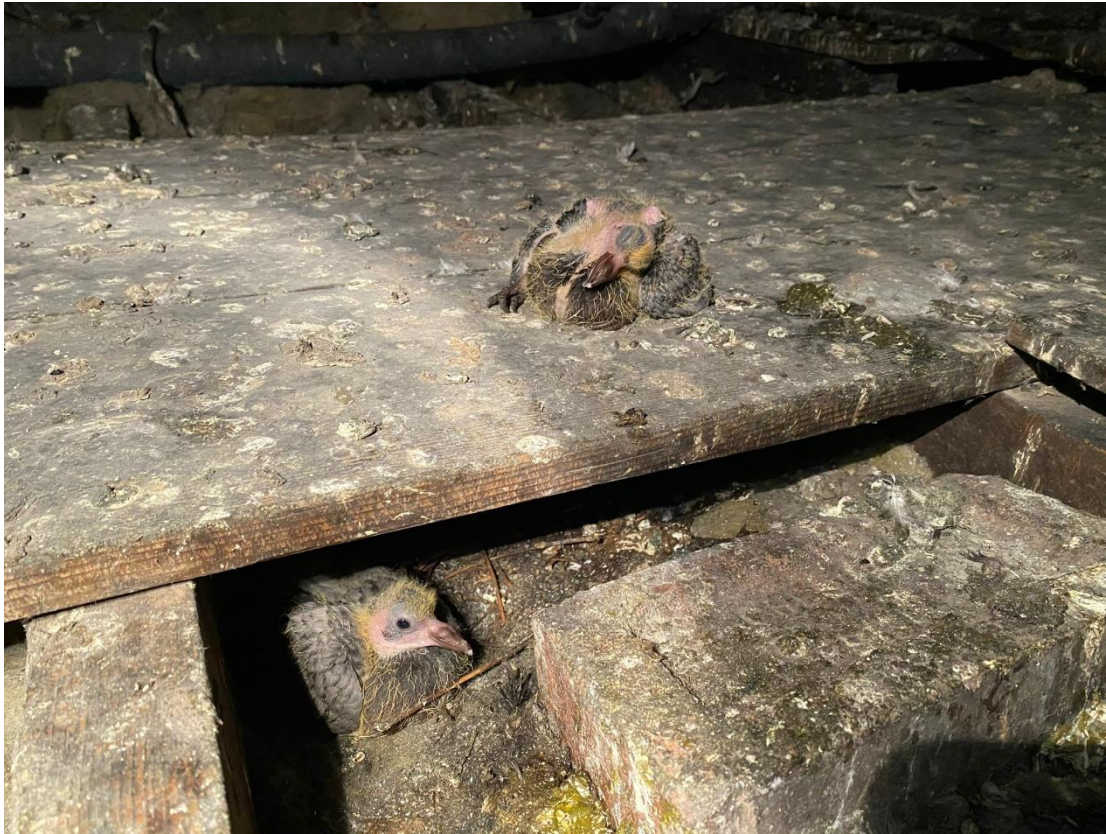
Section 2 is separated from Section 1 by a brick and timber wall. This section lined with timber sarking boards; a skylight is present between the sarking boards with no glass present, granting access for feral pigeons and other birds (see Photograph 14). The roof has a traditional rafter and purlin construction, with dense cobwebs and droppings covering the rafters. The brick gable ends of the building, are in poor condition; there are gaps in the mortar where light ingress is visible at the north-east, north-west and south-west aspects. Light also enters the loft void via large gaps in the eaves and roof at the gable ends void (see Photograph 15). The presence of feral pigeons and high levels of exposure to natural light within the loft void reduces the suitability for roosting bats, however, the size of the void and numerous access points create an ample number of opportunities for roosting bats. Blanket insulation is used on the loft cavity floor, which will stabilize the temperature within the loft void, and which is suitable for bats (see Photograph 16).

Photograph 16 – Live and deceased Pigeon offspring in section 1 of the loft void.

Due to the potential presence of breeding birds in the buildings on site, it is recommended that the initial site clearance (including vegetation) and demolition works take place outside of the breeding bird season and should not be undertaken from March to August inclusive. If this is not possible, a breeding bird nest survey should be undertaken prior to the commencement of works by a suitably experienced ecologist and an ecological clerk of works appointed if considered necessary. A pest control specialist should be contacted to discuss and arrange the control and removal of feral pigeons under general licence prior to the start of the development works.

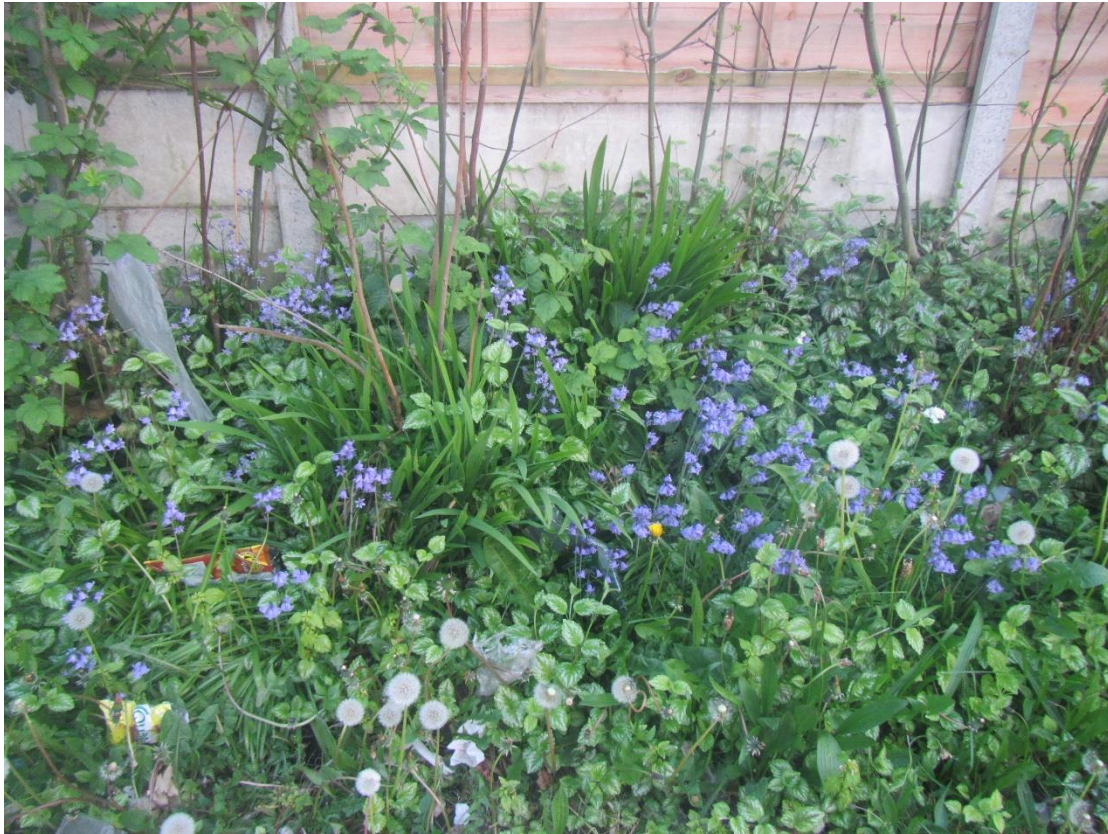
Photograph 17 – Montbretia and variegated yellow archangel observed within the southern section of the site.

A number of invasive species were recorded within the site boundary including montbretia located on the southern and western site boundaries, variegated yellow archangel located on the southern site boundary and Japanese knotweed located on the western and eastern site boundaries (see Appendix 1 – Site Plan). All of these species are listed under Schedule 9 of the Wildlife and Countryside Act 1981 (as amended). As a consequence, it is an offence to cause or allow any of these species to grow or spread in the wild, including as a result of development works. As such, if these areas are going to be disturbed as part of the development, they should be subject to control and eradication measures to ensure that they do not spread across of offsite as a result of the development works.

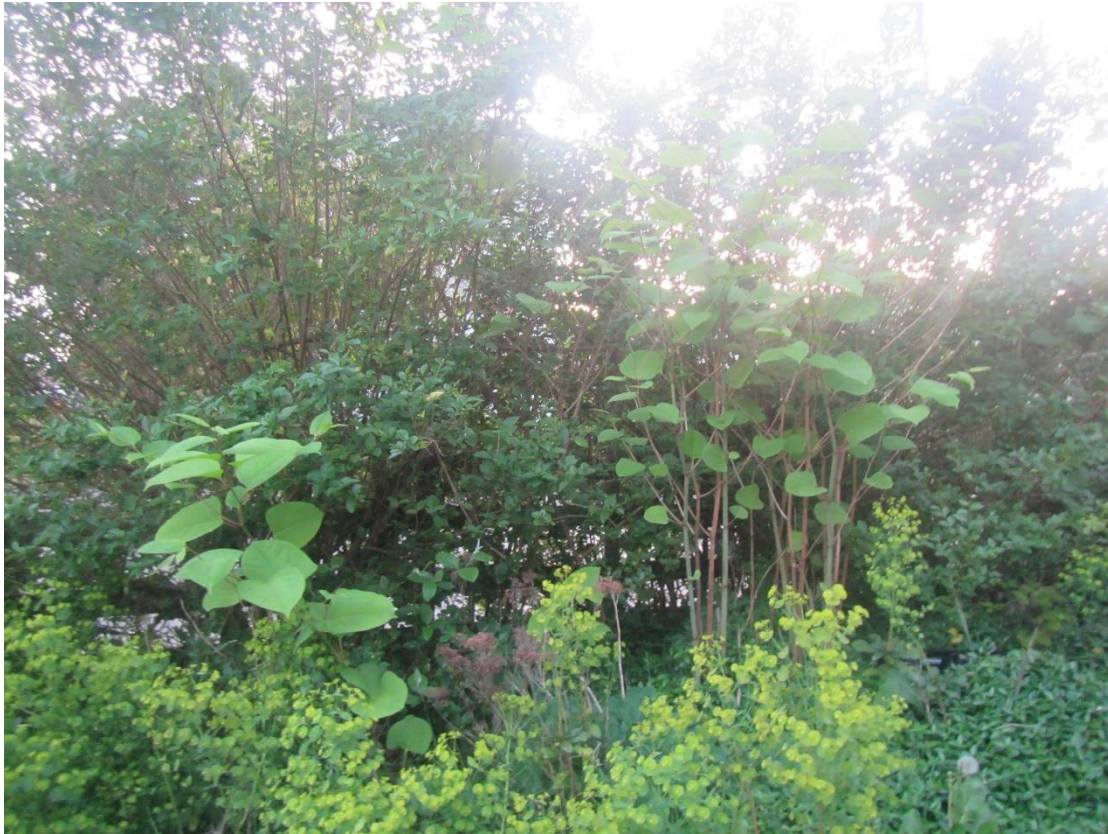
Photograph 18 – Japanese knotweed observed within the western section of the site.

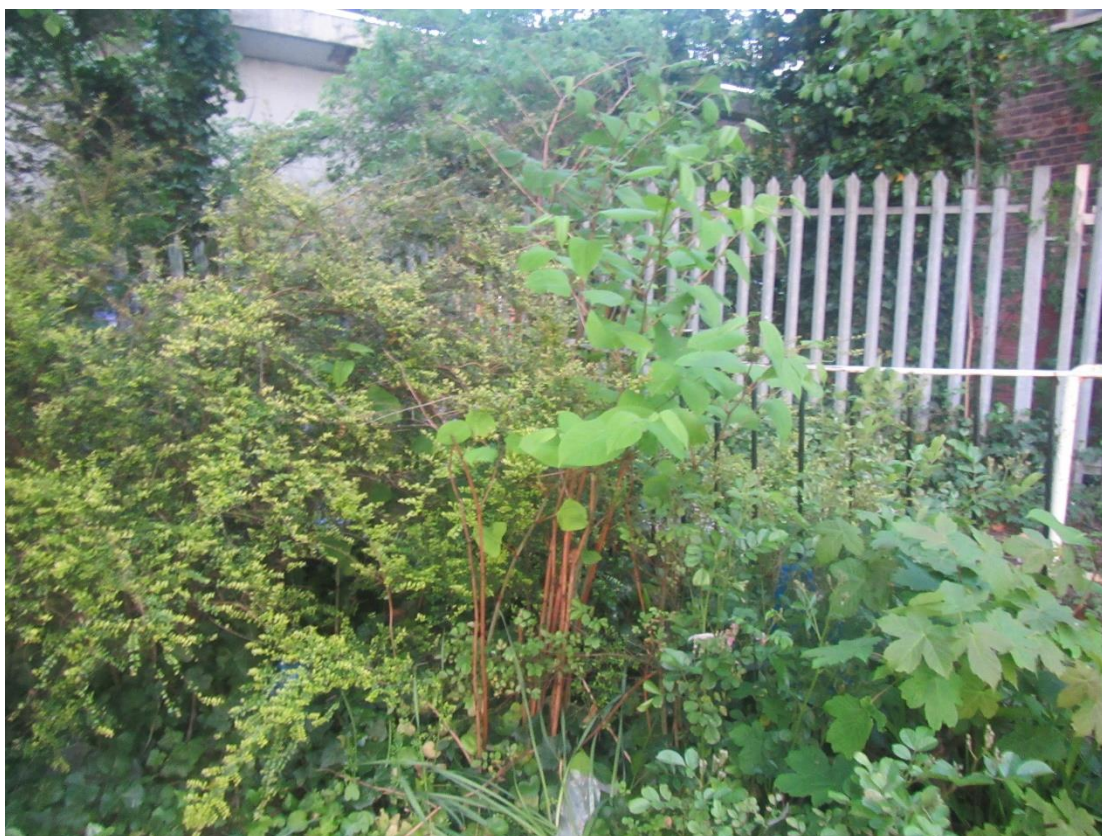
Photograph 19 – Japanese knotweed observed within the eastern section of the site.
