# MANCHESTER COLLEGE CAMPUS MANCHESTER

## SITE COMPLETION REPORT

**Job Number:** LKR191016

**Date:** June 2022

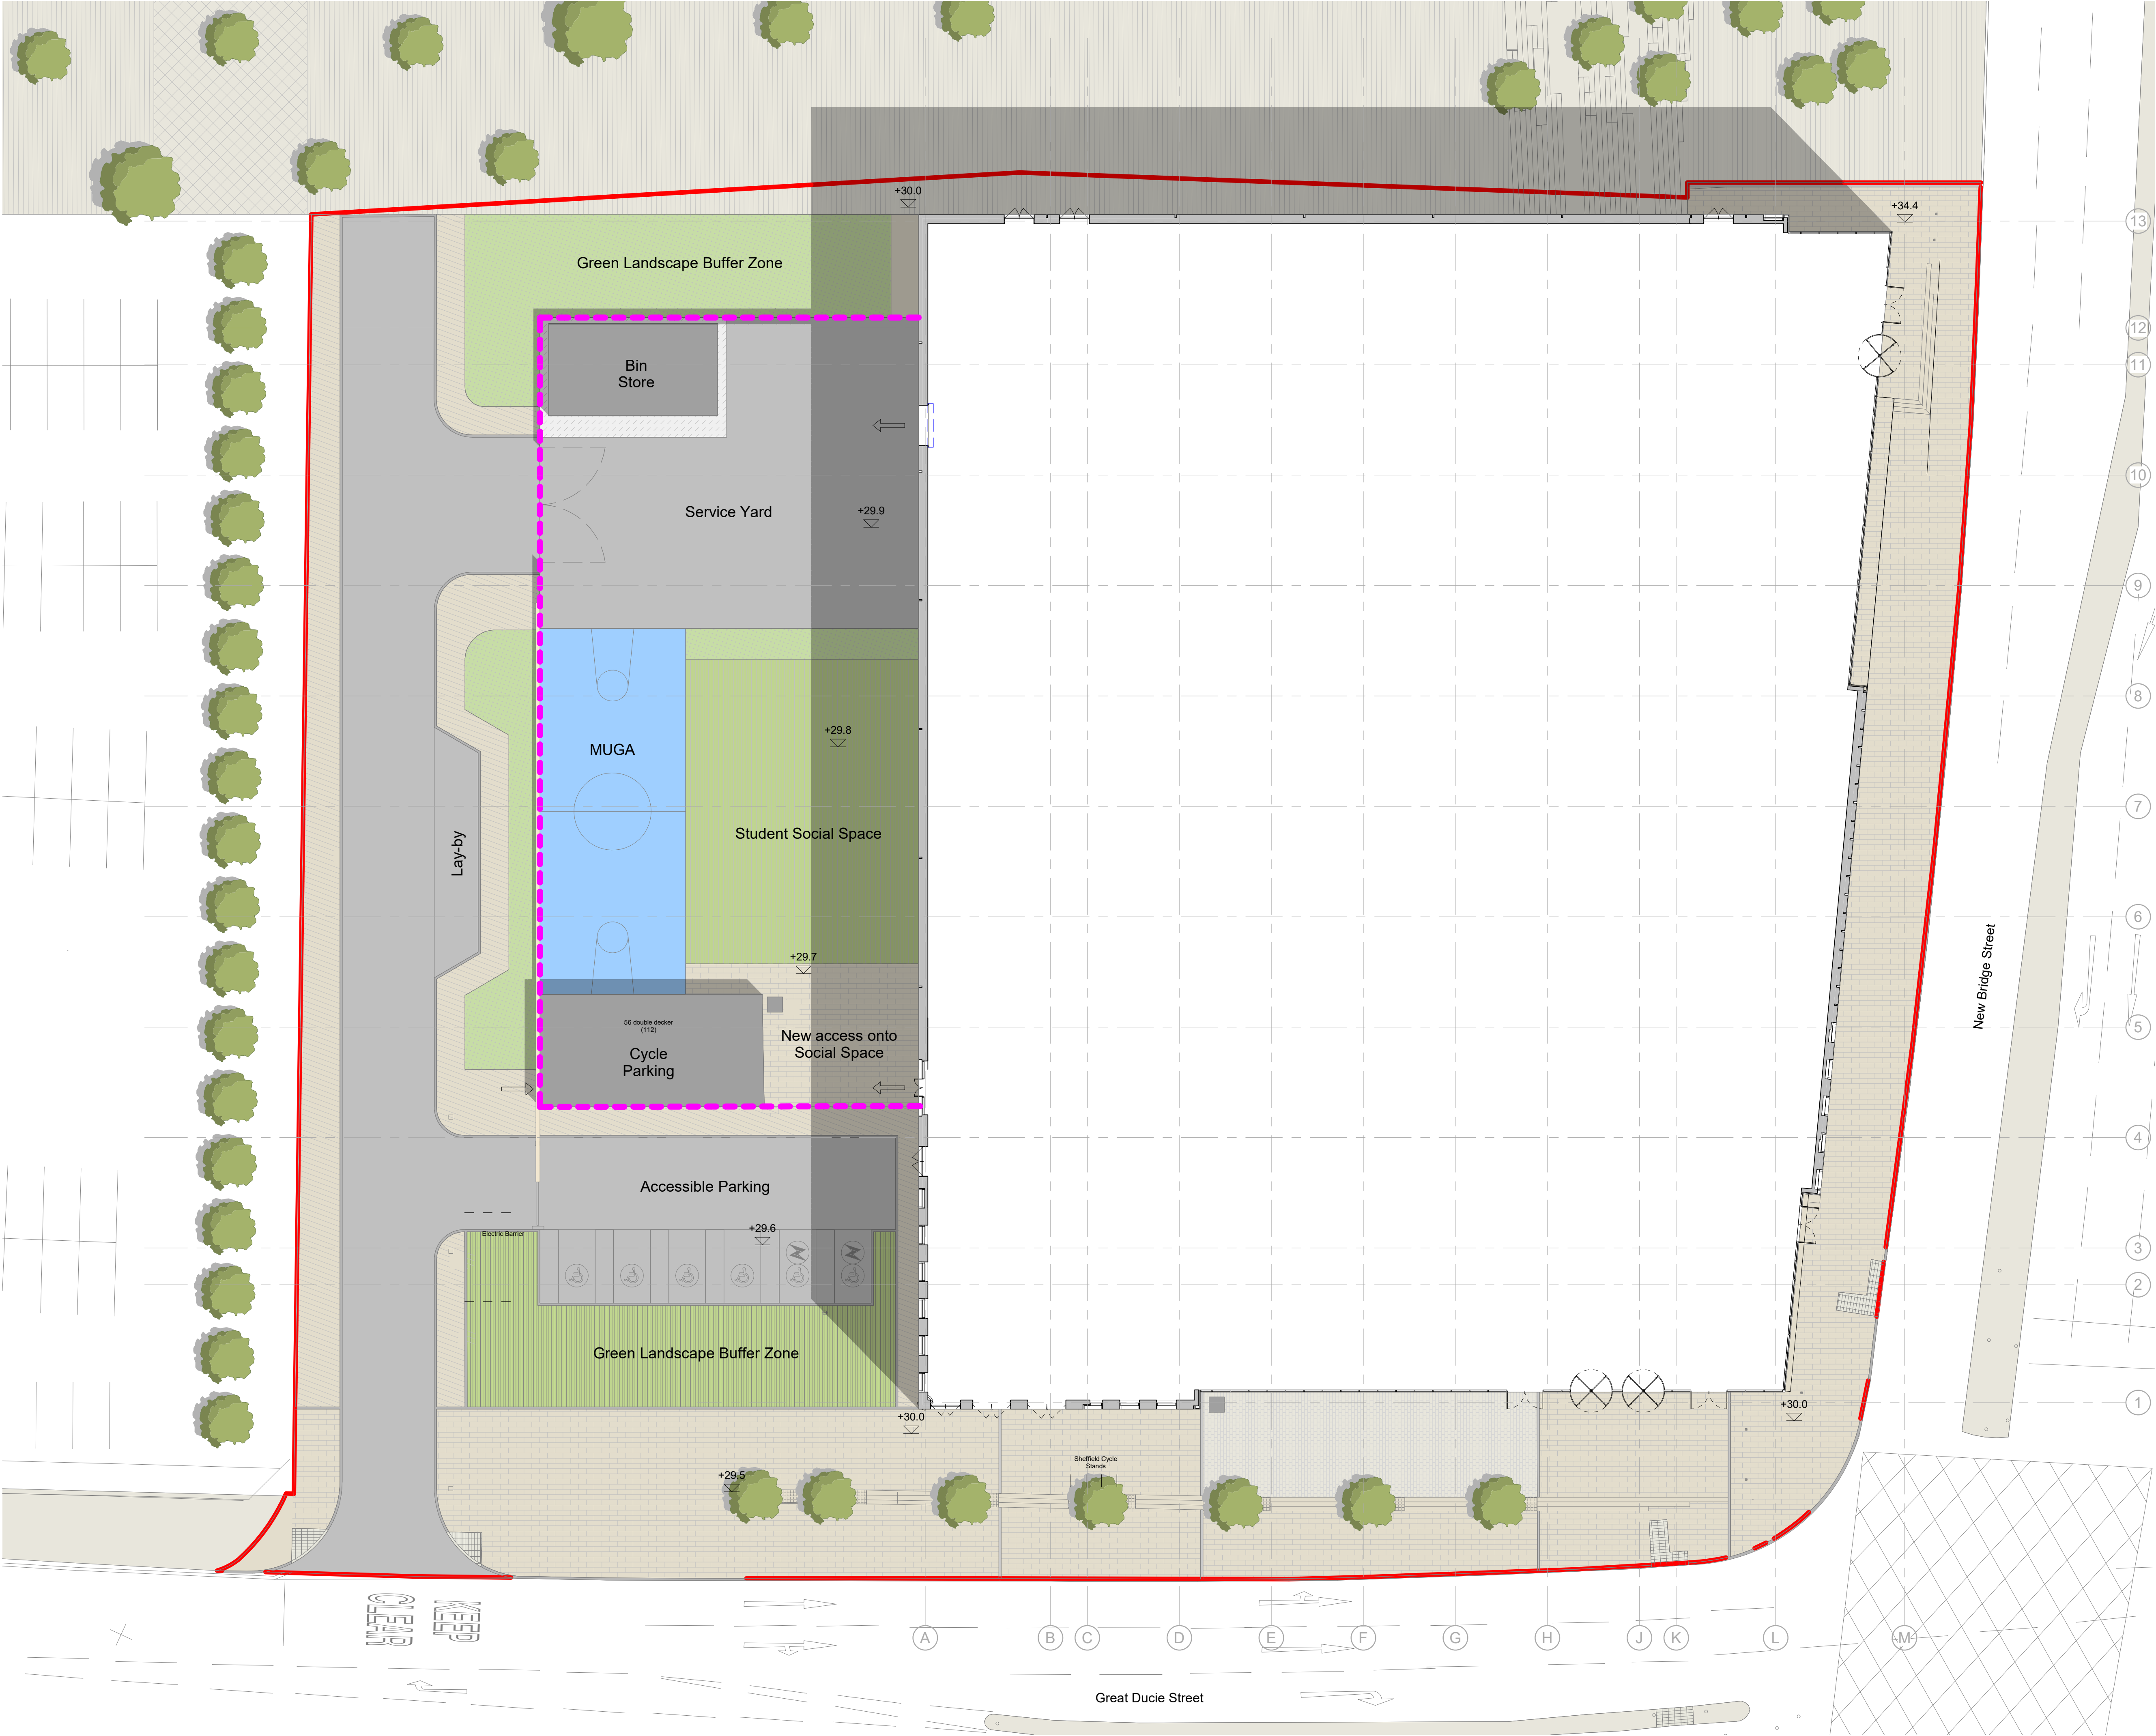
| project | originator | volume | level | type | role | number |
|---|---|---|---|---|---|---|
| CC - SHP - ZZ - XX - DR - A - 1005 | | | | | | |

The site is approximately 0.95ha and centred on NGR 383838E 399191N. The planning application is for the erection of a five storey educational building with associated access, servicing, landscaping, public realm and other associated works following removal of a car park. Drawing CC-SHP-ZZ-XX-DR-A-1005, included in Appendix A) shows the development plan.

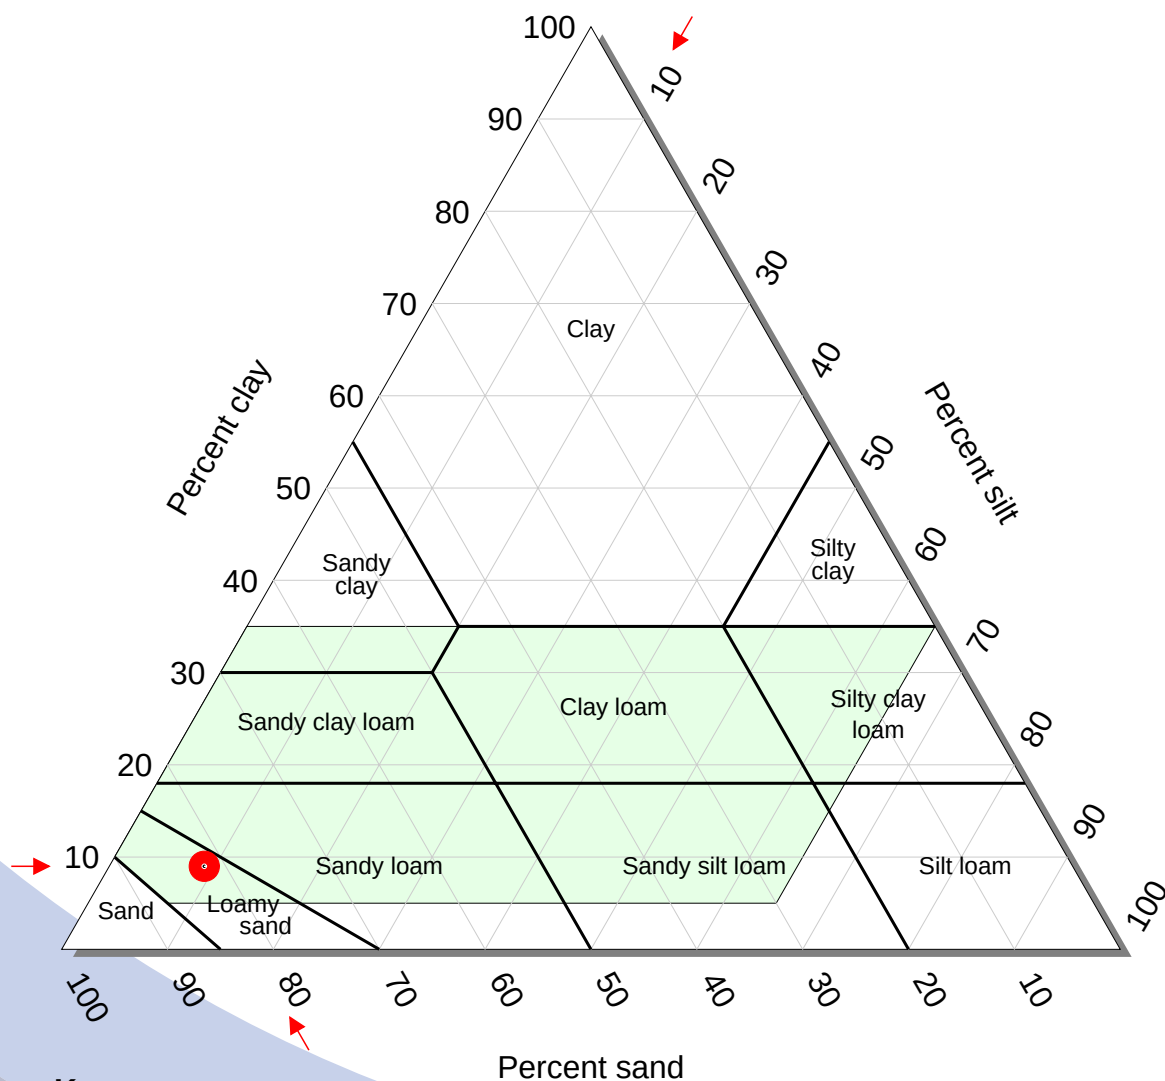
**Fig. 1. Textural Class: Organic Loamy Sand (compliant)**

| | | | | Compliant with range (Y/N) | | | | | |
|---|---|---|---|---|---|---|---|---|---|
| | Textural Class | | Organic Loamy Sand | Y | Y | Y | Y | Y | Y |

Area within which texture of topsoil is required to fall.

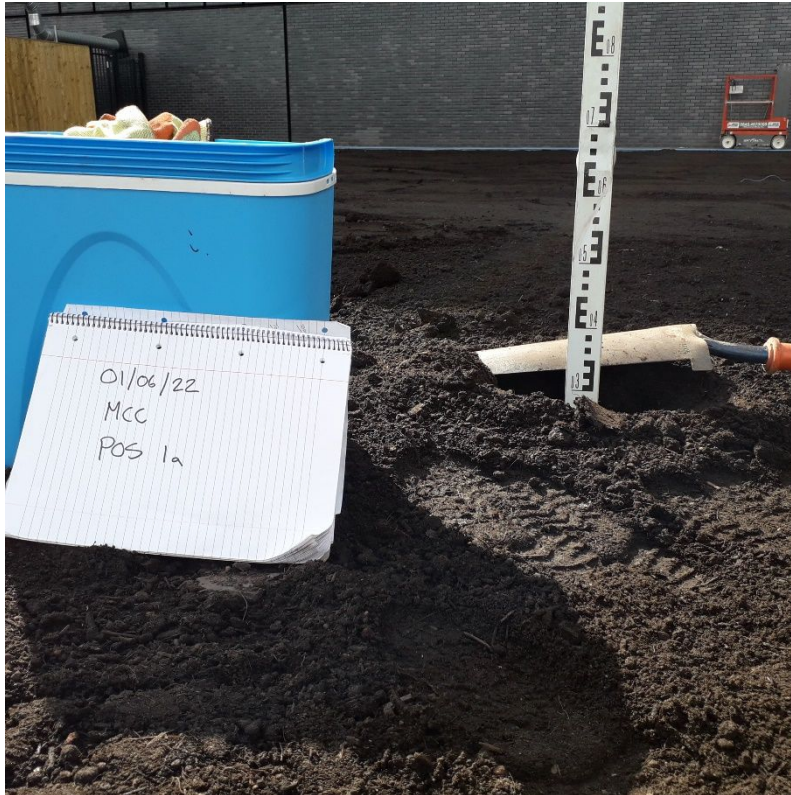
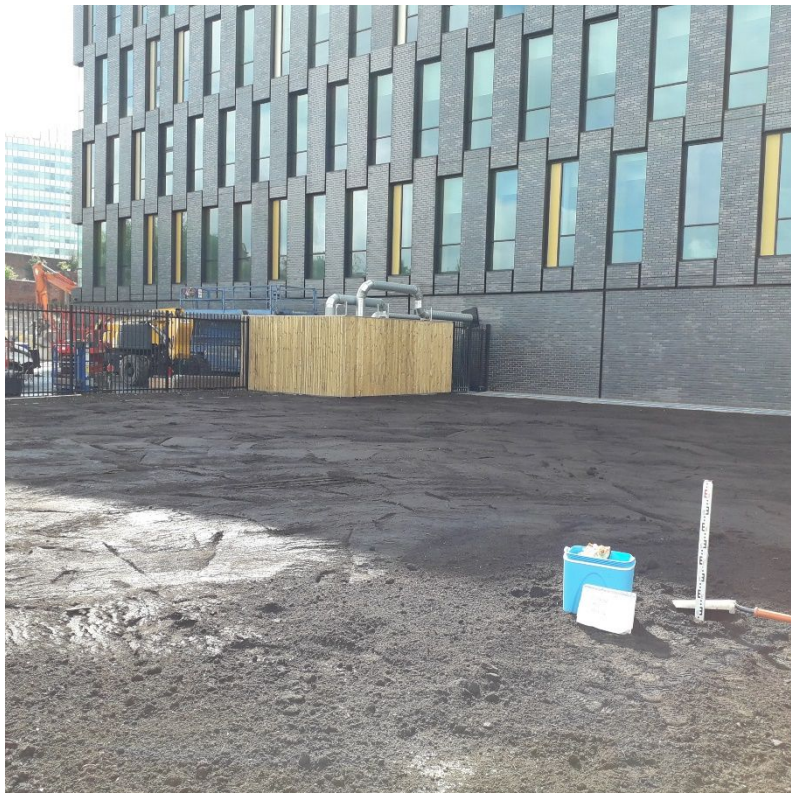
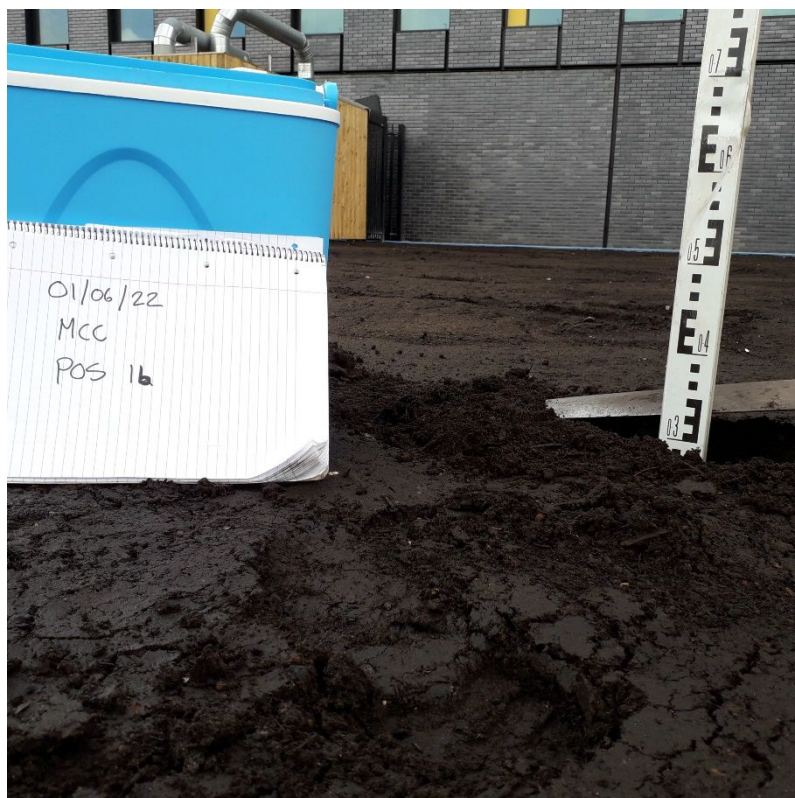
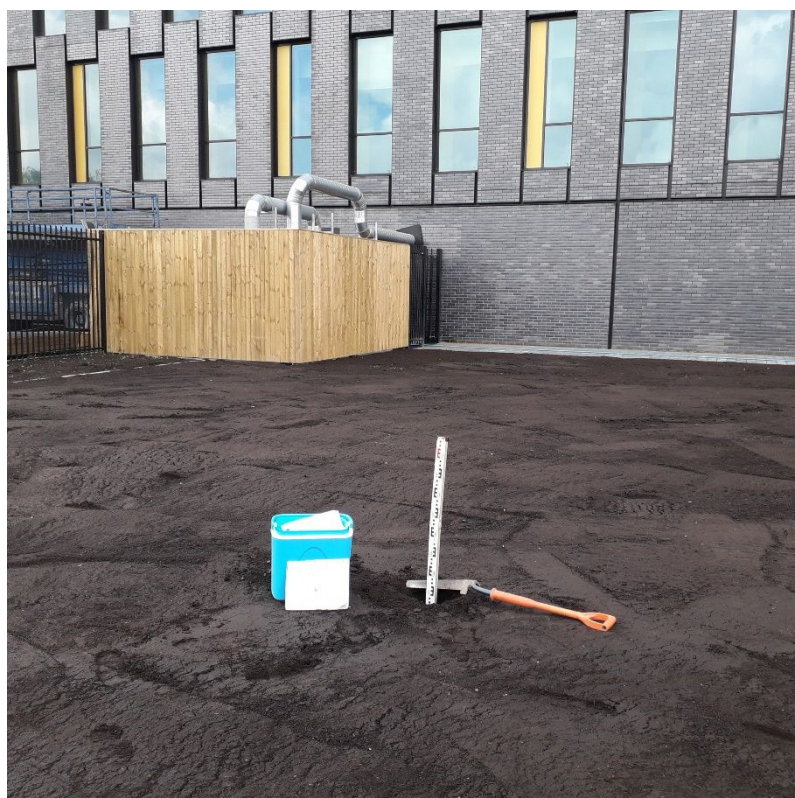
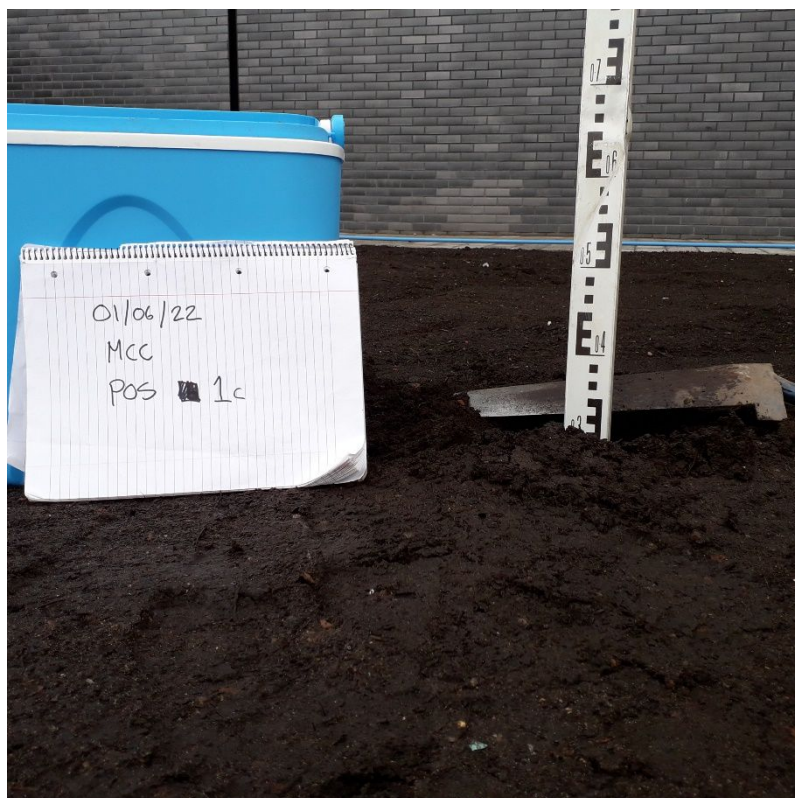
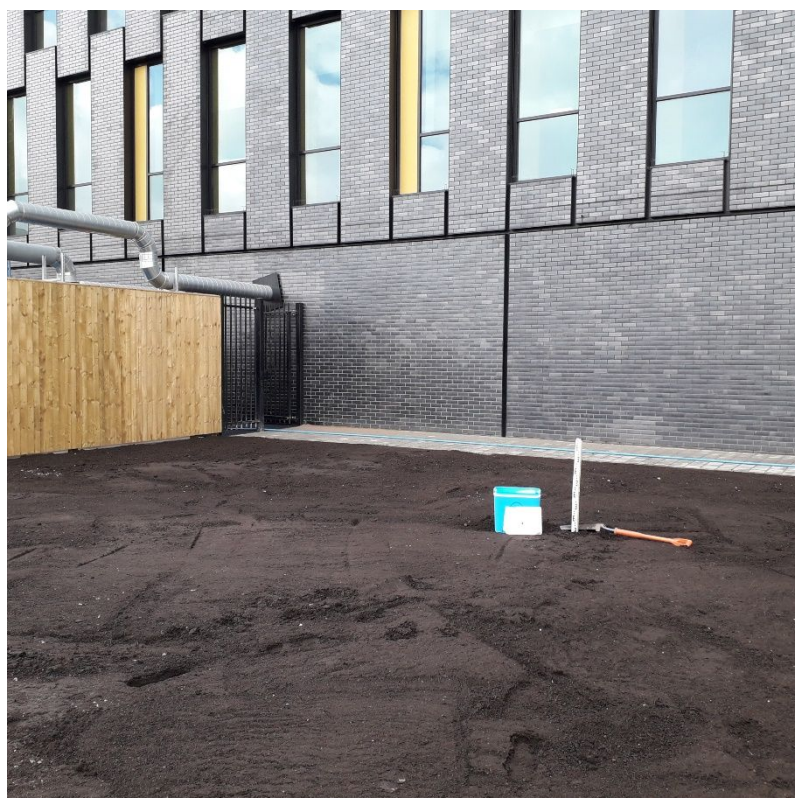
### **Photographic Record**

The requirements for the capping layer in soft landscaped areas were that it was to comprise 300mm depth of clean soils with a minimum of 150mm topsoil as a growing medium.

Photographs of the cover soils depth validation work for the soft landscaping are presented in Appendix D.

LKR consider that at the points of inspection soft landscaping areas at Wolverton Street, Manchester to have a capping layer of suitable cover thickness.

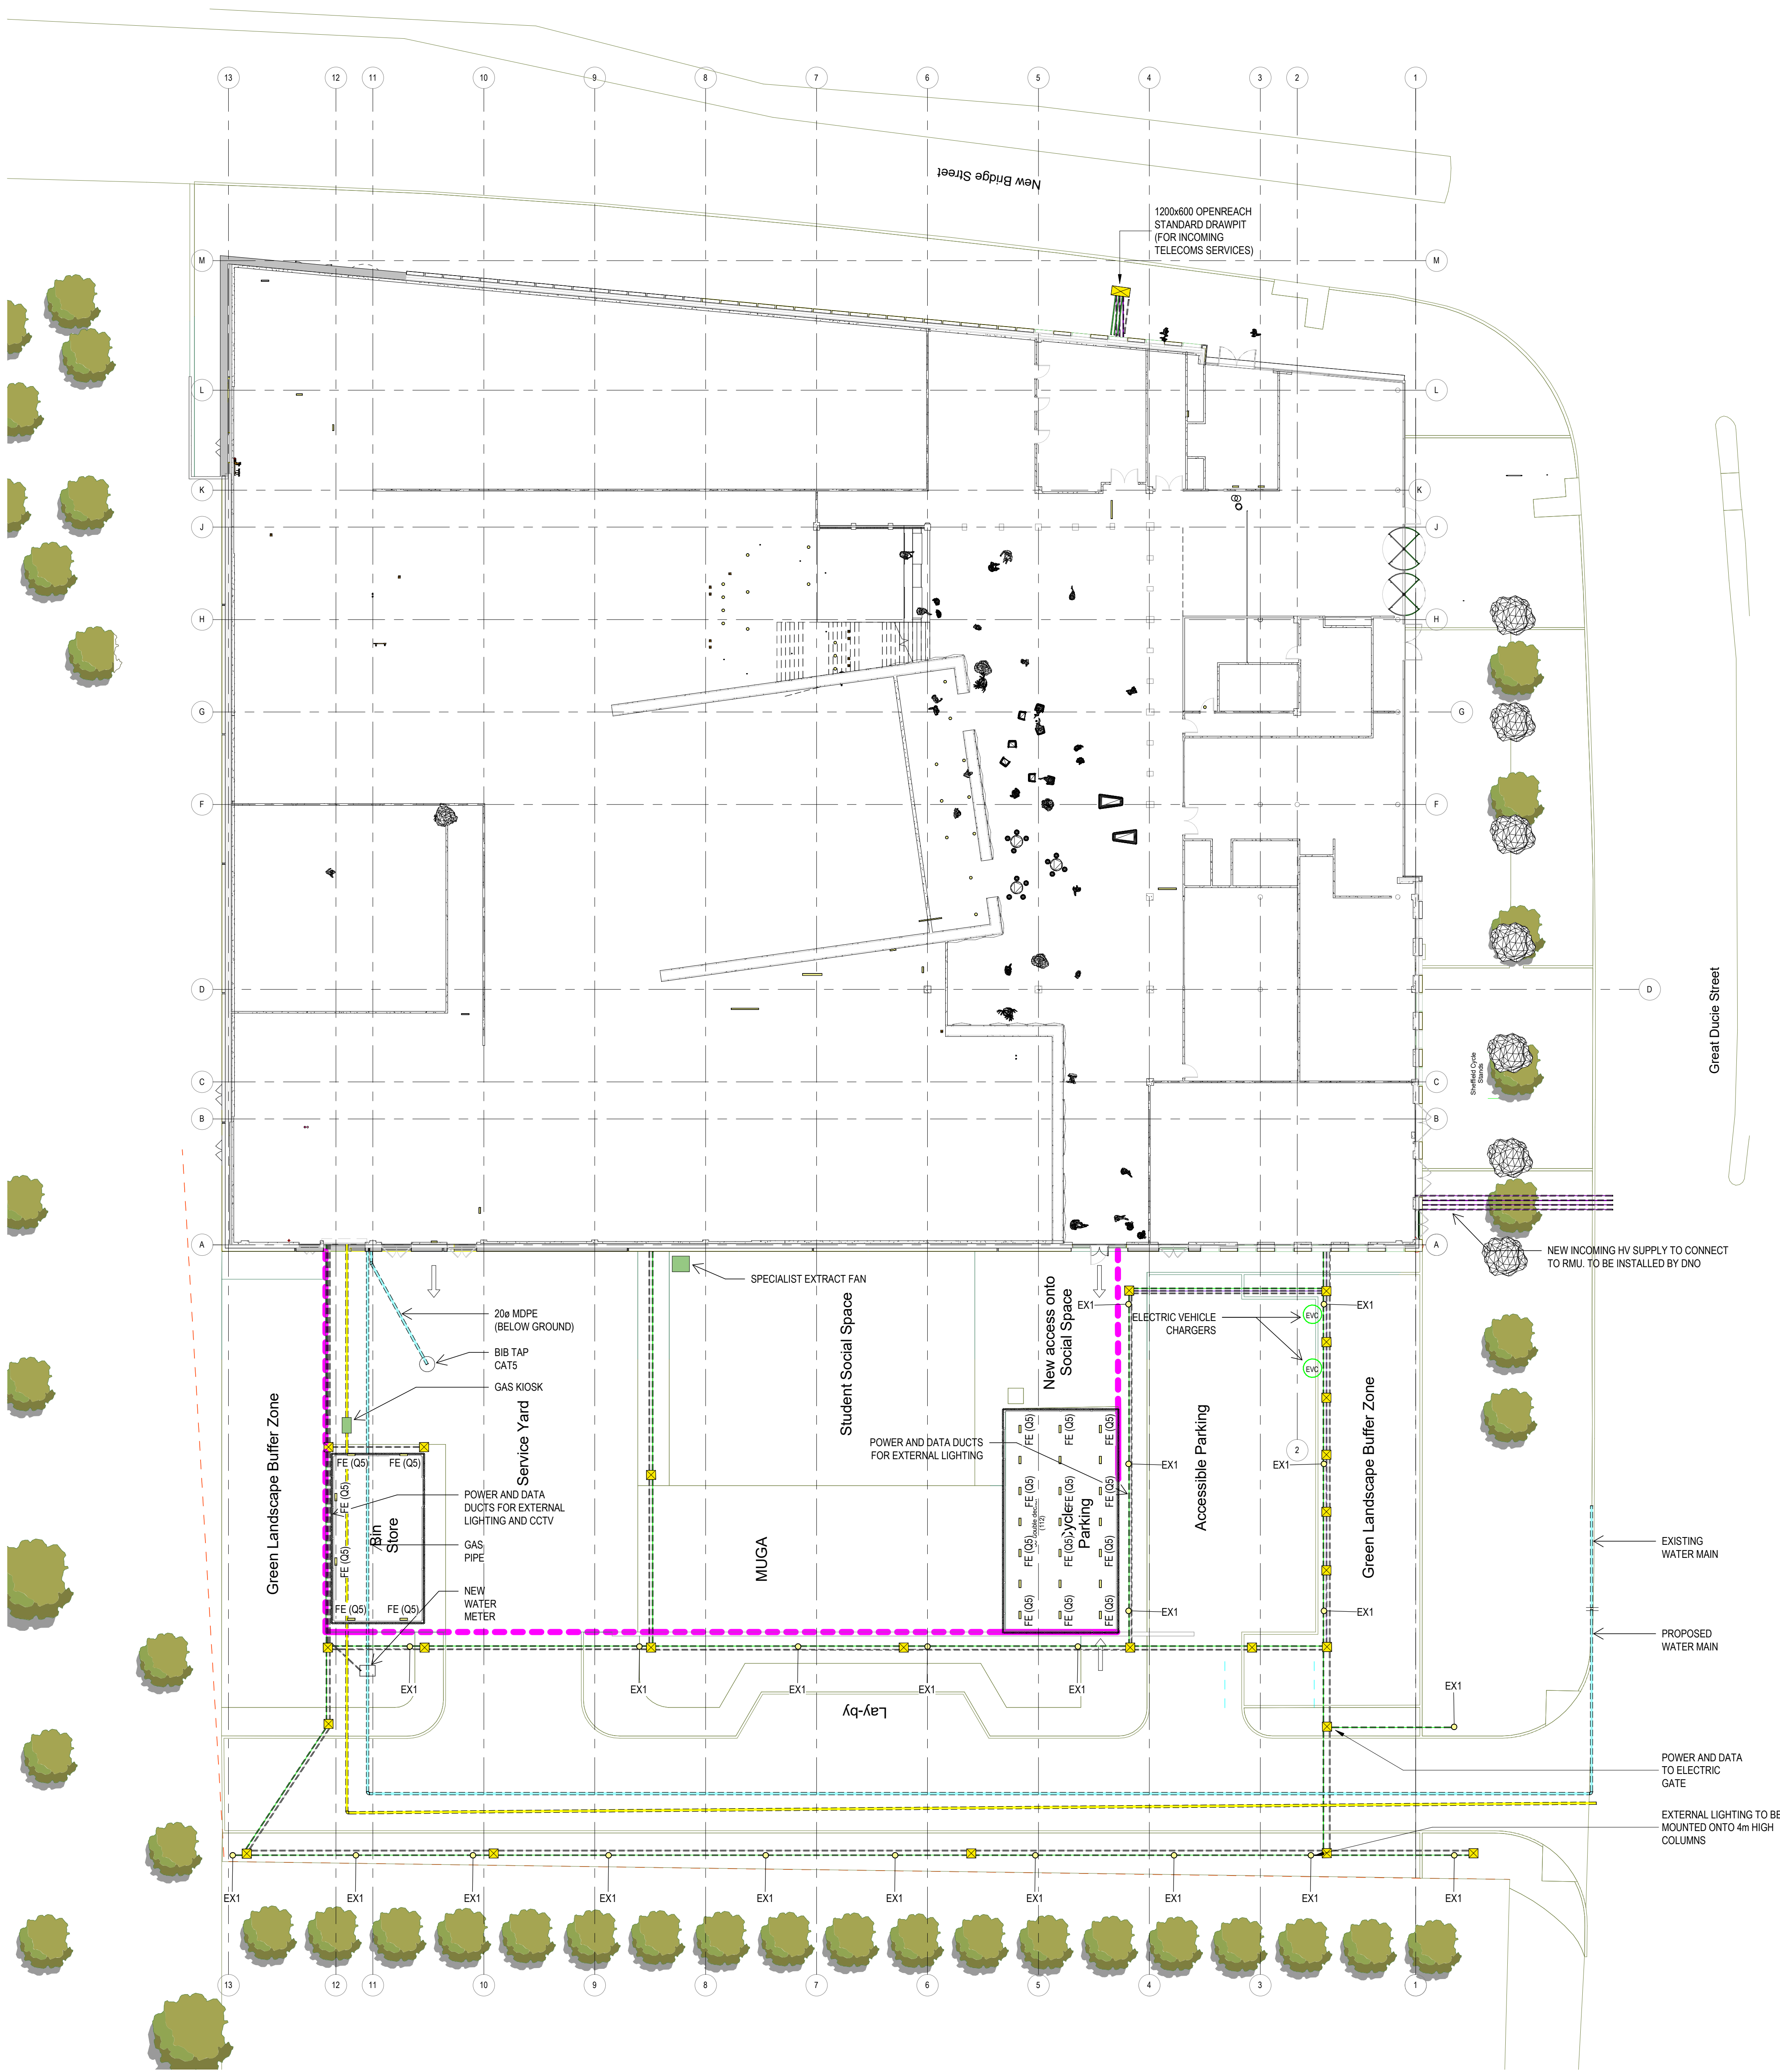
1 ExternalMEP  
1:200

Barrier pipes have been utilised on site in accordance with the recommendations of the United Utilities Pipeline Risk Assessment undertaken for the site and consultation with United Utilities. LKR understand UU have connected and verified the pipework on site.

Development incorporates erection of a five storey educational building with associated access, landscaping, public realm and other associated works following removal of a car park. No bulk storage of chemicals or fuels anticipated. Enabling works includes overturn of made ground to ~4mbgl and re-engineering to new levels of geotechnically and chemically suitable material. Precautionary barrier pipe recommended. Pipeline to be laid into sterile service trench - approximate pipeline route attached.
