**USDAW, Wilmslow Road, Manchester**

***Ecological Appraisal***

December 2020

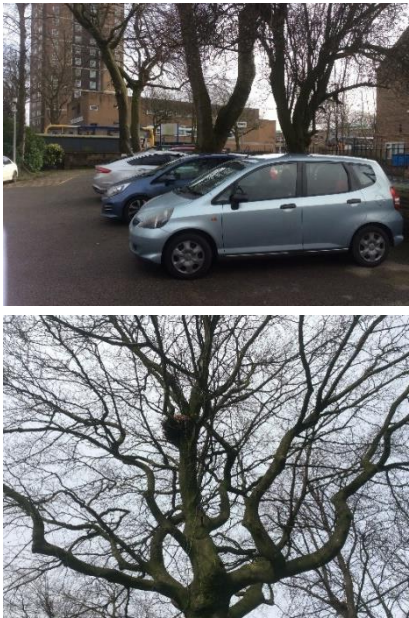
| TN / Tree no. | Description | Photo |
|---|---|---|
| TN1 | Line of mature and semi-mature trees along the southern edge of the eastern car park. Species comprise <i>Prunus</i> sp., ash and beech. These trees were assessed as having negligible potential to support roosting bats. The eastern most beech tree has a large squirrel drey at approximately 10 m. | |

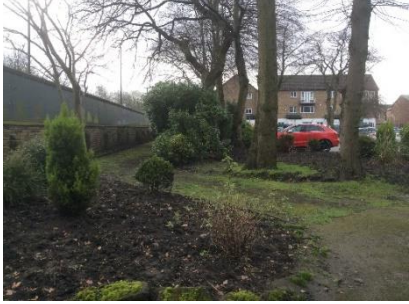
| TN / Tree no. | Description | Photo |
|---|---|---|
| TN2 | Line of mature and semi-mature trees and mature shrubs close to eastern perimeter. Species include lime sp., oak and sycamore, together with a young yew tree and frequent rhododendron shrubs. The ground beneath the trees has been subject to recent ground preparation and planting and was mostly bare soil at the time of survey. Grey squirrels were regularly observed during the survey and dreys were recorded within a number of the trees at this location. | |

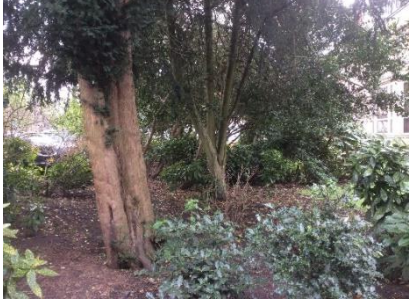
| TN / Tree no. | Description | Photo |
|---|---|---|
| TN3 | Landscaped area surrounded by hardstanding comprising frequent mature rhododendron and other ornamental shrubs, together with occasional holly and yew trees. Ground flora is very limited with abundant dead leaves in places. | |

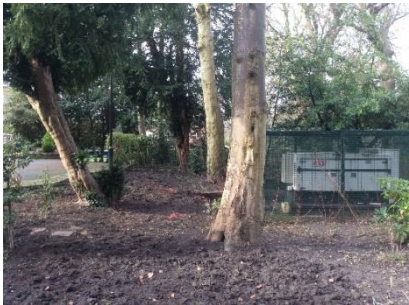
| TN / Tree no. | Description | Photo |
|---|---|---|
| TN4 | The northern boundary comprises semi-mature and mature trees, together with frequent ornamental shrubs and tree saplings. Species include lime sp., holly, rhododendron, yew, beech, and sycamore. Other than BT6 all of these trees were assessed as having negligible potential to support roosting bats. The ground beneath the trees has been subject to recent ground preparation and planting and was mostly bare soil at the time of survey. Grey squirrels were regularly observed during the survey and dreys were recorded within a number of the trees at this | |

| | location. | |

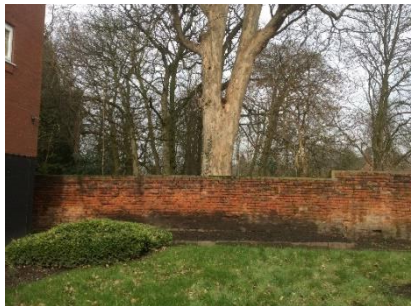
| TN5 | A number of mature trees just beyond the sites north perimeter comprise features that are likely to be suitable for roosting bats. | |

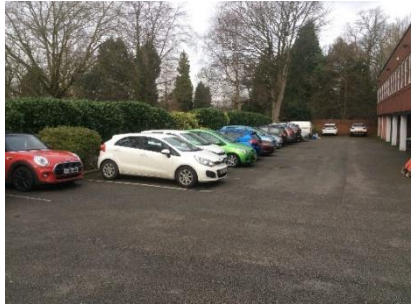
| TN6 | The western perimeter of site comprises a planting bed with a number of ornamental shrubs including rhododendron, privet and Wilson's honeysuckle adjacent to a car park. A mature sycamore tree and small number of beech saplings are located at the edge of the car park, within the north-east corner of the site. | |

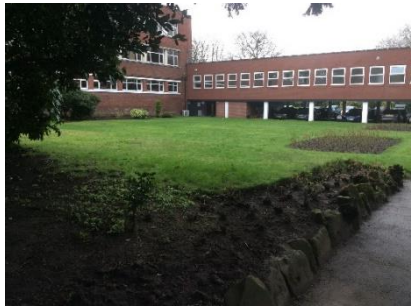
| TN7 | Landscaped area comprising amenity grassland surrounded by planting beds. The amenity grassland is managed and was at a very short sward at the time of survey. The sward is of limited species diversity with daisy, white clover, pointed spear-moss, cats ear and a meadow grass species observed. The planting beds had been subject to recent ground preparation and planting and was mostly bare soil at the time of survey. | |

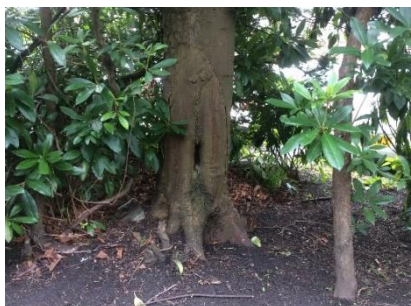
| BT1 | Semi-mature sycamore tree with a small, north facing tear-out feature at 1 metre. No other potential roosting features were observed within the tree. Overall, the tree is assessed as having low potential to support roosting bats. | |

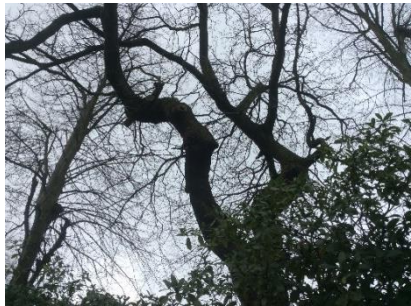
| BT2 | Mature pedunculate oak tree with a number of potential roosting features including a north-east facing knot hole at approximately 8 metres. Overall the tree is assessed as having moderate potential to support roosting bats. | |

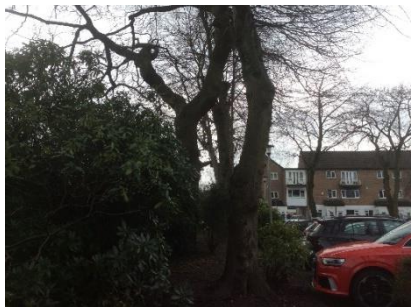
| BT3 | Semi-mature lime sp. with a number of potential roosting features including shallow knot holes and slight fluting. Overall the tree is assessed as having low potential to support roosting bats. A squirrel drey was observed within this tree. | |

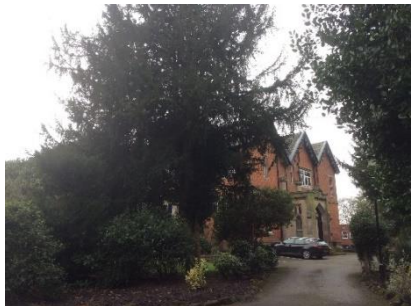
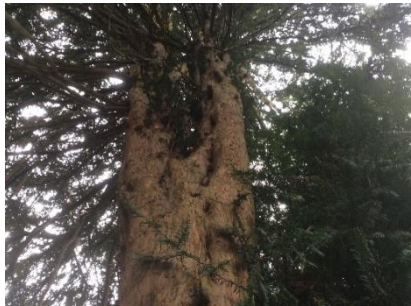
| BT4 | Semi-mature yew tree with frequent shallow fluting. Overall the tree is assessed as having low potential to support roosting bats. | |

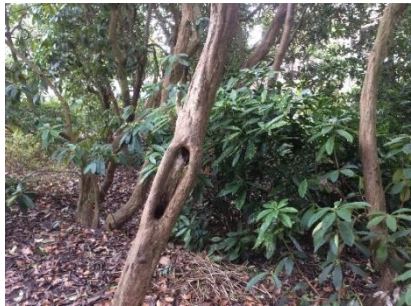
| BT5 | A young holly tree with a north facing tear-out at 1.5 m that comprises narrow but deep upwards leading internal cavity. Overall the tree is assessed as having low potential to support roosting bats. | |

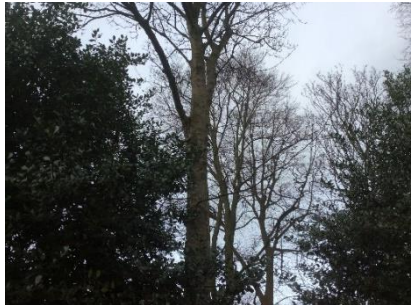
| BT6 | Tall, semi-mature sycamore tree with a knot hole at approximately 10 m that potentially comprises a cavity suitable for roosting bats. Overall the tree is assessed as having low potential to support roosting bats. | |

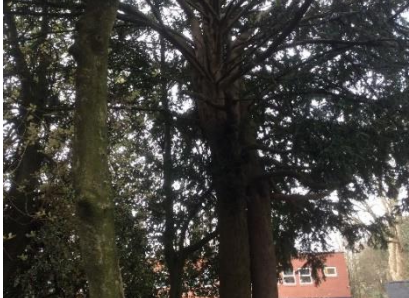
| BT7 | <p>Relatively young yew tree with occasional shallow fluting and a weld feature. Overall the tree is assessed as having low potential to support roosting bats.</p> | |

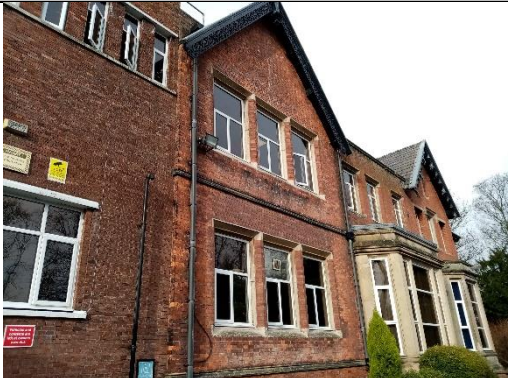
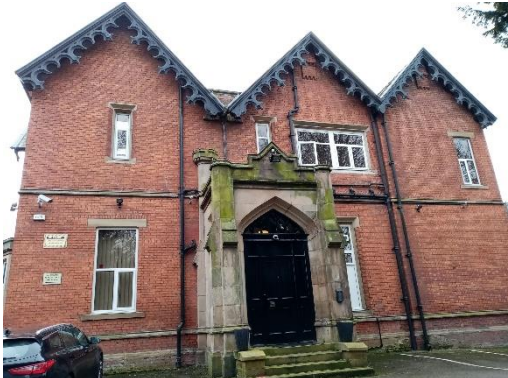
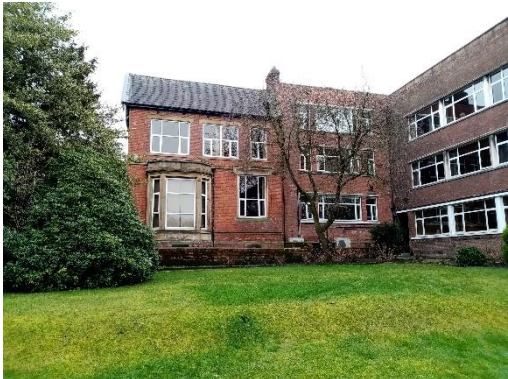
| Building number | Description | Photograph |
|---|---|---|
| B1 | <p><u>External</u> – A mid-19<sup>th</sup> century building of red brick construction, currently used as offices. The building is two to three storeys in height, with a basement. The windows and doors are in good condition and well-sealed to the brickwork, with no access points for bats noted. The roof is multi-pitched with one brick chimney stack; a close-up examination of the pitches on the southern section of the building was undertaken from the roof of B2. The roof tiles and ridge tiles are slate and in moderate condition. Occasional lifted and slipped tiles create Potential Roosting Features (PRF) for bats, missing ridge tiles have been replaced with lead flashing which has warped, creating potential access points and PRF for bats. Lead flashing has also been used to seal the chimney stack to the brickwork, to seal the skylights to the brickwork. The lead flashing across the roof is lifted, creating potential access points and PRF for bats.</p> <p>The gable ends of multi-pitched roofs are present on the eastern (plate 1) and northern (plate 2) elevation and feature timber eaves. From the ground inspection the eaves appear to be well sealed to the brickwork, however it is possible that there are concealed access points for bats beneath the eaves, which were not observed from ground level.</p> <p>The western elevation (plate 3) is pitched, with a timber soffit board present. From the ground level this appears to be well-sealed to the brickwork, however it is possible that there are concealed access points for bats.</p> <p>B2, the modern extension building is adjoined to B1 from the southern elevation (plate 3).</p> <p>White staining on the walls, most likely from nesting / roosting birds is present on the eastern, northern and western elevations. Bird deterrent spikes were also noted on the ledges beneath the eaves.</p> <p><u>Internal</u> – The loft void (plate 4) of the two sections of pitched roof to the south east of B1 was accessible for inspection. The loft voids were naturally lit due to the presence of two skylights. Exposed timber beams have roof membrane lining between them, which is in moderate condition, with only occasional lifting and tears. Insulation is present on the floor between timber ceiling joists. A small hole was noted on the southern elevation of the roof, creating a potential entry point for</p> | <p>Plate 1: B1 eastern elevation</p> <p>Plate 2: B1 northern elevation</p> <p>Plate 3: B1 western elevation</p> |

| Building | Summary of bat PRFs | Overall bat roost potential |
|---|---|---|
| B1 | Raised and slipped roof slates on all roof pitches. Lead flashing replaces missing ridge tiles. Lead flashing is also used to seal roof tiles, chimney stacks and skylights to the brickwork. The lead flashing is warped, creating potential access points for bats. Timber eaves and soffit boards appear well-sealed from the ground inspection; however, it is possible that there are concealed entry points for bats. Internally, timber beams and missing mortar in the brickwork create multiple crevices suitable for roosting bats. The building has multiple loft voids beneath pitched slate roofing, not all of which were accessible for inspection. | <b>Moderate</b> |

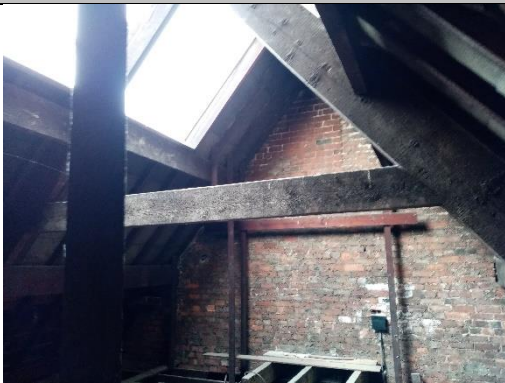
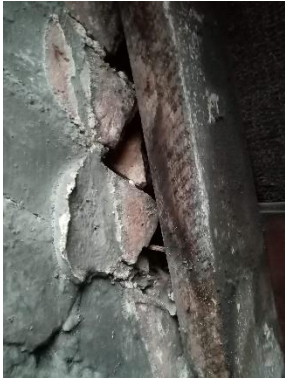
| Building number | Description | Photograph |
|---|---|---|
| | <p>bats. Partitioning brick walls are in poor condition, with holes present which lead to further, inaccessible loft voids. Missing mortar (image 5) in the brickwork provides access points to crevices for bats. Despite being naturally lit, the complex layout of the loft void creates multiple dark areas and crevices for bats.</p> <p>No evidence of bats was noted during the internal or external inspection.</p> <p>Overall the building is considered to have <b>moderate potential for roosting bats</b>.</p> <p>Not all loft voids were accessible for survey, it is possible that those un-surveyed will be more suitable for roosting bats due to the absence of skylights.</p> | <p>Image 4: B1 southern section of loft void</p> <p>Image 5: B1 missing mortar</p> |

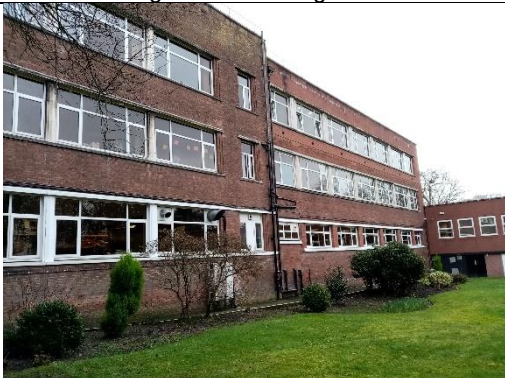
| Building number | Description | Photograph |
|---|---|---|
| B2 | <p>A three-storey extension, which joins the southern elevations of B1 and B3. The building is a modern red brick construction, currently utilised as commercial offices and warehouse space. The roof is flat, with concrete facings, which are well sealed to the wall-top brickwork. No PRFs for bats were noted on the roof or along the wall-tops. The mortar on all elevations is in excellent condition and well-sealed. PVC windows and doors are all in good condition, with no entry points or PRFs for bats.</p> <p>Overall B2 is considered to offer <b>negligible potential for roosting bats</b>.</p> | <p>Figure 6: B2 northern elevation.</p> |

| Building | Summary of bat PRFs | Overall bat roost potential |
|---|---|---|
| B2 | No PRF were noted during the inspection. | <b>Negligible</b> |

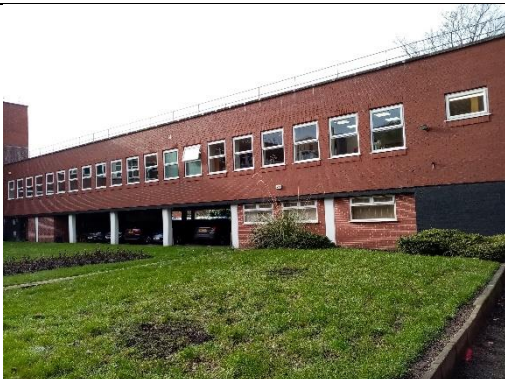
| Building number | Description | Photograph |
|---|---|---|
| B3 | <p>A two-storey modern extension, which joins the northern elevation of B2, is currently utilised as offices and a covered carpark. The roof is flat, with concrete facings that are well sealed to the wall-top brickwork. The brickwork, windows and doors are in excellent condition on all elevations well-sealed to the brickwork and with no gaps in the mortar. Louvered ventilation panels are present on the eastern elevation; however, wire meshing prevents access for bats. There is a covered car park in the centre of the building. The ceiling of the car park is in good condition, with no PRFs for bats noted. The carpark is naturally lit and also has multiple light fittings, creating sub-optimal conditions for bats.</p> <p>Overall B3 is considered to offer <b>negligible potential for roosting bats</b></p> | <p>Figure 7: B3 eastern elevation.</p> |

| Building | Summary of bat PRFs | Overall bat roost potential |
|---|---|---|
| B3 | No PRF were noted during the inspection | <b>Negligible</b> |

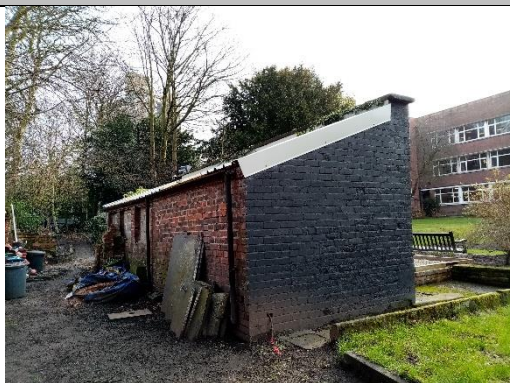
| Building number | Description | Photograph |
|---|---|---|
| B4 | <p>A small, single-storey red brick building, currently utilised as a garden workshop. The roof is a lean-to/mono pitch, north facing roof, which, is constructed of a combination of plastic and corrugated metal sheeting. There are multiple entry points for bats beneath the corrugated sheeting, however, the fluctuations in temperature associated with the roofing materials is considered to create sub-optimal roosting conditions for bats. The brick walls are in moderate condition, with some missing mortar, however, closer inspection revealed that these areas do not lead to crevices suitable for bats. The door is timber and in moderate condition, no access points for bats were noted. The windows have been sealed up with breezeblocks, providing no PRFs or entry points for bats. Internally the building is naturally lit due to the sections of transparent corrugated plastic roofing. No evidence of roosting bats was found.</p> <p>Overall B4 is considered to provide <b>negligible potential for roosting bats.</b></p> | <p>Image 8: B4 north and western elevations</p> |

| Building | Summary of bat PRFs | Overall bat roost potential |
|---|---|---|
| B4 | Multiple access points for bats are present under the corrugated metal and corrugated plastic mono pitched roof. However, the building is considered to provide suboptimal roosting conditions for bats due to extreme temperature fluctuations associated with the roofing material, the internal void being naturally lit and regular disturbance. No internal PRFs were noted. | <b>Negligible</b> |

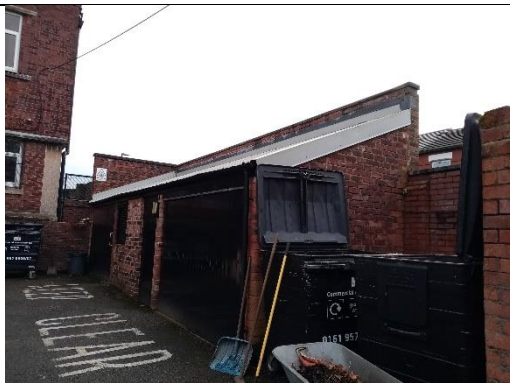
| Building number | Description | Photograph |
|---|---|---|
| B5 | <p>A small, single-storey red brick building, currently utilised as a bike store. The southern elevation forms part of the site boundary wall. The roof is lean-to/mono pitch, south facing and constructed of corrugated metal. Lead flashing seals the roofing to the building. Despite the lead flashing being in good condition, there are multiple entry points for bats beneath the corrugate sheeting. As described in B4, the roofing material is considered to provide sub-optimal conditions for roosting bats due to extreme temperature fluctuations. Three doors are present on the southern elevation, with large gaps, providing entry points for bats above the two outer doorways. The internal inspection revealed that while the space was dark, there were no PRFs for bats and no evidence of roosting bats was found.</p> <p>Overall B5 is considered to provide <b>negligible potential for roosting bats.</b></p> | |

| Building | Summary of bat PRFs | Overall bat roost potential |
|---|---|---|
| B5 | Multiple access points for bats are present under the corrugated metal mono pitched roof. The building is considered to provide sub-optimal roosting conditions for bats due to the extreme temperature fluctuations associated with the roofing material and the internal space being regularly disturbed. No internal PRFs were noted. | <b>Negligible</b> |

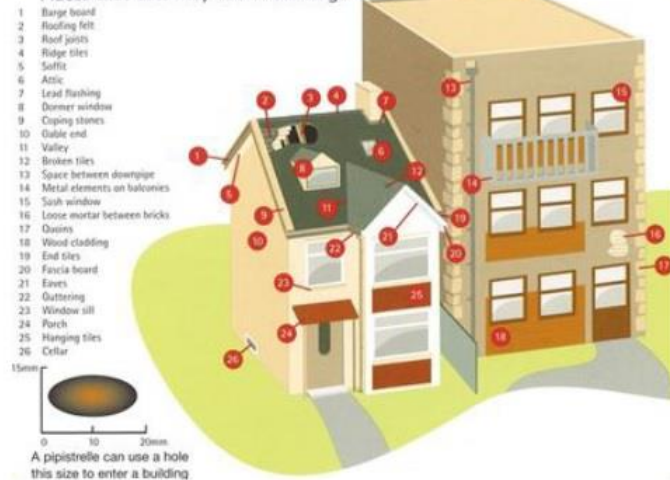
### Places that bats may use in buildings

Schematic from [www.bats.org.uk](http://www.bats.org.uk)

- The top of gable end or dividing wall;
- The top of chimney breasts;
- Ridge and hip beams and other roof beams;
- Mortise and tension joints;
- All beams/ceilings/pipework (free hanging bats);
- The junction of roof timbers, especially where ridge and hip beams meet;
- Behind purlins;
- Between tiles and the roof lining;
- Under flat felt roofs;
- In trees (cracks/holes/ivy cladding) ;
- Under barge boards;
- In cavity walls;
- In cracks in stone or concrete;
- Behind peeling paint/wall coverings;
- Gaps behind window and door frames;
- Between window panes and timber boarding.
