- Ground Floor
  - Easy access
  - Section of building with no scaffolding
- Commence soft strip of internal wall
- Test of 2-3sqm of brick wall cleaning / preparation

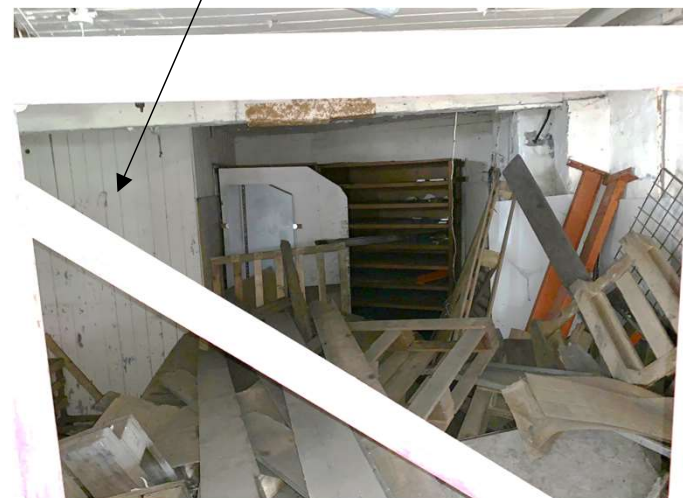
Wall is noted on structural engineer's drawings for demolition. Site photographs suggest this wall is of timber construction.

Architect Drawing  
05013\_B1\_12\_3201  
indicates this wall as  
structural wall.  
Investigation on site  
required to survey and  
determine structural  
nature and condition

Plastered —  
wall

Boarded window with

Scope for this stage is to investigate and seek to remove the wall. Gain access to brick wall behind to evaluate current condition

Test patch of 2-3sqm to removing existing paint / plaster in line with the SLHA Conservation Implementation Strategy

Remove existing plaster. Bricks cleaned in preparation for exposed finish with final design

Aperture filled with reclaimed brickwork from the project.
