# Phase 2 Site Investigation

Manchester Enterprise Academy

Prosperre Learning Trust

27 June 2022

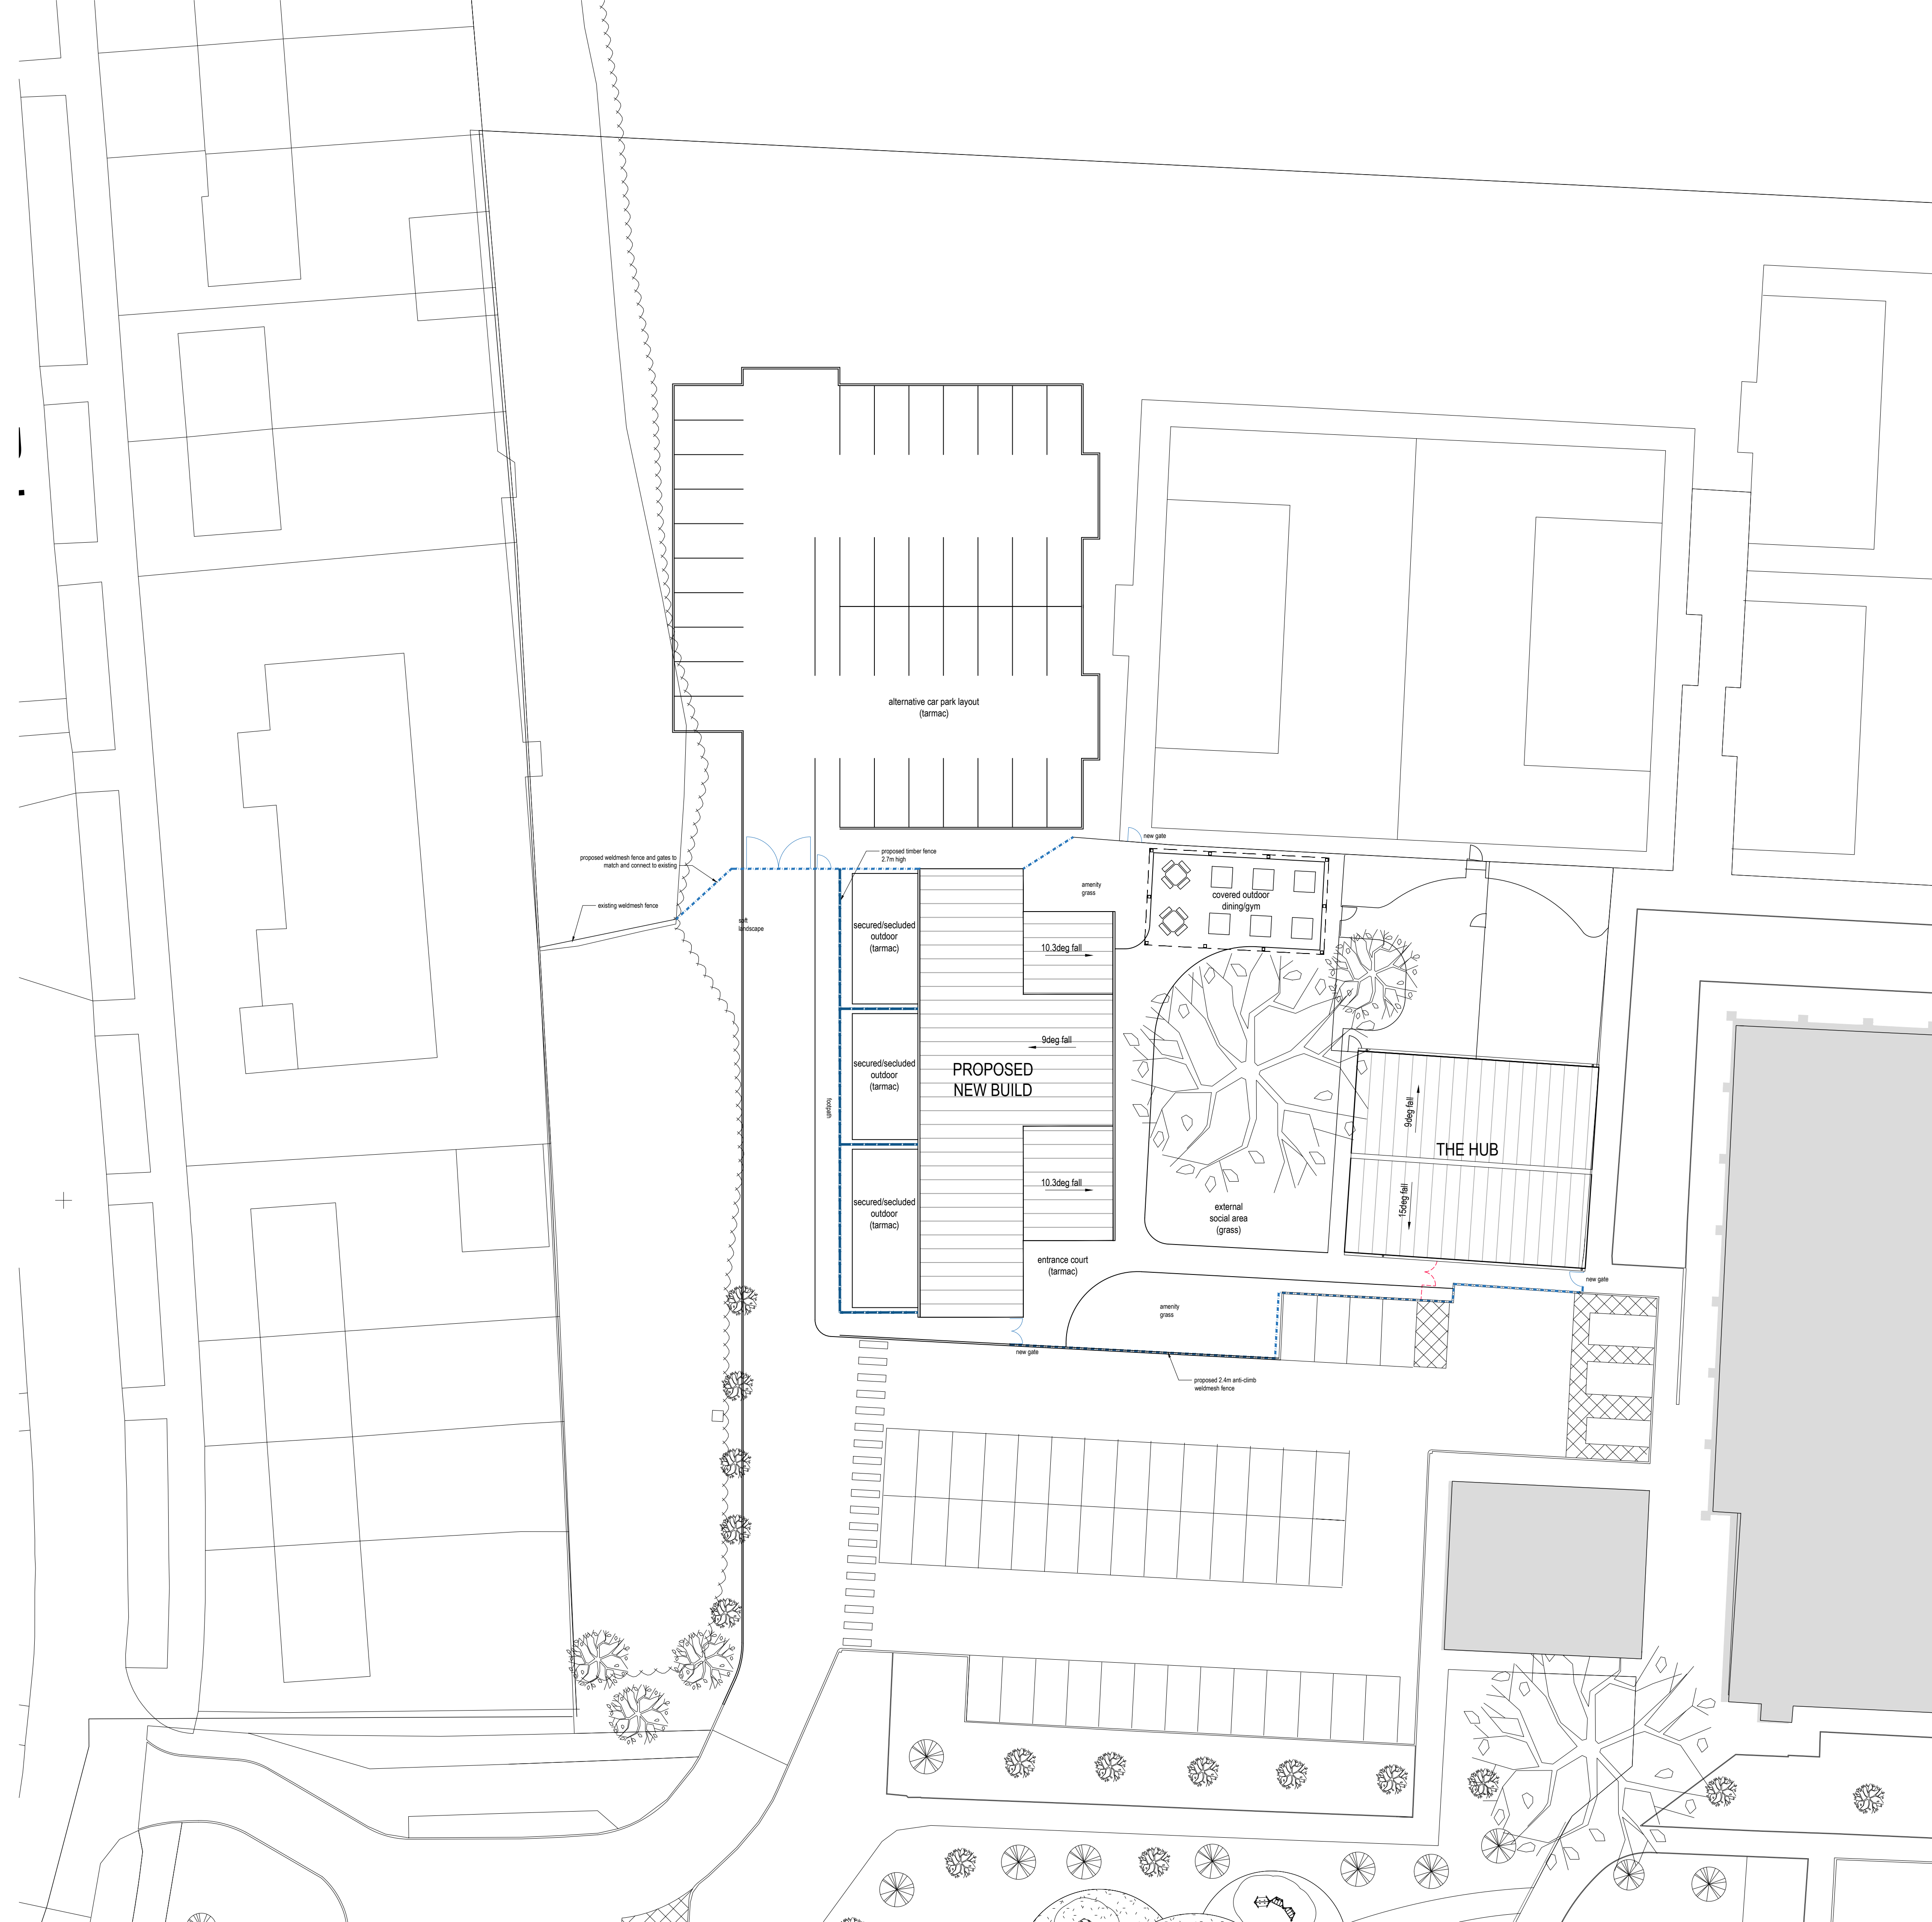
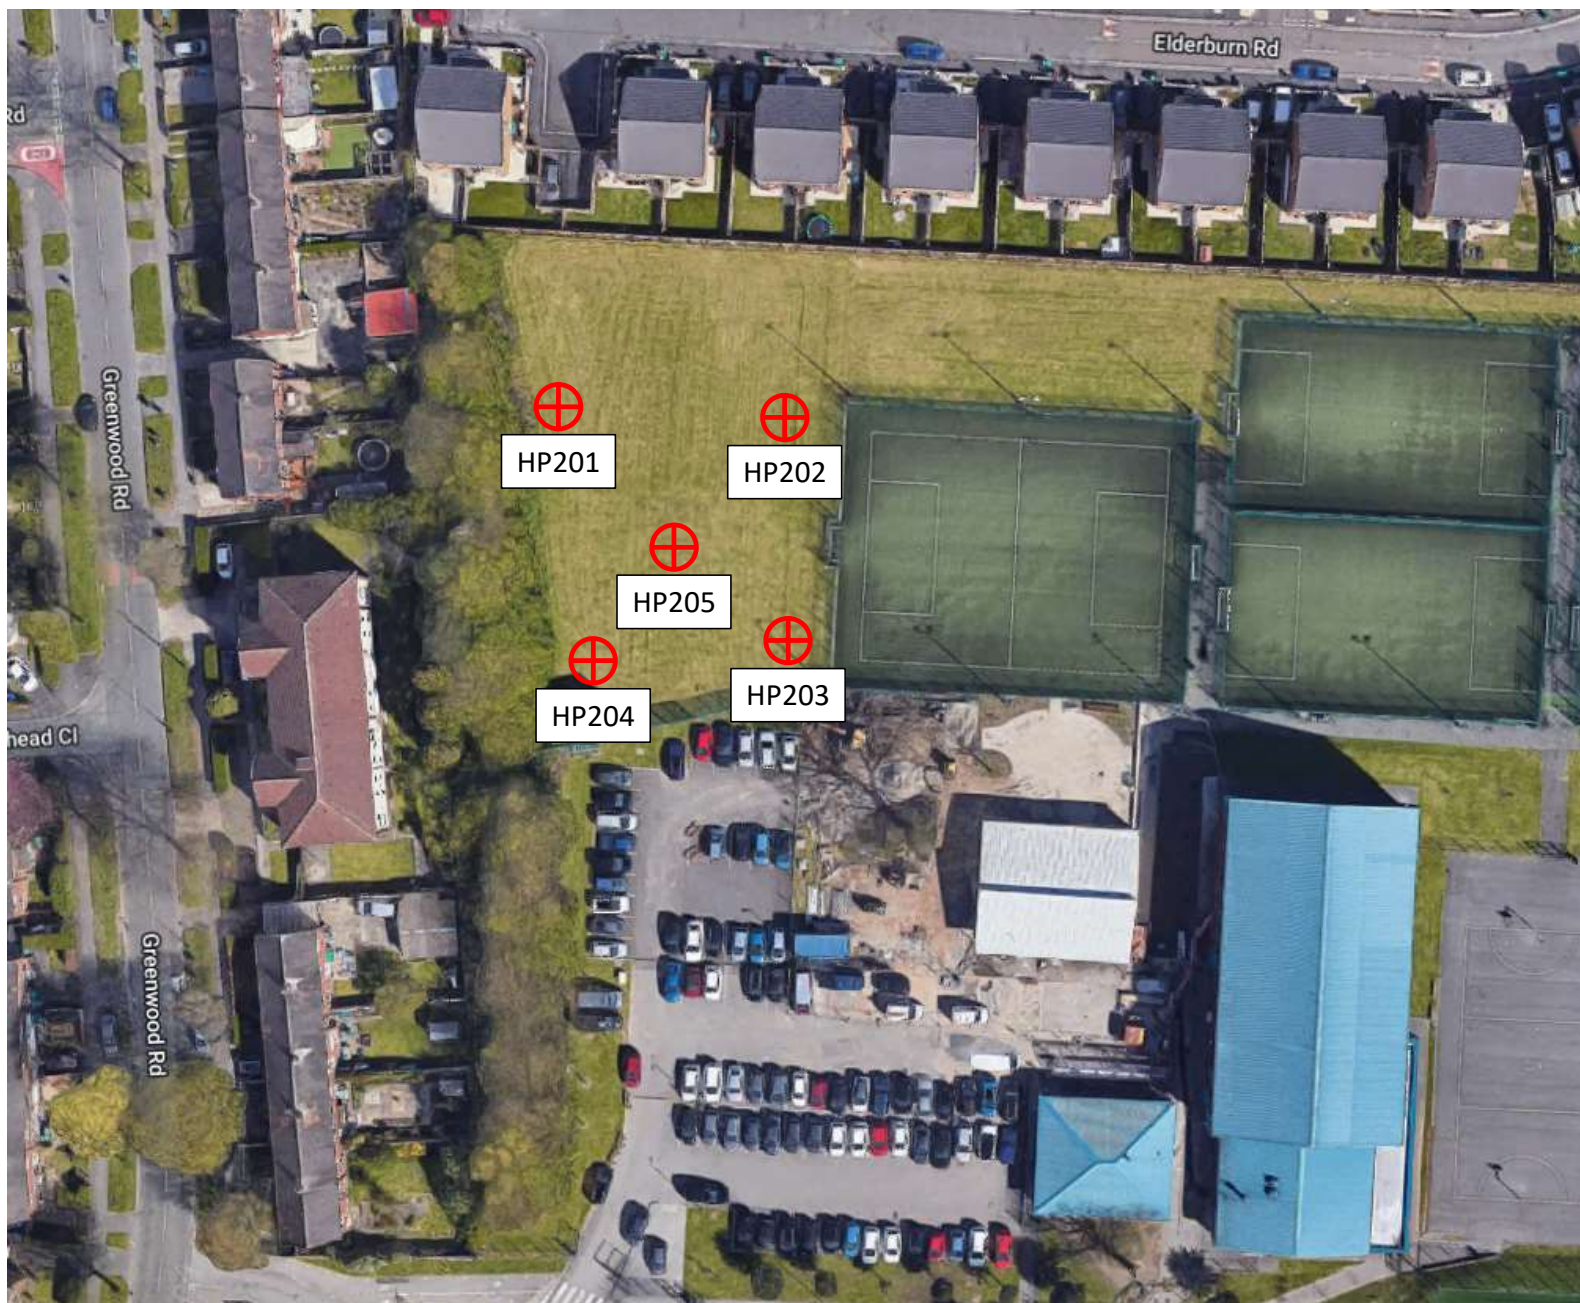
| | PROJECT TITLE | Manchester Enterprise Academy | SKETCH TITLE | Exploratory Hole Location Plan (Existing Site) | |

- 4.0.6 Exploratory hole locations are shown on RoC Consulting drawing ESK101 (Current Site) and ESK102 (Prop Development) provided within Appendix A.
