# Manchester Airport Argosy Drive Development

Phase 1 Tier 1 Geo-environmental and Geotechnical  
Assessment

Project number: 60663052  
Document Reference: 60663052-ACM-ArA-XX-RP-G-00001  
1 March 2022

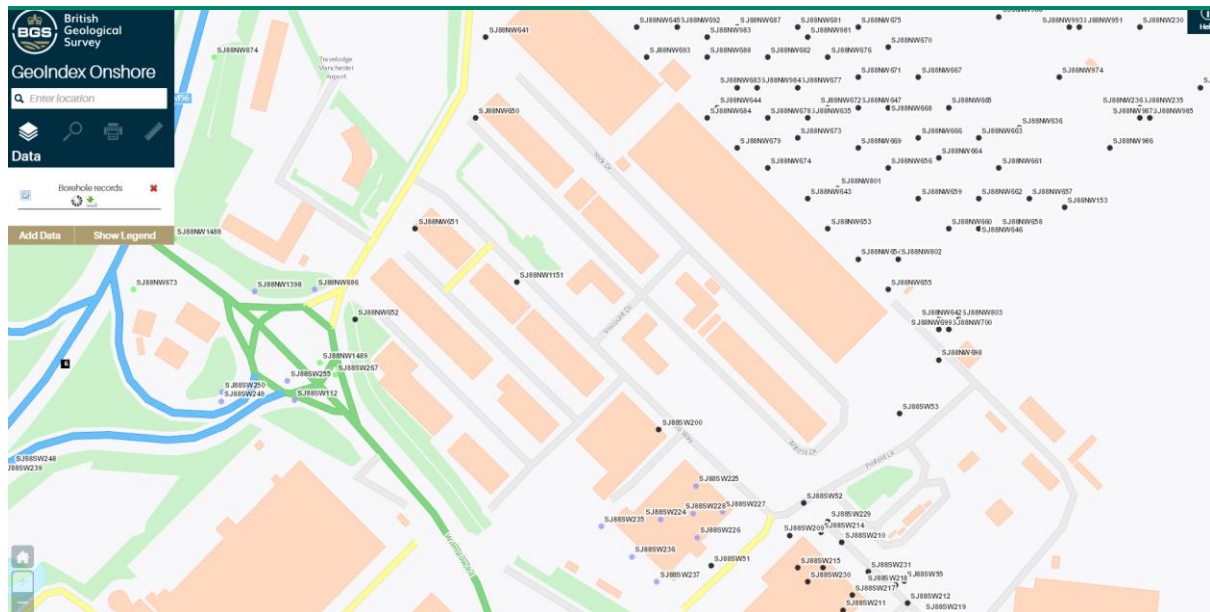
Plate 1 Screenshot of relevant exploratory hole locations from BGS GeoIndex Viewer

<sup>1</sup> The black boreholes, which are closest to the site, are not publicly available. the others are available, although not all of them have online records and are located a considerable distance away from the site.
