# Preliminary Bat Roost Assessment Report

**Pall Mall, King Street,  
Manchester  
8<sup>th</sup> March 2022**

TG Report No. 14426\_R02\_DP\_NC

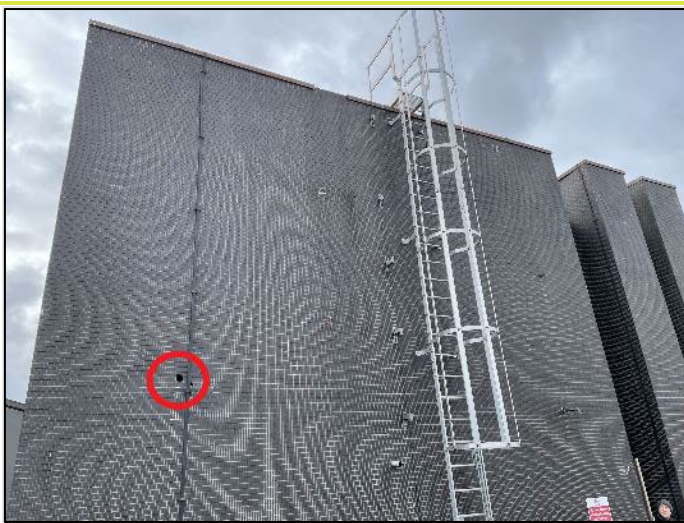
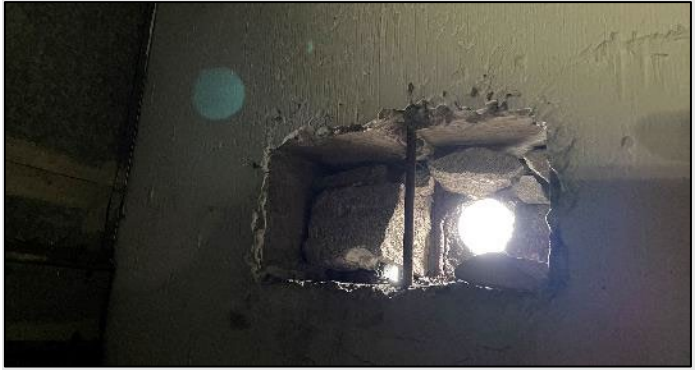
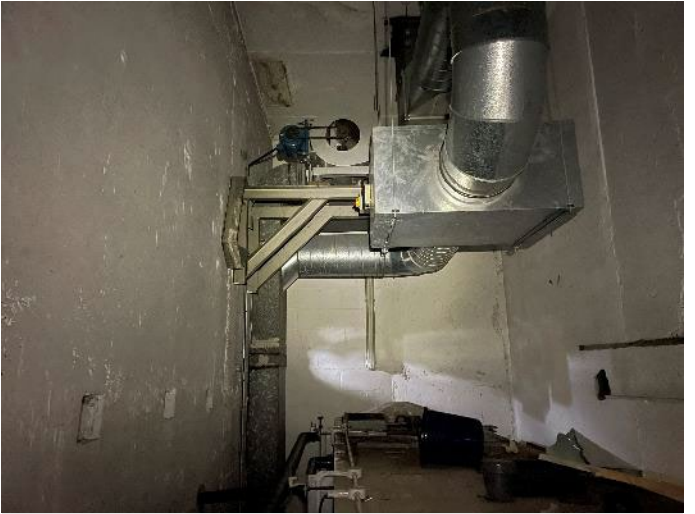
| Potential Roosting Feature | Feature Description and Suitability | Photos |
|---|---|---|
| <p><b>Potential Feature 2</b></p> <p>Hole in façade, leading to an internal void</p> | <p>There is a circular hole in the façade of the utilities unit, located at the top of the building's central column (c. 45m/ 12-storeys) presumed to be the location of an old outlet pipe.</p> <p>The feature itself provides access to a sheltered,</p> | |

| Potential Roosting Feature | Feature Description and Suitability | Photos |
|---|---|---|
| | <p>dark space within, containing water tanks and utilities machinery.</p> <p>There were no signs of bats within the access hole itself, or within the utilities room. There were very few features within the room which could be used by roosting bats i.e. internal crevices.</p> <p>The room was well sealed, offering no further access to adjoining internal rooms.</p> <p>Although this feature could provide shelter for bats, due to the height (45m) and surrounding heavily urbanised habitat with very little foraging opportunities, the feature is considered to provide <b>negligible bat roosting potential</b></p> | |

- 3.7. While the roost feature within the utilities room could, in some circumstances be considered to have low or even moderate potential to support roosting bats (if the feature was located within optimal bat habitat), given the heavily urbanised nature of the site, associated light/noise pollution and the height of this feature – being approximately 45m high (12 storeys), located at the top of the Pall Mall building, it is considered highly unlikely that bats would use the feature as a resource or roosting habitat.
- 3.8. Therefore, the site is considered to have **negligible potential** for roosting bats.

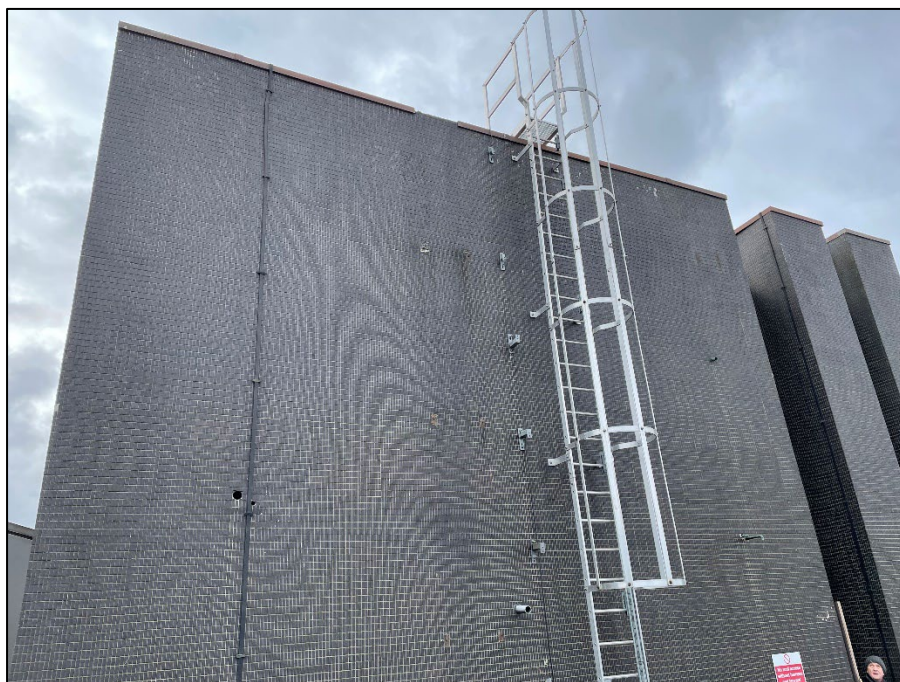
**Photograph A2.2:** Central column, housing utilities, located on the central roof.

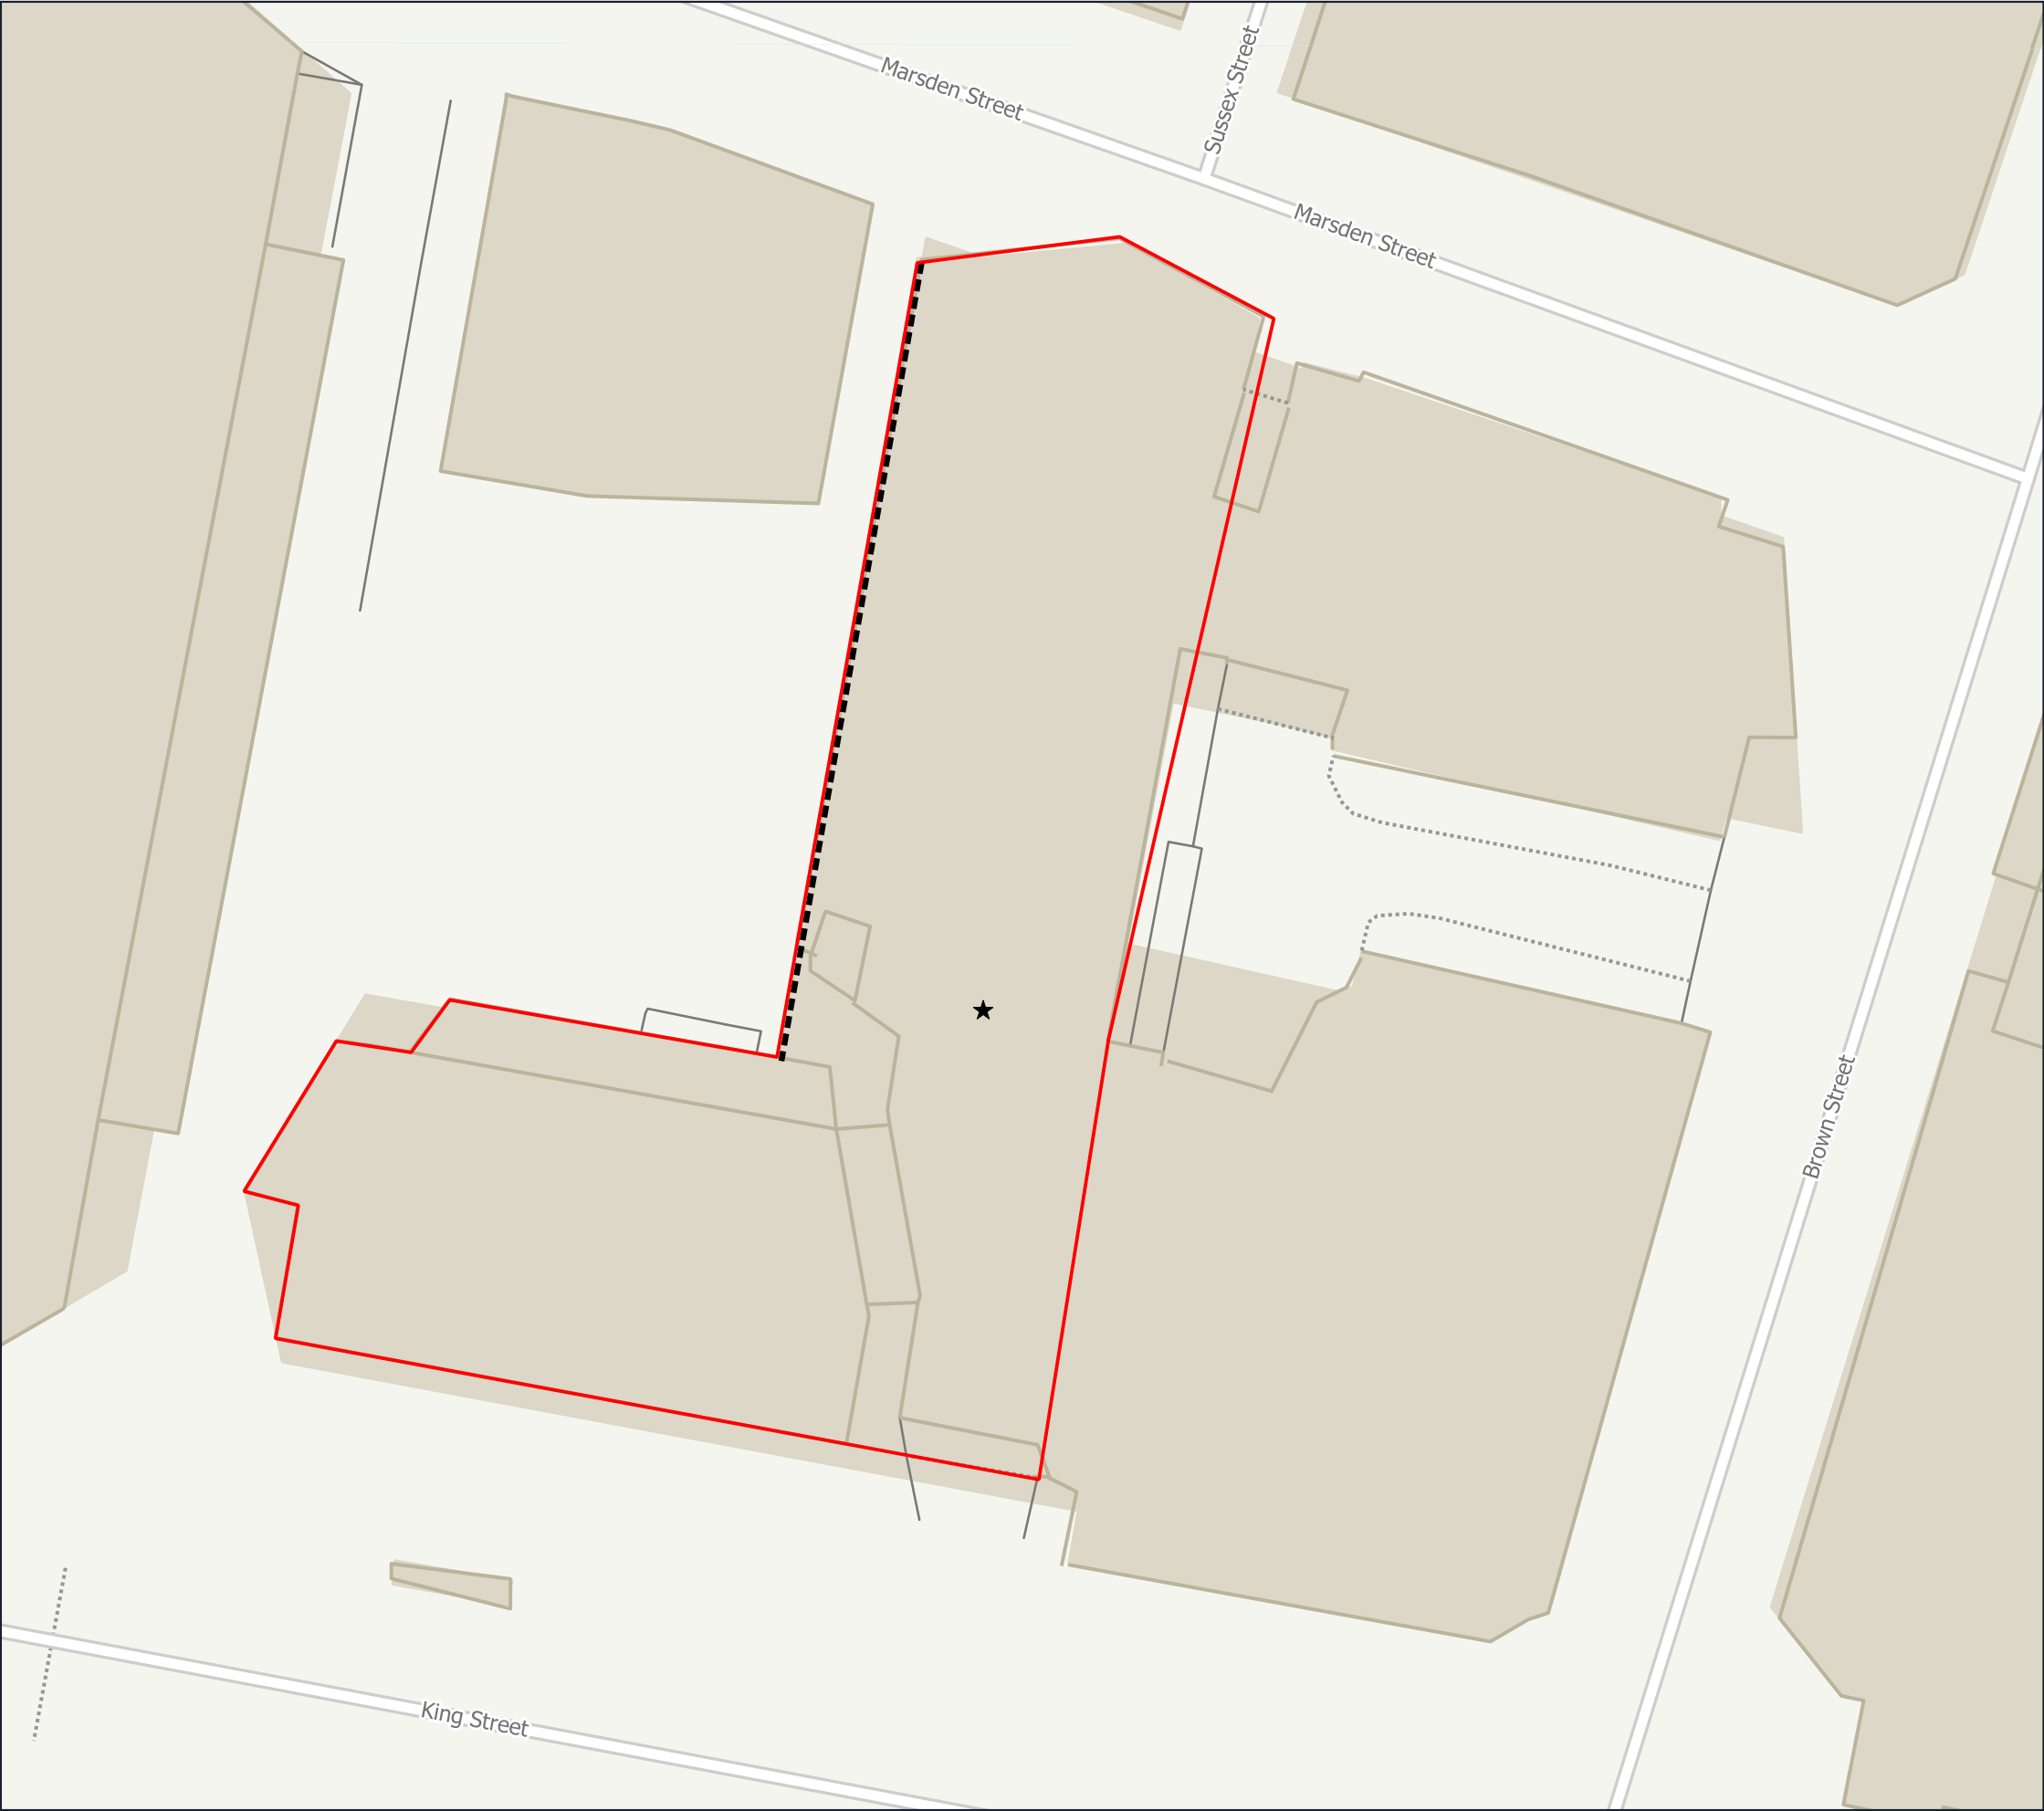
### Plan 1: 14597/P01 Bat Roost Features Location Plan

Potential Roost Feature - Gap running beneath overhang on western facade. Negligible
-

Potential Roost Feature - Location of hole on central column, leading into utilities room. Negligible

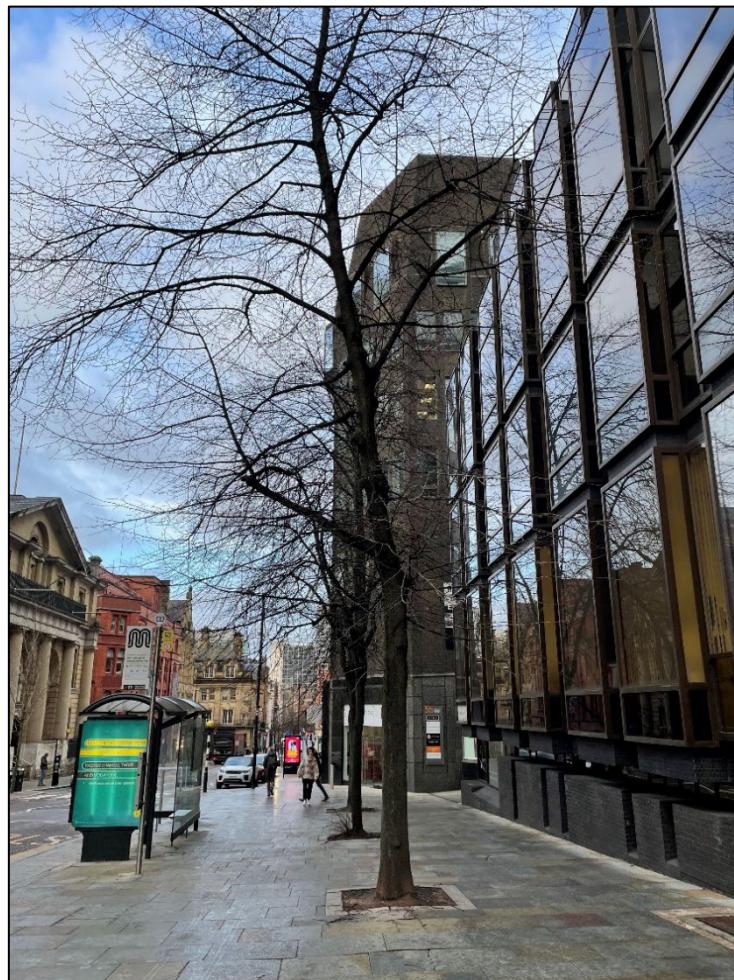
- 3.2. The trees contained no potential roost features or had any associated potential roost features, such as ivy. All three trees were therefore assessed as having **negligible potential** for roosting bats

**Plate 1:** Showing three common lime trees situated in front of the Pall Mall building, King Street.

- 4.1. The PBRA survey characterised the all three trees as having negligible potential to support roosting bats, and therefore no further bat survey is recommended.

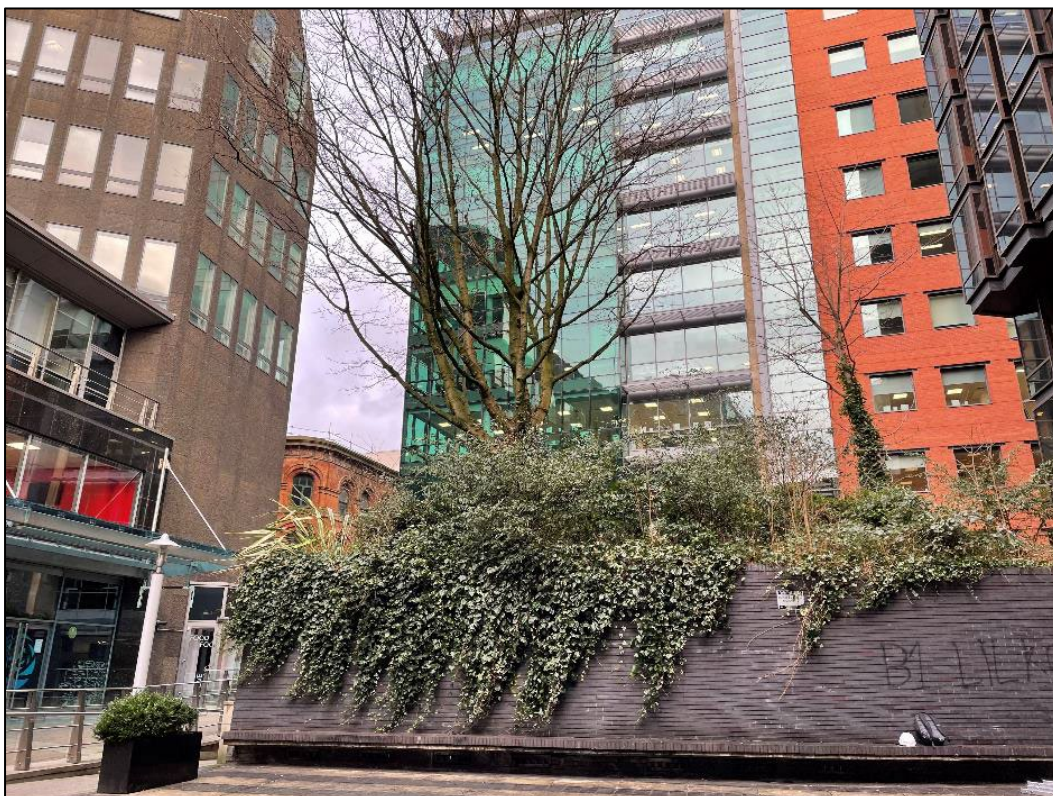
- 3.2. The Norway maple was observed to provide no potential bat roosting features, and therefore was graded as having **negligible potential** to support roosting bats.
- 3.3. The cherry tree was observed to support some ivy *Hedera helix*, however the ivy was considered too thin to act as a potential roost feature itself (the stems were less than 5cm thick and lacking platelet structures that could be considered a potential roost feature); equally the main stem of the cherry tree was considered too thin to support any potential roost features which could otherwise be obscured by the ivy coverage. Therefore, graded as having **negligible potential** to support roosting bats.

**Plate 1:** Showing Norway maple, situated within the raised planter (left of shot) and cherry tree (right of shot) on the Piazza of Pall Mall, King Street.

- 4.1. The PBRA survey characterised the both trees as having negligible potential to support roosting bats, and therefore no further bat survey is recommended.
- 4.2. Direct impacts as a result of the proposed development on bat roosts are considered highly unlikely. However, due to the transient nature of bat and their roosts, during any works impacting the tree, contractors should cease works immediately if bats or signs of bats are identified, and an appropriately qualified, bat licenced ecologist should be contacted.
- 4.3. If more than 12 months elapses between when the PBRA survey was undertaken and the start of an works impacting the tree, an update survey may be required.
- 4.4. Provided the recommendations outlined in this report can be implemented fully and successfully, then development proposals would comply with all relevant wildlife legislation and planning policies.
