## GeoEnvironmental Investigation

Ducie Street

Manchester

**Report Ref: A4210/21/SI**

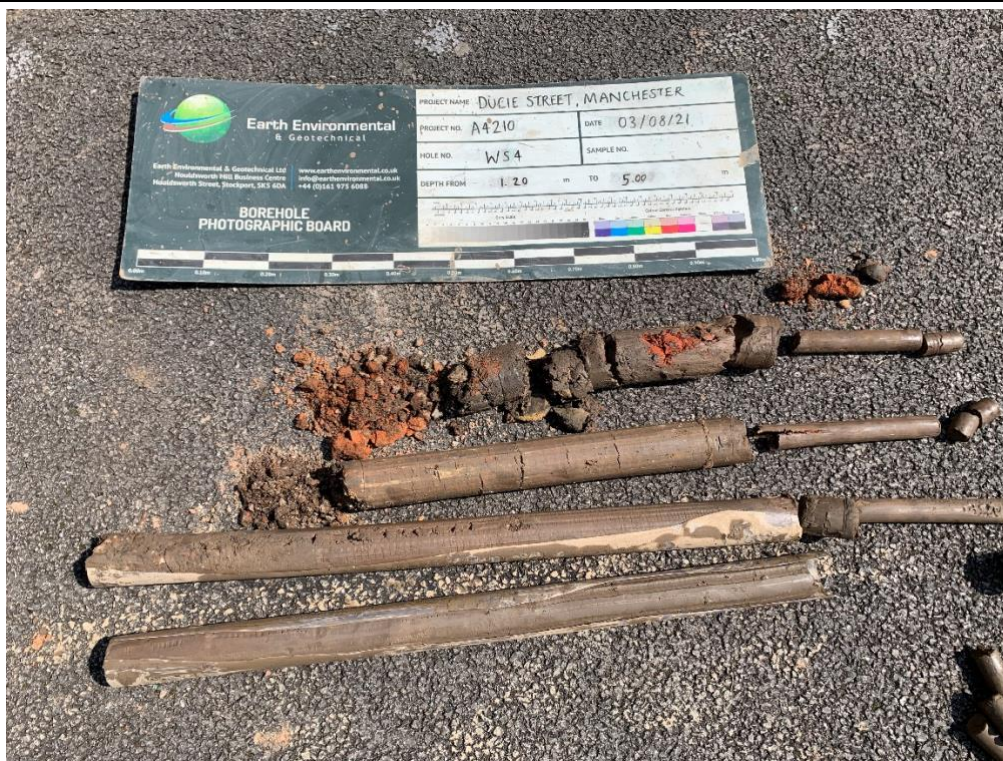
Figure 5 Made Ground and Superficial Deposits Encountered in the Window Sample Boreholes

During the ground investigation, variable Made Ground containing concrete, glass fragments, metal nails, rebar, pottery fragments, plastic and red brick were observed in the exploratory holes.

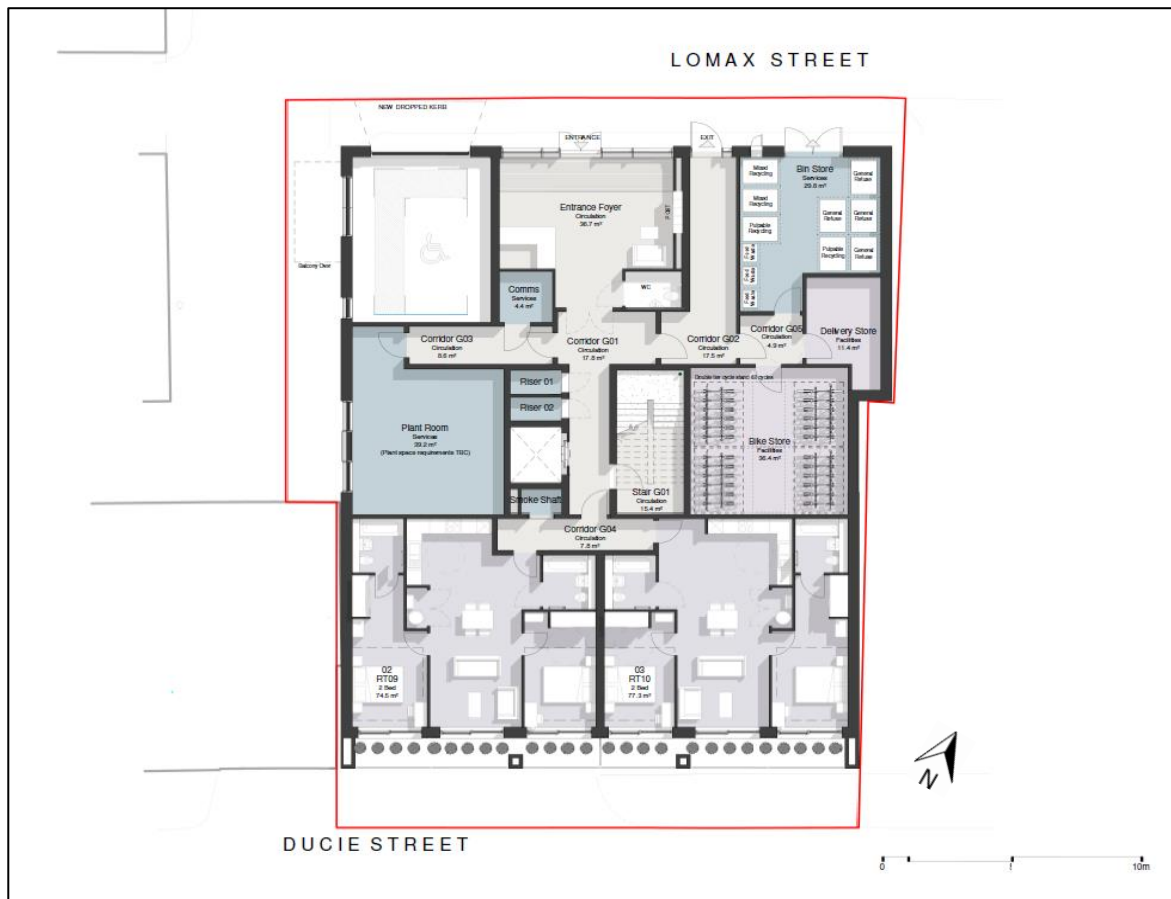
**Figure 6: Proposed Development Plan**

It is understood that the Client intends to construct a 7 to 8 storey residential apartment building that is proposed to include 41 apartments. The development will include a communal roof garden, and street tree planting. The site will be accessed via Lomax Street to the north of the site.
