## Museum of Science & Industry

### Fire Door Survey Report

### Great Western Warehouse

## **Fire Doors Report**

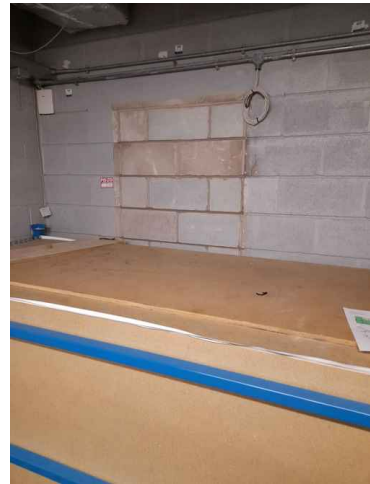
Door details  
1 of 1

| Door details | |
|---|---|
| Doorset no longer present | |
| <b>Compliance:</b> | Satisfactory |

| Door details | |
|---|---|
| <b>Recommended actions:</b> | Doorset is compliant |

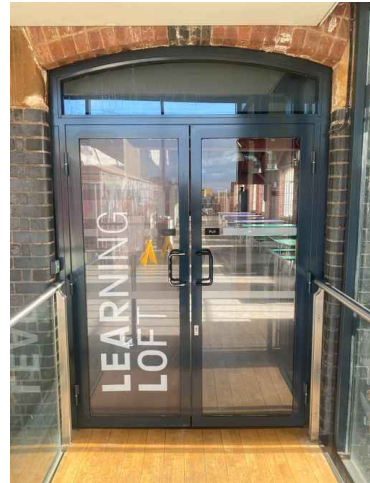
Door details  
1 of 2

| <b>Action required - Door Frame:</b> | Risk of damage to decorative finishes (frames / architrave's) prevented inspection from being performed - Intrusive inspection required |

| Unable to evidence condition of screws as finger guards have been added | |

| Action required - Signage: | Replace/install Fire Door Keep Shut sign |

| Recommended actions: | Doorset can be upgraded to a notional standard Service Pack B - Double Doorset |

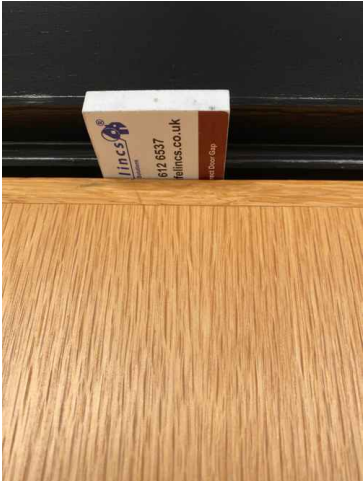
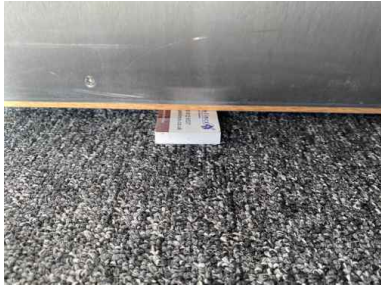
Door leaf  
1 of 2

| Some damage to lipping, door needs to be re-lipped to close gaps also. | |

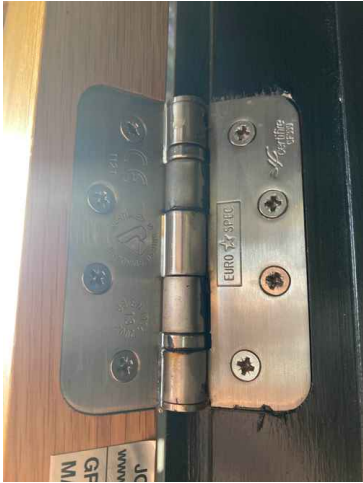
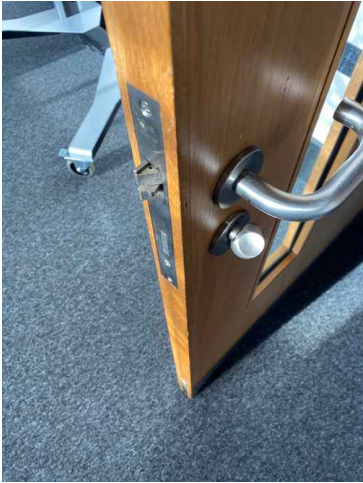
Ironmongery  
1 of 2

| Are the hinges free of metal fragment and oil leakage, which shows signs of wear?: | No |

| Action required - Ironmongery: | Arrange for hinge repairs or replacement due to wear & tear |

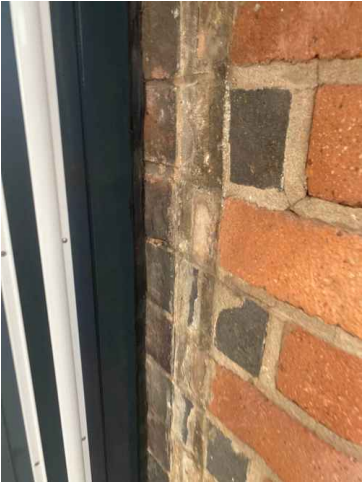
Door frame  
1 of 1

| <b>Action required - Door Frame:</b> | Risk of damage to decorative finishes (frames / architrave's) prevented inspection from being performed - Intrusive inspection required |

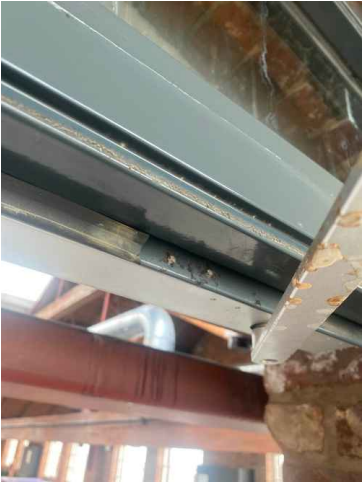
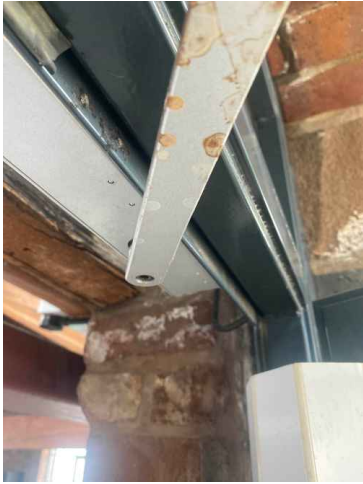
Seals  
1 of 2

| <b>Are the seals free from damage?:</b> | No |

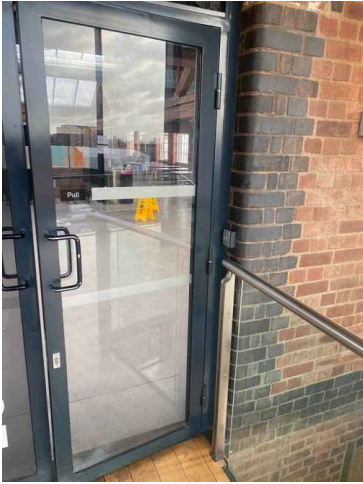
Ironmongery  
1 of 1

| <b>Is all ironmongery free from damage and correctly operating?:</b> | N/A |
| Unable to check conditions of hinges as finger guards have been added | |

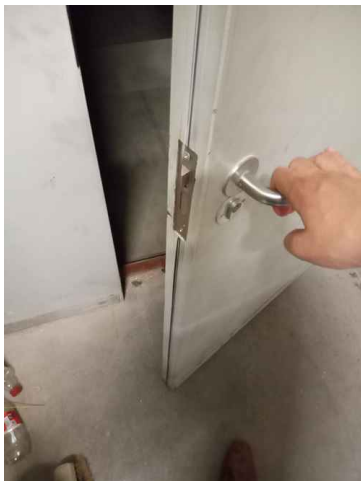
Door leaf  
1 of 2

| Door details | |
|---|---|
| Is the door leaf free from damage affecting its fire integrity?: | Yes |

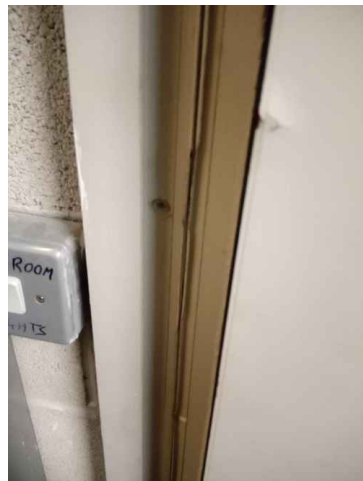
Door frame  
1 of 1

| Door details | |
|---|---|
| Is the door frame free from damage affecting its fire integrity?: | Yes |

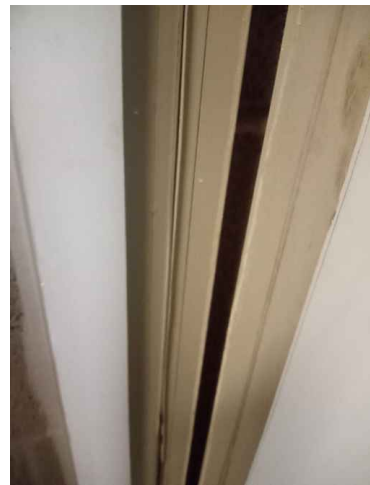
Seals  
1 of 1

| Door details | |
|---|---|
| Are the seals free from damage?: | No |

| Door details | |
|---|---|
| Action required - Seals: | Arrange for replacement intumescent seals/smoke seals FD60 20mm |

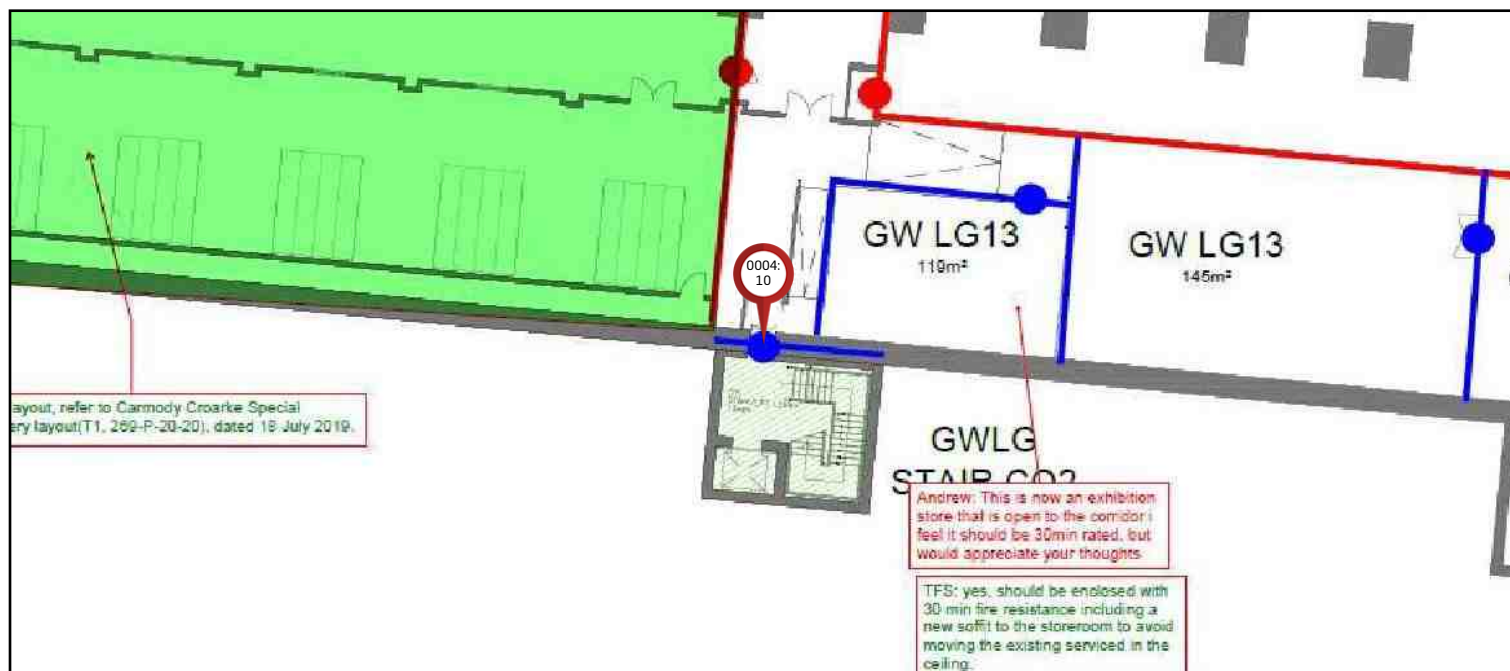
| Door details | |
|---|---|
| Action required - Door Frame: | Risk of damage to decorative finishes (frames / architrave's) prevented inspection from being performed - Intrusive inspection required |

| Recommended actions: | Doorset can be upgraded to certifiable standard Service Pack A - Door & Slave |

| Action required - Signage: | Replace/install Fire Door Keep Shut sign |
| Recommended actions: | Doorset can be upgraded to a notional standard Service Pack B - Single doorset |

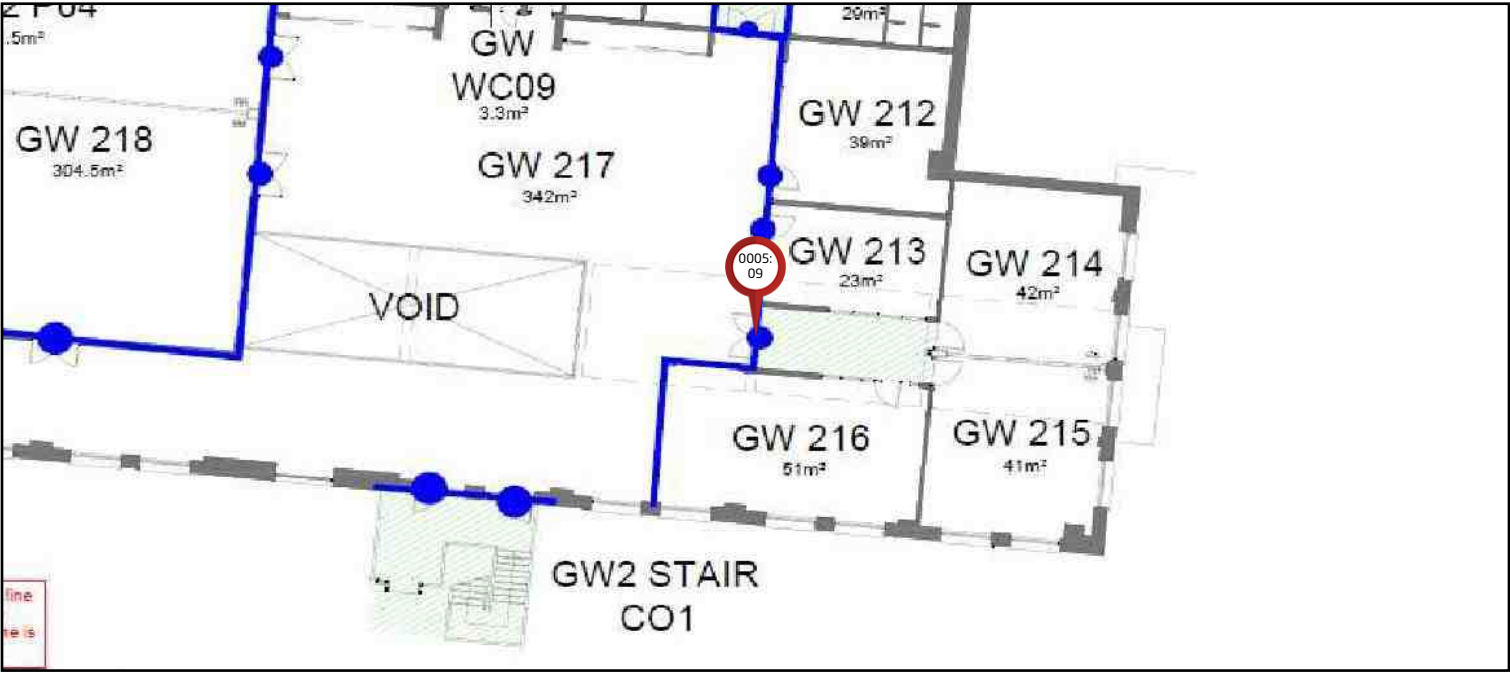
**Pin Number:** 0005:08  
**Company:** Neo Property Solutions  
**Contractor:** Phillip Hands - 23

**Date Added:** 22/03/2022 - 16:08  
**Location:** Science Museum Group 355 / Museum of Science and Industry Manchester / Great Western Warehouse / Great Western Warehouse  
**Status:** Action required

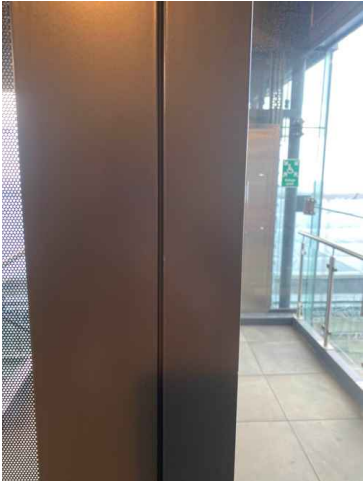
Door leaf  
1 of 2

| <b>Is the door leaf free from damage affecting its fire integrity?:</b> | Yes |

| Recommended actions: | Doorset can be upgraded to a notional standard Service Pack B - Double Doorset |

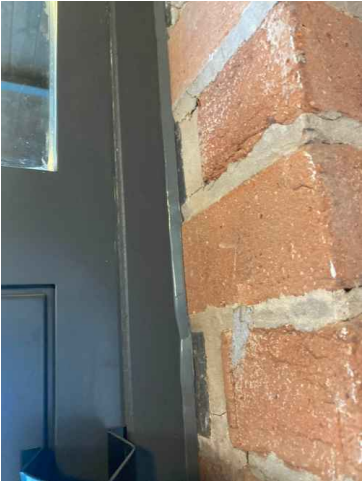
Door frame  
1 of 1

| <b>Is the door frame free from damage affecting its fire integrity?:</b> | Yes |

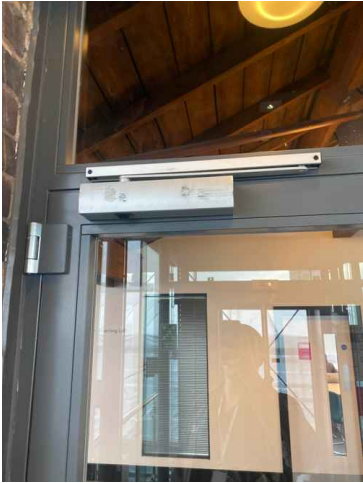
Door closers  
1 of 1

| Is the closer free from damage and not leaking?: | Yes |

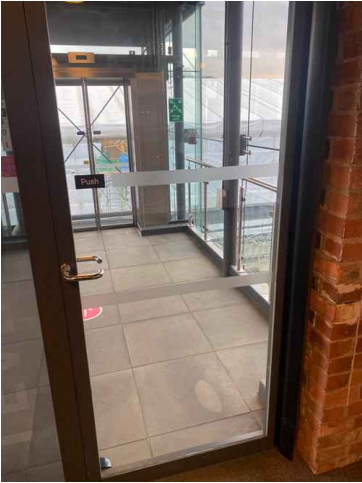
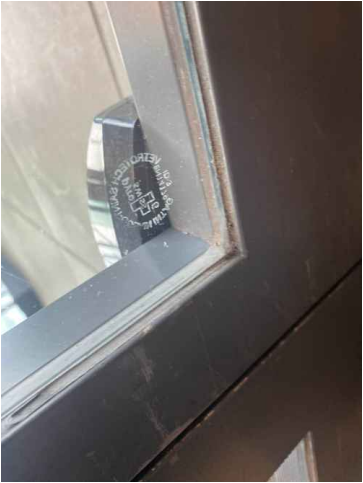
Glazing and Glass  
1 of 2

| Are the glazing beads correctly attached to the frame from both sides and free from damage?: | Yes |
| Is the glass free from damage and cracking?: | Yes |

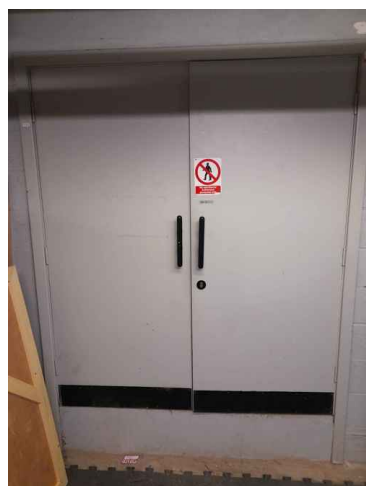
Door details  
1 of 1

| <b>Action required - Door Frame:</b> | Risk of damage to decorative finishes (frames / architrave's) prevented inspection from being performed - Intrusive inspection required |

| Recommended actions: | Doorset is not compliant and cannot be repaired or upgraded to meet a satisfactory standard - Replacement Required Double Doorset |

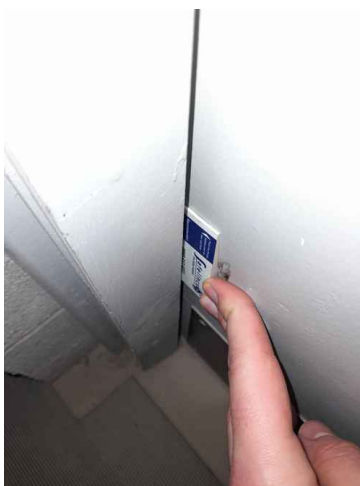
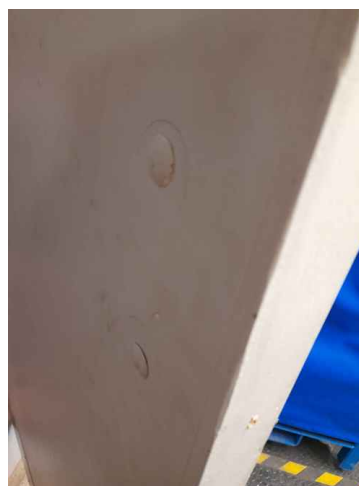
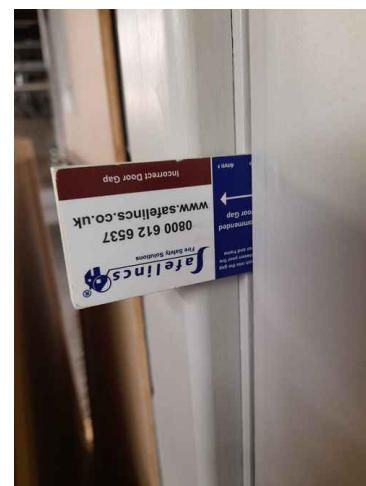
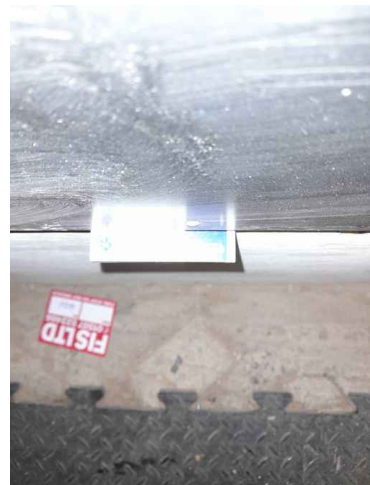
Door leaf  
1 of 4

| <b>Is the door leaf free from damage affecting its fire integrity?:</b> | No |

| <b>Action required - Door Leaf:</b> | Arrange for replacement compliant full door set |

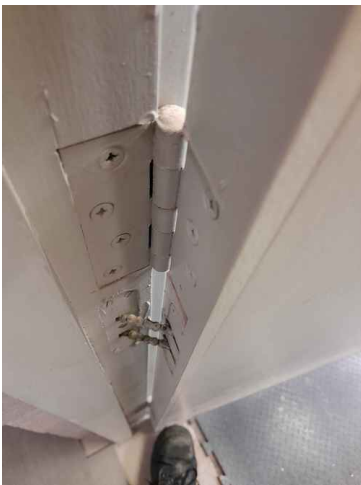
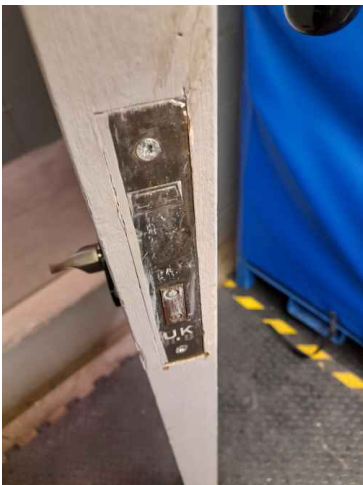
Ironmongery  
1 of 2

| Is all ironmongery free from damage and correctly operating?: | No |

| Action required - Ironmongery: | Ironmongery is not to a compliant standard and needs to be replaced |

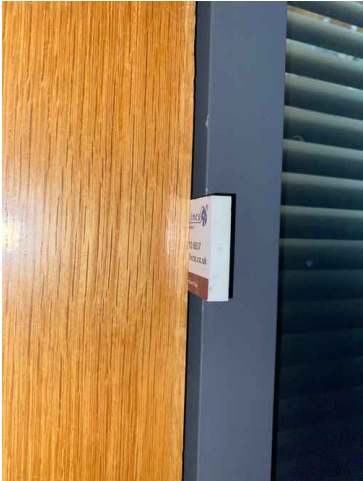
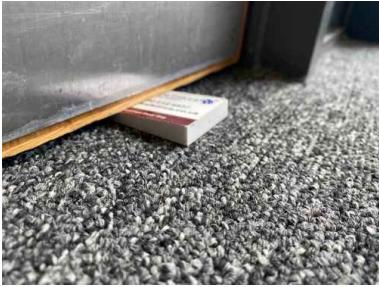
Door leaf  
1 of 2

| Door details | |
|---|---|
| Is the door leaf free from damage affecting its fire integrity?: | Yes |

| Recommended actions: | Doorset can be upgraded to a notional standard Service Pack B - Single doorset |

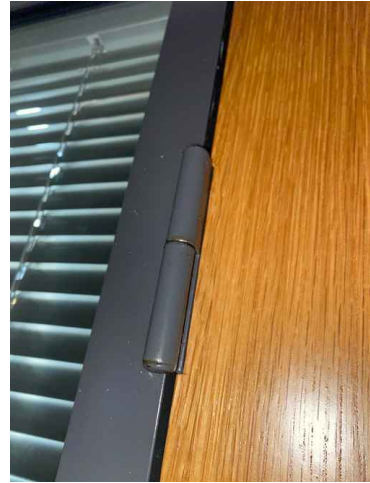
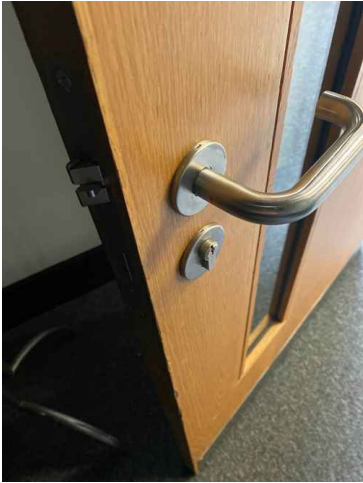
Ironmongery  
1 of 2

| Is all ironmongery free from damage and correctly operating?: | Yes |

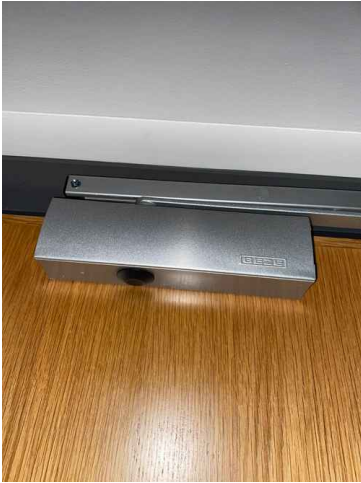
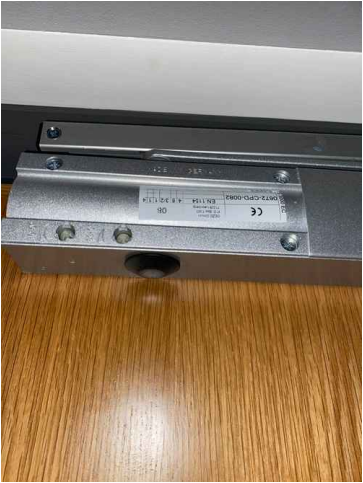
Door closers  
1 of 2

| Is the closer free from damage and not leaking?: | Yes |

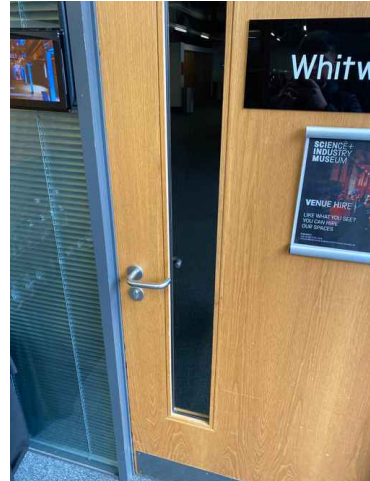
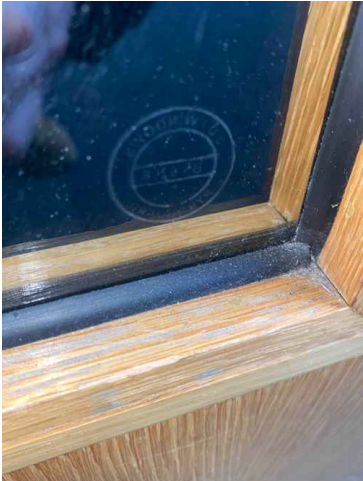
Glazing and Glass  
1 of 2

| Are the glazing beads correctly attached to the frame from both sides and free from damage?: | Yes |
| Is the glass free from damage and cracking?: | Yes |

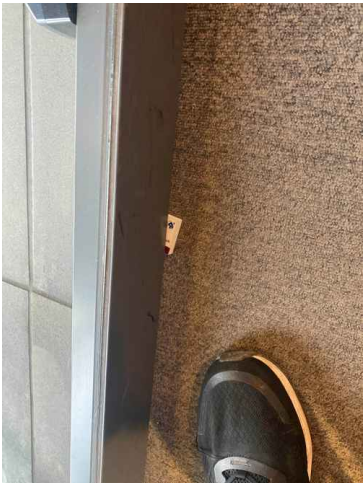
Door leaf  
1 of 1

| Door details | |
|---|---|
| Is the door leaf free from damage affecting its fire integrity?: | Yes |

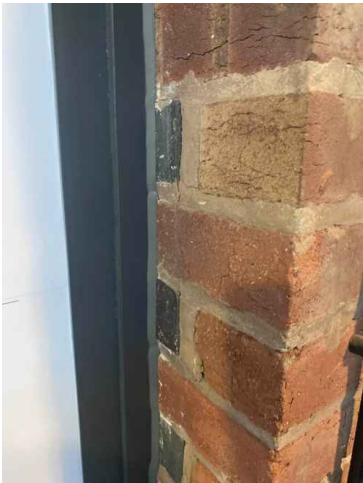
Door frame  
1 of 1

| Door details | |
|---|---|
| Is the door frame free from damage affecting its fire integrity?: | Yes |

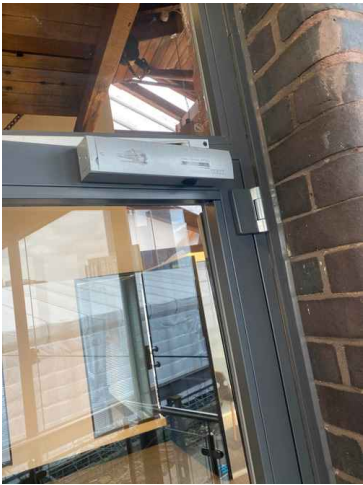
Door closers  
1 of 1

| Is the closer free from damage and not leaking?: | Yes |

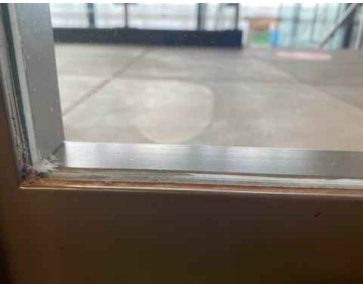
Glazing and Glass  
1 of 1

| Are the glazing beads correctly attached to the frame from both sides and free from damage?: | Yes |
| Is the glass free from damage and cracking?: | Yes |

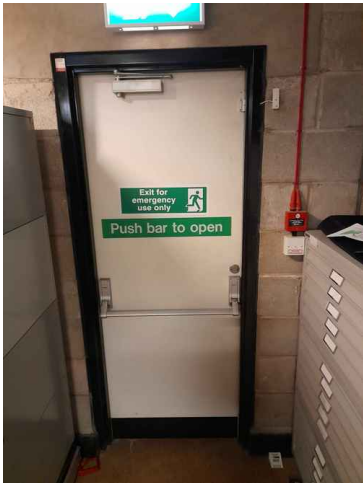
Door details  
1 of 1

| <b>Action required - Door Frame:</b> | Risk of damage to decorative finishes (frames / architrave's) prevented inspection from being performed - Intrusive inspection required |

| Action required - Signage: | Replace/install Fire Door Keep Shut sign |
| Recommended actions: | Doorset can be upgraded to a notional standard Service Pack B - Single doorset |

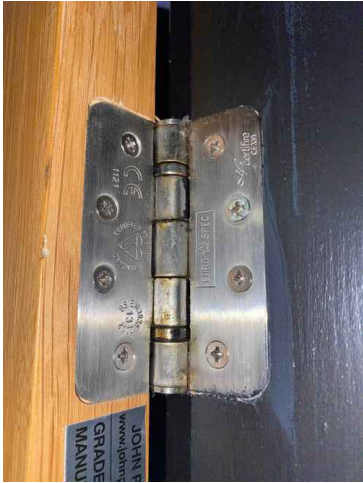
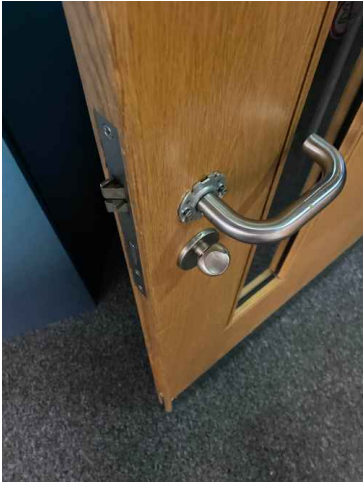
Ironmongery  
1 of 2

| <b>Are the hinges free of metal fragment and oil leakage, which shows signs of wear?:</b> | No |

| Action required - Ironmongery: | Arrange for hinge repairs or replacement due to wear & tear |

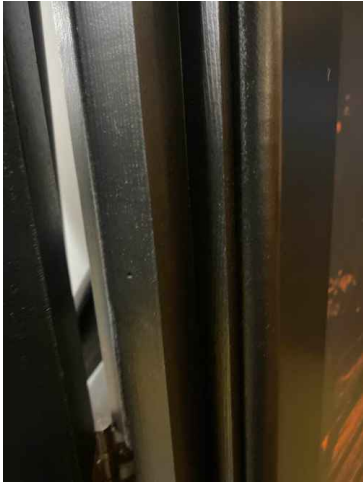
Door frame  
1 of 1

| <b>Action required - Door Frame:</b> | Risk of damage to decorative finishes (frames / architrave's) prevented inspection from being performed - Intrusive inspection required |

| <b>Action required - Signage:</b> | Replace/install Fire Door Keep Shut sign |
| <b>Recommended actions:</b> | Doorset can be upgraded to a notional standard Service Pack B - Door & Slave |

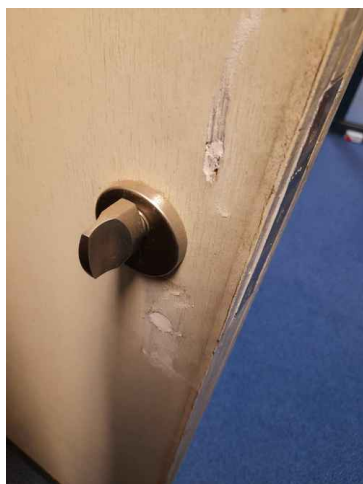
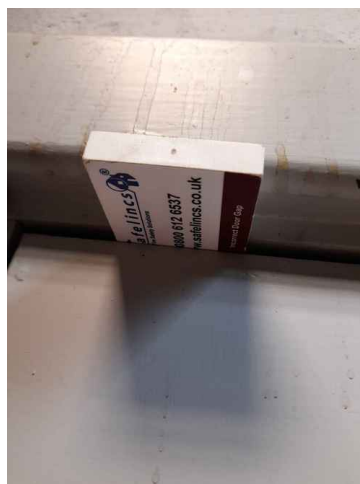
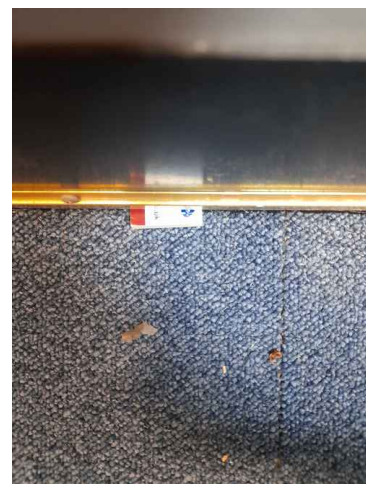
Door leaf  
1 of 3

| <b>Is the door leaf free from damage affecting its fire integrity?:</b> | No |
| <b>Action required - Door Frame:</b> | Risk of damage to decorative finishes (frames / architrave's) prevented inspection from being performed - Intrusive inspection required |

| Are the hinges free of metal fragment and oil leakage, which shows signs of wear?: | No |

| Action required - Ironmongery: | Arrange for hinge repairs or replacement due to wear & tear |
| Action required - Signage: | Replace/install Fire Door Keep Locked sign |
| Recommended actions: | Doorset can be upgraded to a notional standard Service Pack B - Single doorset |

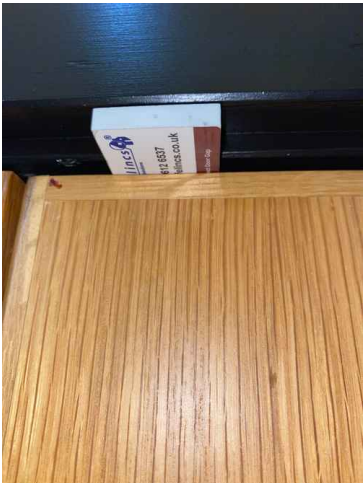
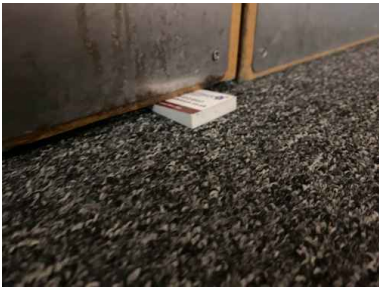
Door leaf  
1 of 2

| <b>Is the door leaf free from damage affecting its fire integrity?:</b> | Yes |

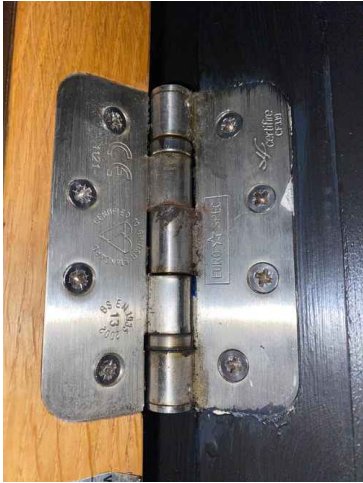
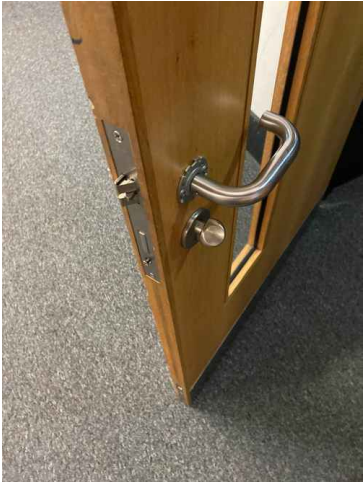
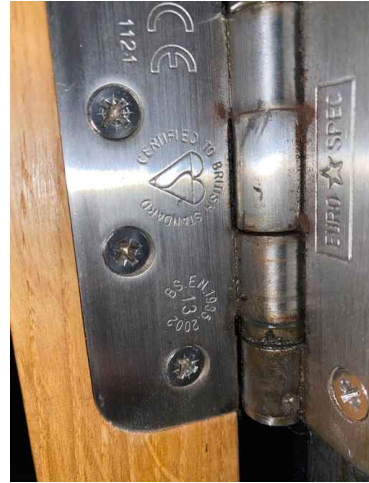
Ironmongery  
1 of 3

| <b>Are the hinges free of metal fragment and oil leakage, which shows signs of wear?:</b> | No |

| Action required - Ironmongery: | Arrange for hinge repairs or replacement due to wear & tear |

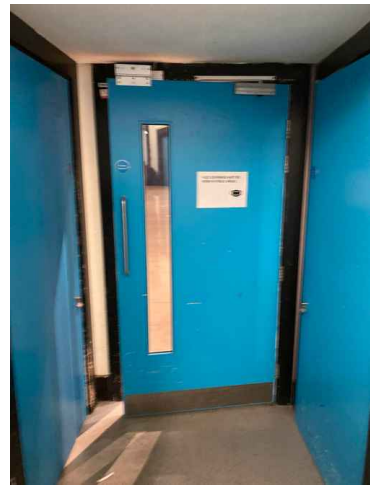
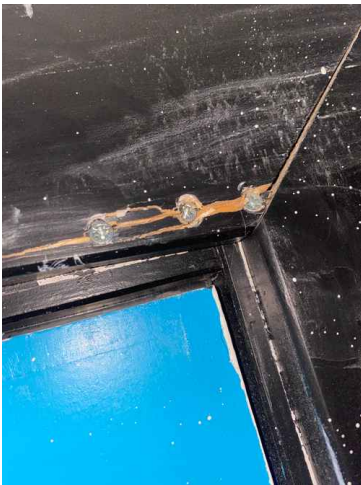
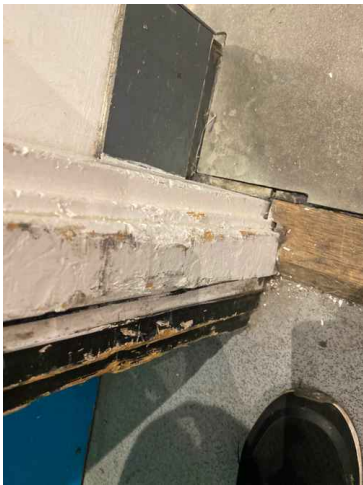
Door details  
1 of 4

| Door details | |
|---|---|
| Door frame is heavily damaged repair required | |

| Door details | |
|---|---|
| Recommended actions: | Doorset is not compliant and cannot be repaired or upgraded to meet a satisfactory standard - Replacement Required Single Doorset |

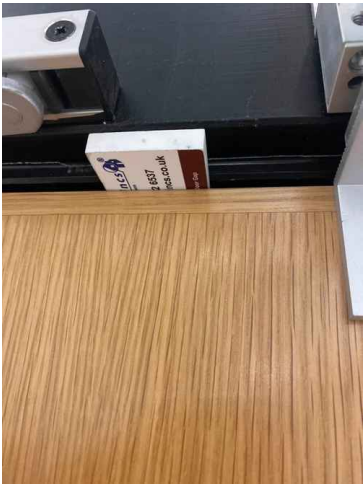
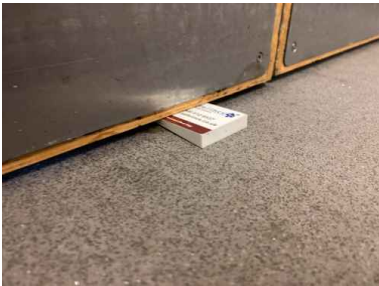
Door leaf  
1 of 2

| <b>Is the door leaf free from damage affecting its fire integrity?:</b> | No |
| Veneer is badly damaged across door leaf. Replacement is recommended. | |

| <b>Action required - Door Leaf:</b> | Arrange for replacement compliant full door set |

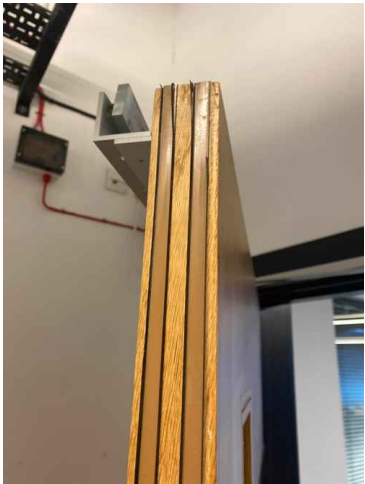
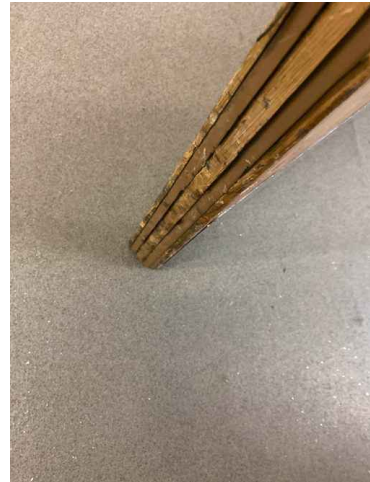
Seals  
1 of 2

| <b>Are the seals free from damage?:</b> | No |

| Action required - Seals: | Arrange for replacement intumescent seals/smoke seals FD30 10mm |

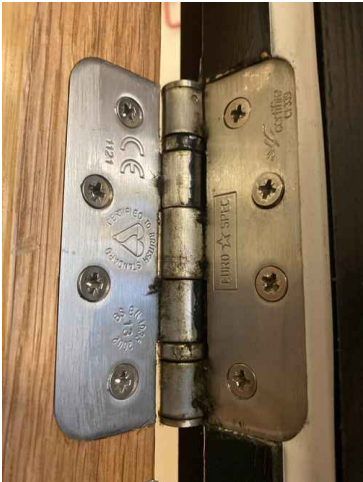
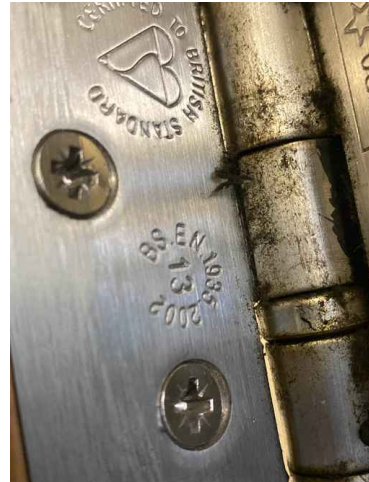
Ironmongery  
1 of 2

| Are the hinges free of metal fragment and oil leakage, which shows signs of wear?: | No |

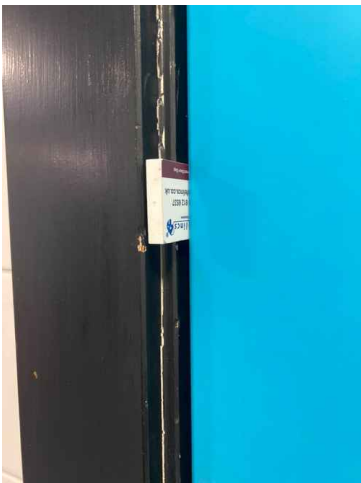
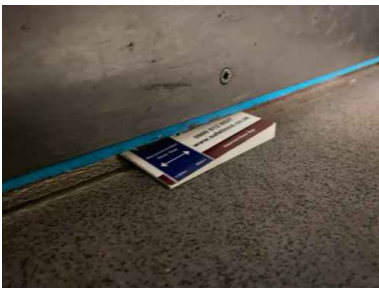
Door leaf  
1 of 2

| <b>Is the door leaf free from damage affecting its fire integrity?:</b> | Yes |

| Recommended actions: | Doorset can be upgraded to a notional standard Service Pack B - Single doorset |

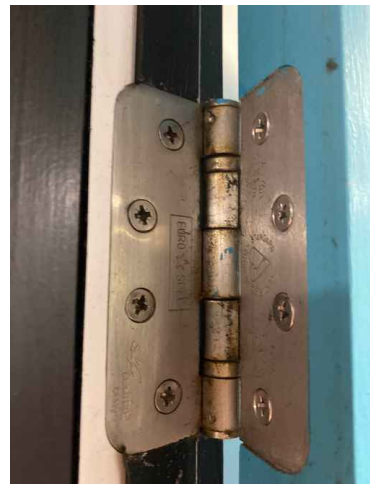
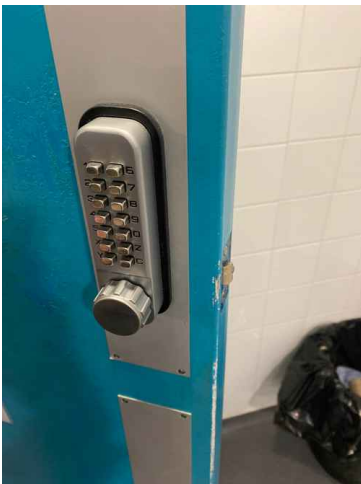
Ironmongery  
1 of 2

| Are the hinges free of metal fragment and oil leakage, which shows signs of wear?: | No |

| Action required - Ironmongery: | Arrange for hinge repairs or replacement due to wear & tear |

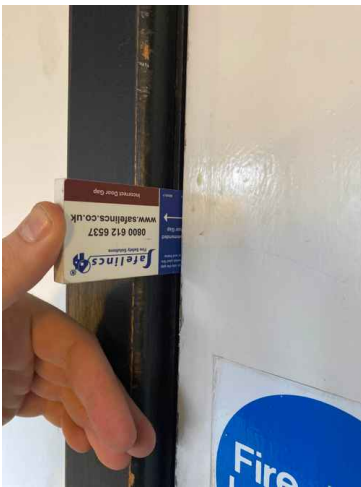
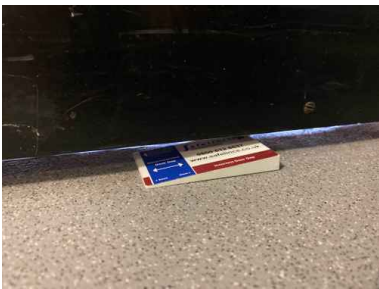
Door leaf  
1 of 2

| Door is warped. Replacement required. | |

| Recommended actions: | Doorset is not compliant and cannot be repaired or upgraded to meet a satisfactory standard - Replacement Required Single Doorset |

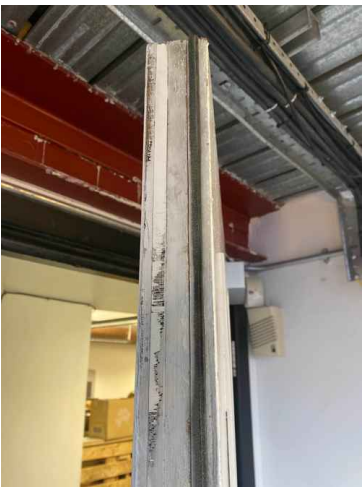
Seals  
1 of 1

| <b>Are the seals free from damage?:</b> | No |

| Action required - Seals: | Arrange for replacement intumescent seals/smoke seals FD60 20mm |

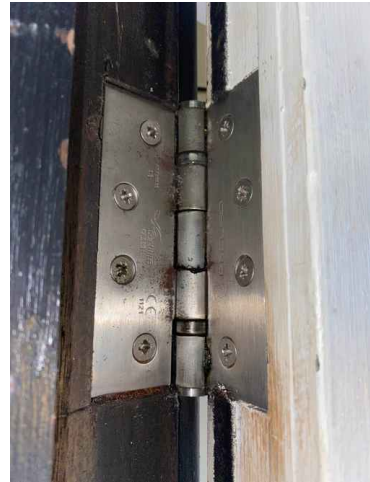
Ironmongery  
1 of 1

| Are the hinges free of metal fragment and oil leakage, which shows signs of wear?: | No |

| Action required - Ironmongery: | Arrange for hinge repairs or replacement due to wear & tear |

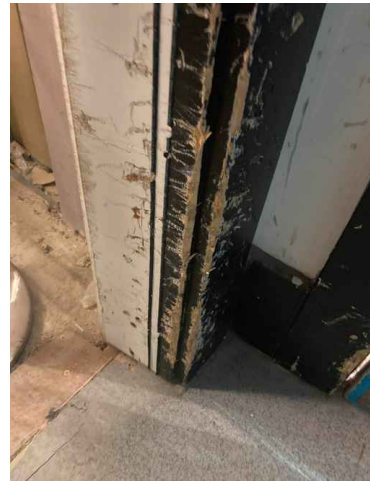
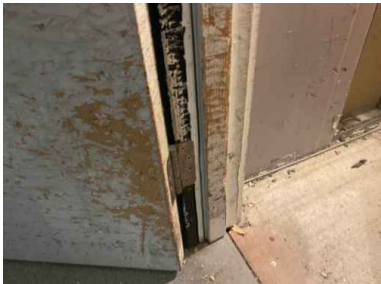
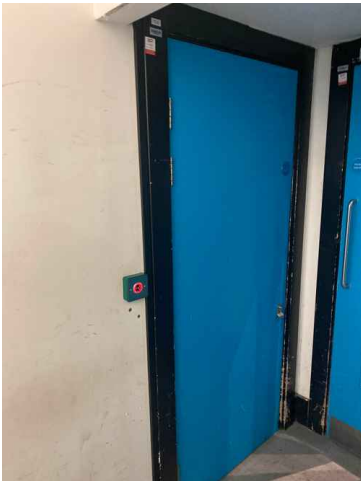
Door details  
1 of 3

| Door details | |
|---|---|
| Frame is heavily damaged replacement required | |

| Door details | |
|---|---|
| Recommended actions: | Doorset is not compliant and cannot be repaired or upgraded to meet a satisfactory standard - Replacement Required Single Doorset |

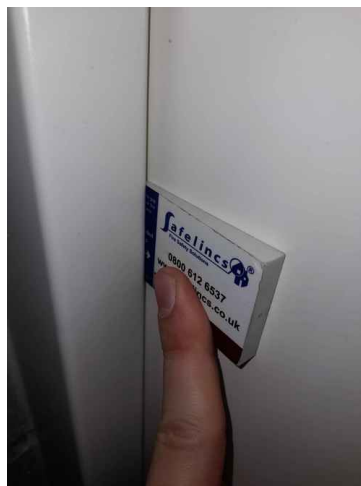
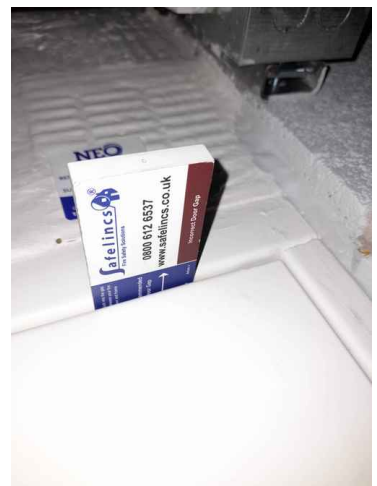
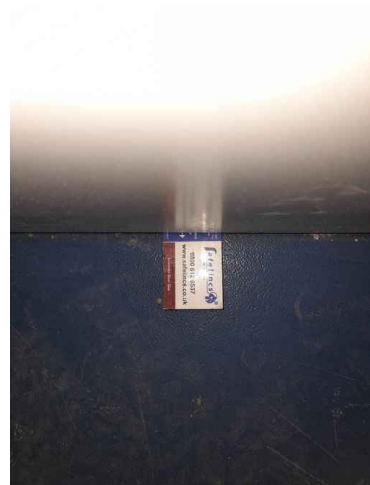
Door leaf  
1 of 3

| <b>Is the door leaf free from damage affecting its fire integrity?:</b> | Yes |

| <b>Action required - Door Leaf:</b> | Arrange for replacement compliant full door set |

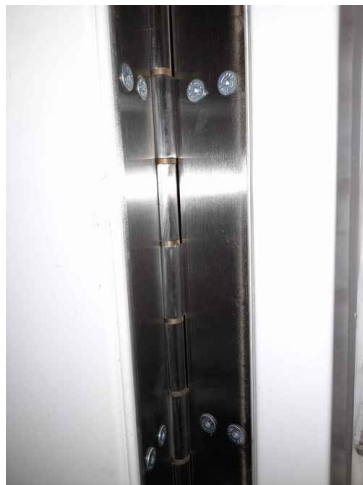
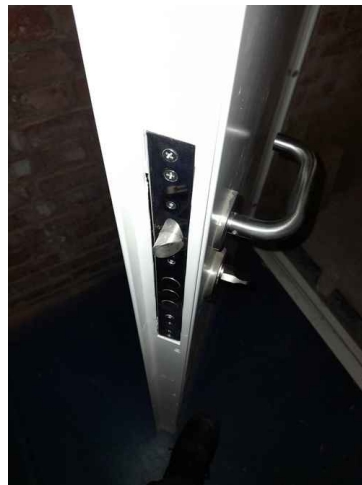
Ironmongery  
1 of 2

| <b>Are the hinges free of metal fragment and oil leakage, which shows signs of wear?:</b> | Yes |

| Recommended actions: | Doorset is not compliant and cannot be repaired or upgraded to meet a satisfactory standard - Replacement Required Single Doorset |

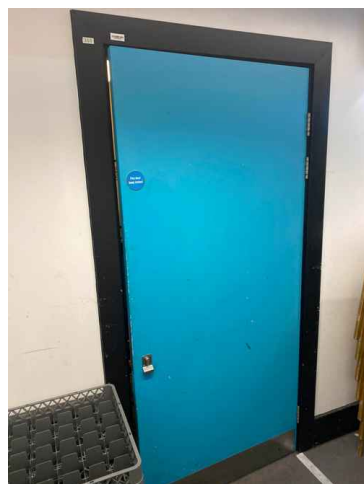
Door details  
1 of 1

| Door details | |
|---|---|
| Is the door leaf free from damage affecting its fire integrity?: | Yes |

| Recommended actions: | Doorset can be upgraded to a notional standard Service Pack B - Single doorset |

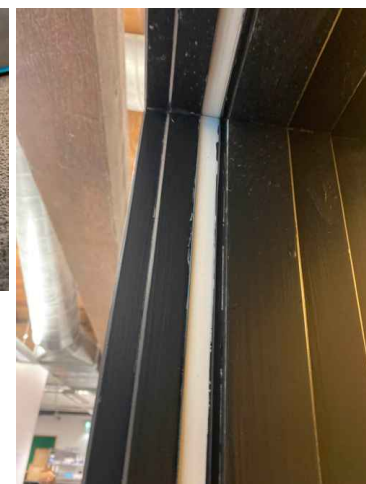
Seals  
1 of 1

| Door details | |
|---|---|
| Are the seals free from damage?: | Yes |

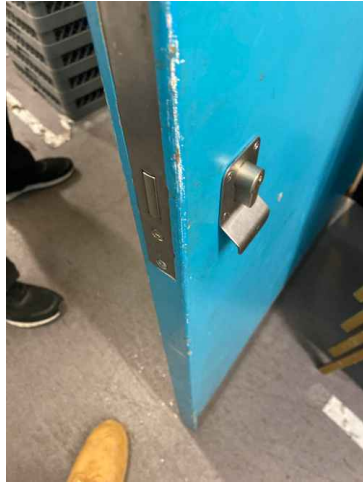
Ironmongery  
2 of 2

| Are the hinges free of metal fragment and oil leakage, which shows signs of wear?: | No |

| Action required - Ironmongery: | Arrange for hinge repairs or replacement due to wear & tear |

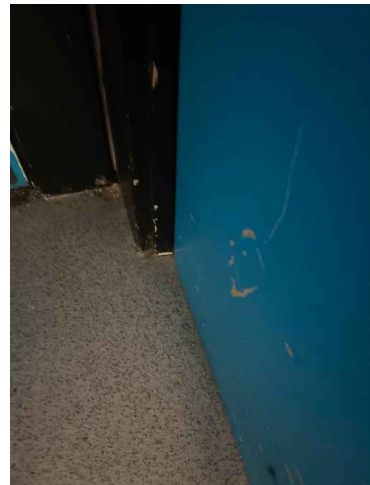
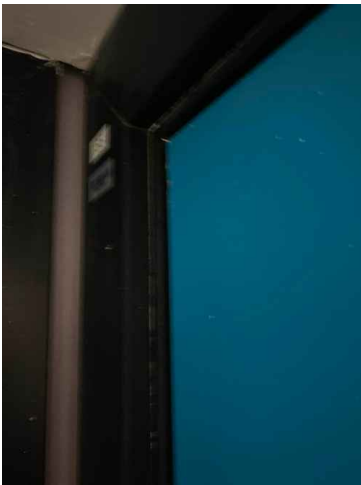
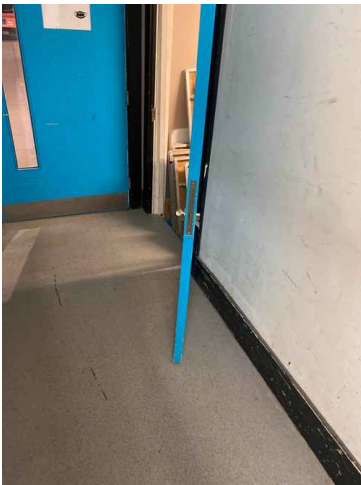
Door details  
1 of 3

| Door details | |
|---|---|
| Door set is warped replacement required | |

| Door details | |
|---|---|
| Recommended actions: | Doorset is not compliant and cannot be repaired or upgraded to meet a satisfactory standard - Replacement Required Single Doorset |

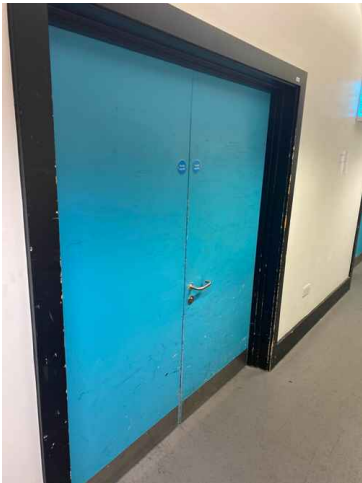
Door details  
1 of 1

| It needs to be replaced with a 54mm FD60 door. | |

| Recommended actions: | Doorset is not compliant and cannot be repaired or upgraded to meet a satisfactory standard - Replacement Required Double Doorset |

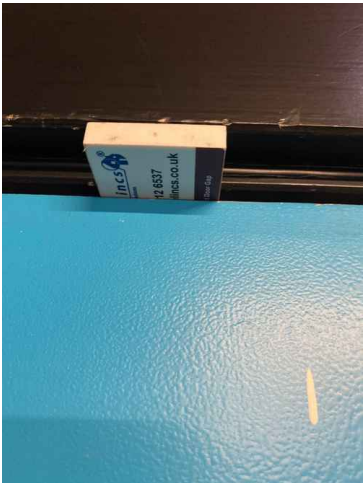
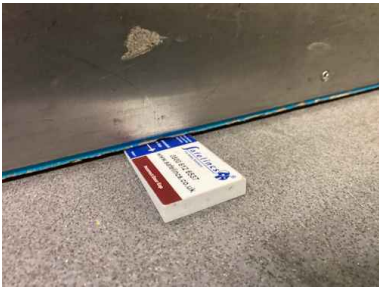
Door leaf  
1 of 2

| <b>Is the door leaf free from damage affecting its fire integrity?:</b> | Yes |

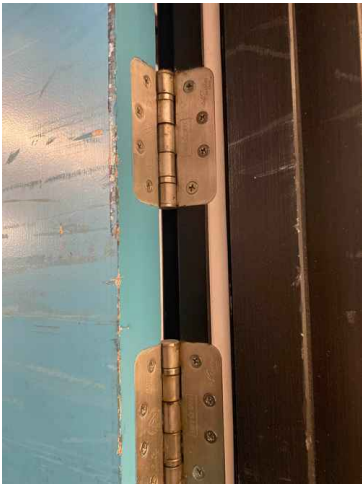
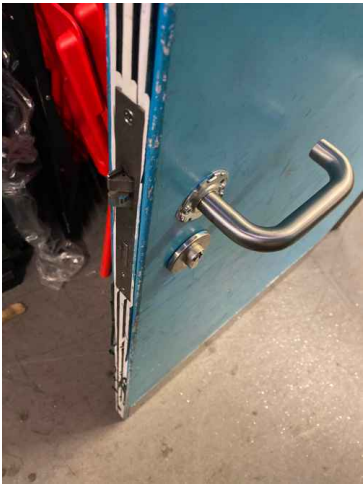
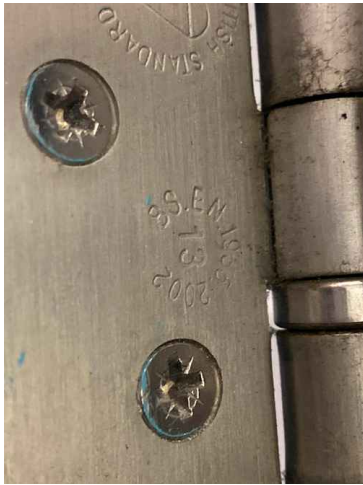
Ironmongery  
1 of 3

| Are the hinges free of metal fragment and oil leakage, which shows signs of wear?: | No |

| Action required - Ironmongery: | Arrange for hinge repairs or replacement due to wear & tear |

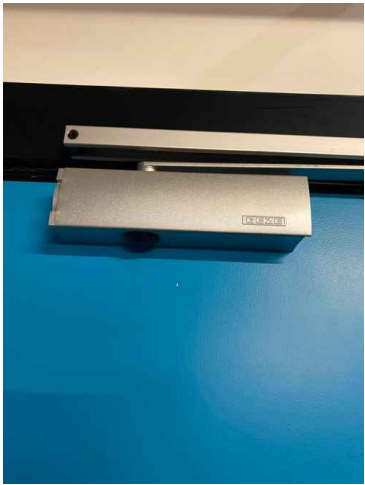
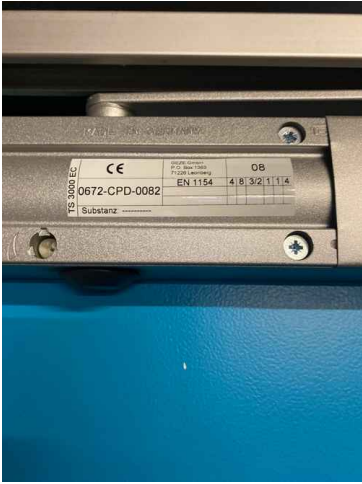
Door closers  
1 of 2

| Is the closer free from damage and not leaking?: | Yes |

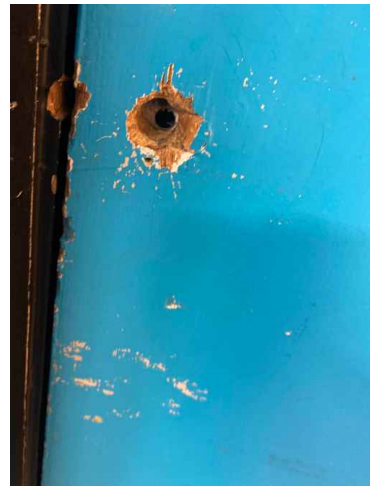
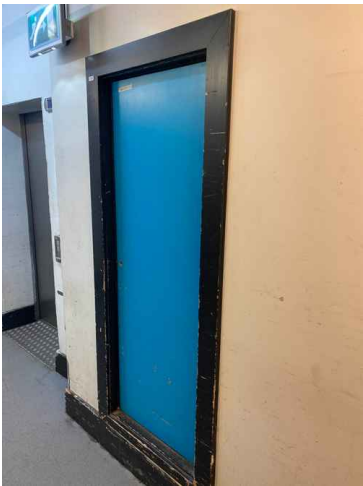
Door details  
1 of 2

| Door details | |
|---|---|
| Door leaf and frame is badly damaged replacement door required | |

| Door details | |
|---|---|
| Recommended actions: | Doorset is not compliant and cannot be repaired or upgraded to meet a satisfactory standard - Replacement Required Single Doorset |

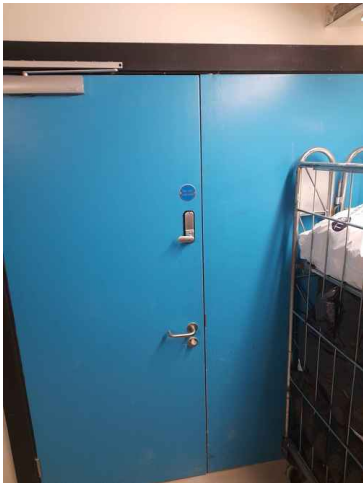
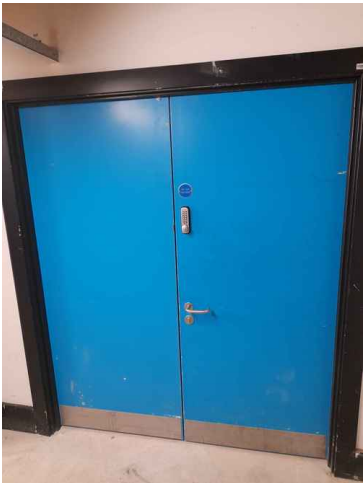
Door details  
1 of 2

| Door details | |
|---|---|
| Is the door frame free from damage affecting its fire integrity?: | Yes |

| Door details | |
|---|---|
| Action required - Door Frame: | Risk of damage to decorative finishes (frames / architrave's) prevented inspection from being performed - Intrusive inspection required |

| Recommended actions: | Doorset can be upgraded to a notional standard Service Pack B - Double Doorset |

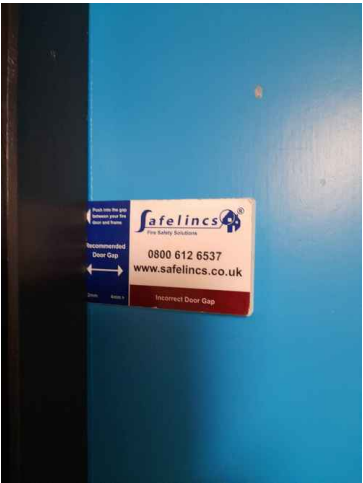
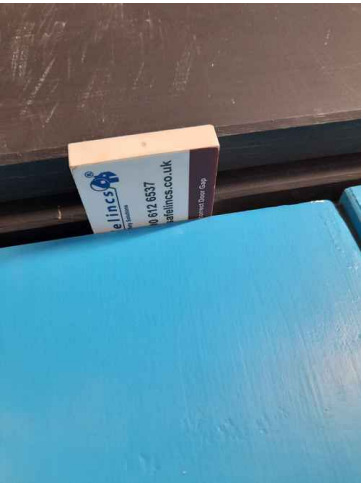
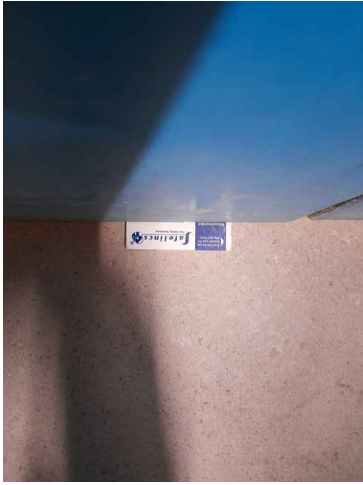
Door leaf  
1 of 3

| Door details | |
|---|---|
| Is the door leaf free from damage affecting its fire integrity?: | Yes |

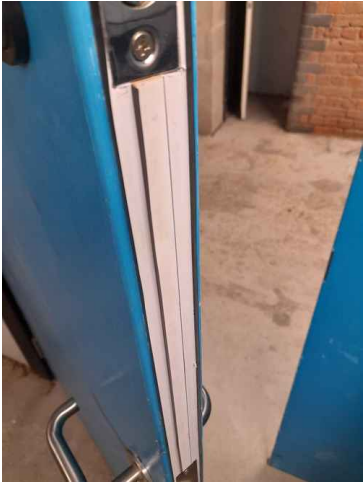
Seals  
1 of 1

| Door details | |
|---|---|
| Are the seals free from damage?: | Yes |

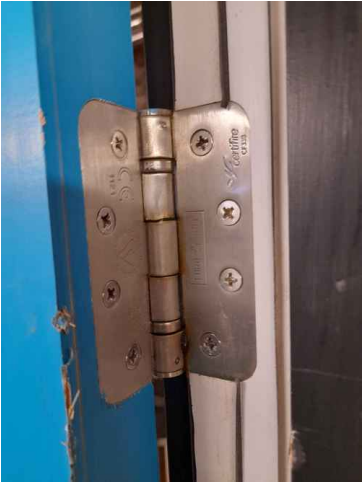
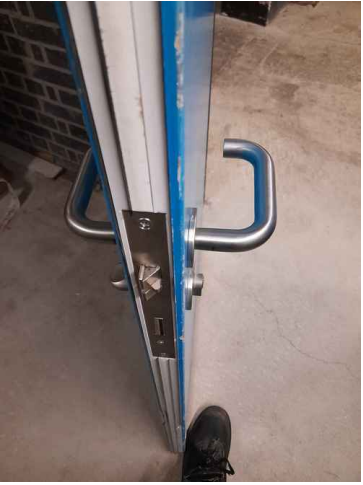
Ironmongery  
1 of 2

| Are the hinges free of metal fragment and oil leakage, which shows signs of wear?: | Yes |
| Is all ironmongery free from damage and correctly operating?: | Yes |

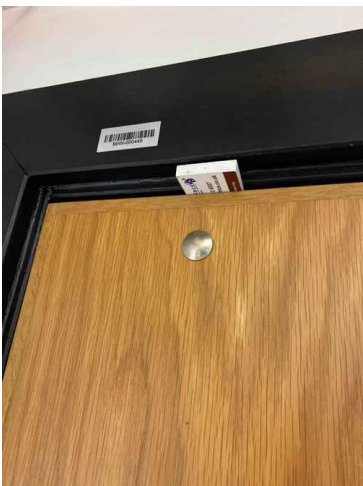
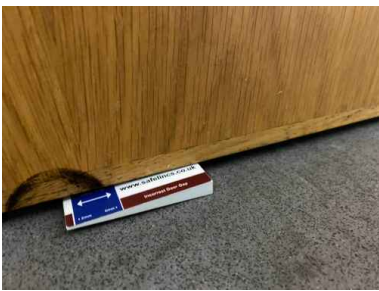
Door leaf  
1 of 2

| <b>Is the door leaf free from damage affecting its fire integrity?:</b> | Yes |

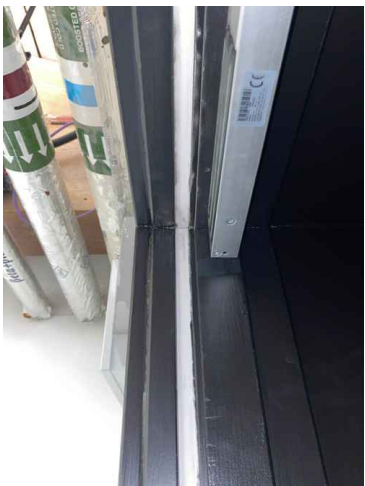
Seals  
1 of 1

| <b>Are the seals free from damage?:</b> | Yes |

| <b>Action required - Seals:</b> | Arrange for replacement intumescent seals/smoke seals FD30 10mm |
