## Museum of Science & Industry

### Fire Door Survey Report

### Great Western Warehouse

## **Fire Doors Report**

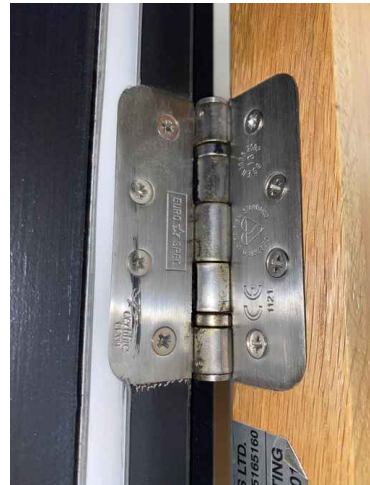
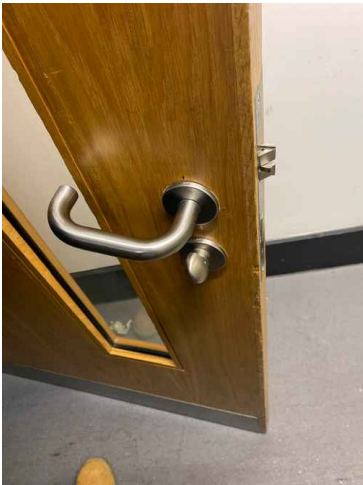
Ironmongery  
1 of 2

| <b>Are the hinges free of metal fragment and oil leakage, which shows signs of wear?:</b> | No |
| <b>Is all ironmongery free from damage and correctly operating?:</b> | Yes |

| <b>Action required - Ironmongery:</b> | Arrange for hinge repairs or replacement due to wear & tear |

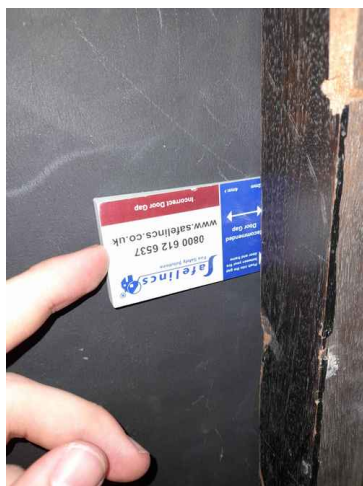
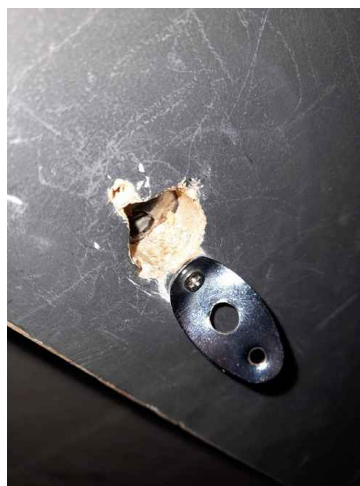
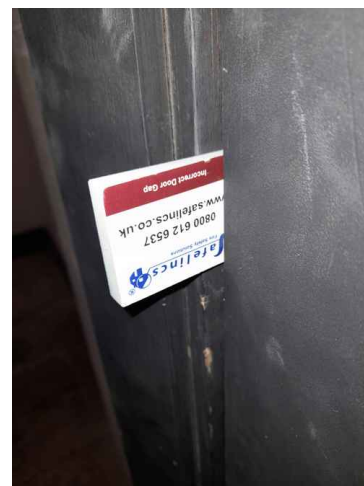
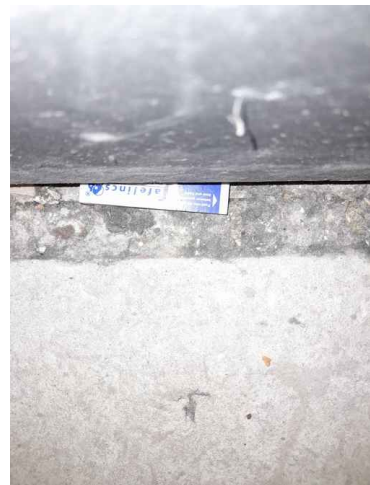
Door leaf  
1 of 4

| <b>Is the door leaf free from damage affecting its fire integrity?:</b> | No |

| <b>Action required - Door Leaf:</b> | Door leaf to be re-lipped to close gaps to within tolerance, Arrange for fire door repairs, Install a new dropdown seal |

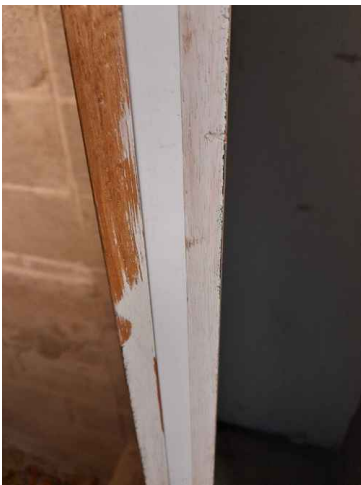
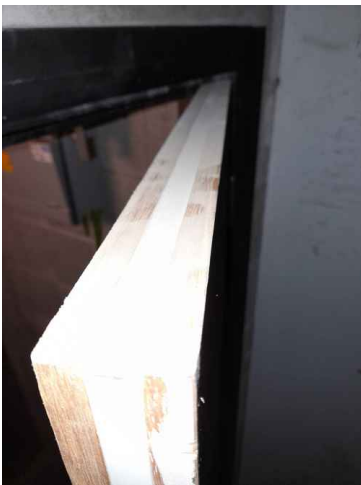
Seals  
1 of 2

| <b>Are the seals free from damage?:</b> | Yes |

| <b>Action required - Seals:</b> | Arrange for replacement intumescent seals/smoke seals FD30 10mm |

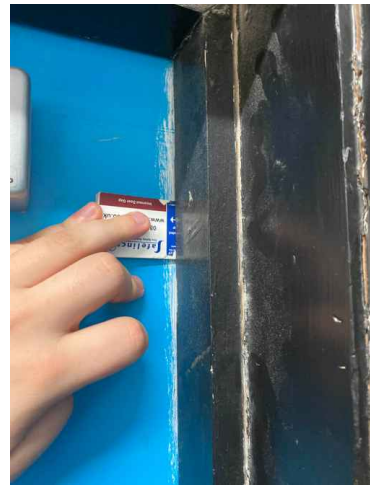
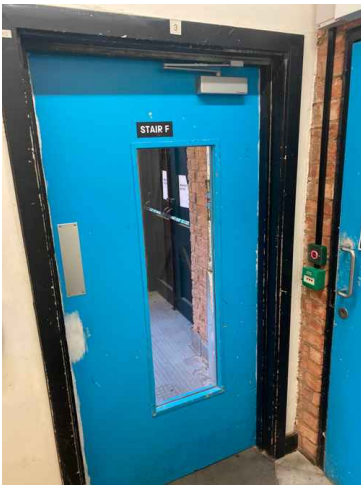
Door details  
1 of 3

| Door details | |
|---|---|
| Door set is warped replacement required | |

| Door details | |
|---|---|
| Recommended actions: | Doorset is not compliant and cannot be repaired or upgraded to meet a satisfactory standard - Replacement Required Single Doorset |

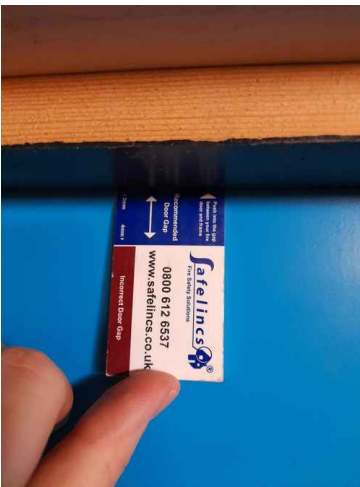
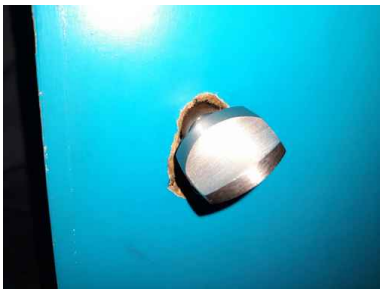
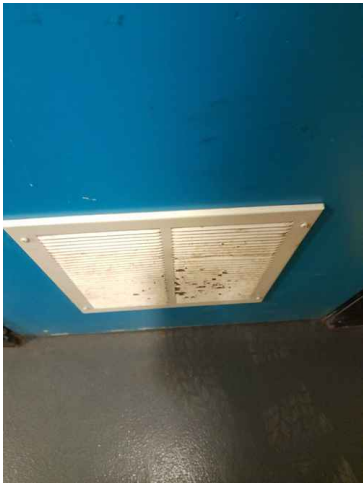
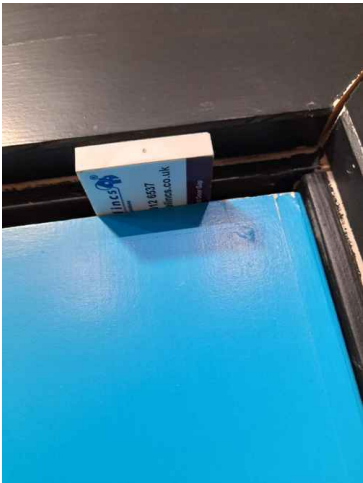
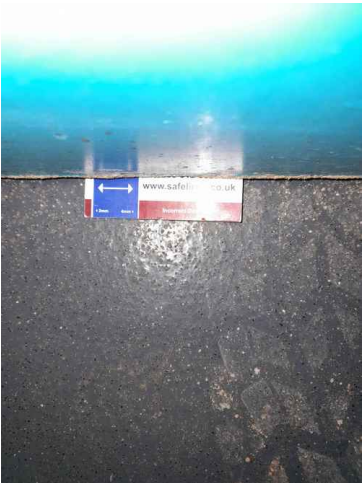
Door leaf  
1 of 5

| <b>Is the door leaf free from damage affecting its fire integrity?:</b> | No |

| Recommended actions: | Doorset can be upgraded to a notional standard Service Pack B - Single doorset |

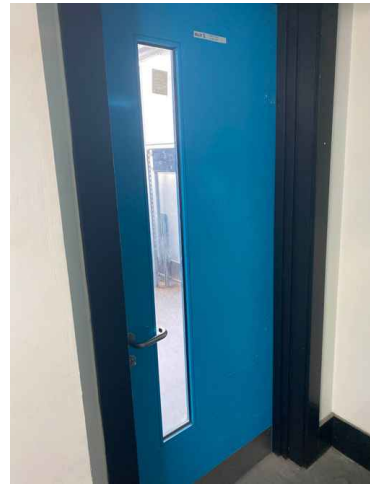
Door details  
1 of 1

| Door details | |
|---|---|
| Replacement with a FD60 door is required. | |

| Recommended actions: | Doorset is not compliant and cannot be repaired or upgraded to meet a satisfactory standard - Replacement Required Single Doorset |

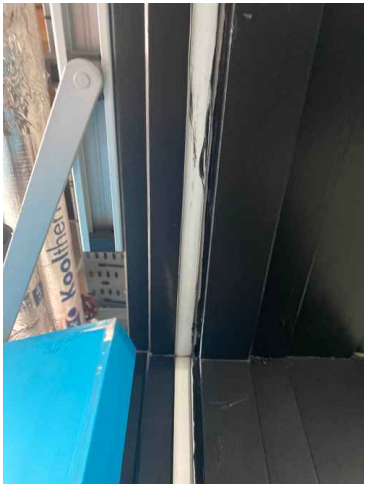
Seals  
1 of 1

| Action required - Seals: | Arrange for replacement intumescent seals/smoke seals FD60 20mm |

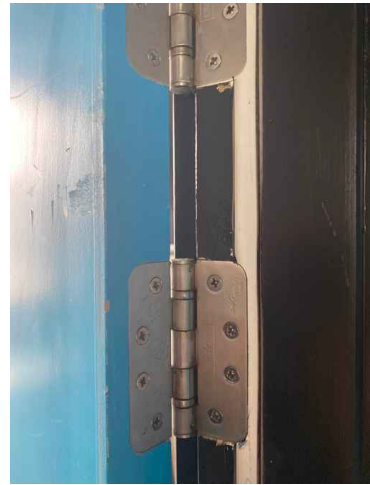
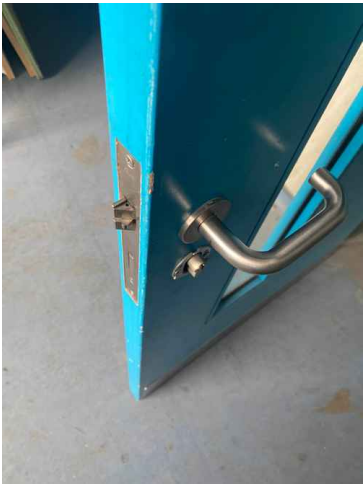
| Are the hinges free of metal fragment and oil leakage, which shows signs of wear?: | No |
| Action required - Ironmongery: | Arrange for hinge repairs or replacement due to wear & tear |

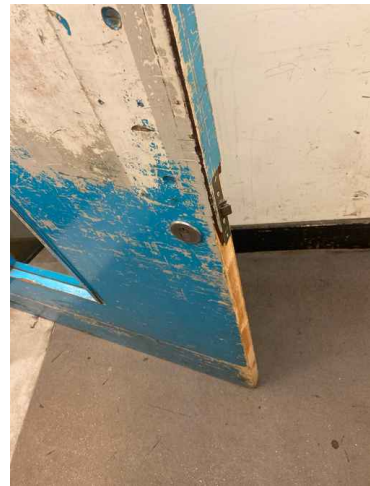
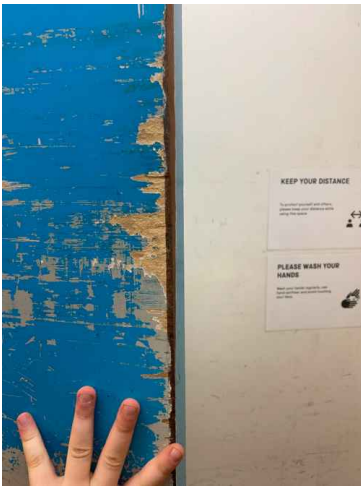
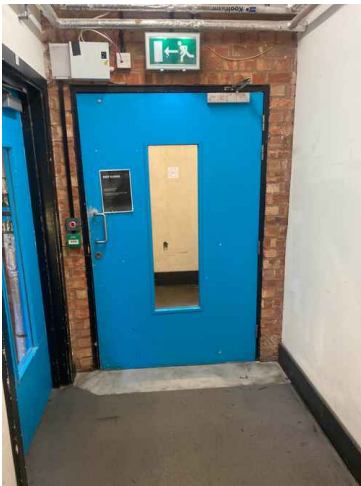
| Door details | |
|---|---|
| Door set is badly damaged replacement door required | |
| Recommended actions: | Doorset is not compliant and cannot be repaired or upgraded to meet a satisfactory standard - Replacement Required Single Doorset |

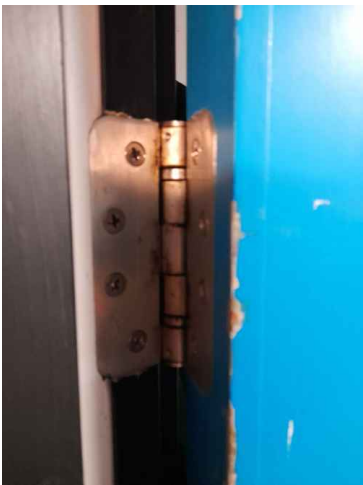
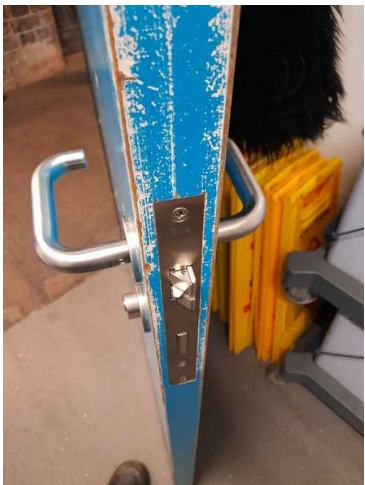
| Are the hinges free of metal fragment and oil leakage, which shows signs of wear?: | No |

| Recommended actions: | Doorset can be upgraded to a notional standard Service Pack B - Single doorset |

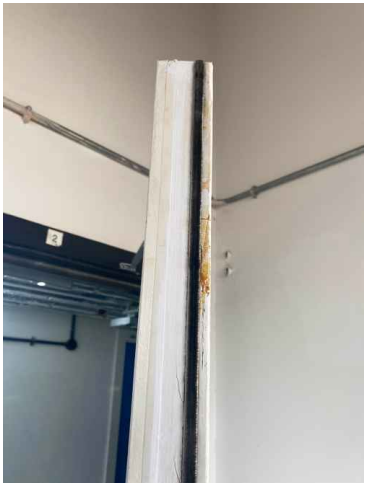
Seals  
1 of 1

| <b>Action required - Seals:</b> | Arrange for replacement intumescent seals/smoke seals FD60 20mm |

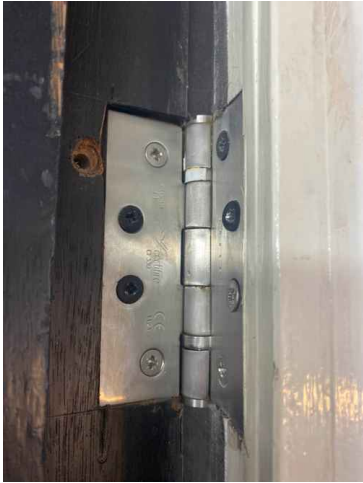
Ironmongery  
1 of 1

| <b>Are the hinges free of metal fragment and oil leakage, which shows signs of wear?:</b> | No |
| <b>Action required - Ironmongery:</b> | Arrange for hinge repairs or replacement due to wear & tear |

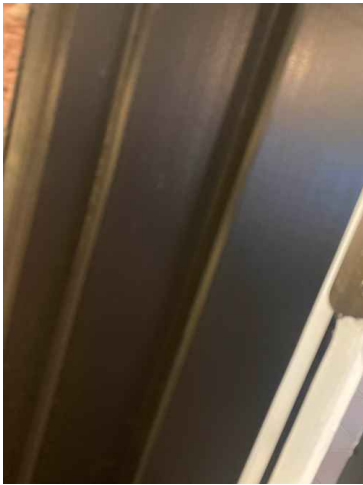
Door frame  
1 of 1

| <b>Action required - Door Frame:</b> | Risk of damage to decorative finishes (frames / architrave's) prevented inspection from being performed - Intrusive inspection required |

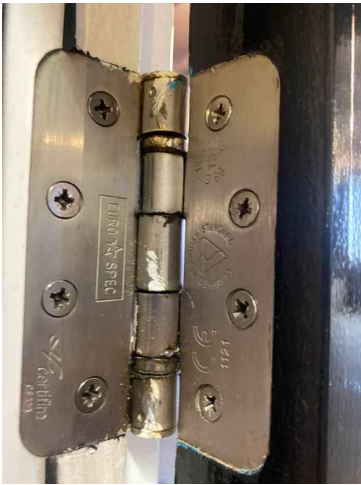
Ironmongery  
1 of 1

| Is all ironmongery free from damage and correctly operating?: | Yes |

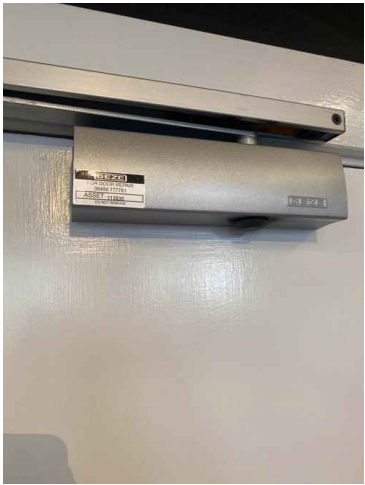
Door closers  
1 of 1

| Is the closer free from damage and not leaking?: | Yes |

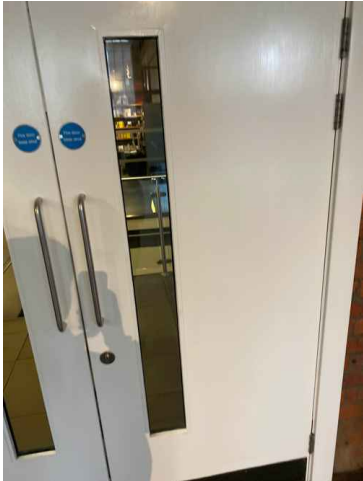
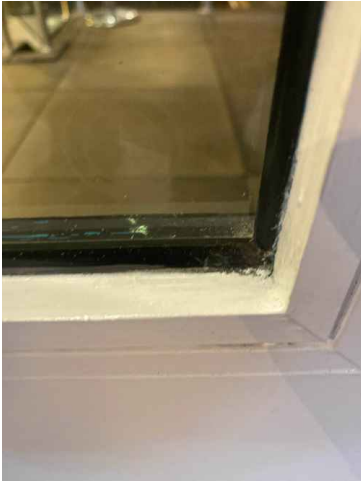
Glazing and Glass  
1 of 2

| Are the glazing beads correctly attached to the frame from both sides and free from damage?: | Yes |
| Is the glass free from damage and cracking?: | Yes |

| Recommended actions: | Doorset can be upgraded to a notional standard Service Pack B - Double Doorset |

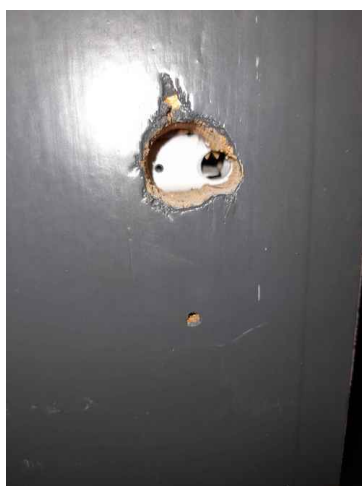
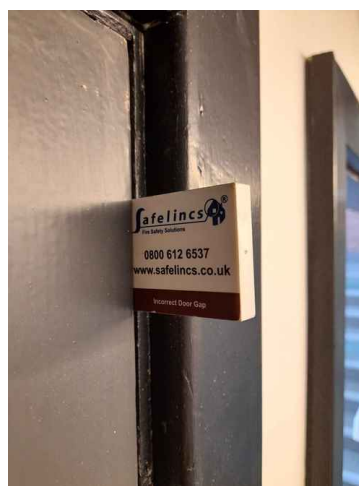
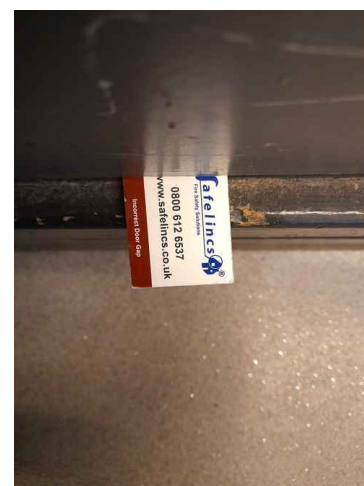
| <b>Is the door leaf free from damage affecting its fire integrity?:</b> | No |

| Recommended actions: | Doorset can be upgraded to a notional standard Service Pack B - Single doorset |

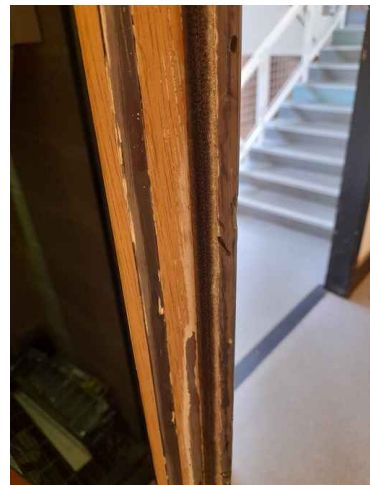
Seals  
1 of 1

| <b>Are the seals free from damage?:</b> | Yes |

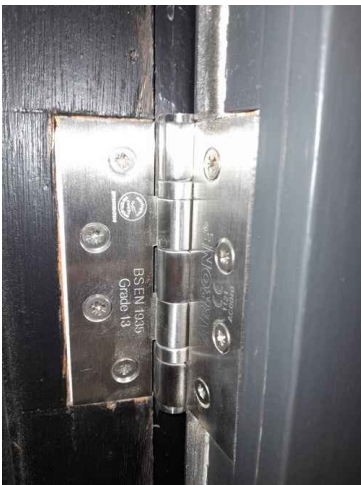
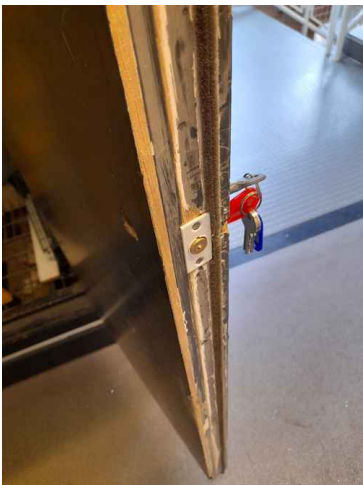
| Is all ironmongery free from damage and correctly operating?: | Yes |

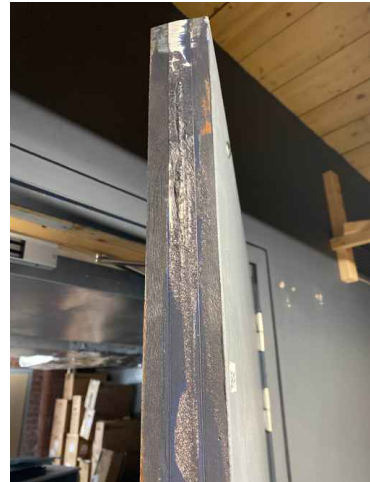
Seals  
1 of 1

| Door details | |
|---|---|
| Are the seals free from damage?: | No |

| Action required - Seals: | Arrange for replacement intumescent seals/smoke seals FD60 20mm |

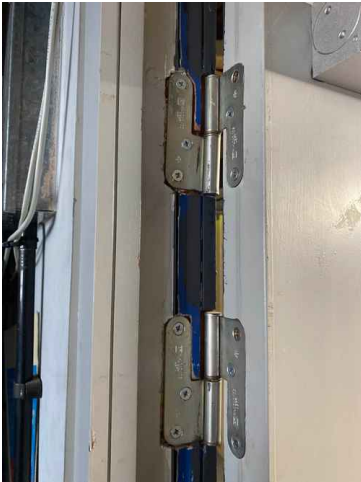
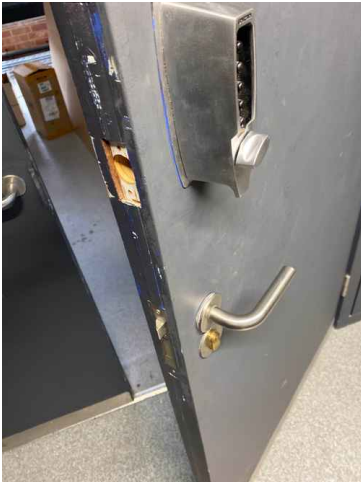
| Are the hinges free of metal fragment and oil leakage, which shows signs of wear?: | No |
| Is all ironmongery free from damage and correctly operating?: | Yes |

| Recommended actions: | Doorset is not compliant and cannot be repaired or upgraded to meet a satisfactory standard - Replacement Required Double Doorset |

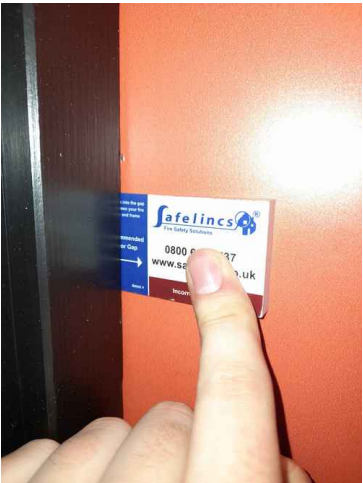
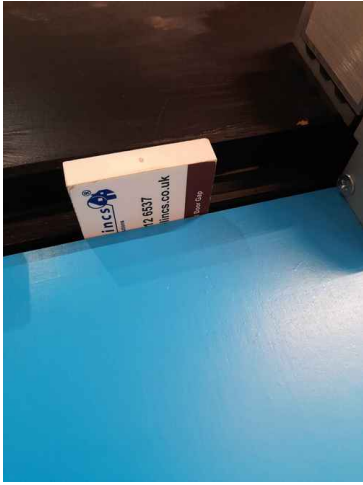
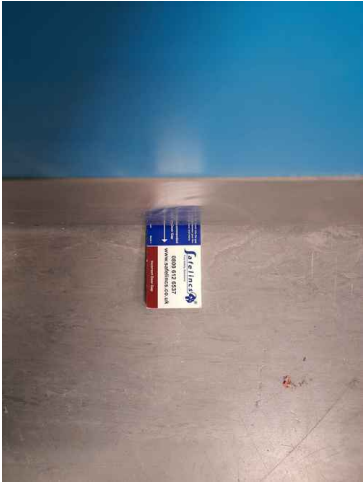
| <b>Is the door leaf free from damage affecting its fire integrity?:</b> | No |

| Recommended actions: | Doorset can be upgraded to a notional standard Service Pack B - Single doorset |

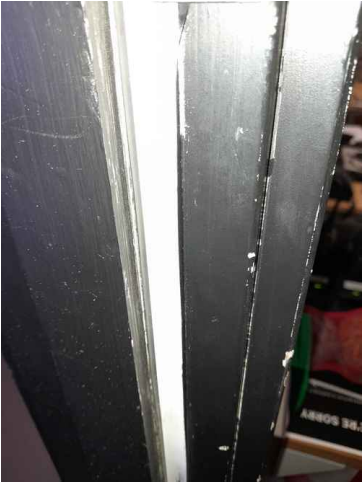
Seals  
1 of 1

| <b>Are the seals free from damage?:</b> | Yes |

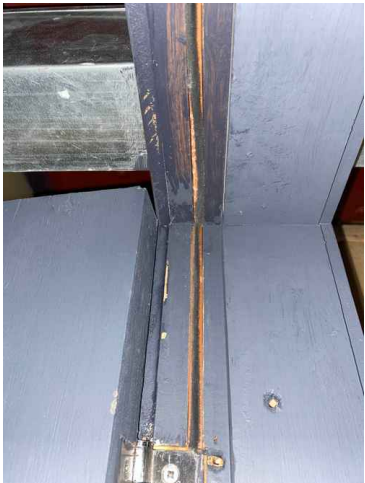
Seals  
1 of 1

| <b>Are the seals free from damage?:</b> | No |

| <b>Action required - Seals:</b> | Arrange for replacement intumescent seals/smoke seals FD30 10mm |

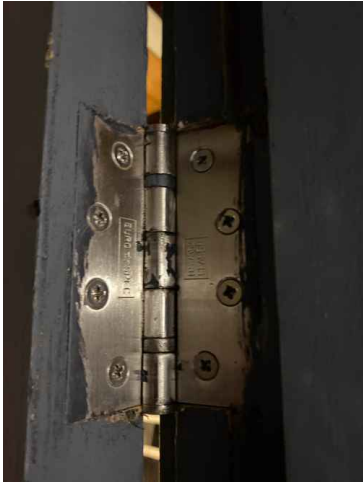
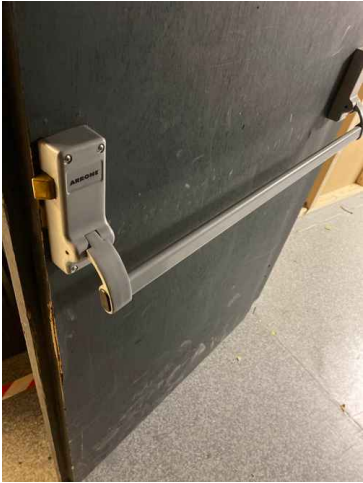
Ironmongery  
1 of 2

| <b>Are the hinges free of metal fragment and oil leakage, which shows signs of wear?:</b> | No |

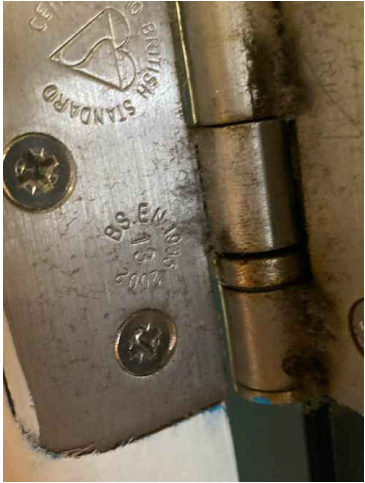
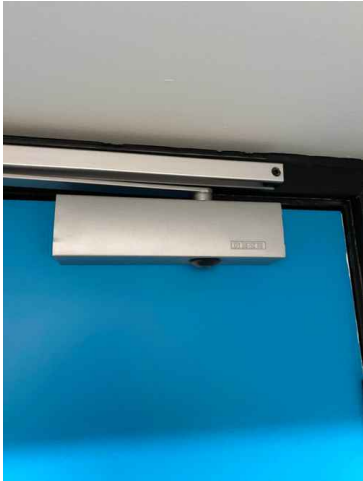
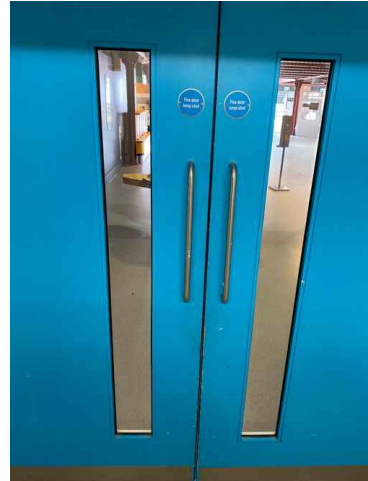
Ironmongery  
2 of 3

| Are the hinges free of metal fragment and oil leakage, which shows signs of wear?: | No |

| Action required - Ironmongery: | Arrange for hinge repairs or replacement due to wear & tear |

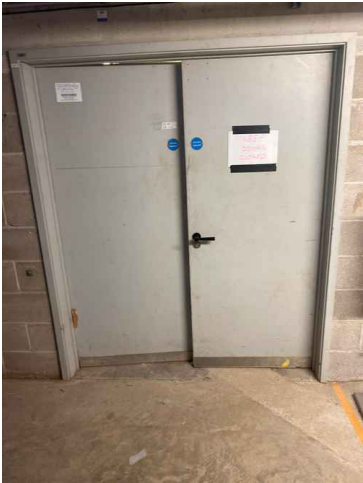
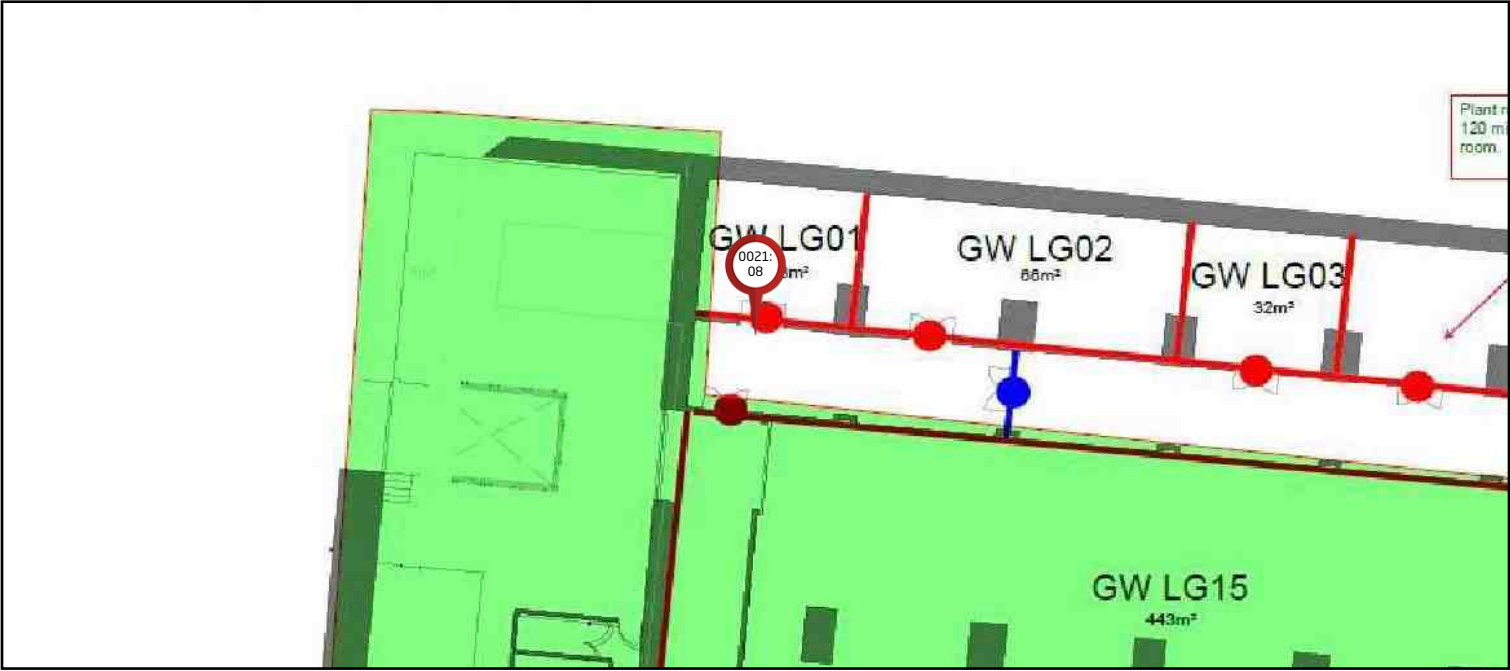
Door details  
1 of 2

| Door details | |
|---|---|
| Damage to the leaf is substantial replacement required | |

| Door details | |
|---|---|
| Recommended actions: | Doorset is not compliant and cannot be repaired or upgraded to meet a satisfactory standard - Replacement Required Double Doorset |

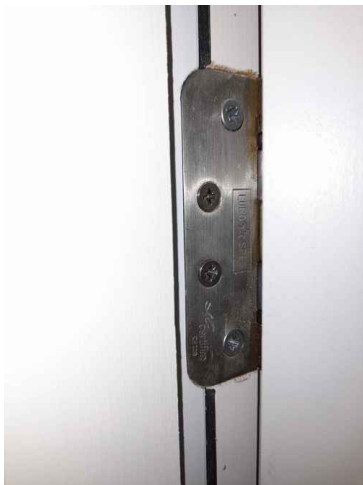
Seals  
1 of 1

| <b>Are the seals free from damage?:</b> | Yes |

| <b>Action required - Door Leaf:</b> | Door leaf to be re-lipped to close gaps to within tolerance, Install a new dropdown seal, Arrange for fire door repairs |

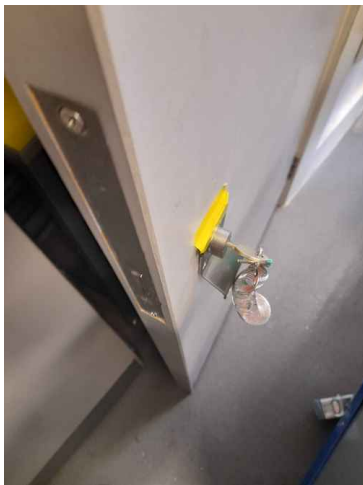
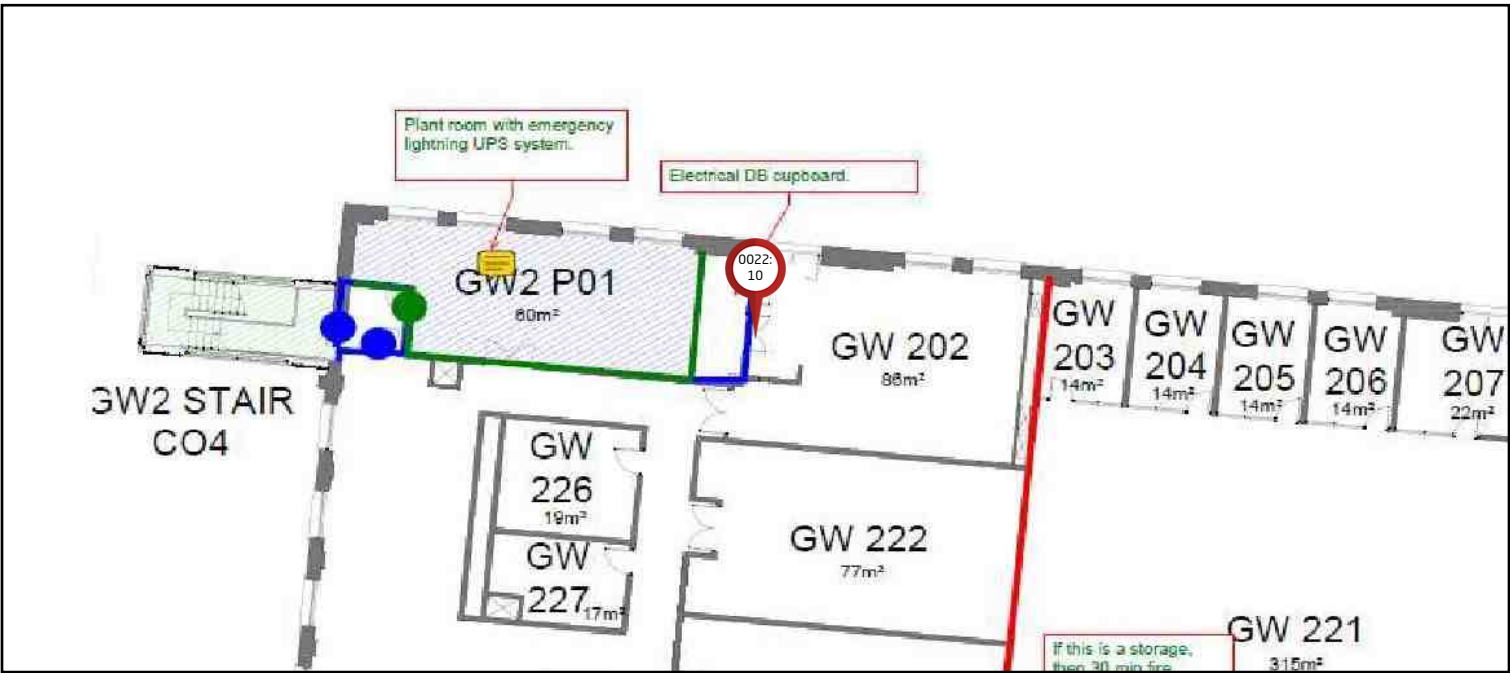
Ironmongery  
1 of 2

| Ironmongery | |
|---|---|
| Is all ironmongery free from damage and correctly operating?: | Yes |

| Ironmongery | |
|---|---|
| Recommended actions: | Doorset can be upgraded to a notional standard Service Pack B - Double Doorset |

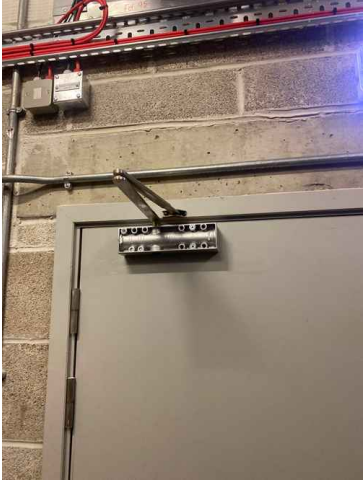
Ironmongery  
1 of 1

| <b>Is all ironmongery free from damage and correctly operating?:</b> | Yes |

| <b>Recommended actions:</b> | Doorset can be upgraded to a notional standard Service Pack B - Double Doorset |

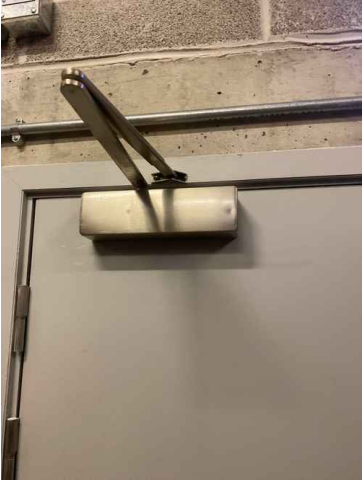
Door closers  
1 of 2

| <b>Is the closer free from damage and not leaking?:</b> | Yes |

| <b>Action required - Door Closers:</b> | Replace with a CE marked certified closer - Double Door or Door & Slave |

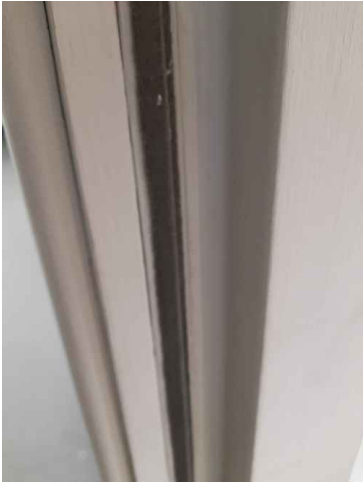
Seals  
1 of 1

| Door details | |
|---|---|
| Are the seals free from damage?: | Yes |

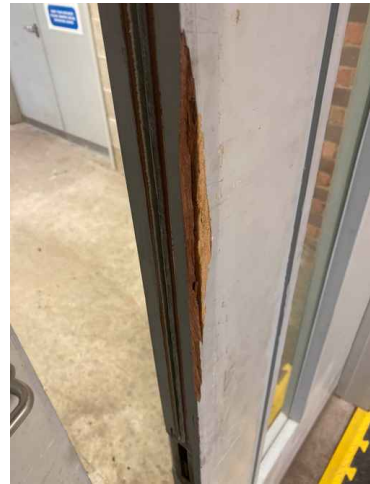
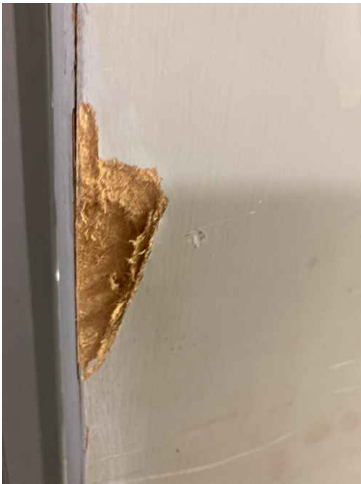
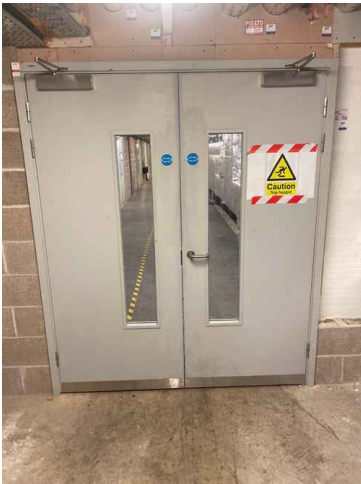
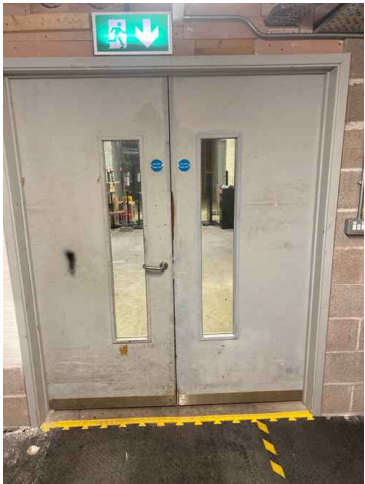
Door details  
1 of 4

| Door details | |
|---|---|
| Substantial damage to leaf replacement required | |
| Compliance - Door Frame: | Unable to evidence |

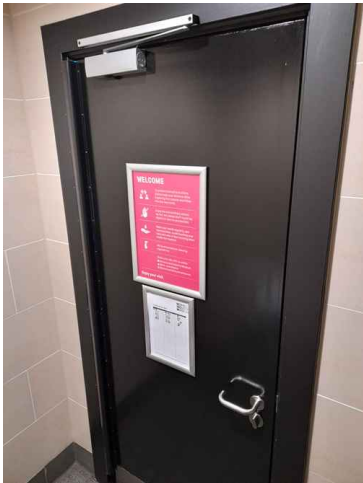
Door details  
1 of 2

| <b>Is the door frame free from damage affecting its fire integrity?:</b> | Yes |

| <b>Action required - Door Frame:</b> | Risk of damage to decorative finishes (frames / architrave's) prevented inspection from being performed - Intrusive inspection required |

| Recommended actions: | Doorset can be upgraded to a notional standard Service Pack B - Single doorset |

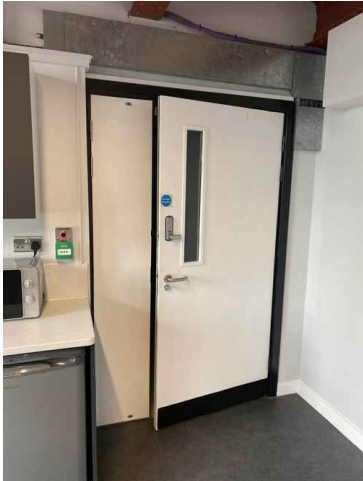
Door details  
1 of 1

| Door details | |
|---|---|
| Replacement with FD60 door is required. | |

| Recommended actions: | Doorset can be upgraded to a notional standard Service Pack B - Door & Slave |

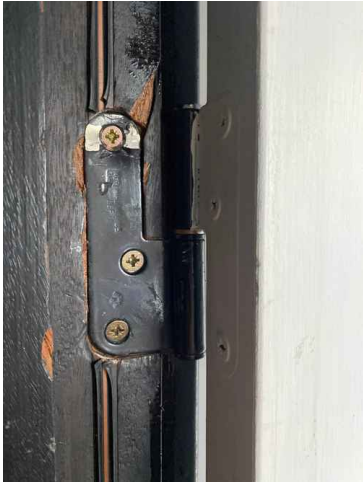
Ironmongery  
1 of 2

| Are the hinges free of metal fragment and oil leakage, which shows signs of wear?: | No |
| Is all ironmongery free from damage and correctly operating?: | Yes |

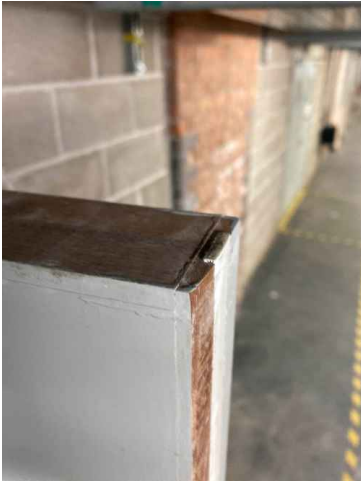
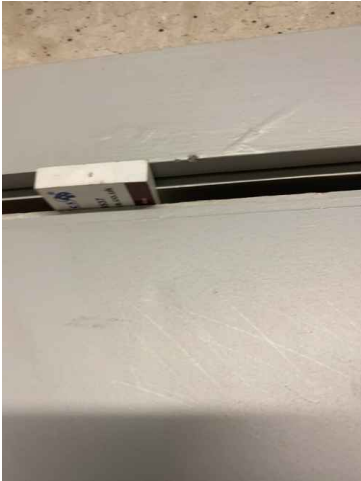
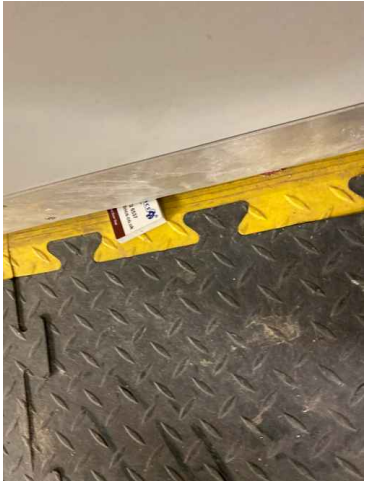
| Door details | |
|---|---|
| Is the door leaf free from damage affecting its fire integrity?: | Yes |

| <b>Recommended actions:</b> | Doorset can be upgraded to a notional standard Service Pack B - Double Doorset |

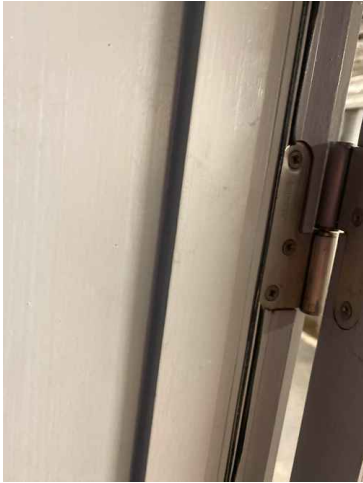
Door frame  
1 of 1

| Door details | |
|---|---|
| Is the door frame free from damage affecting its fire integrity?: | Yes |
| Action required - Door Frame: | Risk of damage to decorative finishes (frames / architrave's) prevented inspection from being performed - Intrusive inspection required |

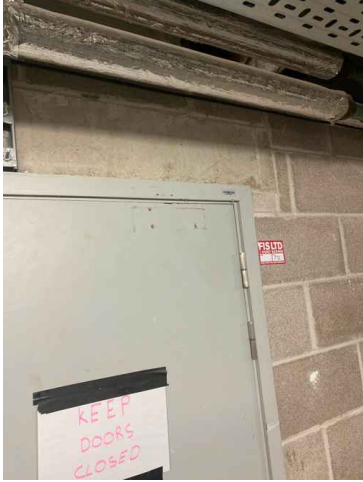
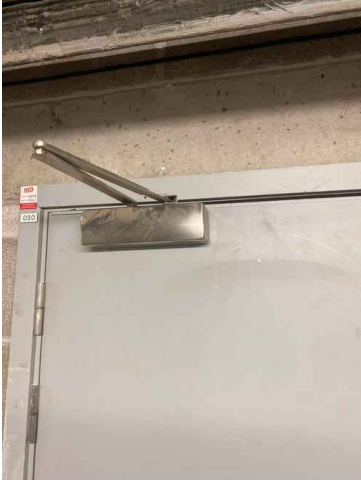
| <b>Is the closer free from damage and not leaking?:</b> | Yes |

| <b>Action required - Door Closers:</b> | Replace with a CE marked certified closer - Single Door |

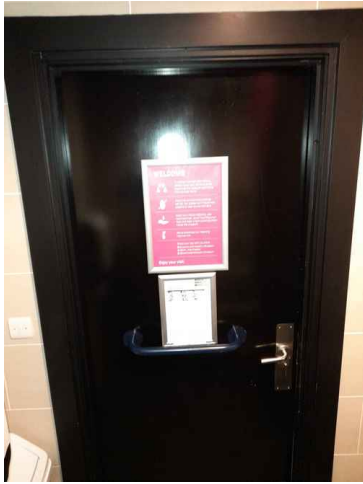
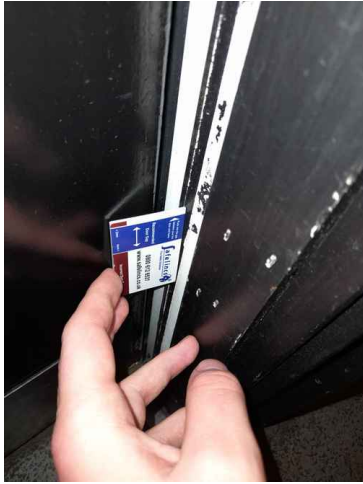
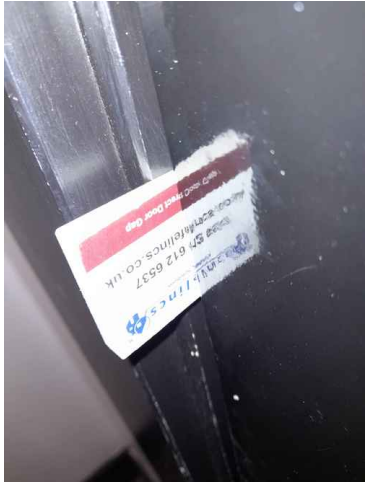
| <b>Is the door leaf free from damage affecting its fire integrity?:</b> | Yes |

| <b>Action required - Door Leaf:</b> | Arrange for replacement compliant full door set |

| Recommended actions: | Doorset is not compliant and cannot be repaired or upgraded to meet a satisfactory standard - Replacement Required Single Doorset |

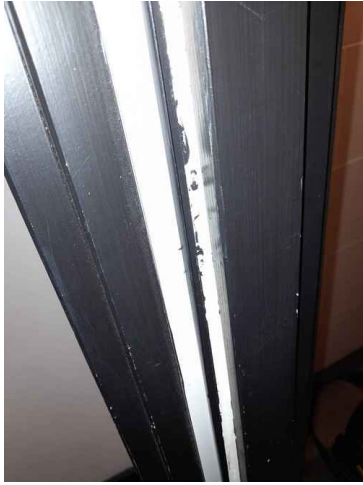
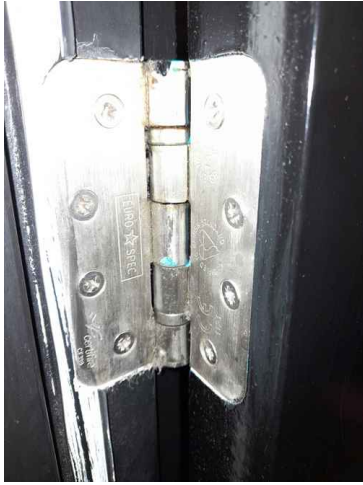
| Are the hinges free of metal fragment and oil leakage, which shows signs of wear?: | No |
| Is all ironmongery free from damage and correctly operating?: | Yes |

| Action required - Ironmongery: | Arrange for hinge repairs or replacement due to wear & tear |

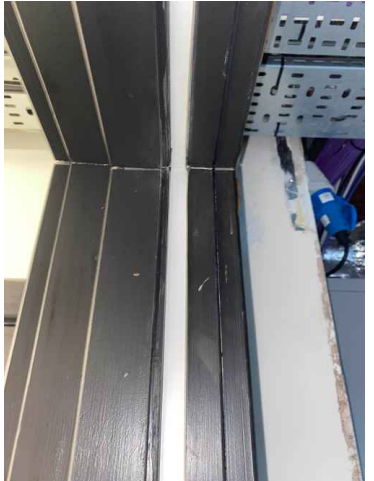
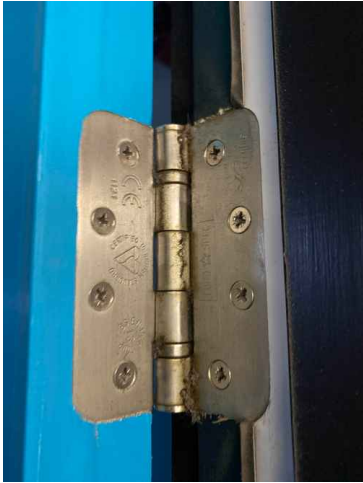
| Are the hinges free of metal fragment and oil leakage, which shows signs of wear?: | No |
| Is all ironmongery free from damage and correctly operating?: | Yes |

| Action required - Ironmongery: | Arrange for hinge repairs or replacement due to wear & tear |

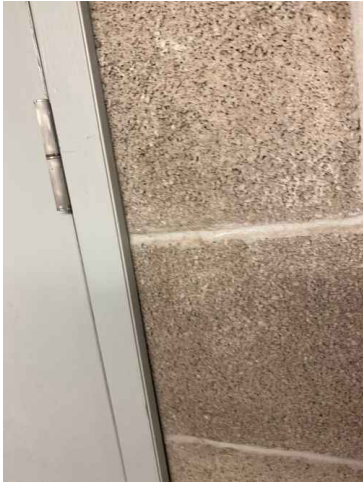
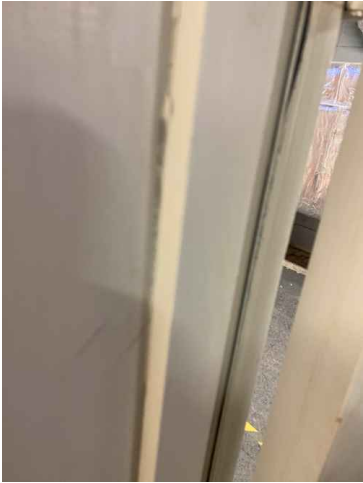
| <b>Is the door frame free from damage affecting its fire integrity?:</b> | Yes |
| <b>Action required - Door Frame:</b> | Risk of damage to decorative finishes (frames / architrave's) prevented inspection from being performed - Intrusive inspection required |

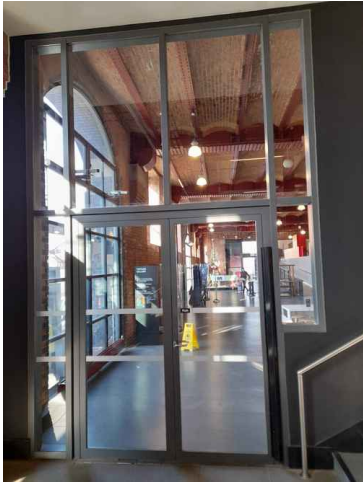
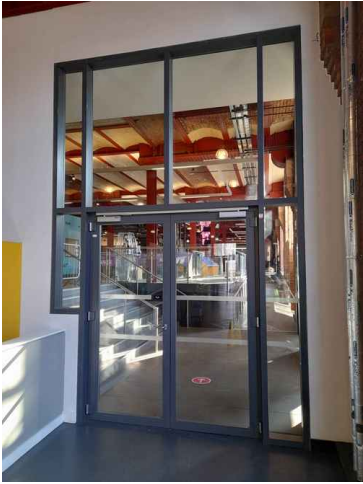
Door details  
1 of 2

| Action required - Signage: | Replace/install Fire Door Keep Shut sign |
| Recommended actions: | Doorset is compliant |

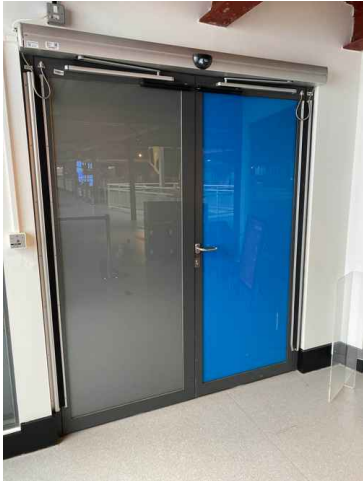
Door details  
1 of 1

| Action required - Signage: | Replace/install Fire Door Keep Shut sign |

| Recommended actions: | Doorset can be upgraded to certifiable standard Service Pack B - Double Doorset |

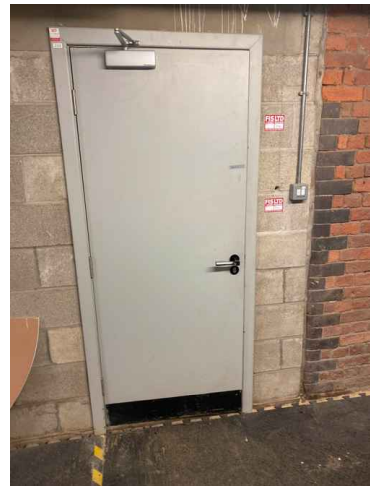
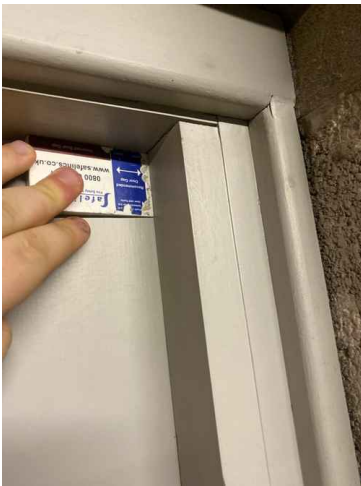
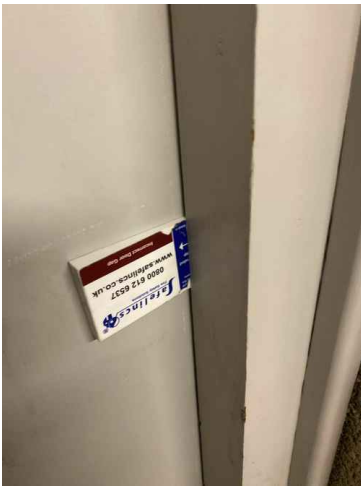
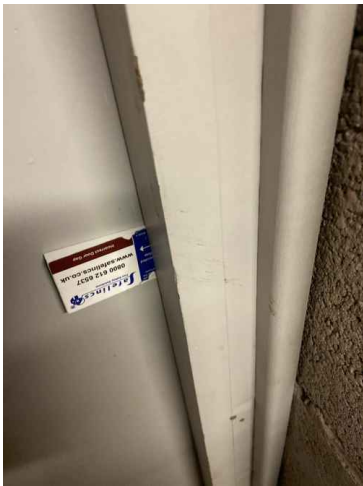
Door details  
1 of 4

| Door details | |
|---|---|
| Door set is warped replacement required | |

| Door details | |
|---|---|
| Recommended actions: | Doorset is not compliant and cannot be repaired or upgraded to meet a satisfactory standard - Replacement Required Single Doorset |

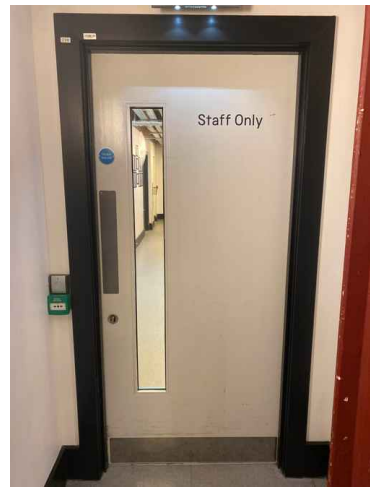
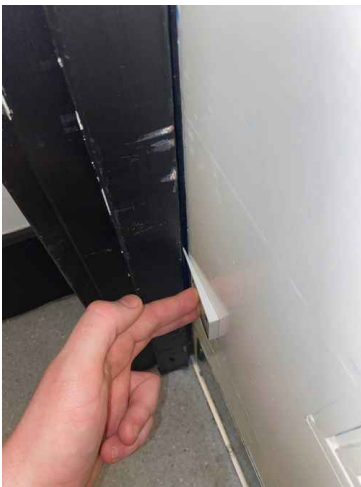
Door details  
1 of 2

| Door details | |
|---|---|
| Door is warped. Replacement required. | |

| Recommended actions: | Doorset is not compliant and cannot be repaired or upgraded to meet a satisfactory standard - Replacement Required Single Doorset |

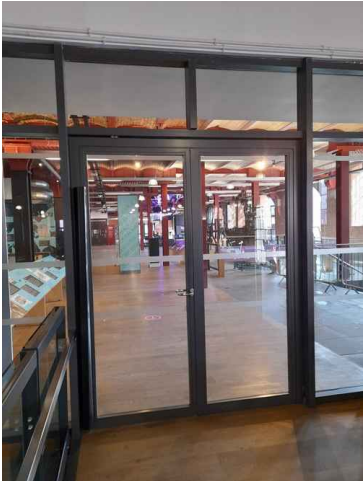
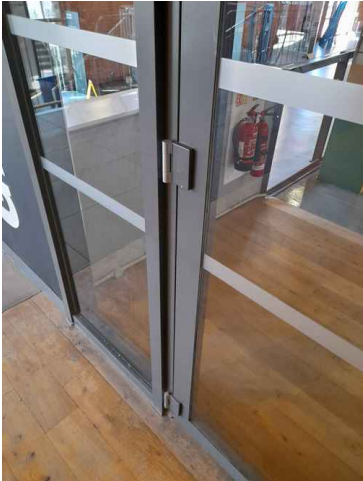
Ironmongery  
1 of 2

| Is all ironmongery free from damage and correctly operating?: | Yes |

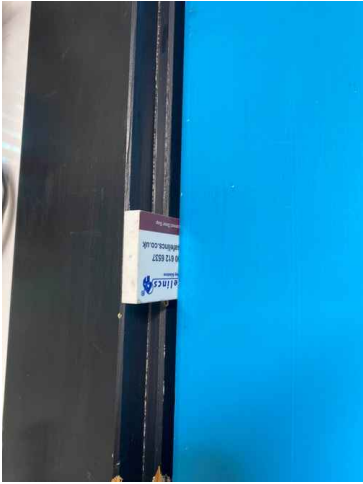
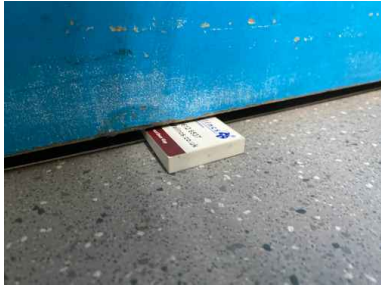
Door leaf  
1 of 2

| <b>Is the door leaf free from damage affecting its fire integrity?:</b> | Yes |

| Recommended actions: | Doorset can be upgraded to a notional standard Service Pack B - Single doorset |

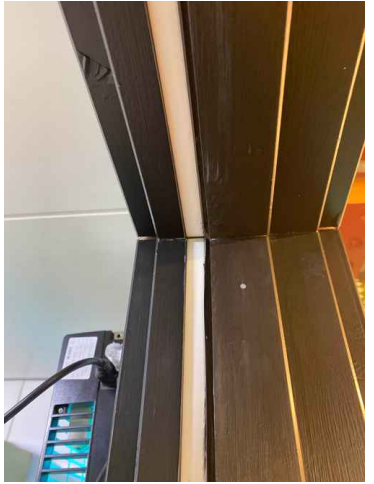
Seals  
1 of 1

| <b>Are the seals free from damage?:</b> | Yes |

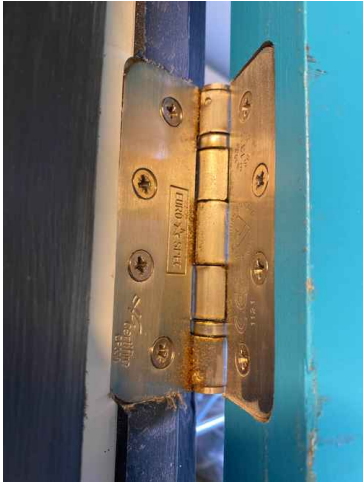
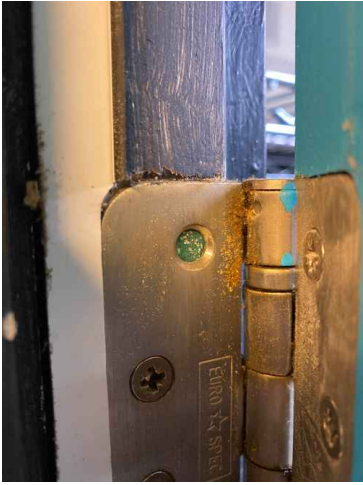
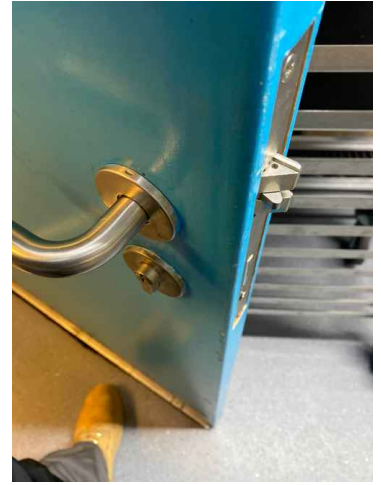
Ironmongery  
1 of 3

| Are the hinges free of metal fragment and oil leakage, which shows signs of wear?: | No |
| Is all ironmongery free from damage and correctly operating?: | Yes |

| Action required - Ironmongery: | Arrange for hinge repairs or replacement due to wear & tear |

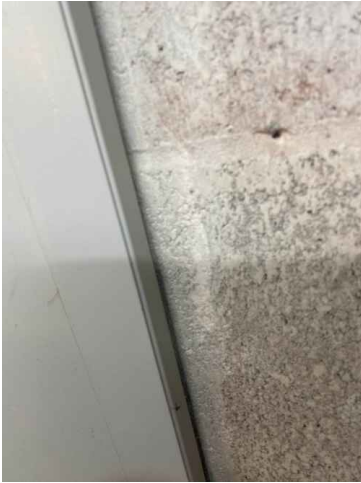
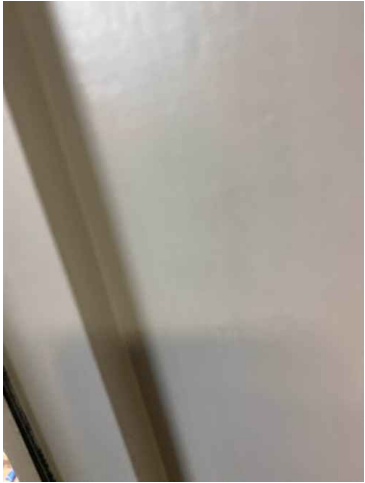
Door frame  
1 of 2

| <b>Is the door frame free from damage affecting its fire integrity?:</b> | Yes |

| <b>Action required - Door Frame:</b> | Risk of damage to decorative finishes (frames / architrave's) prevented inspection from being performed - Intrusive inspection required |

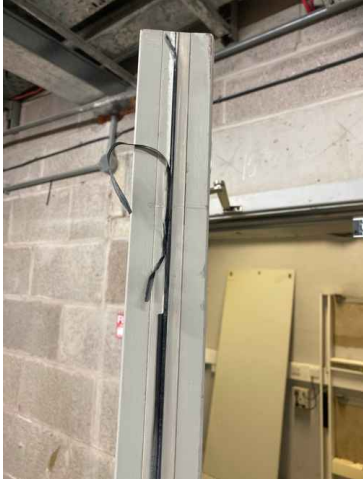
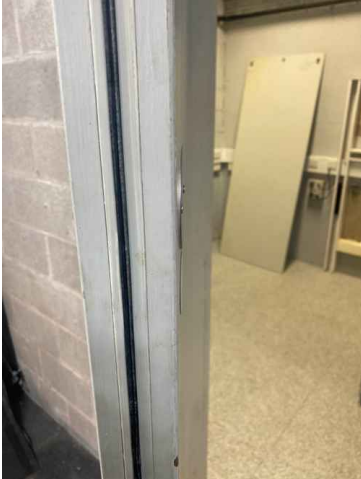
Seals  
1 of 2

| <b>Are the seals free from damage?:</b> | No |

| <b>Action required - Seals:</b> | Arrange for replacement intumescent seals/smoke seals FD60 20mm |

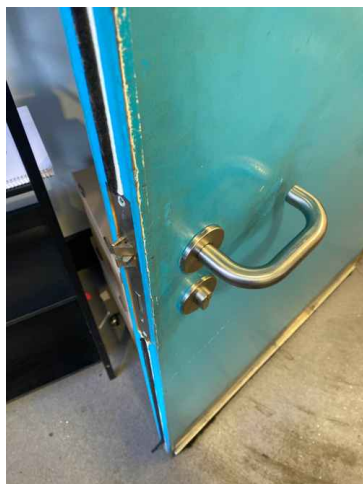
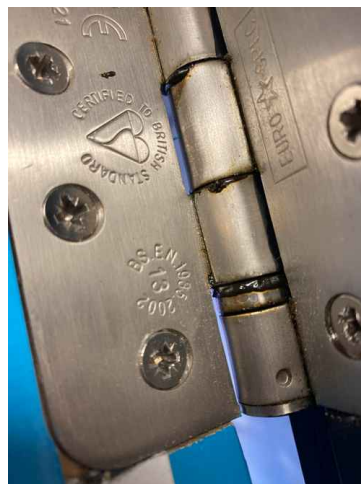
Ironmongery  
2 of 3

| Are the hinges free of metal fragment and oil leakage, which shows signs of wear?: | No |

| Action required - Ironmongery: | Arrange for hinge repairs or replacement due to wear & tear |
