## Museum of Science & Industry

### Fire Door Survey Report

### Great Western Warehouse

## **Fire Doors Report**

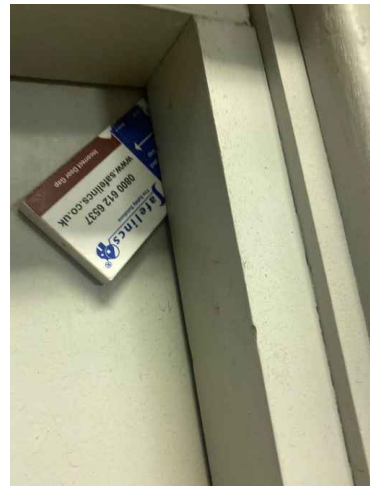
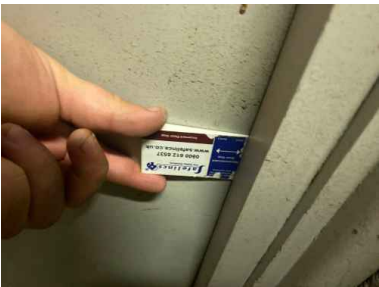
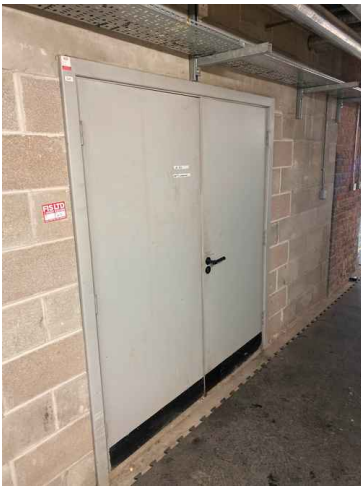
Door details  
1 of 3

| Door details | |
|---|---|
| Door set is warped replacement required | |

| Door details | |
|---|---|
| Recommended actions: | Doorset is not compliant and cannot be repaired or upgraded to meet a satisfactory standard - Replacement Required Single Doorset |

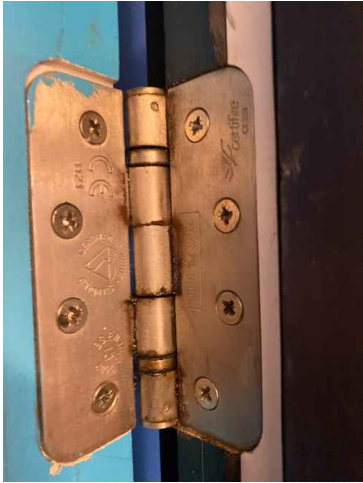
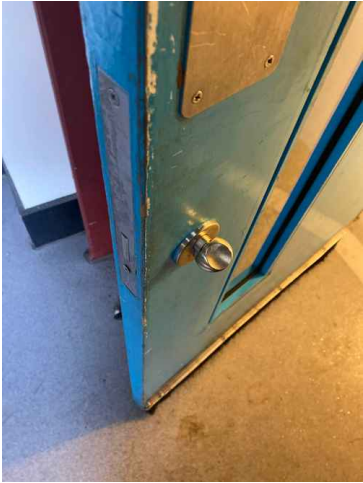
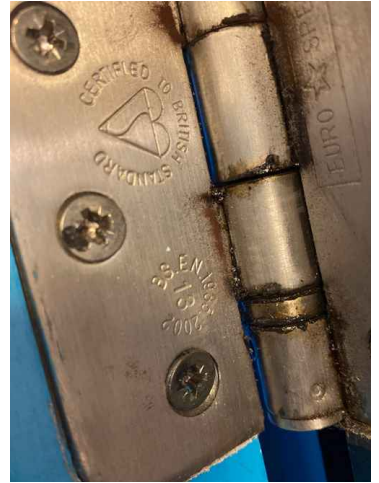
Ironmongery  
1 of 3

| Are the hinges free of metal fragment and oil leakage, which shows signs of wear?: | No |

| Action required - Ironmongery: | Arrange for hinge repairs or replacement due to wear & tear |

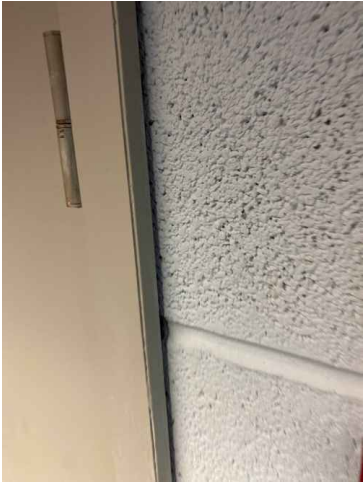
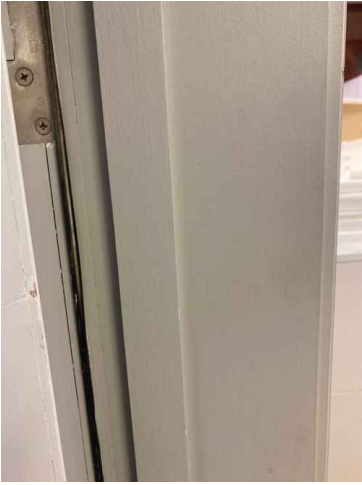
Door frame  
1 of 2

| Door details | |
|---|---|
| Action required - Door Frame: | Risk of damage to decorative finishes (frames / architrave's) prevented inspection from being performed - Intrusive inspection required |

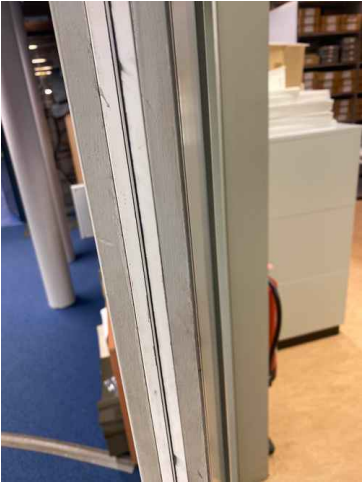
Seals  
1 of 1

| Door details | |
|---|---|
| Are the seals free from damage?: | No |

| Door details | |
|---|---|
| Action required - Seals: | Arrange for replacement intumescent seals/smoke seals FD60 20mm |

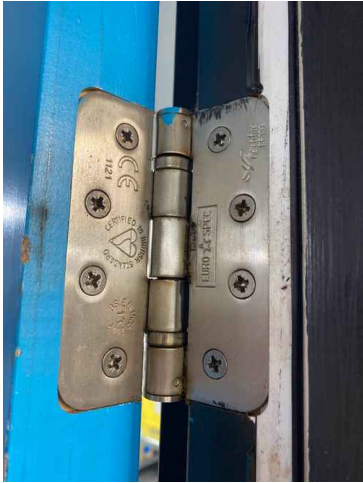
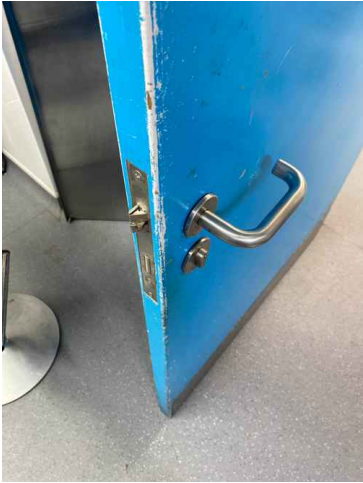
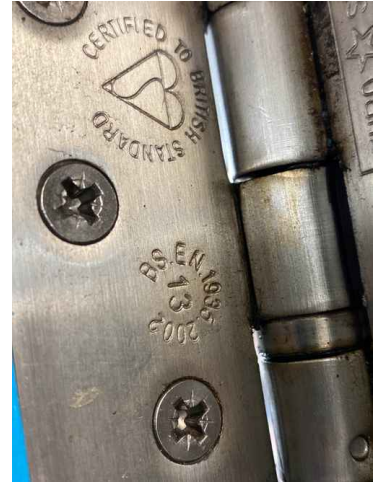
Ironmongery  
1 of 3

| Are the hinges free of metal fragment and oil leakage, which shows signs of wear?: | No |

| Action required - Ironmongery: | Arrange for hinge repairs or replacement due to wear & tear |

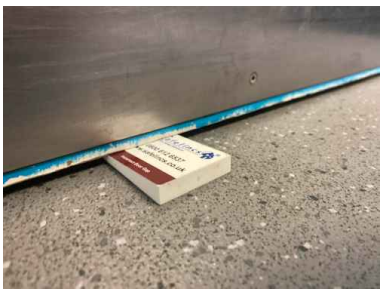
Door leaf  
2 of 2

| Door details | |
|---|---|
| Lipping and door leaf damaged affecting fire integrity of the door. | |
| Is the door leaf free from damage affecting its fire integrity?: | No |

| Door details | |
|---|---|
| Replacement required. | |

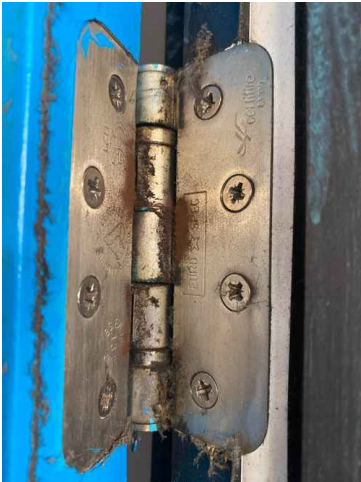
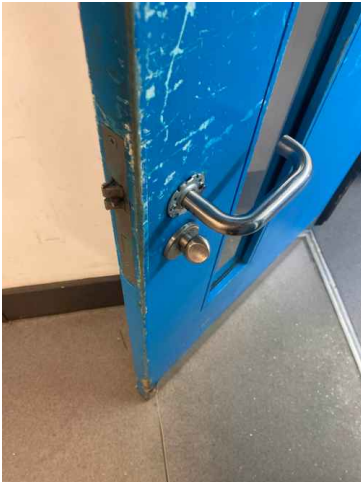
Ironmongery  
1 of 2

| Are the hinges free of metal fragment and oil leakage, which shows signs of wear?: | No |

| Action required - Ironmongery: | Arrange for hinge repairs or replacement due to wear & tear |

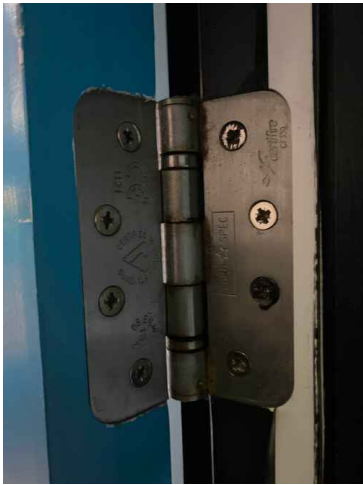
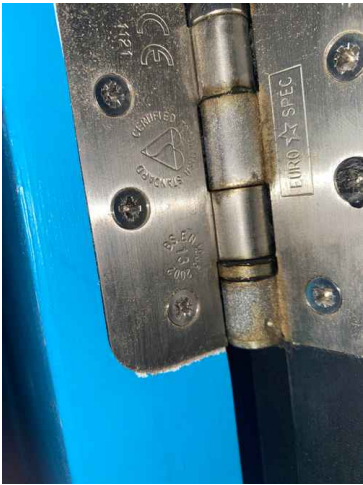
Ironmongery  
1 of 2

| Are the hinges free of metal fragment and oil leakage, which shows signs of wear?: | No |

| Action required - Ironmongery: | Arrange for hinge repairs or replacement due to wear & tear |

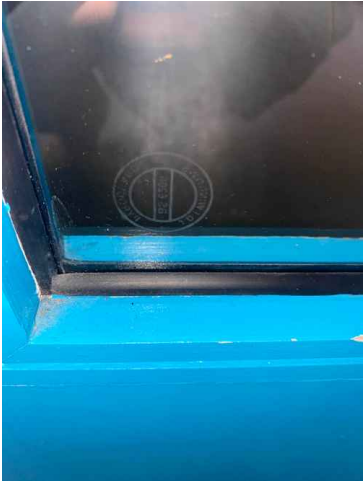
Glazing and Glass  
1 of 2

| Are the glazing beads correctly attached to the frame from both sides and free from damage?: | Yes |
| Is the glass free from damage and cracking?: | Yes |

| Recommended actions: | Doorset can be upgraded to certifiable standard Service Pack B - Double Doorset |

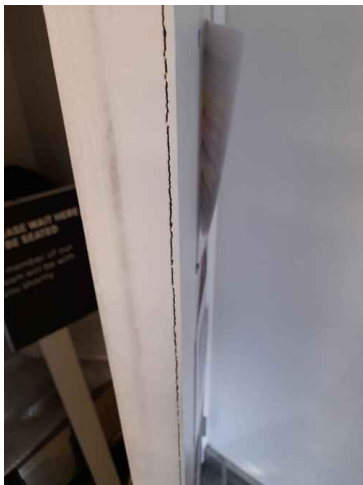
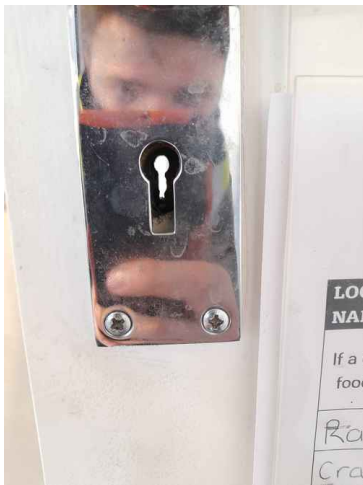
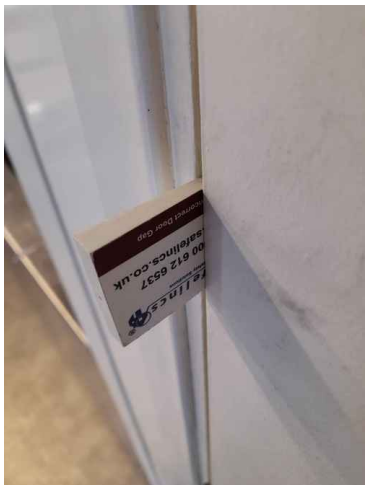
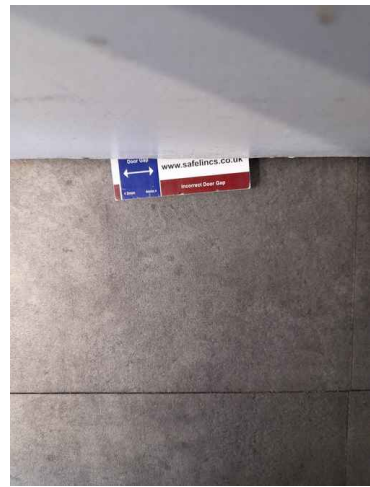
Door leaf  
1 of 4

| Door details | |
|---|---|
| Is the door leaf free from damage affecting its fire integrity?: | No |

| Door details | |
|---|---|
| Action required - Door Leaf: | Arrange for replacement compliant full door set |

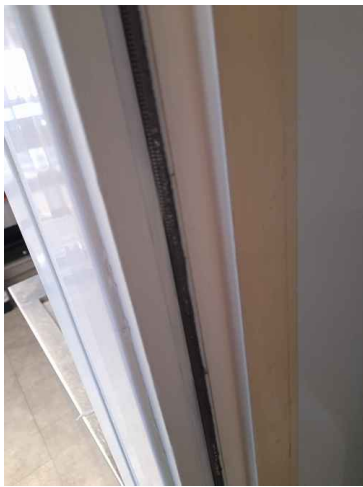
Seals  
1 of 1

| Door details | |
|---|---|
| Are the seals free from damage?: | Yes |

| Action required - Seals: | Arrange for replacement intumescent seals/smoke seals FD30 10mm |

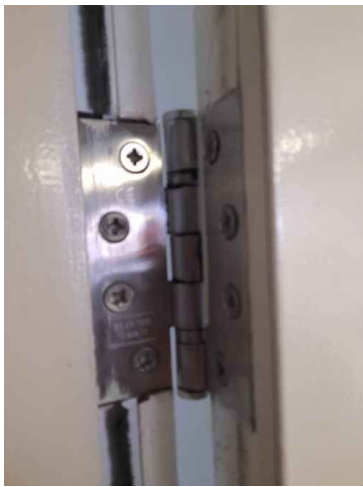
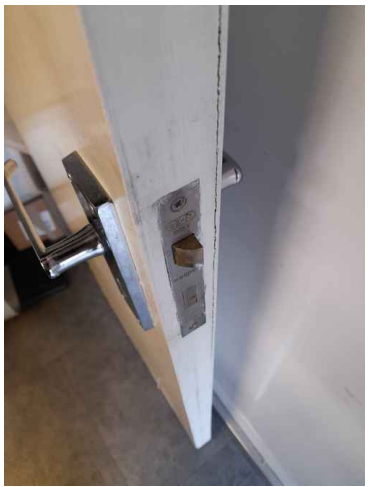
Ironmongery  
1 of 2

| Is all ironmongery free from damage and correctly operating?: | Yes |

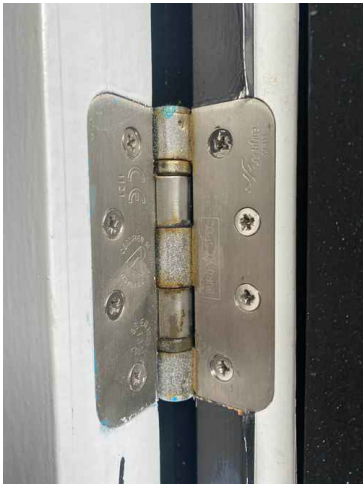
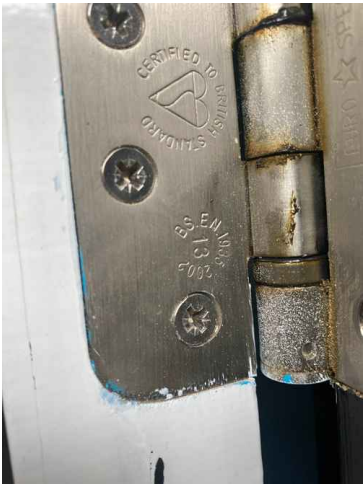
Ironmongery  
1 of 2

| Are the hinges free of metal fragment and oil leakage, which shows signs of wear?: | No |
| Is all ironmongery free from damage and correctly operating?: | Yes |

| Action required - Ironmongery: | Arrange for hinge repairs or replacement due to wear & tear |

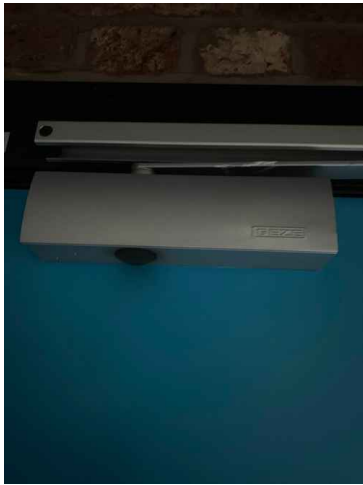
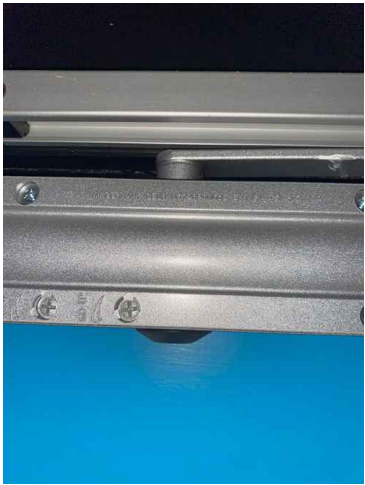
Door closers  
1 of 2

| Is the closer free from damage and not leaking?: | Yes |

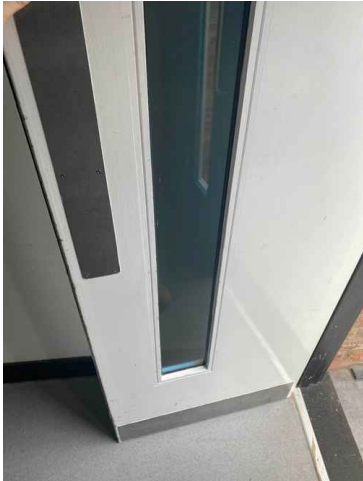
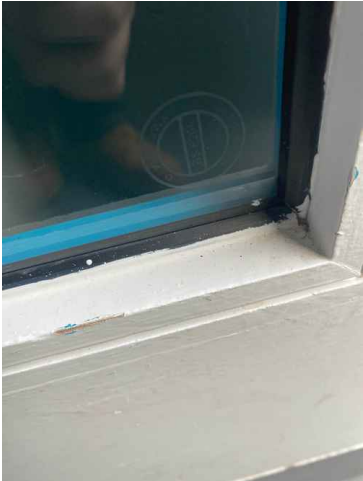
Glazing and Glass  
1 of 2

| Are the glazing beads correctly attached to the frame from both sides and free from damage?: | Yes |
| Is the glass free from damage and cracking?: | Yes |

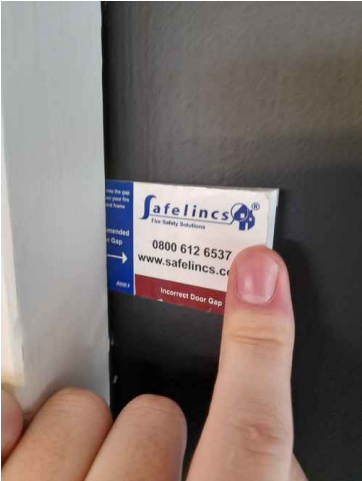
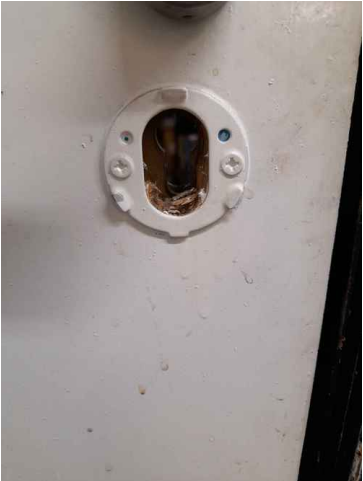
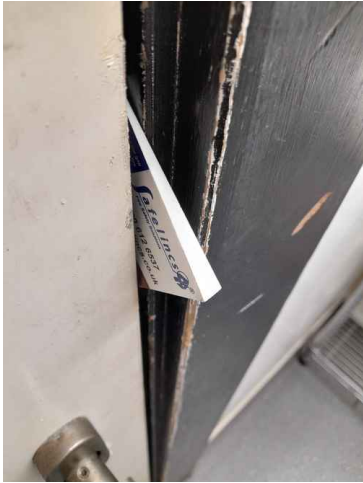
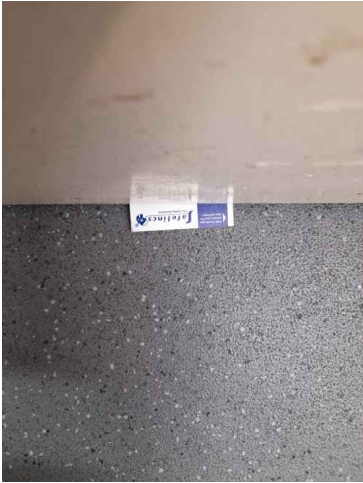
Door leaf  
1 of 4

| <b>Is the door leaf free from damage affecting its fire integrity?:</b> | No |

| <b>Action required - Door Leaf:</b> | Arrange for replacement compliant full door set |

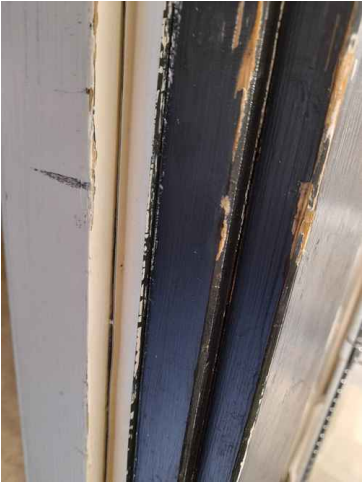
Seals  
1 of 1

| <b>Are the seals free from damage?:</b> | Yes |

| Action required - Seals: | Arrange for replacement intumescent seals/smoke seals FD30 10mm |

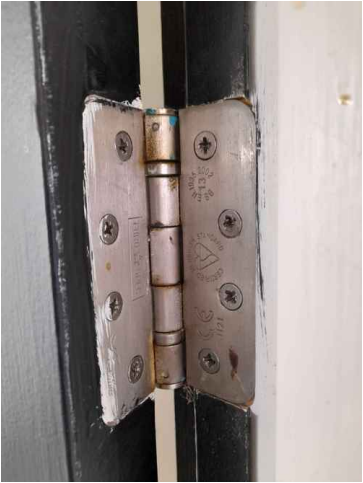
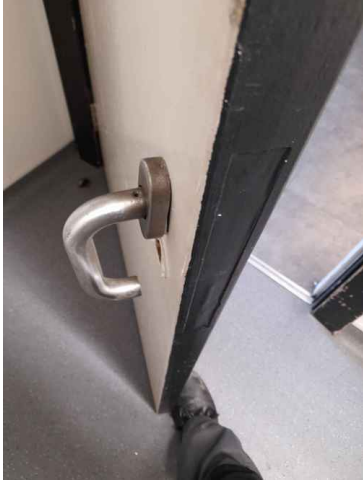
Ironmongery  
1 of 2

| Are the hinges free of metal fragment and oil leakage, which shows signs of wear?: | No |
| Is all ironmongery free from damage and correctly operating?: | No |

| Action required - Ironmongery: | Arrange for hinge repairs or replacement due to wear & tear, Ironmongery is not to a compliant standard and needs to be replaced |

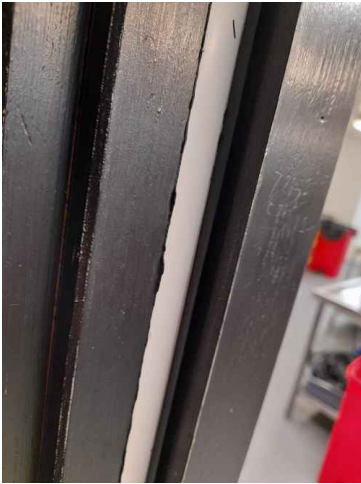
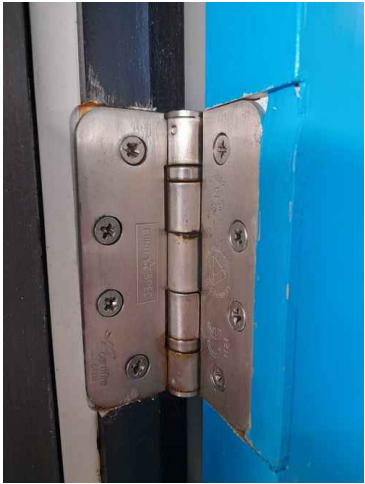
Seals  
1 of 2

| <b>Are the seals free from damage?:</b> | No |

| Action required - Seals: | Arrange for replacement intumescent seals/smoke seals FD30 10mm |

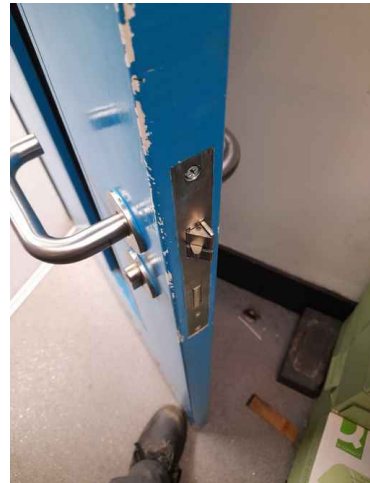
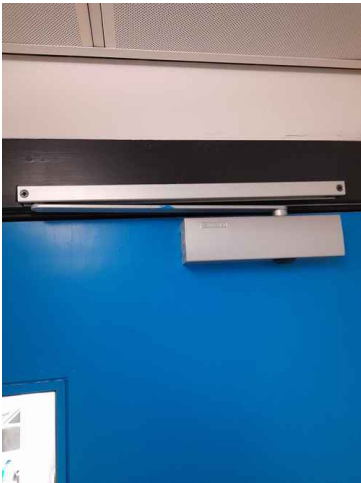
Ironmongery  
1 of 2

| Are the hinges free of metal fragment and oil leakage, which shows signs of wear?: | No |

| Action required - Ironmongery: | Arrange for hinge repairs or replacement due to wear & tear |

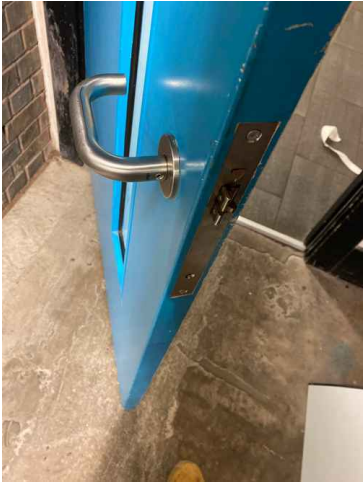
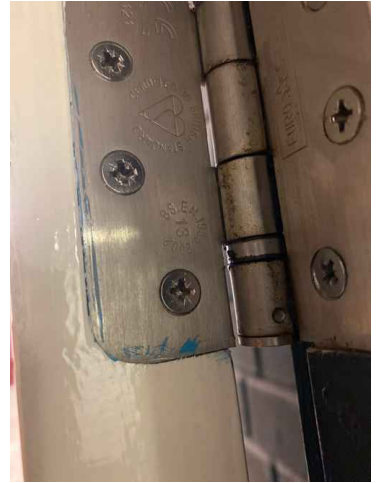
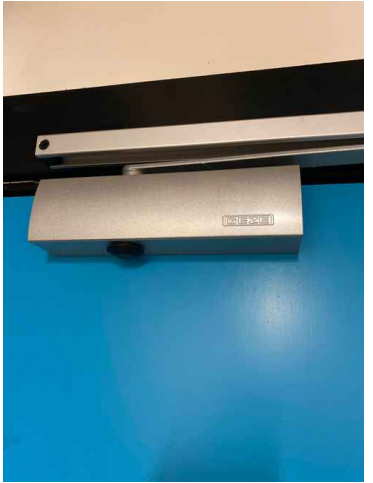
Ironmongery  
1 of 3

| Are the hinges free of metal fragment and oil leakage, which shows signs of wear?: | No |

| Action required - Ironmongery: | Arrange for hinge repairs or replacement due to wear & tear |

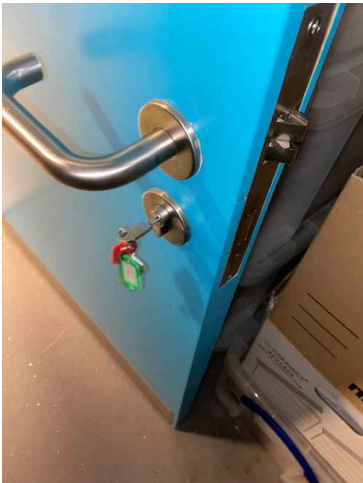
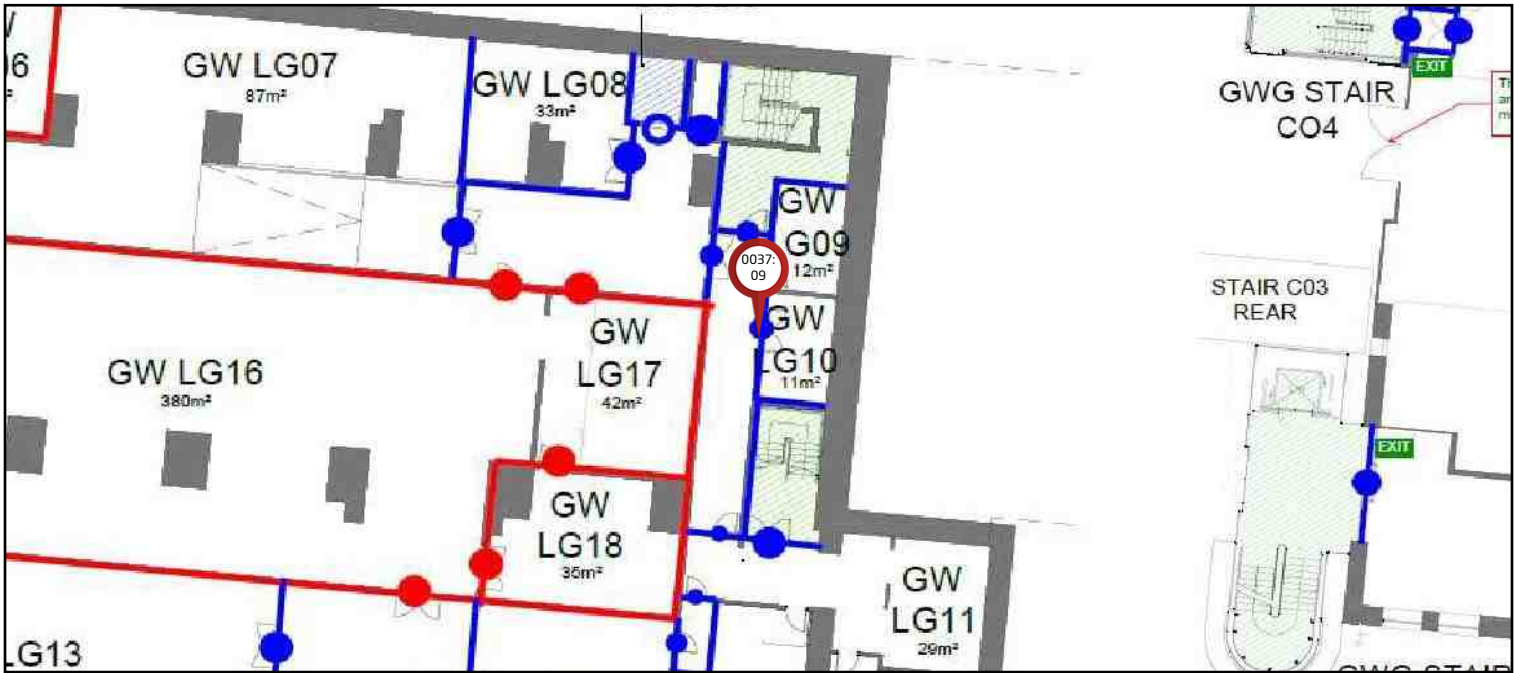
Ironmongery  
1 of 2

| Are the hinges free of metal fragment and oil leakage, which shows signs of wear?: | No |

| Action required - Ironmongery: | Arrange for hinge repairs or replacement due to wear & tear |

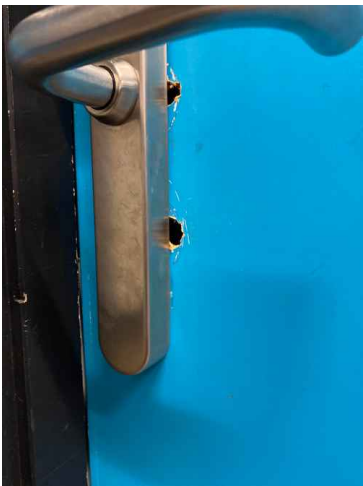
Door details  
1 of 1

| Door details | |
|---|---|
| Recommended actions: | Doorset is not compliant and cannot be repaired or upgraded to meet a satisfactory standard - Replacement Required Single Doorset |
| Priority: | Urgent |

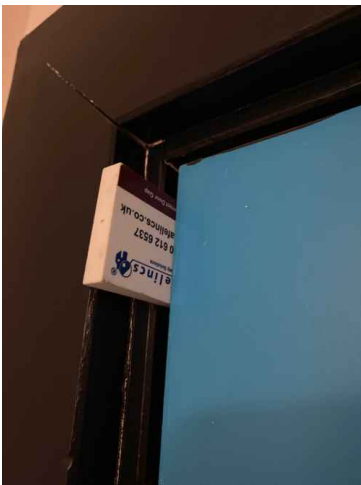
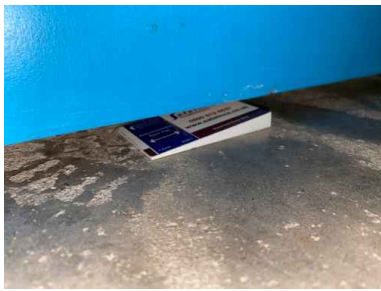
Door leaf  
1 of 2

| <b>Is the door leaf free from damage affecting its fire integrity?:</b> | Yes |

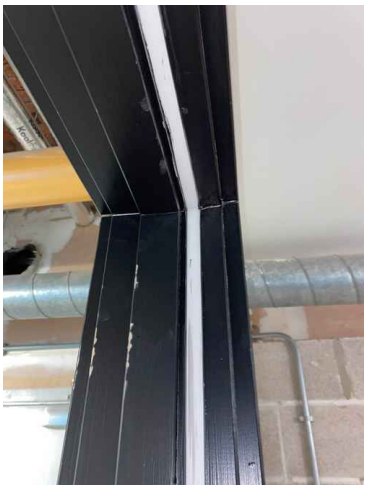
Seals  
1 of 1

| <b>Are the seals free from damage?:</b> | Yes |

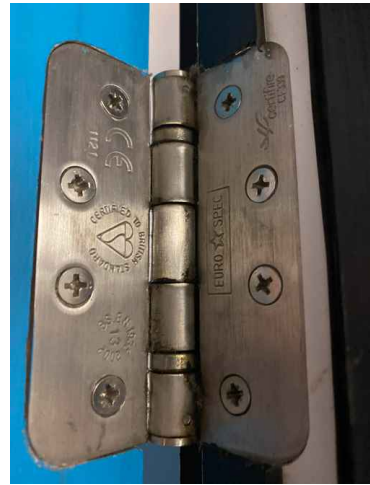
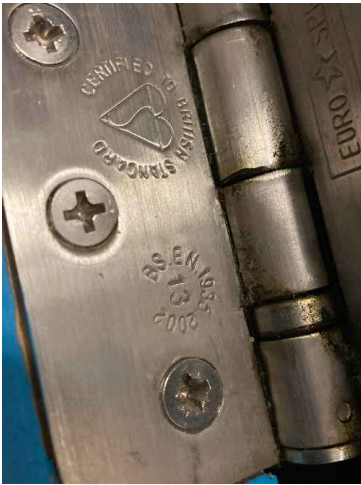
Ironmongery  
1 of 2

| Are the hinges free of metal fragment and oil leakage, which shows signs of wear?: | No |

| Action required - Ironmongery: | Arrange for hinge repairs or replacement due to wear & tear |

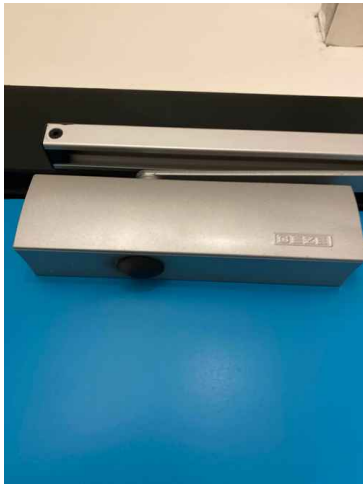
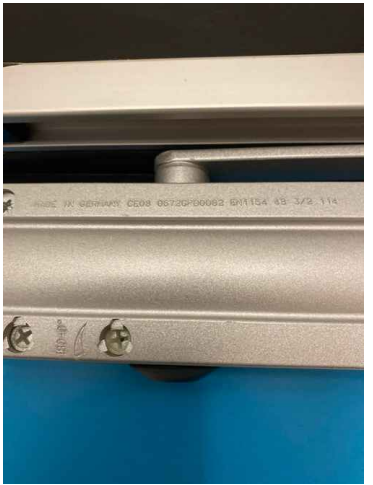
Door closers  
1 of 2

| Is the closer free from damage and not leaking?: | Yes |

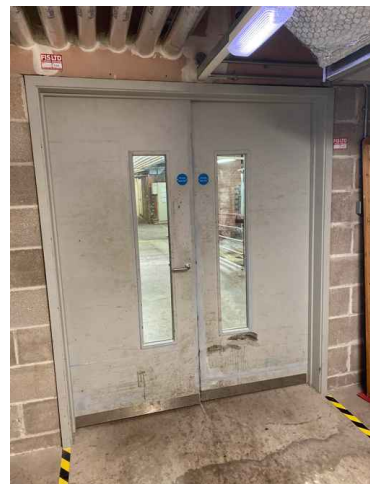
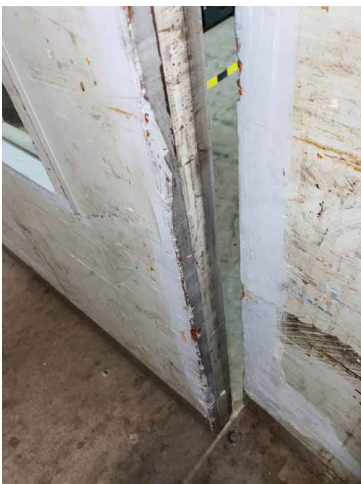
Door details  
1 of 2

| Doorset is in poor condition. Lipping and veneer is damaged affecting fire integrity. | |

| Replacement required. | |

| Additional work | |
|---|---|
| Recommended actions: | Doorset is not compliant and cannot be repaired or upgraded to meet a satisfactory standard - Replacement Required Double Doorset |

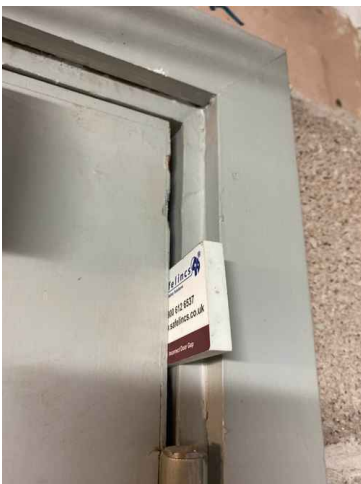
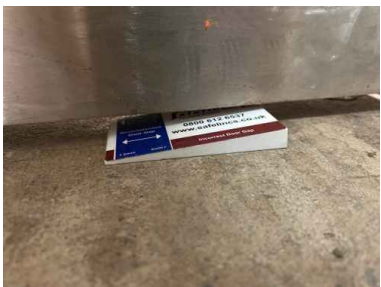
Door leaf  
1 of 2

| <b>Is the door leaf free from damage affecting its fire integrity?:</b> | No |

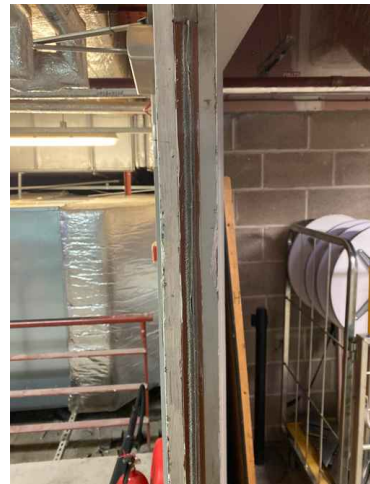
Seals  
1 of 1

| <b>Are the seals free from damage?:</b> | No |

| Action required - Seals: | Arrange for replacement intumescent seals/smoke seals FD60 20mm |

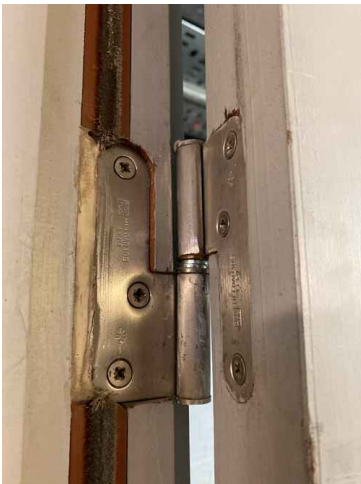
Ironmongery  
1 of 1

| Are the hinges free of metal fragment and oil leakage, which shows signs of wear?: | No |

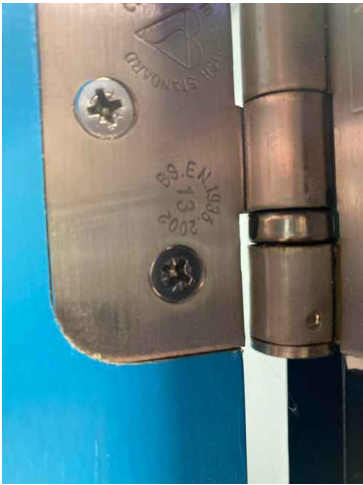
Ironmongery  
1 of 2

| Are the hinges free of metal fragment and oil leakage, which shows signs of wear?: | No |

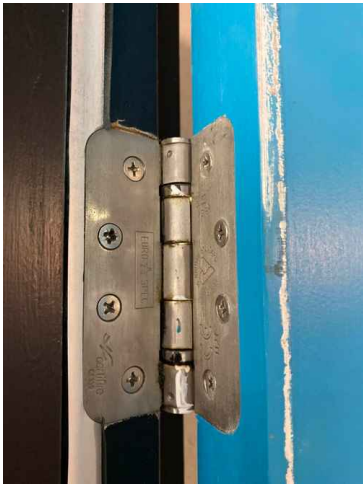
Ironmongery  
1 of 3

| Are the hinges free of metal fragment and oil leakage, which shows signs of wear?: | No |

| Action required - Ironmongery: | Arrange for hinge repairs or replacement due to wear & tear |

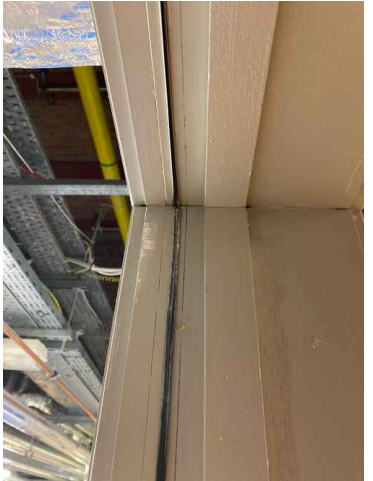
Seals  
1 of 1

| <b>Are the seals free from damage?:</b> | Yes |

| <b>Action required - Seals:</b> | Arrange for replacement intumescent seals/smoke seals FD60 20mm |

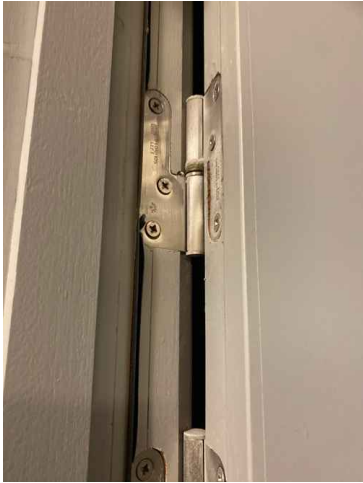
Ironmongery  
1 of 2

| <b>Are the hinges free of metal fragment and oil leakage, which shows signs of wear?:</b> | No |

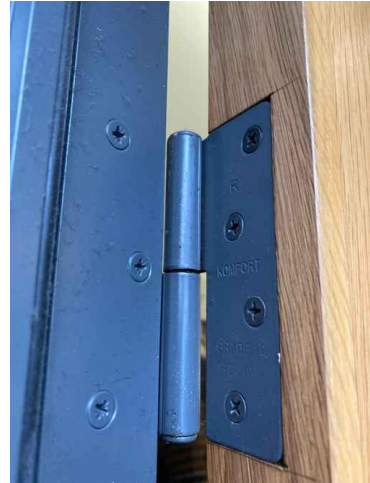
Ironmongery  
1 of 2

| Are the hinges free of metal fragment and oil leakage, which shows signs of wear?: | No |

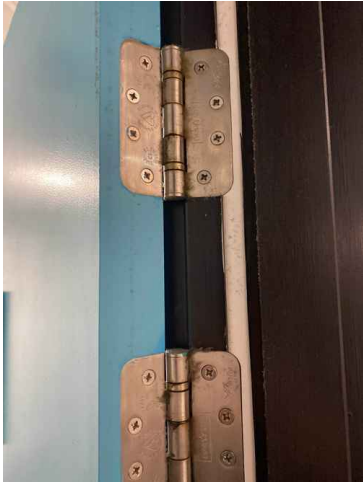
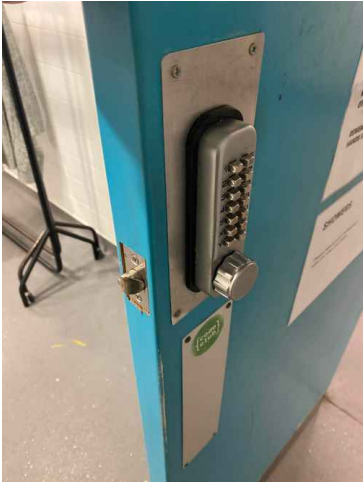
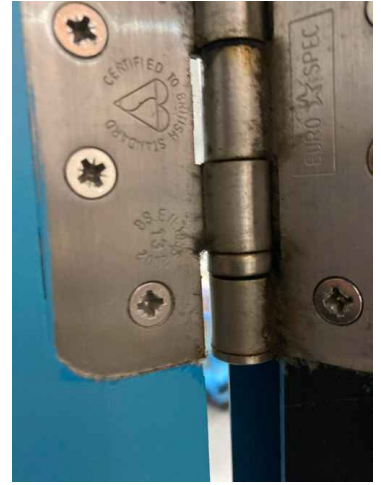
Ironmongery  
1 of 3

| Are the hinges free of metal fragment and oil leakage, which shows signs of wear?: | No |

| Action required - Ironmongery: | Arrange for hinge repairs or replacement due to wear & tear |

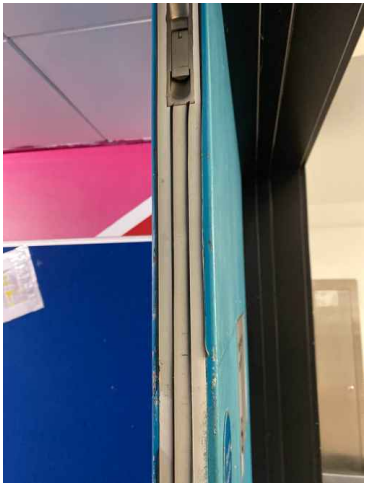
Seals  
1 of 1

| <b>Are the seals free from damage?:</b> | No |

| <b>Action required - Seals:</b> | Arrange for replacement intumescent seals/smoke seals FD30 10mm |

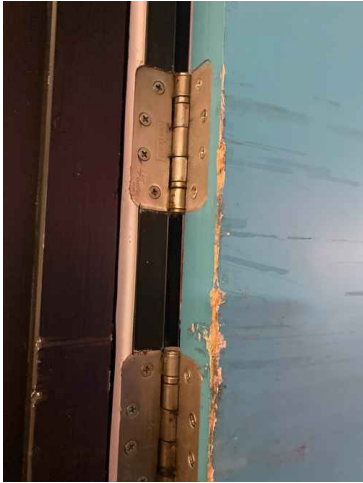
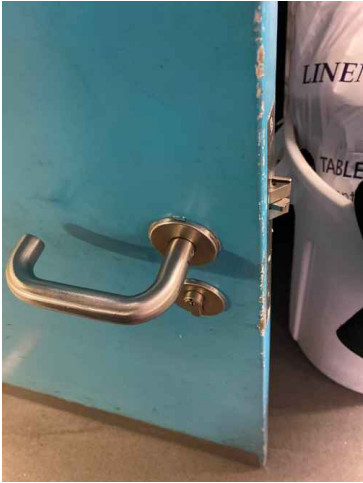
Ironmongery  
1 of 2

| <b>Are the hinges free of metal fragment and oil leakage, which shows signs of wear?:</b> | No |

| <b>Action required - Ironmongery:</b> | Arrange for hinge repairs or replacement due to wear & tear |

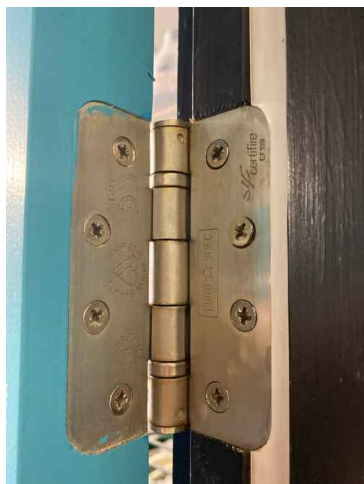
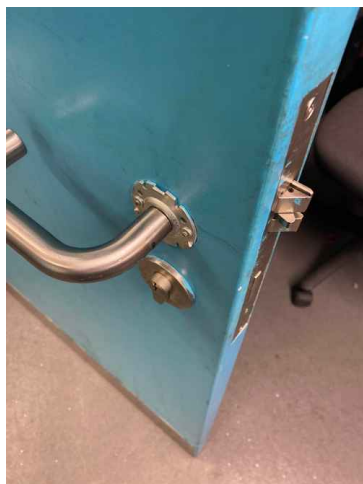
Ironmongery  
2 of 2

| <b>Are the hinges free of metal fragment and oil leakage, which shows signs of wear?:</b> | No |

| <b>Action required - Ironmongery:</b> | Arrange for hinge repairs or replacement due to wear & tear |

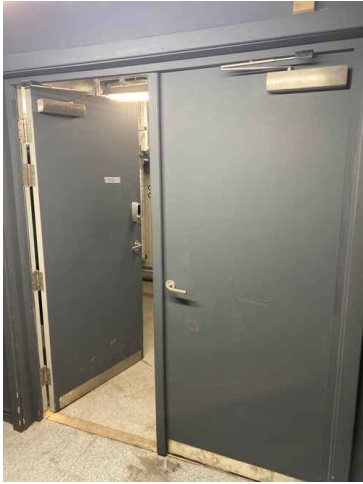
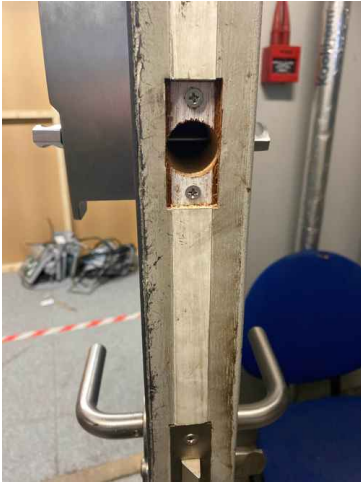
Door details  
1 of 2

| Replacement with a 120 minute fire resistant door required. | |

| Recommended actions: | Doorset is not compliant and cannot be repaired or upgraded to meet a satisfactory standard - Replacement Required Double Doorset |

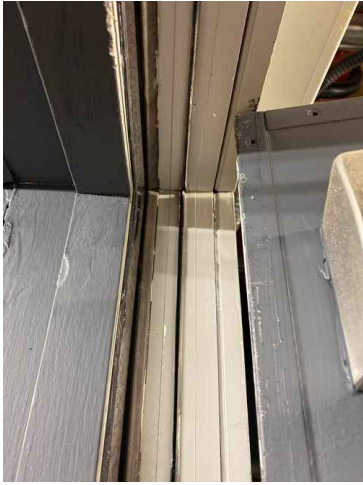
Seals  
1 of 1

| <b>Are the seals free from damage?:</b> | Yes |

| Action required - Seals: | Arrange for replacement intumescent seals/smoke seals FD60 20mm |

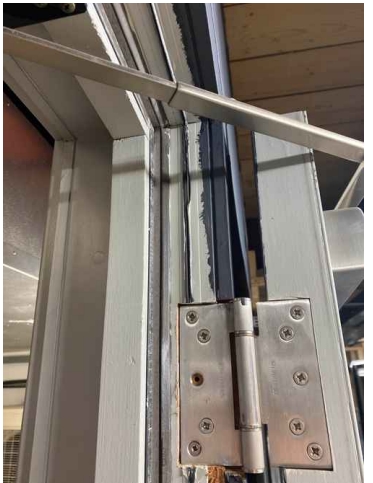
Seals  
1 of 1

| <b>Are the seals free from damage?:</b> | No |

| <b>Action required - Seals:</b> | Arrange for replacement intumescent seals/smoke seals FD60 20mm |

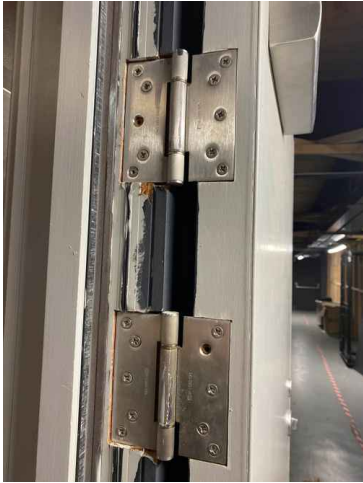
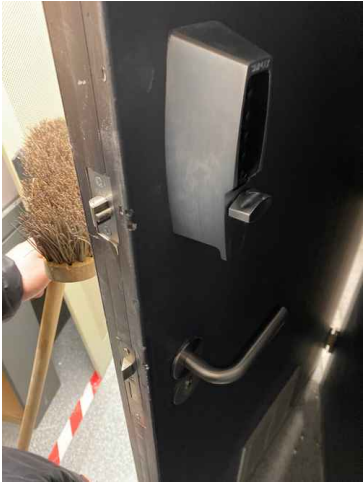
Ironmongery  
1 of 2

| <b>Are the hinges free of metal fragment and oil leakage, which shows signs of wear?:</b> | No |

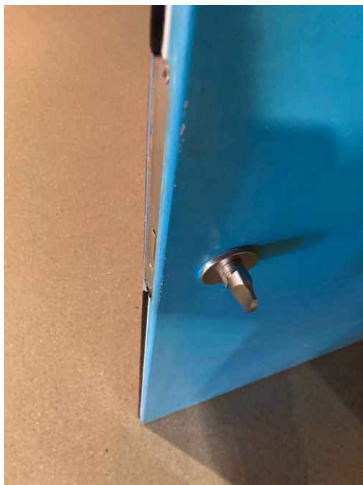
Ironmongery  
1 of 2

| Are the hinges free of metal fragment and oil leakage, which shows signs of wear?: | No |

| Action required - Ironmongery: | Arrange for hinge repairs or replacement due to wear & tear |

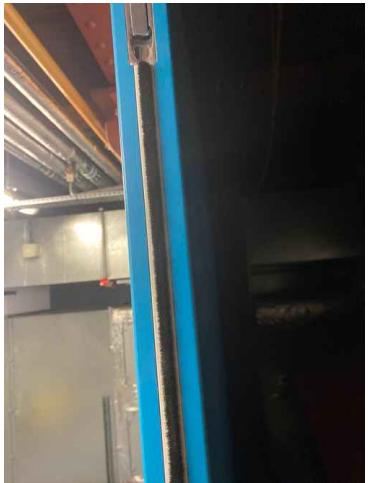
Seals  
1 of 1

| Door details | |
|---|---|
| Are the seals free from damage?: | Yes |

| Action required - Seals: | Arrange for replacement intumescent seals/smoke seals FD60 20mm |

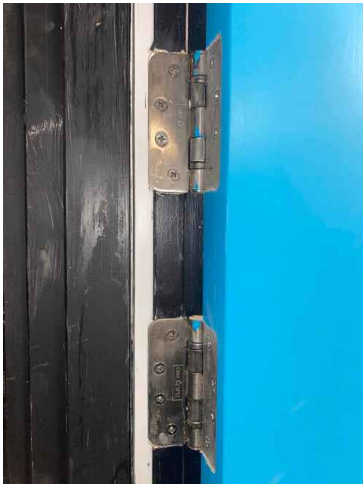
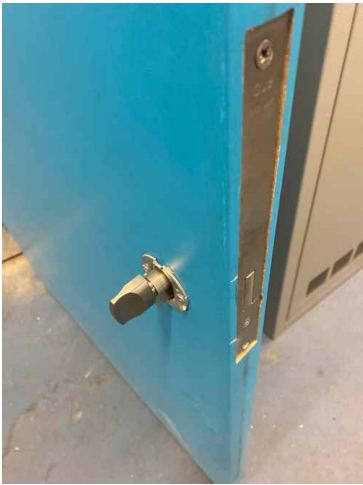
Ironmongery  
1 of 2

| Are the hinges free of metal fragment and oil leakage, which shows signs of wear?: | No |

| Action required - Ironmongery: | Arrange for hinge repairs or replacement due to wear & tear |

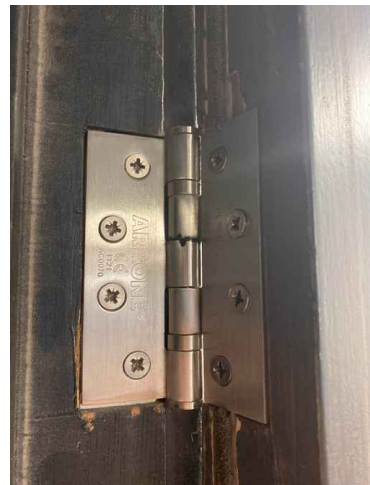
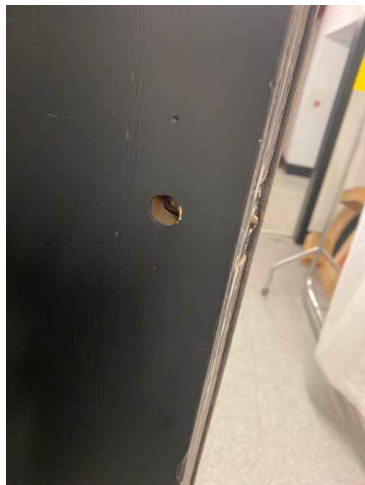
Ironmongery  
1 of 2

| Penetration through key hole. Replacement required. | |

| Are the hinges free of metal fragment and oil leakage, which shows signs of wear?: | No |

| Action required - Ironmongery: | Install minimum of 3 hinges with all the screws fitted. Use ironmongery stamped with CE stamp or BSEN 1935 grade 13 (or equivalent), Replace lock/latch with a CE certified tested set |

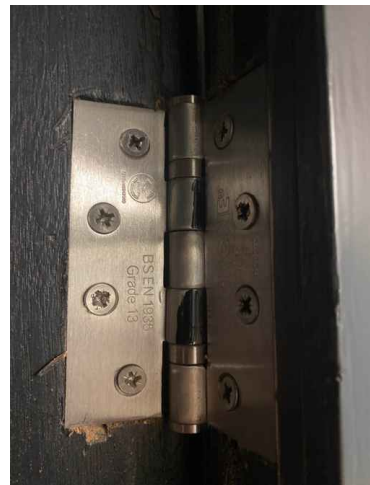
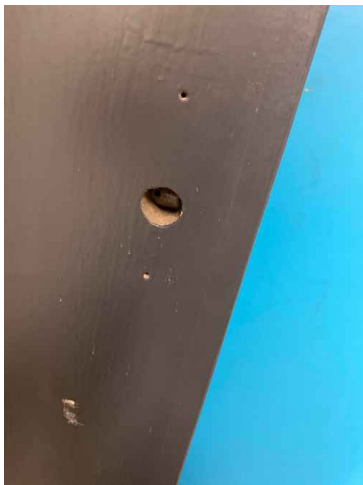
Ironmongery  
1 of 2

| Penetration through key hole. Replacement required. | |

| Are the hinges free of metal fragment and oil leakage, which shows signs of wear?: | No |

| Action required - Ironmongery: | Replace lock/latch with a CE certified tested set, Arrange for hinge repairs or replacement due to wear & tear |

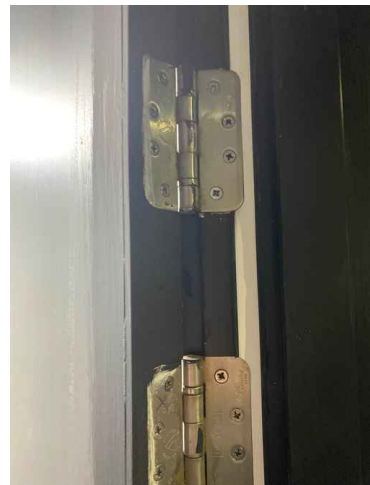
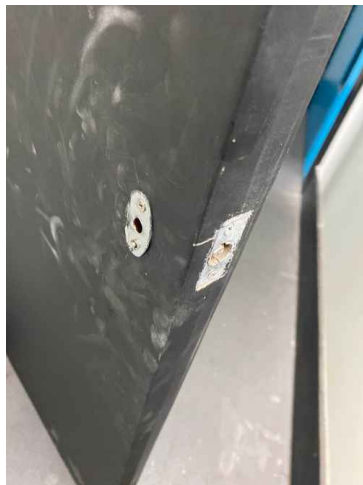
Ironmongery  
1 of 2

| Are the hinges free of metal fragment and oil leakage, which shows signs of wear?: | No |

| Action required - Ironmongery: | Arrange for hinge repairs or replacement due to wear & tear |

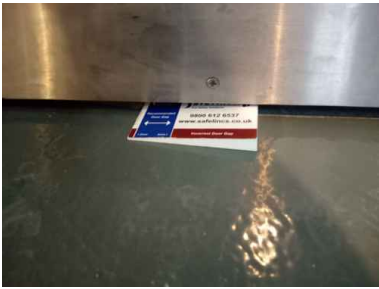
Door leaf  
2 of 2

| <b>Is the door leaf free from damage affecting its fire integrity?:</b> | Yes |

| Recommended actions: | Doorset can be upgraded to a notional standard Service Pack B - Double Doorset |

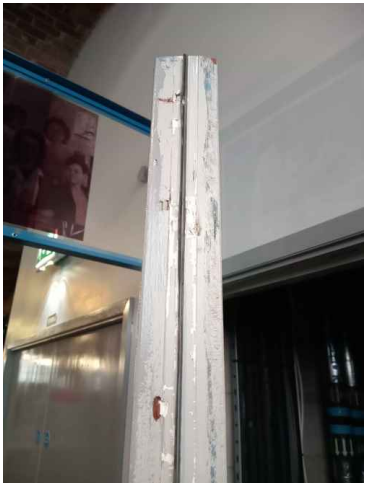
Seals  
1 of 1

| <b>Are the seals free from damage?:</b> | No |

| Action required - Seals: | Arrange for replacement intumescent seals/smoke seals FD60 20mm |

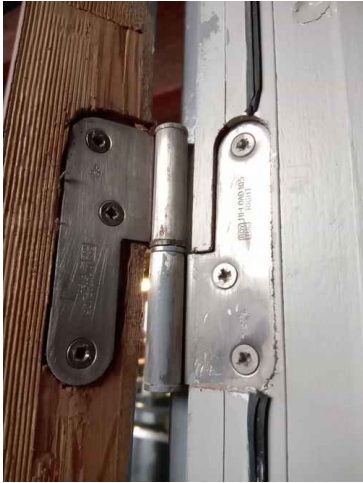
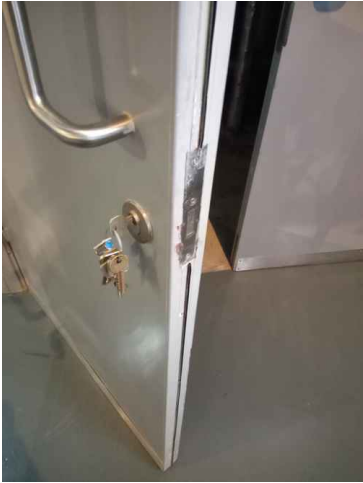
Ironmongery  
1 of 2

| Are the hinges free of metal fragment and oil leakage, which shows signs of wear?: | No |

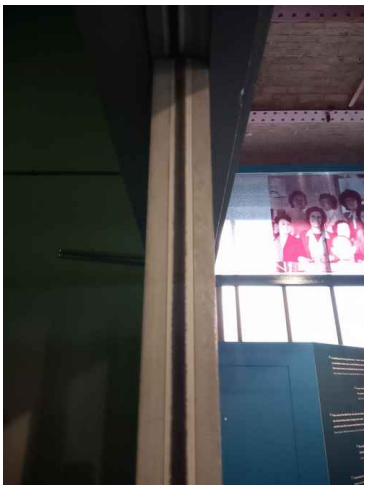
Seals  
1 of 1

| <b>Are the seals free from damage?:</b> | Yes |

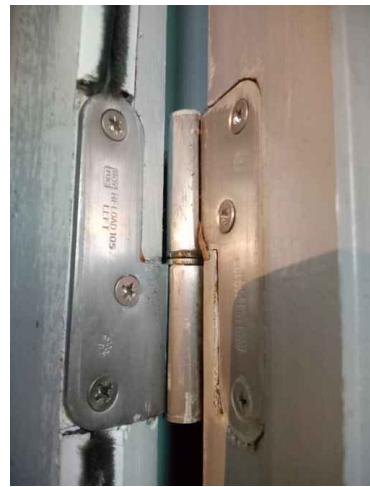
Ironmongery  
1 of 1

| Are the hinges free of metal fragment and oil leakage, which shows signs of wear?: | No |

| Recommended actions: | Doorset can be upgraded to a notional standard Service Pack B - Double Doorset |

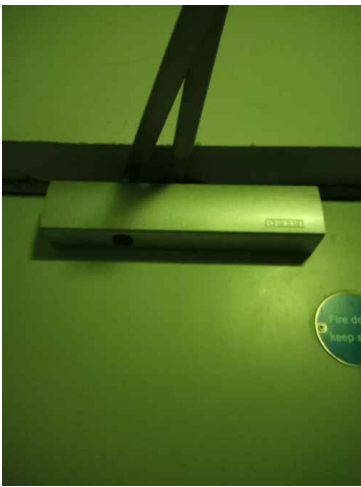
Door closers  
1 of 1

| Is the closer free from damage and not leaking?: | Yes |

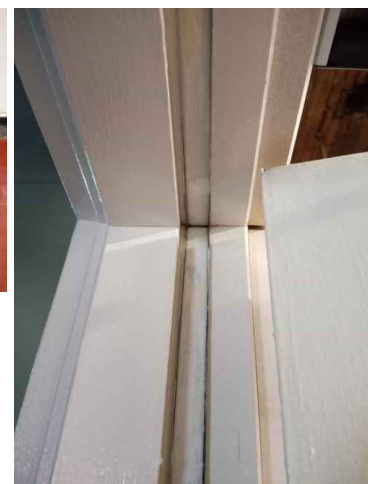
Seals  
1 of 1

| Door details | |
|---|---|
| Are the seals free from damage?: | No |

| Action required - Seals: | Arrange for replacement intumescent seals/smoke seals FD60 20mm |

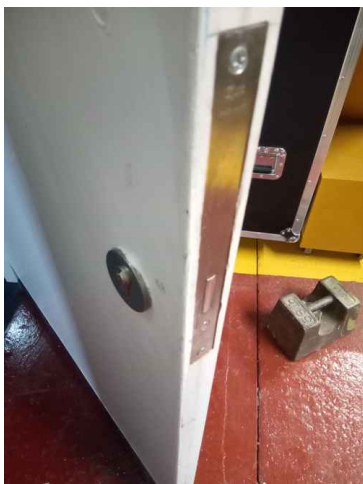
Ironmongery  
2 of 2

| Are the hinges free of metal fragment and oil leakage, which shows signs of wear?: | No |

| Action required - Ironmongery: | Arrange for hinge repairs or replacement due to wear & tear |

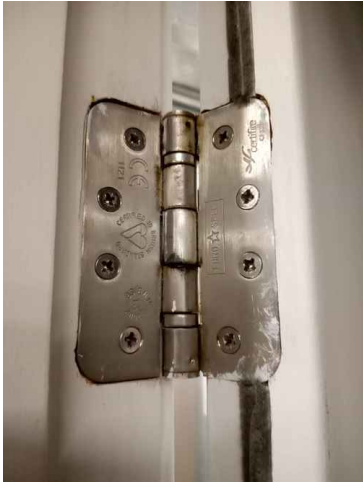
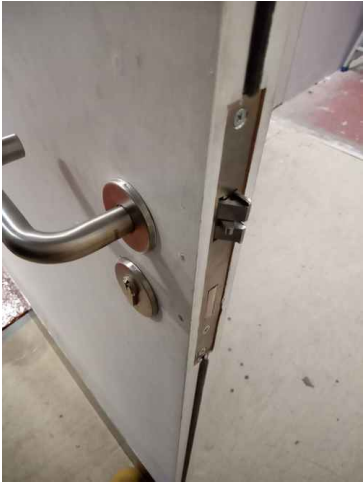
Ironmongery  
1 of 2

| Are the hinges free of metal fragment and oil leakage, which shows signs of wear?: | No |

| Action required - Ironmongery: | Arrange for hinge repairs or replacement due to wear & tear |

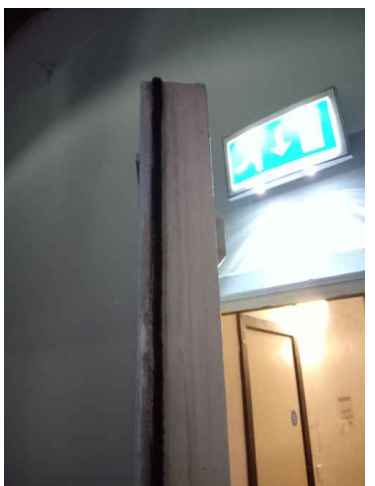
Seals  
1 of 1

| <b>Are the seals free from damage?:</b> | No |

| Action required - Seals: | Arrange for replacement intumescent seals/smoke seals FD60 20mm |

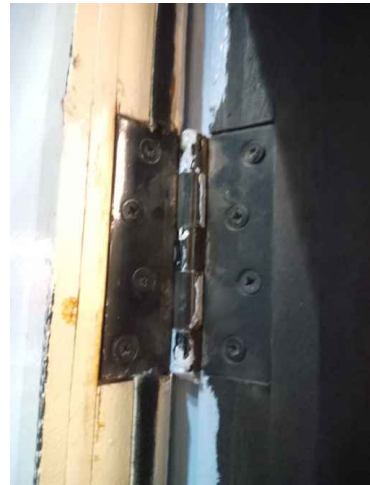
Ironmongery  
1 of 2

| Are the hinges free of metal fragment and oil leakage, which shows signs of wear?: | No |

| Recommended actions: | Doorset can be upgraded to a notional standard Service Pack B - Single doorset |

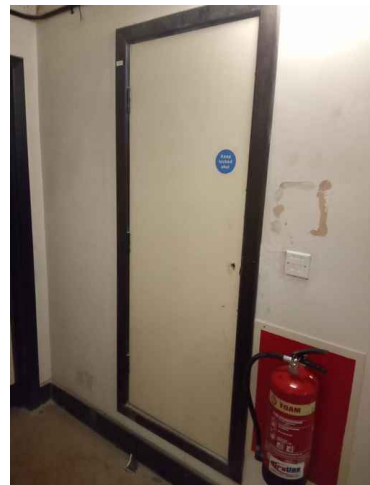
Door details  
1 of 1

| Penetration through key hole. Replacement required. | |

| Recommended actions: | Doorset is not compliant and cannot be repaired or upgraded to meet a satisfactory standard - Replacement Required Single Doorset |

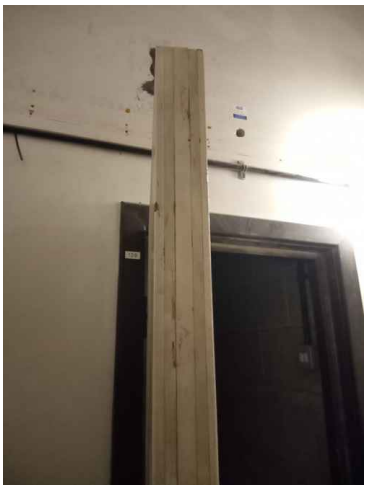
Seals  
1 of 1

| <b>Are the seals free from damage?:</b> | No |

| Action required - Seals: | Arrange for replacement intumescent seals/smoke seals FD30 10mm |

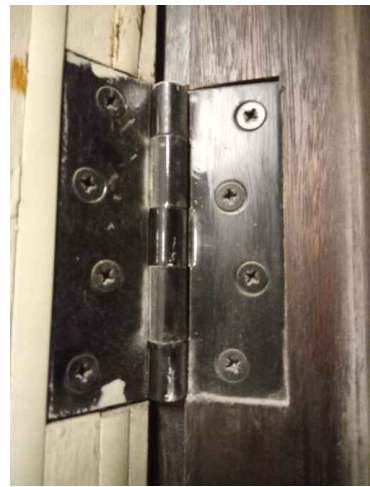
Ironmongery  
1 of 1

| Are the hinges free of metal fragment and oil leakage, which shows signs of wear?: | No |

| Action required - Ironmongery: | Arrange for hinge repairs or replacement due to wear & tear |

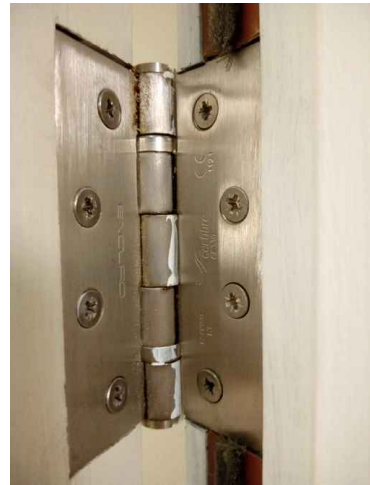
Ironmongery  
1 of 2

| Are the hinges free of metal fragment and oil leakage, which shows signs of wear?: | No |

| Action required - Ironmongery: | Arrange for hinge repairs or replacement due to wear & tear |
