## Museum of Science & Industry

### Fire Door Survey Report

### Great Western Warehouse

## **Fire Doors Report**

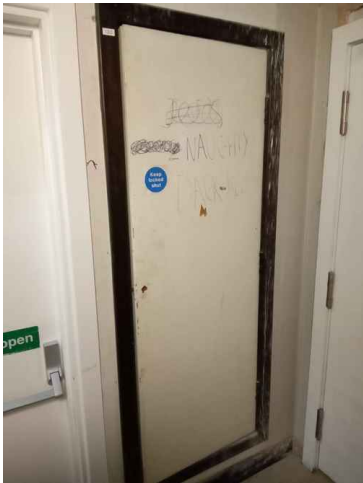
Door details  
1 of 1

| Penetration through key hole. Replacement required. | |

| Recommended actions: | Doorset is not compliant and cannot be repaired or upgraded to meet a satisfactory standard - Replacement Required Single Doorset |

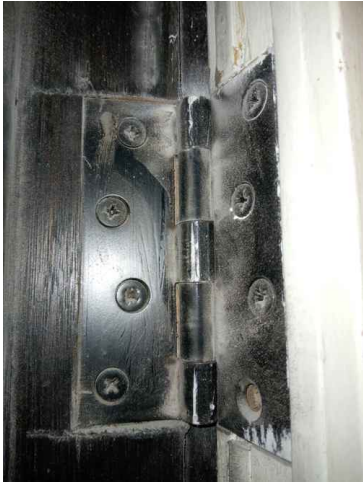
Ironmongery  
1 of 2

| Are the hinges free of metal fragment and oil leakage, which shows signs of wear?: | No |

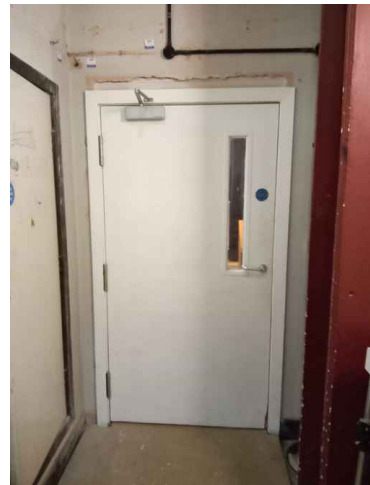
Door details  
1 of 2

| Door details | |
|---|---|
| Veneer is damaged. Replacement required. | |

| Recommended actions: | Doorset can be upgraded to a notional standard Service Pack B - Single doorset |

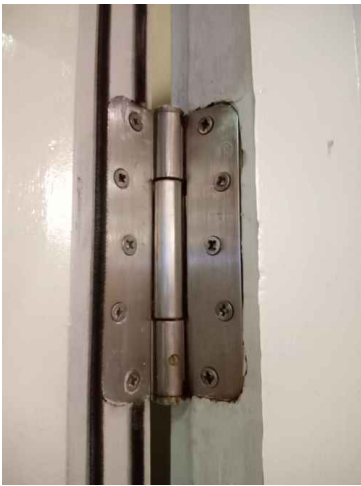
Ironmongery  
1 of 2

| Are the hinges free of metal fragment and oil leakage, which shows signs of wear?: | No |

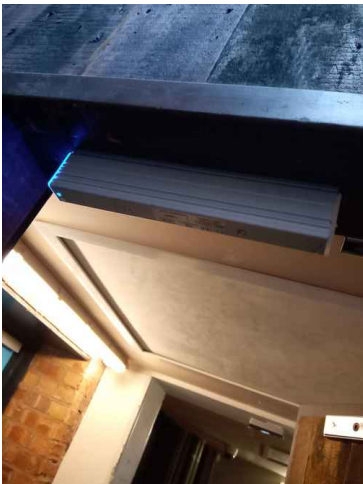
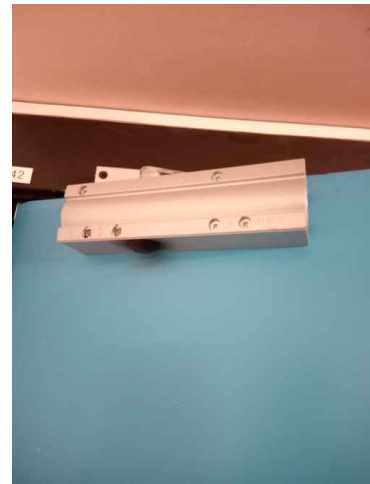
Ironmongery  
1 of 2

| Are the hinges free of metal fragment and oil leakage, which shows signs of wear?: | No |

| Action required - Ironmongery: | Arrange for hinge repairs or replacement due to wear & tear |

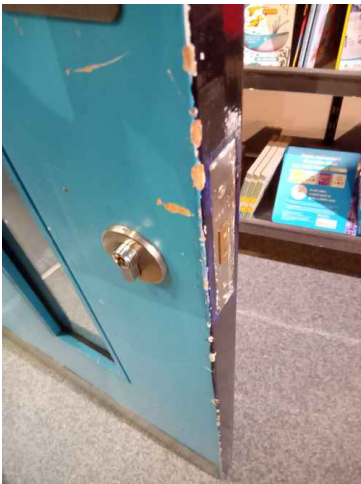
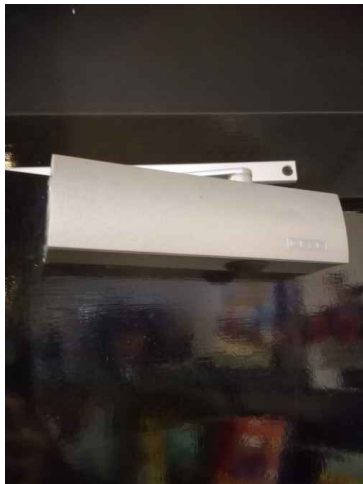
Ironmongery  
1 of 2

| Are the hinges free of metal fragment and oil leakage, which shows signs of wear?: | No |

| Action required - Ironmongery: | Arrange for hinge repairs or replacement due to wear & tear |

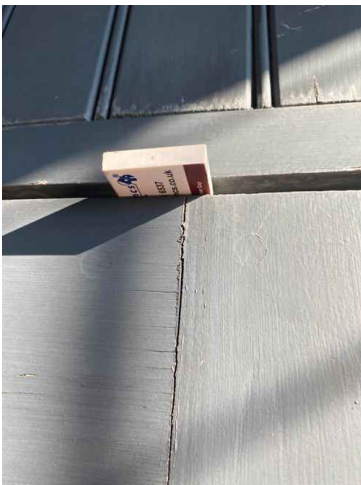
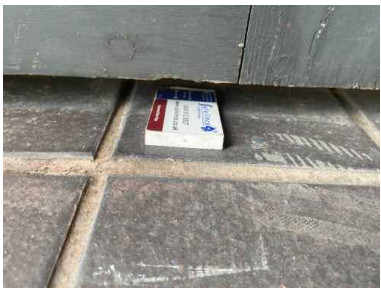
Door leaf  
1 of 2

| Door details | |
|---|---|
| Damage to door leaf. Replacement required. | |
| Is the door leaf free from damage affecting its fire integrity?: | No |

| Recommended actions: | Doorset is not compliant and cannot be repaired or upgraded to meet a satisfactory standard - Replacement Required Double Doorset |
| Priority: | Urgent |
