# **Bennett Street, Manchester Preliminary Ecological Appraisal**

**Kellen Homes Ltd**

Report Title: **Bennett Street, Manchester – Preliminary Ecological Appraisal**

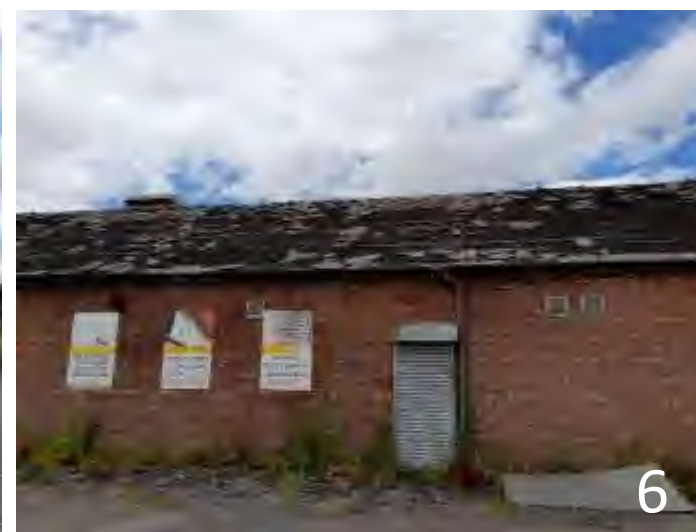
6

| Ref. | Grid Reference | Feature Description | Bat Roost Potential |
|---|---|---|---|
| B1 | SJ8626196924 | Single-story, red brick-built building with a pitched tiled roof.<br><br>The external inspection of the building identified numerous potential access points for bats including missing roof tiles, exposed felt and slats through to the main external construction and gaps present to the top of the wall plate along a wooden gutter/fascia board located on the south-east aspect of the building. However, the brick walls were in good condition. | Moderate |

Photo 6. B1 PRFs- roof tiles missing and felt and slats exposed.

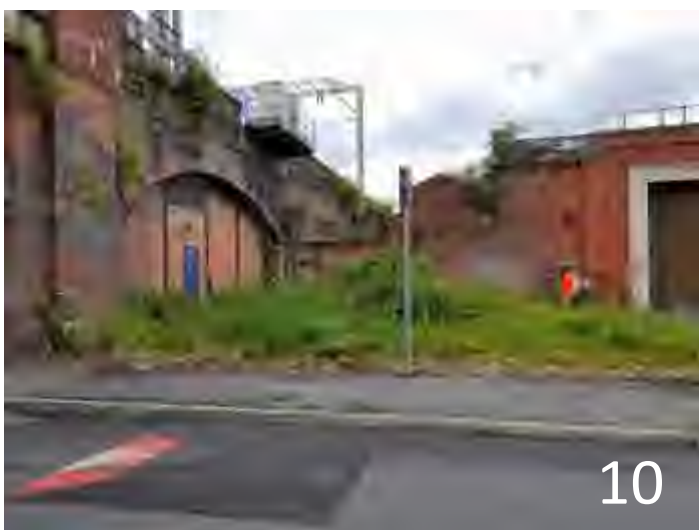
10

| Ref. | Grid Reference | Feature Description | Bat Roost Potential |
|---|---|---|---|
| B2 | SJ8622896893 | Single-story, red brick-built building with a high ceiling. There is a flat concrete roof on the entrance of the building, pitched tiled roof on the western aspect with wooden fascia boards on the gable end and large steel exit gates on the south-east aspect.<br><br>The external inspection of the building identified numerous potential access points for bats including missing roof tiles and exposed felt and slats through to the main | Moderate |

**Photo 10. B2 PRFs- tiles missing and felt and slats exposed.**

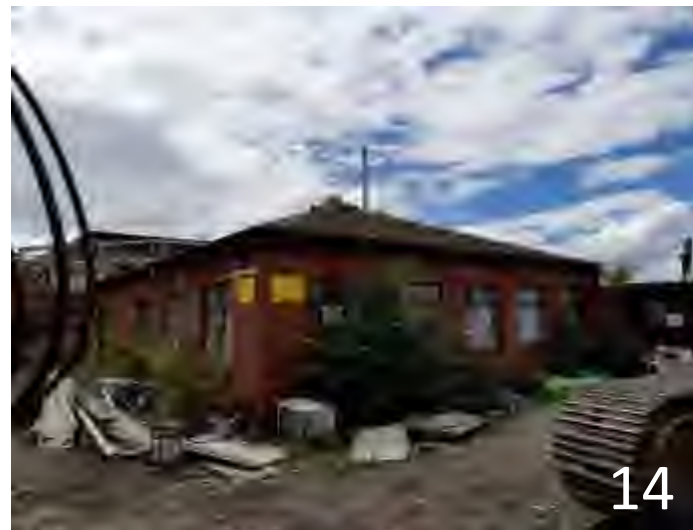
14

| B4 | SJ8623896961 | Single-story, red brick-built building with a pitched tiled roof and no gable.<br><br>The external inspection of the building identified numerous potential access points for bats including missing roof tiles and exposed felt and slats through to a potential loft space.<br><br>It is connected to building 3. | Moderate |

**Photo 14. B4 PRFs- tiles missing and felt and slats exposed.**

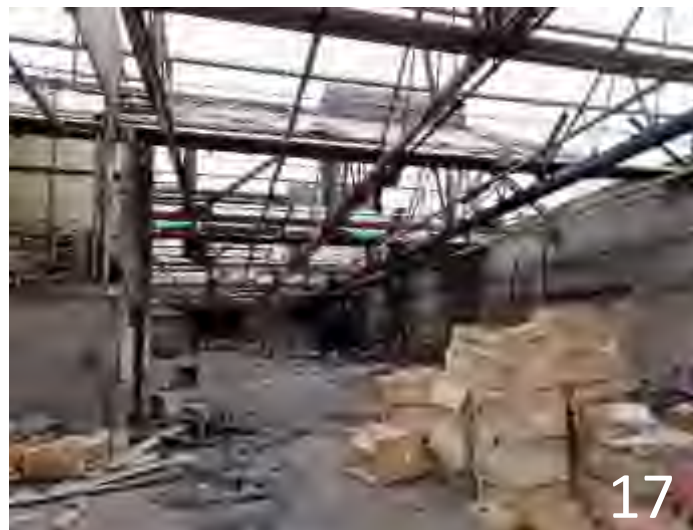
17

| B5 | SJ8621296923 | Single-story, red brick-built warehouse building with a high ceiling and a multi-pitched roof consisting of slate tiles and plastic light panels.<br><br>The external inspection of the building identified numerous potential access points for bats including missing roof tiles, roof partially falling in and exposed felt and slats through to the main external construction.<br><br>The internal construction consists of multiple brick-built, flat-roofed rooms that are well lit throughout the daytime. It is connected to building 2. | Moderate |

**Photo 17. B5 PRFs- roof tiles missing and partially falling in.**
