# BAT SURVEY REPORT

**July 2022**

**Former St. George's Nursing Home,**  
Abbey Hey Lane,  
Manchester,  
M18 8RP

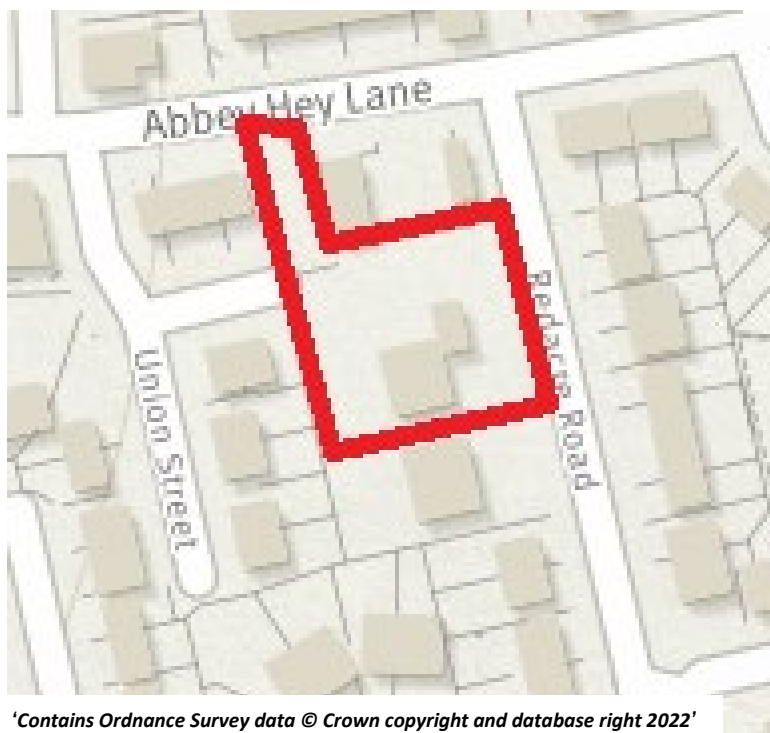
**Figure 1 – Site Extent**

The site is located at National Grid Reference SJ 89319 96558 and comprises a total area of 0.15ha (see Figure 1).

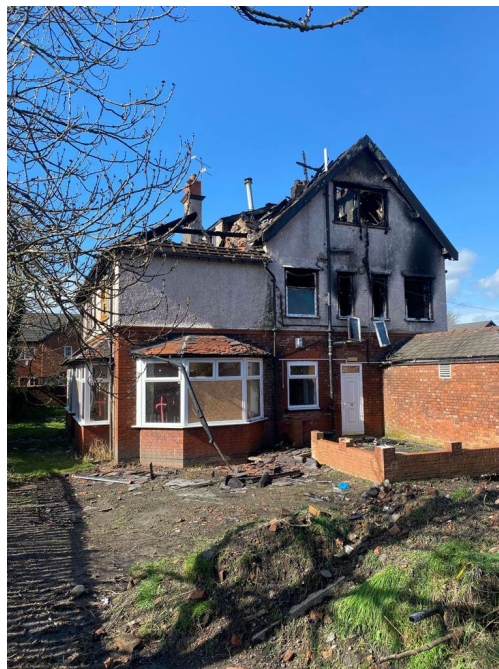
Following the arson and subsequent extensive fire damage at the building, the bat roost potential of the building was reduced from **High** to **Moderate** due to the lack of suitable bat features that were now present within B1a.

Photograph 2 – Building 1a following arson and fire damage.

B1 was assessed as having **moderate** suitability for roosting bats. As such, two separate nocturnal bat surveys, consisting of one dusk emergence and one dawn re-entry survey, were recommended as to follow guidance set out in Collins (2016).

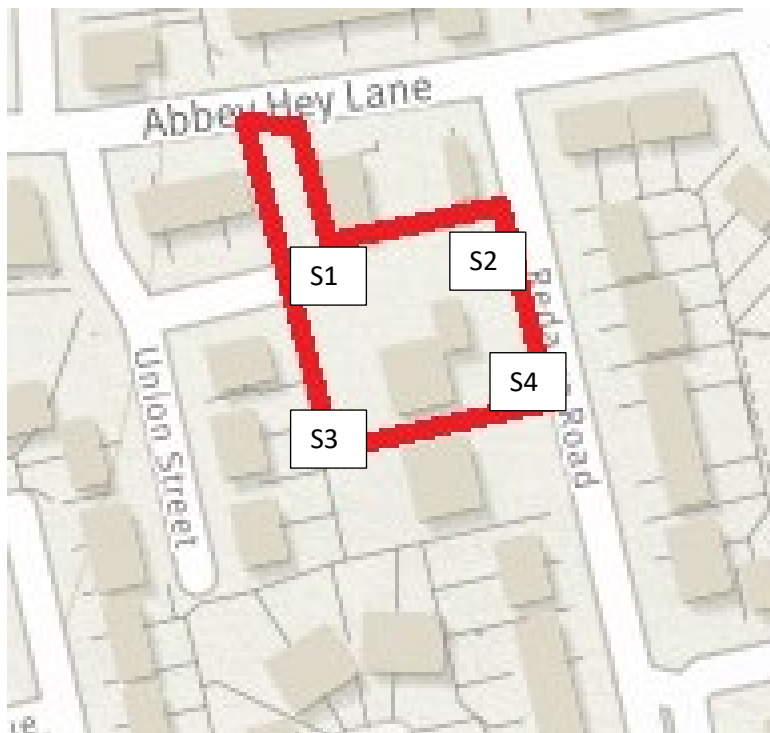
Surveyor locations during the survey.
