**Ground Investigation Report**

**Crabtree Lane, Openshaw**

**REPORT NO: 21CHE276/DSGI**

**Document:** Desk Study and Initial Ground Investigation Report

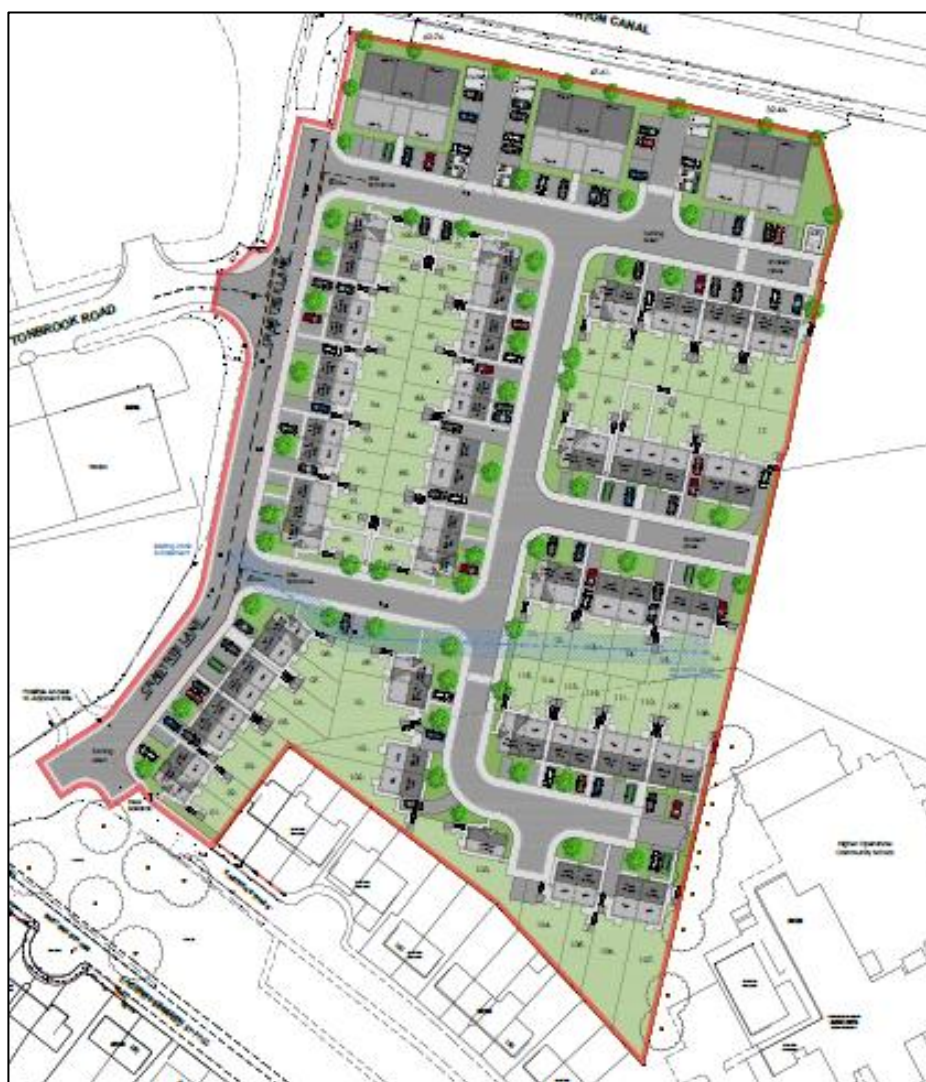
The proposed site layout is shown below;

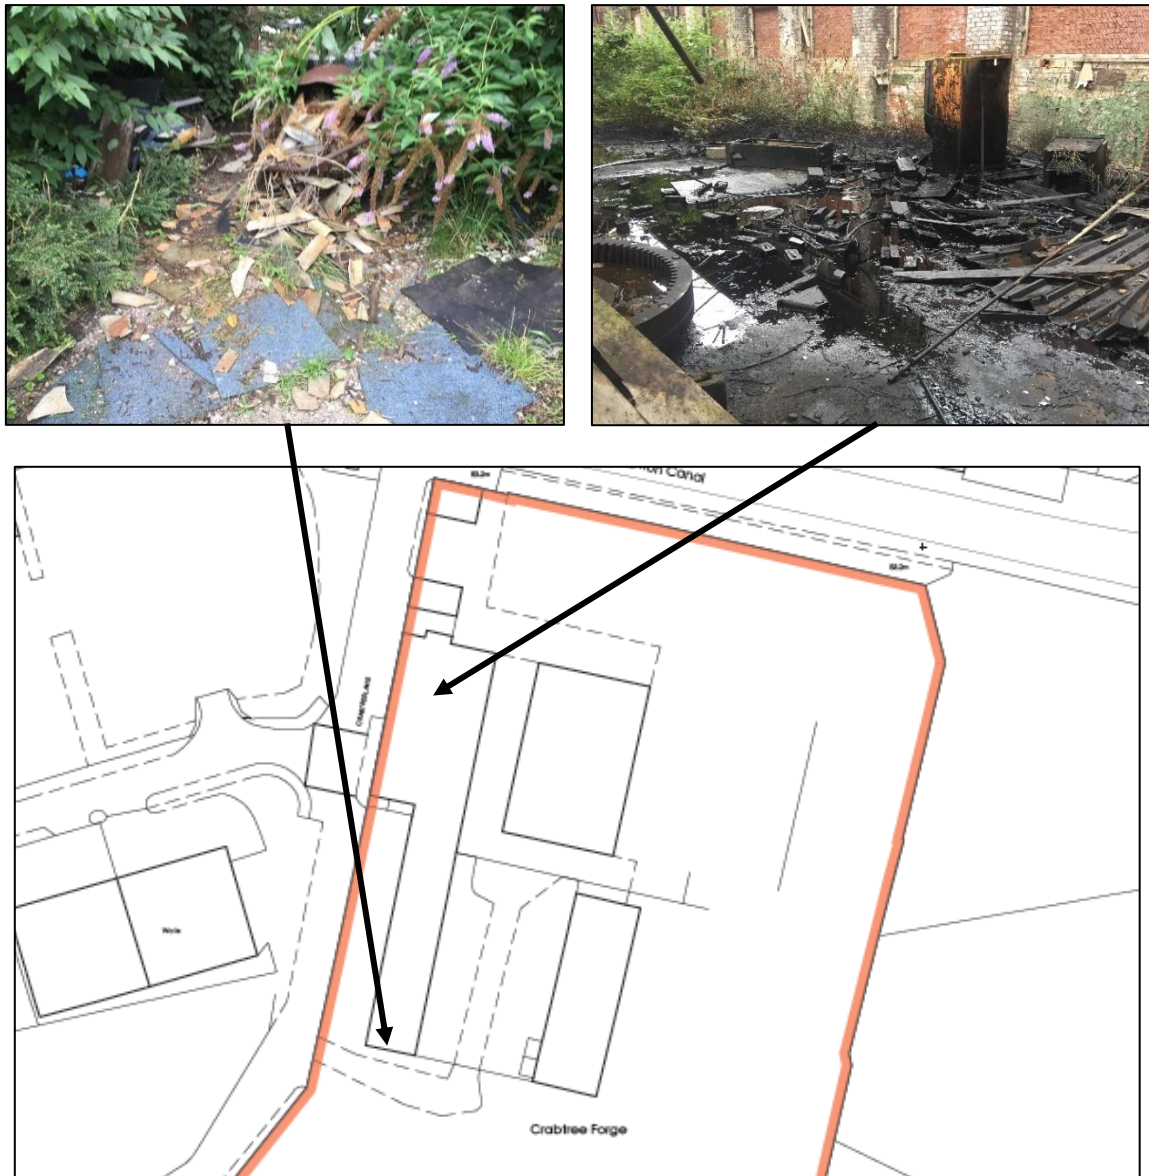
The buildings are largely empty however, some machinery remains, as does significant amount of waste. Asbestos was noted at the surface across the site but was focussed on the southern end of the western building. Also, within this building was a large 'oil' spill. These are shown on the photos below;

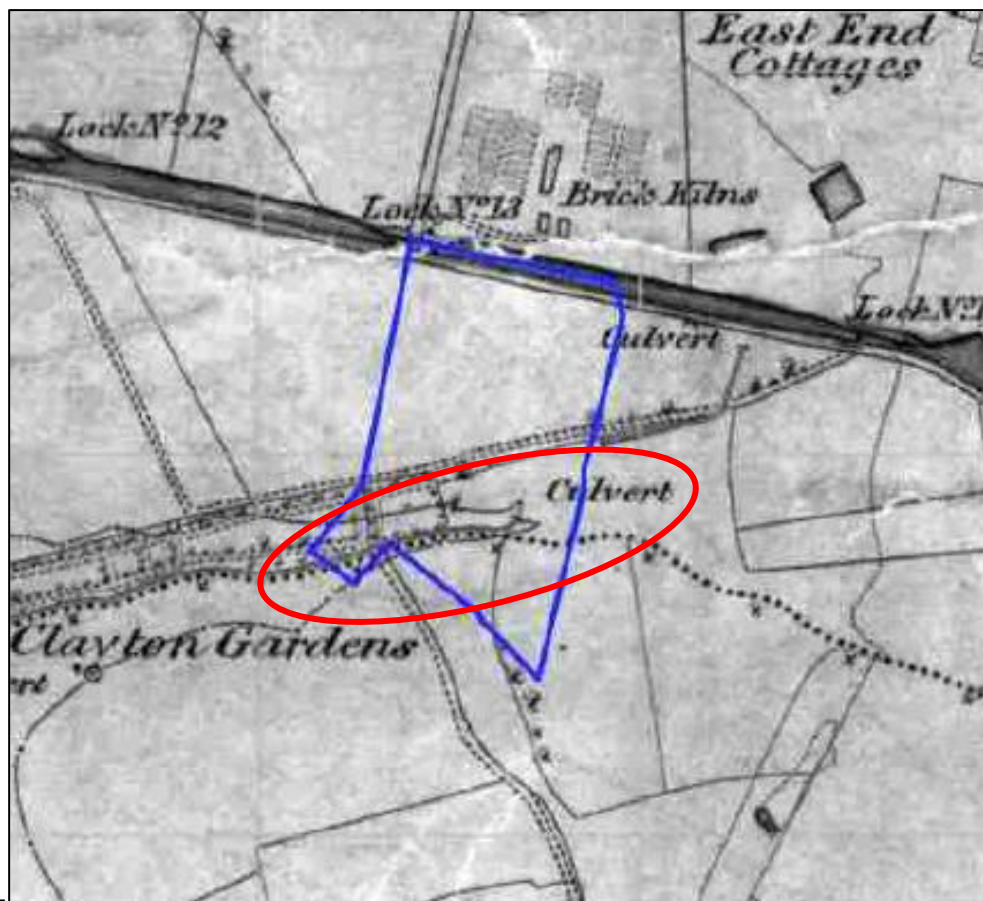
1845 1:10,560 Map

The earliest available map of site is the 1845 1:10,560 map which shows the site to be largely undeveloped land with a culvert crossing the site. An extract of this map is shown below;

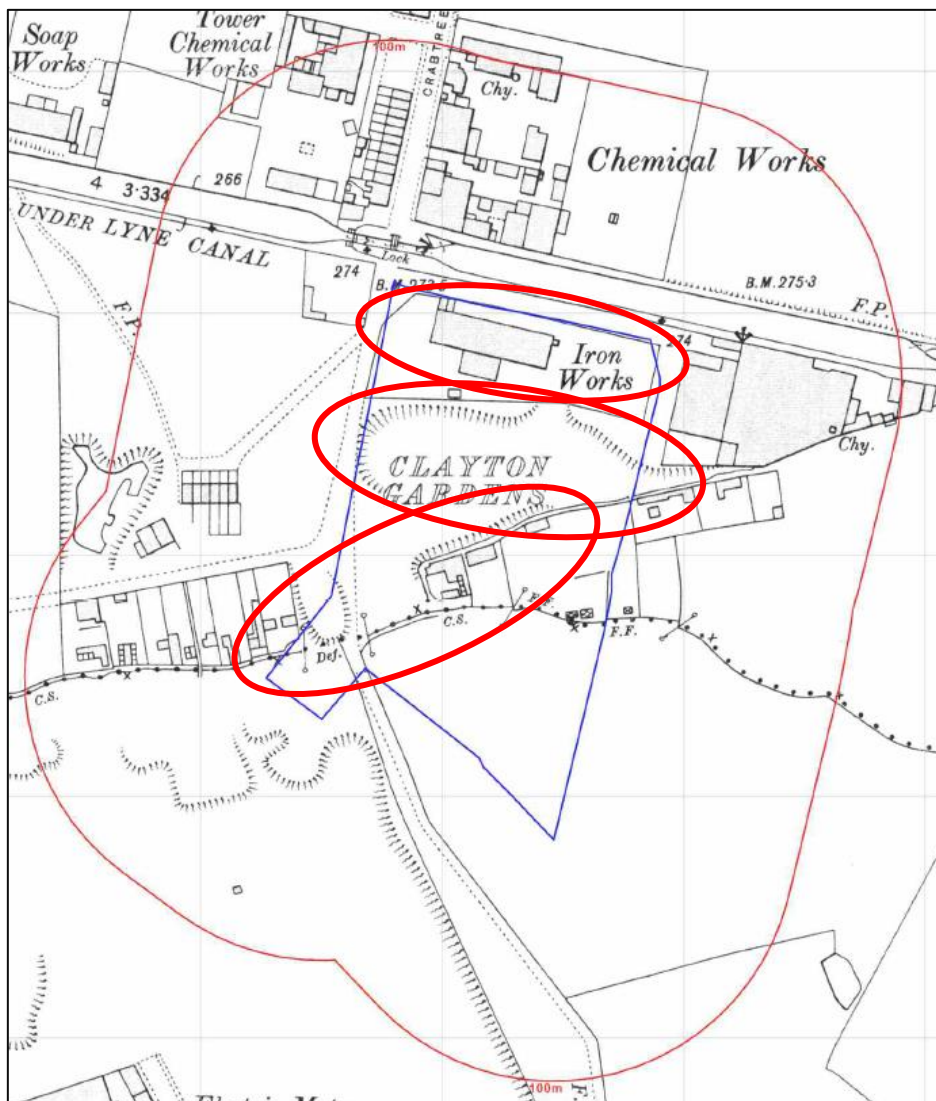
1908 1:2,500 Map

The 1908 1:2,500 map which shows the construction of a number of buildings in the north, and central areas of the site. The northern building is labelled as an iron works. The area to the south of the works is detailed as steep slopes indicating removal of materials. A smaller slope is also present in the southwest. An extract of this map is shown below;

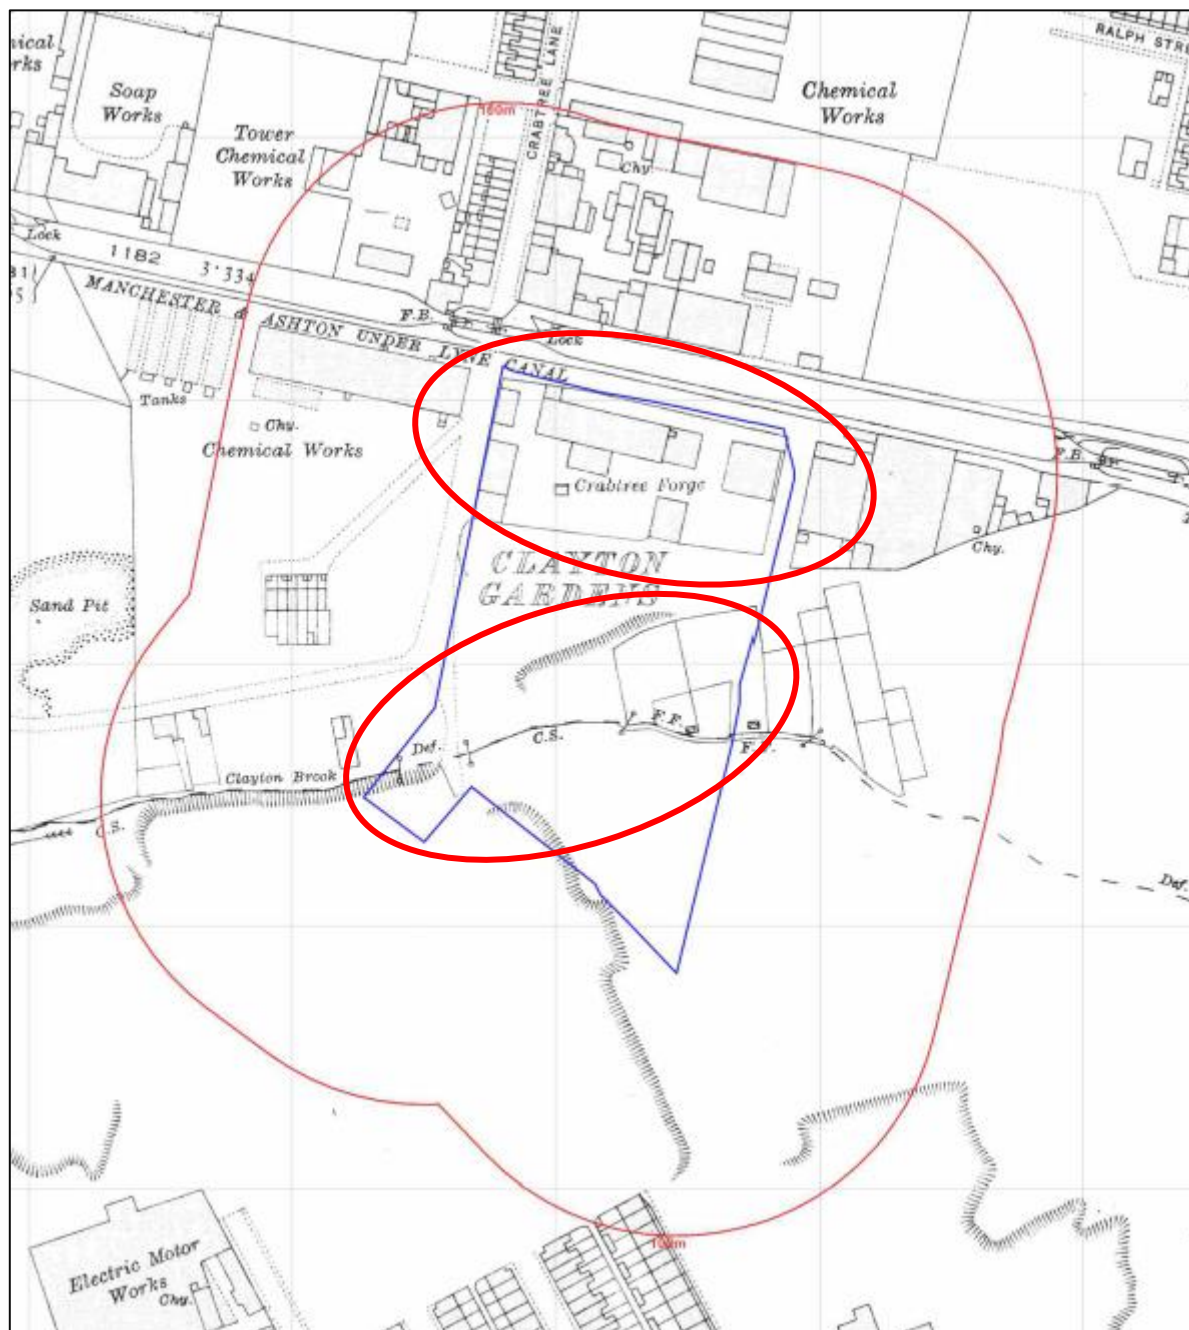
**1922 1:2,500 Map**

The 1922 1:2,500 map which shows the construction of additional buildings in the north, and demolition in the south with alterations of the steep slopes. An extract of this map is shown below;

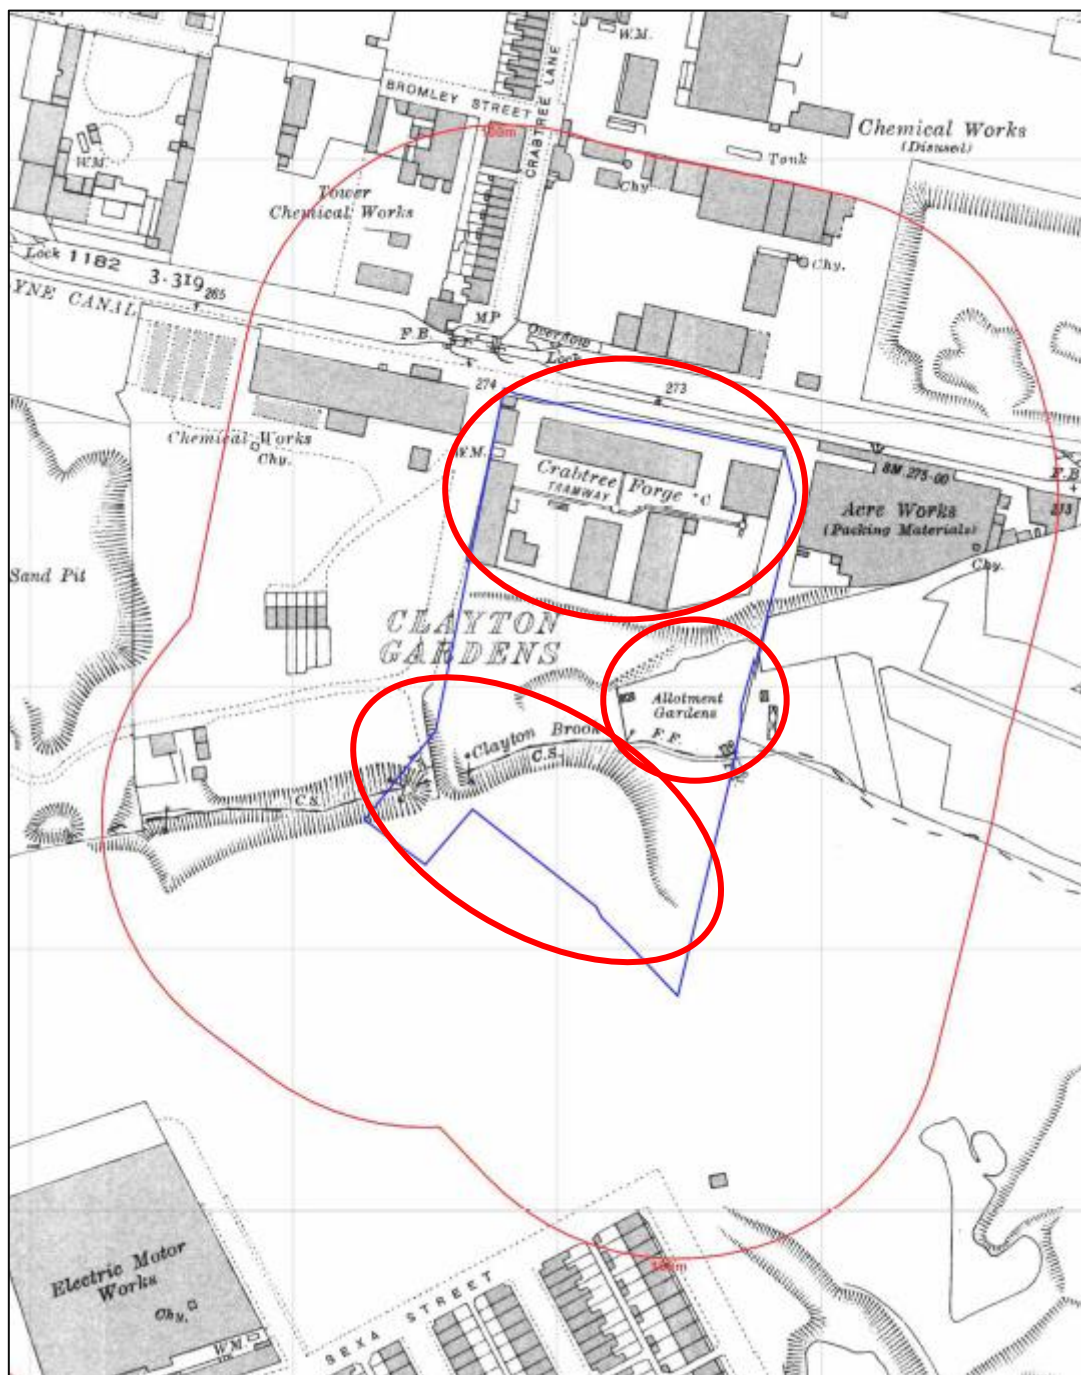
**1932-1933 1:2,500 Map**

The 1932-1933 1:2,500 map which shows further construction in the north, and demolition with creation of allotment gardens in the south, again with alterations of the steep slopes. An extract of this map is shown below;

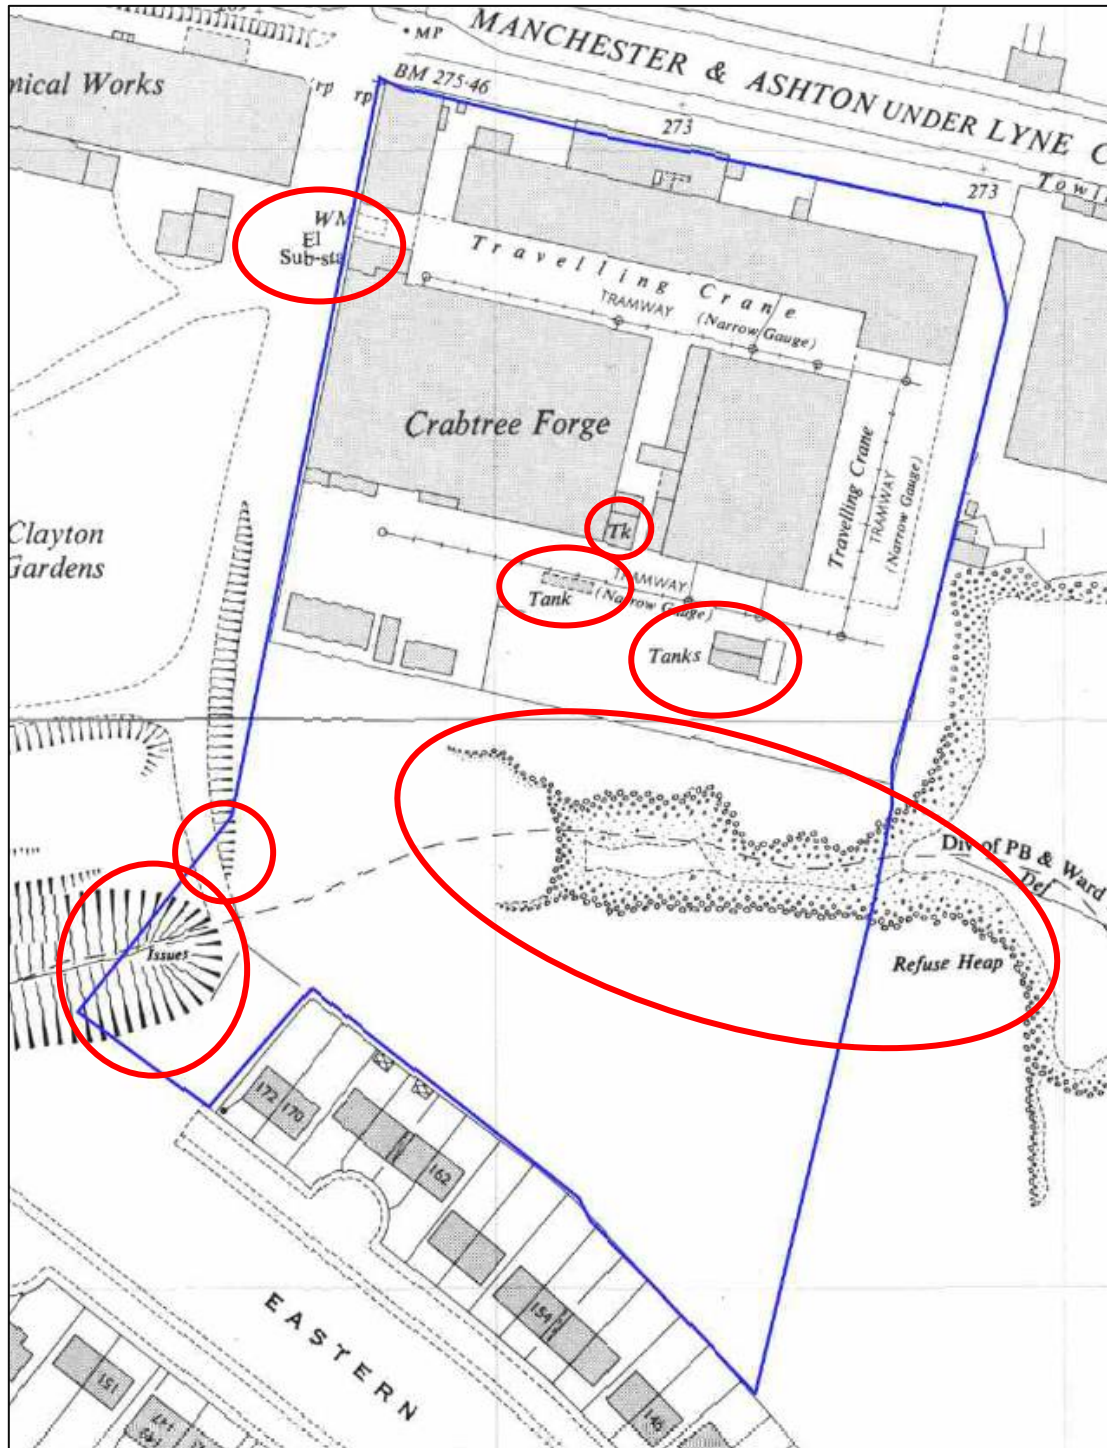
1949-1950 1:1,250 Map

The 1949-1950 1:1,250 map shows significant extension to the buildings in the north of the site with the introduction of travelling cranes and tanks. An electrical substation is also shown on the western boundary. The steep slopes are shown as a refuse heap along Clayton Brook. Steep slope is still shown around the stream in the southwest. An extract of this map is shown below;

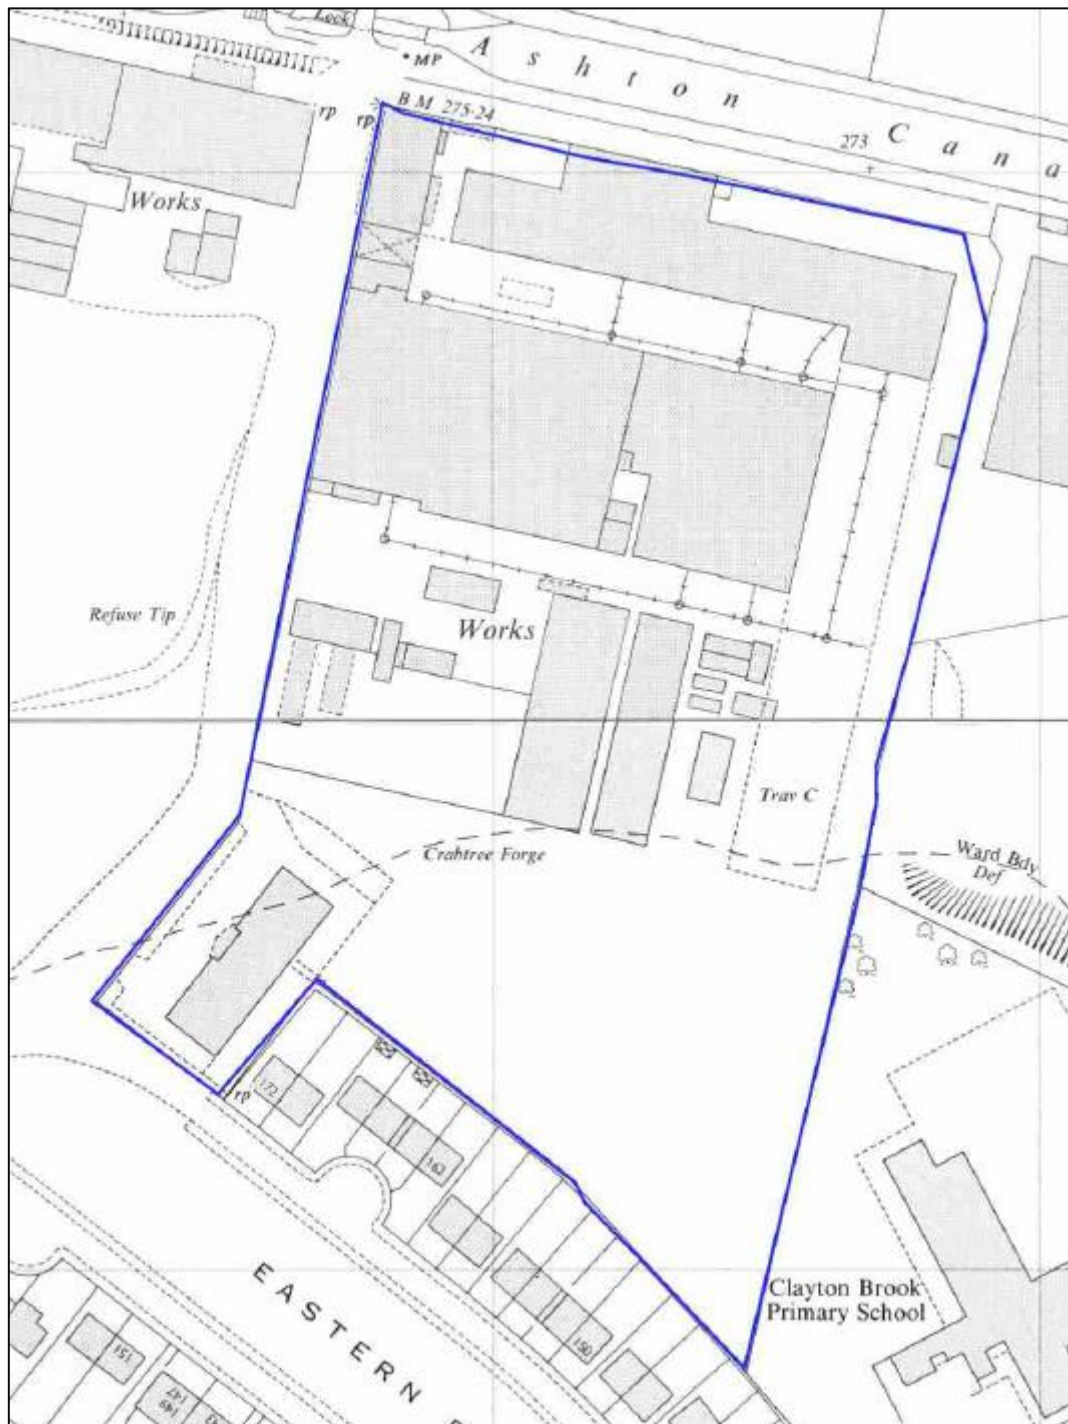
**1964-1968 1:1,250 Map**

The 1964-1968 1:1,250 map shows significant changes across the site, with the extension of existing buildings and construction of new ones. An extract of this map is shown below;

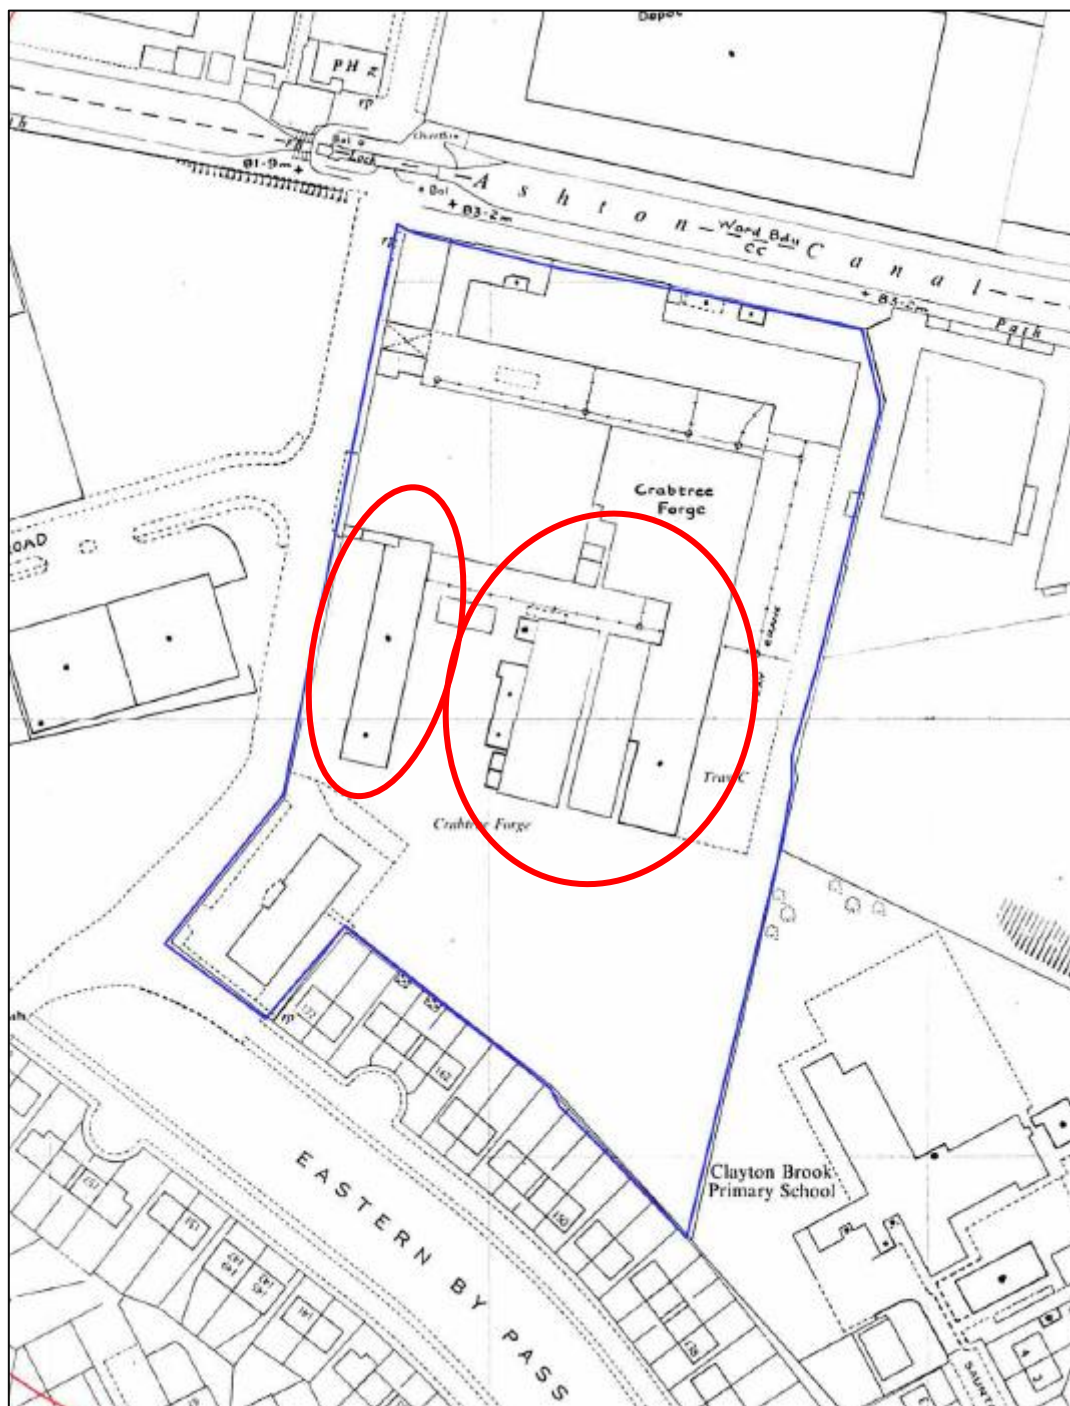
**1983-1986 1:1,250 Map**

The 1983-1986 1:1,250 map shows significant changes across the site, with the extension of existing buildings and construction of new ones. Clayton Brook no longer shown. An extract of this map is shown below;

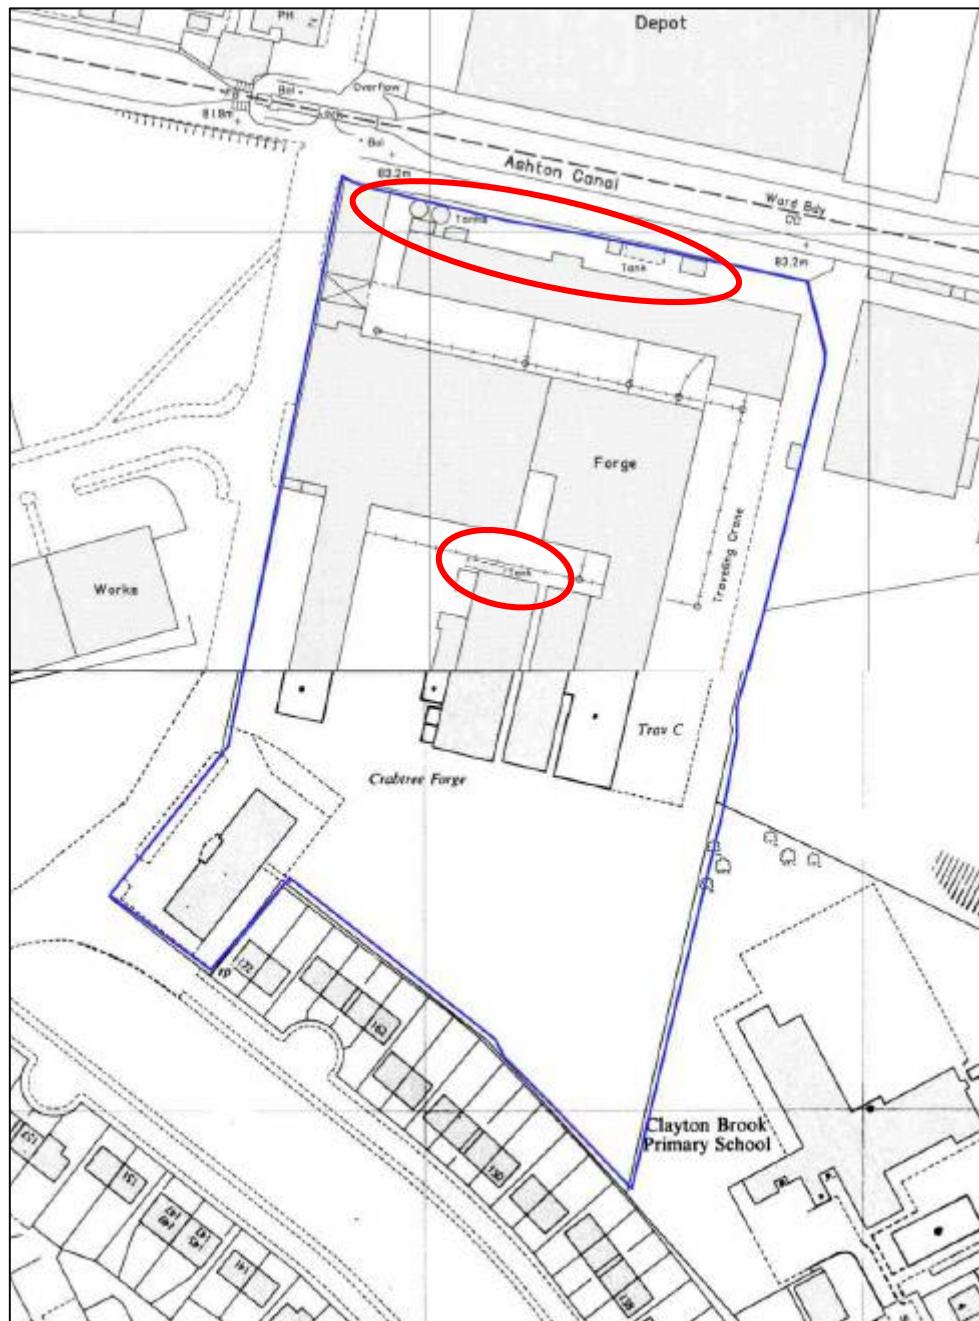
**1983-1986 1:1,250 Map**

The 1988-1991 1:1,250 map shows additional tanks in the north and the centre of the site. An extract of this map is shown below;

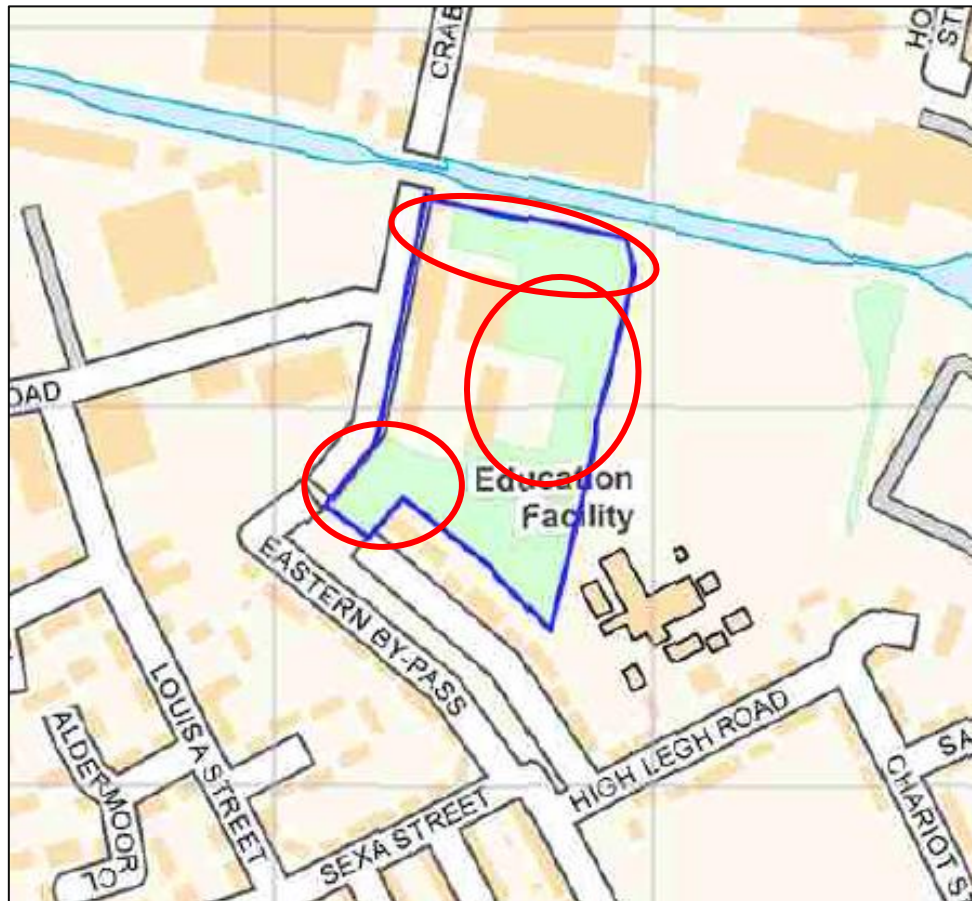
**2021 1:10,000 Map**

There were no significant changes until the 2021 1:10,000 map which shows the site in its current state following demolition of several buildings. An extract of this map is shown below;

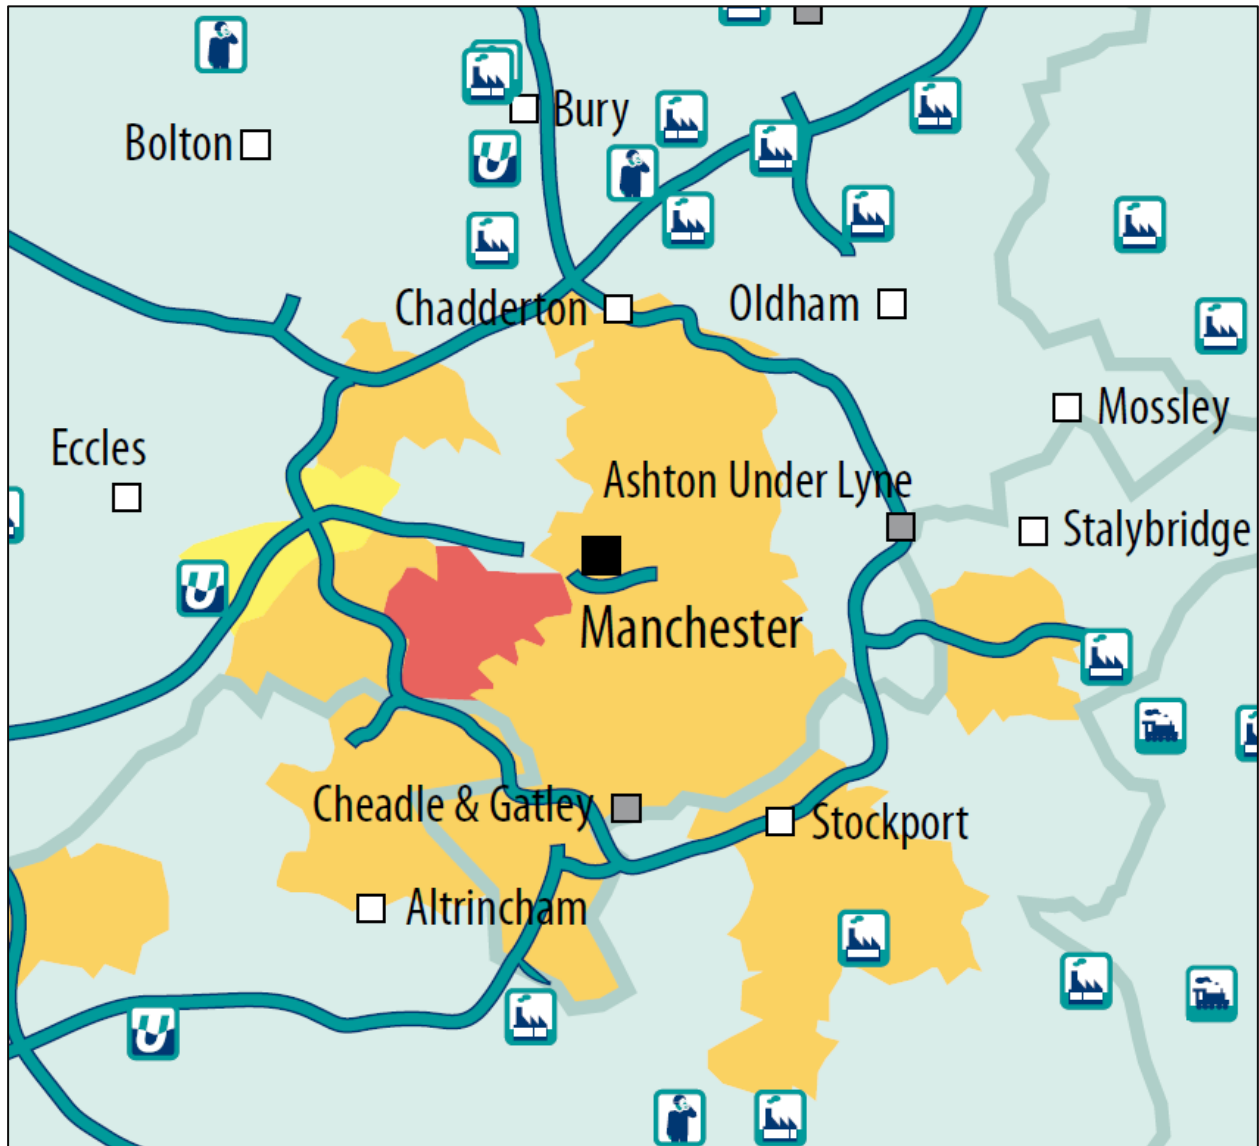
Zetica's indicative UXO risk mapping places Manchester, and the site, within a 'moderate bomb risk' area. As shown below;

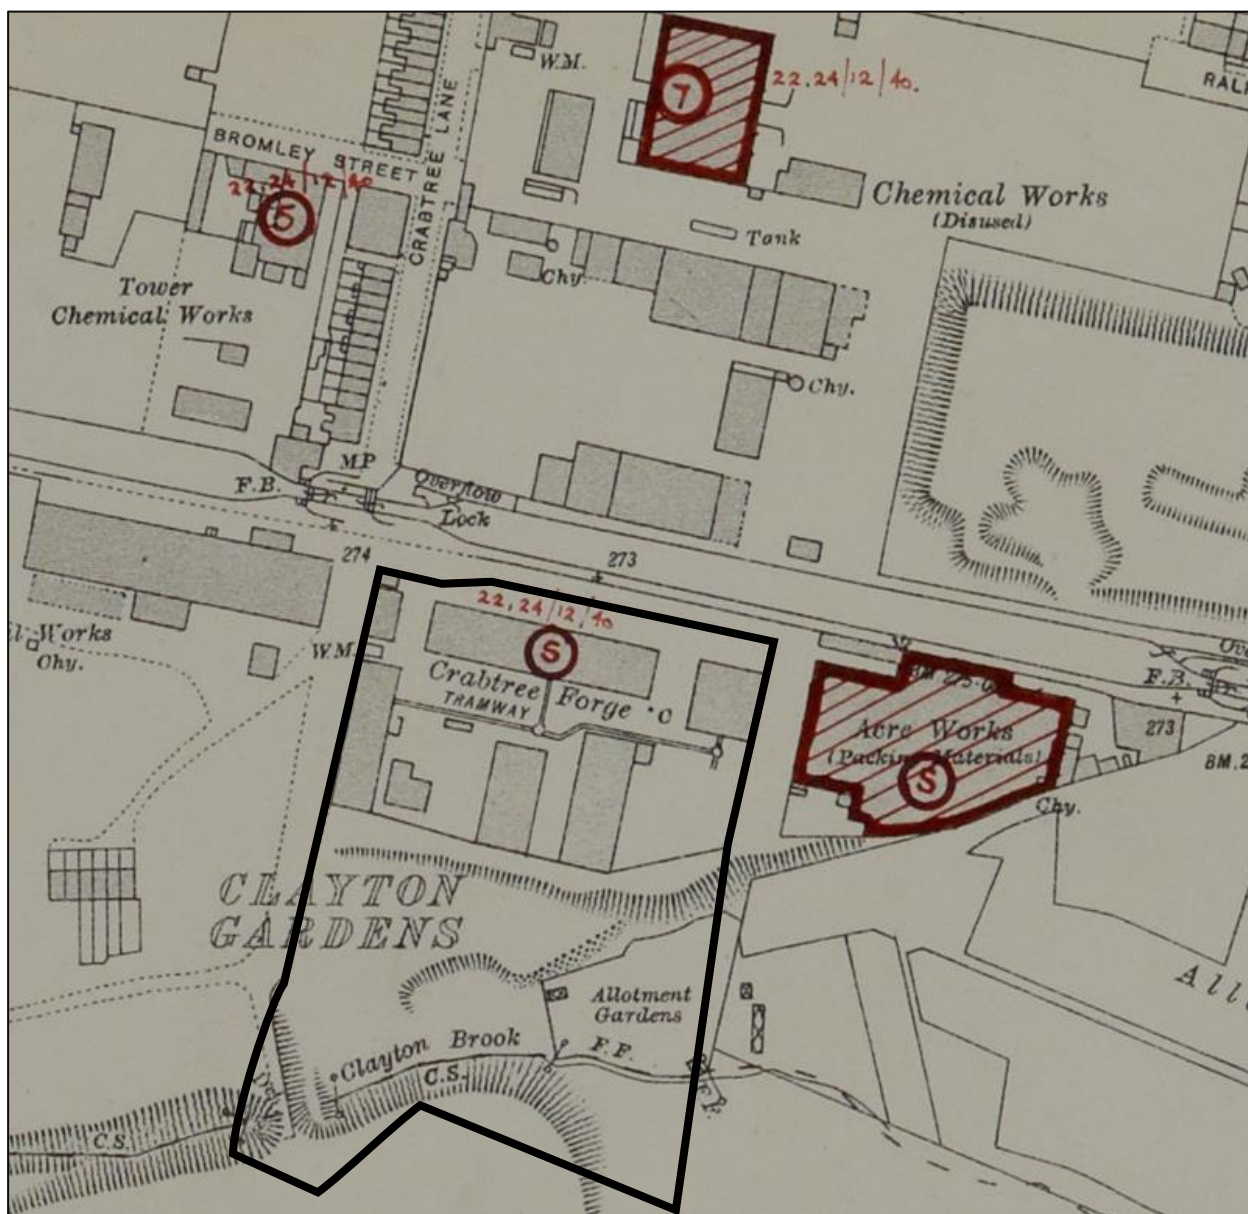
A brief internet search of open source records and historical mapping provided by GroundSure has shown there were a number of bomb strikes on and around the site, with at least one recorded strike on the north of the site (firebombs), as shown on the extracts listed below. This mapping ONLY covers the Blitz period 1940-1941, and is therefore not exhaustive;

Original map of Manchester: Ordnance Survey Revisions of 1932-1935. Scale: 25" to 1 mile. Annotated with: red circles for fire bombs; blue circles for high explosives; pink shading for damaged buildings; red shading for demolished buildings; green marks: line mines, indicating bomb damage by the Luftwaffe during the Blitz. Detailing Openshaw and Gorton.

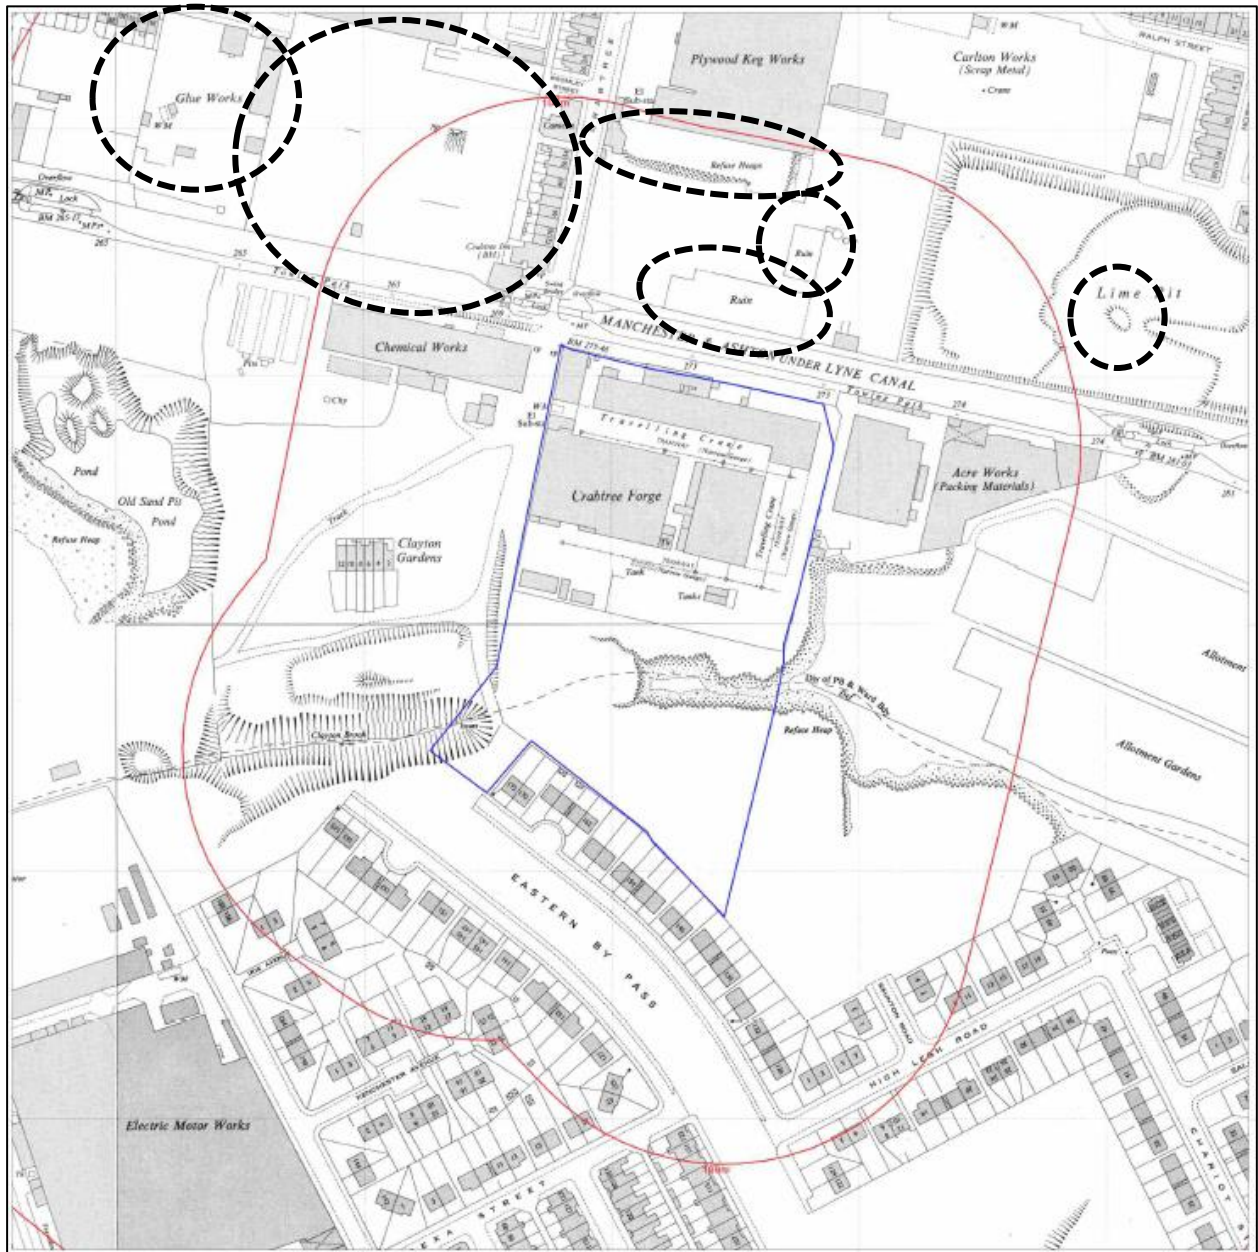
Mapping from 1949-1950 shows a number of ruins located around the site, as well as the disappearance of buildings not listed as a ruin, but have gone during WWII period. Bomb strikes outside of developed areas are unlikely to be recorded. These are shown on plan below;

As the site has been developed prior to, during and after WWII, the likelihood of UXO remaining on site from a direct strike is considered **unlikely**. However, dropped ordnance can hit the ground outside of the site boundary and migrate under the boundary in a typical 'J' shape. Due to the number of strikes around the site, and the strikes recorded on the north of the site, discussion with a suitably qualified and experienced UXO consultant is considered prudent.

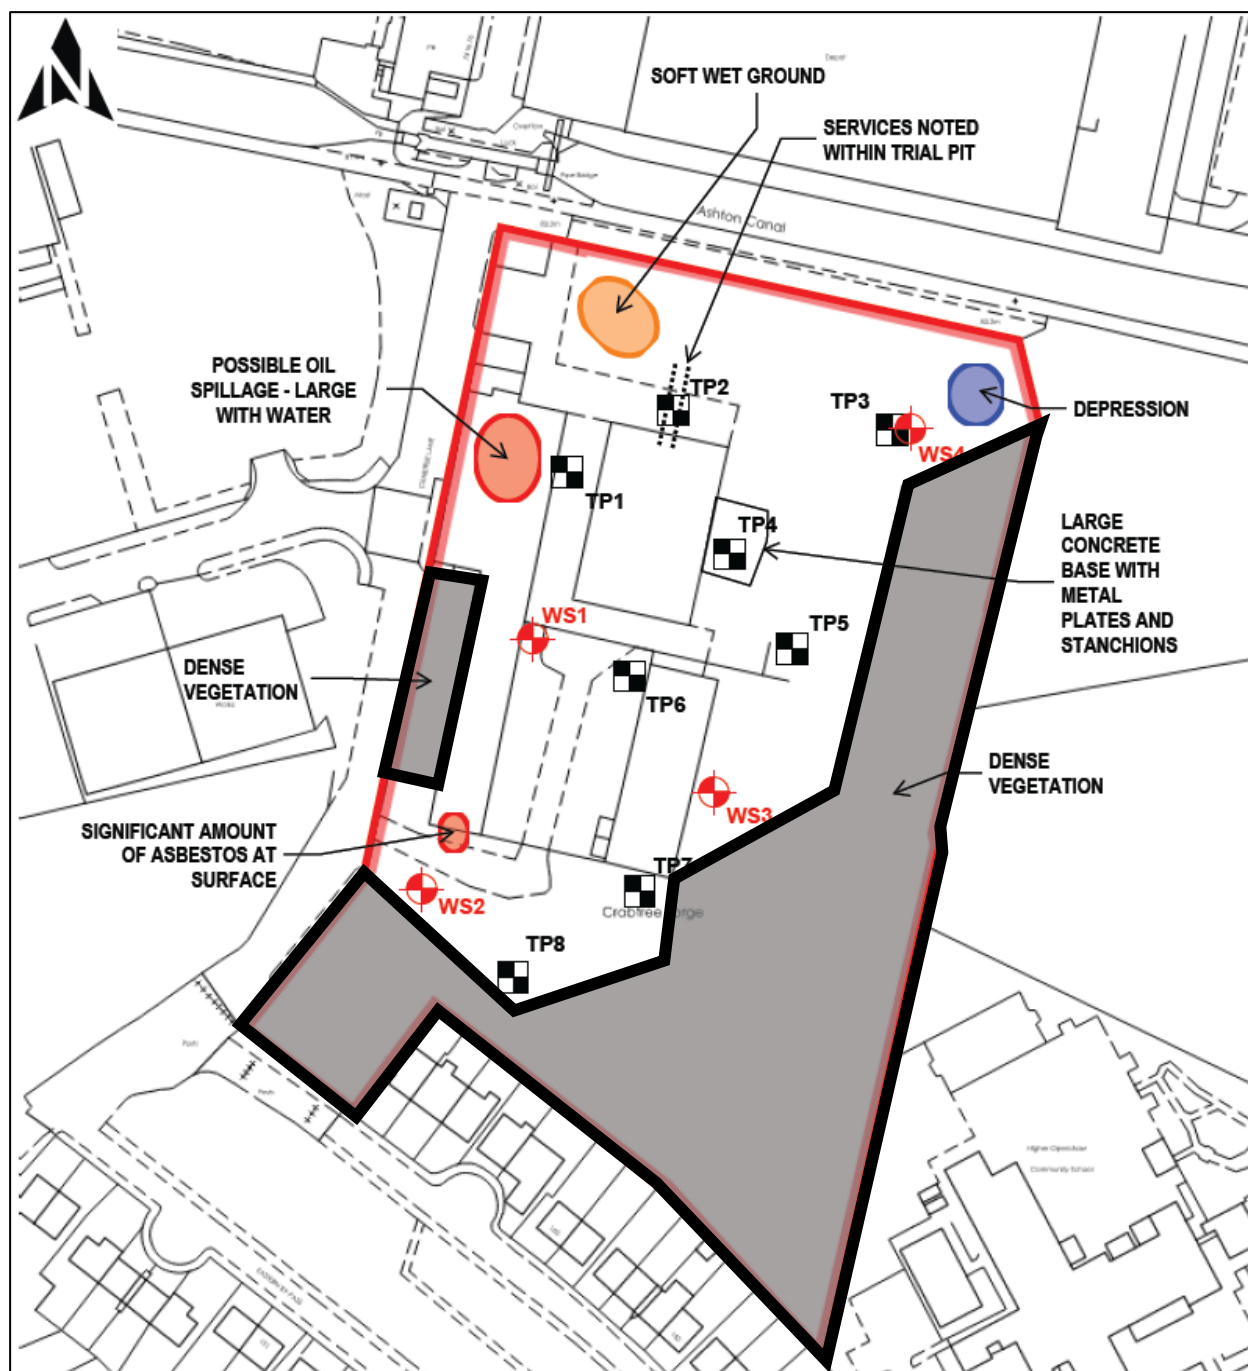
As shown on the sketch below, some areas were not accessible due to dense vegetation.

| Target (Receptor) | Potential Source-Pathway Linkage | Remedial Action Required (where appropriate) | Est. Degree of Risk to Target Following Remedial Action Where Necessary |
|---|---|---|---|
| Site End Users | Inhalation of soil gases, odours or dust. | Amber 1/CS2 ground gas protection is recommended across site. Additional ground gas monitoring is required in the areas that could not be accessed due to dense vegetation/existing buildings (post demo) during the initial investigation. | Low |

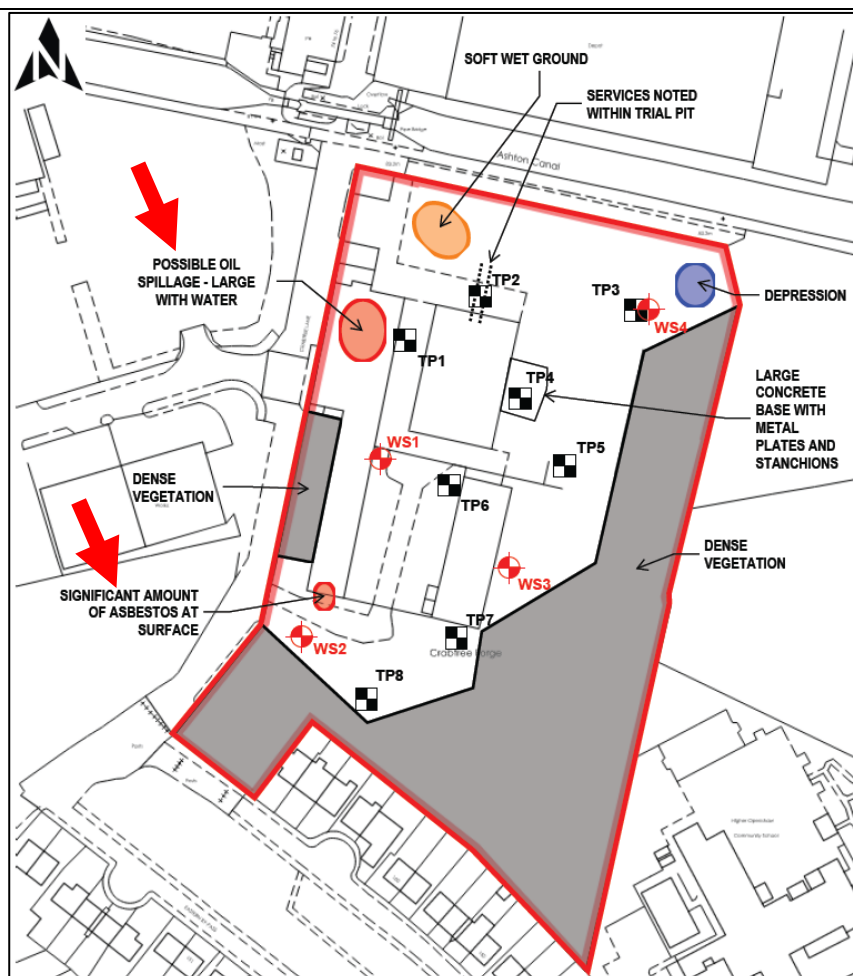
Surface contamination was noted in the locations below;

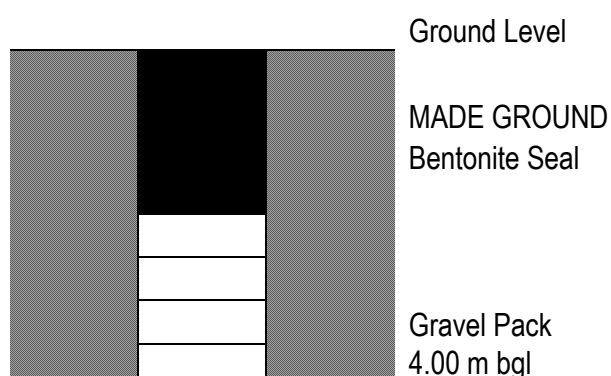
Three (3 No.) window sample boreholes were all installed to depths between 3.00mbgl and 4.00mbgl into both Made Ground. An example installation is shown below;
