**Ground Investigation Report**

**Crabtree Lane, Openshaw**

**REPORT NO: 21CHE276/DSGI**

**Document:** Desk Study and Initial Ground Investigation Report

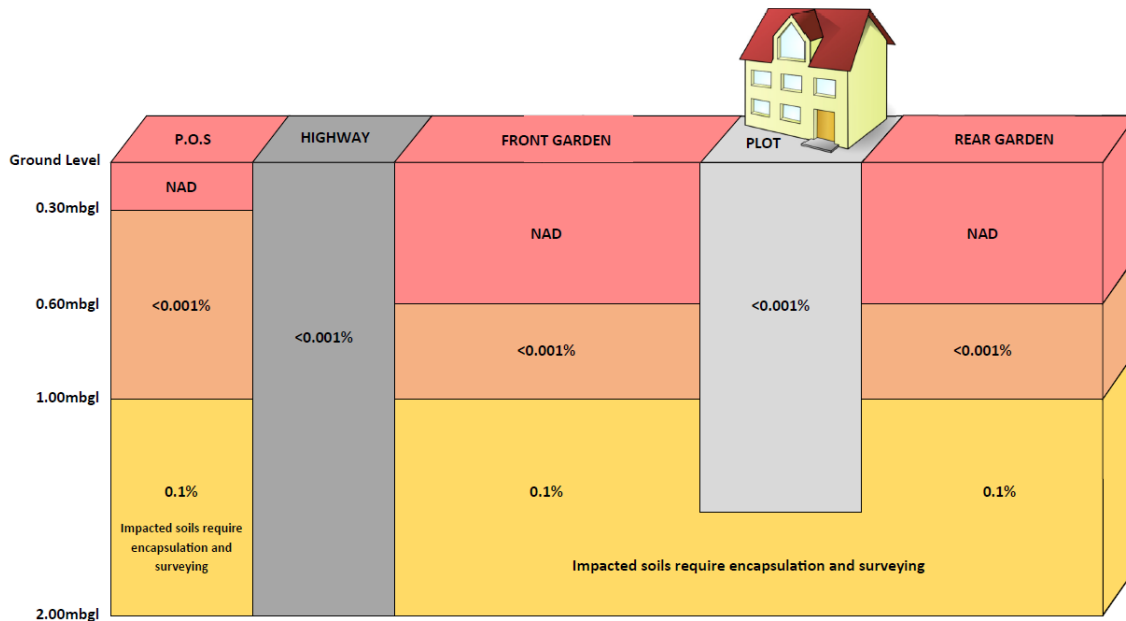
Below is a sketch showing levels of asbestos concentrations and locations where they are commonly accepted / unacceptable. This should be confirmed with the Local Authority prior to implementation, and should therefore only be used as a guide;
