# EXTENDED PHASE 1 HABITAT SURVEY & DAYTIME BAT SURVEY

YEW TREE MANOR CARE HOME,  
NORTHERN MOOR, WYTHENSHAW,  
GREATER MANCHESTER

APRIL 2022

**RACHEL  
HACKING  
ECOLOGY**

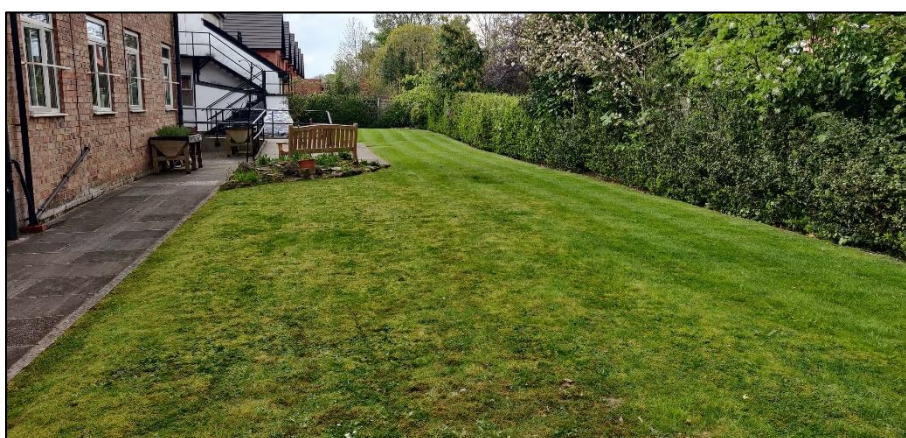
- 3.2 Amenity grassland occurs to the front and rear of the care home (see Photograph 1). The grassland is managed by mowing and is species-poor, including mainly Perennial Rye-grass *Lolium perenne*, Annual Meadow-grass *Poa annua*, Selfheal *Prunella vulgaris*, Creeping Buttercup *Ranunculus repens*, Red Fescue *Festuca rubra*, Daisy *Bellis perennis* and bryophytes.

Photograph 1 showing the amenity grassland at the rear of the site

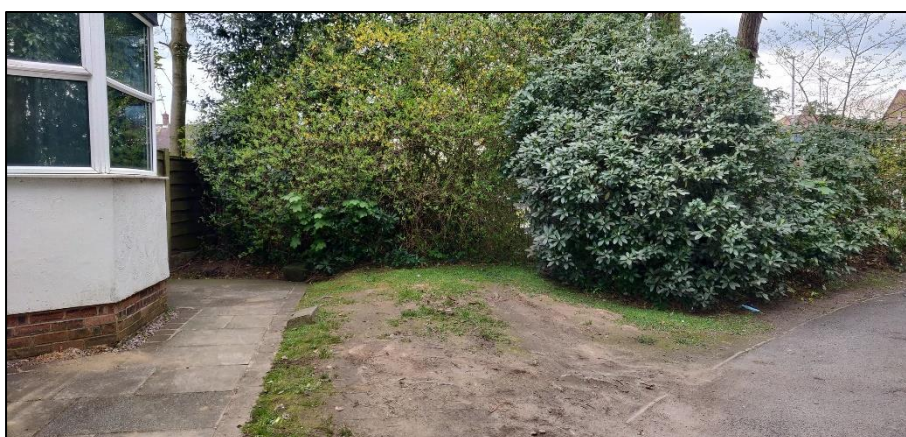
- 3.3 Mature shrub beds occur on site, mostly at the front of the site (see Photograph 2). These are planted with garden varieties such as Rhododendron *Rhododendron ponticum*, Wall Cotoneaster *Cotoneaster horizontalis*, Snowberry *Symphoricarpos albus*, Forsythia, Firethorn *Pyracantha* var. and Cherry Laurel *Prunus laurocerasus*.

Photograph 2 showing one of the shrub beds

- 4.8 Wall Cotoneaster and Rhododendron were found within the shrub beds on site. These are invasive, non-native species. It is expected that these plants will be removed during site clearance as all shrub beds are to be removed. Eradication must be undertaken carefully.

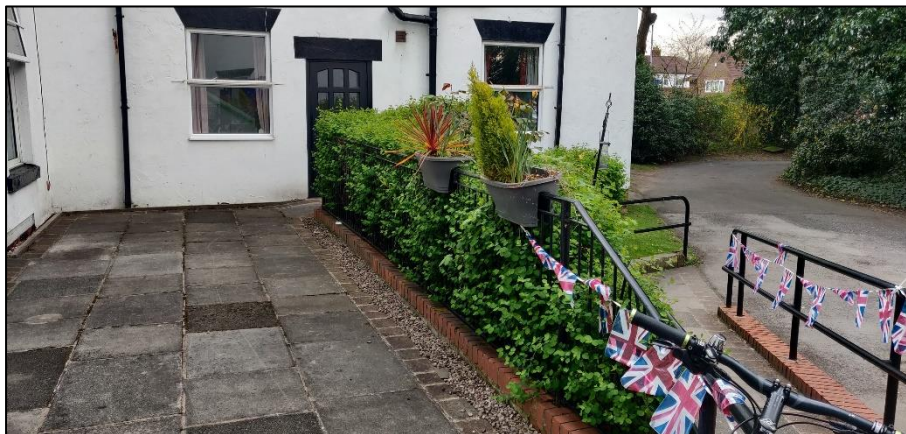
- 3.4 Bare ground exists around the building as paths and patios, as well as the access driveway and parking areas (see Photograph 3). The bare ground comprises hardstanding or flags.

Photograph 3 showing some of the bare ground

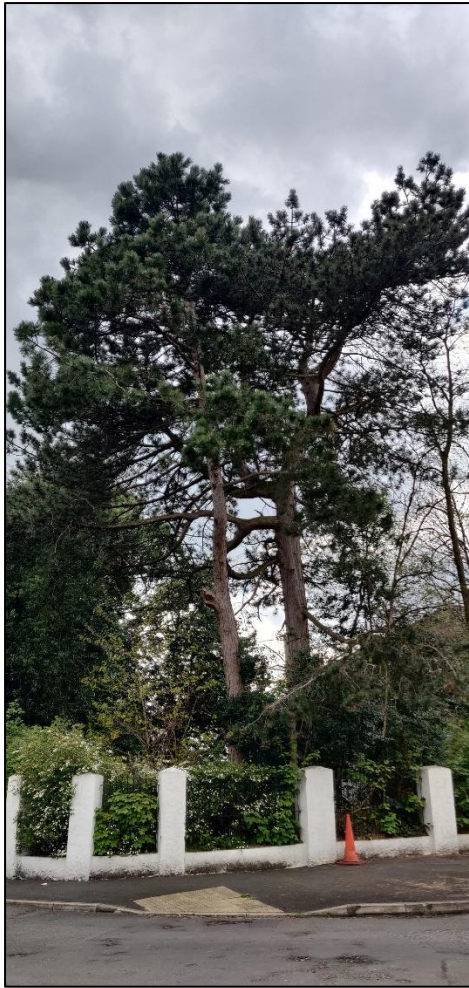
- 3.6 A number of trees, both mature and semi-mature, exist on site (see Photographs 4 and 5). These are Sycamore *Acer pseudoplatanus*, Scot's Pine *Pinus sylvestris*, Silver Birch *Betula pendula* and Cherry *Prunus* var.

Photograph 5 showing some of the trees

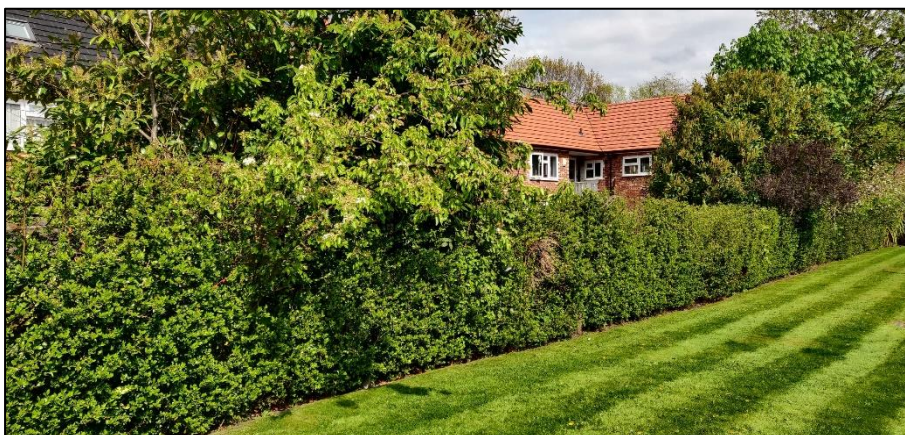
- 3.7 The majority of the boundaries comprise walls or fencing. A species-poor intact hedgerow exists along the northern boundary (see Photograph 6). Species include Garden Privet *Ligustrum ovalifolium* and Cherry Laurel *Prunus laurocerasus*.

Photograph 6 showing the hedgerow

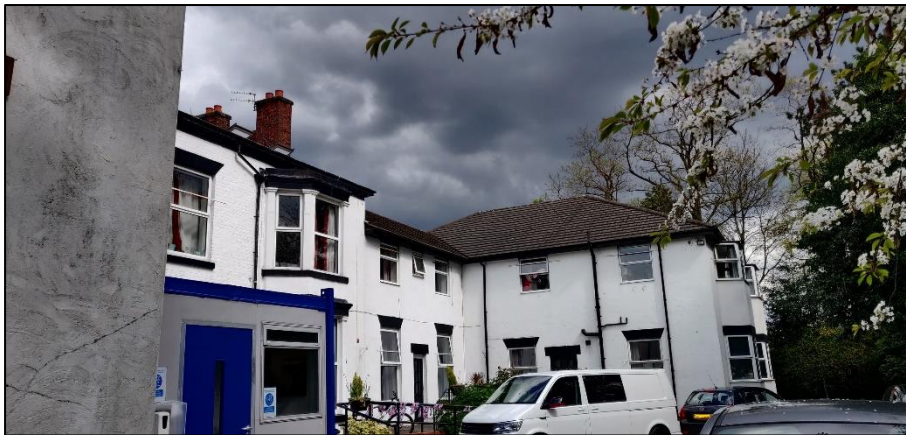
- 3.11 One large two-storey detached building exists on site and this is proposed to be demolished. The building is of brick construction with pitched tiled roofs (see Photographs 7 and 8). The central section is the oldest part of the building, with two newer extensions added to each side. The front elevation is rendered and painted. The render and exposed brickwork are in good material condition, with no missing bricks, mortar or render. The stone window lintels and uPVC window frames are in good condition. The windows and doors throughout are intact.

Photograph 7 showing the front exterior of the building

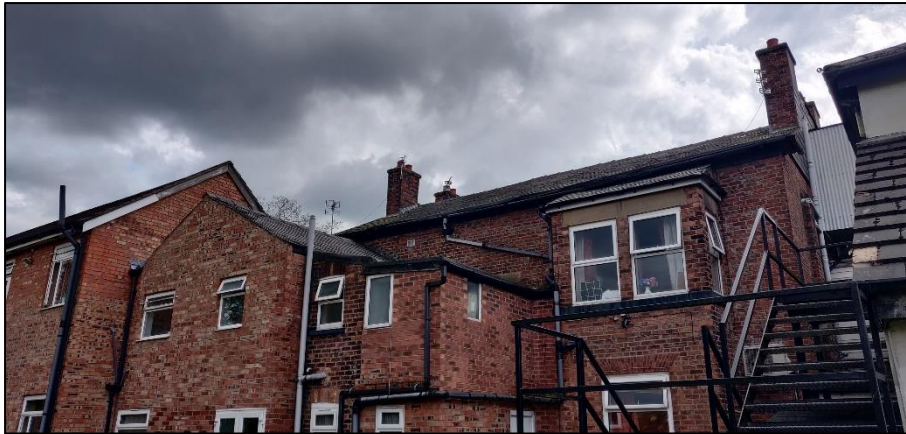
*Photograph 8 showing the rear elevation of the building*

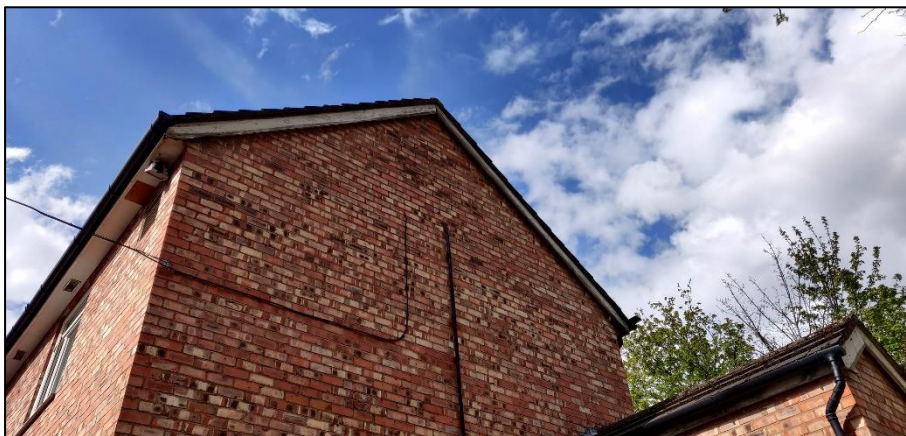
- 3.12 The brickwork at the newer gable ends of the building is in excellent condition (see Photograph 9). The soffits and bargeboards are mostly in excellent condition and flush to the brickwork (see Photograph 10). Small parts of the corners of the bargeboards have weathered.

*Photograph 9 showing one of the gables and bargeboards*

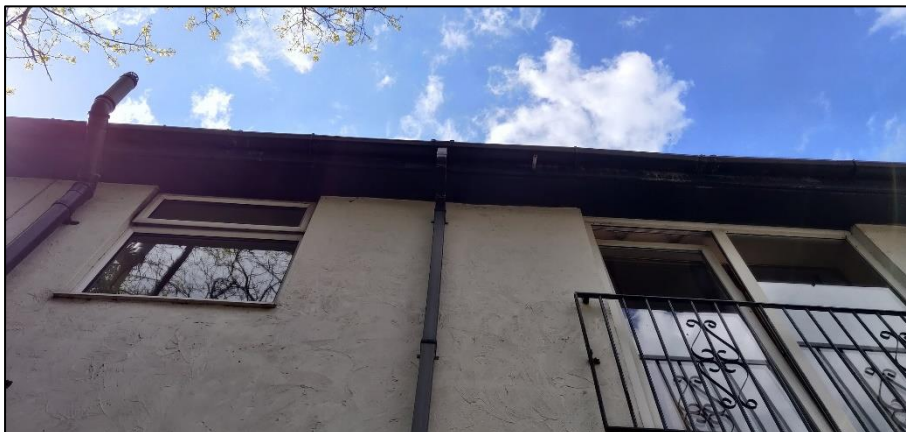
*Photograph 10 showing the soffits*

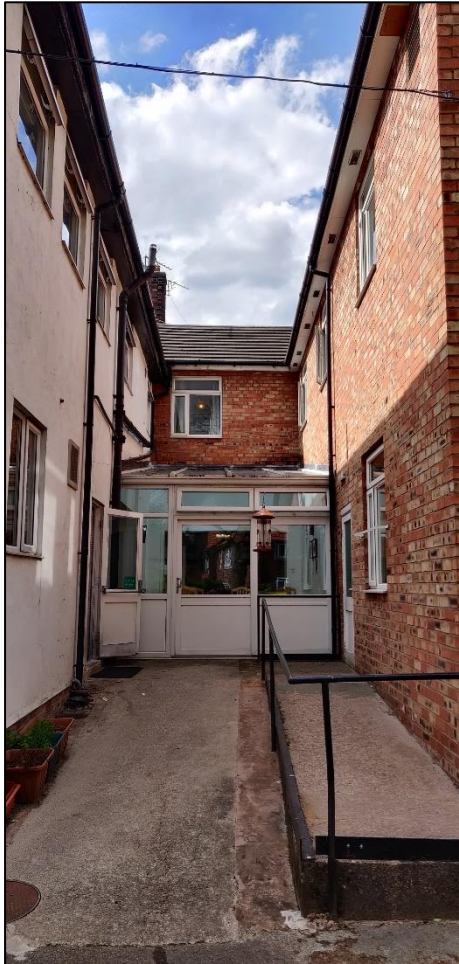
- 3.13 The building has multiple pitched roofs, with slate tiles and composite tiles in use (see Photographs 7, 8 and 11). Most roof tiles appear to be intact although not all the roof was easily visible from the exterior. A small number of slate tiles have slipped. Where small single-storey extensions exist, these roofs are intact. No evidence of bat activity was found externally. Very limited potential bat entry points were found.

*Photograph 11 showing part of the roof of the building*

- 4.5 The building on site has been the subject of a daytime bat survey. No evidence of bat activity was located within any of the accessible loft voids. However, a very small number of potential bat entry points do exist on the external features as well as some slipped slate roof tiles. Part of the older loft voids were inaccessible. Therefore, the building is considered to offer low suitability for a bat roost and a single precautionary bat emergence survey should be undertaken. The trees on site offer no potential bat roosting features. The trees are considered to offer negligible suitability for a bat roost. Only the northern hedgerow on site offers suitable bat foraging and commuting habitat and this is to be retained. This should be maintained as a dark wildlife corridor.

- **Bats** – It is recommended that a precautionary single bat emergence survey at dusk is undertaken, concentrating on the potential entry points and slipped tiles. This must be undertaken between May and September, in suitable weather conditions and with enough surveyors to observe the different features of the building.

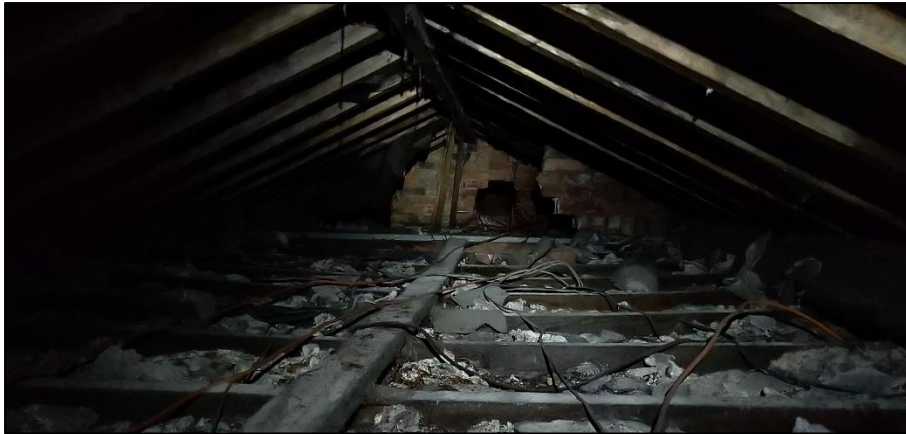
- 3.14 Internally, the ground floor and first floor rooms are in use and do not offer suitable bat roosting habitat. The oldest central part of the building has four small loft voids, which were mostly accessible, although some areas could not be reached due to the amount of storage material and brick dividing walls (see Photographs 12 and 13). Within these voids, the roof timbers are intact with no gaps or cavities. The roof is lined with felt and this supports tears. Daylight could be seen where pipes enter through broken brickwork. The voids are extremely dusty and covered with thick cobwebs. No evidence of bat activity was found within these voids. A number of rodent droppings were found within these voids.

*Photograph 12 showing one of the loft voids*

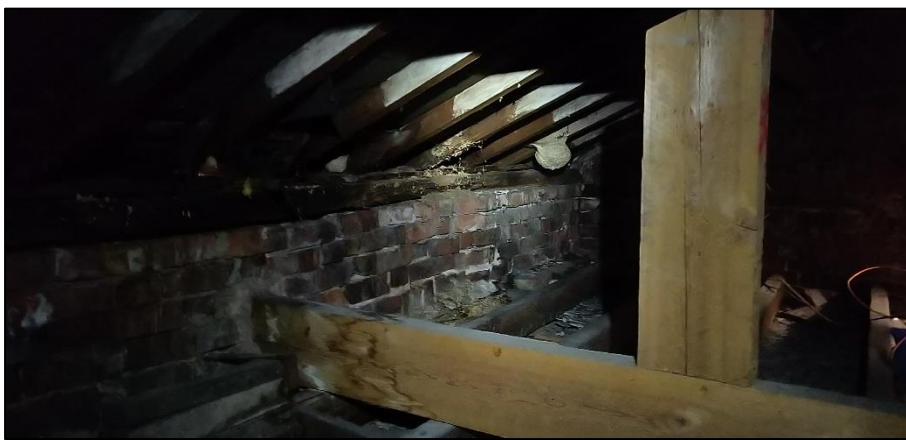
*Photograph 13 showing the timbers within one of the voids*

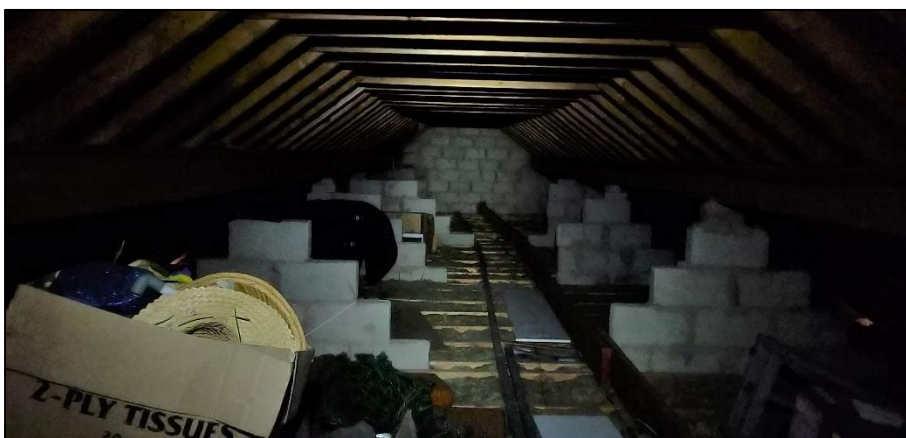
- 3.15 The newer extensions support loft voids and all were accessible and very similar in construction. The felt roofing liner is intact throughout. The roof timbers are new and support no cavities. The voids are insulated. Daylight could be seen from around vents. A large number of rodent droppings were found within these voids. No evidence of bat activity was found.

*Photograph 14 showing one of the loft voids within the extensions*

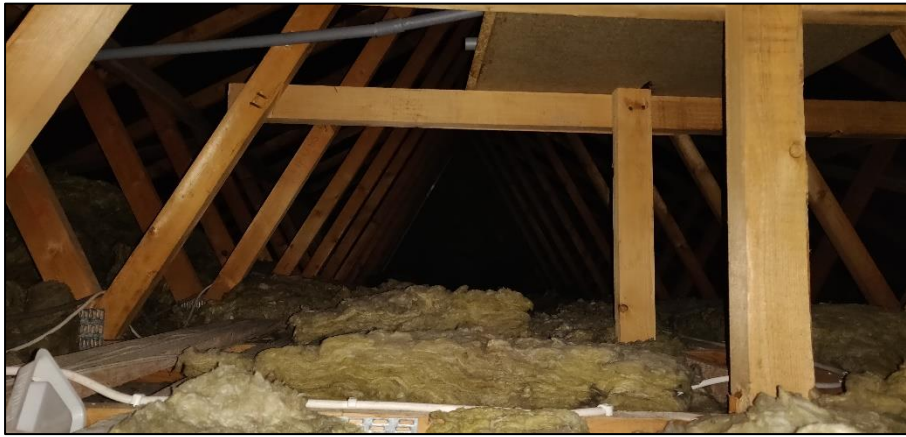
*Photograph 15 showing one of the newer loft voids and timbers*

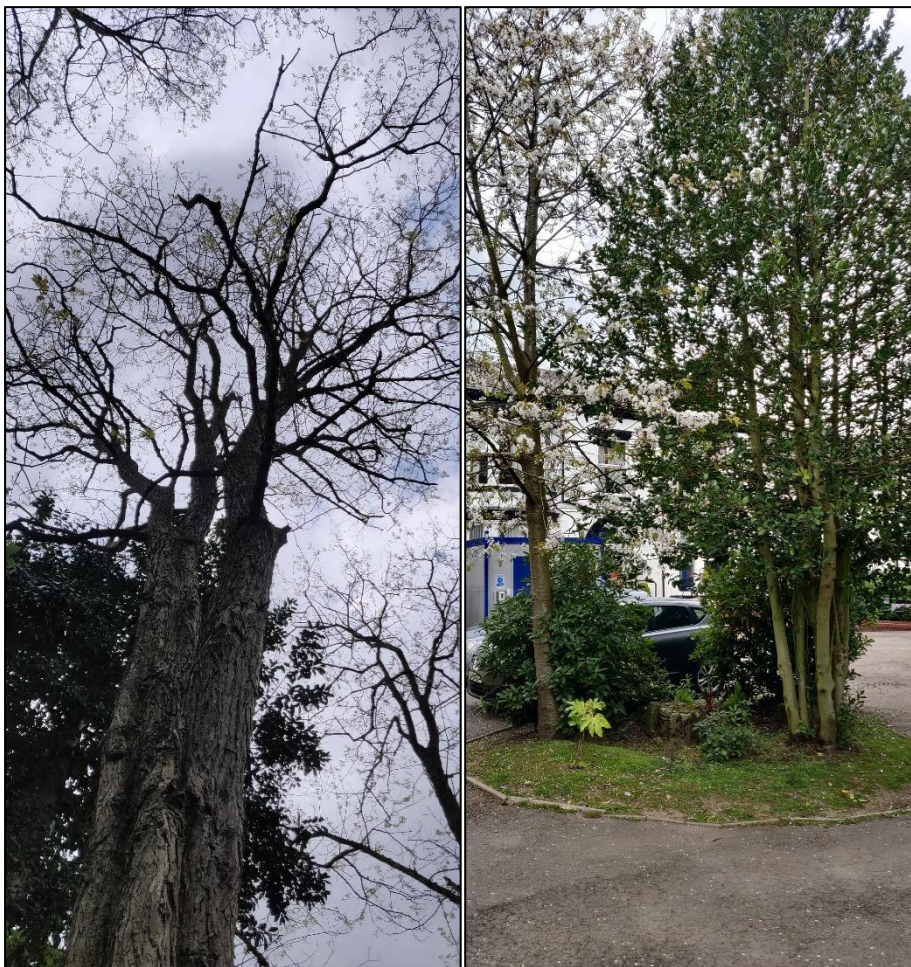
- 3.16 The trees were all searched for potential bat roosting features (PRFs) such as cavities and limb damage (see Photographs 16 and 17). None of the trees support PRFs. Any loose bark was endoscoped and no evidence of bat usage found.

*Photographs 16 and 17 showing some of the trees*

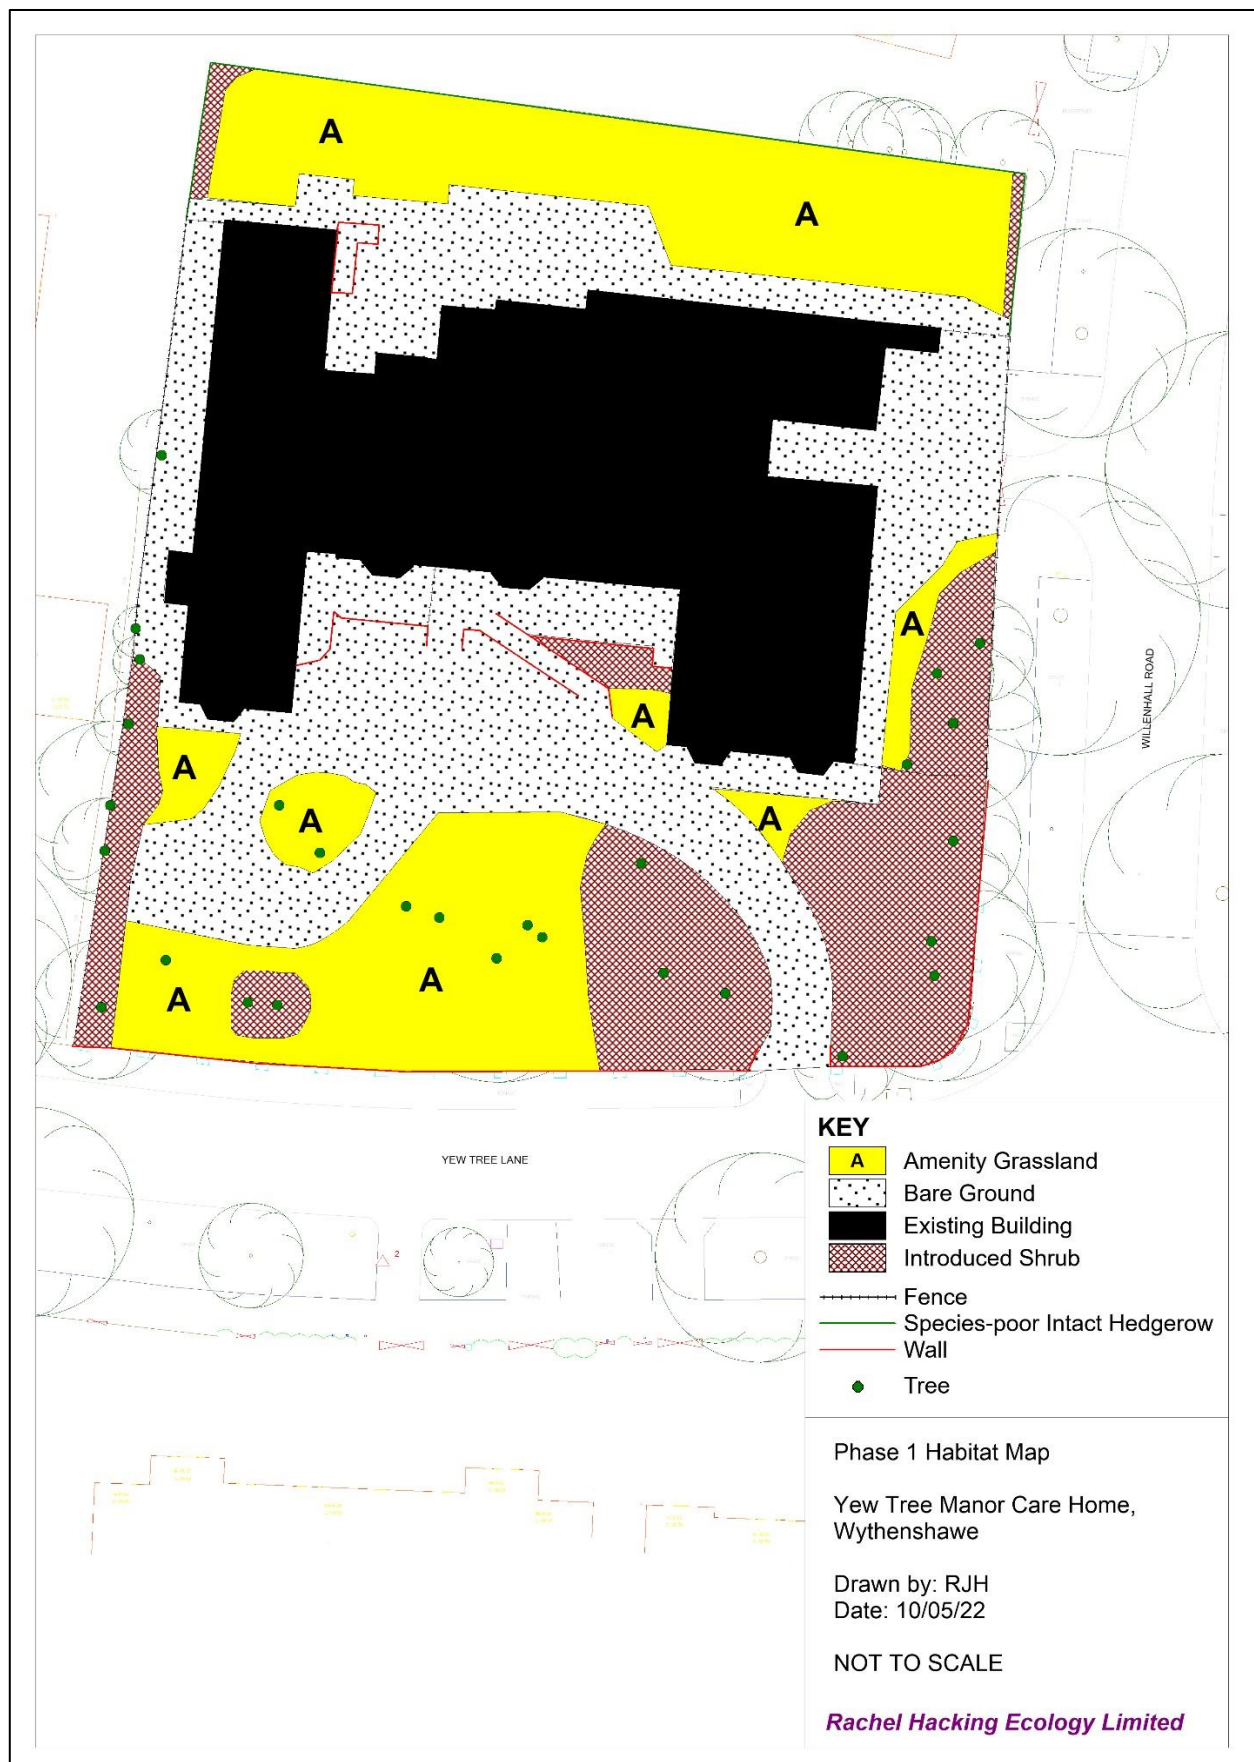
## APPENDIX A – PHASE 1 HABITAT MAP

- 3.1 The Phase 1 Habitat Map can be found at the back of the report. The habitats on the proposed development site are described below.
